INVESTIGATION OF DAM FAILURES

Samar Chatterjee

Submitted in partial fulfillment of  
the requirements for the degree of  
Master of Applied Science

December 1970

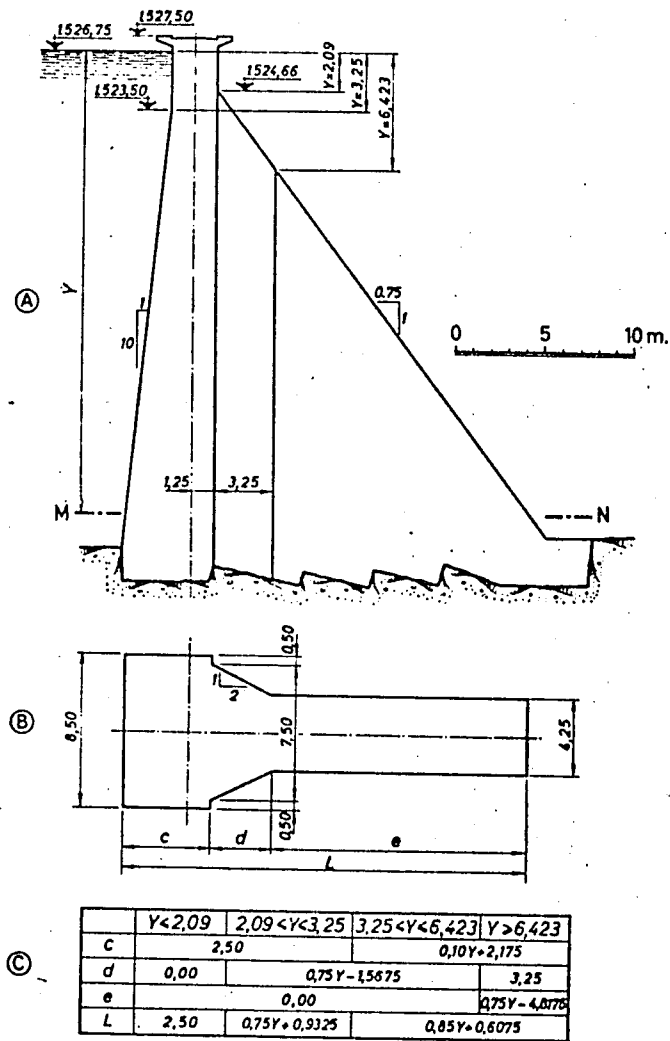
FIG. III (A) LATERAL ELEVATION (B) PLAN AND (C) DIMENSIONS OF THE VEG DE TE RA DAM MODEL TESTED AFTER THE FAILURE.  
Source: Guitart (Ref. 16).

Obviously, the distribution of stresses within the buttresses were affected by the different buttress heights as a result of varying foundation level. Hence, the designers of the Veg de Te ra dam were completely unaware of the actual stresses. Evidently, defective

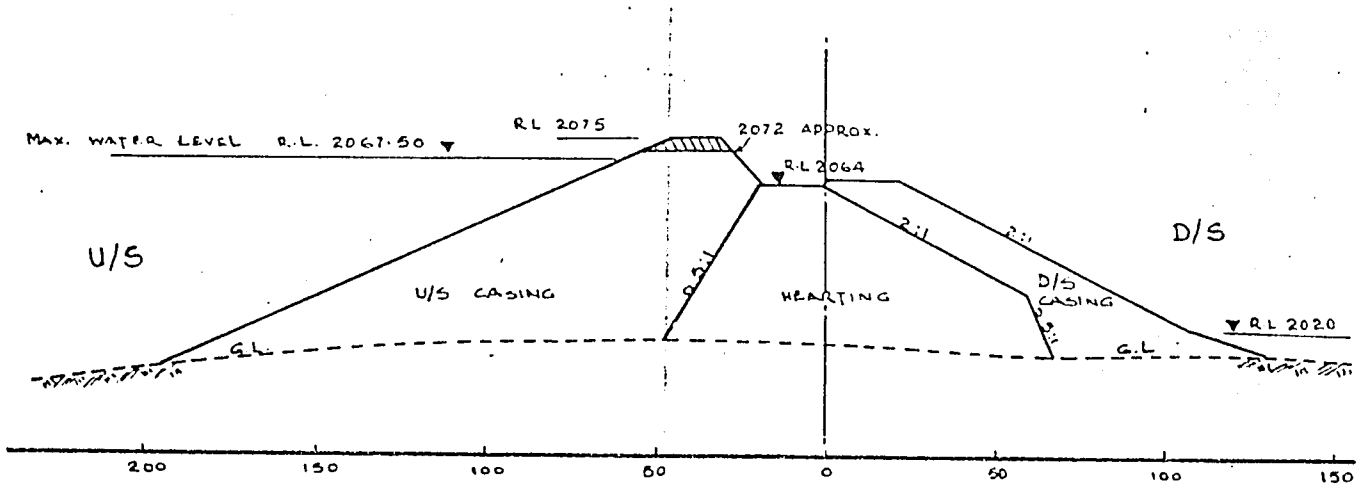
FIG. IV TRANSECTION OF THE PANSHET DAM OVER THE OUTLET CULVERT.

- Note: (i) The measurements are recorded in feet.
- (ii) Subsidence first occurred under the latched portion of the upstream casing.
- (iii) Details of portion below ground level is not shown. An outlet culvert with upstream gate passes beneath this section.

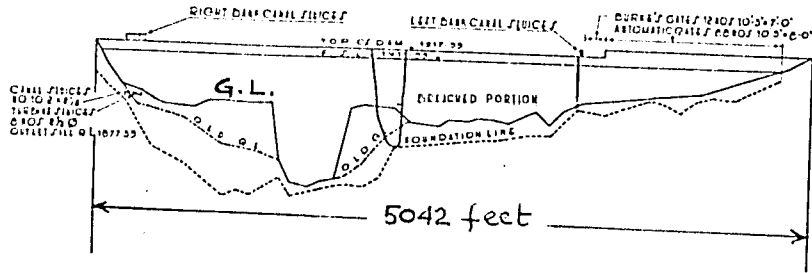
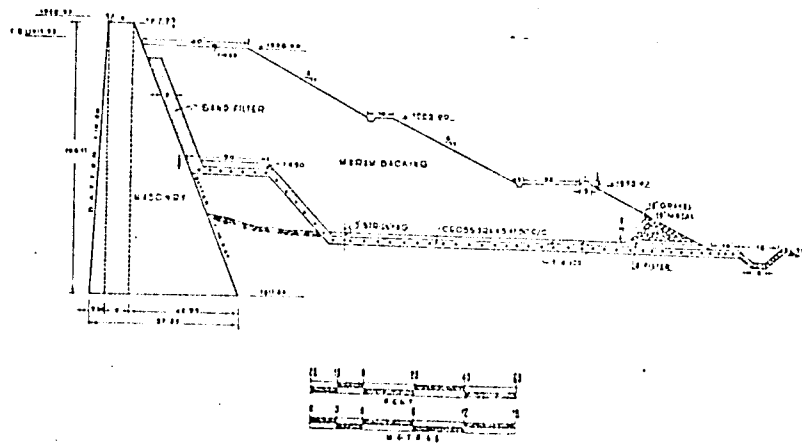
FIG. V KHADAKWASLA DAM BREACHING. SOURCE: MURTI (REF. 20)

A two-dimensional stability analysis was carried out to determine the causes of failure after the mishap. The results are quite revealing. The maximum tension at the upstream heel of the deepest section of the dam, with full reservoir level and uplift, was found to be 56.0 p.s.i., and such conditions existed for about three months every year. With 9 ft. of water over the top of the dam, the calculated tension was found as 105 p.s.i. But, still the failure did not occur at the deepest section, even though the dam was subjected to a stress of 75% of the ultimate tensile strength of the masonry for a few hours. Under the same conditions of overtopping, the horizontal forces were found to be 1.1 times the total vertical forces, and the resultant force fell outside the base by 5 ft. (beyond the toe) for 3 to 4 hours. Still, it is surprising to note that the dam neither failed by sliding nor by overturning. The downstream backfill was scoured away by the overflowing water.

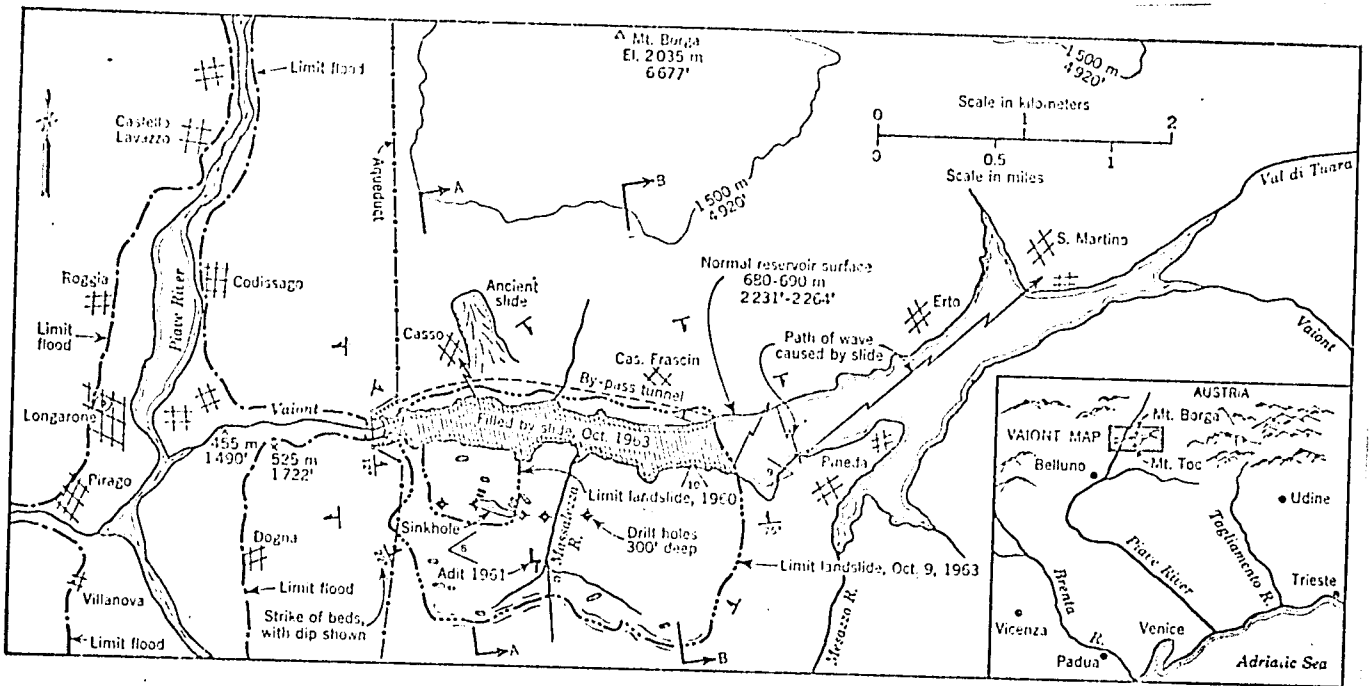
FIG. VII THE COMPLETED VAIONT DAM SHOWN ON THE RIGHT AND THE LIMITS OF SLIDE AND DESTRUCTIVE FLOOD WAVES SHOWN IN THE BOTTOM MAP.  
SOURCE: Kiersch (Ref. 23).

On the night of October 9, 1963, the Vaiont dam, was overtopped by a 330-ft. flood wave which inflicted a loss of 3000 lives, the heaviest loss due to a dam failure ever known to history. The flood was caused by an unprecedented landslide, having an appropriate volume of 350 million cu. yds., which filled up 1.25 miles of the reservoir with slide materials up to a height of 575 ft. above the reservoir level. The dam can no longer be used for generation of hydro power as the cost of clearing the reservoir seems to be rather prohibitive. A by-pass tunnel under the right bank of the reservoir allows the water behind the "slide-dam" to be drained out into the river.
