# **Repair and Retrofit of Non-Ductile Reinforced Concrete Frames with Diagonal Steel Compression Struts**

**By  
Frédéric Caron**

Thesis submitted to the  
Faculty of Graduate and Postdoctoral Studies  
in partial fulfillment of the requirements  
for the degree Master of Applied Science in  
Civil Engineering

**Department of Civil Engineering  
Faculty of Engineering  
The University of Ottawa**

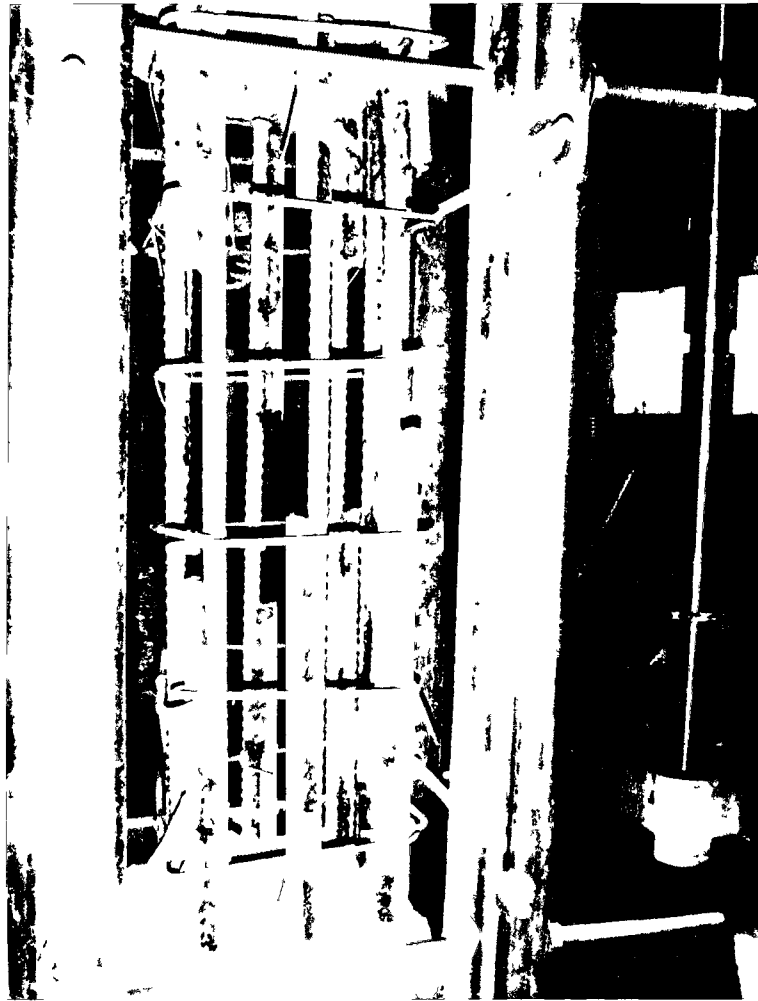
*Figure 3.15: Newly installed longitudinal reinforcement and transverse ties in Frame BR-3R*

After aligning the frame, new transverse ties were added in the column. The ties, 6.35 mm in diameter, were inserted through the openings of the cut longitudinal reinforcement and placed at the bottom of the opening. New pieces of longitudinal bars, consisting of No. 15 M (similar to the existing reinforcement), were welded to the remaining reinforcement to replace the portions of the reinforcement that had buckled. The ties were then spaced at 125 mm and tied to the longitudinal reinforcement as shown in Figure 3.15.

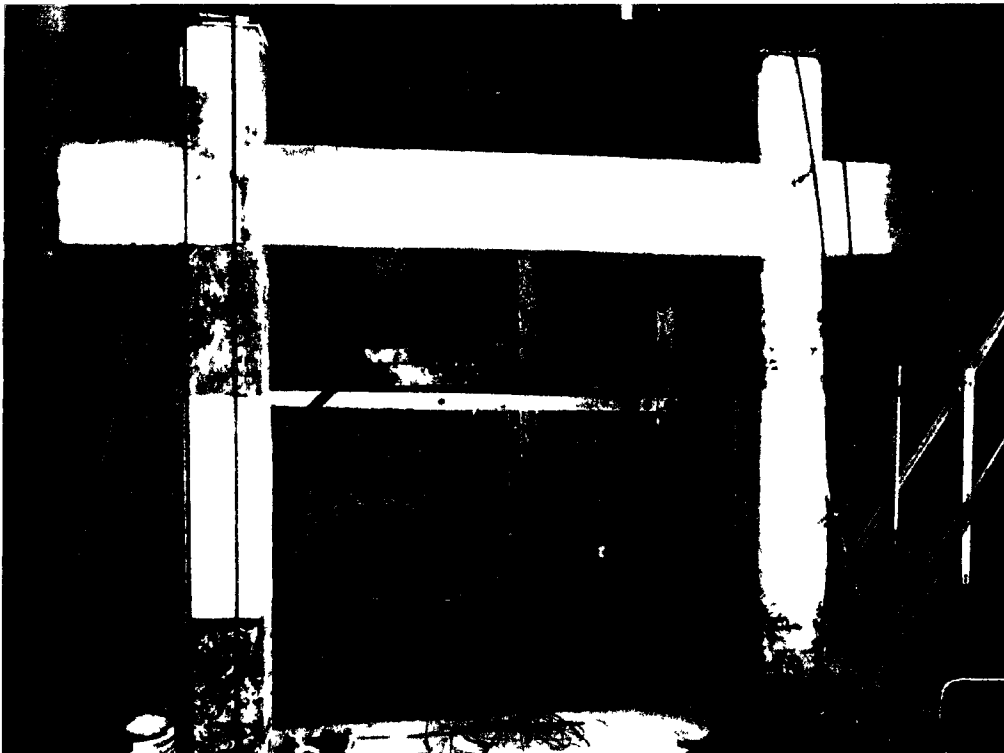
*Figure 3.20: Fully repaired frame BR-3R*

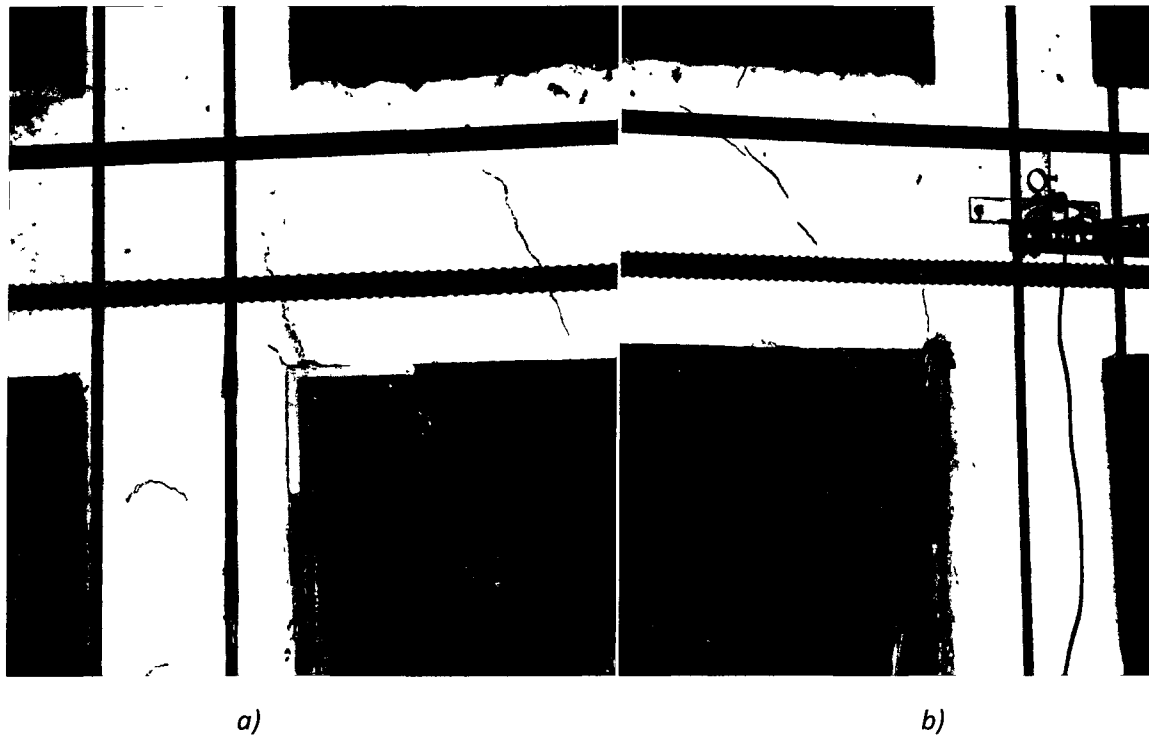
Figure 4.37: Small cracks in the corners of BL-3R (0.20% lateral drift): a) Top left corner; b) Top right corner

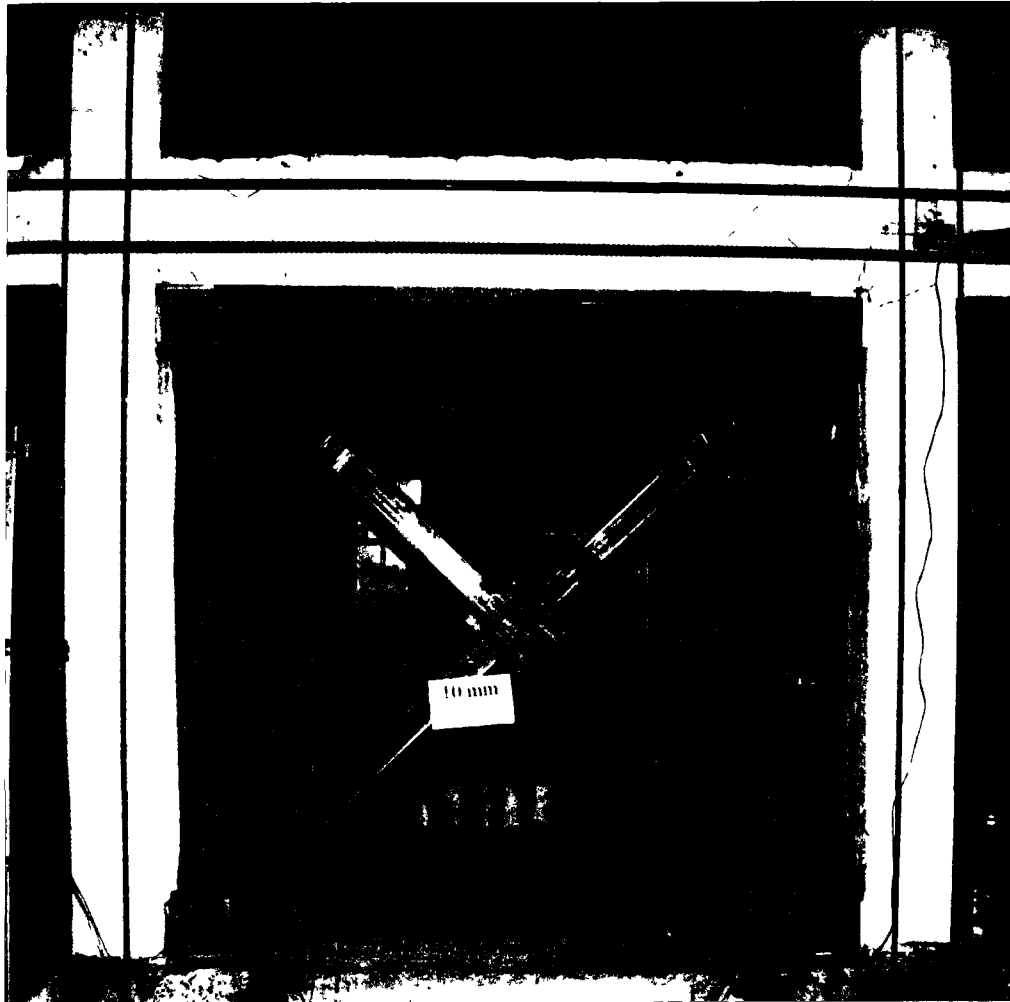
*Figure 4.44: Cracking in Frame BL-3R (0.5% lateral drift)*

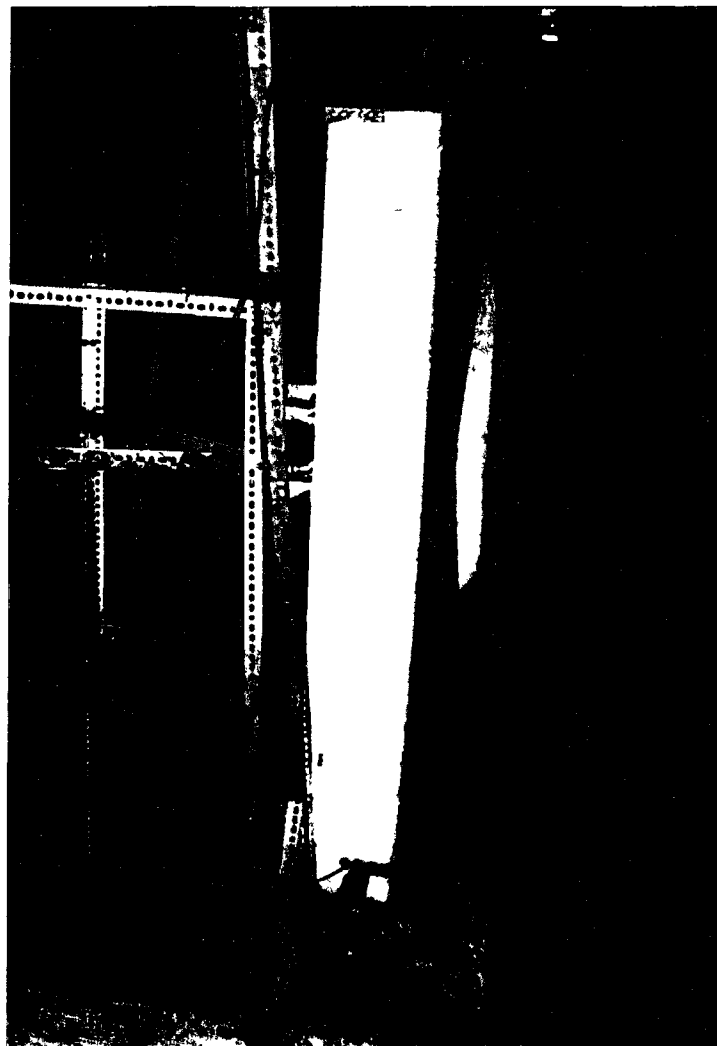
*Figure 4.47: Re-opening of flexural cracks in column of BL-3R (0.5% lateral drift)*

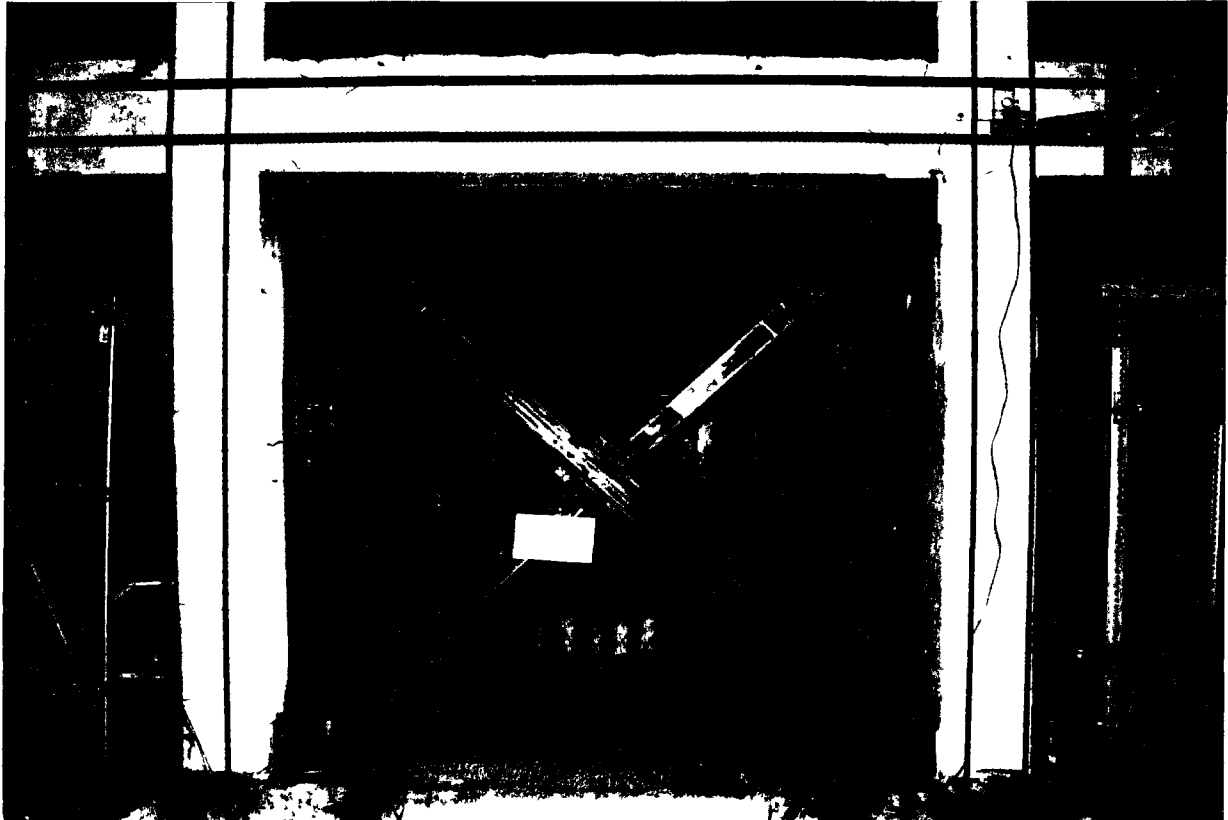
Following the tenth load cycle to 0.55% lateral drift (11 mm), the cracks were still slightly less than 1 mm wide and are shown in Figure 4.48. A small portion of concrete spalled off in one of the corners of the frames. Many of the pre-existing cracks reopened in the columns (Figure 4.49). In the negative direction, the peak load was -324.1 kN, the out-of-plane displacement was 0.76 mm, the column base anchorage slip measured 1.27 mm, the vertical displacement of the column was 0.48 mm, the strain in Gauge X3 measured  $-328 \mu\epsilon$ , and the strain in Gauge X6 measured  $-765 \mu\epsilon$ .

*Figure 4.48: Cracking in Frame BL-3R (0.55% later drift)*

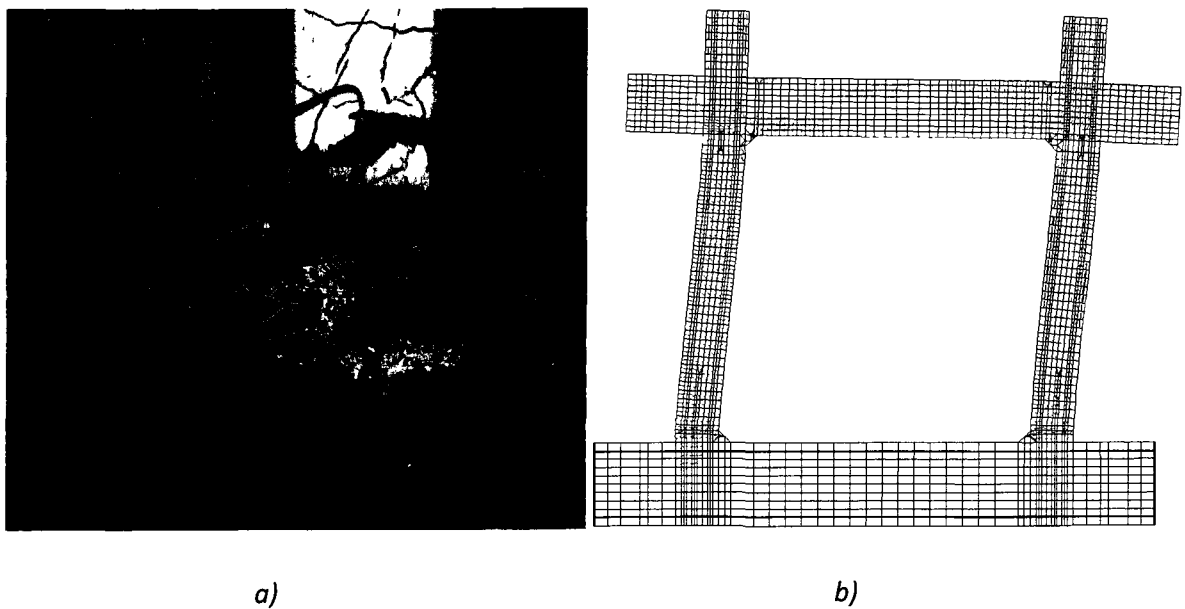
Figure 6.12: Failure Condition of Frame BL-3R: a) Experimental Observations; b) Finite Element Model
