A STUDY OF PERMAFROST TERRAIN DISTURBANCES,  
ARCTIC CANADA

by Lynne Dwyer

2  
Thesis presented to the School of Graduate Studies  
in partial fulfillment of the requirements for the  
degree of Master of Arts in Geography.

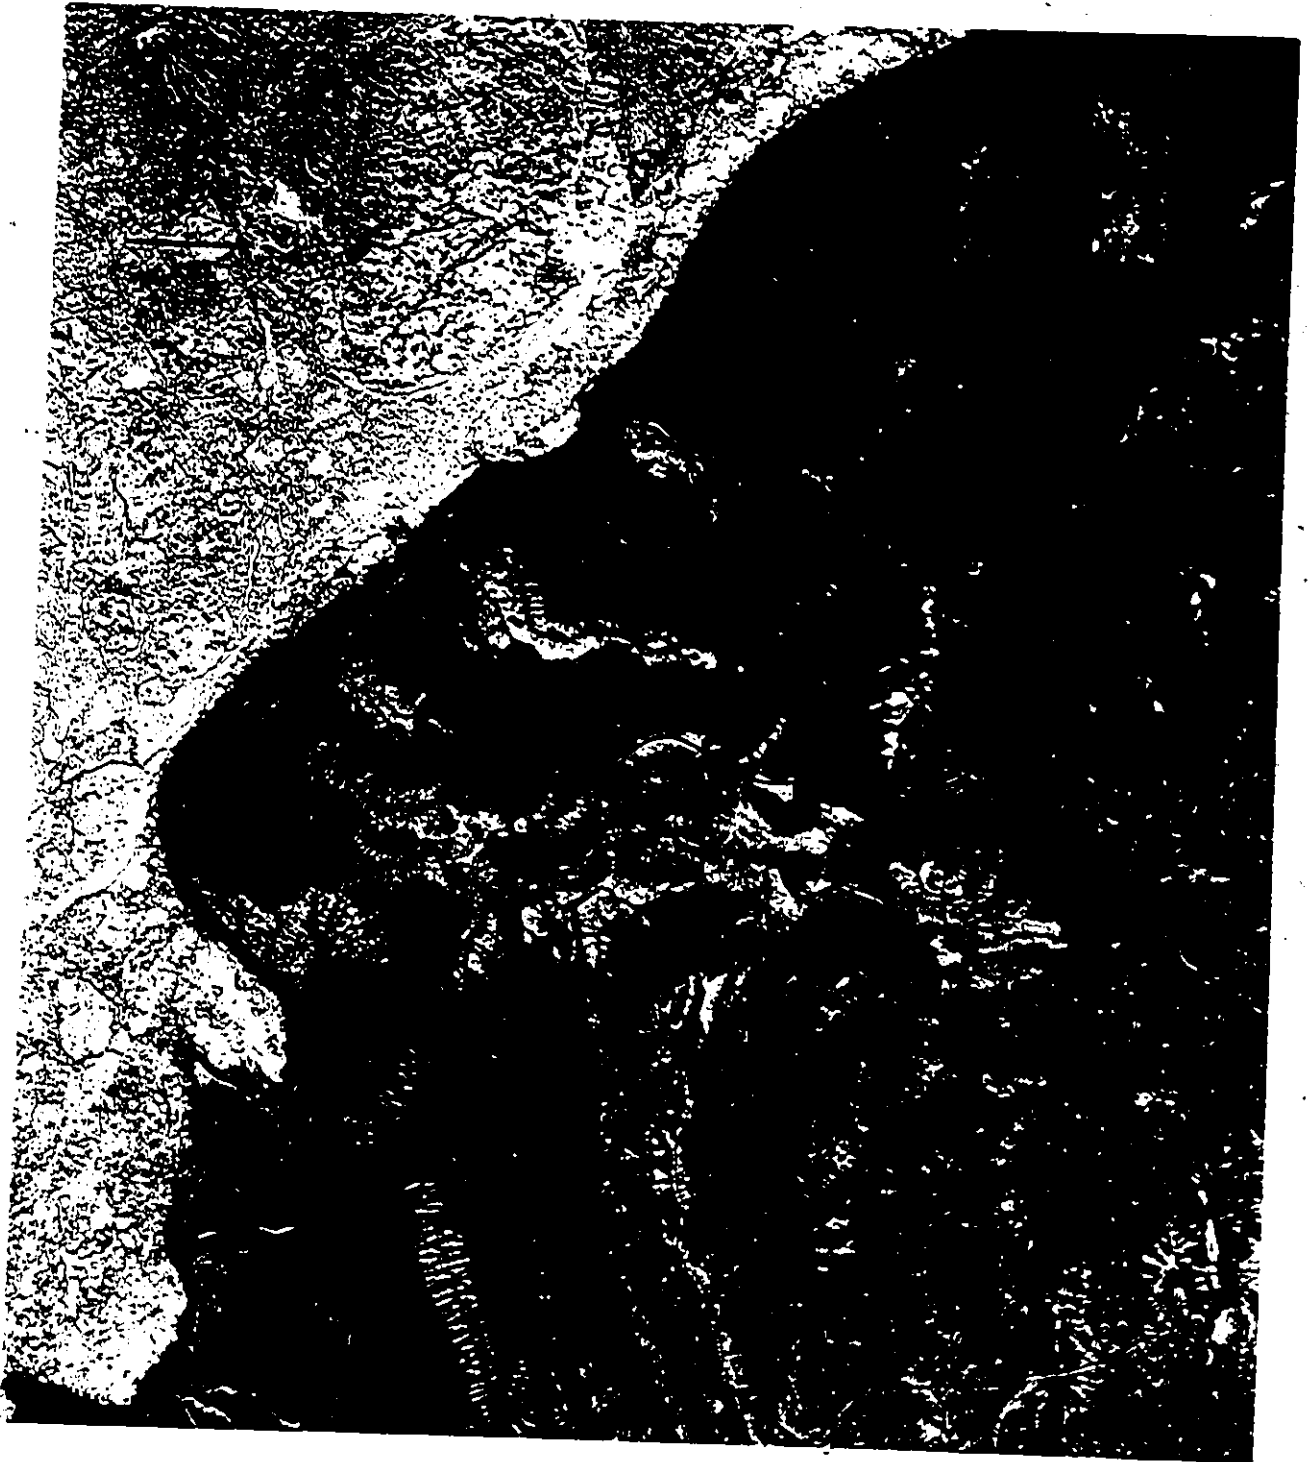
Figure 6. Air photo of Dome Wallis A-73 area, showing wellsite location and major terrain features (NAPL A16751-178).

The Dome Wallis A-73 well is located on the north-western corner of the island, within 0.5 km of the coast, at an elevation of 5.4 m above sea level. The site is a shallow interfluvium between two northwest-southeast flowing rivers (figure 6).

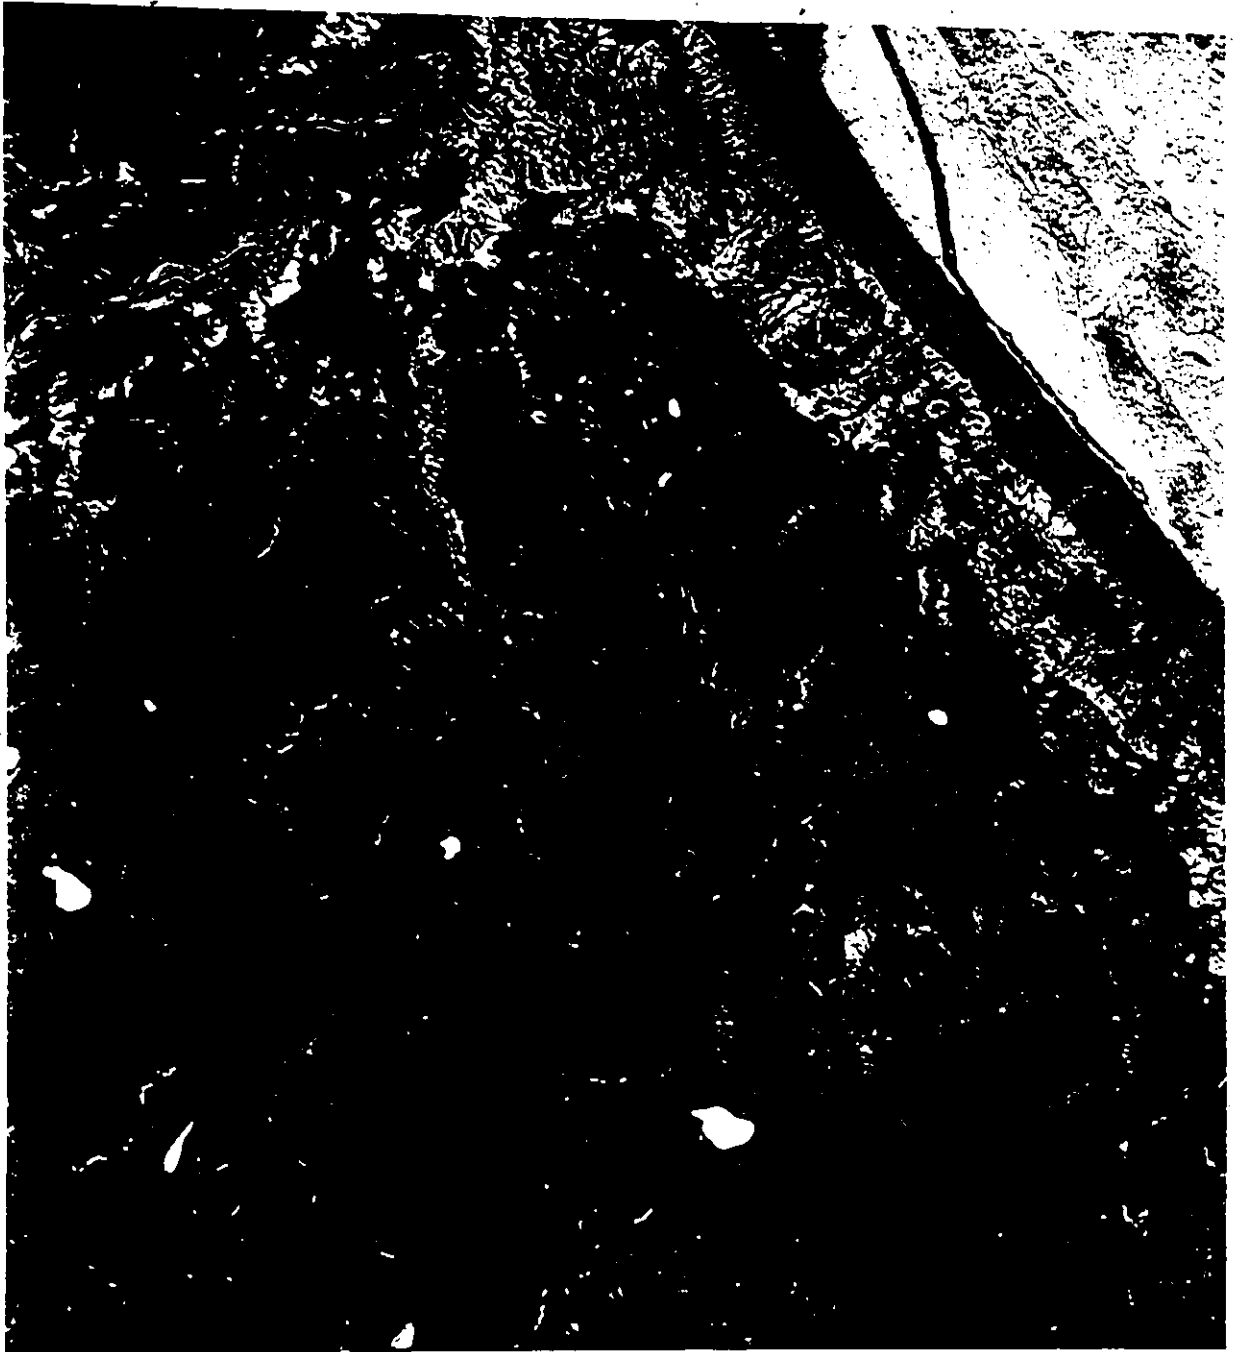
Figure 10. Air photo of part of northeast Banks Island showing the location of the Chevron Parker River J-72 wellsite (NAPL A 17683-5).

The Chevron Parker River J-72 wellsite is located approximately 15 km inland from Passage Point (figure 10). The site is gently inclined towards the northwest and is drained by two small creeks.

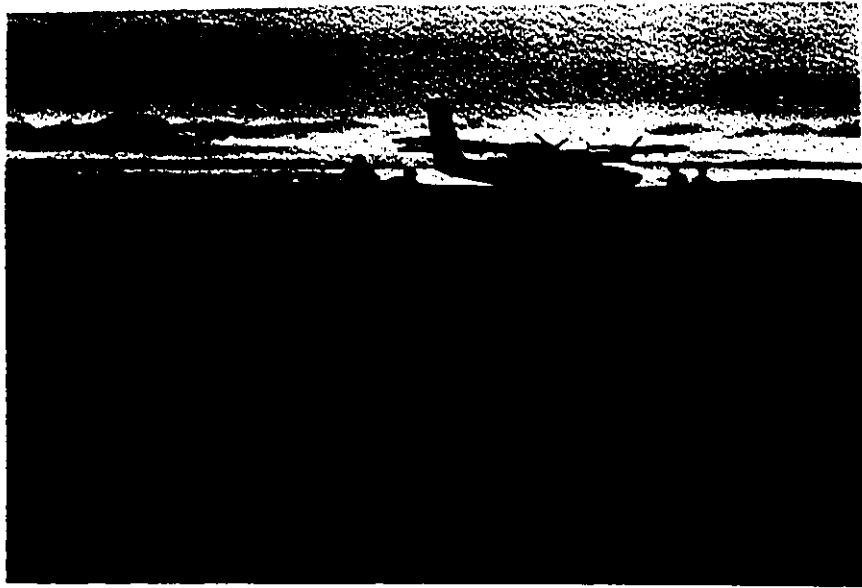
Figure 28. Typical felsenmeer surface adjacent to the Stokes Range wellsite, northern Bathurst Island, July 27, 1980.

Compared with other sites visited during the summer of 1980, the Dome Wallis site possesses a high sensitivity to disturbance. For example, at the Stokes Range wellsite on northern Bathurst Island, the underlying bedrock is a consolidated sandstone, there is little ground ice, and vegetation is virtually non-existent. As a result, terrain sensitivity is low (figure 28). The area is well-drained and the abandoned wellsite is located on a felsenmeer, or block field surface. Disturbance was minimal. For example, the construction of the airstrip
