***In Vitro* Simulation of Modular Neck Fracture, Wear, Corrosion, and  
Distraction in Total Hip Replacements**

Master of Applied Science  
in  
Mechanical Engineering

Ottawa-Carleton Institute for Mechanical and Aerospace Engineering  
Faculty of Engineering  
University of Ottawa

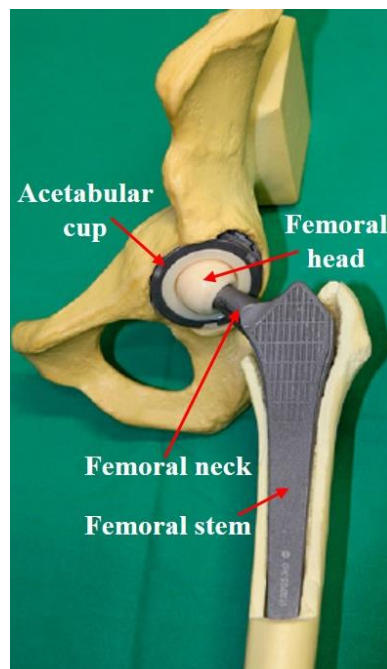
exclusively used in reference to the stem-type devices for the purpose of this thesis. In a THR, as seen in Figure 2.7, an acetabular cup (socket) is implanted in the pelvis to provide an articulating surface for the femoral head. The femoral head (ball) mates to a neck attached to a stem that is imbedded into the femur. There are two major methods to fix the THR components: the cemented and the cementless fixation. Different materials (polymers, metal alloys, and ceramics) are used to manufacture THR components. These materials are qualified to be implanted in the human body based on their biocompatibility, wear and corrosion resistance, relative stiffness to the bone, and mechanical properties that will allow them to withstand great amounts of stresses and torsional forces. With the variety of implant materials available, it is common to have a combination of materials for a single THR.

**Figure 2.7:** An illustration model of THR featuring a cementless fixated femoral stem and ceramic-on-ceramic bearing surface (picture adapted from Knahr, 2012 [24]).

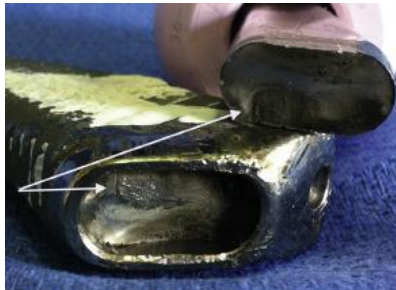
**Figure 2.22:** Image of an *in vivo* fractured long CoCrMo modular neck showing the fractured neck fragment inside the stem pocket [48].

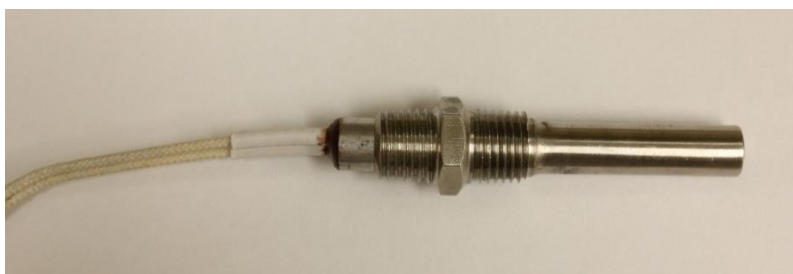
**Figure 3.3:** 316 Stainless steel cartridge immersion heater.

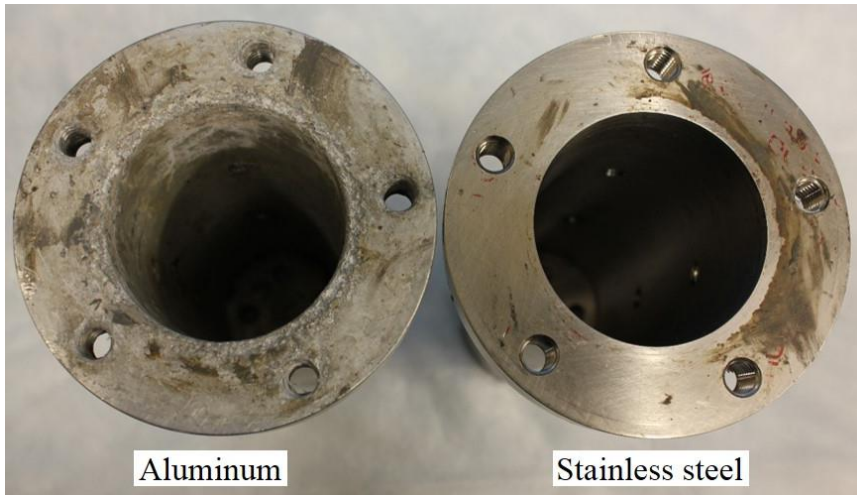
**Figure 3.9:** The effect of the corrosive testing environment at the top of the inner edge of the aluminum specimen holder.

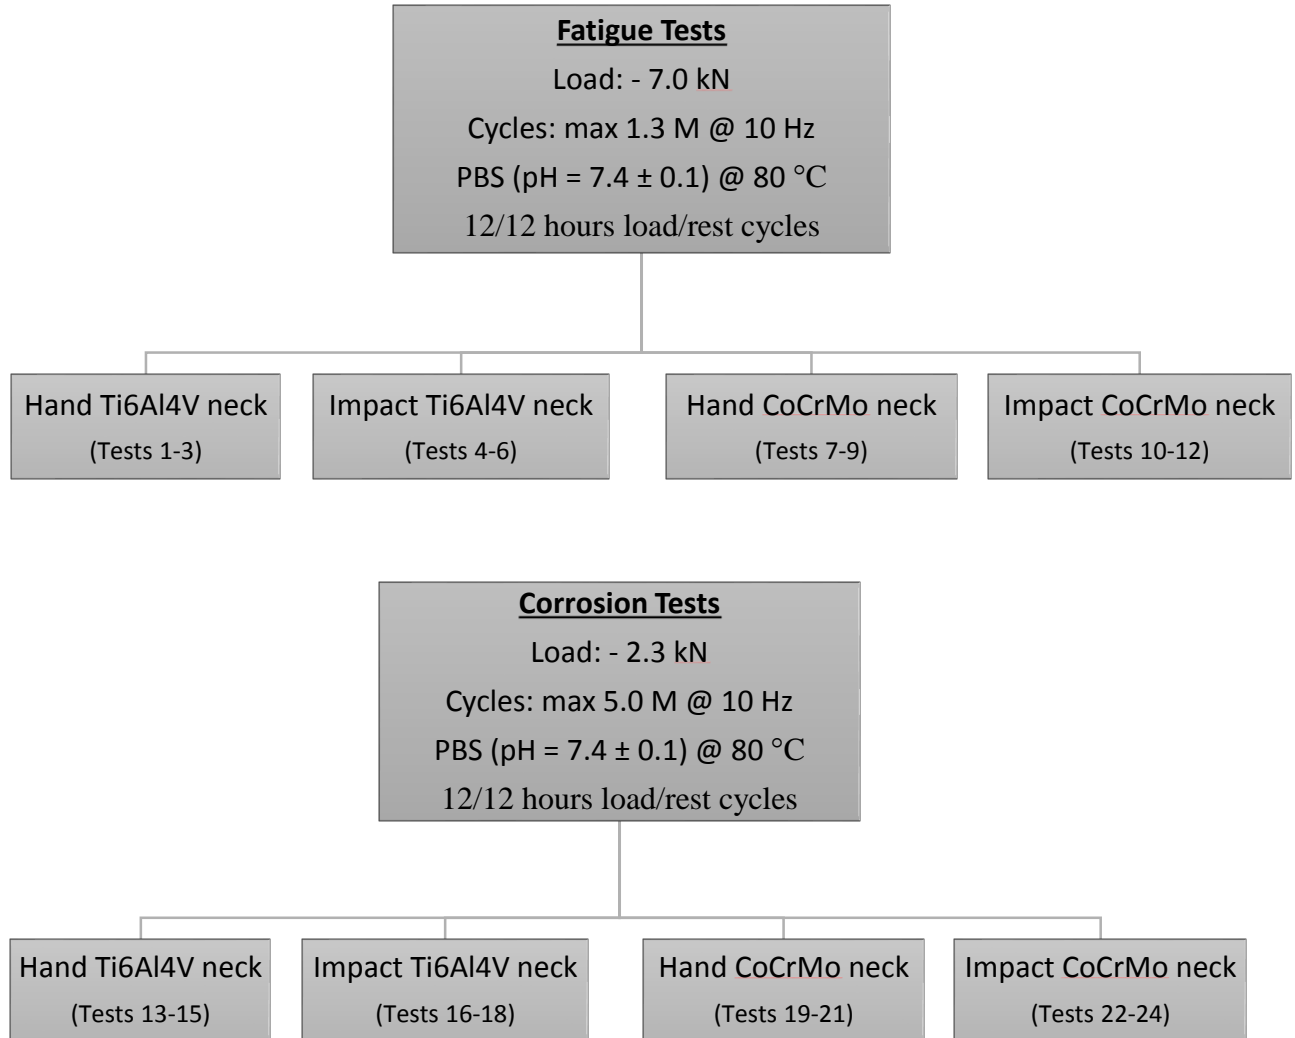
**Figure 3.14:** Fatigue and corrosion tests protocol.

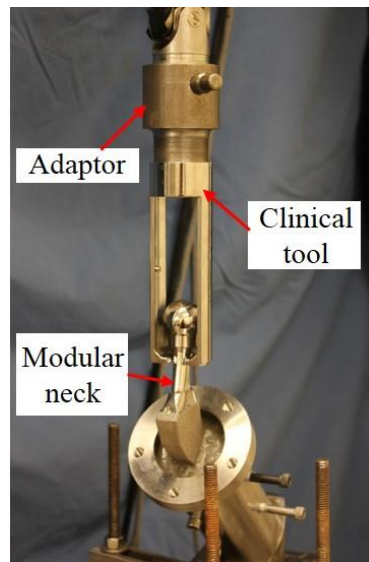
**Figure 3.17:** Neck distraction process.

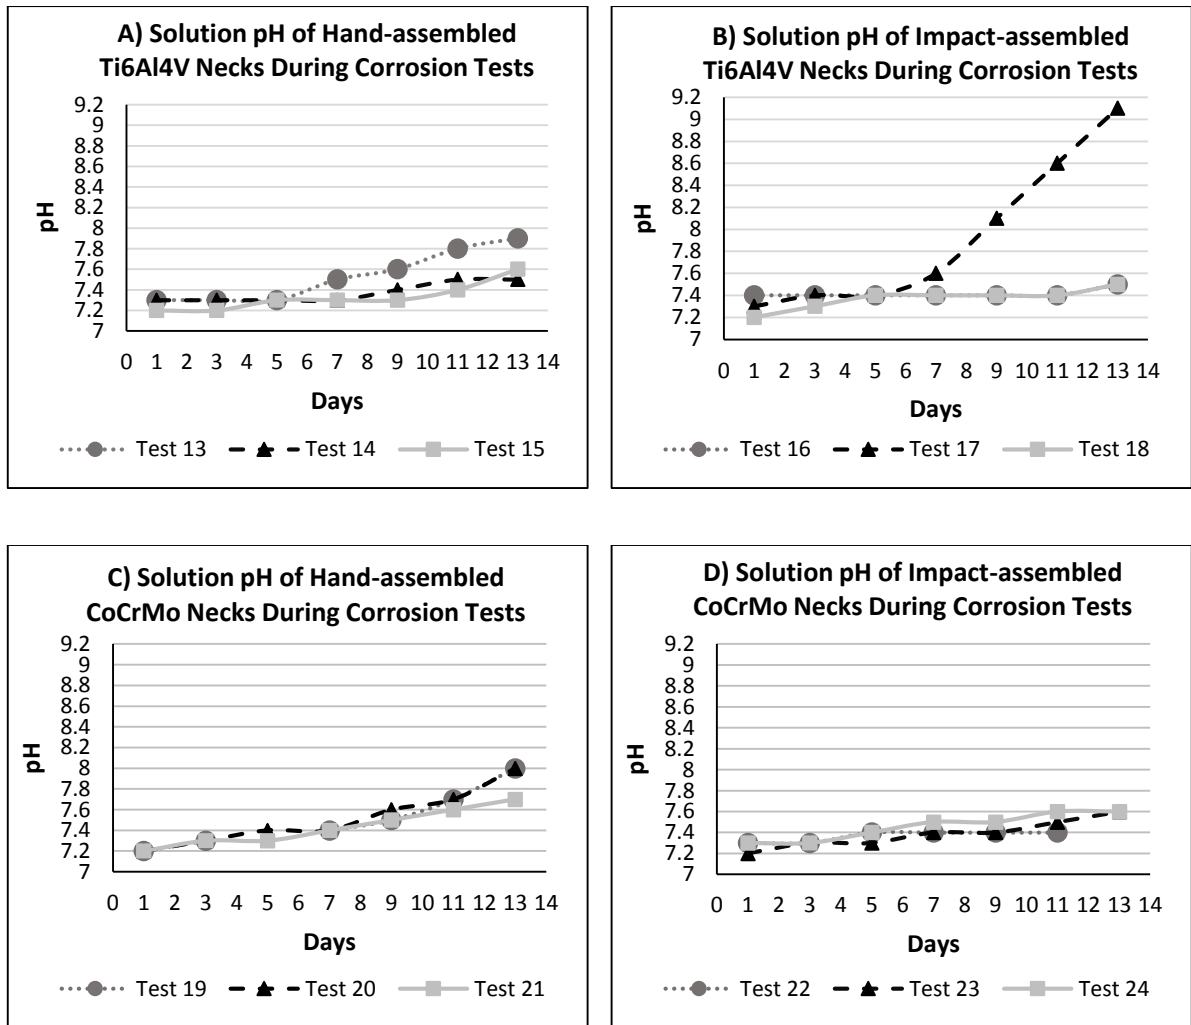
**Figure 4.2:** pH change of the test solution during corrosion tests of : A) Hand-assembled Ti6Al4V necks; B) Impact-assembled Ti6Al4V necks; C) Hand-assembled CoCrMo necks; D) Impact-assembled CoCrMo necks. Note: the solution pH for day 5 of test 19 and day 13 of test 22 were not measured.

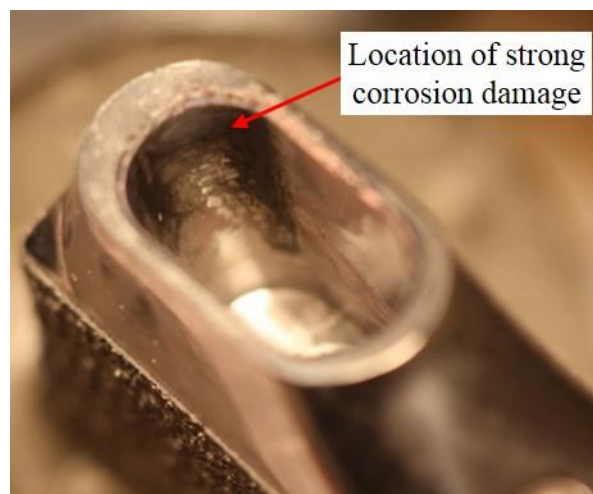
**Figure 4.6:** Corrosion (black debris) on the medial surface of a Ti6Al4V stem following a corrosion test with a hand-assembled CoCrMo neck.

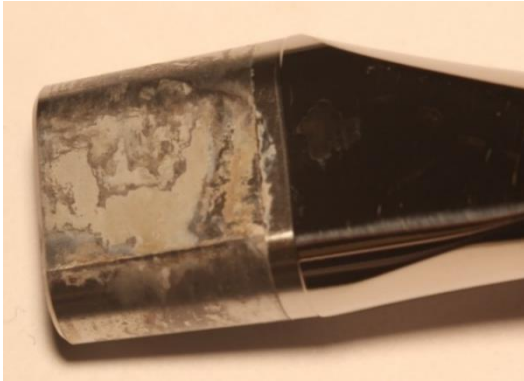
**Figure 4.13:** Advanced fretting associated with corrosion damage on the anterior surface of a hand-assembled CoCrMo neck following a fatigue test.

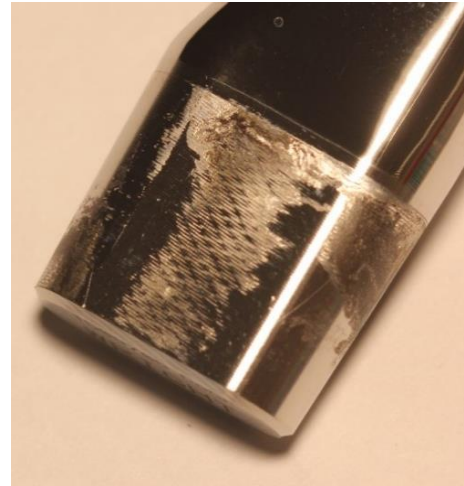
**Figure 4.14:** Severe wear on the anterior surface of an impact-assembled Ti6Al4V neck following a fatigue test leading to material removal off the neck taper.
