**Structural performance and damage evaluation of corroded infill  
slabs from the Champlain Bridge after 60 years in service**

**Doctor of Philosophy in Civil Engineering**

University of Ottawa

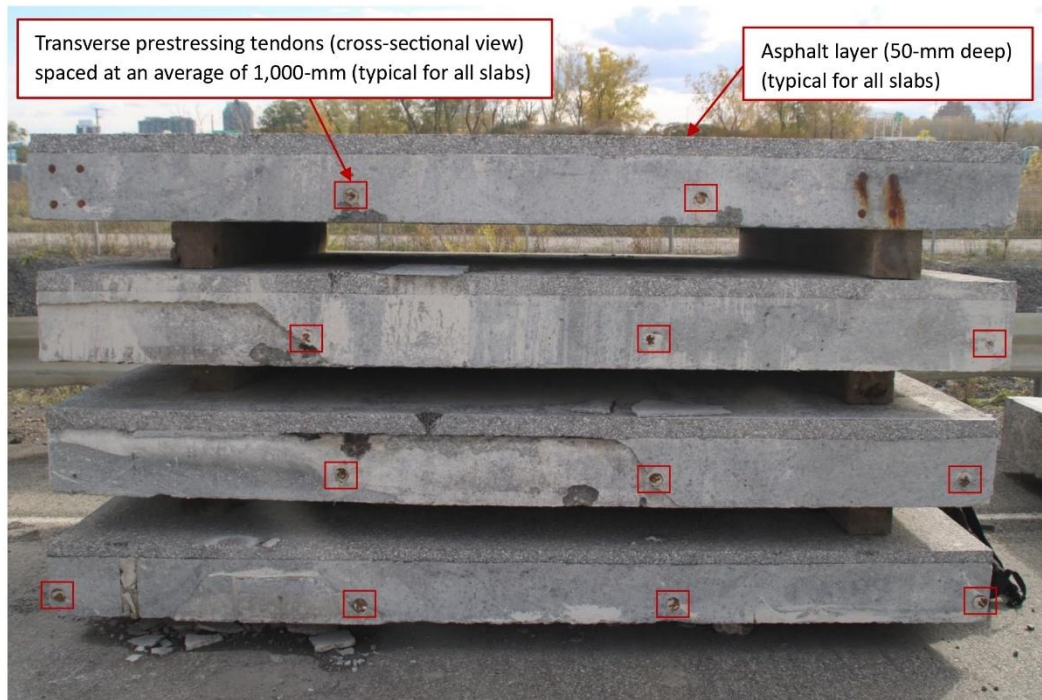
Figure 3-2 Stacked infill deck slab samples (longitudinal edge)

The obtained slab sample measured 225 mm deep, 2,000 mm wide and 3,000 mm long, with a 50 mm layer of asphalt topping. Grouted post-tensioning tendons consisted of twelve 7-mm diameter cables, spaced at an average of 1,000 mm. The slabs functioned as a one-way system, spanning 1,970 mm between the girders. Figure 3-2 and Figure 3-3 show the primary and the secondary reinforcement, respectively.

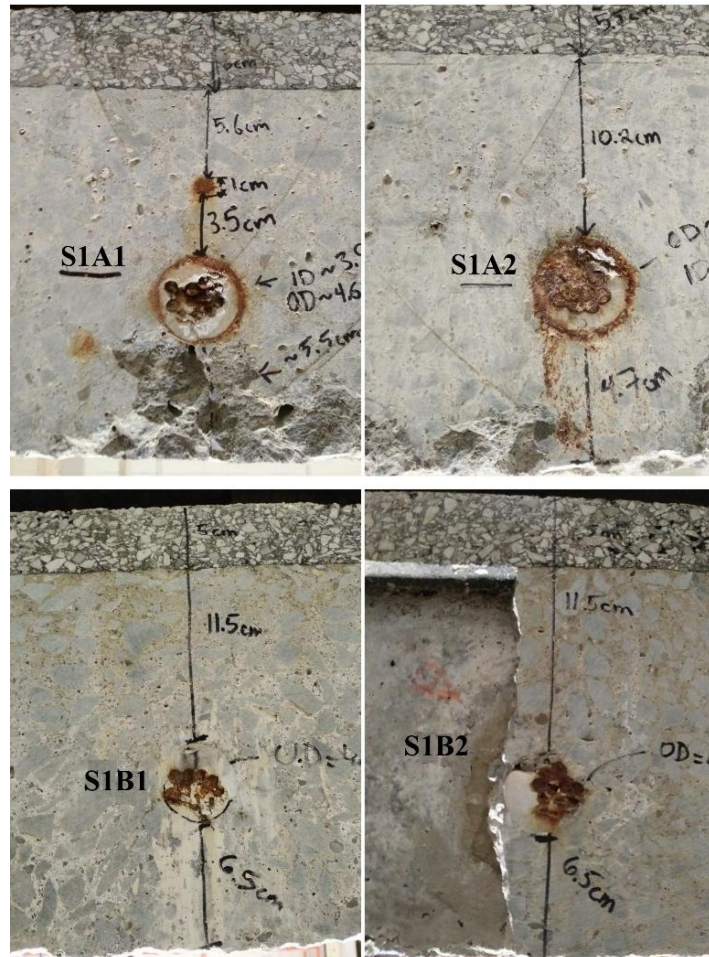
Figure 3-10. Tendon cross-sections at cut surfaces

one side of the metal duct, leaving the opposite side in direct contact with the cables due to insufficient grouting. This deficiency in grout coverage on one side of the duct may have exposed the cables, increasing the risk of corrosion. Small gaps were also observed between the individual cables.

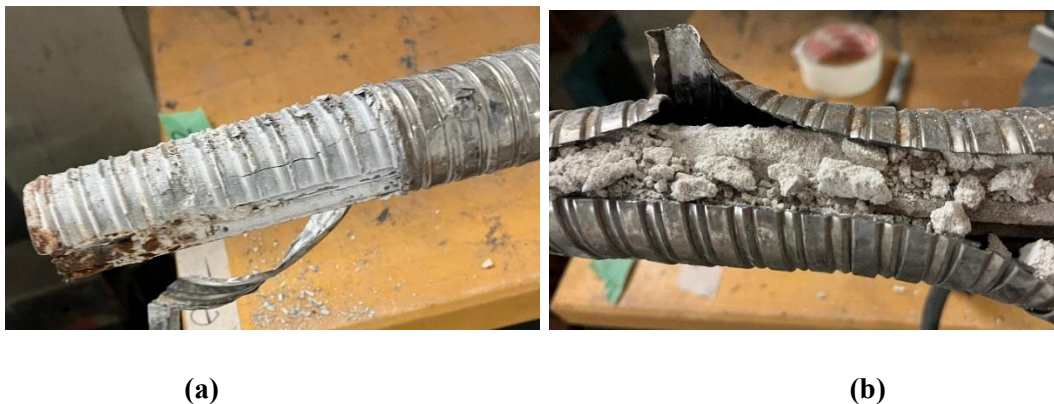
Figure 4-12 Grout conditions in tendon ducts: (a) solid in S5A2-S5B2, and (b) crumbled in remaining tendons
