Seismic Retrofit of Reinforced Concrete Frames with Diagonal Prestressing Cables

A thesis presented to the School of Graduate Studies and Research of the
University of Ottawa in partial fulfillment of the requirement for the degree of
Master's in Applied Science

Ottawa-Carleton Institute for Civil Engineering
Department of Civil Engineering
Faculty of Engineering
University of Ottawa
February 2014

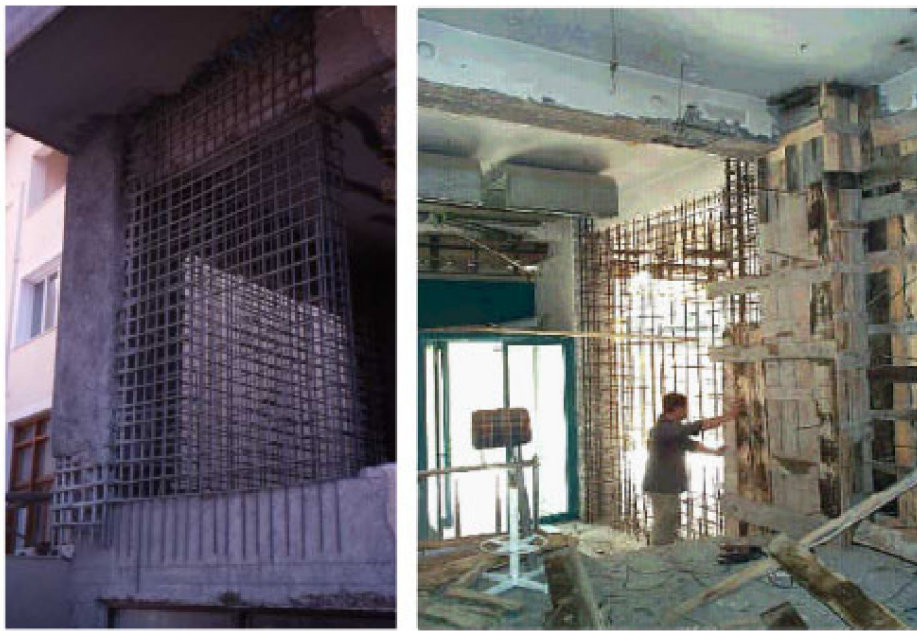
Fig. 2. 1 Adding shear walls as a retrofit technique (Thermou and Elnashi 2006)

or as replacement of infill masonry walls. Second, the existing structure should have the capability to transfer in-plane diaphragm forces to the added shear walls. Proper interlocking of the new elements and the existing structure can be achieved by detailing the connections. A sample of implementation of this retrofit technique is illustrated in Fig. 2.1 (Thermou and Elnashi 2006). The reinforcement should be detailed according to the current seismic provisions with special attention given to the reinforcement in potential plastic hinges in boundary elements for confinement of concrete. A convenient approach for implementing shear walls is to use the existing beams and columns while adding a web by placing concrete in the selected bay either by shotcreting or placing cast-in-place concrete. Figure 2.1 illustrates the application of the method.

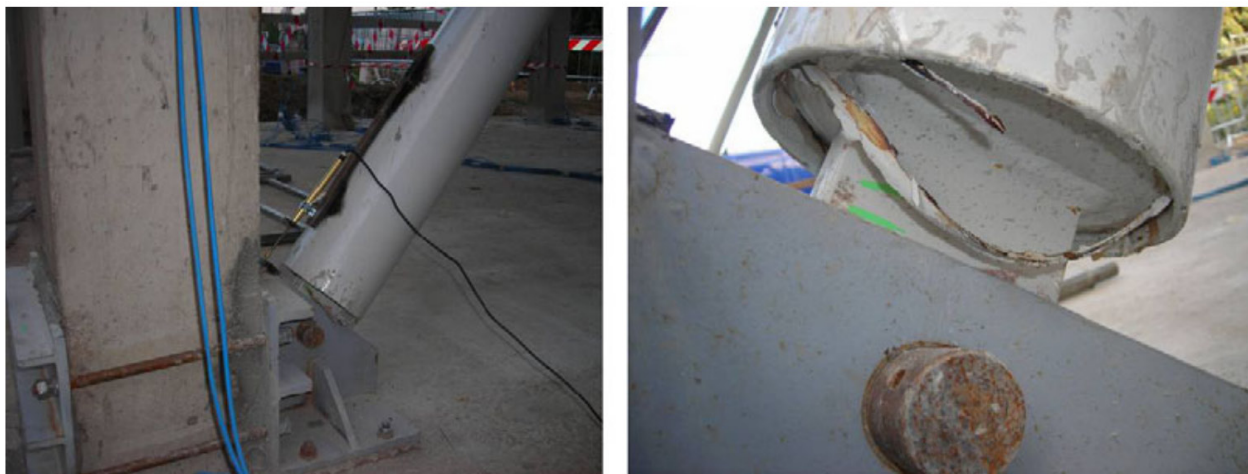
Fig. 2.7 Retrofitted specimen; close-up view (left) and yielding of BRB element (right) - Sarno and Manfredi (2011)

Sarno and Manfredi (2011) performed experimental studies on full-scale unretrofitted reinforced concrete frames using BRBs. Two 2-storey 2-bay specimens were designed, detailed and constructed for gravity loads only. One was tested without a BRB as benchmark and the other was equipped with a BRB system. The samples were tested under monotonically increasing static lateral loads (push over) and dynamic loads. The results indicated more than twice the capacity in both lateral strength and ductility. Fig. 2.7 shows a brace element after yielding.

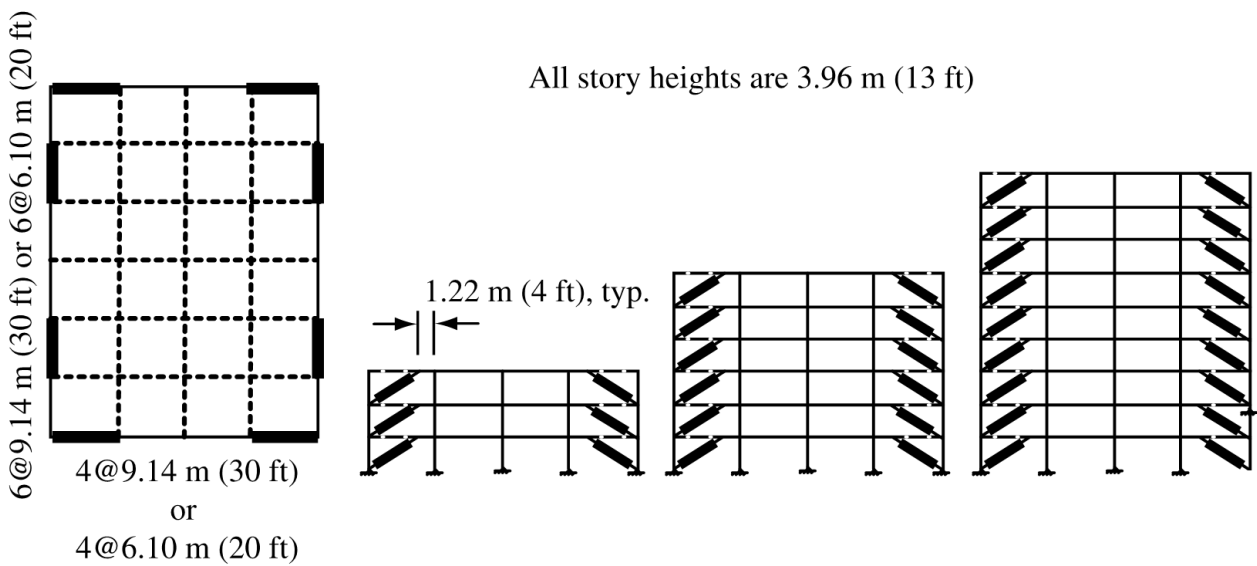
Fig. 2.9 Building plan and elevation views of the analytical model - Prinz et al. (2012)

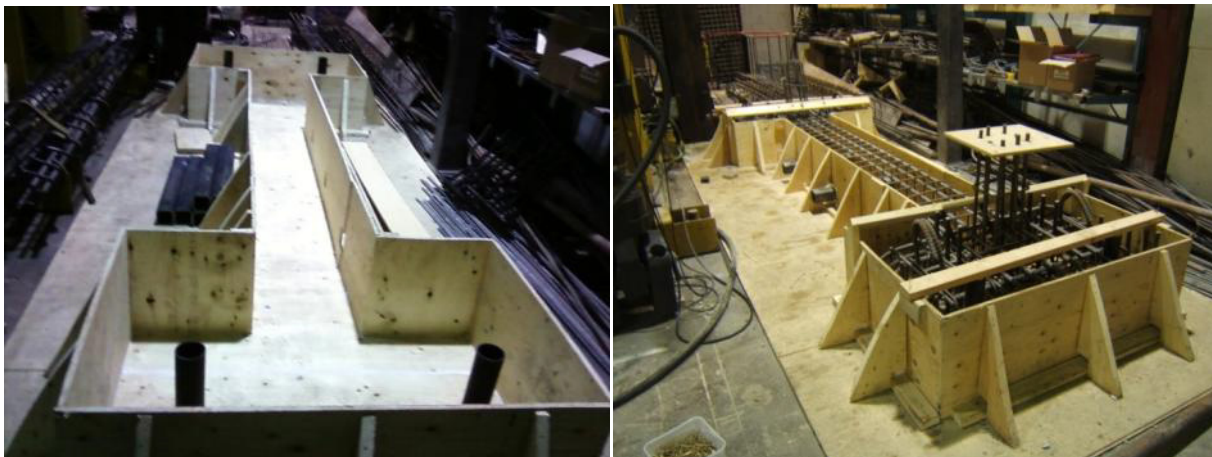
(a) Formwork with 3 inch pipes

A total of four 3-inch plastic pipes, two per side, were placed in the formwork prior to casting. These holes matched the locations of existing holes on the laboratory strong floor. They were used to insert 3-inch diameter high-strength steel bolts to connect the foundation to the strong floor. The plastic pipes and the overall view of the formwork are shown in Fig. 3.4.

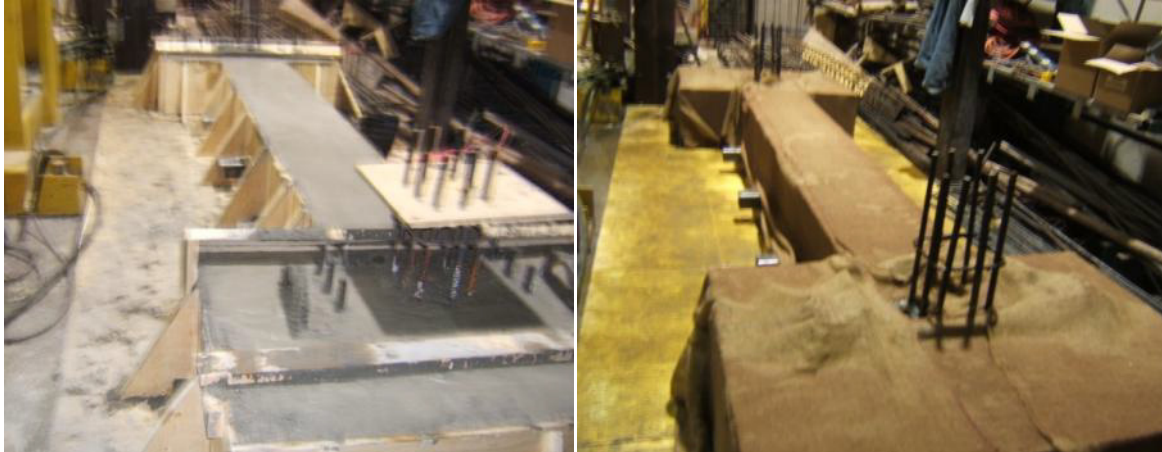
a) Fresh concrete after finishing

Fig. 3.5 Placement and curing of foundation concrete

concrete was moist cured for seven days. The entire exposed concrete surface was covered with burlaps, and watered frequently to maintain the moist environment for continued curing. This is shown in Fig. 3.5(b).

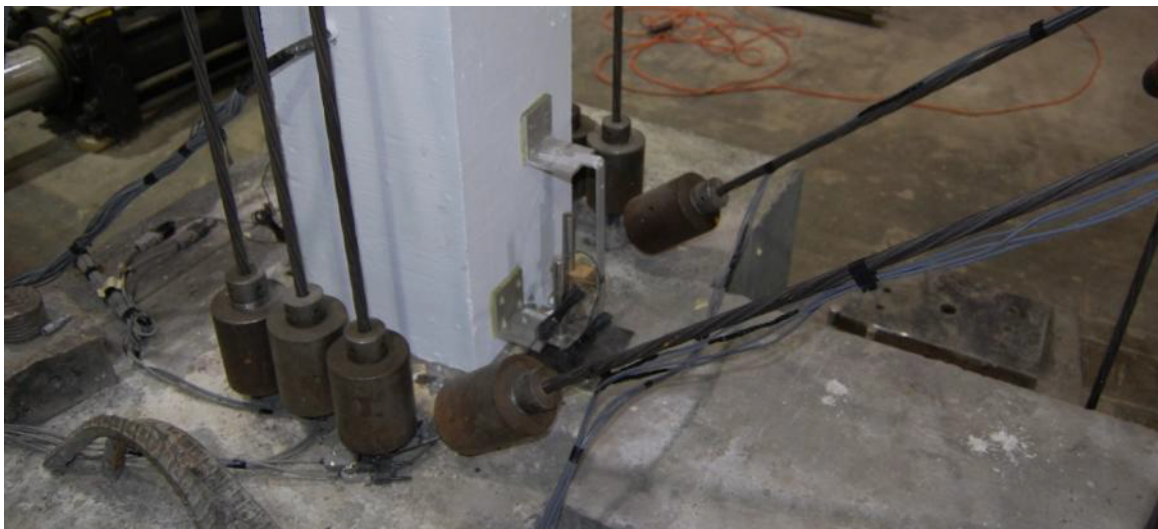
Fig. 3.7 Cable connection mechanism to the foundation

In the second frame (Frame No. 2), two cables were used in each diagonal. The cables were positioned so that each cable would pass on one side of the column. The cables were connected to one inch high-strength threaded bolts that had been cast in concrete near the base of each column. The cylindrical prestressing anchors were threaded at their ends and connected to the bolts. This is illustrated in Fig. 3.7.

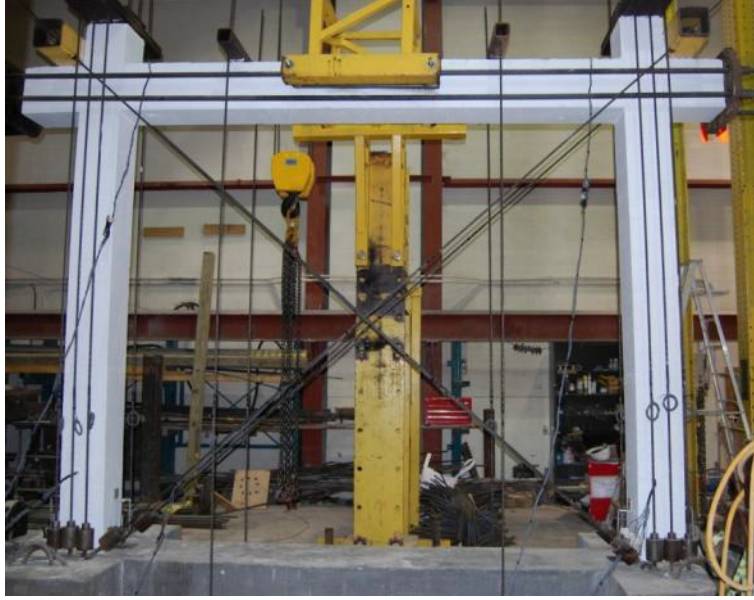
Fig. 3.8 Frame 2 with installed double cables

Hollow steel sections were placed at top joints on the opposite side of beam-column joint. The steel sections had pre-drilled holes to accommodate the strands. The cable is run through these holes and locked in by friction wedges. The prestressing operation was done at the top end of the strands. Fig. 3.8 illustrates the diagonal cables in place for Frame No. 2.

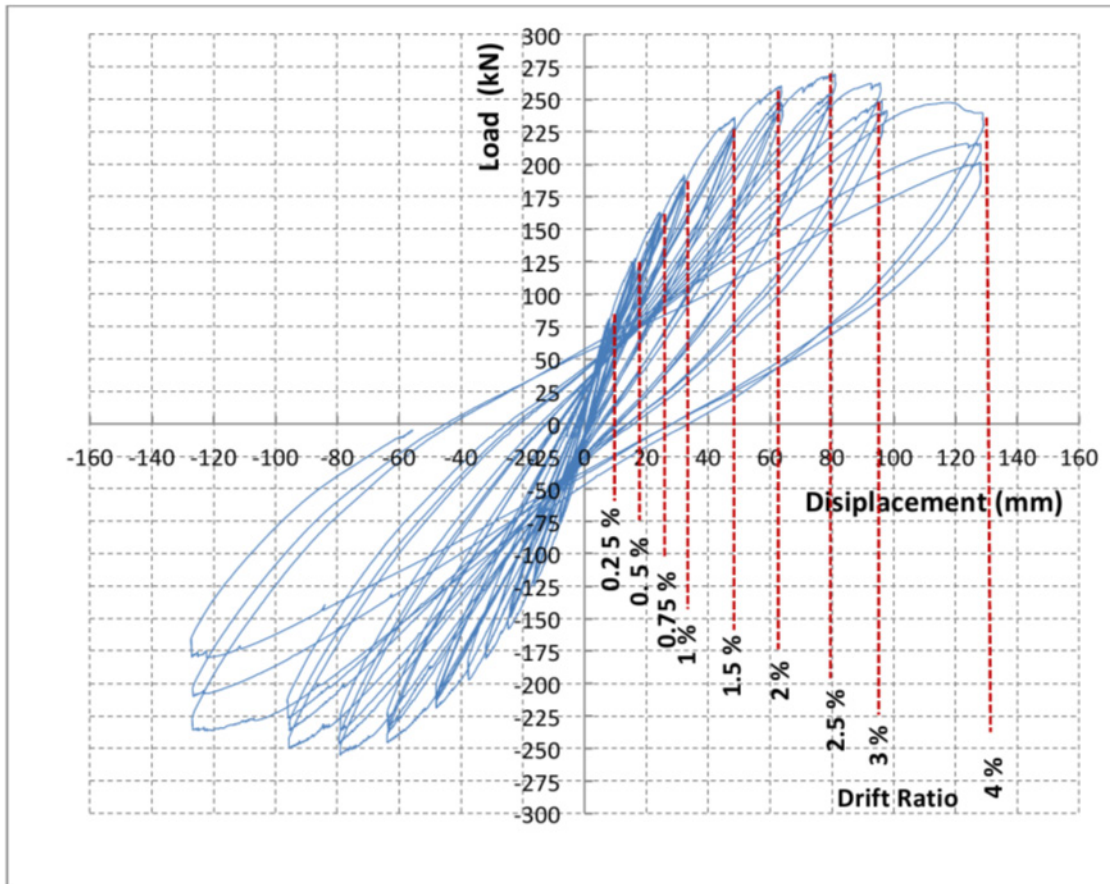
Fig. 4. 1 Hysteretic force-displacement response of an unretrofitted frame (Al-Sadoon, 2013)

cycles. The frame subsequently failed at about 4% drift ratio when it developed significant strength decay. The frame represented a prototype building, which did not meet the seismic force requirements of the current National Building Code of Canada (NBCC 2010), as illustrated by Al-Sadoon (2013). Therefore it had to be strengthened and stiffened for drift control.

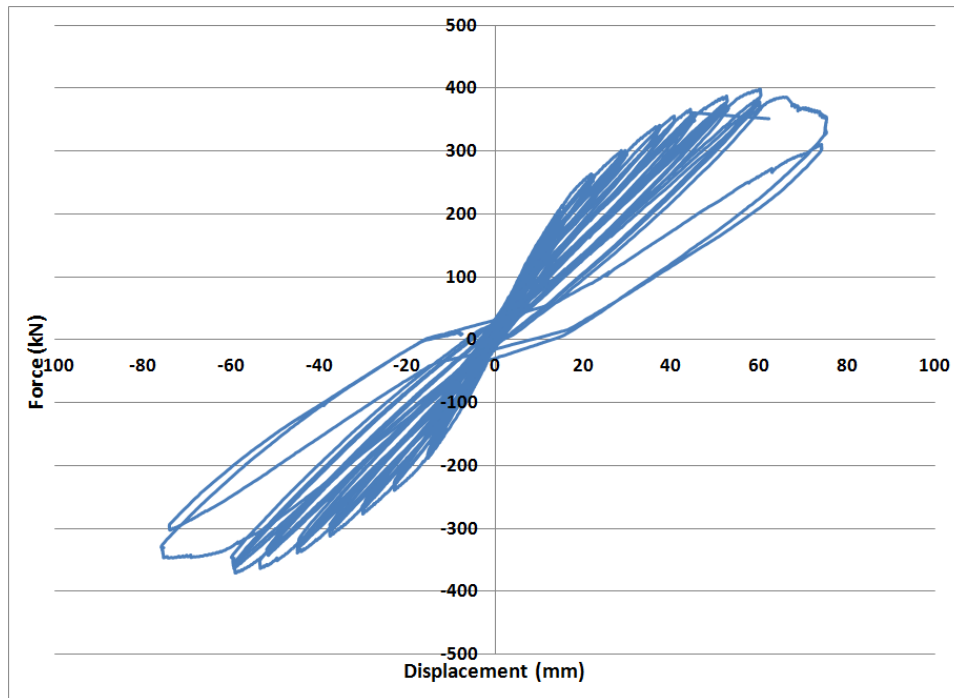
Fig. 4.2 Hysteretic force-displacement relationship of Frame No. 1

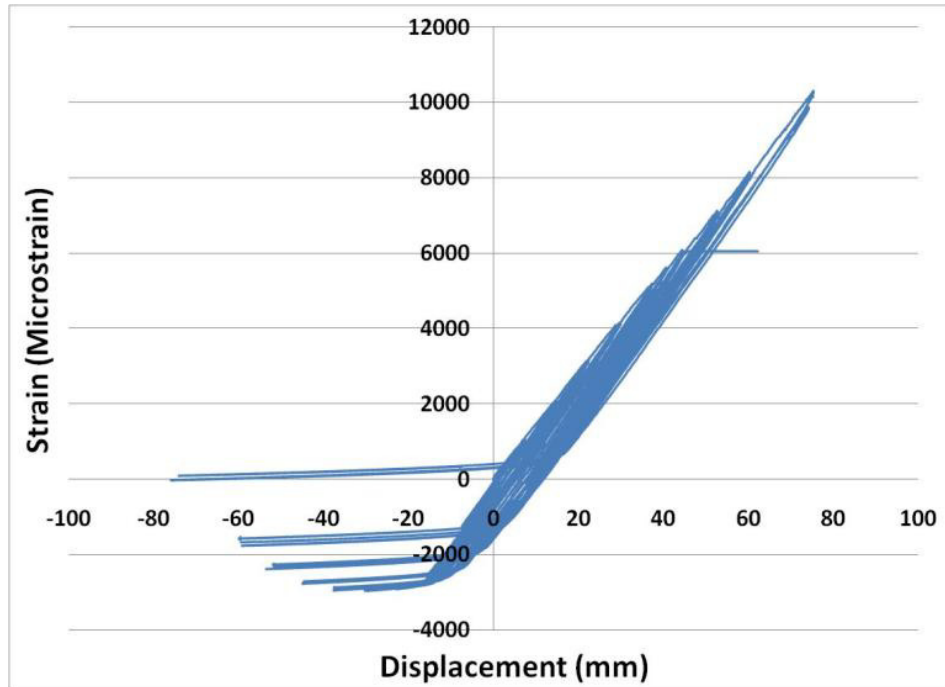
Fig. 4.3 Diagonal cable strain vs. lateral frame displacement for Frame No. 1 in the cable where tension increases during push

The strain in diagonal cables were measured and plotted as shown in Figs. 4.3 and 4.4. These strains are used to determine the contribution of cables to lateral load resistance, while also indicating the stage of loading at which the cable along the compression diagonal has lost its initial tension and became slack. The strain data also provides an indication of the additional stiffness provided to the frame by means of prestressing. Figs. 4.3 and 4.4 show the strain values in the strands during push and pull. It can be seen in the figures that the strains became constant when the initial prestress was completely released along the compression diagonal. The initial displacement increment was selected to be 0.25% lateral drift, corresponding to 7.5 mm lateral displacement of the top beam relative to the base of the column. In this step the specimen behaved elastically with high initial stiffness and no observed cracks. The displacement was subsequently increased to 0.5% drift ratio, corresponding to 15 mm lateral displacement. No cracks were observed at this deformation level.

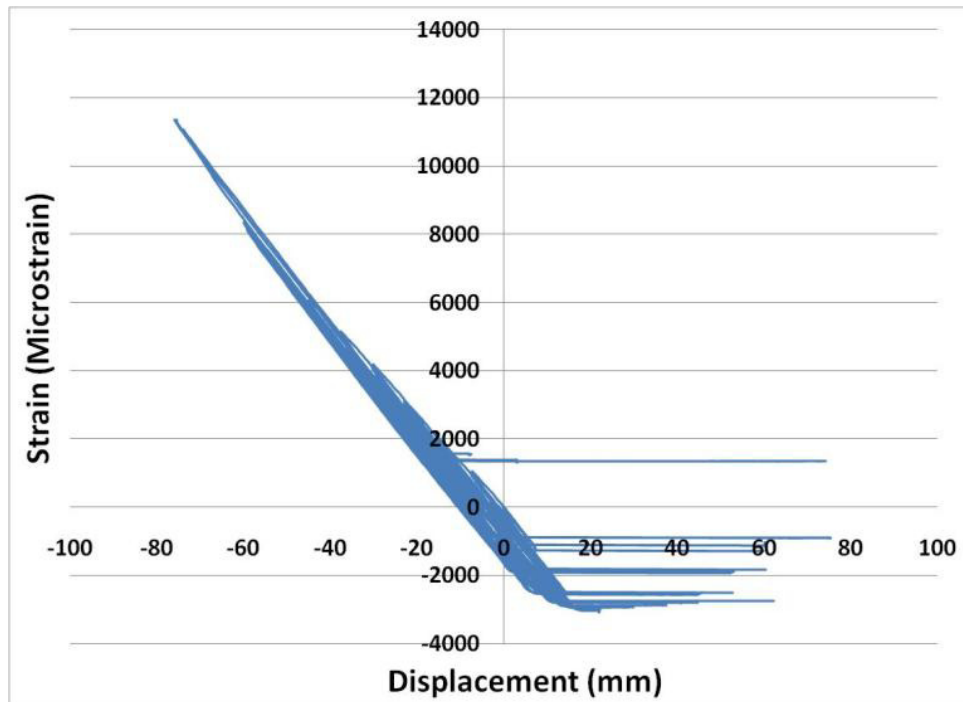
Fig. 4.4 Diagonal cable strain vs. lateral frame displacement for Frame No. 1 in the cable where tension increases during pull

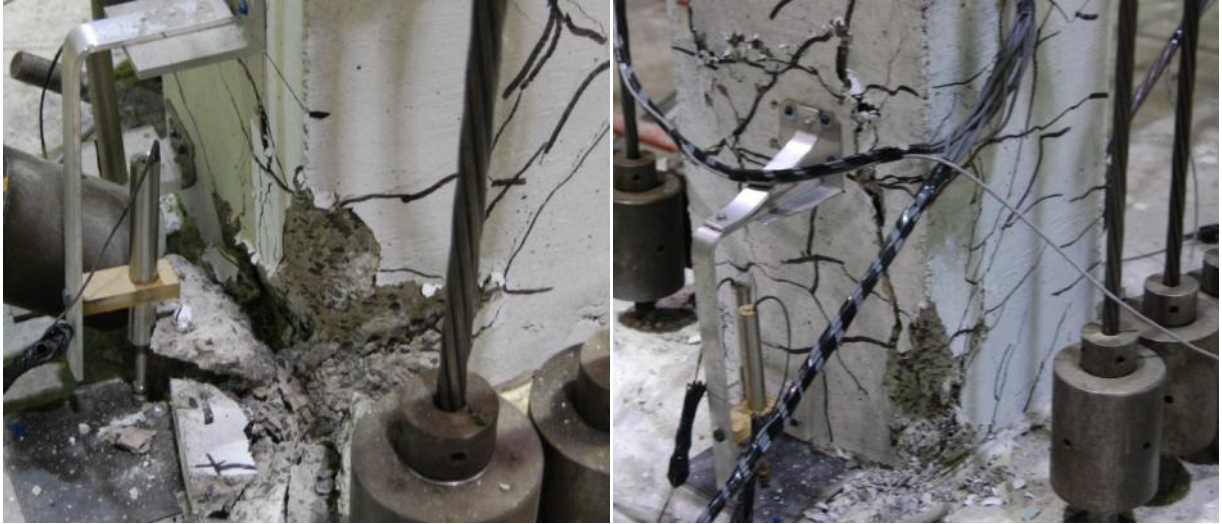
Fig. 4.5 Damage at column base at the end of 2.5% cycles (failure cycles)

The strain gauge reading taken on diagonal strands indicated that both strands reached their yield strains and slightly exceeded them by developing 0.0100 to 0.0115 strains. This implies that the yielding of diagonal prestressing strands and the failure of columns occurred at the same deformation level. When compared with the post peak behaviour of unretrofitted frame, which continued up to 4% lateral drift before the column concrete crushed and the specimen lost a significant portion of its lateral load capacity, it may be argued that the relatively early crushing of the column concrete in Wall No. 1 at 2.5% drift ratio may have been caused by the additional axial compression imposed on the columns by diagonal strands.

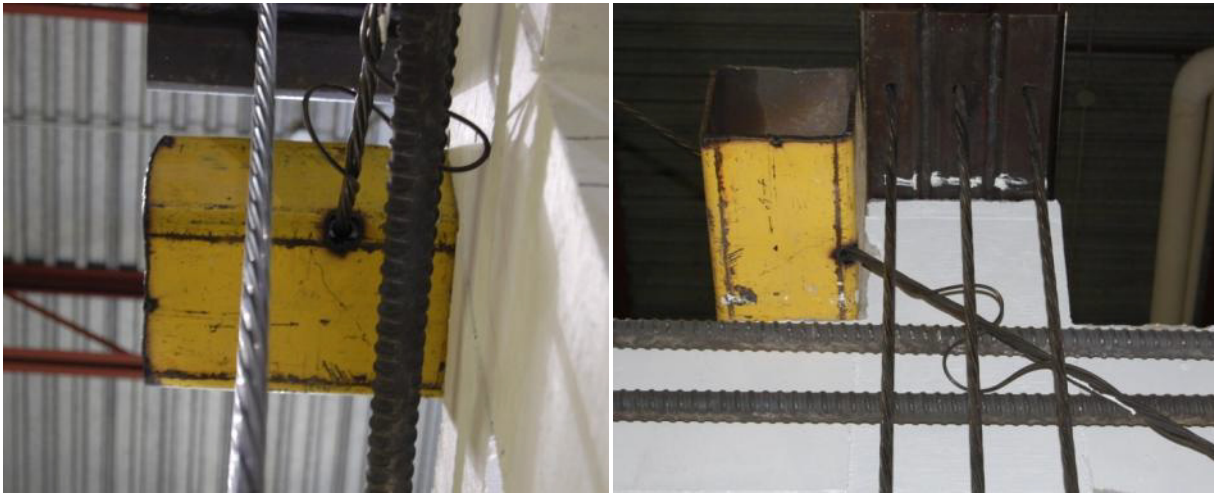
Fig. 4. 9 Ruptured diagonal prestressing tendon during testing of Frame No. 2

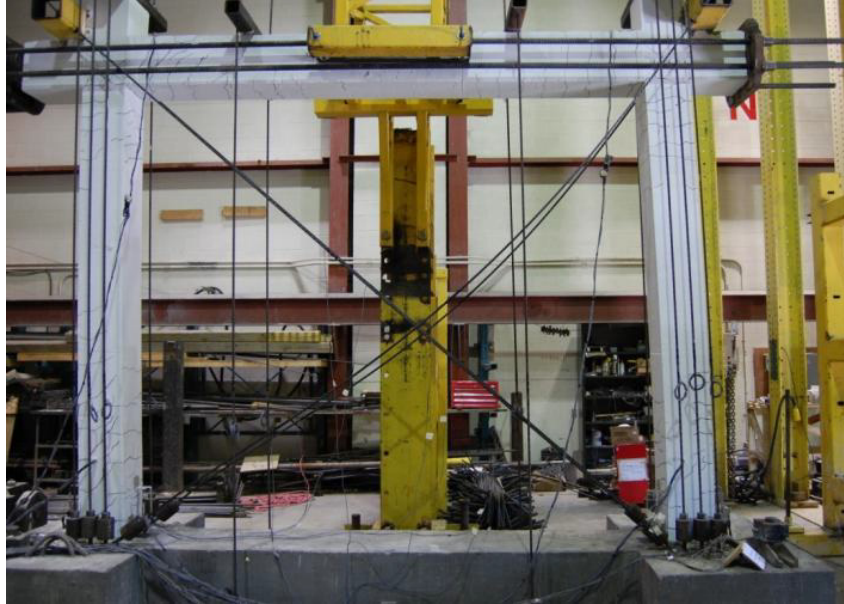
Fig. 4.10 Frame No. 2 at 1.75% drift during the pull cycle

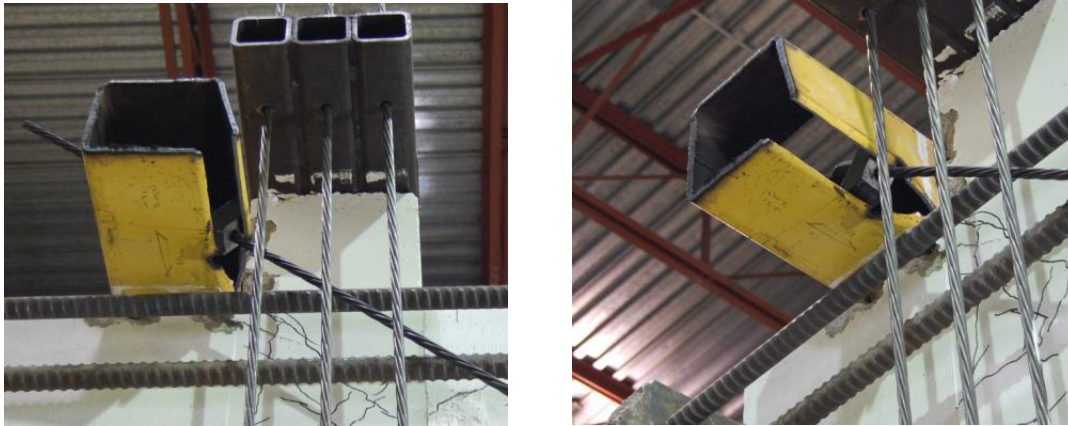
Fig. 4.11 Failure of the HSS section as a result of tendon rupturing

At 2.0% drift ratio, corresponding to 60 mm lateral deflection, the frame showed no reduction in capacity and maintained its yield force level. Some additional concrete crushing was observed at the bottom corners of columns when subjected to compression. The crack patterns remained the same with increased crack widths. During the third cycle of 2.0% drift, the cables ruptured once again and the impact of the shock caused the attached HSS section to rupture along its length with a loud noise. This is illustrated in Fig. 4.11.

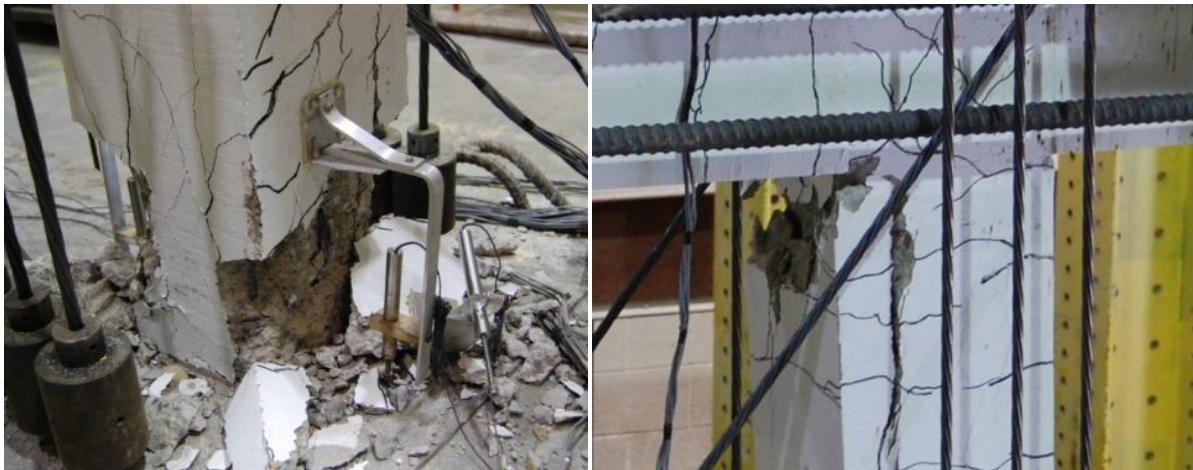
Fig. 4.15 Column damage at 2.5% drift; (a) crushing of column concrete near the base, (b) spalling of column cover near the top joint

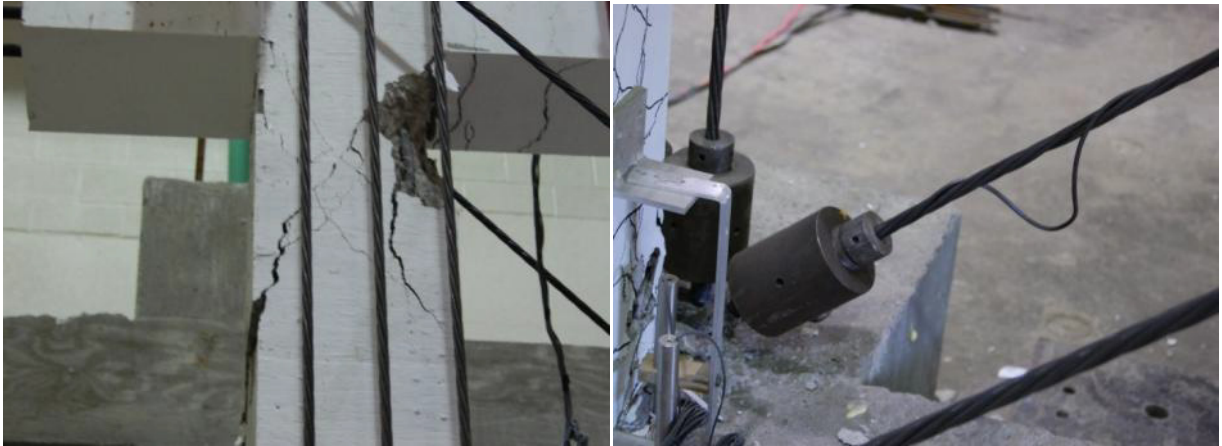
Fig. 4.16 Damage during the last cycle of 2.5% drift; (a) diagonal tension failure of column at the top, (b) ruptured wire of a strand

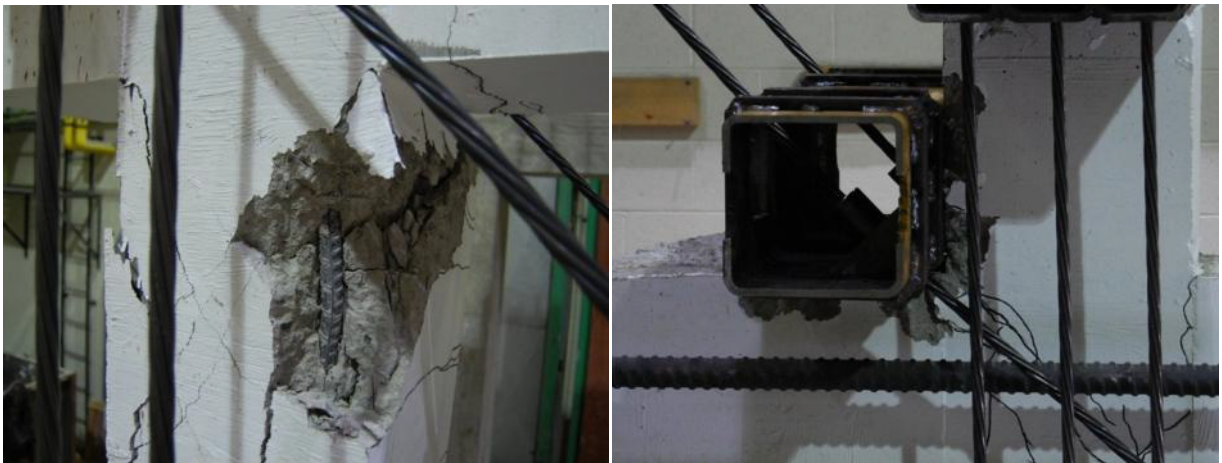
Fig. 4. 17 (a) Buckled longitudinal bar at the top of column, (b) localized crushing of concrete under bearing stresses

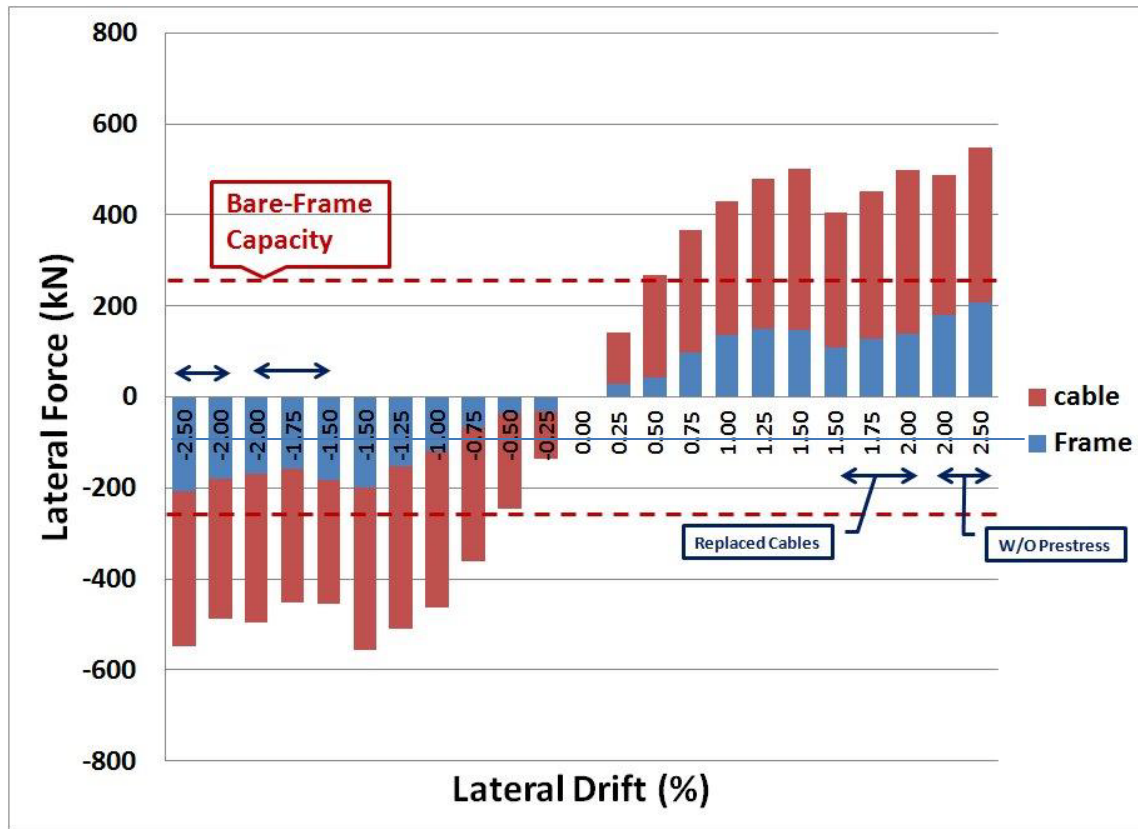
Fig. 5.7 Lateral force resistance contributions in Frame No. 2
