**INCREASING THE BLAST RESISTANCE OF CONCRETE MASONRY
WALLS USING FABRIC REINFORCED CEMENTITIOUS MATRIX
(FRCM) COMPOSITES**

Thesis submitted to the University of Ottawa
in partial fulfillment of the requirements for the degree of
Master of Applied Sciences
in Civil Engineering

Department of Civil Engineering
Faculty of Engineering
University of Ottawa

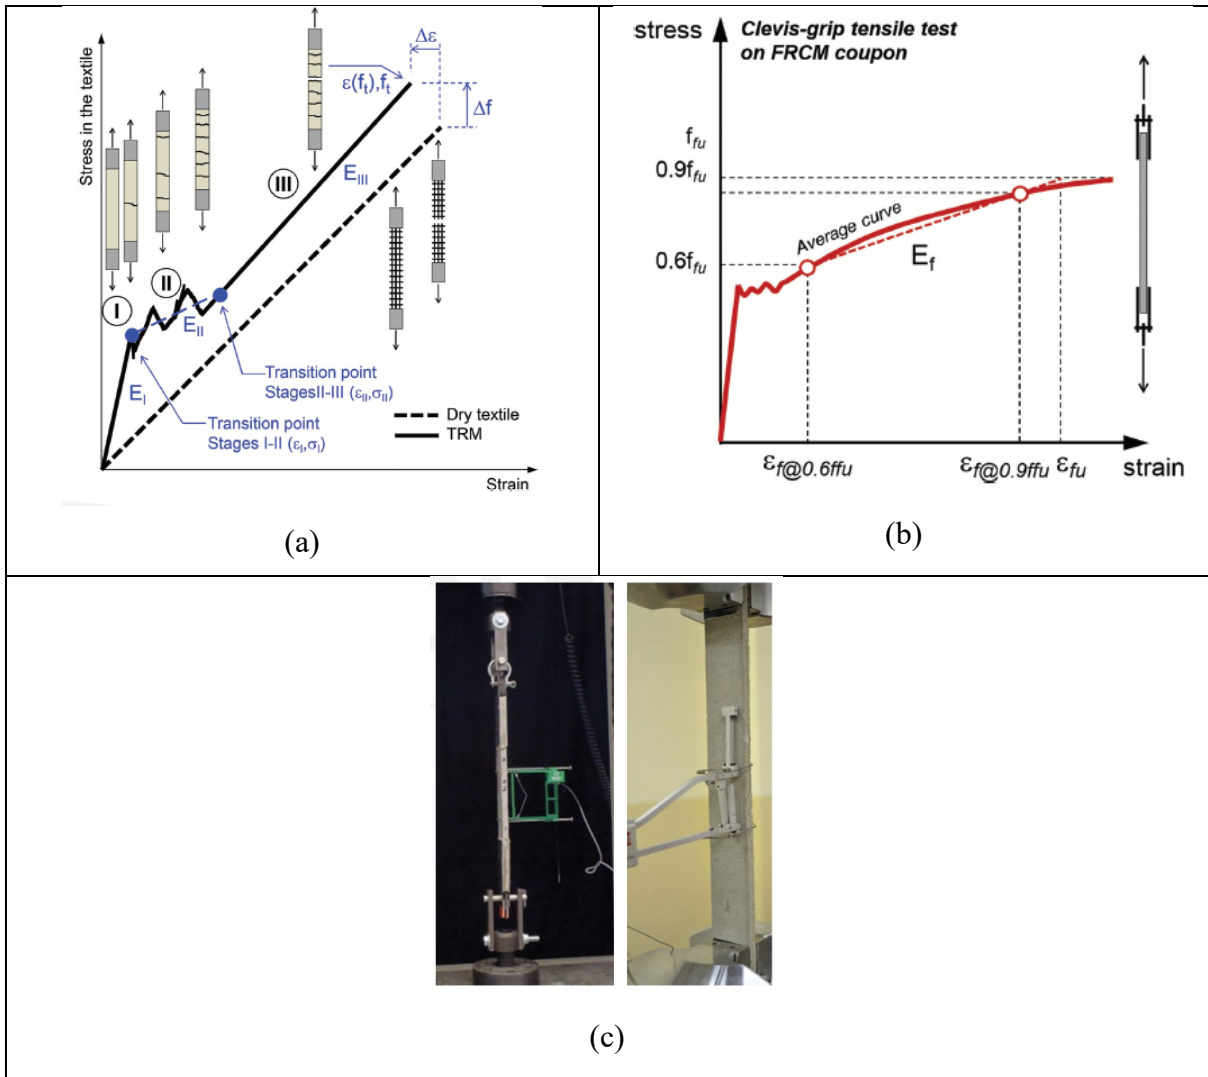
Figure 2-5. FRCM tensile response: (a) stages in response for clamped systems, (b) stages in response for clevis-grip systems, (c) clevis and clamped test setups (Reproduced from ACI 549.6R-20)

FRCM systems are typically characterized by their tensile stress-strain response. This response typically shows three stages as shown in Figure 2-5 (ACI 549, 2020). In the first stage (I), the mortar is uncracked, and therefore the capacity and stiffness is governed by the mortar properties. The first crack occurs at the start of second stage (II), and during this stage the crack pattern is gradually developed. This stage is dependant on the matrix and matrix-to-fabric bond properties and is not always easily discernable. The third stage is typically associated with a nearly linear response. No further cracks develop in stage, with widening of the existing cracks. This crack widening results in local sliding and debonding at the fiber-matrix interface. The response (stiffness and load-bearing capacity) in stage III is dependant on the test configuration, and is similar to that of the bare fabrics in the case of clamped systems, and more dependant on the fabric-matrix bond in the case of clevis-grip configurations (ACI 549, 2020).

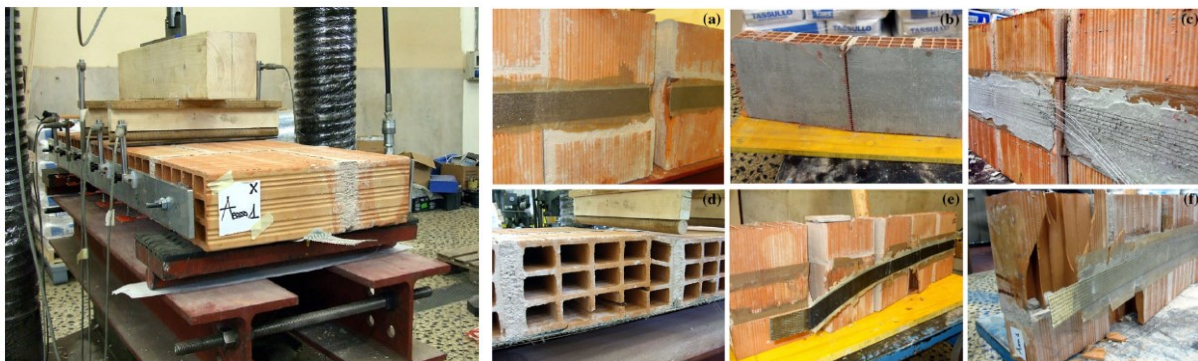
Figure 2-9. Test setup and failure modes, Tensile rupture of a) Flax FRP and b) Plaster net; c) splitting of fibres; d) shear failure in Basalt TRM; debonding in e) Basalt FRP and f) HD SRP (Valluzzi et al., 2014)

The results showed that the reinforcement systems were effective in enhancing the out-of-plane behavior, reaching 3 to 10 times the maximum bending load resistance of plain masonry. It was also noted that the best-performing materials were CFRP and HD SRP and they had the highest load capacities. Moreover, the lowest values in terms of peak load was obtained from natural fibers combined with epoxy, due to tensile fiber failure; even though, the ultimate displacement capacity was very large in comparison with the other composites. Finally, it was concluded that improving the performance of masonry walls does not need big levels of reinforcement, as the use of high-performance materials (SRP or CFRP) can lead to shear failure in the masonry. Hence, it is desirable to use systems in which the application of inorganic mortars (low-density steel textiles or various types of meshes, even quite weak ones like plaster nets) can ensure good performance for both load and displacement (Figure 2-9).

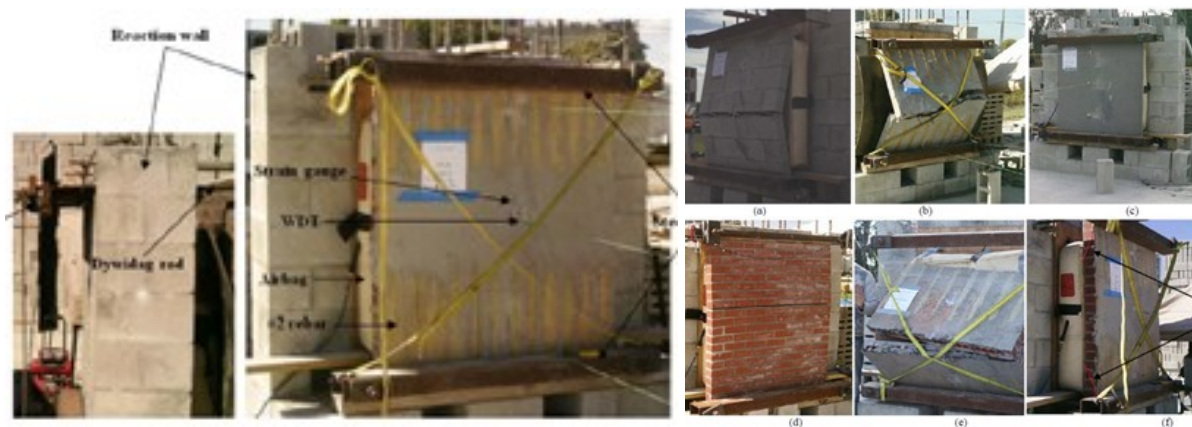
Figure 2-13. Test setup and failure mode of wall specimens: CMU-Control (a); CMU-1ply (b); CMU-4ply (c); CL-Control (d); CL-1ply (e); and CL-4ply (f) (Babaeidarabad et al., 2014)

The results show an increase in the ultimate out-of-plane moment capacity related to the amount of FRCM. The increment of flexural capacity increase was of 2.7 and 7.8 for concrete block masonry walls and 2.8 and 7.5 for clay brick walls, for 1-ply and 4-ply carbon FRCM, respectively. Additionally, two basic mode of failure were observed (Figure 2-13): shear failure in the substrate at the supports and cracking of the masonry at the mid-height with FRCM slippage. It was noted that FRCM enhanced flexural strength, stiffness, and pseudo-ductility; nonetheless, pseudo-ductility is higher for lower FRCM amounts given that flexure controls the failure mode. Finally, the authors concluded that FRCM and FRP strengthening methods are comparable and provide similar increments in flexural capacity, for the same level of the calibrated reinforcement ratio, ω_f . But when ω_f is larger than 0.6 for the clay brick and 0.8 for the concrete brick walls, shear controls the failure mode. Therefore, increments of FRCM beyond this value may be ineffecient.

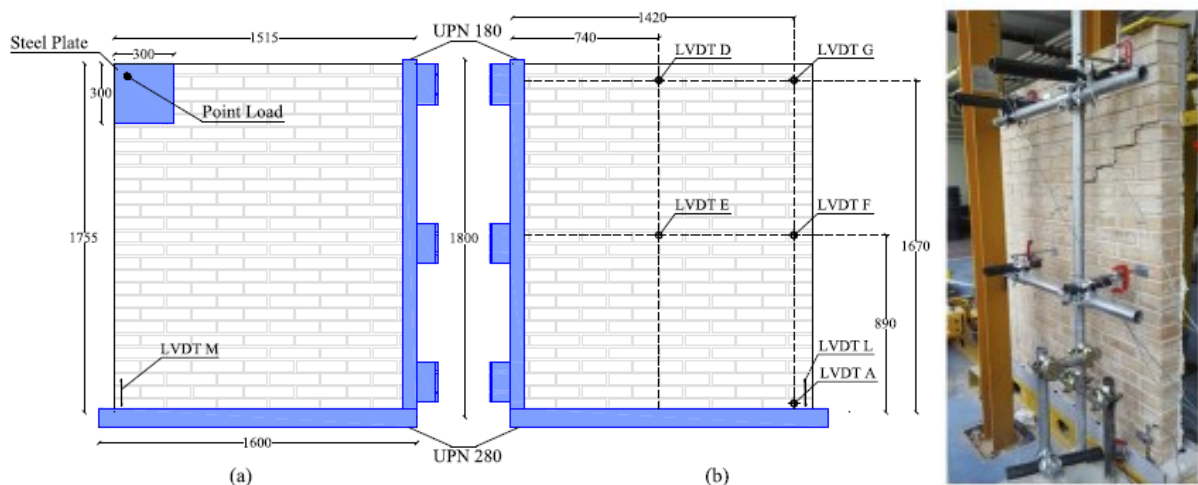
Figure 2-18. Test setup, Rear view (left), Front view (middle) and test results (D'Ambra et al., 2018)

The results showed a progressive stiffness reduction for unreinforced masonry walls which was associated with progressive damage of the joints, with cracks mostly in the mortar and no other elements which remained elastic (Figure 2-18). The behavior of the repaired and reinforced walls, was characterized by a force-displacement curve which showed trilinear behavior. Finally, strengthening with FRCM increased the out-of-plane capacity of the walls to almost two times their original capacity; in spite of the complex stresses induced by the loading setup.

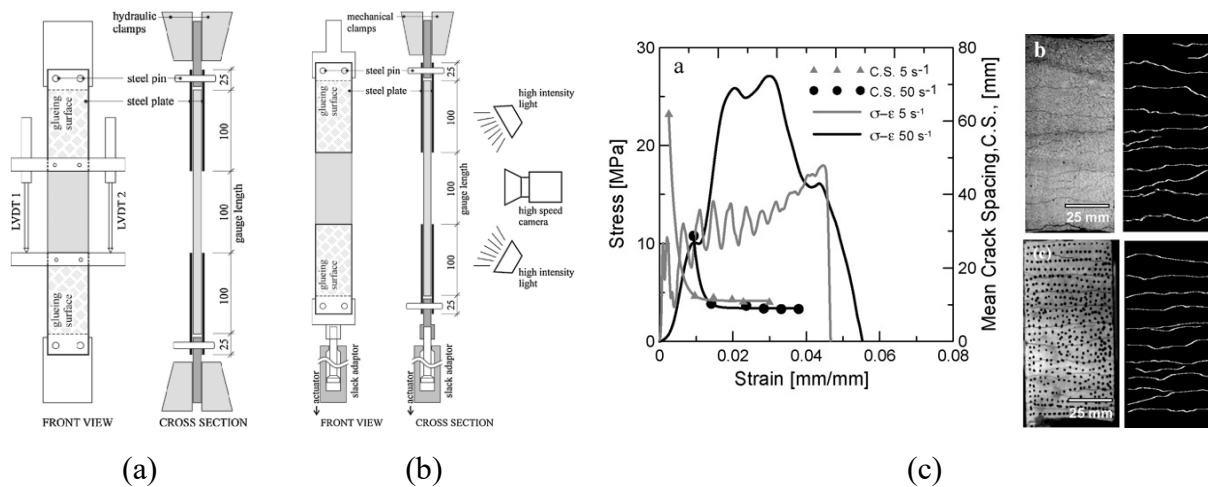
Figure 2-27. Test setup for low strain rate (a) and high strain rate (b), and results (c) (Silva et al., 2011)

The results showed that the strain capacity, tensile strength, work-to-fracture and first crack strength were enhanced for all the specimens when subjected to low-rate tensile loadings. The work-to-fracture and tensile strength were increased up to strain-rate of 50 s^{-1} ; nonetheless, the strain capacity was reduced due to the increased stiffness of the composites in the post-crack region. It was also concluded that the short fibers added in the cement-based matrix resulted in bigger values for first-cracking and tensile strengths. Also, when the gauge length was increased, a decreased strain capacity and tensile strength was observed.

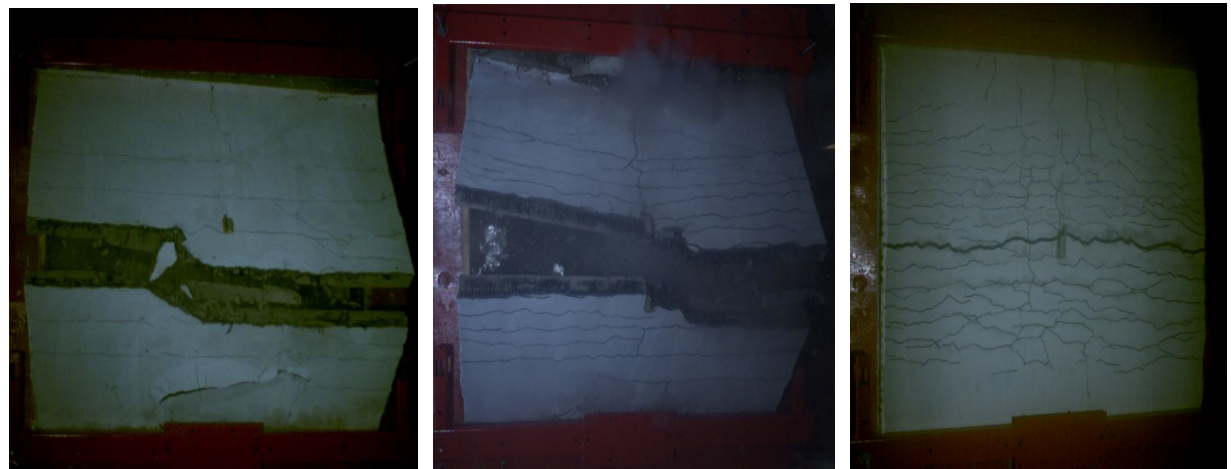
Figure 5-11. Retrofit Ratio Damage Comparison: RCL-NC-1, RCL-YC-2, RCL-YC-3 (continuation)

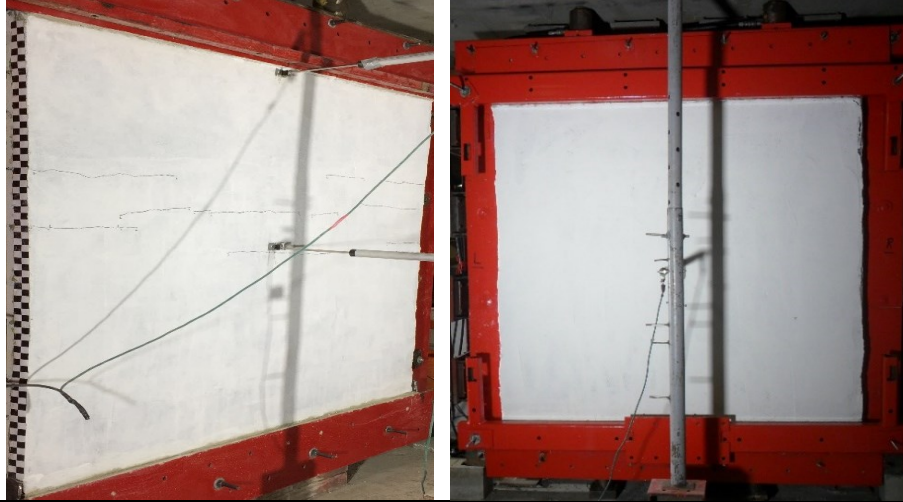
Blast ID 11 Damage Comparison: RCL-YC-3 vs R-S-L (Left: Jung, 2020)

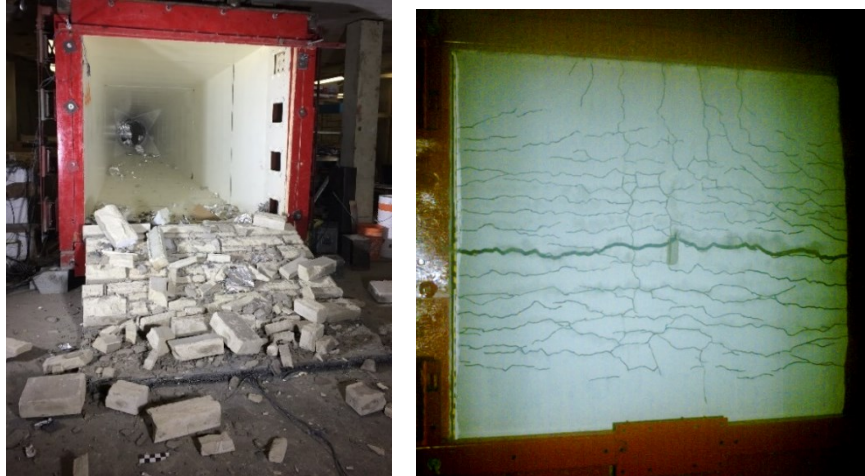
Figure 5-14. Load-Bearing Walls (CMU vs Stone), Retrofit Comparison: RCL-YC-3 vs R-S-L (R-S-L data from Jung, 2020)

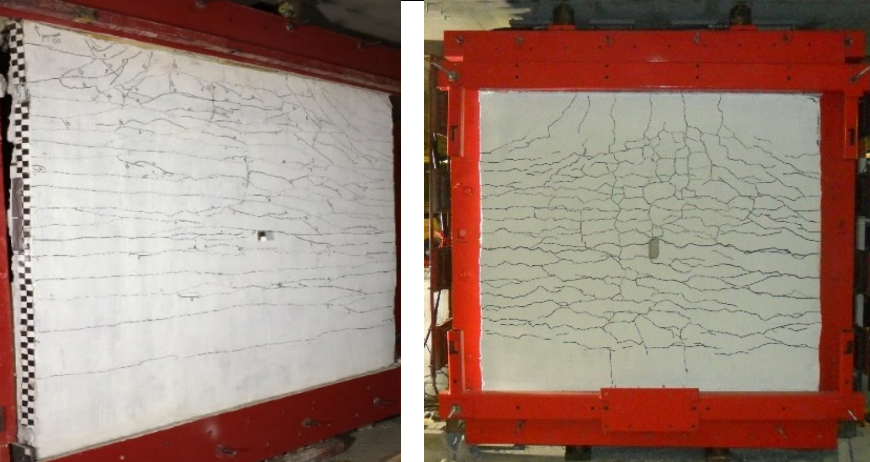
Figure 5-17. Axial Effect on CMU Walls, Performance Comparison:RCL-YC-3 vs R-C-N (R-C-N data from Jung, 2020)

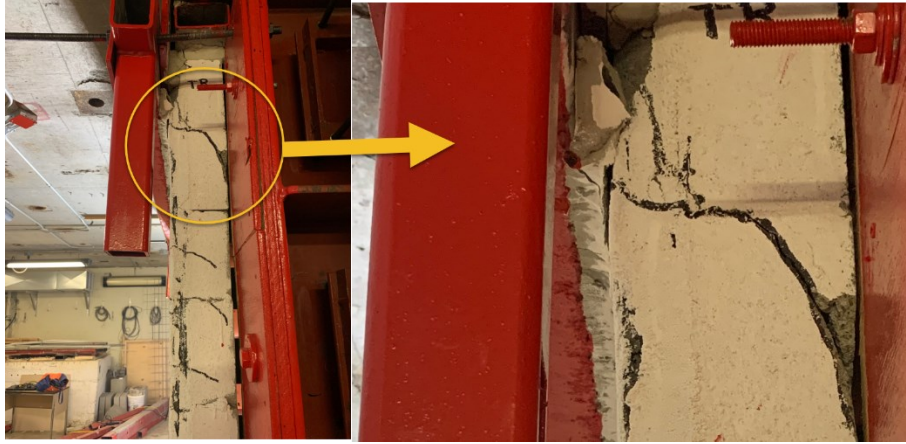
Figure 6-1. Out-of-plane shear demand on RCL-YC-3 after Blast ID #15
