**Active Layer Detachment Morphology, Sedimentology and Mechanisms, Fosheim Peninsula,
Ellesmere Island**

Thesis submitted to the
Faculty of Graduate and Postdoctoral Studies
In partial fulfillment of the requirements
For the MSc degree in Geography

Department of Geography
Faculty of Arts
University of Ottawa

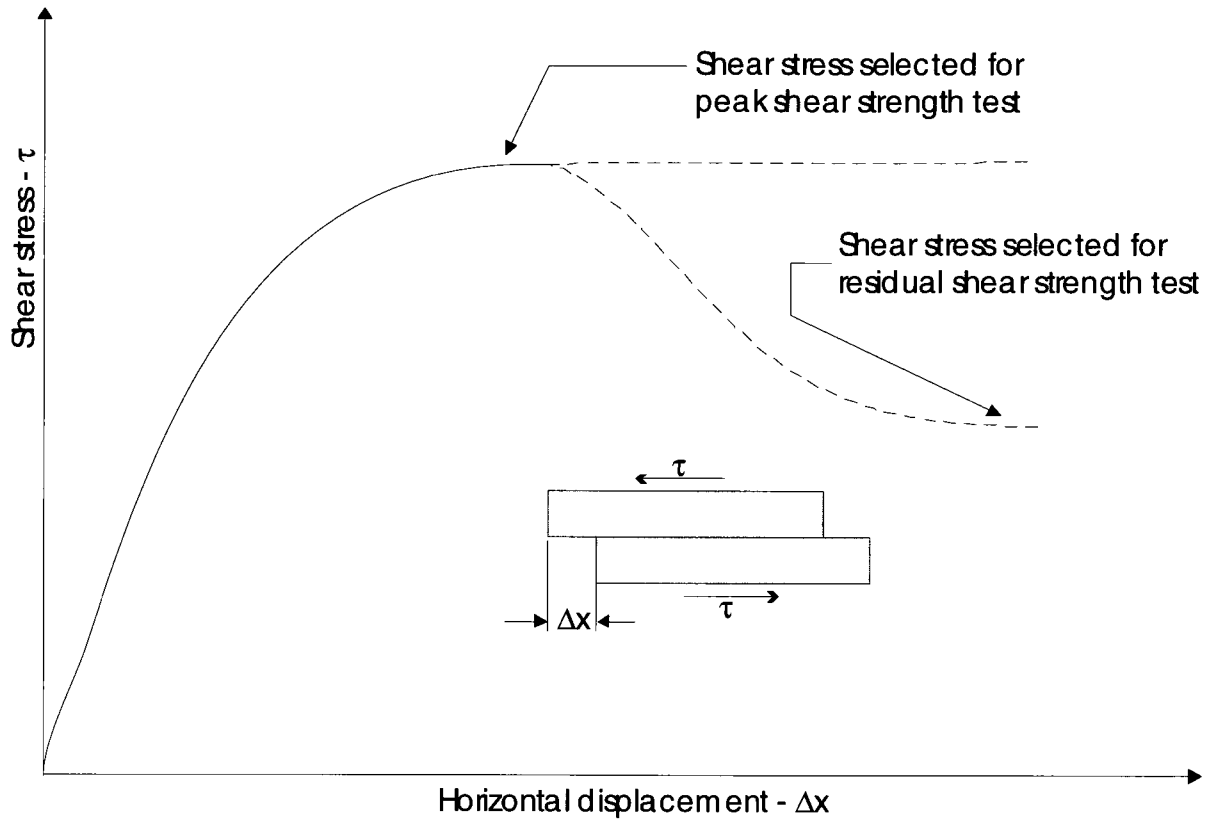
Figure 3-6. Stress-displacement curve showing selected maximum shear stress value for peak and residual direct shear tests (modified from Duncan and Wright 2005).

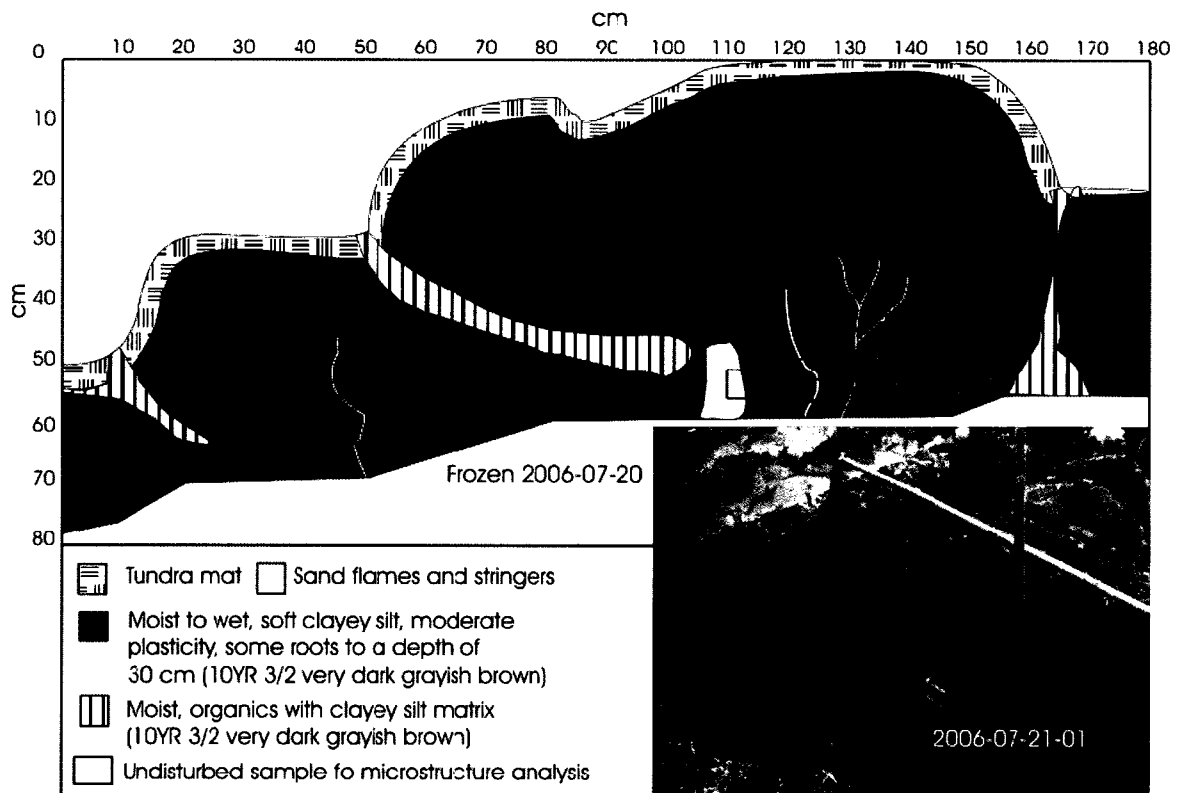
Figure 4-8. Trial pit description of TP 3 excavated across a transverse ridge within the compression zone of SC-2005-01. Trial pit face is parallel to movement direction (towards the left).

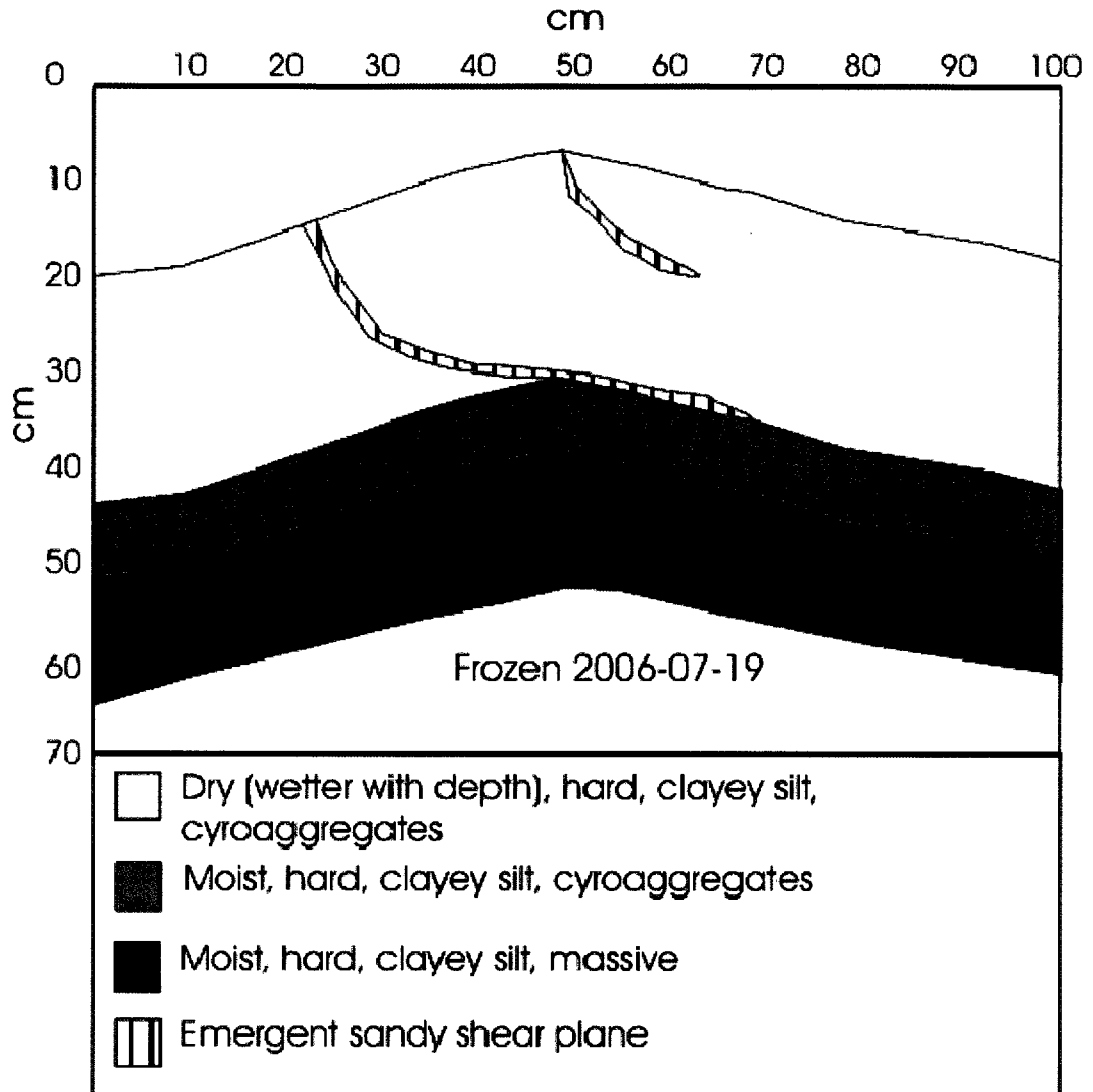
Figure 4-16. Trial pit description of BTC-2005-04 TP 2 across transverse ridge within the compression zone. Movement direction towards the left.

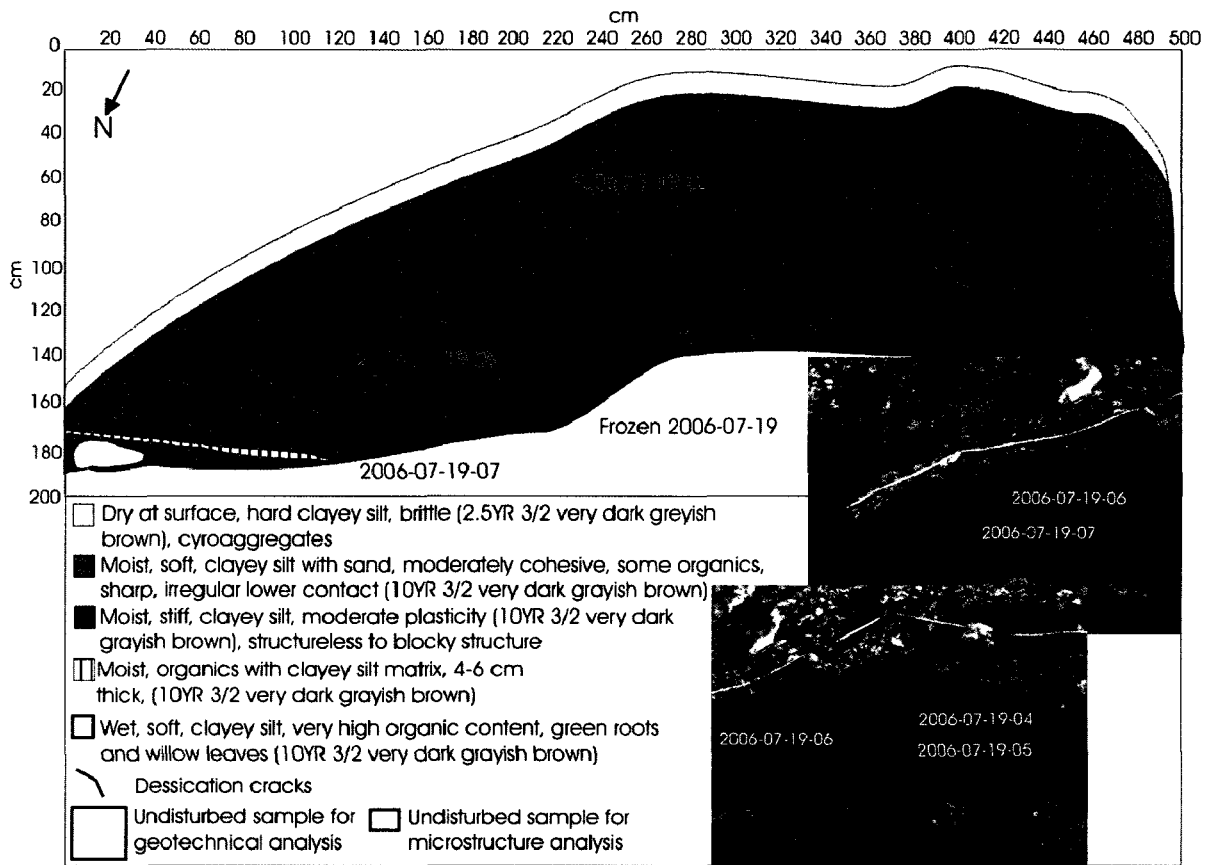
Figure 4-17. Trial pit description of BTC-2005-04 TP 3 across transverse ridge within the compression zone at the Black Top Creek top of bank. Direction of movement towards the left.

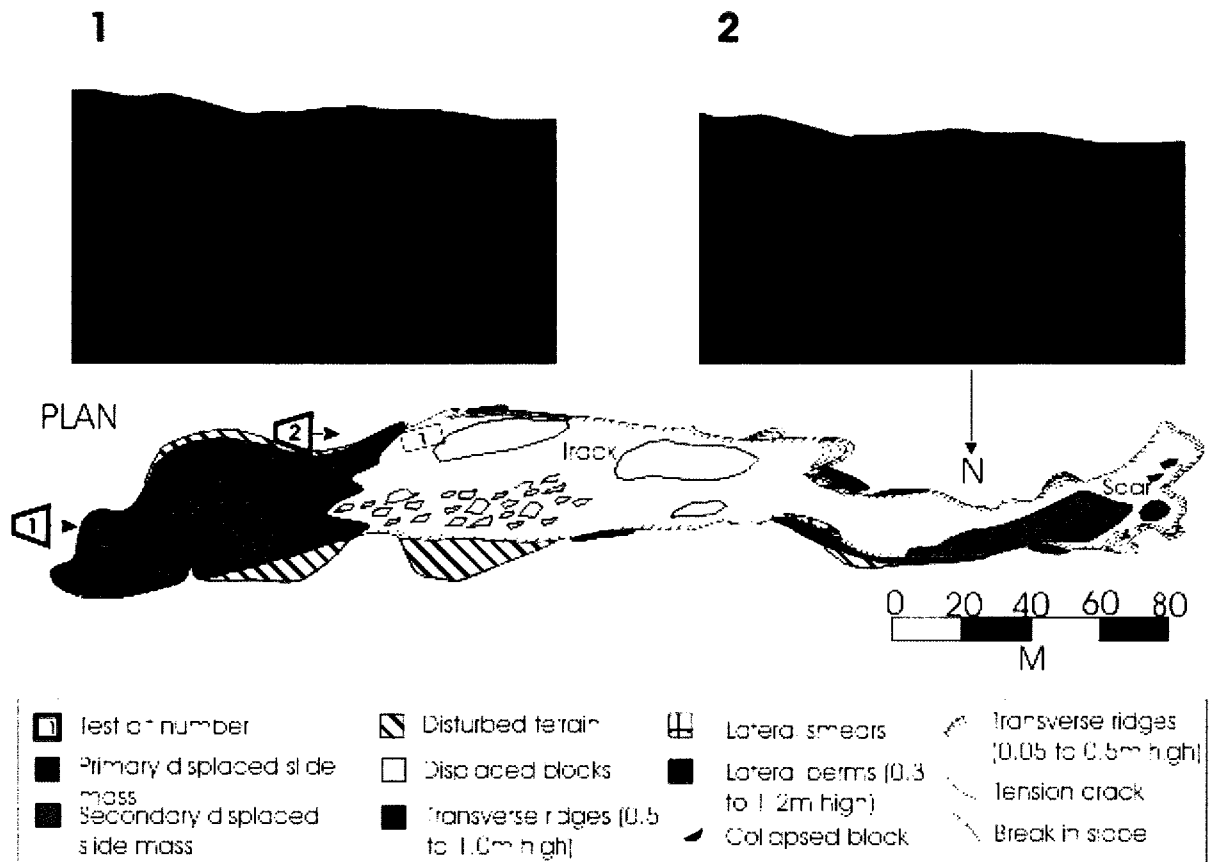
Figure 4-30. Plan and profile of elongate failure, BSC-2005-01. Movement direction towards the left. Sketch developed from a combination of field mapping with tape measure and GPS, and aerial mapping from helicopter surveys. Photo locations and orientation are shown on the map.
