Static and Dynamic Analyses of a Long-Span Cable-Stayed Bridge with Corroded Cables

Thesis submitted to the Faculty of Graduate and Postdoctoral Studies
in the partial fulfillment of the requirements for the degree of

Department of Civil Engineering

University of Ottawa

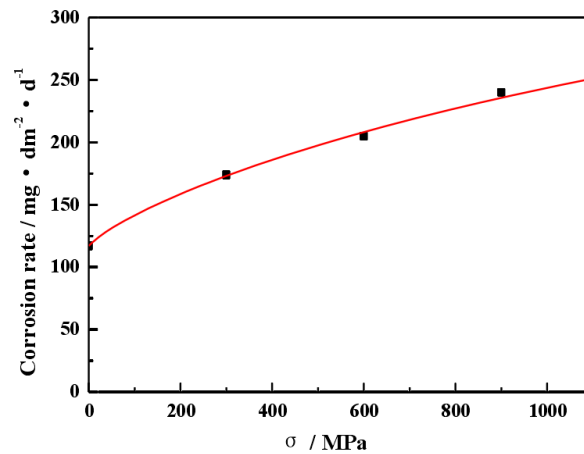
Fig. 2.7. Corrosion rate of steel wire under different stresses (Liang, 2008)

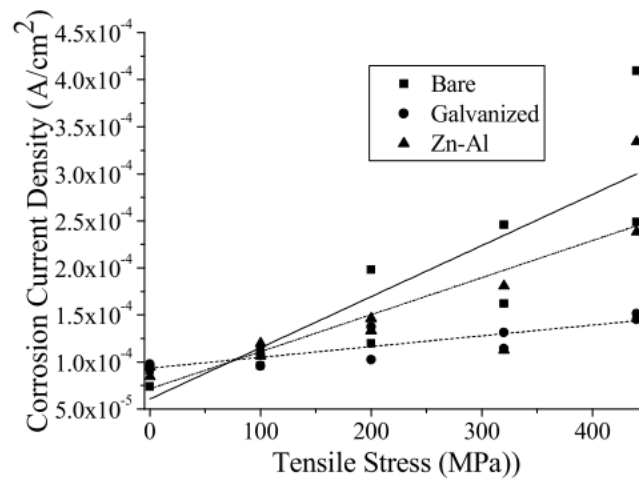
Fig. 2.9. Corrosion current densities of cable wires with different stresses (Xie et al., 2015)

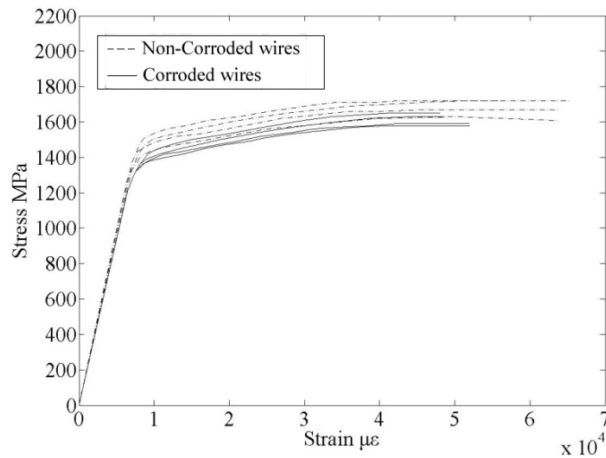
Fig. 2.13. The relationship between stress and strain of wires (Li et al., 2012)

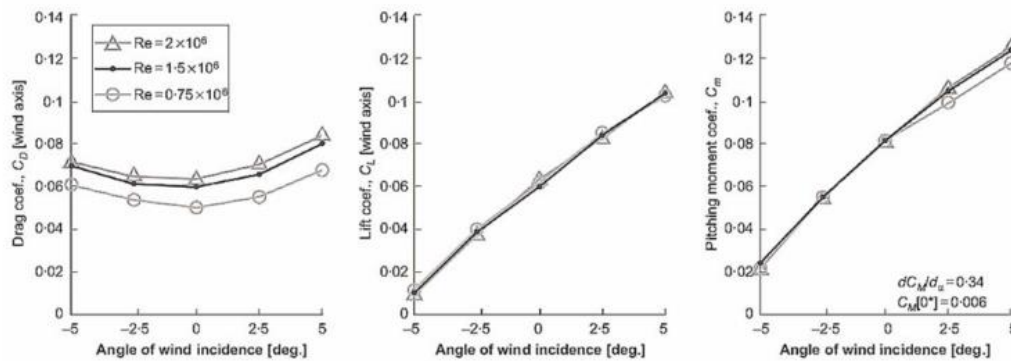
Fig. 2.17. The wind load coefficients obtained for Stonecutters cable-stayed bridge model (Larsen et al., 2012)

obtain the three important wind load coefficients. Figure 2.17 provides the details for the experimental results.

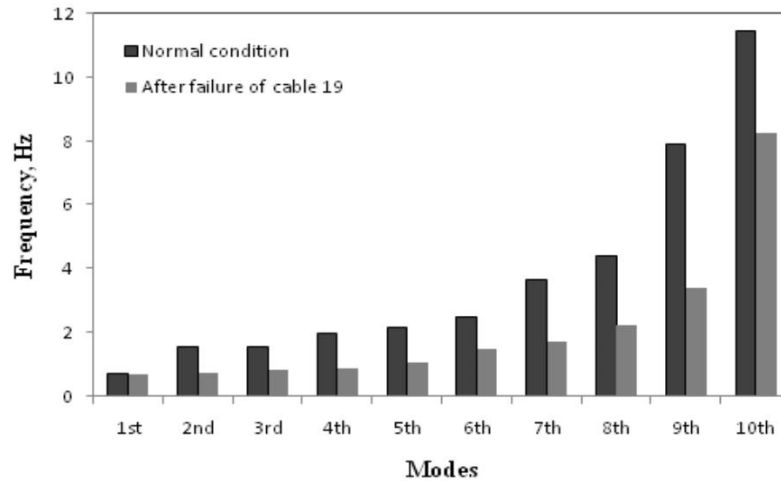
Fig. 2.20. Comparison of natural frequencies before and after cable failure (Vikas et al., 2013)

The authors found that the internal forces of cables around the ruptured cable were increased and that those of cables away from the ruptured cable were reduced. The deflection of half deck, illustrated in Figure 2.19, shows an increase of 6.9% around the location where the cable failed. A gradual decrease in natural frequency as the corrosion level increased was observed in the dynamic analysis, as illustrated in Figure 2.20.

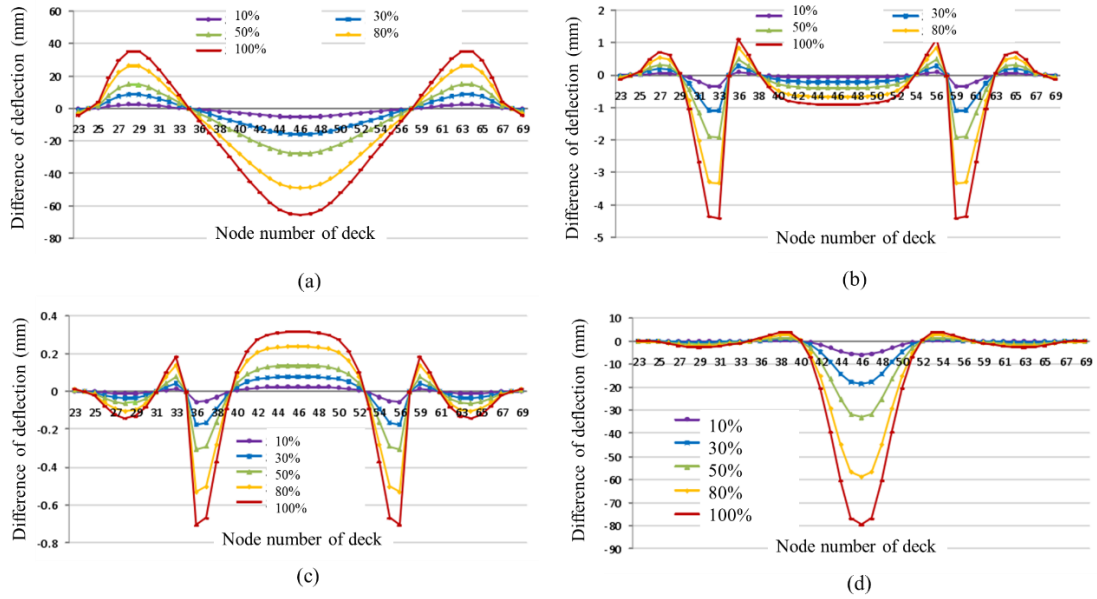
Fig. 2.23. The deck deflection change at different corrosion levels, and the corrosion cable located at (a) L1 and R1 cables, (b) L10 and R10 cables, (c) L11 and R11 cables, (d) L20 and R20 cables (Zhang, 2015)

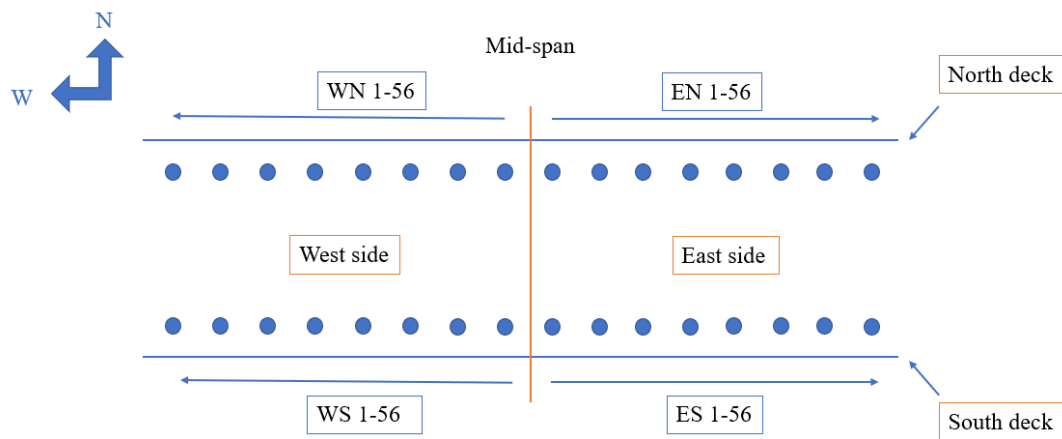
Fig. 3.7. Numbering and notation convention of cables in the plan view

are not the same throughout the bridge owing to diverse forms of load distribution among the cables. In order to easily identify the cables, they are named and numbered by specifying their location in the bridge. The x-direction and z-direction in ABAQUS represent the South and West directions in global coordinates, respectively (Figure 3.5(a)). The numbering and notation convention for each cable can be found in Figure 3.7. The point of origin is set at the mid-span. The west-side of the north and south decks are named as WN and WS, respectively. In the east side, the north deck and south deck are referred to as EN and ES, respectively. Cables are numbered sequentially from the first cable near the mid-span to the last cable on the back span. For instance, cable ES1 represents the first cable near the mid-span on the east side of the south deck. Table 3.2 provides the details of the 224 stay cables of the bridge.

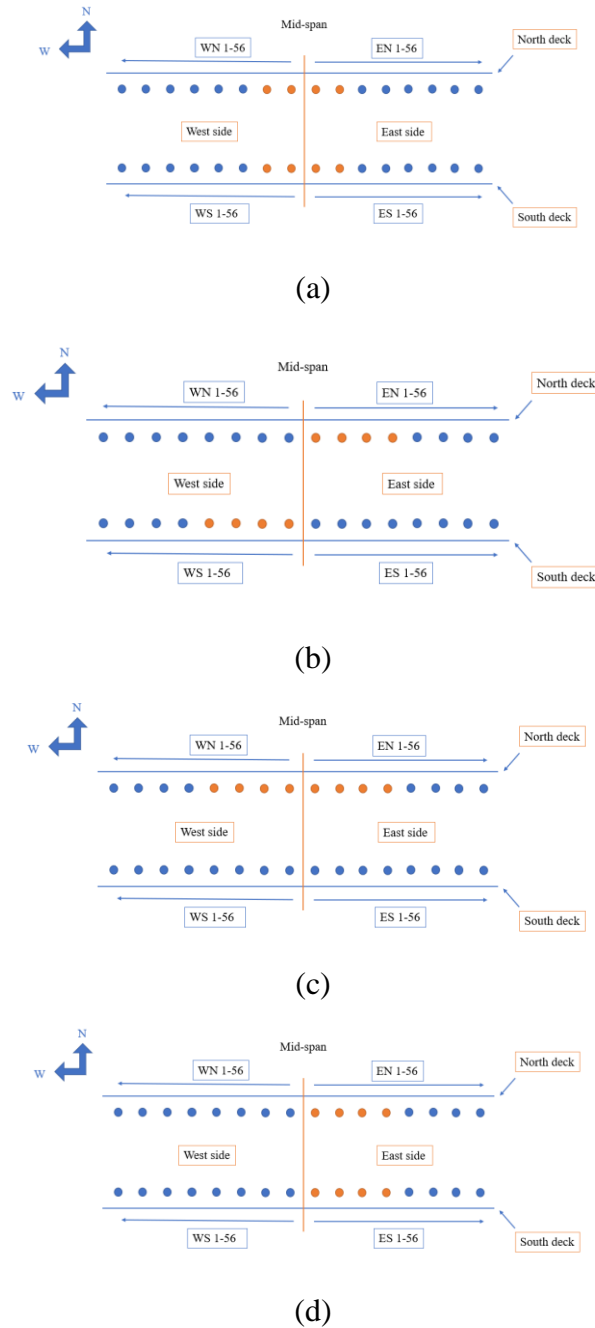
Fig. 4.3. Four major corroded configurations with respect to middle point of the span: (a) major case 1, (b) major case 2, (c) major case 3, and (d) major case 4

research is available for groups of several corroded cables, which could have a significant impact on the structural response of the bridge. In this research, a group of eight cables were selected for corrosion simulation, and these were classified into four major configurations which are shown in Figure 4.3.(a) to (d). Note that corroded cables are denoted as orange in Figure 4.3.

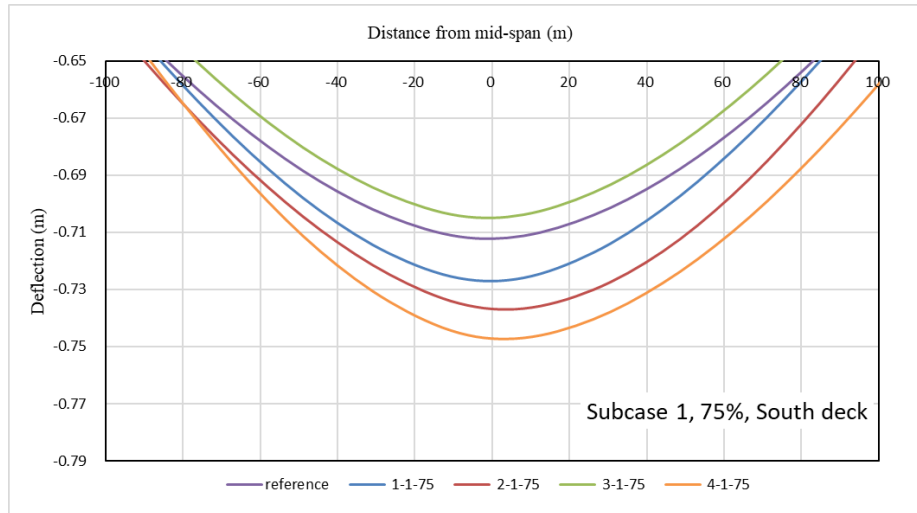
advanced corrosion damage of 75% cross-section loss.

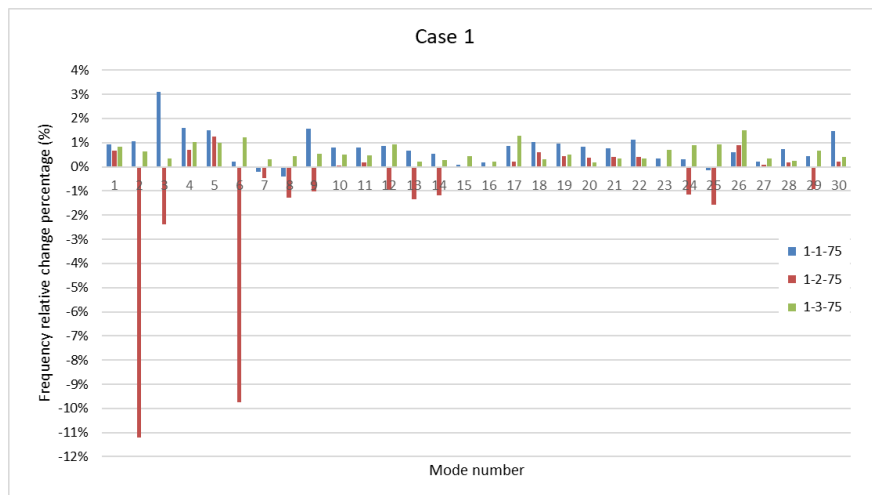
Fig. 5.5. Frequency relative change percentage for different subcases of case 1

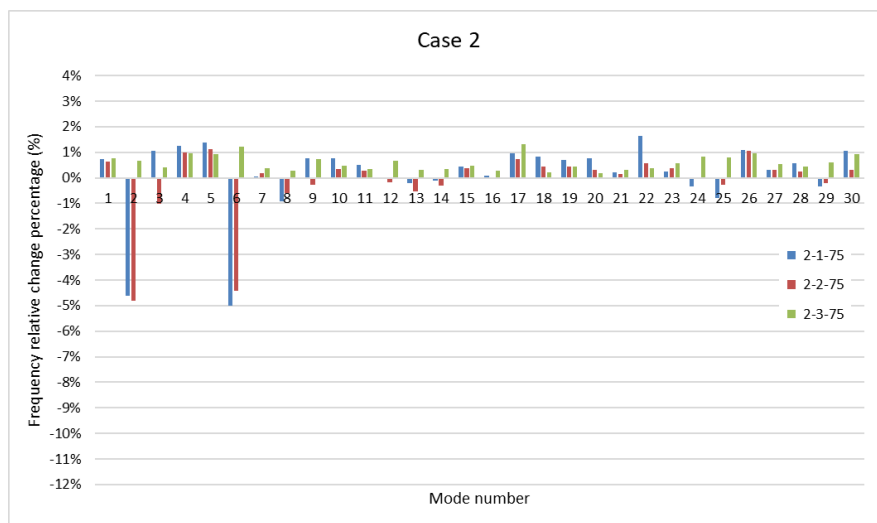
Fig. 5.6. Frequency relative change percentage for different subcases of case 2

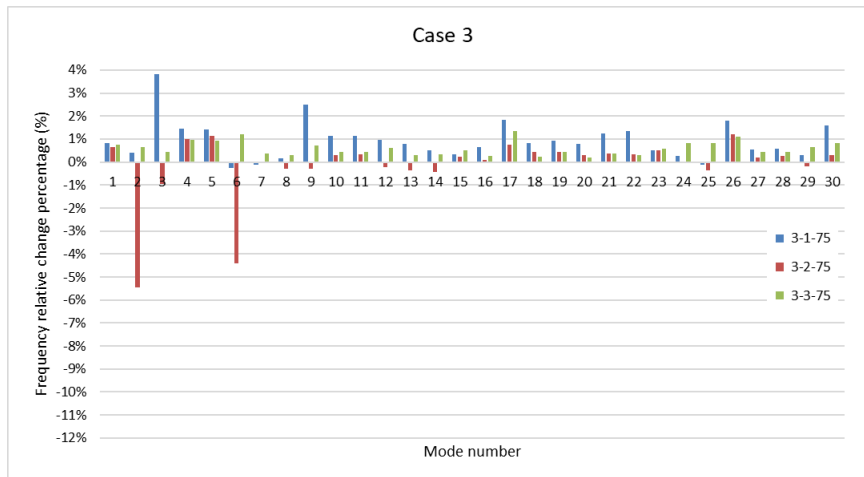
Fig. 5.7. Frequency relative change percentage for different subcases of case 3

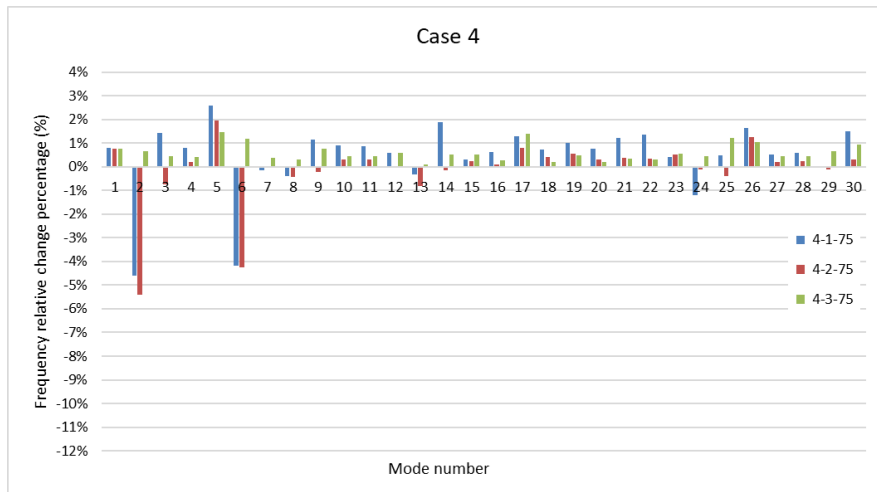
Fig. 5.8. Frequency relative change percentage for different subcases of case 4

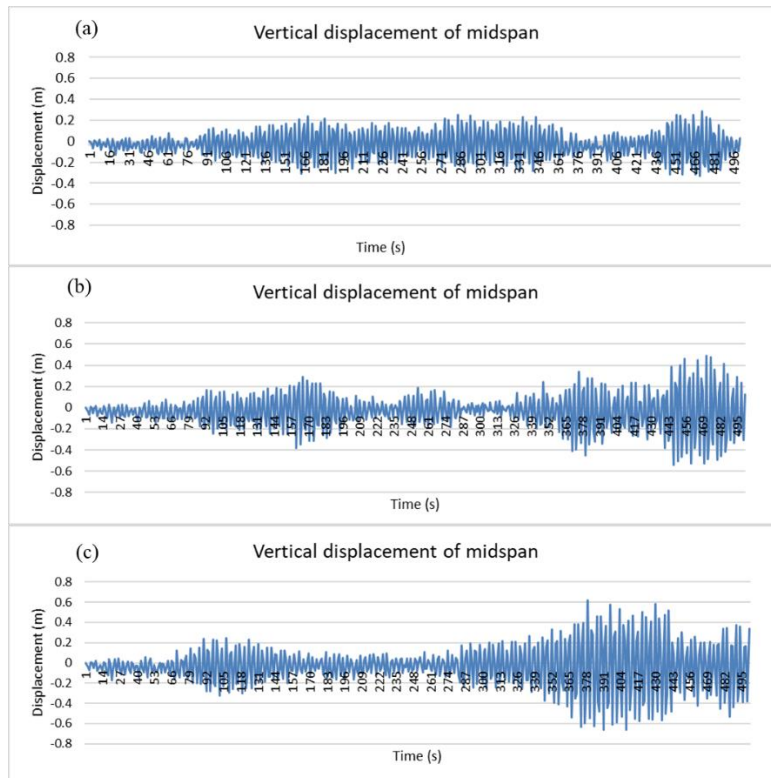
Fig. 5.30. Vertical displacement of mid-span for subcase 4-1: (a) reference case; (b) subcase 4-1-25; (c) subcase 4-1-75
