# **Seismic Retrofitting of Concrete Bridge Columns by External Prestressing**

A thesis submitted to the Faculty of Graduate Studies and Research  
in partial fulfillment of the requirements for the degree

**Masters of Applied Science - Civil Engineering**

January 1999

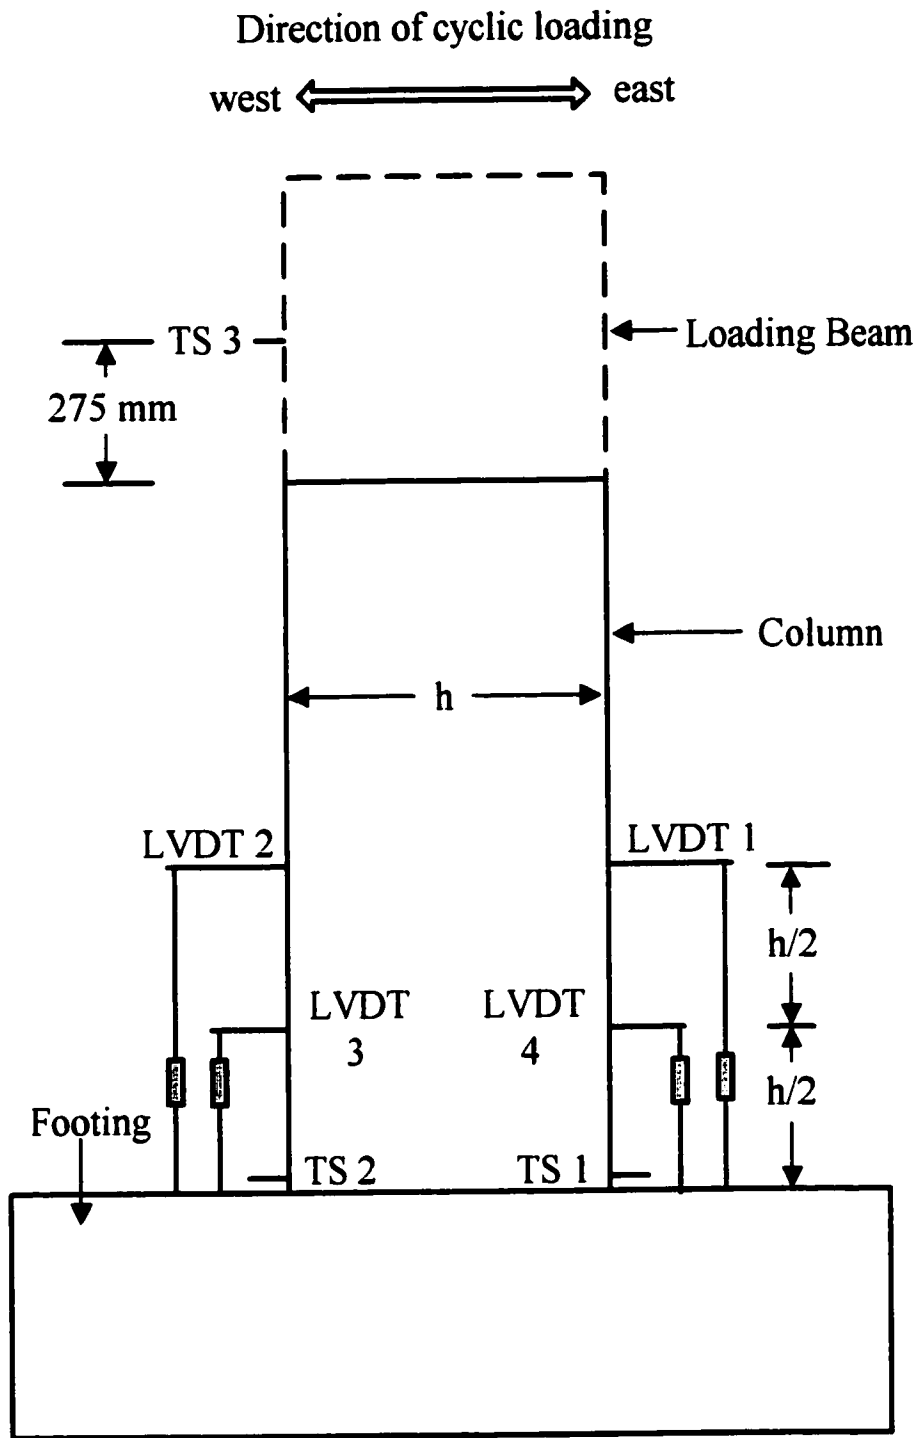
Note: TS = Temposonic LVDT

Fig. 2.16 Column instrumentation

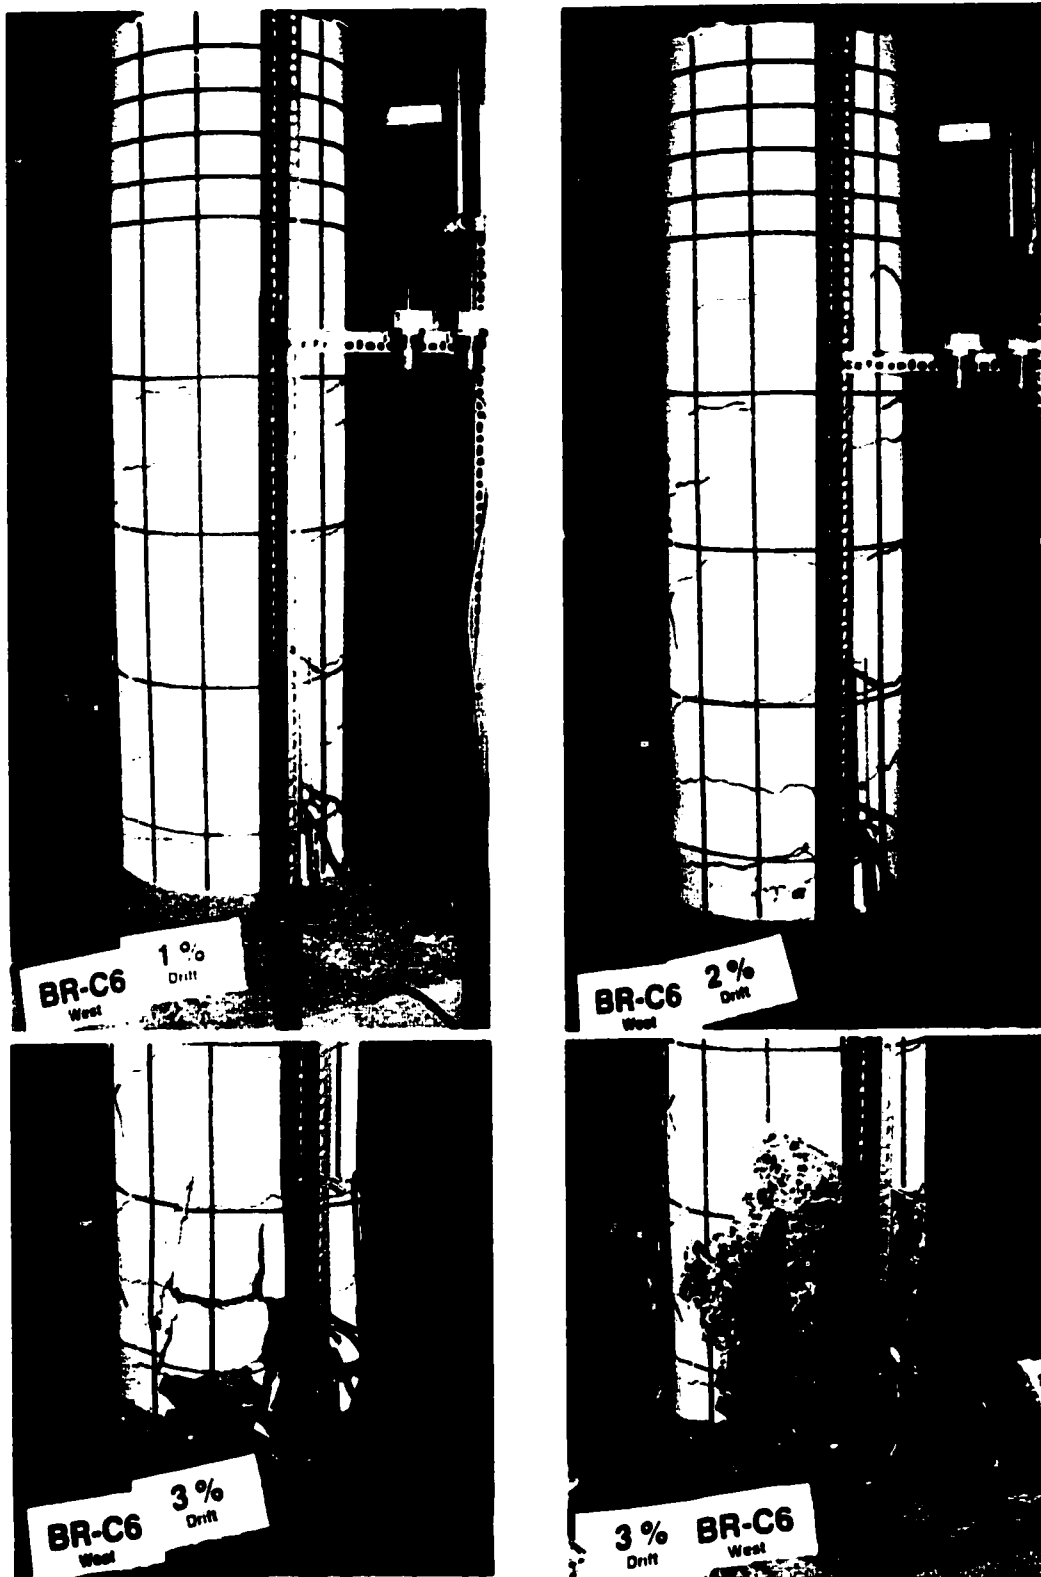
Fig. 3.1a Column BR-C6 at 1% drift (upper left), 2% drift (upper right) and 1<sup>st</sup> and 2<sup>nd</sup> cycles of 3% drift (lower left and right respectively)

The progression of damage observed during testing is illustrated in Fig. 3.1, at different stages of loading. Initial flexural cracks formed in the bottom half of the column during the cycles at 0.5% drift. No other signs of deterioration were noted at this load level. The lateral load resistance during the first cycle at 0.5% drift reached 172 kN. The load resistance increased to 228 kN during the initial cycle at 1% drift. The cycles at 1% drift

caused yielding of longitudinal bars and lengthening of the flexural cracks.

By the end of the cycles at 2% drift, there were signs of shear cracking on side faces, as well as crushing and spalling of concrete under flexural compression at the base of the column. The flexural cracks started to widen and the strain gauges recorded values reaching up to half the yield strength in hoops. The lateral load resistance reached its peak value of 246 kN during the initial cycle at 2% drift, and did not drop below 95% of this value during the subsequent cycles at 2% drift. The lateral load resistance dropped to 206 kN (85% of peak lateral load) during the initial cycle at 3% drift. It continued to drop to 176 kN and below 100 kN in the second and third cycles, respectively. A lateral load resistance of less than 80% of the peak capacity is considered by many researchers to represent column failure. Therefore, this column would be considered failed after having completed the first cycle at 3% drift. At the start of the cycles at 3% drift, the lowest level hoop yielded and the concrete cover started to spall more severely. By the second cycle, the concrete cover in the lower portion of the column was completely spalled off and buckling of the longitudinal bars was evident. The second hoop from the bottom of the column (425 mm above the footing) opened during the third cycle. This caused all the longitudinal bars to buckle out, and the column to collapse. The failure was quite sudden and explosive once the hoop opened up, which was a good indication that hoops with overlapping ends were unreliable once the concrete cover spalled off.

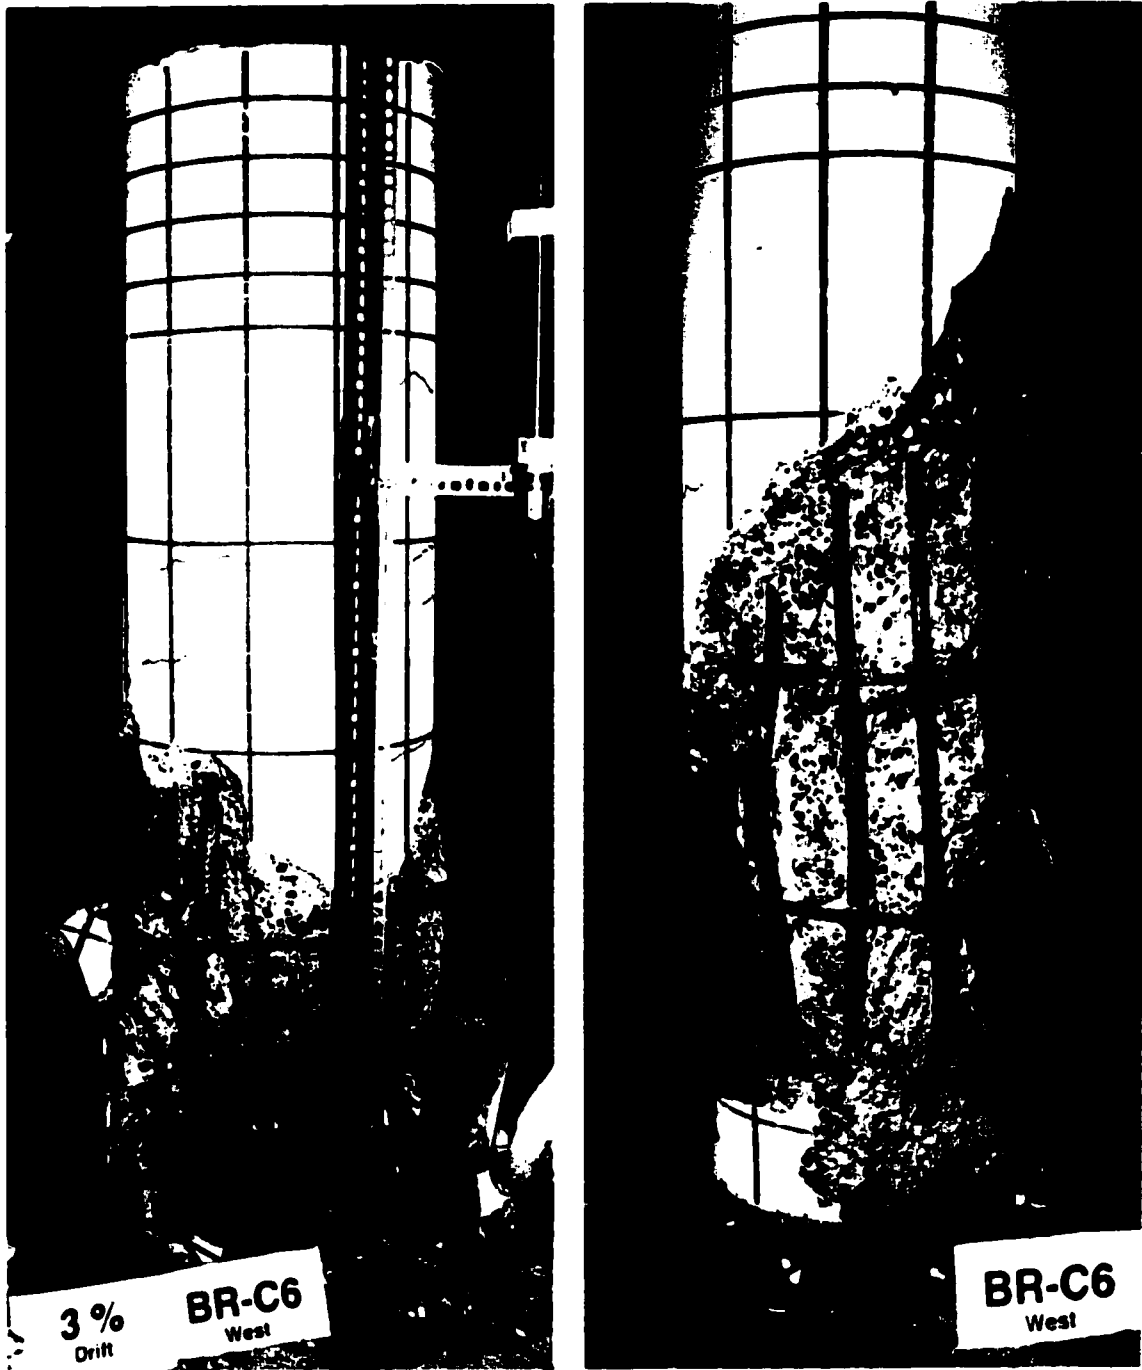
Fig. 3.1b Column BR-C6 at the end of the third cycle at 3% drift (left) and at the end of test (right)

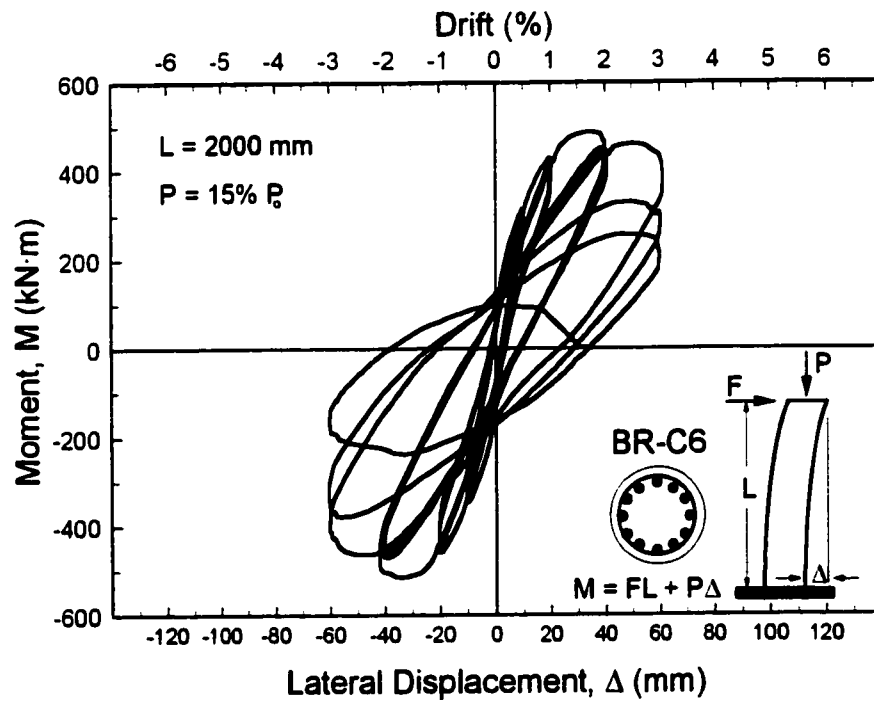
Fig. 3.2 Force and Moment-Displacement relationships for column BR-C6

The test observations mentioned in the previous section were substantiated by the test data collected and plotted. Figure 3.2 depicts Force-Displacement and Moment-Displacement hysteretic relationships recorded for Column BR-C6, clearly showing the degradation of load resistance under cyclic loading. The column behaved quite well until the first cycle at 3% drift, after which, it deteriorated quite rapidly.

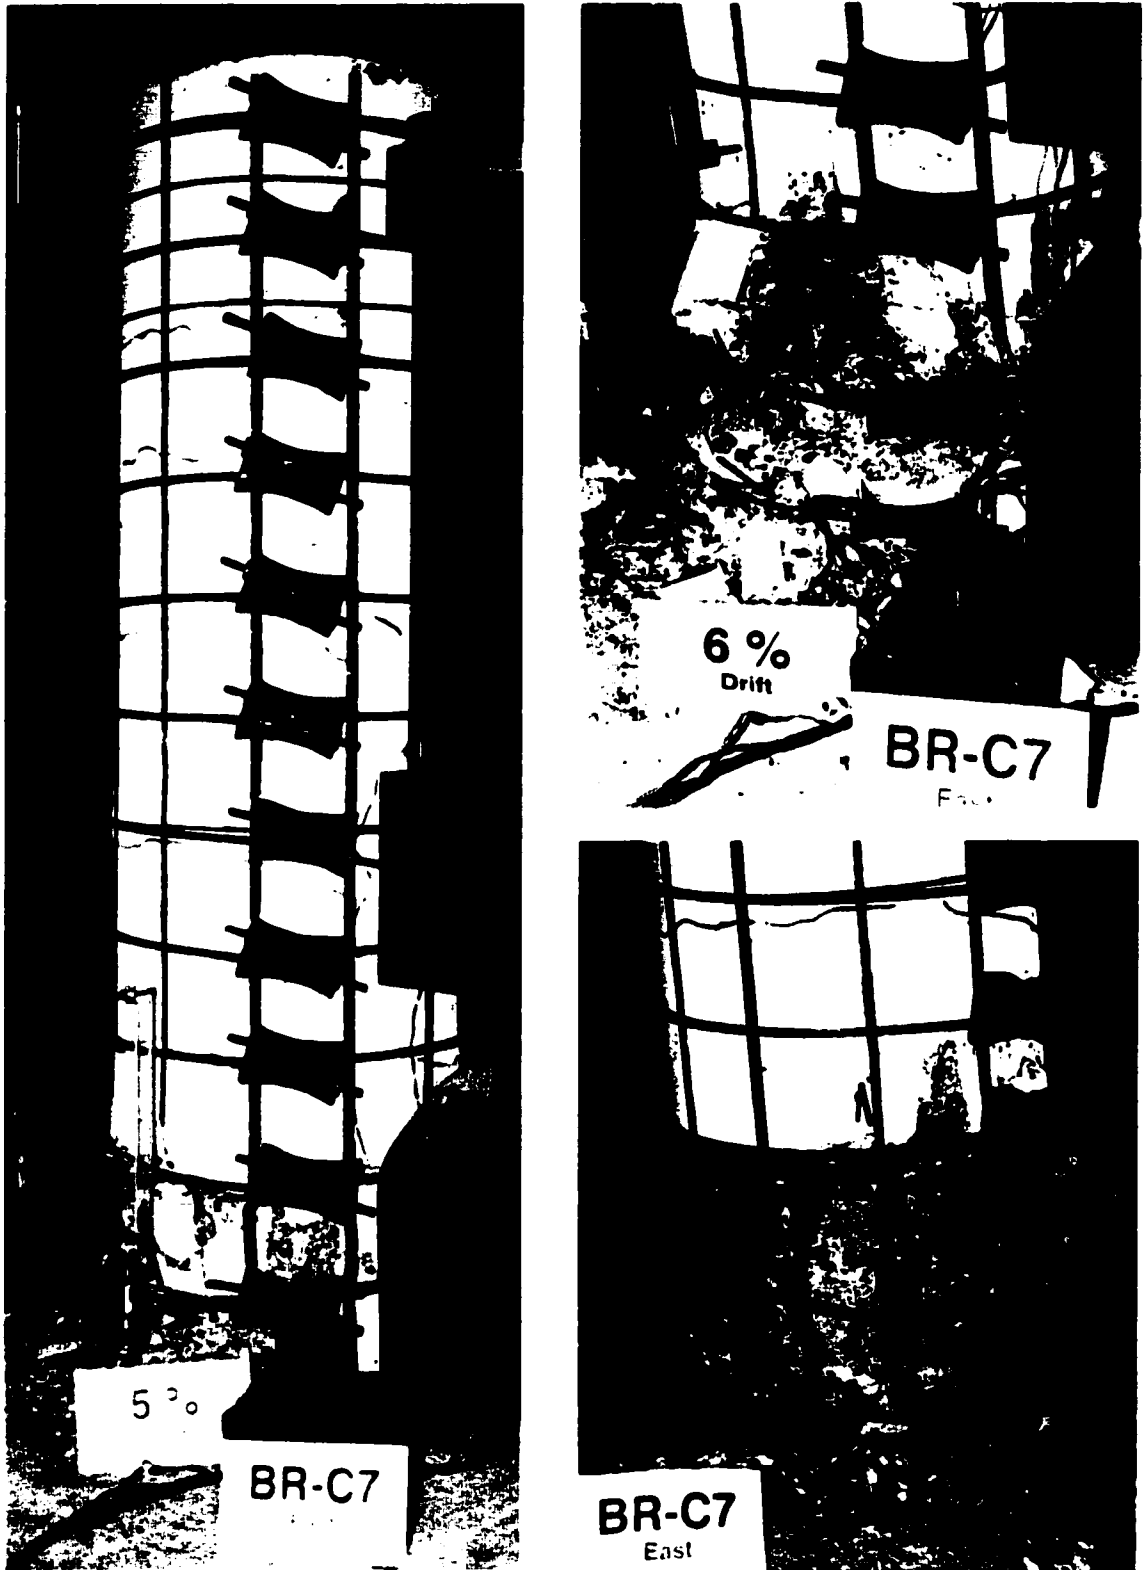
Fig. 3.6c Column BR-C7 at 5% drift (left) and 6% drift (upper right) and at the end of test (lower right)

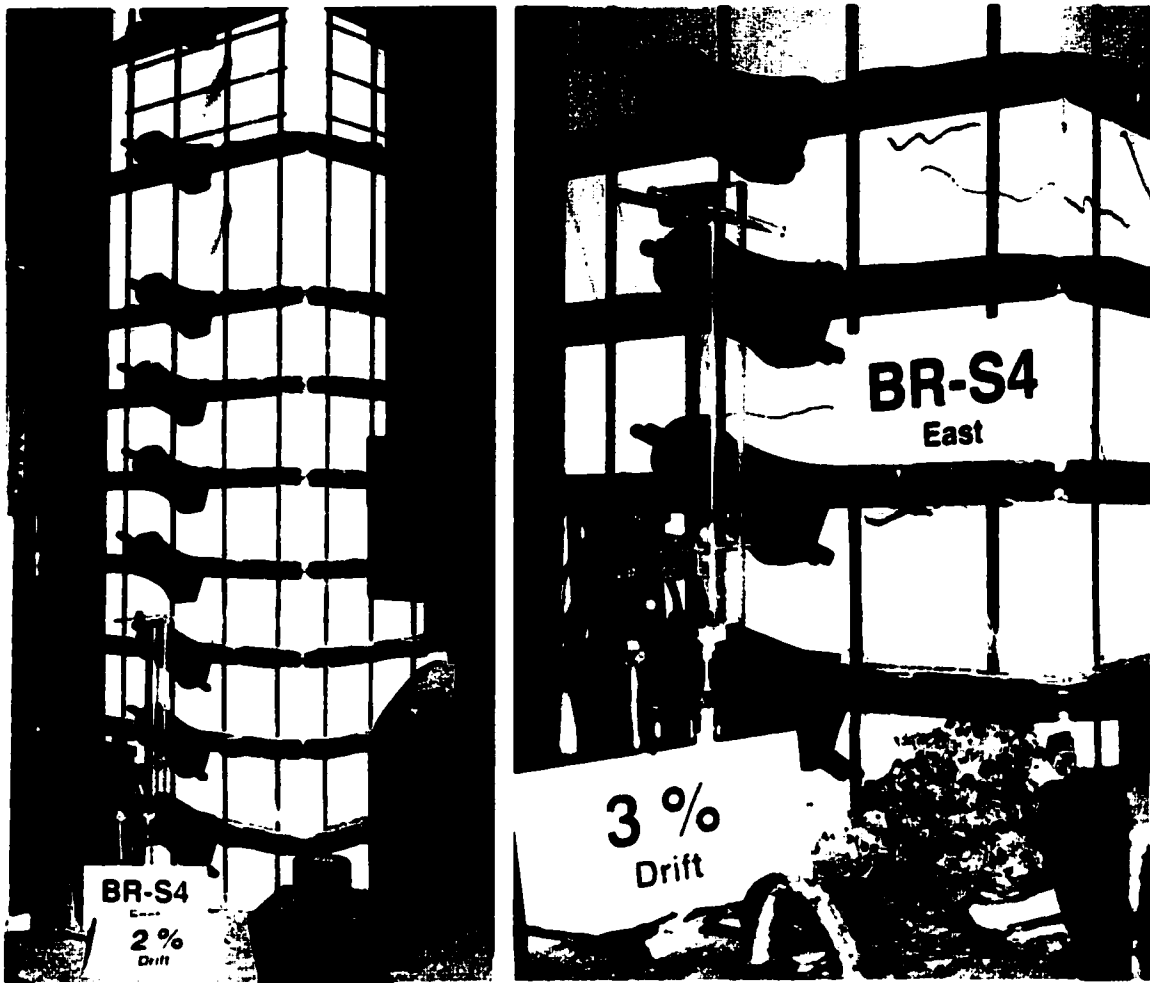
Fig. 3.19a Column BR-S4 at 2% drift (left) and 3% drift (right)

Figure 3.19 depicts the observed damage in Column BR-S4 at various stages of

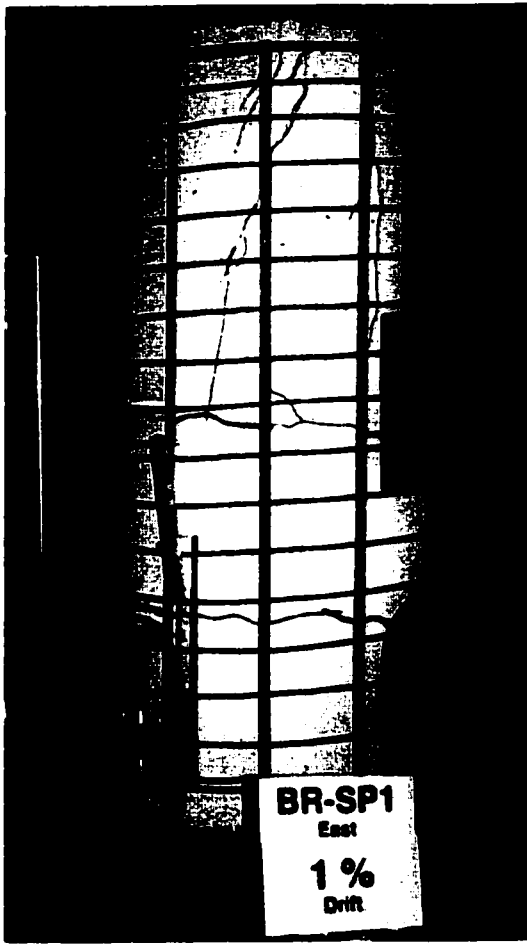
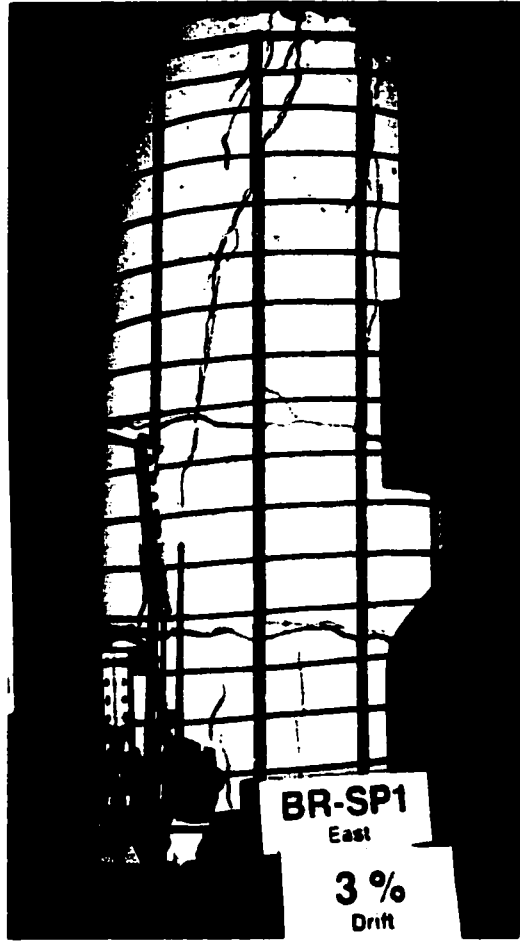
Fig. 3.27a Column BR-SP1 at 1% (upper left), 3% (upper right) and 4% (lower) drift

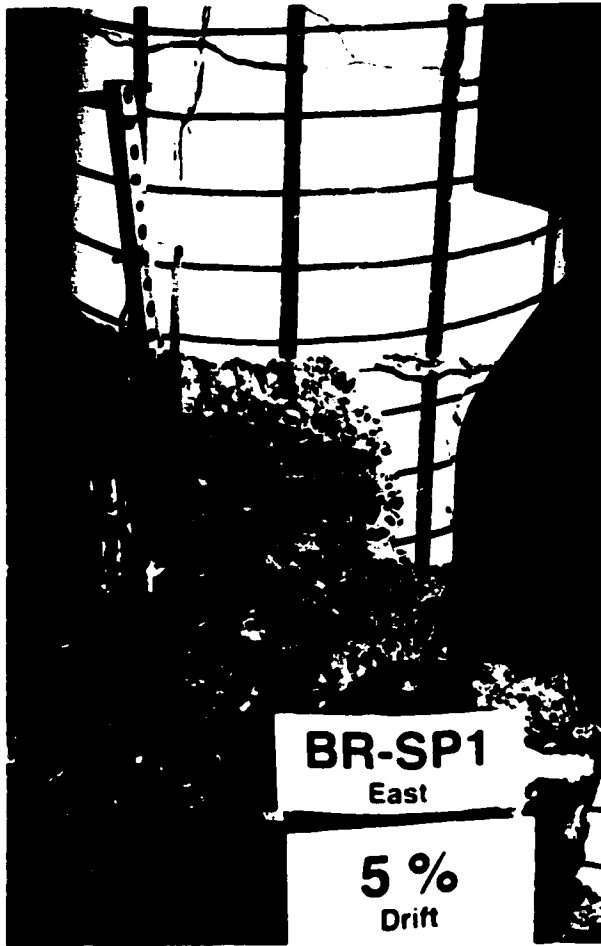
Fig. 3.27b Column BR-SP1 at 5% drift (left) and 6% drift (right)

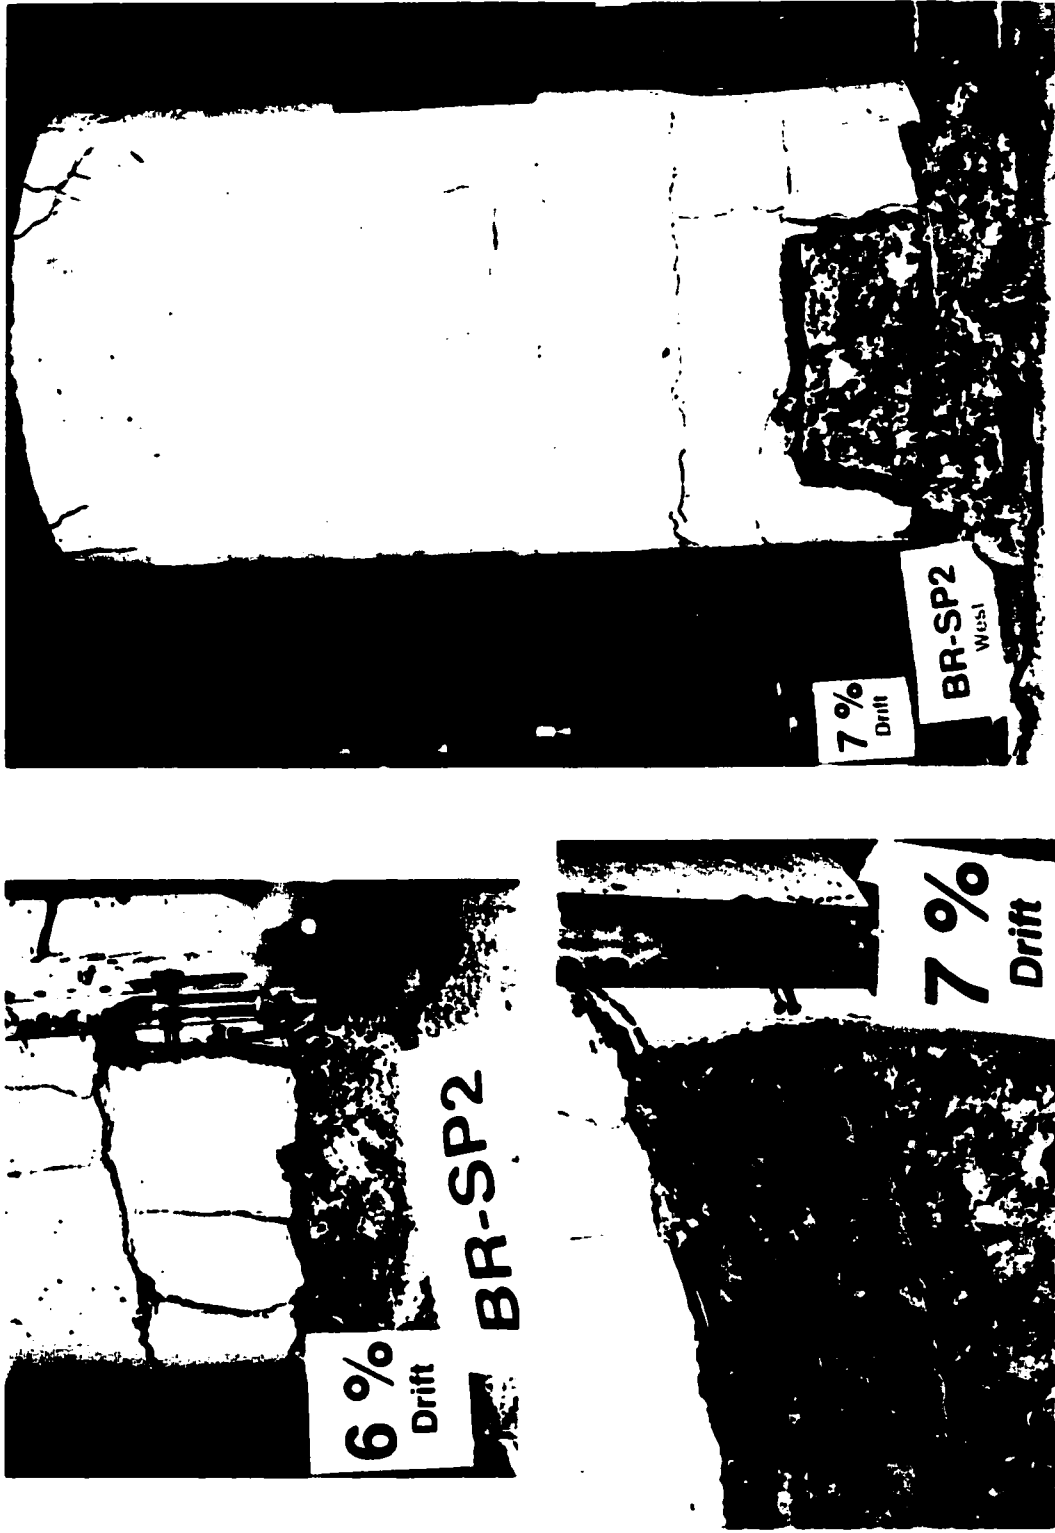
Fig. 3.32b Column BR-SP2 at 6% drift (upper left) and 7% drift (right & lower left) with ruptured longitudinal bars
