# **Seismic Risk Assessment of Wood Frame Construction Using Fuzzy Based Techniques**

By  
**Sajjad Ghorbani Komsari**

**Master of Applied Science**

in Civil Engineering

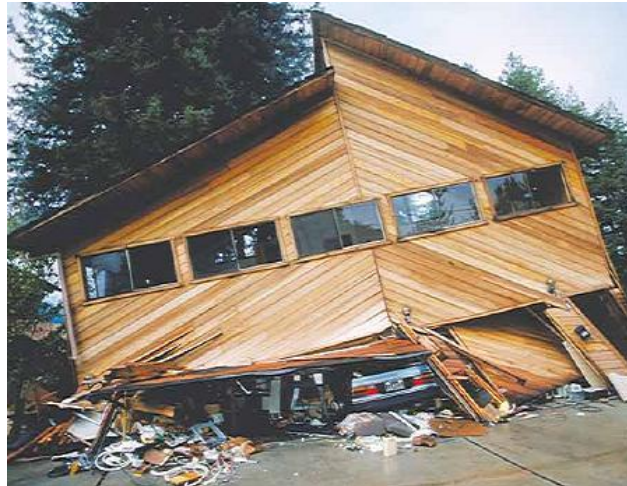
**Figure 1-1: A light wood frame building in Santa Cruz Mountains, California, collapsed in the 1989 magnitude 6.9 Loma Prieta Earthquake**  
(Photo from USGS)

The historical seismic performance of wood frame construction has shown that in general, properly constructed wood-framed buildings are capable of resisting the damaging effects of earthquake ground motion especially with regard to life safety (Park and van de Lindt, 2010). However, societal and economic losses due to recent earthquakes in urban areas have been surprisingly high (Rojhan and Eghuchi, 2000) which can be attributed to many factors. From the structural point of view, although the seismic behaviour of light wood frame subsystems, such as walls and floors, have performed well individually, the primary deficiencies have been related to the interfaces between them; such as connections between floors and walls, roofs and walls, and walls and foundations. On the other hand, low rise buildings are typically non-engineered. Therefore, even if they are light weight and have many connectors (nails) which provide redundancy and ductility, the lack of engineering makes seismic reliability not consistent from one building to another. Also, what used to be considered as “typical light frame”, has changed substantially with time. In the 1960s, the size of the building was smaller, the structure was more regular and contained many walls (and less openings). Modern day structures are larger and have more openings and open spaces which may increase their damageability. Figure 1-1 shows a light wood frame building in California, collapsed in the 1989 magnitude 6.9 Loma Prieta Earthquake.

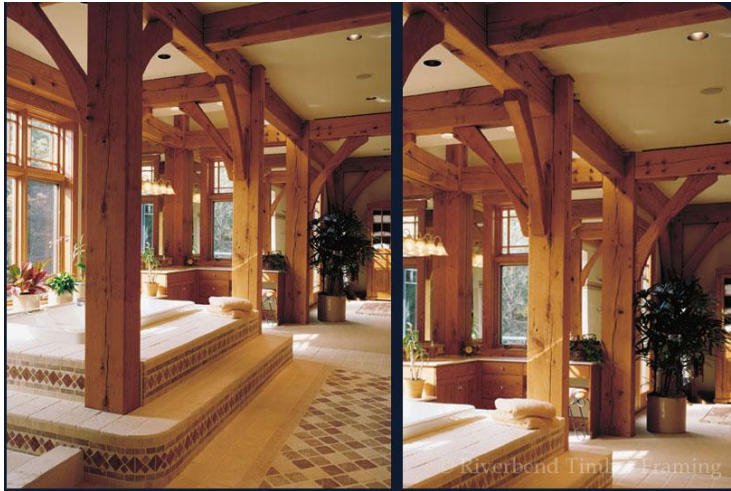
**Figure 1-3: Traditional Timber Frame Construction**  
(Riverbend Timber Framing, 2014)

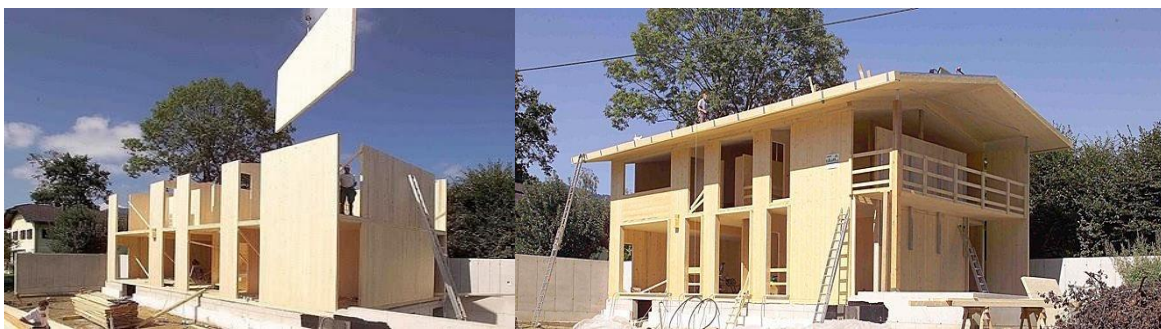
**Figure 1-6: Cross Laminated Timber Building**  
(KLH GmbH, 2010)

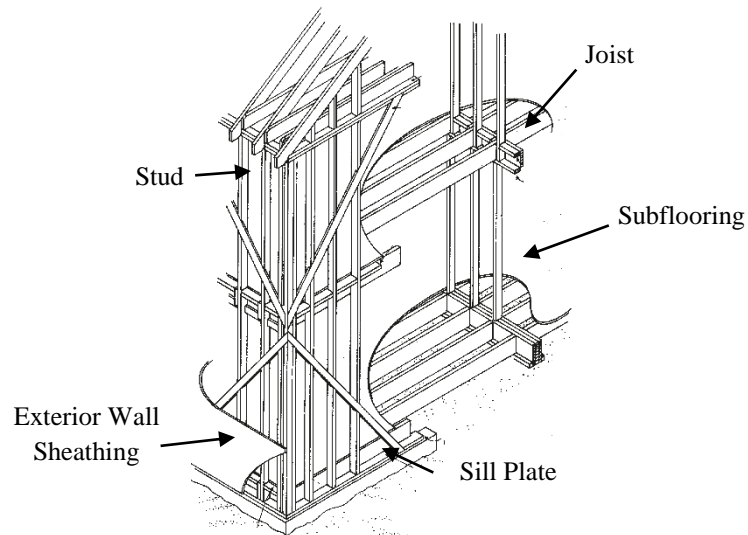
**Figure 1-7: Typical Balloon Frame Construction**  
(AWC, 2001)

possible. In this method, the studs used for exterior and some interior walls pass through the floors and end at the roof level (Figure 1-7). It considerably sped up the construction process. However, since the connections between floor joist and studs are not prefabricated and not easy to be assembled on site, and are relatively costly, this type of framing is rarely used in the current construction practice (Ventura and Kharrazi, 2003; CMHC, 1999).

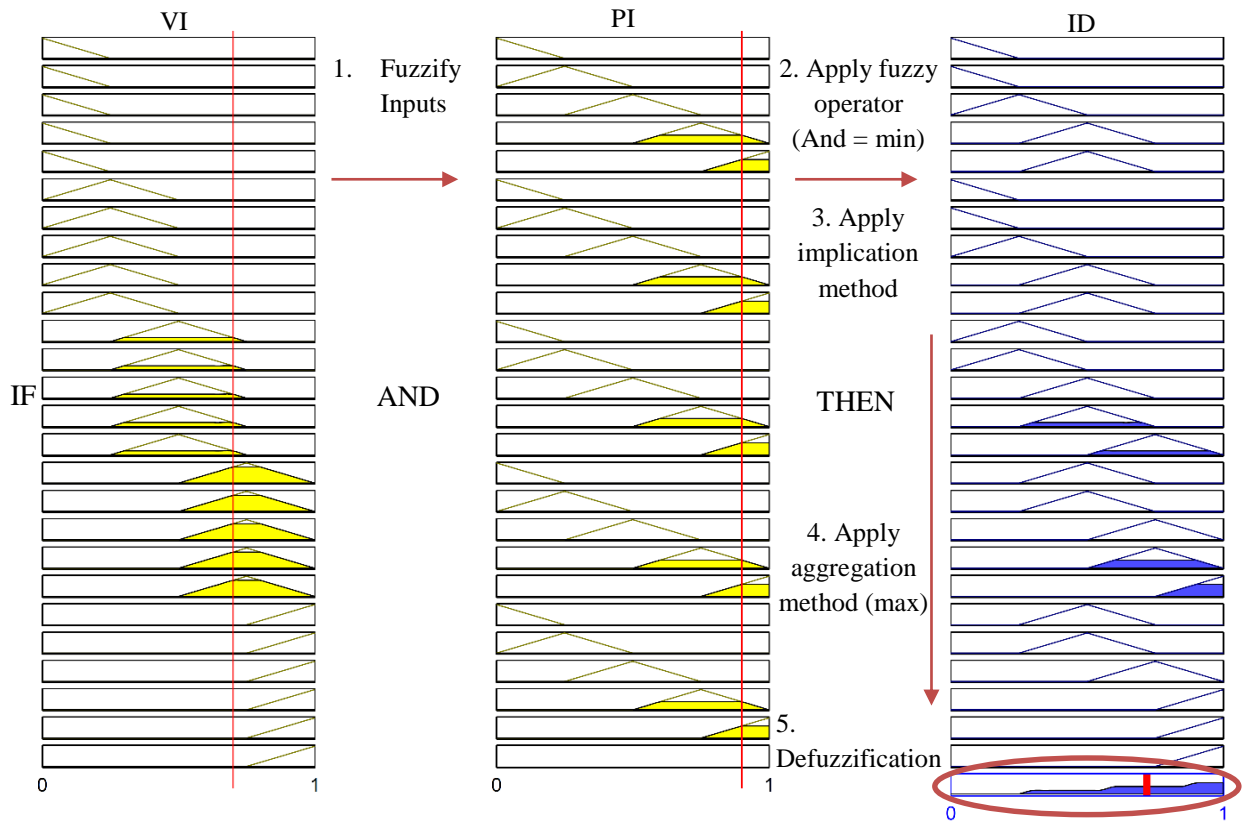
**Figure 2-3: Graphical Illustration of the Example Fuzzy Inference System** (MathWorks, 1997)

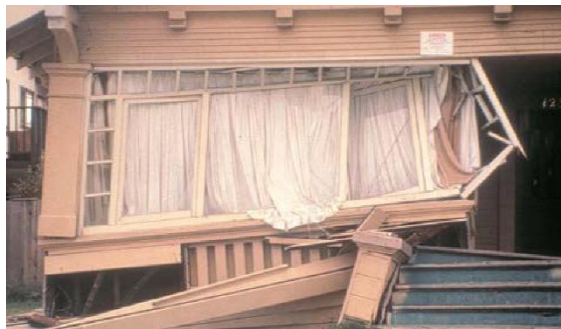
**Figure 2-5: Failure of Cripple Wall in Loma Prieta Earthquake**  
(Photo: C.Stover, U.S. Geological Survey)

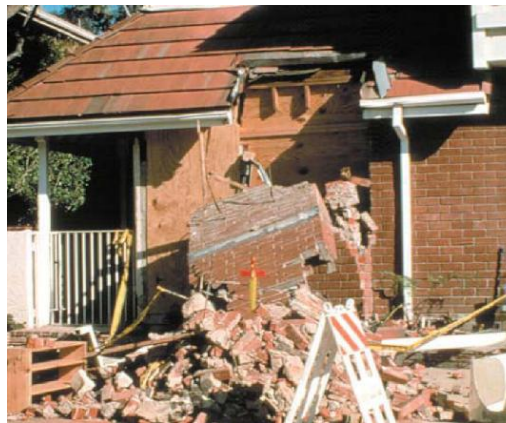
**Figure 2-6: Chimney Damage in Northridge Earthquake**

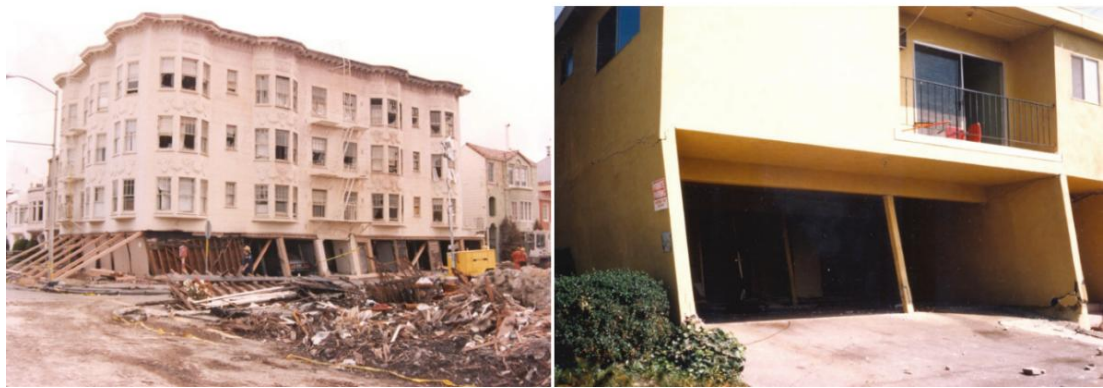
**Figure 2-7: Failure in a Typical Wood Frame Construction Caused by Soft Story, in Loma Prieta Earthquake (Left) and Northridge Earthquake (right)**  
(ATC, 2012)

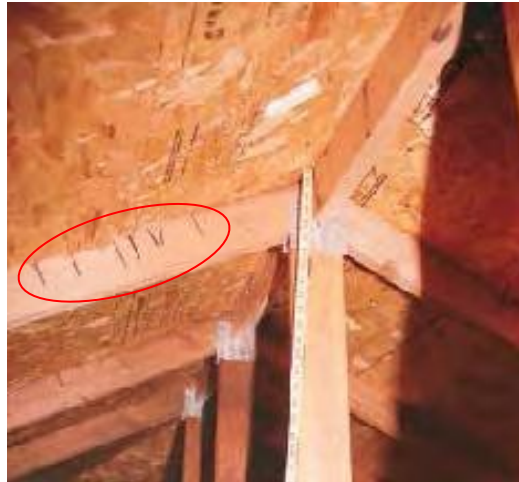
**Figure 2-8: Nails Missing the Truss**  
(Fowler, 1998)

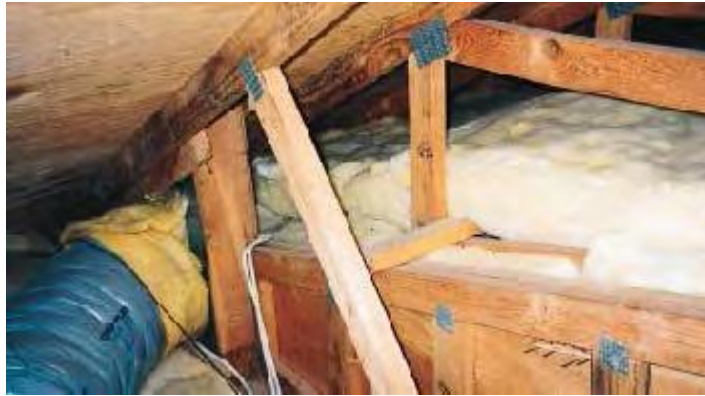
**Figure 2-9: The Sheathing Panel on the Interior Shearwall not extended to the Roof Diaphragm**  
(Fowler, 1998)

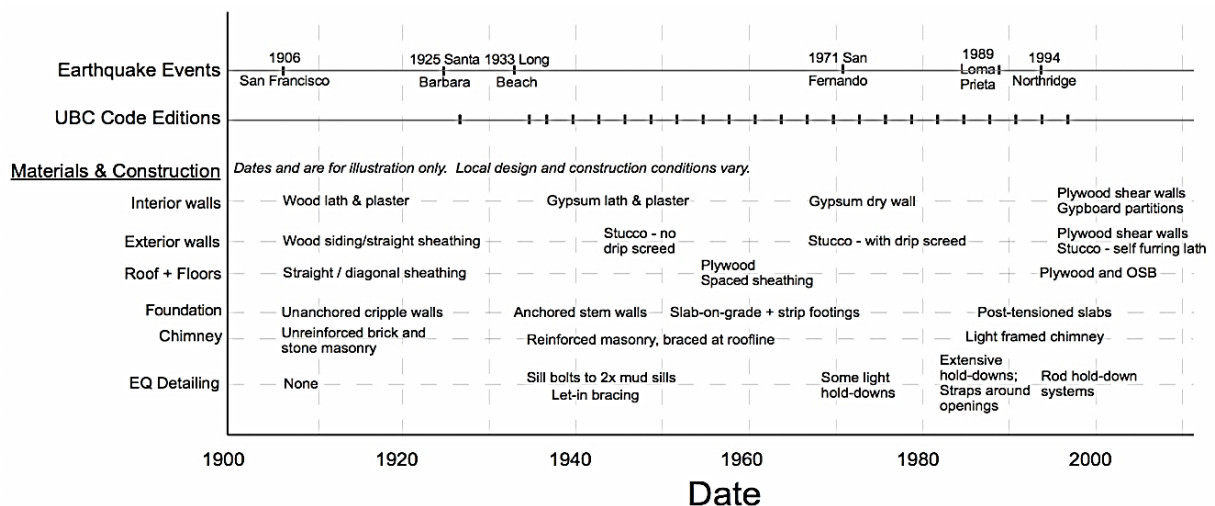
Figure 2-10: Evolution of Wood Frame Construction in United States under UBC (Graf, 2008)

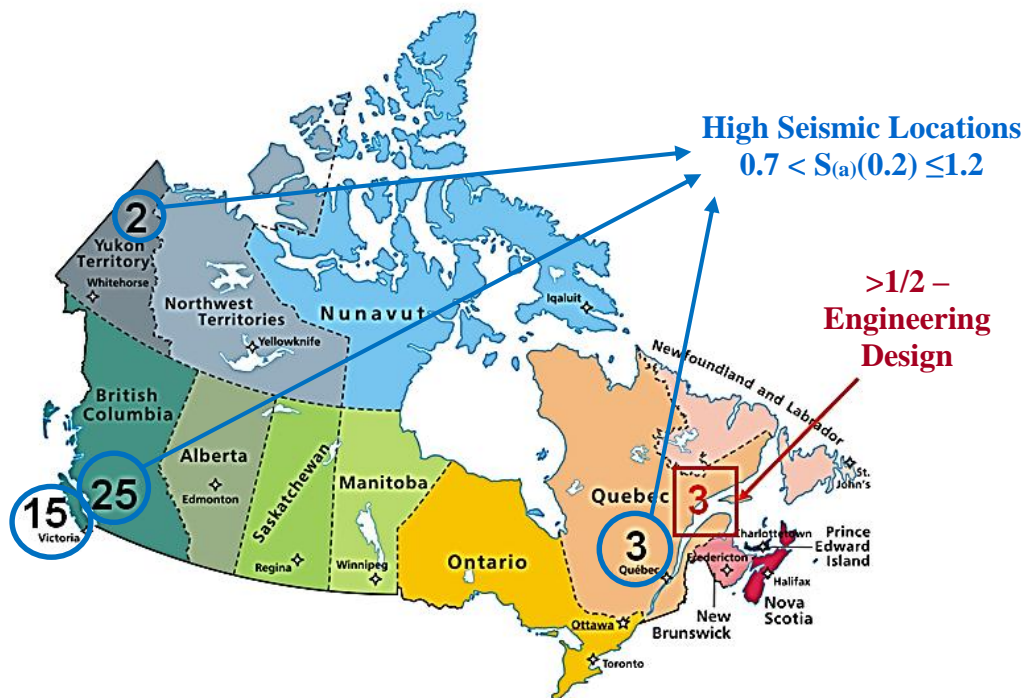
**Figure 2-11: The Impact of the New Categorization, Proposed in Part 9 of NBCC 2010, Across Canada, Due to Earthquake** (NRCC, 2011; Taraschuk, 2011)

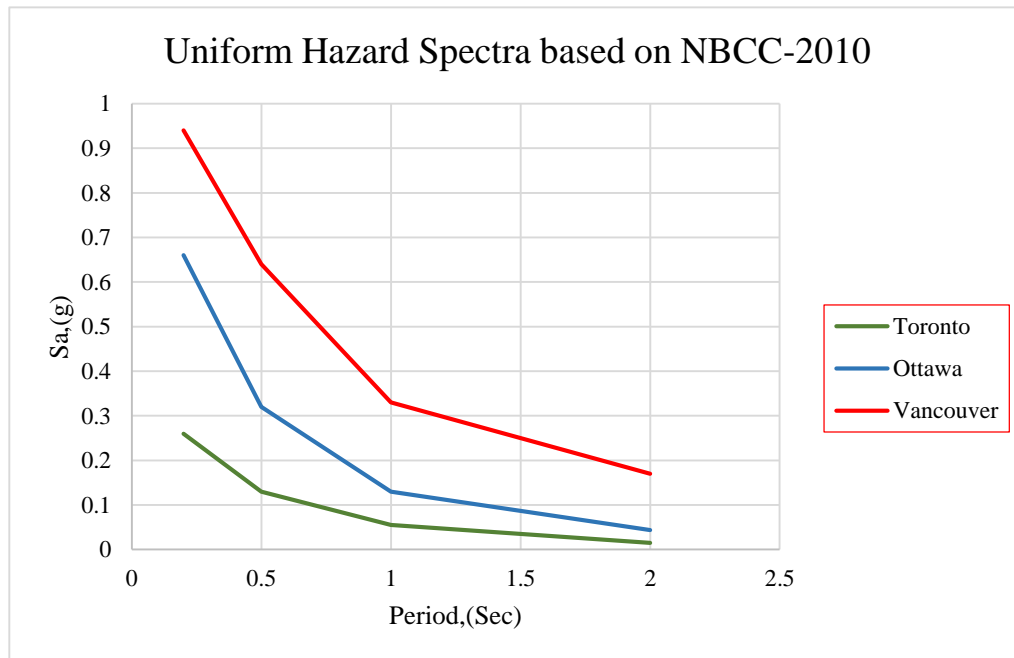
**Figure 3-4: Uniform Hazard Spectra based on NBCC-2010**

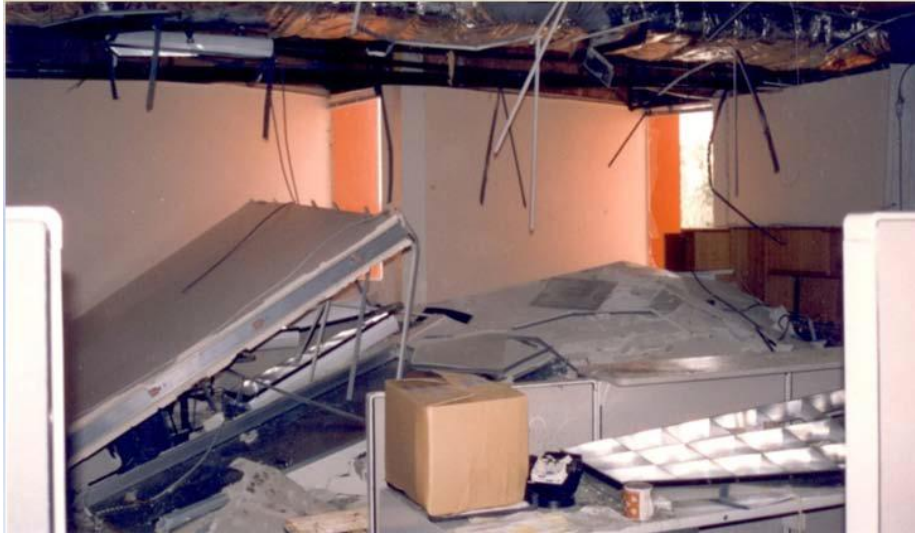
**Figure 3-6: Failure of office partitions, ceilings, and light fixtures in the 1994 Northridge Earthquake (FEMA 74, 1994)**

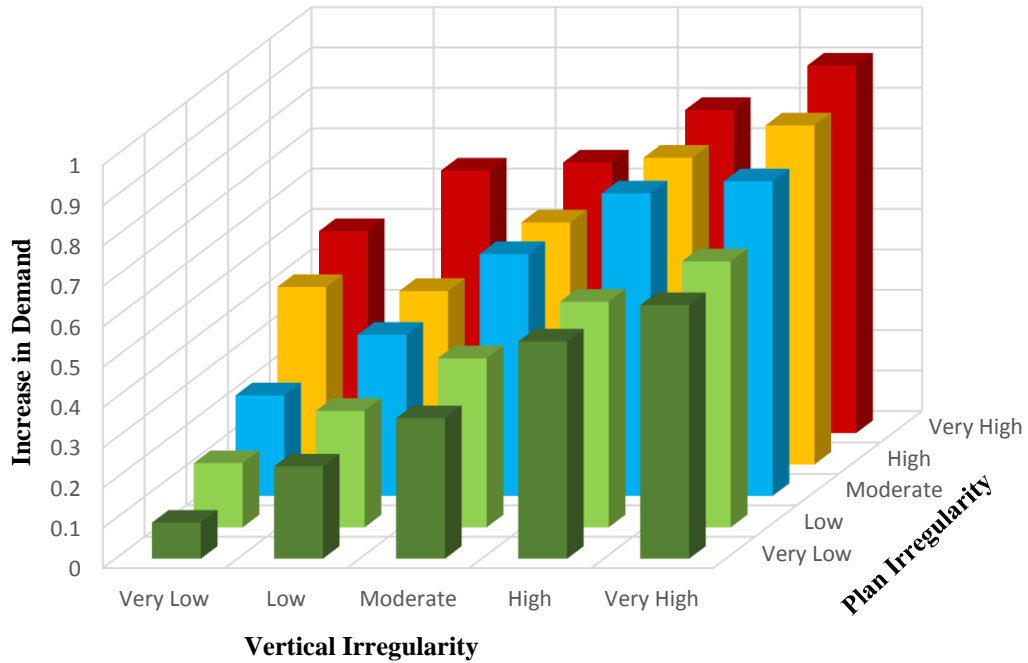
**Figure 4-1: Increase in Demand of a Building**

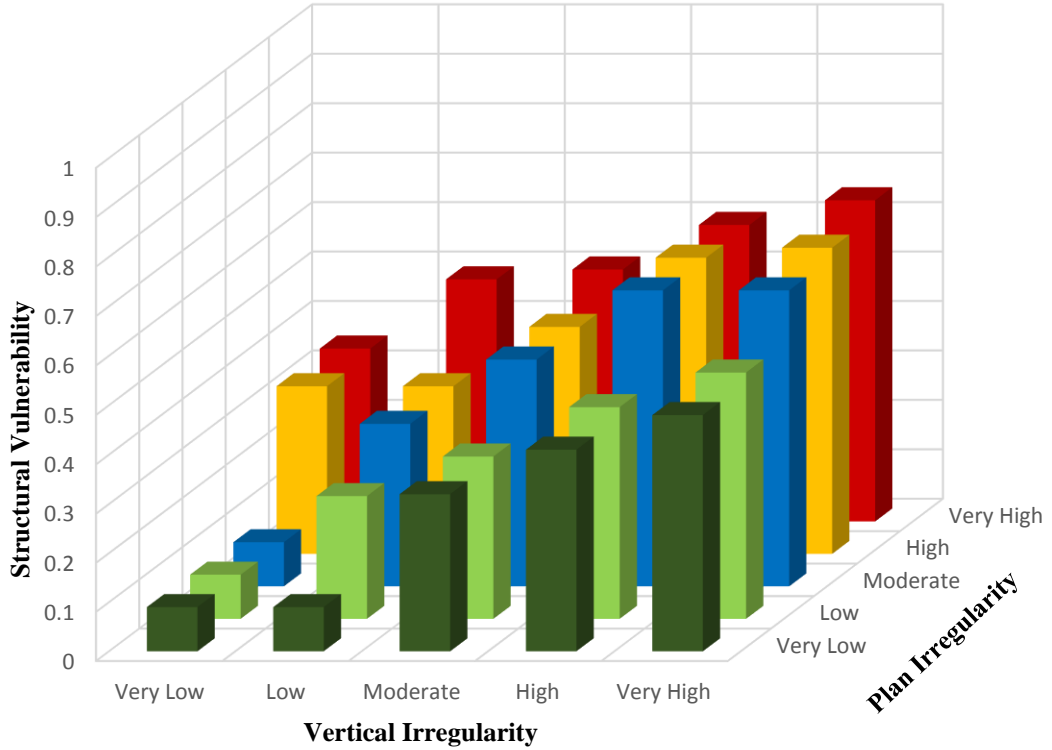
Figure 4-3: Structural Vulnerability of a Building built in 2010 with good construction quality

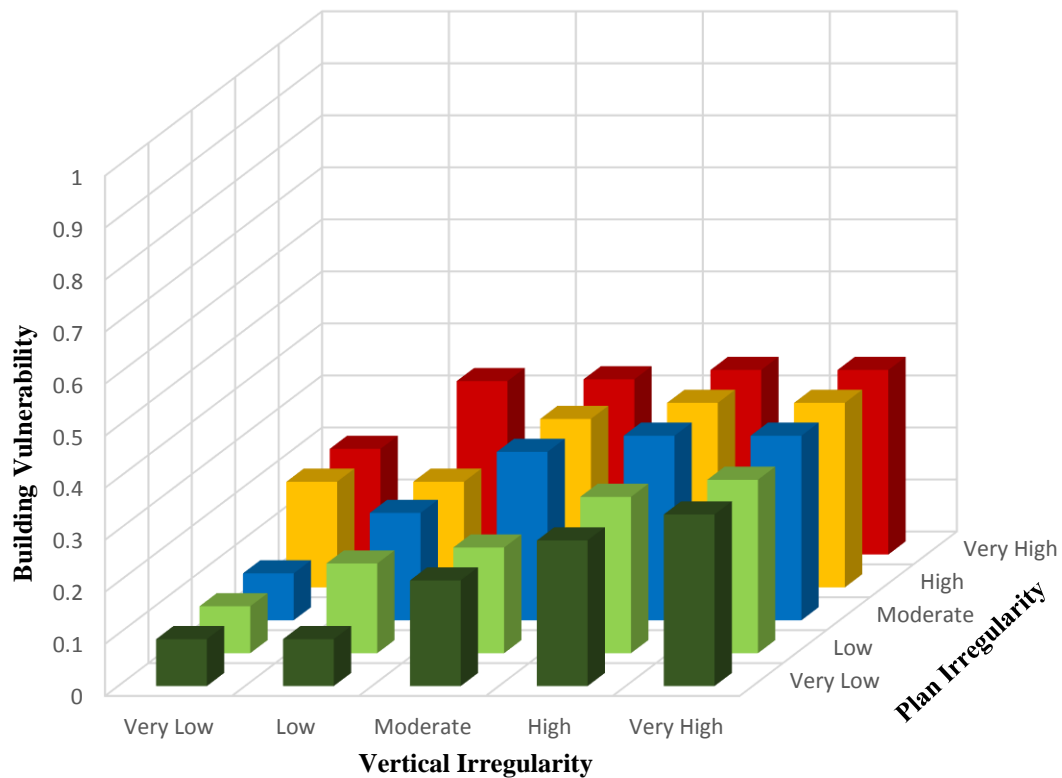
**Figure 4-4: Building Vulnerability of a Wood Light Frame Building built prior to 1940 with poor construction quality**

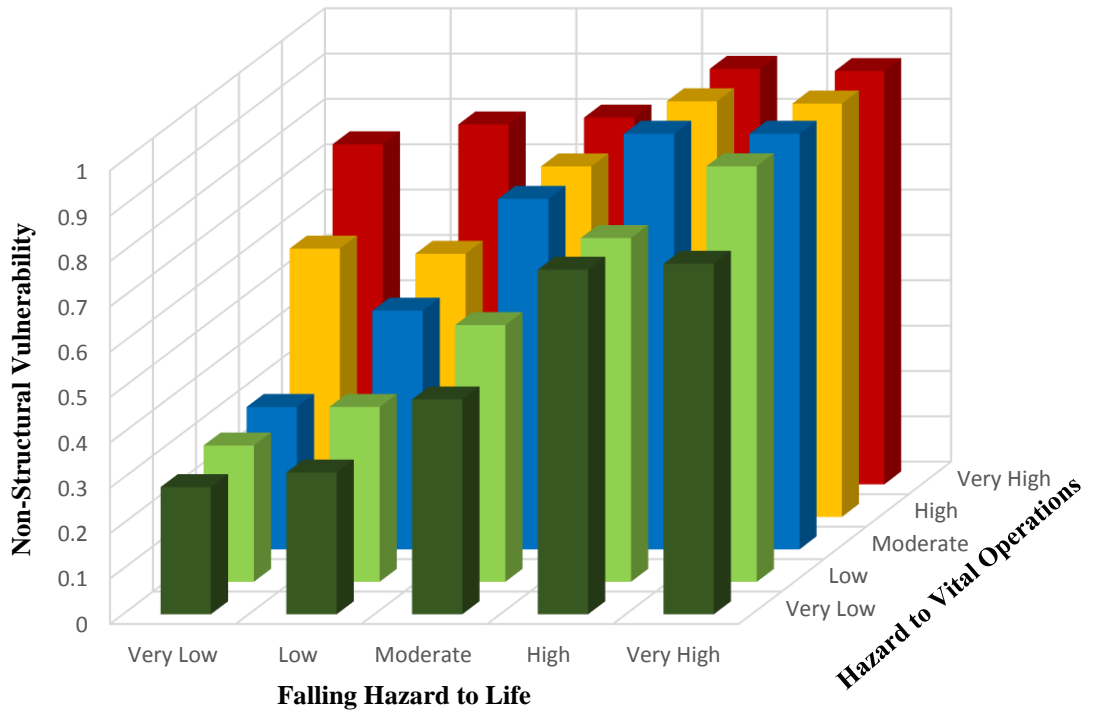
Figure 4-7: Non-Structural Vulnerability of a Building built prior to 1970 with very high ID

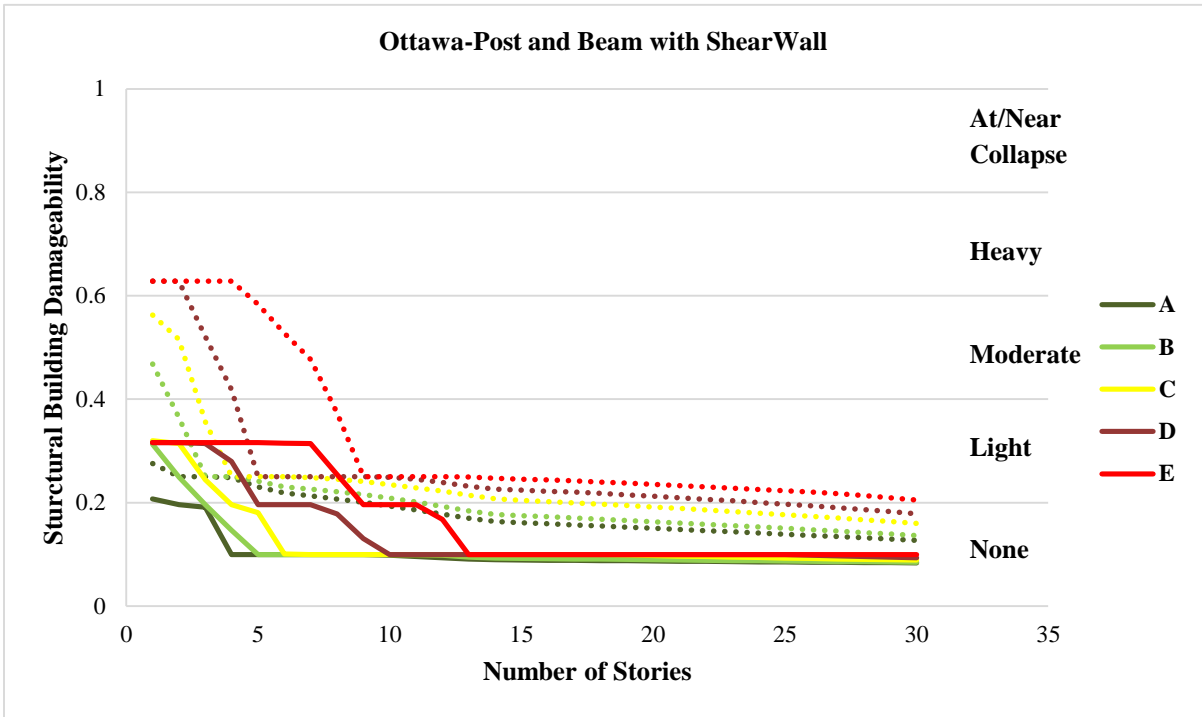
Figure 4-9: Upper and Lower Bound Limits of Building Damageability for Post and Beam Structures resting on various soil conditions in Ottawa, Ontario

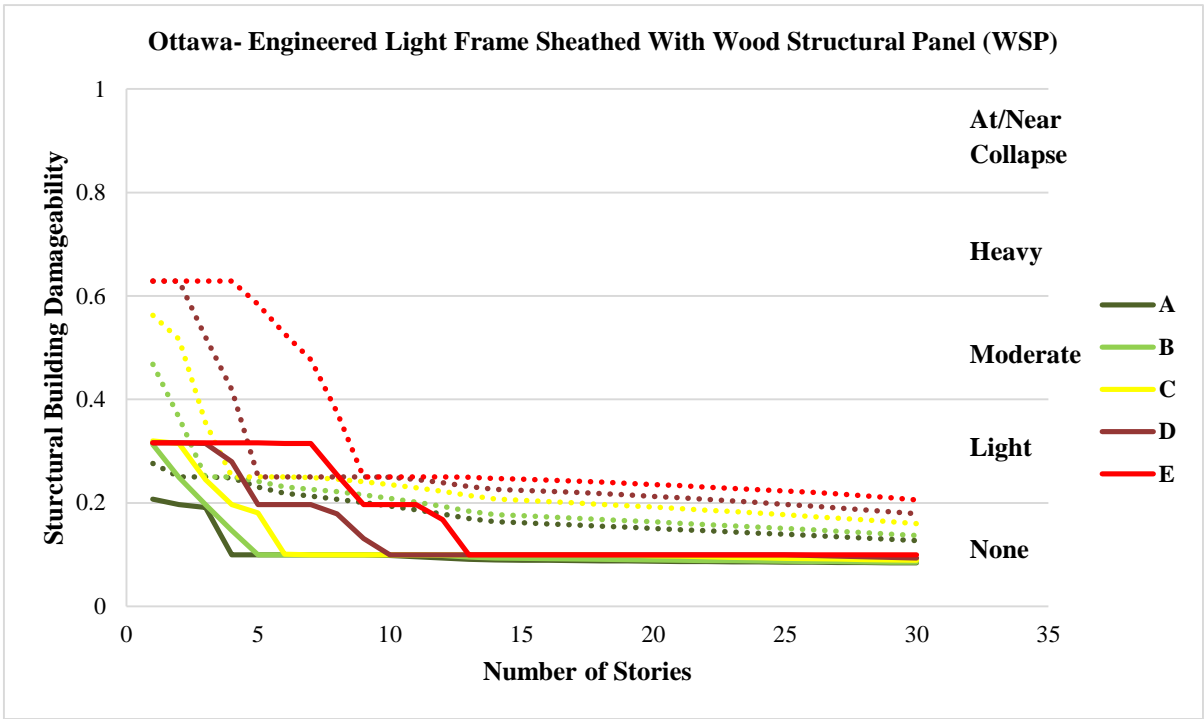
**Figure 4-11: Upper and Lower Bound Limits of Building Damageability for Engineered Light Wood Frame Structures sheathed with WSP resting on various soil conditions in Ottawa, Ontario**

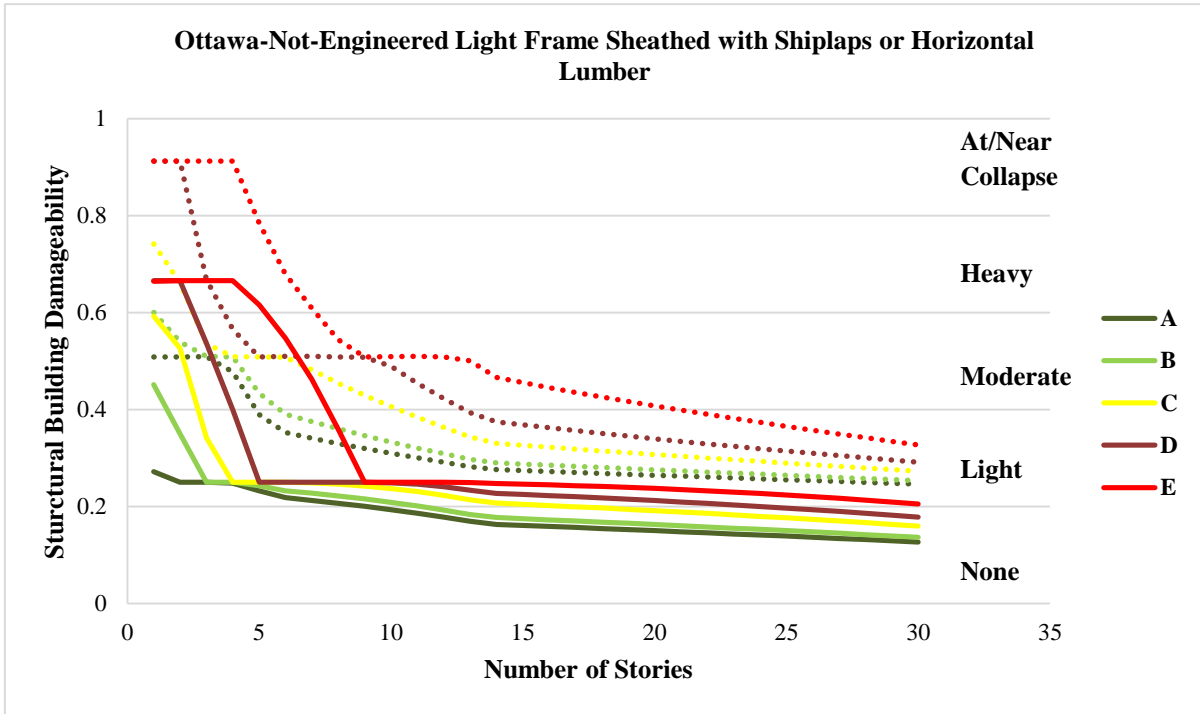
**Figure 4-14: Upper and Lower Bound Limits of Building Damageability for Non-Engineered Light Wood Frame Structures sheathed with Horizontal Lumber or Shiplaps resting on various soil conditions in Ottawa, Ontario**

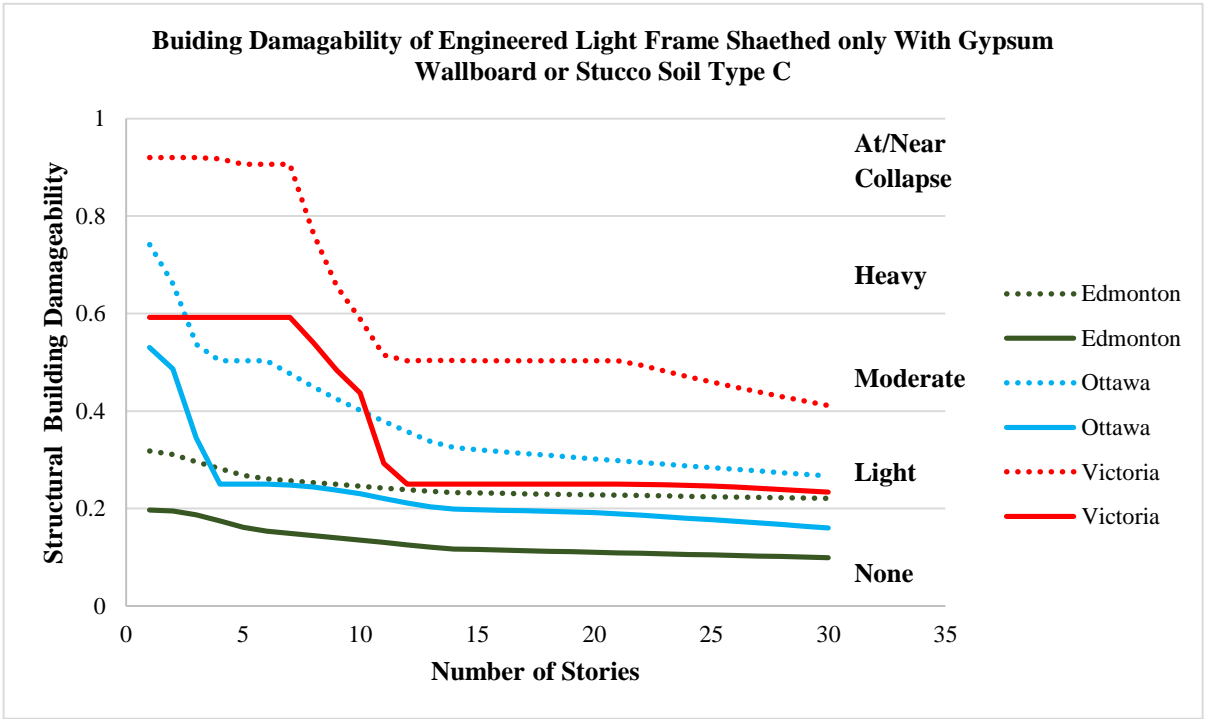
Figure 4-17: Comparison of Upper and Lower Bound Limits of Building Damageability for Engineered Light Frame structures sheathed Only with Gypsum Wallboard or Stucco Resting on Reference Site Soil Class C

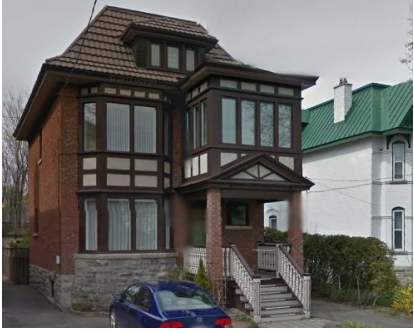
<p>6</p>

To select the input parameters (performance modifiers) used in CanRisk for the buildings under investigation, a site visit was conducted to each building to evaluate the building configuration, number of stories, building use, economic impact, vertical irregularity, plan irregularity, construction quality, falling hazards to life and hazards to vital operations. Also, the fire insurance plans, provided from the City of Ottawa, and the GIS information were used to determine the year of construction of the buildings. The occupied area of the buildings is computed by calculating the area of the buildings' footprint, using the GIS software, and multiplying the computed area by the number of stories. Using the available microzonation maps for the city of Ottawa (Motazedian et al., 2011), the soil types were identified. Finally, the spectral acceleration  $S_a(T1)$  was computed using the procedure outlined in NBCC 2010 by considering the selected soil type, the empirical formulas to determine building period, and the corresponding seismic data for Ottawa, Ontario. The collected data is summarized in Table 5-2.

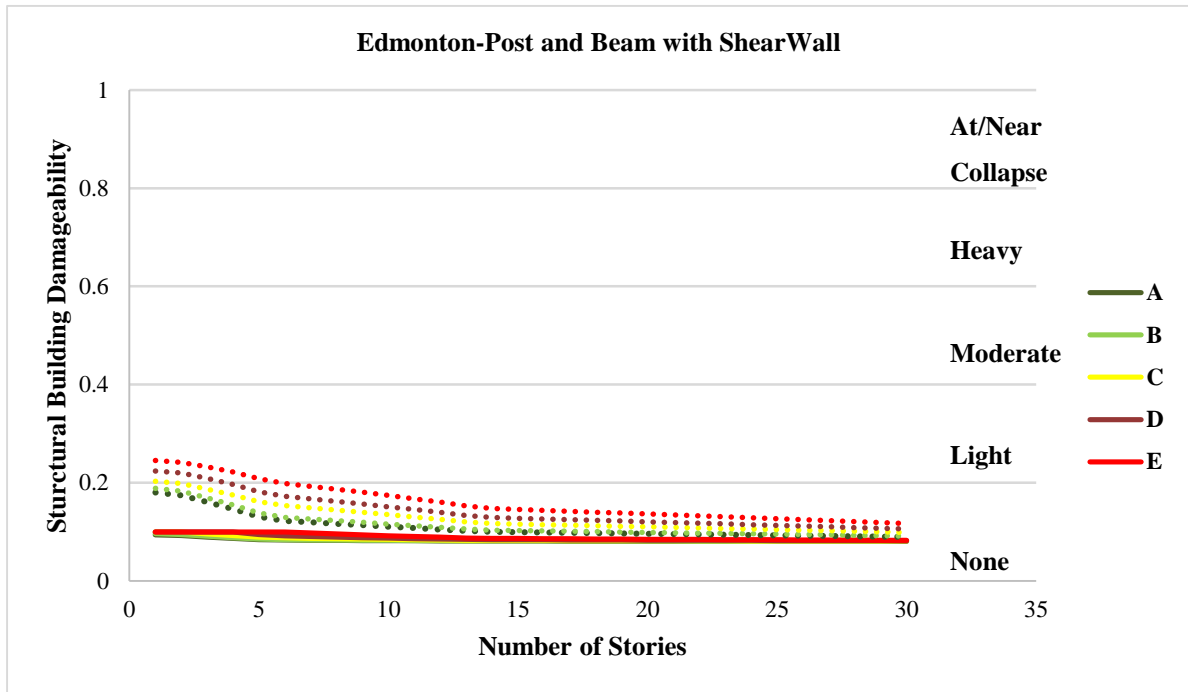
Figure A-1: Upper and lower bound limits of  $I^{BD}$  for Post and Beam structures with shearwall resting on various soil conditions in Edmonton, Alberta

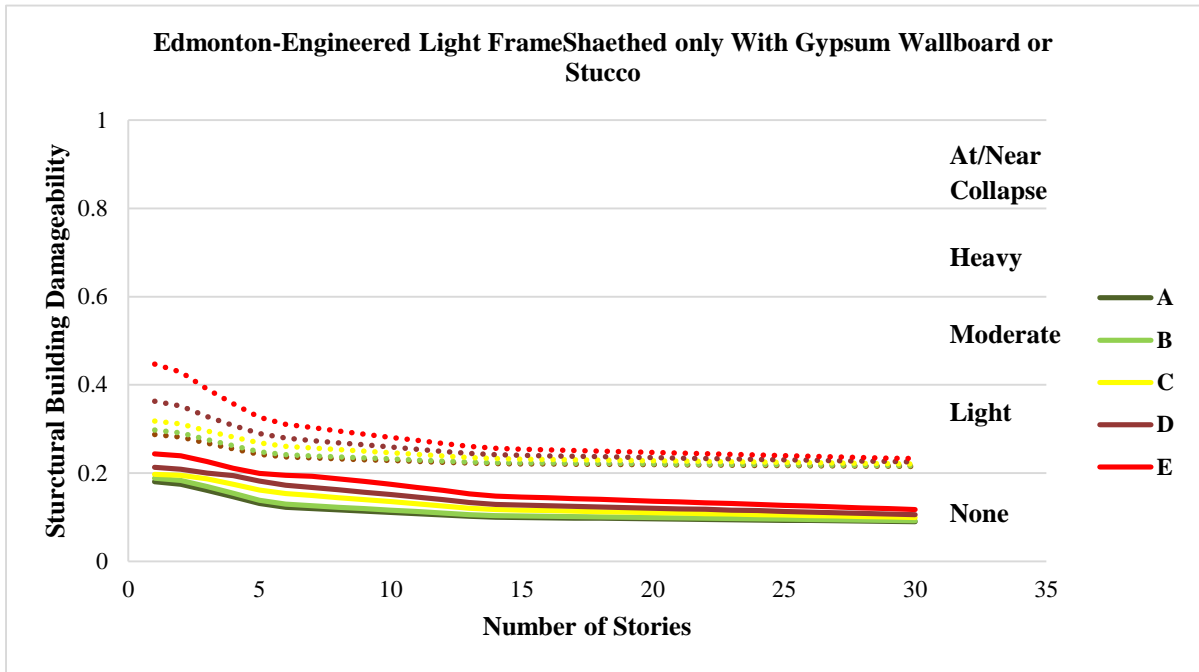
Figure A-5: Upper and lower bound limits of  $I^{BD}$  for Engineered Wood Light Frame structures sheathed only With Gypsum Wallboard or Stucco resting on various soil conditions in Edmonton, Alberta

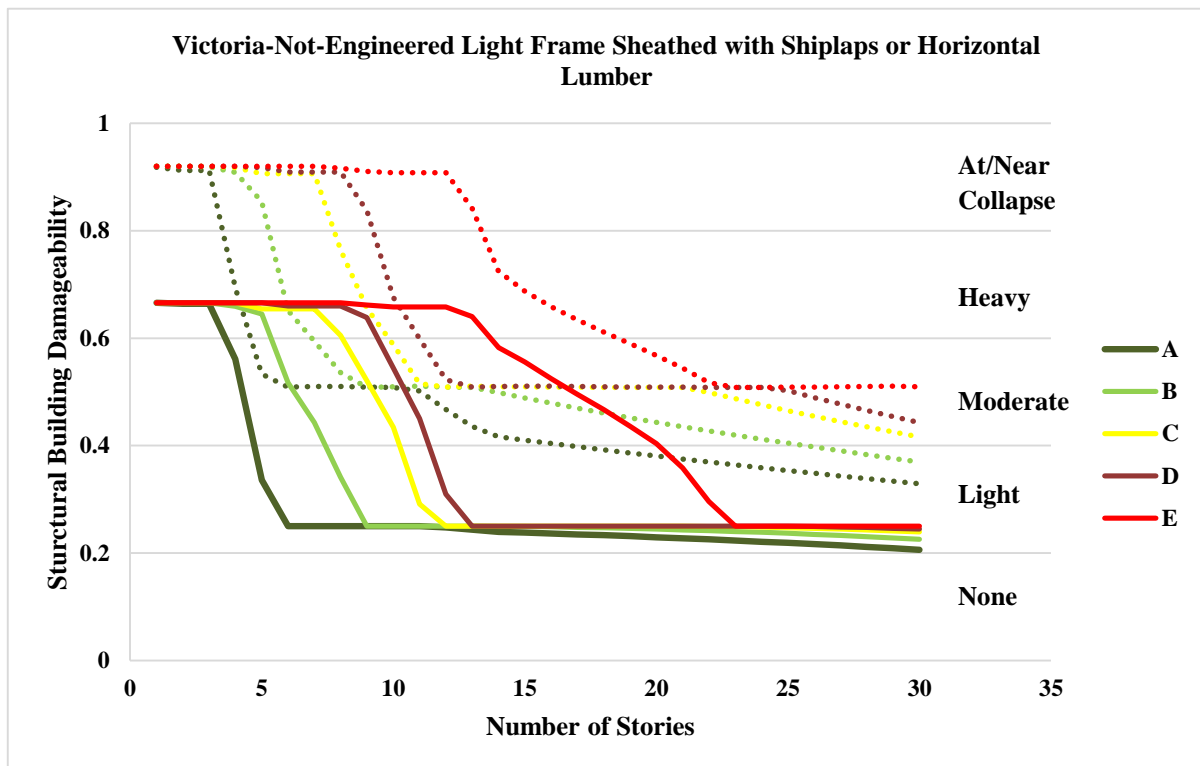
**Figure A-12: Upper and Lower Bound Limits of Building Damageability for Non-Engineered Light Frame Structures sheathed with Horizontal Lumber or Shiplaps resting on various soil conditions in Victoria, British Columbia**
