Analysis of Crack Propagation in Concrete Containing Recycled Concrete Aggregates

Ho, G.^{1,2}, Noël, M.¹, Sanchez, L.¹, Meika, H.¹
¹ Department of Civil Engineering, University of Ottawa, Canada
² gho012@uottawa.ca

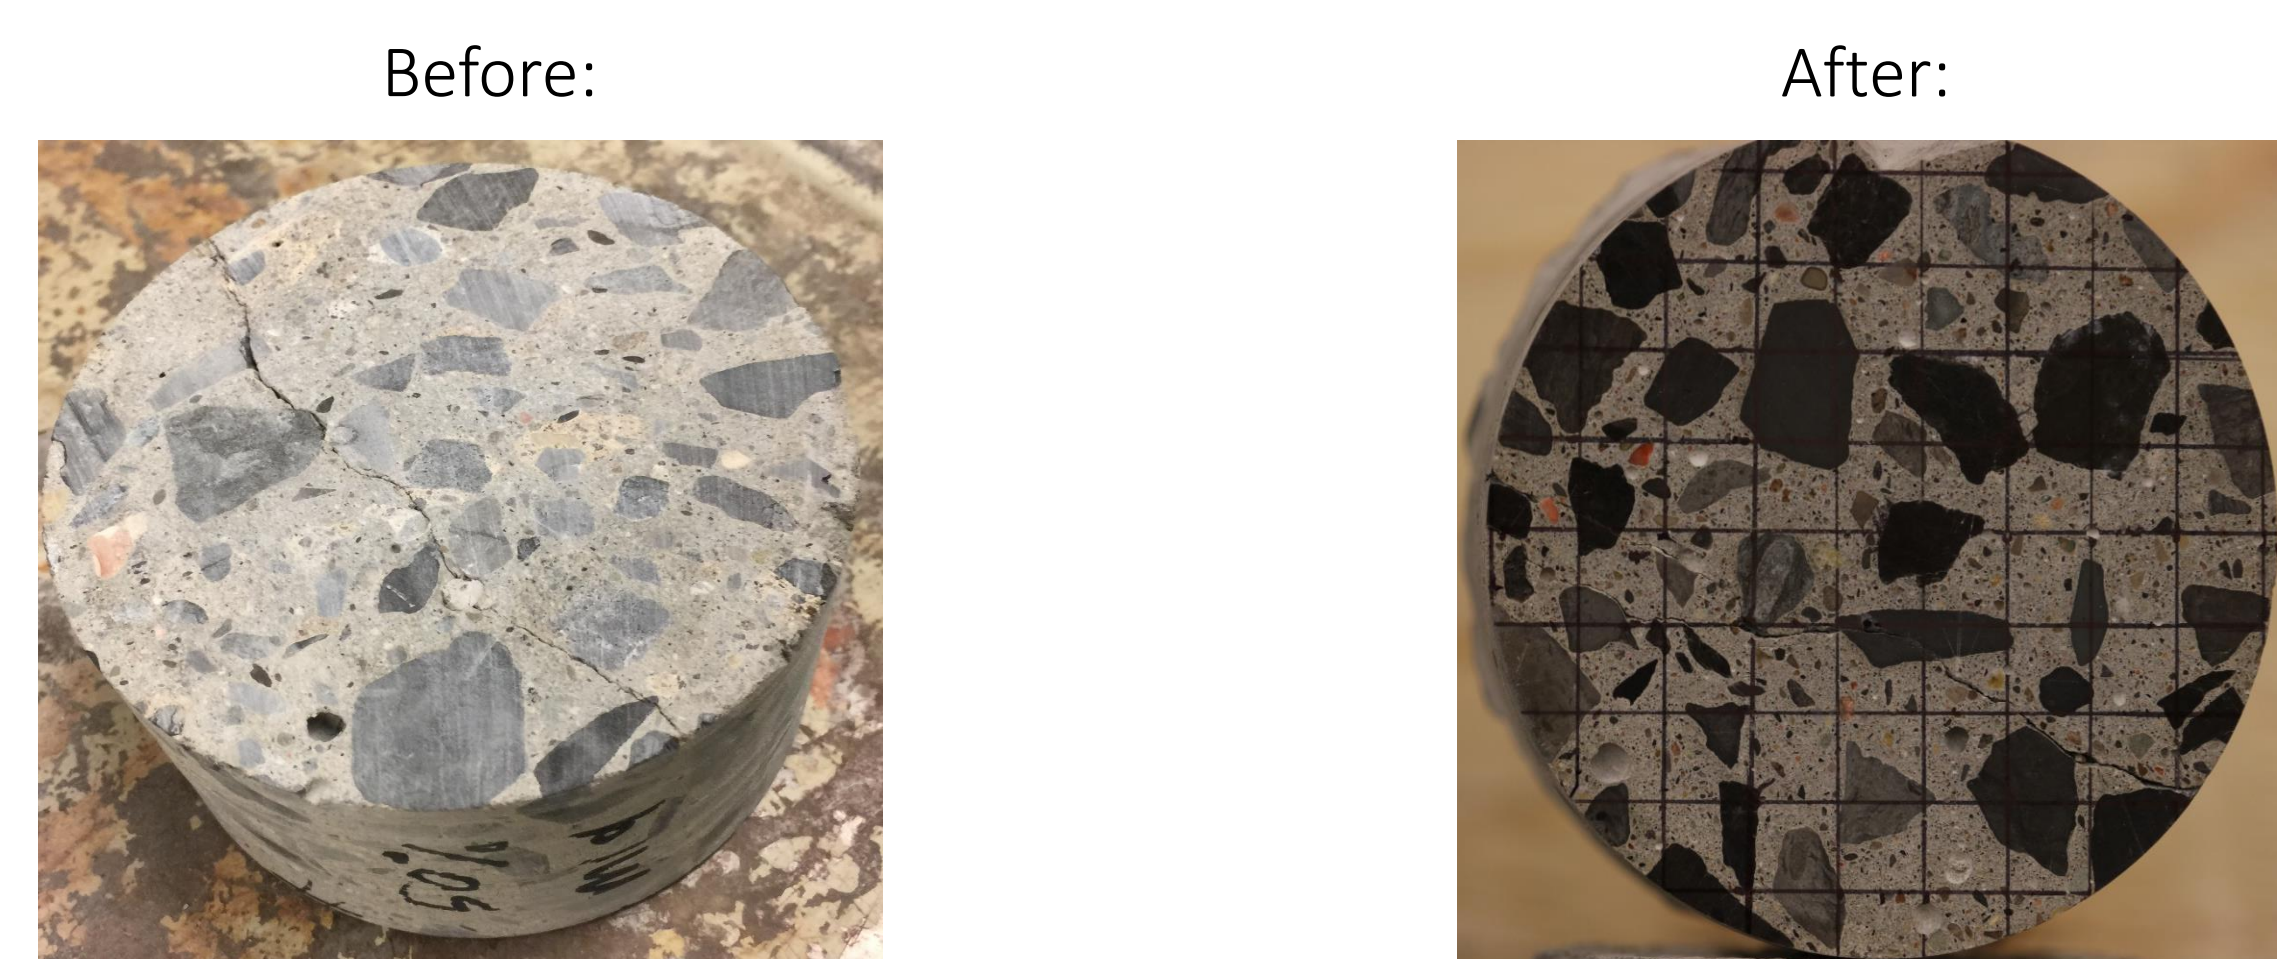
- After loading the beams to failure, cores were extracted from each beam at crack locations for microscopic examination

- The cores were cut, polished and a grid of 1 cm² squares were drawn onto each sample to provide an organized structure for microscopic analysis (7 cm by 6 cm layout)

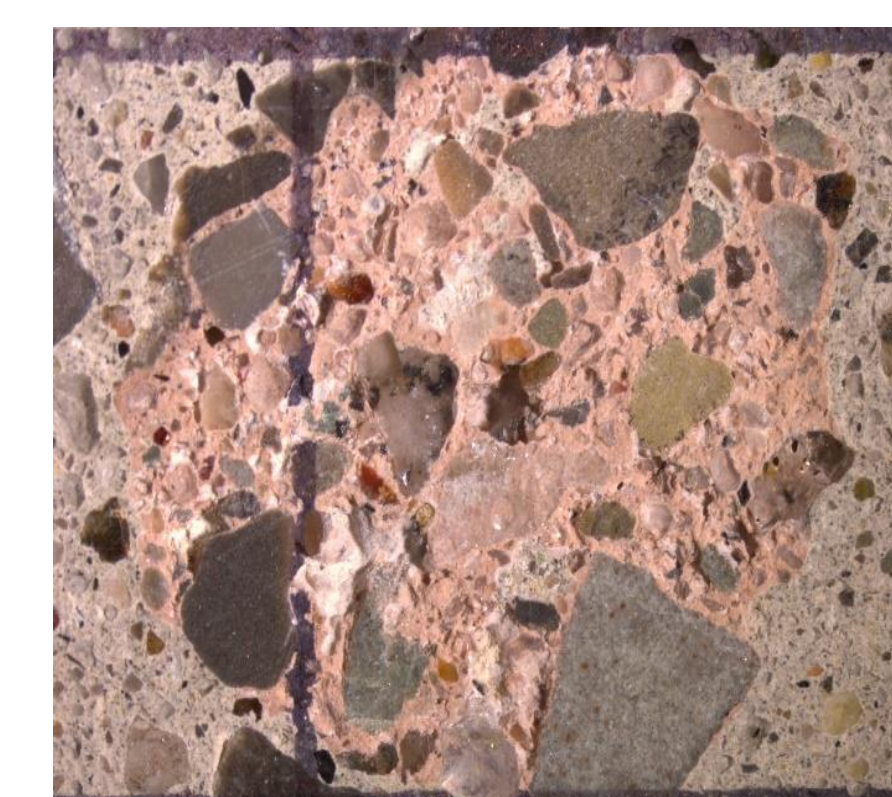
Residual mortar was easily distinguished from new mortar due to the difference of hue and texture

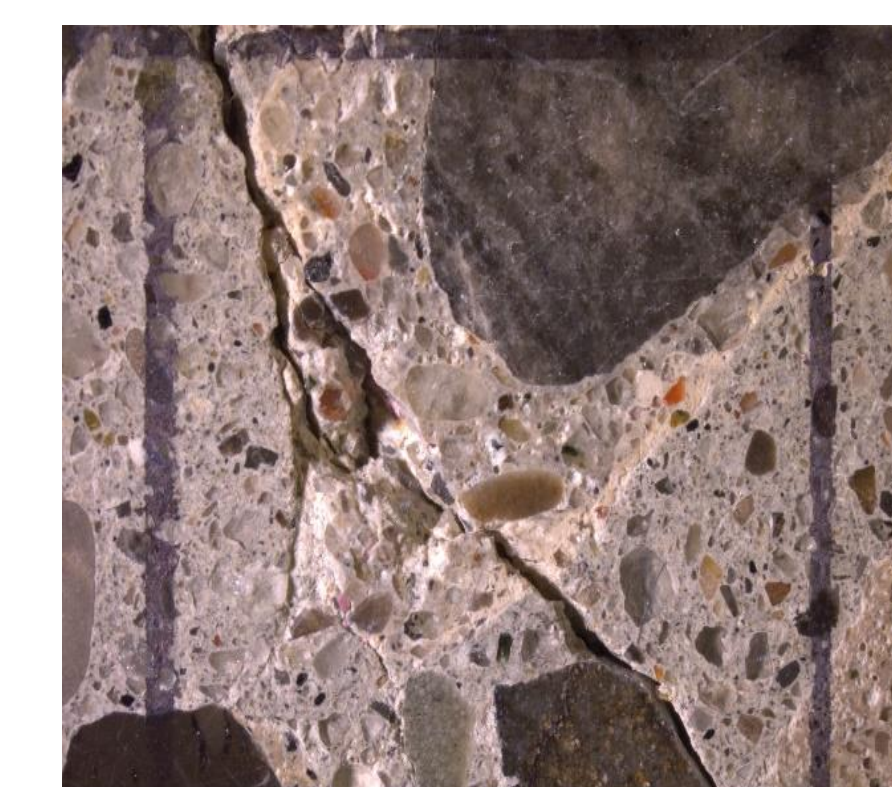
The crack splits into a fork within the residual mortar

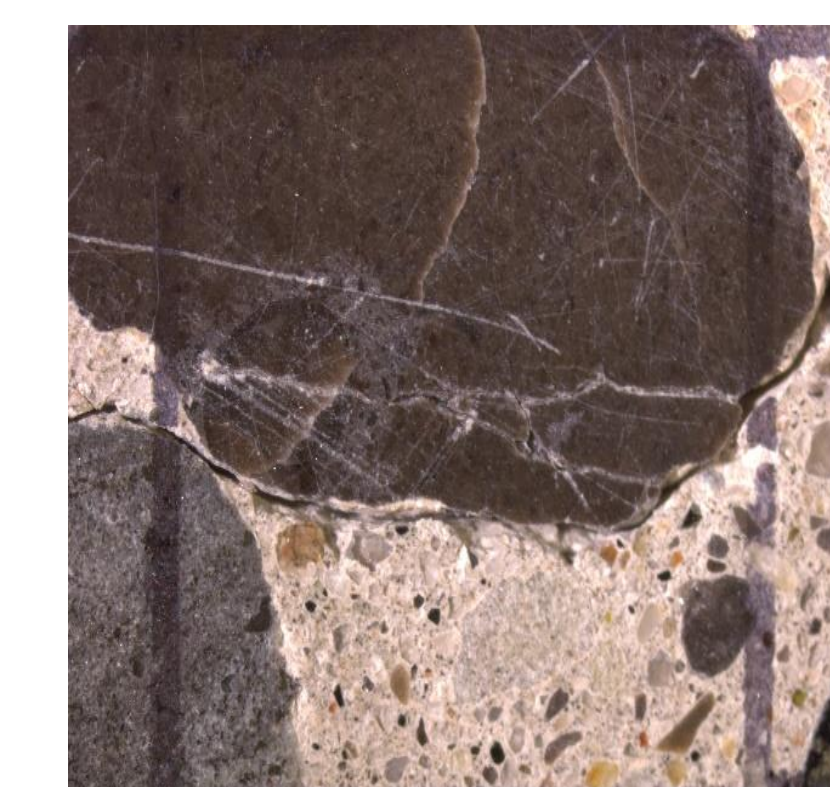
Closed crack, crack fork within the virgin aggregate and another crack propagating through the ITZ between the aggregate and the new mortar
