# Experimental Testing and Reliability Analysis of Repaired SMA and Steel Reinforced Shear Walls

Department of Civil Engineering  
University of Ottawa  
Ottawa, Canada  
August 2016

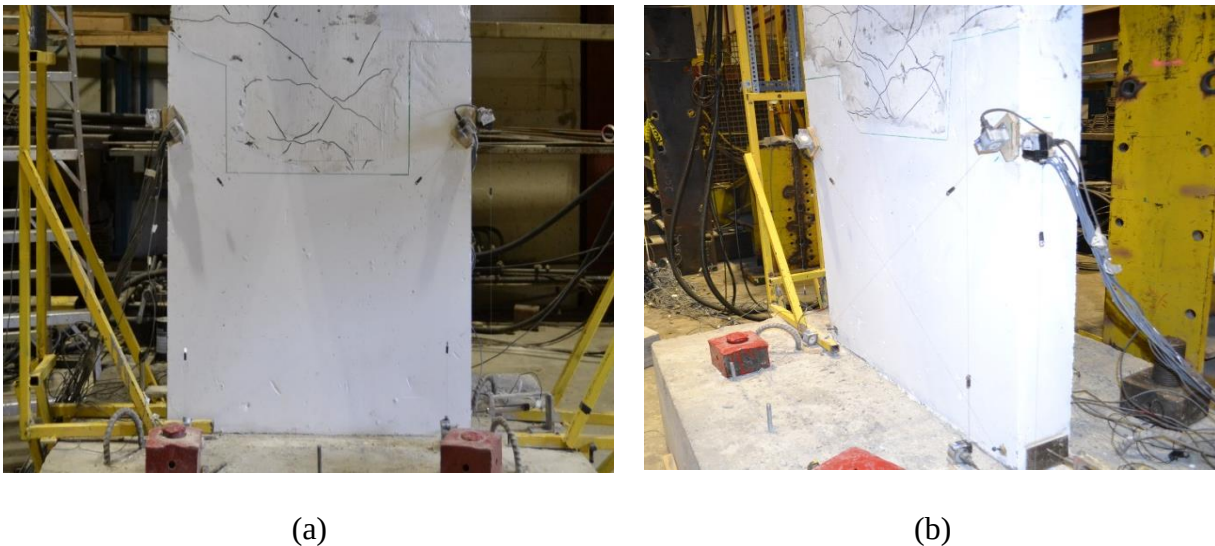
Figure 3.36: DCTS in Plastic Hinge Region: (a) Front View; and (b) Side View

DCTs C4 and C5 were placed at the top of the base foundation and extended to the bottom of the top of the beam to measure the vertical displacements at the ends of the wall relative to the base foundation. C6 and C7 were placed at 800 mm from the base of the wall and extended down to the top of the foundation to measure the vertical displacement at the top of the plastic hinge region at both ends. C8 and C9 were attached to the wall at 45 degrees to calculate the diagonal deformation of the plastic hinge region with a combination of recordings from both C8 and C9. Figure 3.36 illustrates the DCTS in the plastic hinge region.

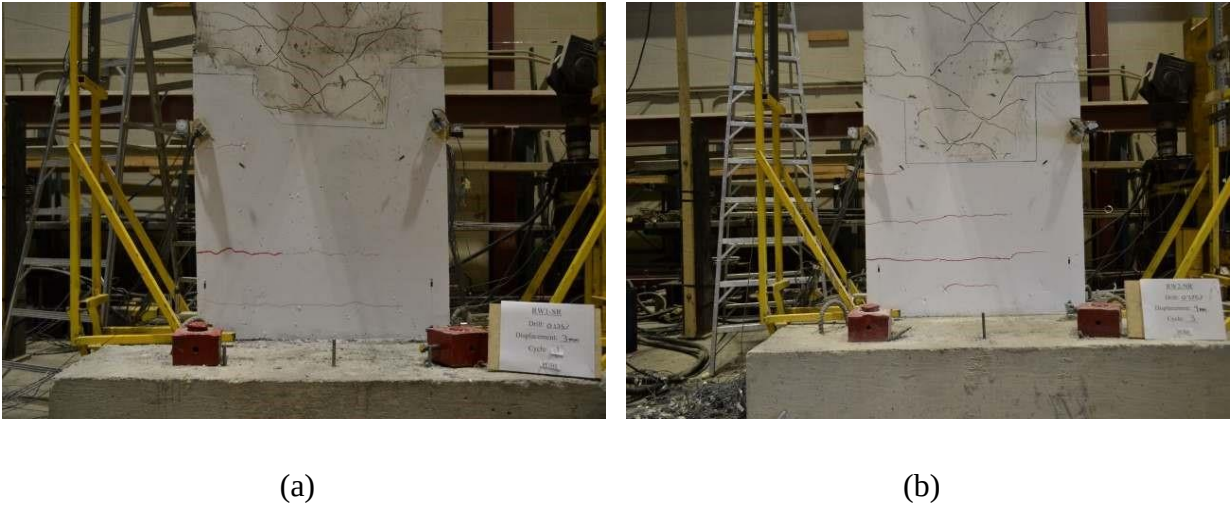
Figure 4.1: Initial Flexure Crack Pattern: (a) RW1-SR; and (b) RW2-NR

entire width of the wall, while the third crack from the base of the wall was confined to the left repaired boundary region. In Wall RW2-NR, the initial crack pattern was similar to that of RW1-SR except one additional crack surfaced. Moreover, they appeared at slightly different heights (140 mm, 260 mm, 440 mm and 690 mm) from the base of the wall. The recovery of crack opening was evident for the crack located at 140 mm from the base. At the end of first cycle, this crack was only visible in the web region of the wall. The crack located at 260 mm from the base of the wall surfaced just below the six-inch coupler used to connect SMA rod to the deformed reinforcing steel. The crack at 440 mm from the base of the wall surfaced above the six-inch coupler. The cracks at 260 mm and 440 mm from the base propagated across the entire width of the wall. The initial crack patterns for both walls are illustrated in Figure 4.1.

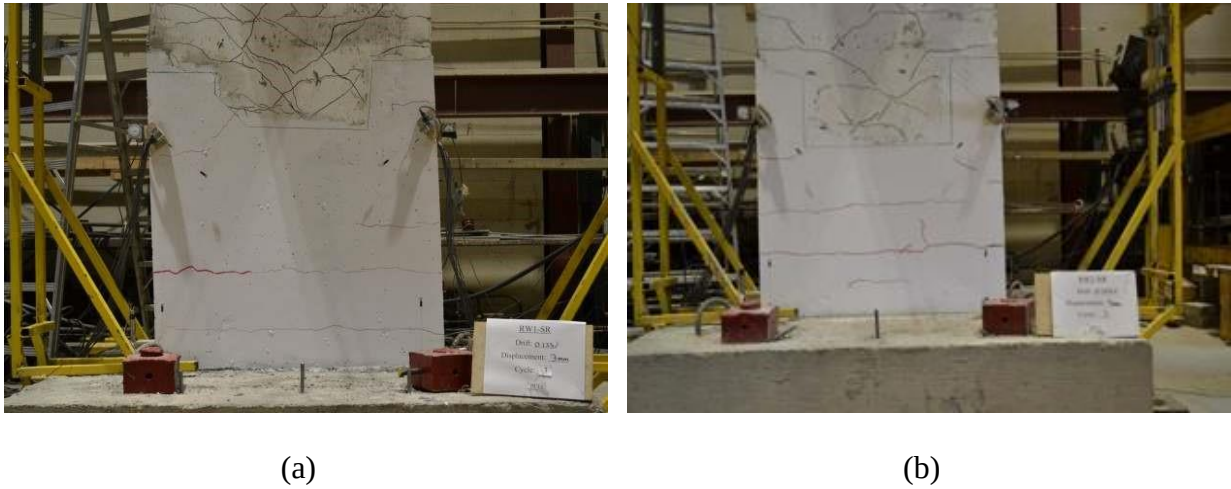
Figure 4.2: First Diagonal Crack: (a) RW1-SR; and (b) RW2-NR

The first diagonal crack was observed in Walls RW1-SR and RW2-NR at the end of the first loading repetition to 3 mm (0.13% drift) and 9 mm (0.4% drift), respectively. The diagonal crack surfaced in RW1-SR at 830 mm from the base of the wall, and in RW2-NR at 610 mm from the base of the wall (Figure 4.2). At this stage, more flexure cracks were observed in both walls.

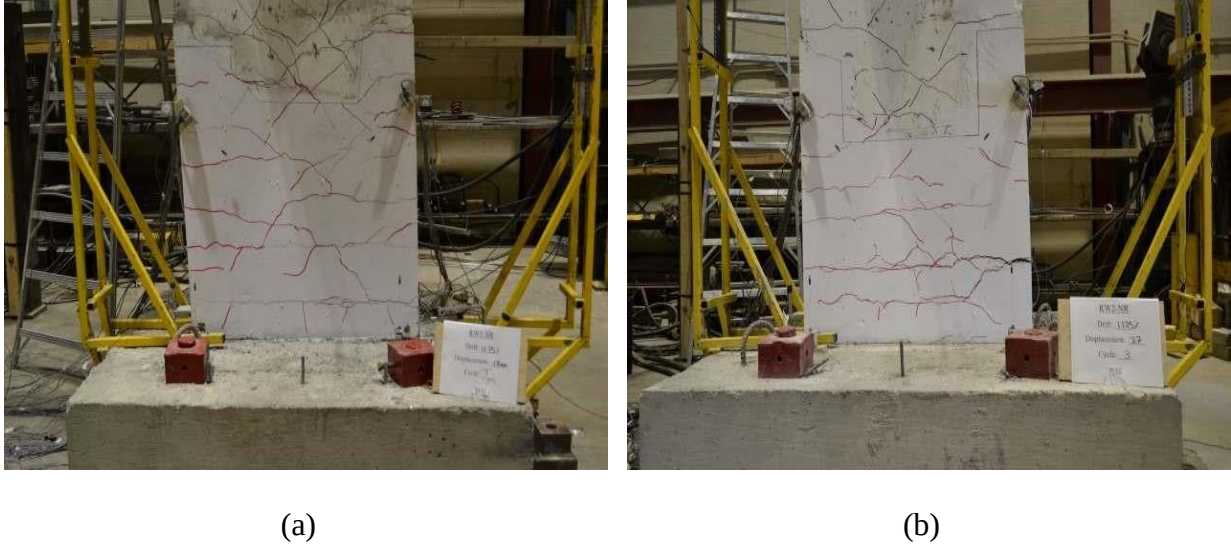
Figure 4.3: Post-Yield Crack Pattern at Drift Level of 1.12%: (a) RW1-SR; and (b) RW2-NR

the repaired region, while in RW2-NR the diagonal cracks were concentrated in the web region. The crack pattern at 1.12 % drift is shown in Figure 4.3.

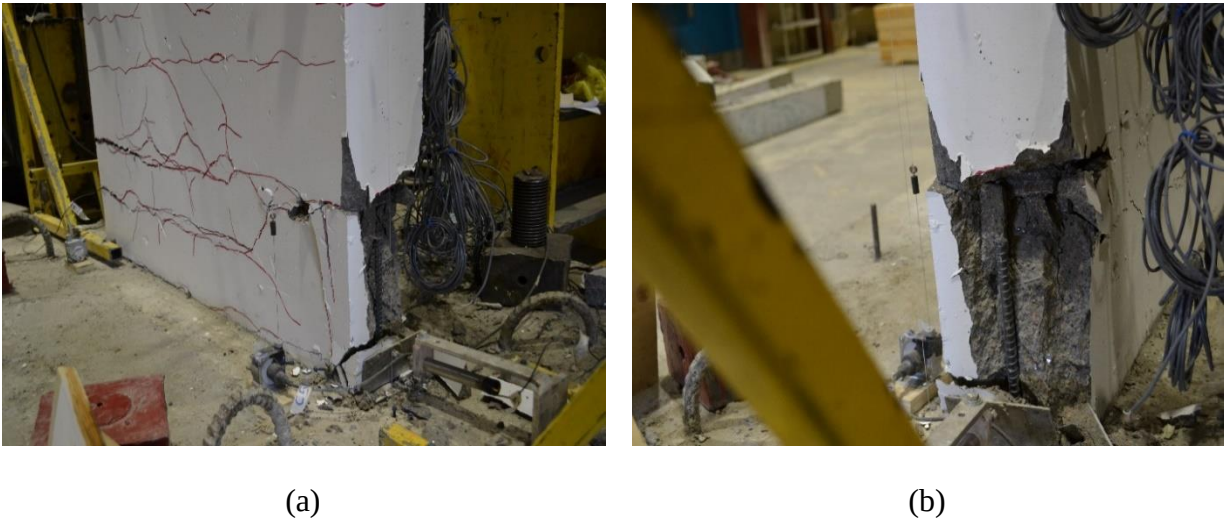
Figure 4.6: Spalled Concrete in RW2-NR at Drift Level of 2.25%: (a) Front View; and (b) Side View

At drift level of 2.25% (54 mm displacement), a large portion of concrete from the right side of the boundary of Wall RW2-NR spalled from the wall, exposing the bar used to maintain uniform cover in the boundary zone as shown in the Figure 4.6.

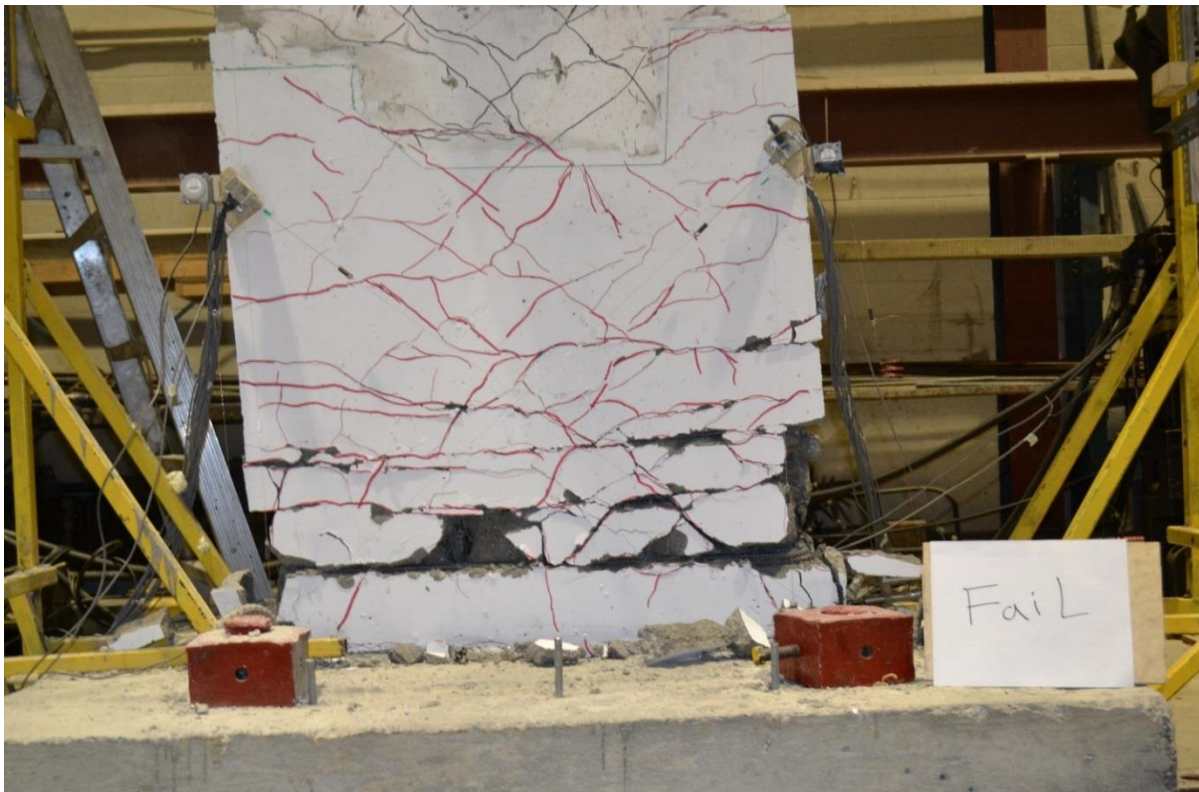
Figure 4.7: Crack Pattern at Failure of Wall RW1-SR: (a) Front view, (b) Back view; and (c) Side view

new cracks surfaced in the region above the plastic hinge zone that remained intact after the original test. However, existing cracks in this region re-opened during testing.

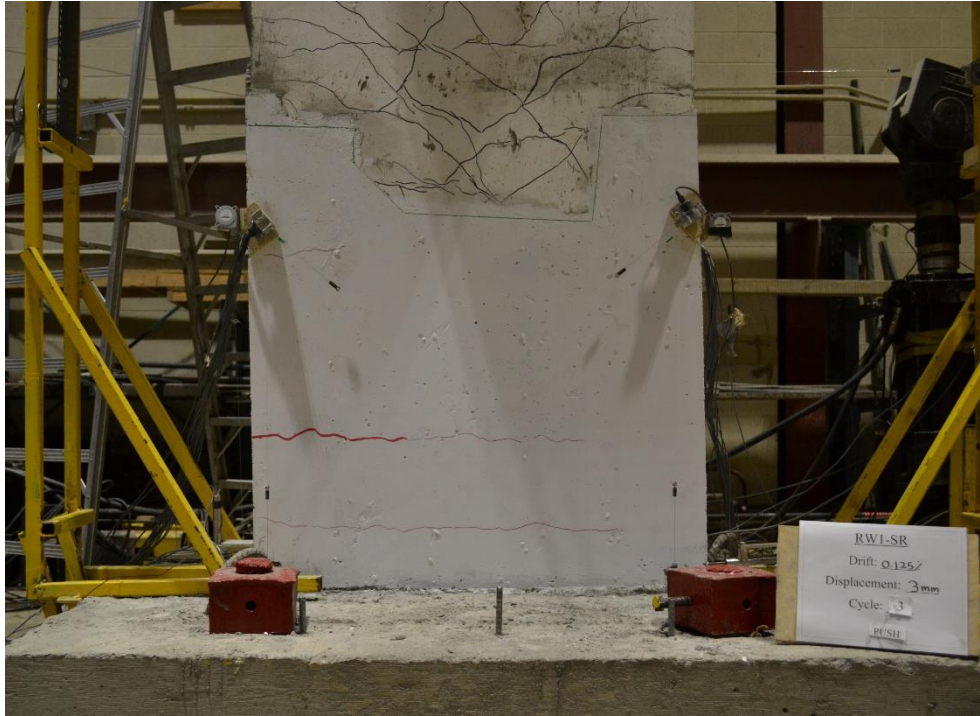
Figure A.1.2: Crack Pattern of Wall RW1-SR at 0.125% Drift (3 mm Displacement)

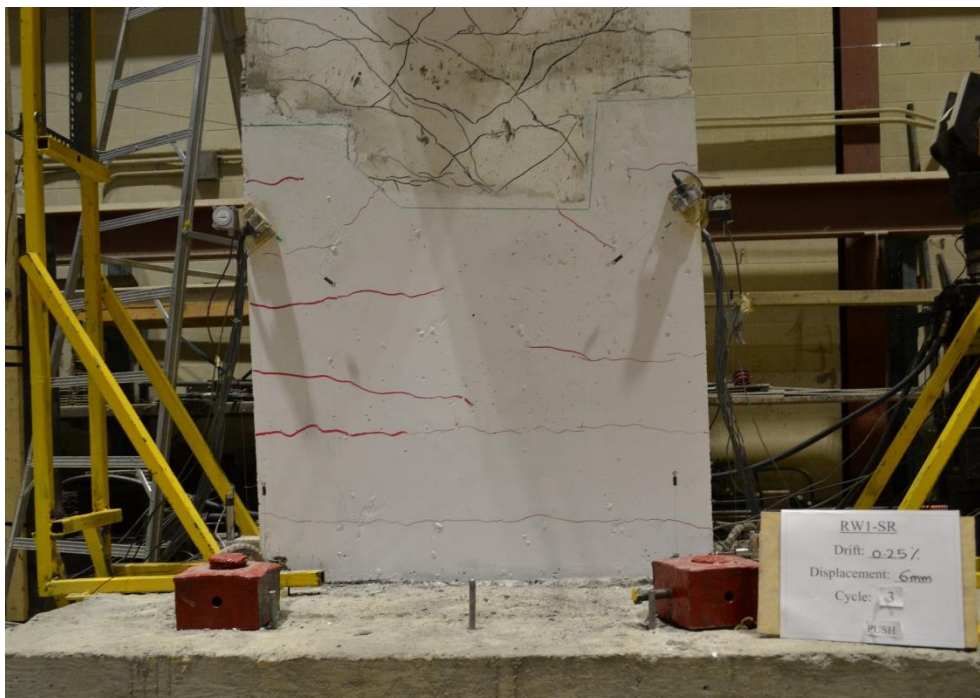
Figure A.1.3: Crack Pattern of Wall RW1-SR at 0.25% Drift (6 mm Displacement)

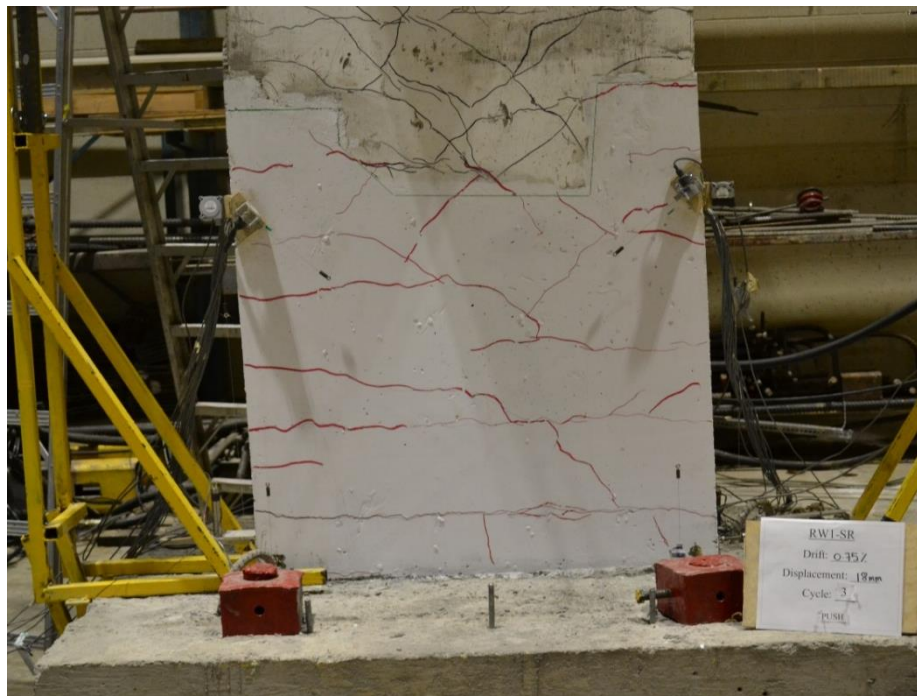
Figure A.1.5: Crack Pattern of Wall RW1-SR at 0.75% Drift (18 mm Displacement)

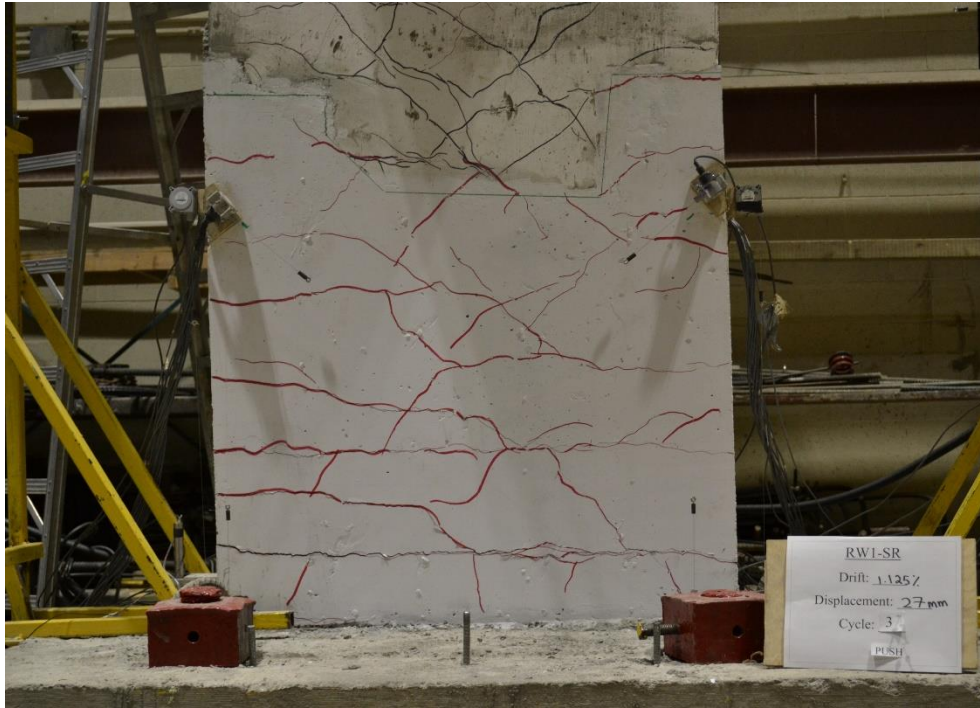
Figure A.1.6: Crack Pattern of Wall RW1-SR at 1.125% Drift (27 mm Displacement)

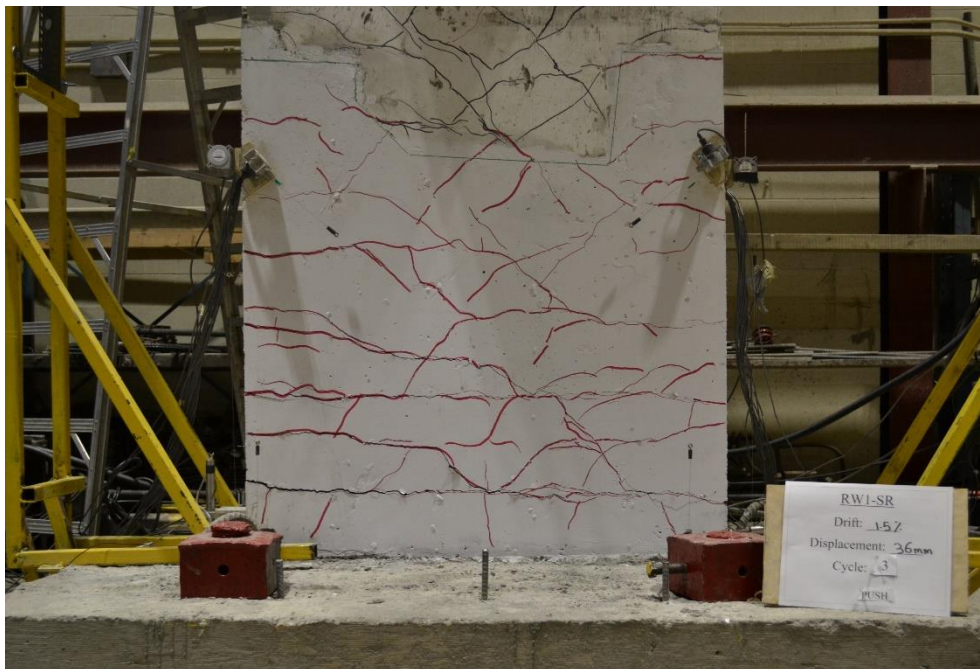
Figure A.1.7: Crack Pattern of Wall RW1-SR at 1.5% Drift (36 mm Displacement)

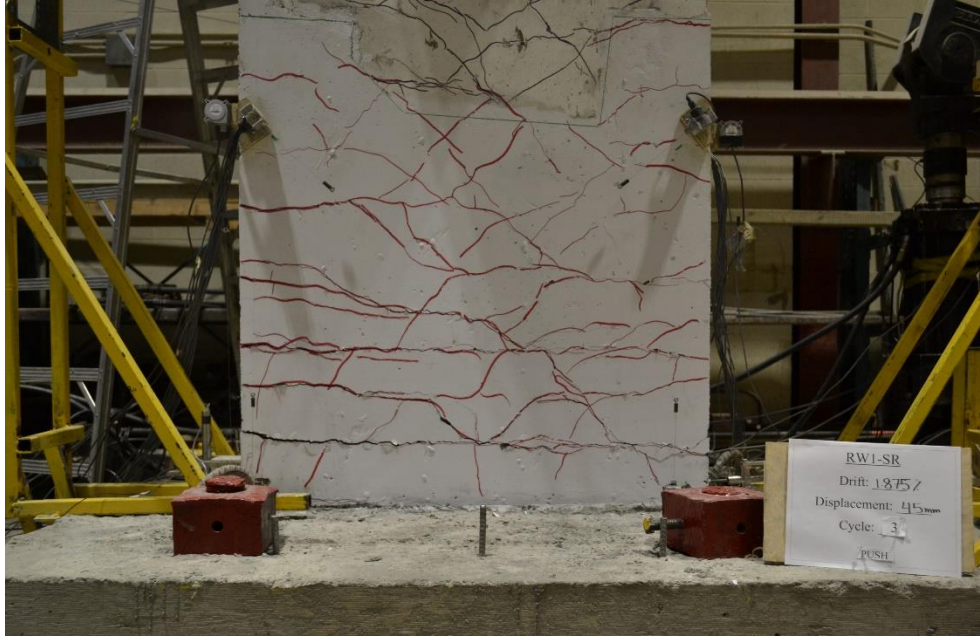
Figure A.1.8: Crack Pattern of Wall RW1-SR at 1.875% Drift (45 mm Displacement)

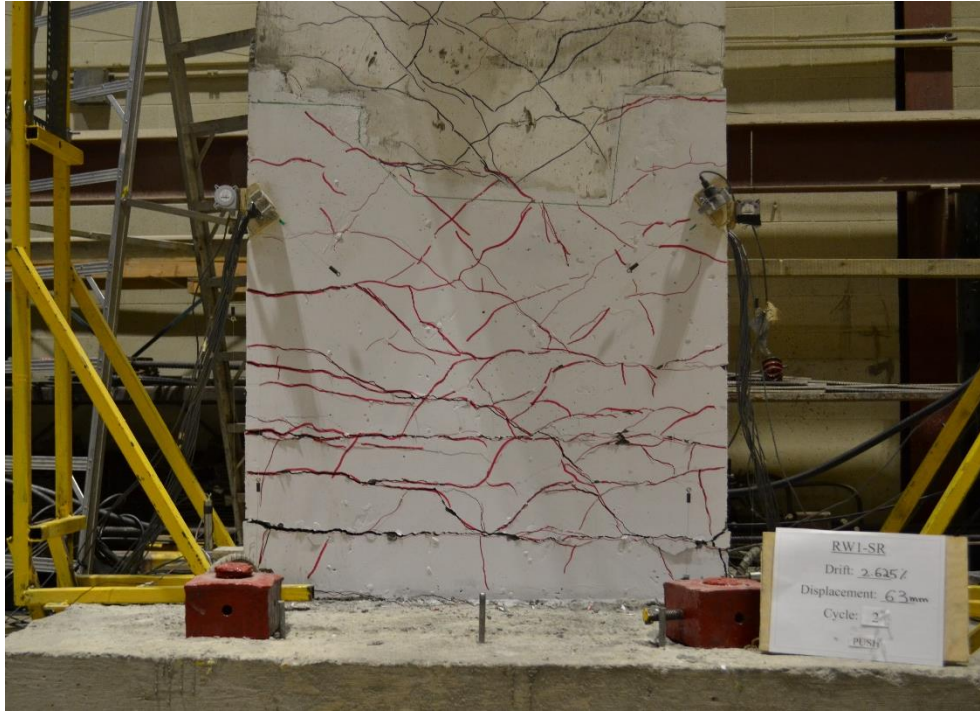
Figure A.1.10: Crack Pattern of Wall RW1-SR at 2.625% Drift (63 mm Displacement)

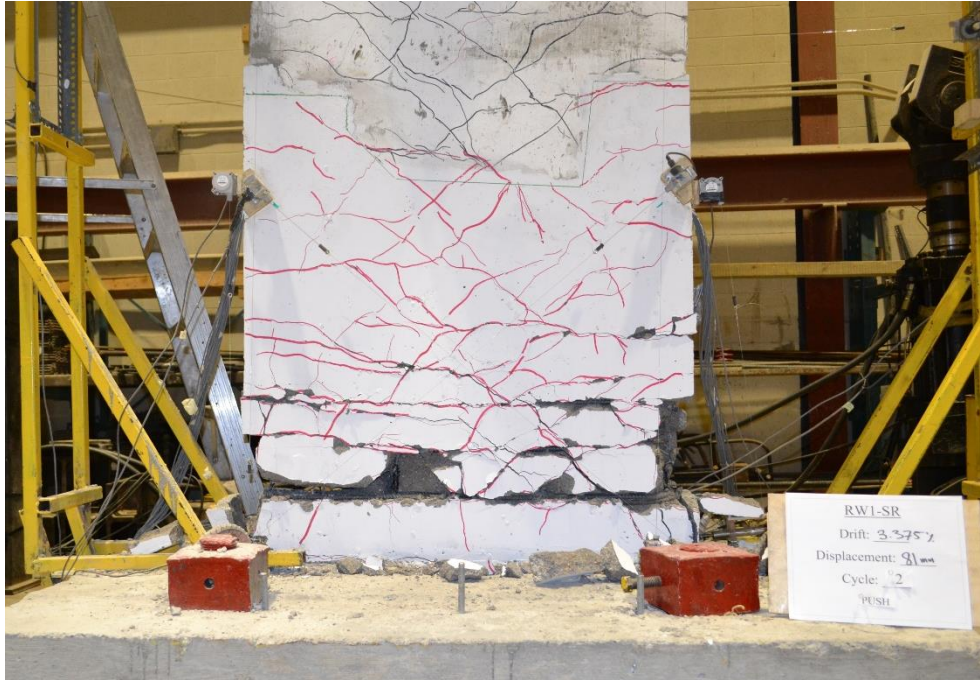
A.1.12: Crack Pattern of Wall RW1-SR at 3.375% Drift (81 mm Displacement)

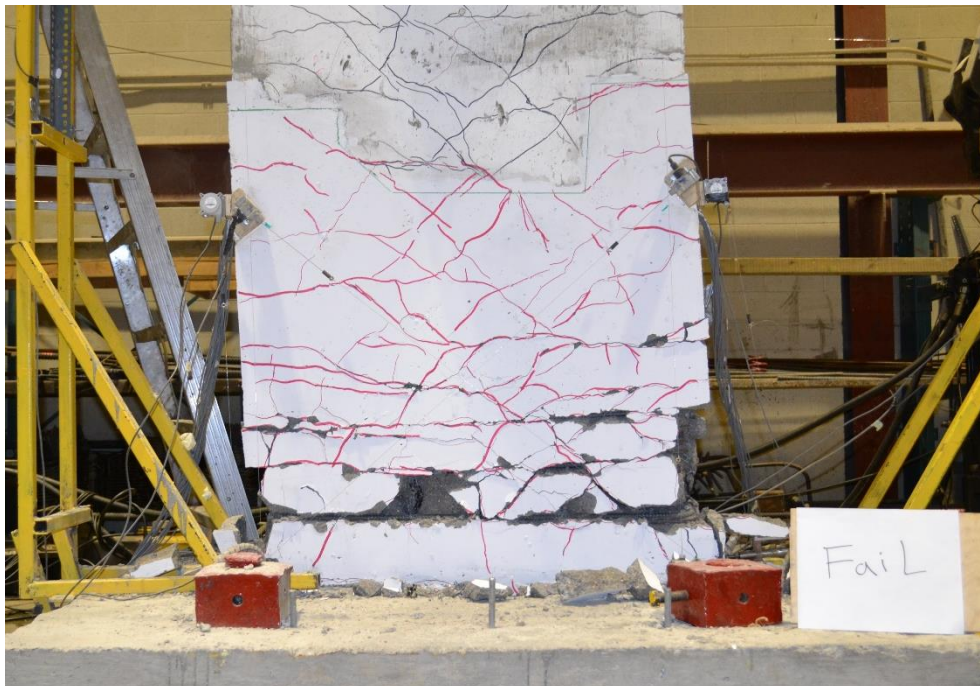
A.1.13: Crack Pattern of Wall RW1-SR at Failure

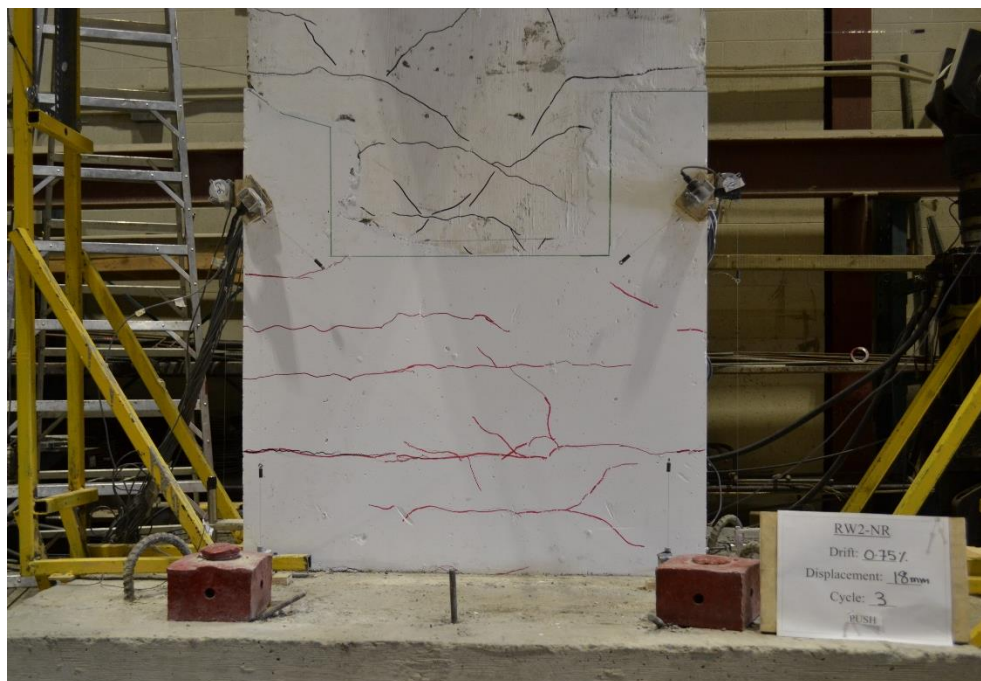
Figure A.2.3: Crack Pattern of Wall RW2-NR at 0.75% Drift (18 mm Displacement)

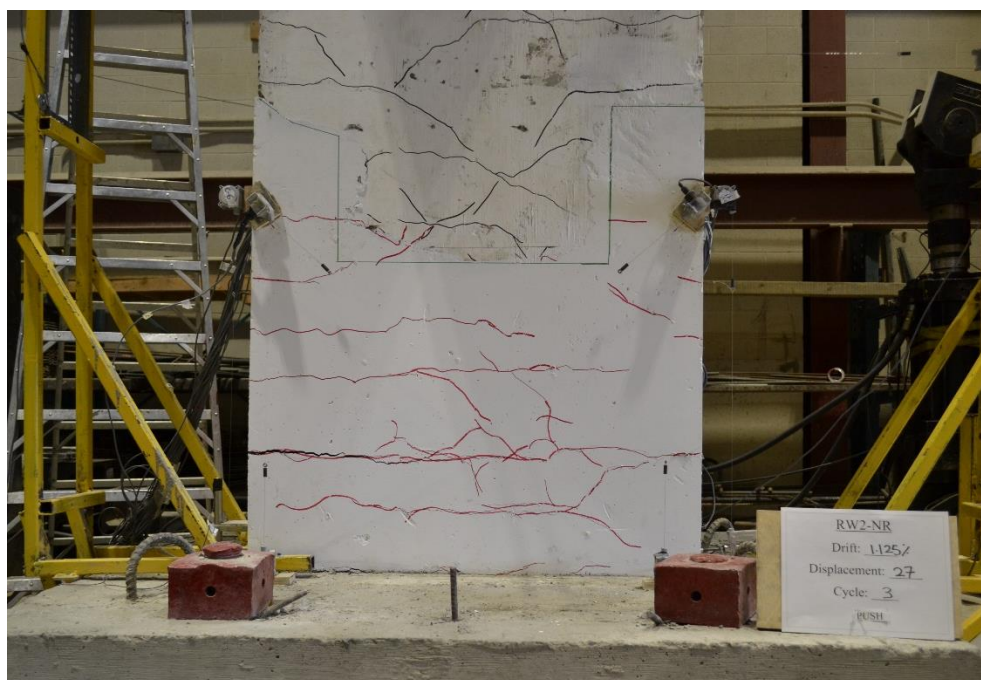
Figure A.2.4: Crack Pattern of Wall RW2-NR at 1.125% Drift (27 mm Displacement)

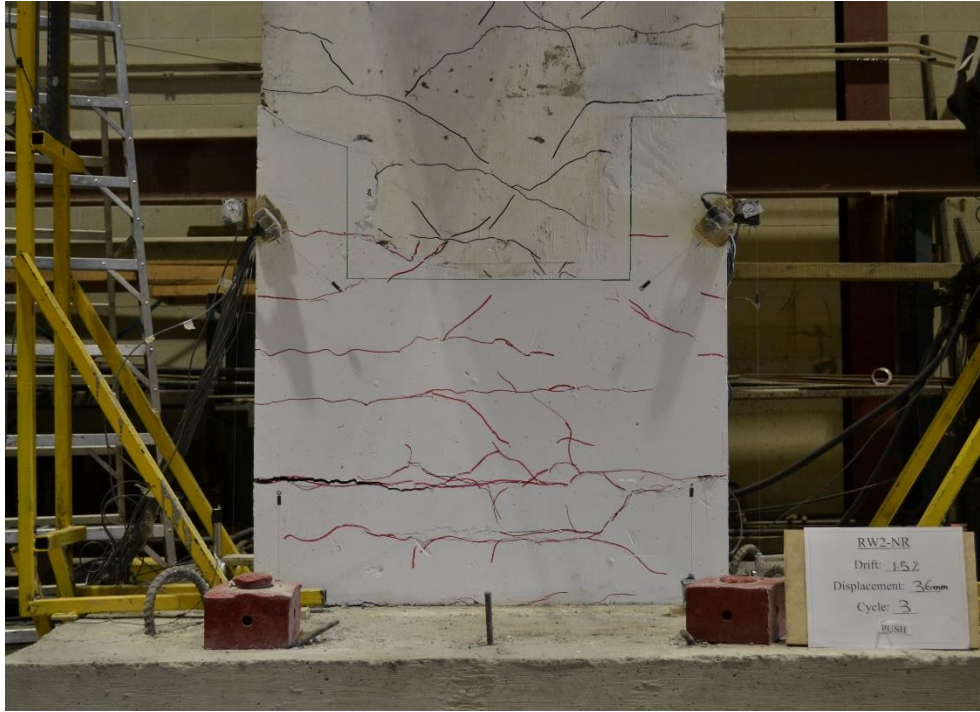
Figure A.2.5: Crack Pattern of Wall RW2-NR at 1.5% Drift (36 mm Displacement)

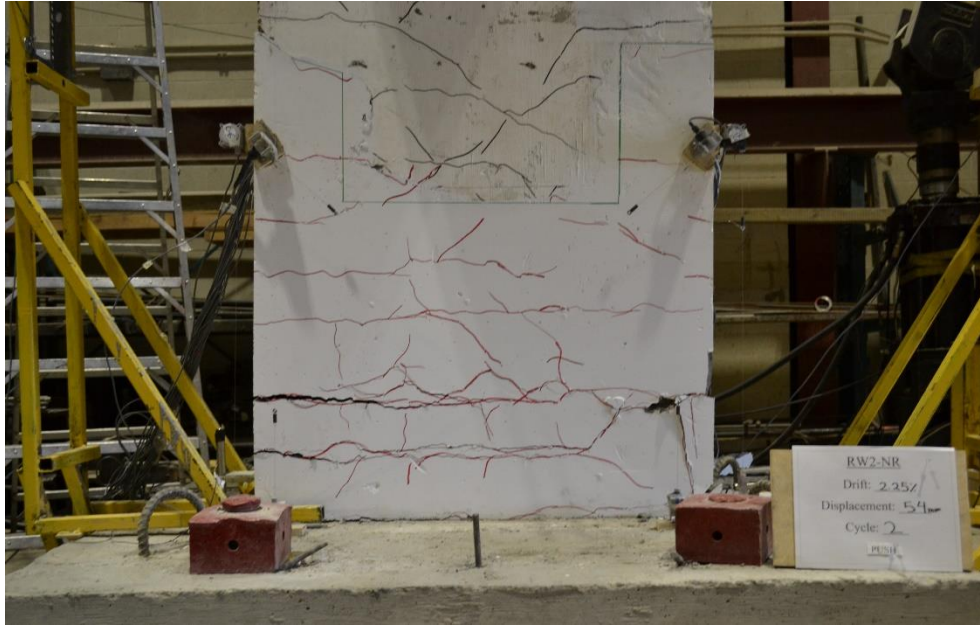
Figure A.2.7: Crack Pattern of Wall RW2-NR at 2.25% Drift (54 mm Displacement)

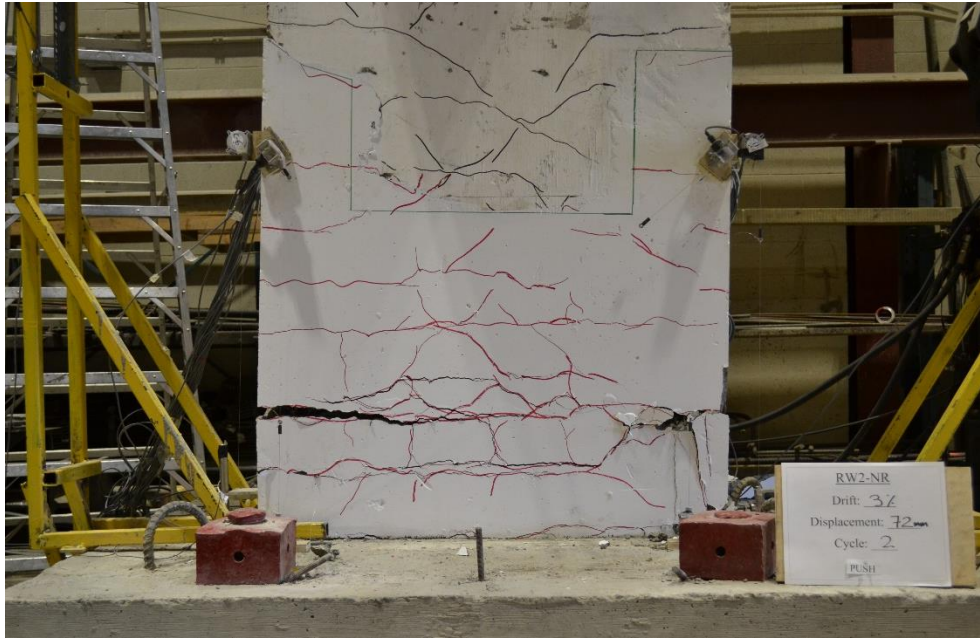
Figure A.2.9: Crack Pattern of Wall RW2-NR at 3% Drift (72 mm Displacement)

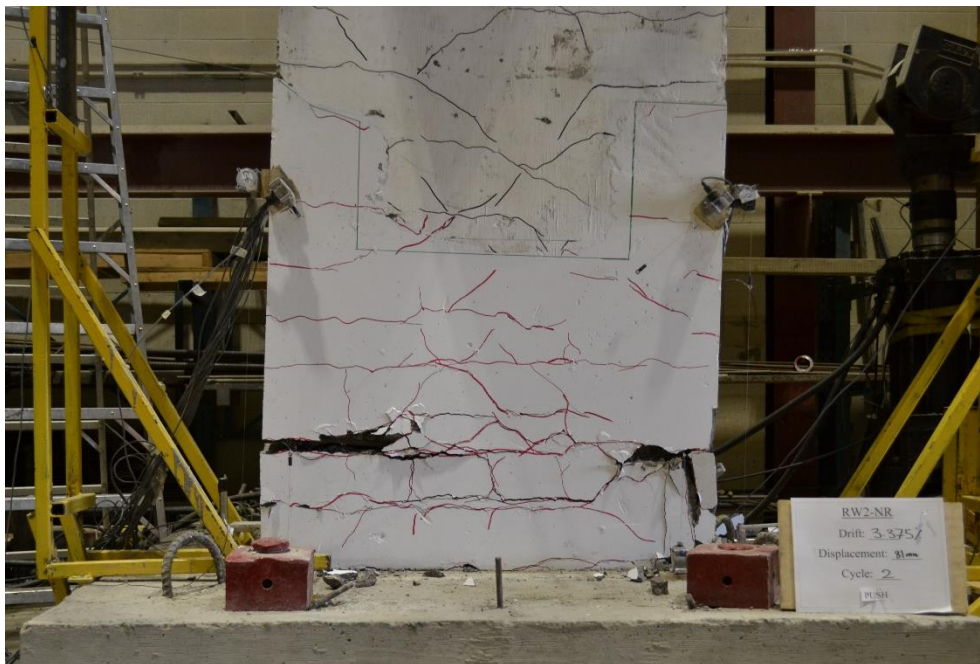
Figure A.2.10: Crack Pattern of Wall RW2-NR at 3.375% Drift (81 mm Displacement)

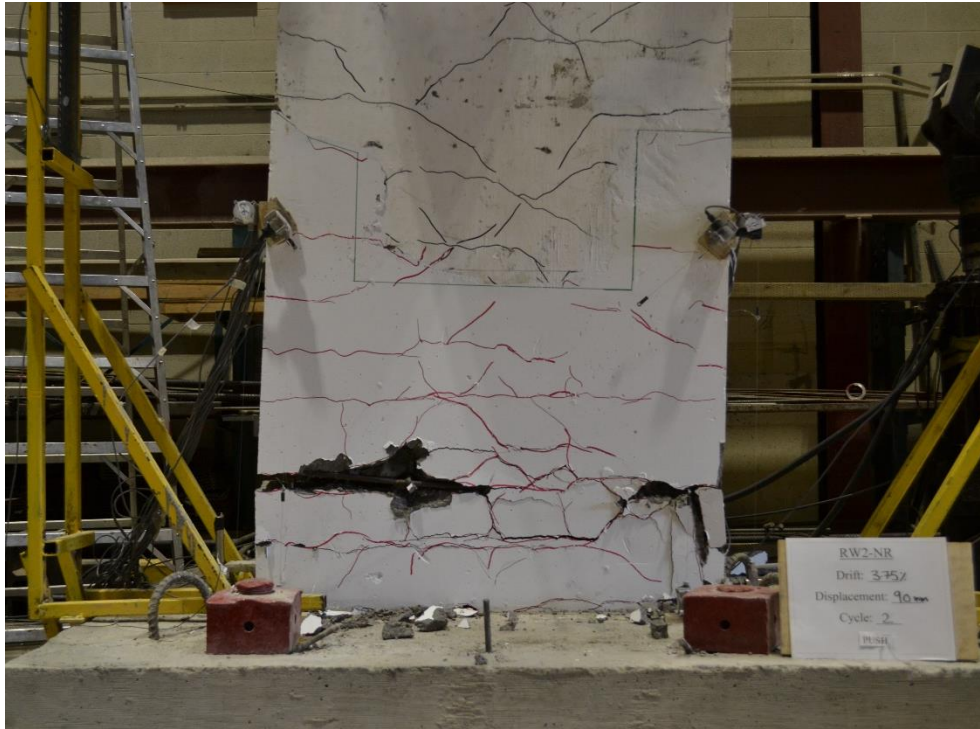
Figure A.2.11: Crack Pattern of Wall RW2-NR at 3.75% Drift (90 mm Displacement)

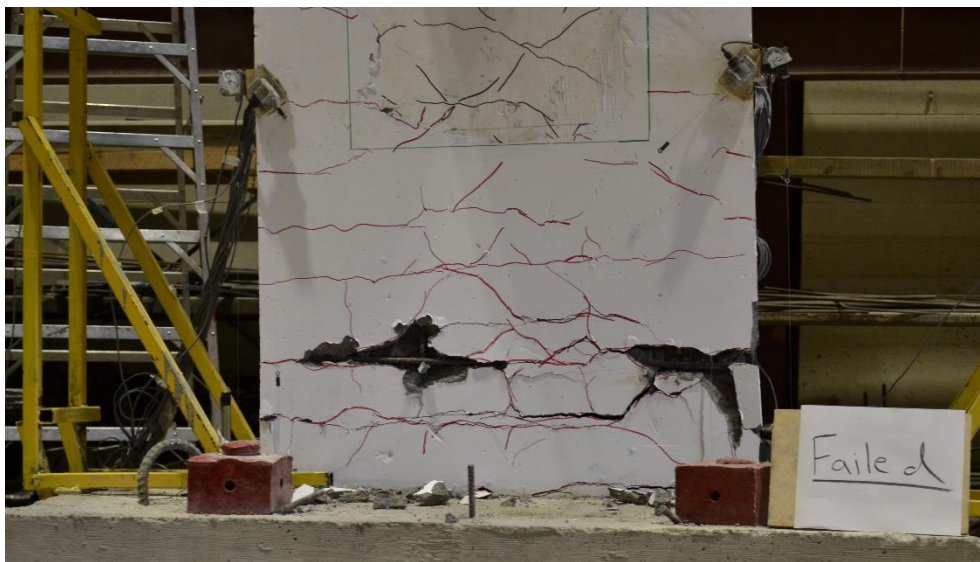
Figure A.2.142: Crack Pattern of Wall RW2-NR at Failure
