**EXPERIMENTAL INVESTIGATION OF CORROSION-INDUCED CRACKING,
SPALLING AND DELAMINATION OF BRIDGE DECKS**

**Presented to the University of Ottawa in fulfillment of the requirements for
Master of Applied Science in Civil Engineering**

Department of Civil Engineering

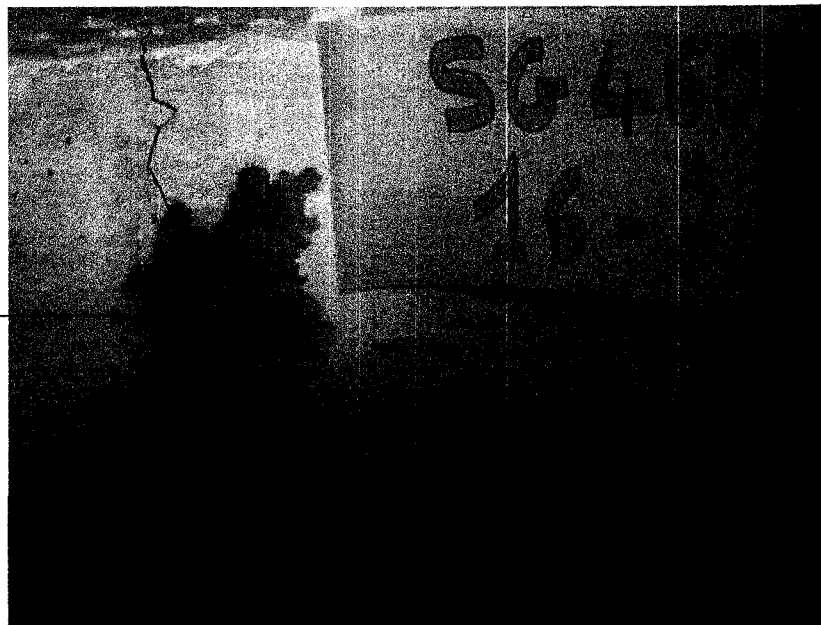
Figure 4.41: Cracks 2, 3, 4, 13 and 14 in specimen SG460-16-2

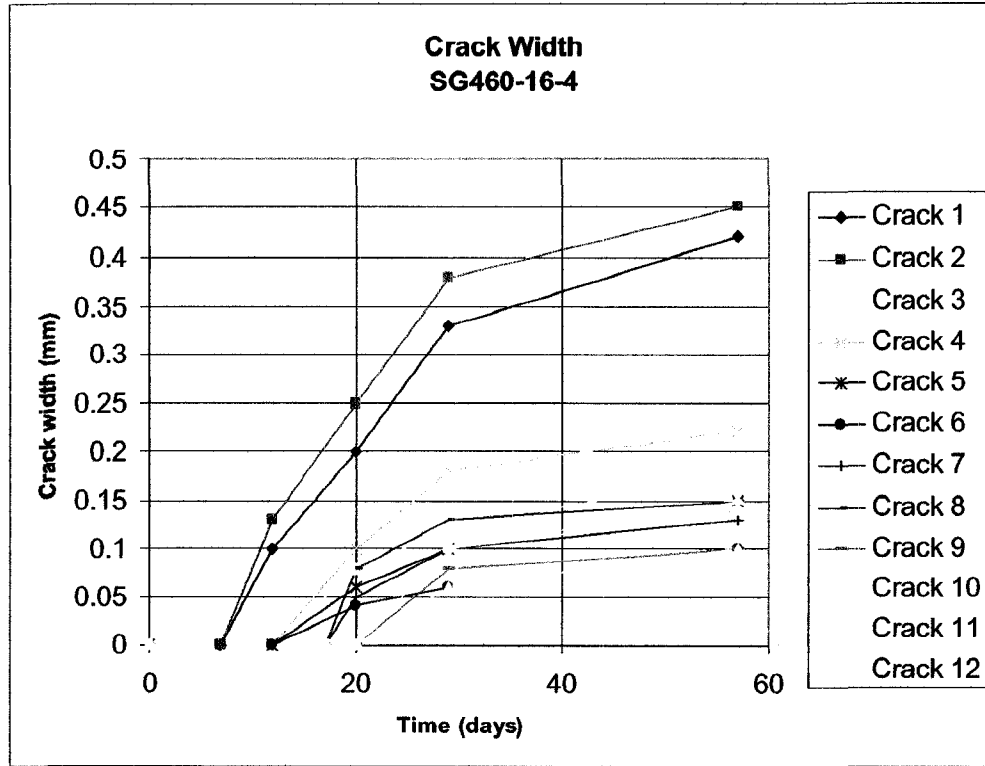
Figure 4.61: Cracks width increase with time in specimen SG460-16-4
