SLIDING SHEAR IN LOW RISE SHEAR WALLS UNDER LATERAL LOAD REVERSALS

by
Zbigniew Feliks Wasiewicz

Abstract

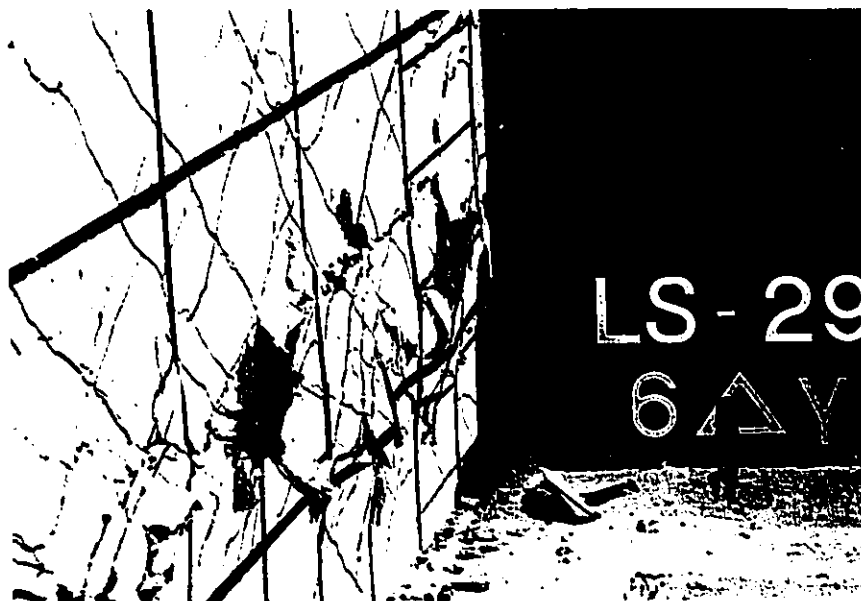
Figure 1.3: Diagonal compression failure

Cycles of load reversals produce two sets of diagonal shear cracks in two opposite directions. Further cycling causes opening and closing of the intersecting diagonal cracks, and consequently reduces the compression strength of concrete. Diagonal compression failure occurs when compressive stresses in diagonal struts exceed compressive strength of concrete. This type of failure is likely to occur when the wall has enough horizontal reinforcement to resist diagonal tension, and all other forms of failure are eliminated. Fig.1.3 illustrates a typical diagonal compression failure.

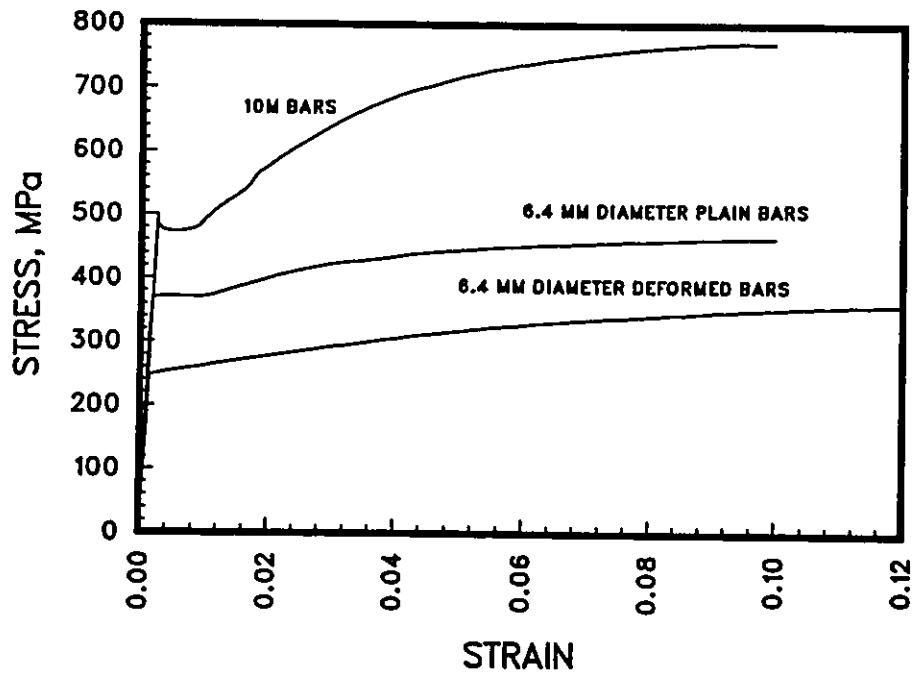
Figure 2.23: Stress-strain relationship for all reinforcement used in both walls.

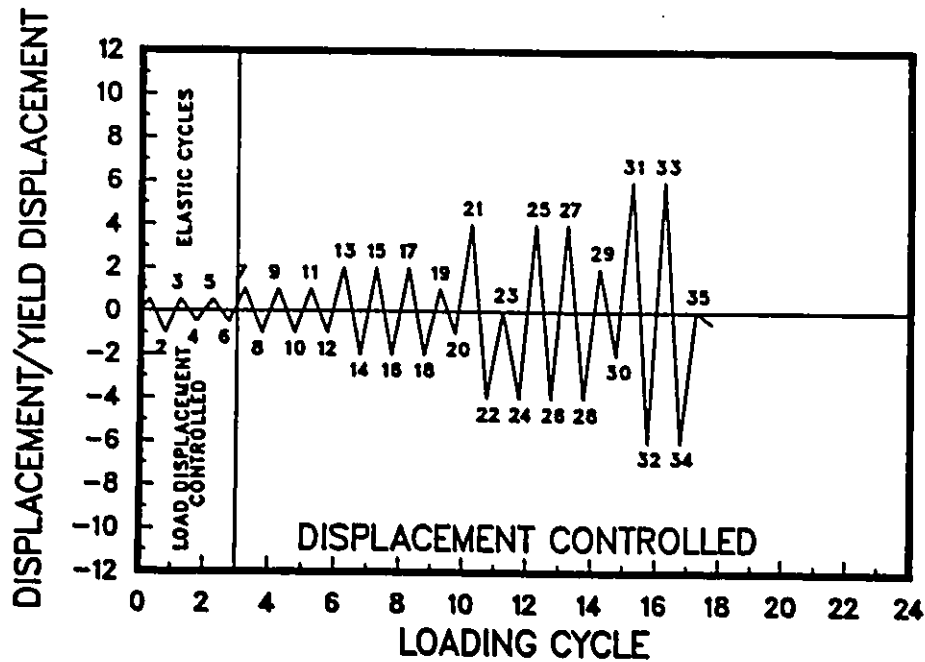
Figure 3.1: Actual loading history for Wall 3

Wall 3 with an aspect ratio of $1/4$, and minimum horizontal reinforcement ratio of 0.0025 , was subjected to the loading program shown in Fig. 3.1. The actual loading program differed somewhat from the intended shown in

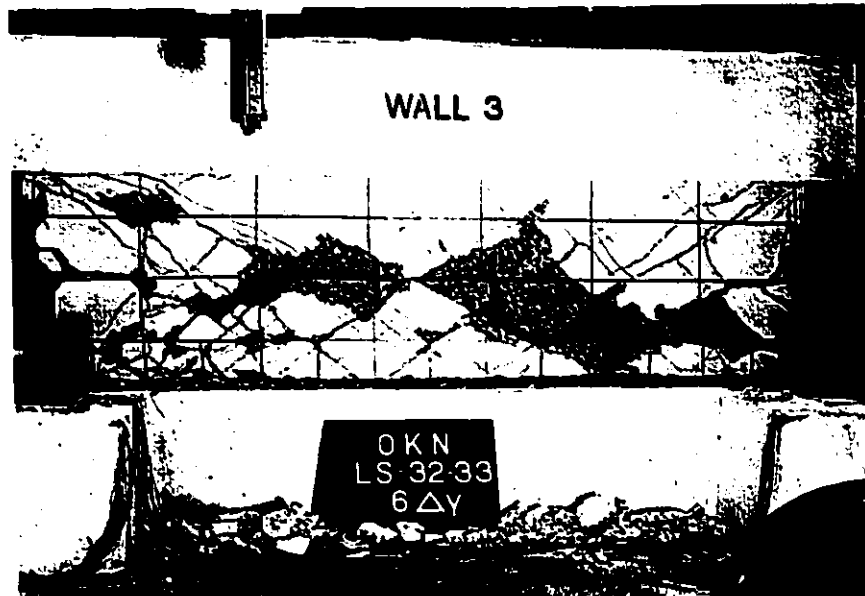
Figure 3.10: Wall 3 after the test

During the first cycle of $6\Delta_y$, the wall developed a maximum load of about 830 kN, before reaching the desired level of deformation. As the displacement was increased, a drop in load resistance was observed. There was visible swelling of concrete in the compression zone extending approximately a third of the wall width. The load dropped suddenly, and displacement was uncontrollable. This behavior was attributed to diagonal compression failure. Similar situation but in lesser intensity occurred when the load was reversed. The wall first reached a maximum load of about -460 kN which then dropped suddenly. There was massive spalling of concrete in the previously overstressed compression region. The test was continued with another cycle at $6\Delta_y$. In this cycle, the specimen sustained only about 200 kN in the positive direction, and about -120 kN in the negative direction. Progressive spalling and deterioration of concrete occurred above the sliding shear reinforcement. The bottom portion of the wall, where the shear keys formed, remained essentially intact. Figure 3.9 shows the specimen at $6\Delta_y$, when failure occurred. Figure 3.10 shows the specimen at the end of the test.
