**BLAST RETROFIT OF UNREINFORCED MASONRY WALLS USING FABRIC  
REINFORCED CEMENTITIOUS MATRIX (FRCM) COMPOSITES**

Thesis submitted to the University of Ottawa  
in partial Fulfillment of the requirements for the  
Master of Applied Science

Department of Civil Engineering  
Faculty of Engineering  
University of Ottawa

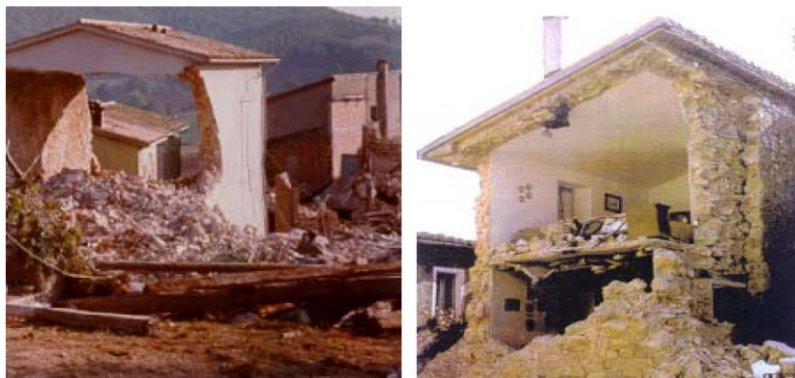
**Figure 1-1. Out-of-plane failures of load-bearing walls, Umbria, Italy, 1997 (Babaeidarabad, 2013)**

Because they are constructed by stacking units using thin layers of mortar, such unreinforced masonry (URM) walls are especially vulnerable to brittle and sudden collapse under the effects of out-of-plane bending (Babaeidarabad, 2013). Figure 1-1 shows examples of out-of-plane flexural failures of URM walls during the 1997 Umbria Earthquake in Italy (Babaeidarabad, 2013).

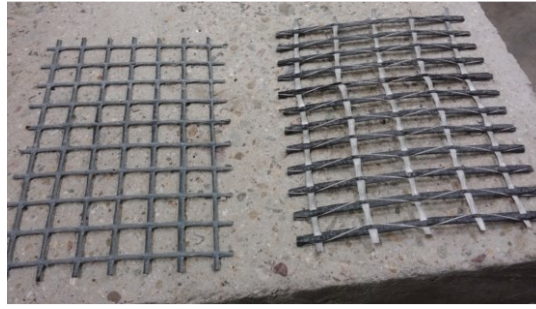
**Figure 2-4. FRCM carbon grid: Bidirectional (left) and unidirectional (right) (taken from manufacturer's data sheet)**

Either unidirectional or bidirectional fabrics can be used depending on the loading condition as shown in Figure 2-4.

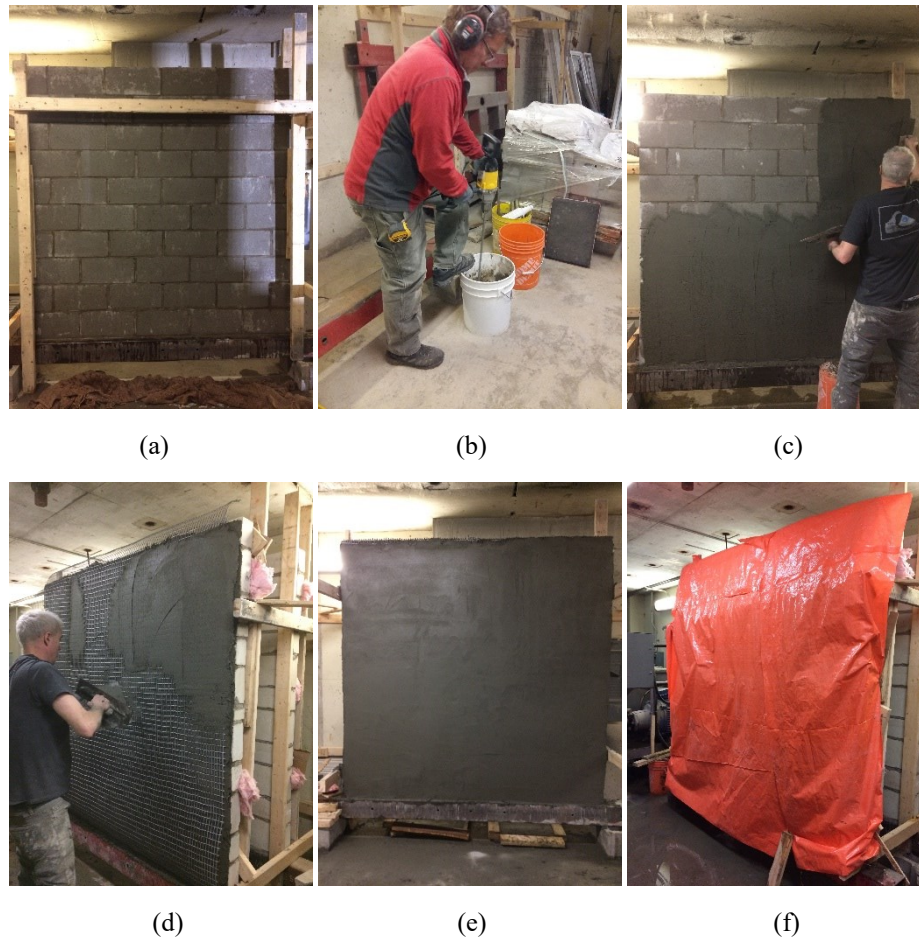
**Figure 3-7. FRCM application: (a) Surface Preparation, (b) Mortar mixing, (c) Base mortar (1/2''), (d) Additional mortar (1/4''), (e) Final mortar (1/2''), (f) Water curing with burlap and plastic tarp**

The procedure of FRCM installation was the same for both walls, and the main steps of installation are shown in Figure 3-7. The average total thickness of the FRCM strengthening system was 45 mm (1.8 in) for the CMU wall, and 43 mm (1.7 in) for the stone masonry wall. In both cases, 3 layers of FRCM composites were applied onto the walls.

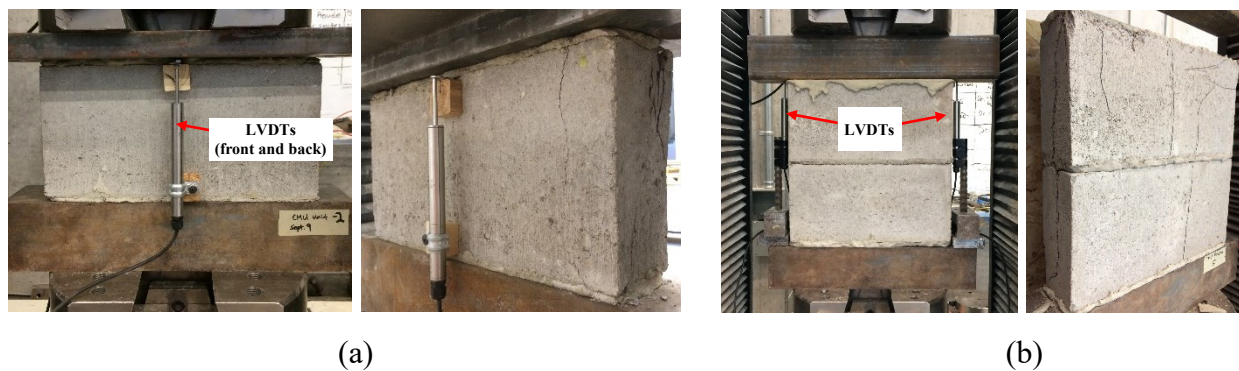
**Figure 3-19. Compressive test set up, and typical failures: (a) CMU units, (b) CMU prisms**

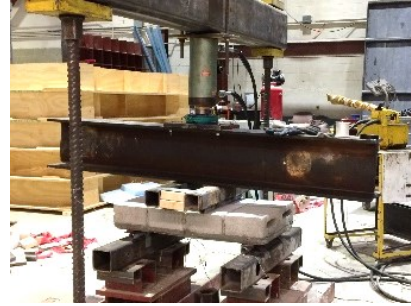
**Figure 3-33. The third-point loading test setup for small beams**

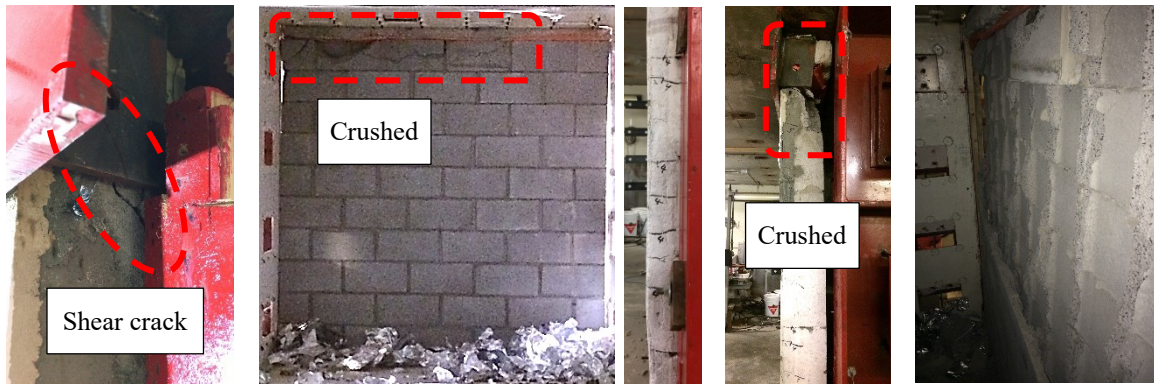
(a) from 3<sup>rd</sup> shot      (b) 7<sup>th</sup> shot (back and side)      (c) 8<sup>th</sup> shot      (d) 9<sup>th</sup> shot (back)

**Figure 4-3. Major shear cracks and CMU crushing (R-C-N)**

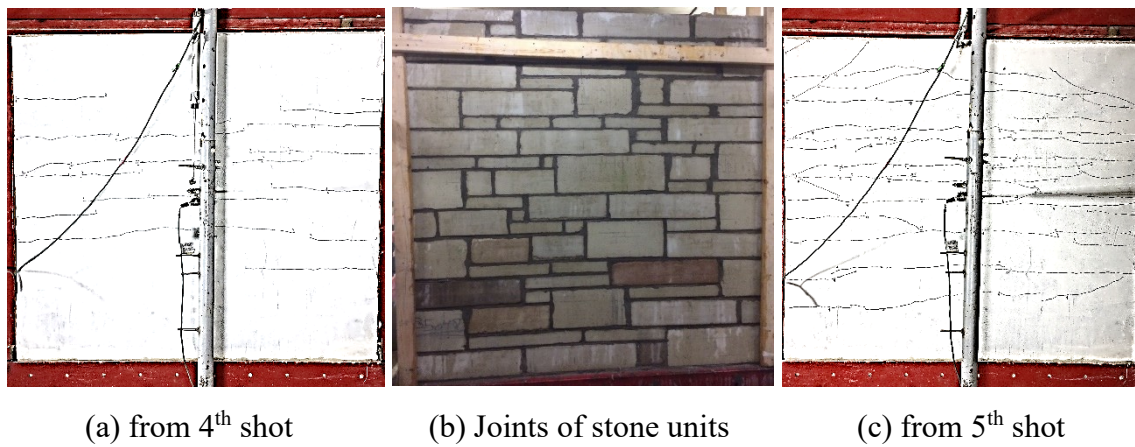
**Figure 4-9. Comparison between the patterns of flexural cracks and joints of stone units**

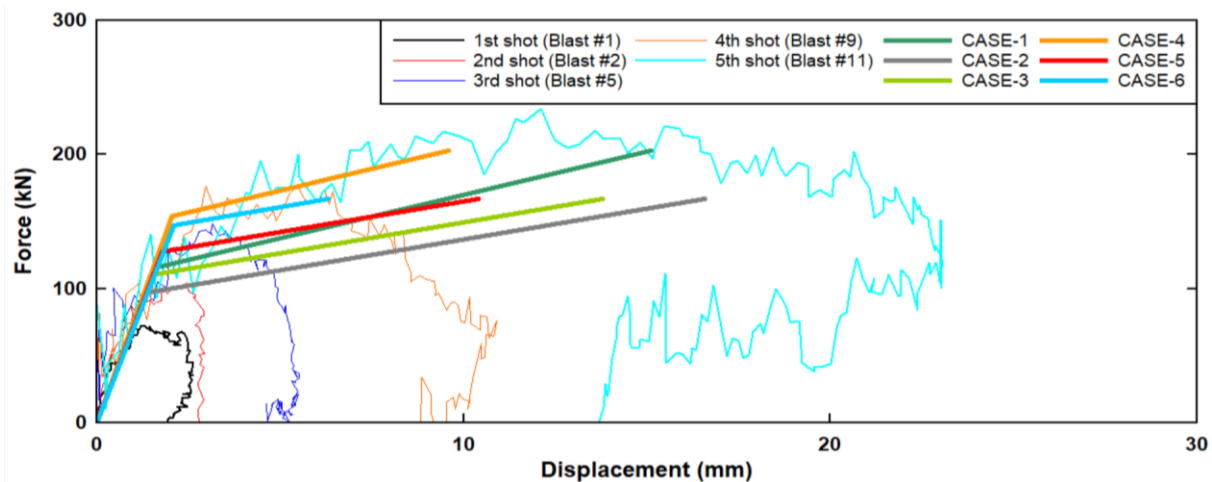
**Figure 6-15.** Idealized resistance curves: CASE-1 to CASE-6
