An Experimental Study on the Cyclic Behaviour of Riveted Stiffened Seat Angle Connection with Concrete Encasement

**Thesis submitted to the School of Graduate Studies
in partial fulfilment of the requirements for the
Master of Applied Science Degree in Civil Engineering
under the auspices of the
Ottawa-Carleton Institute for Civil Engineering**

June 1997

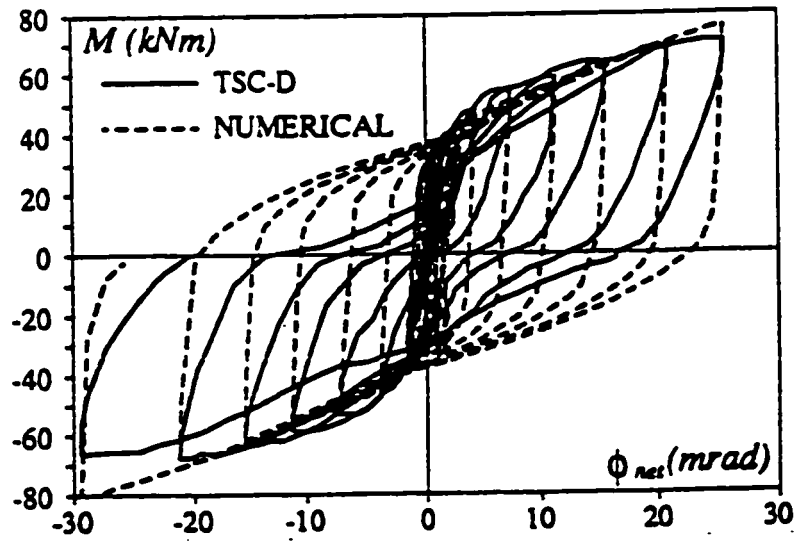
Figure 2.4 Comparison between experimental and numerical response of top and seat angle connection (De Luca, 1995)

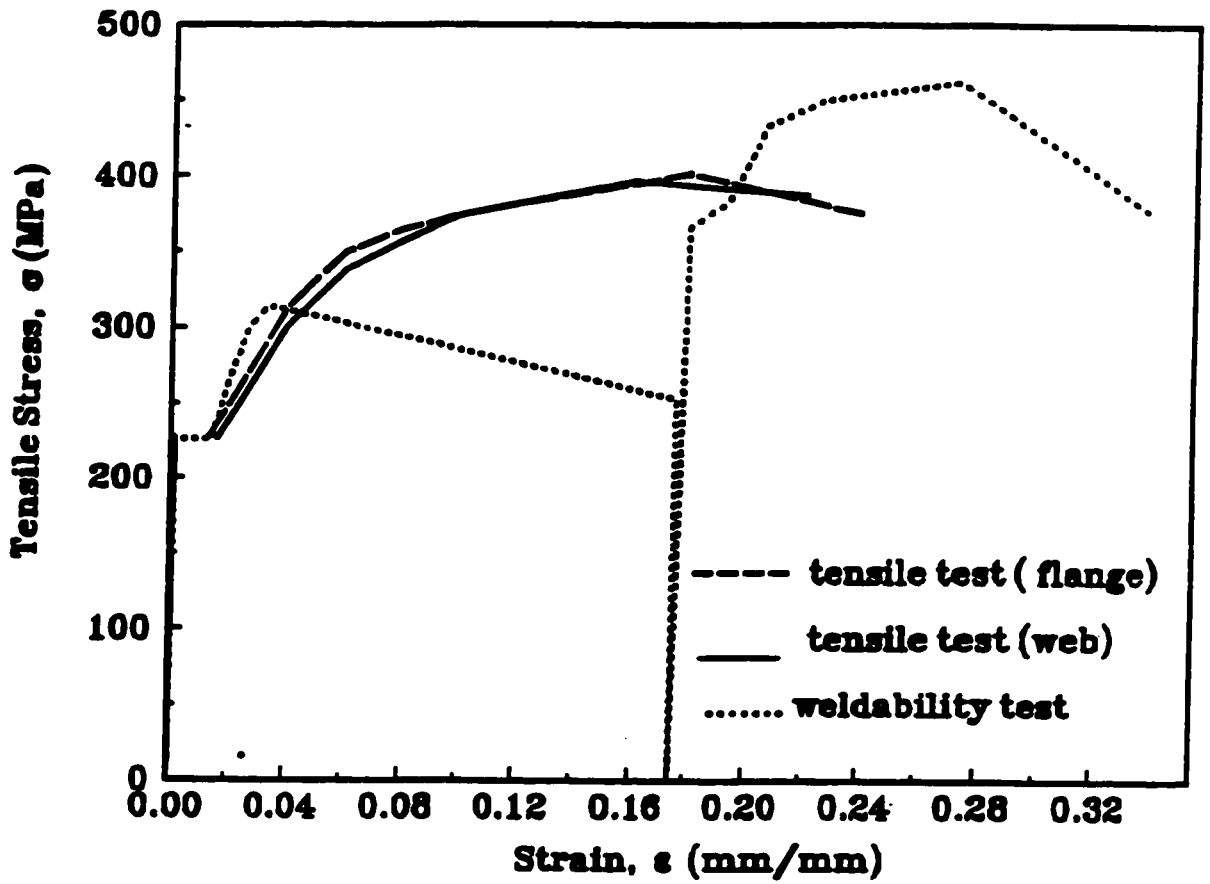
Figure 3.2 Stress-strain relationship for existing steel, as seen in Bruneau and Sarraf (1996)

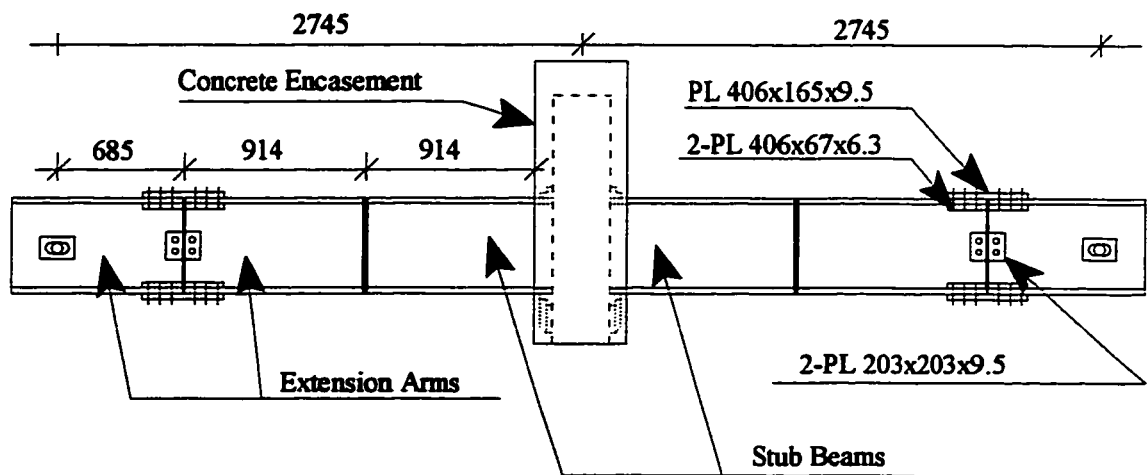
Figure 3.4 Typical specimen showing existing stub beams, additional extension arms and splice locations.

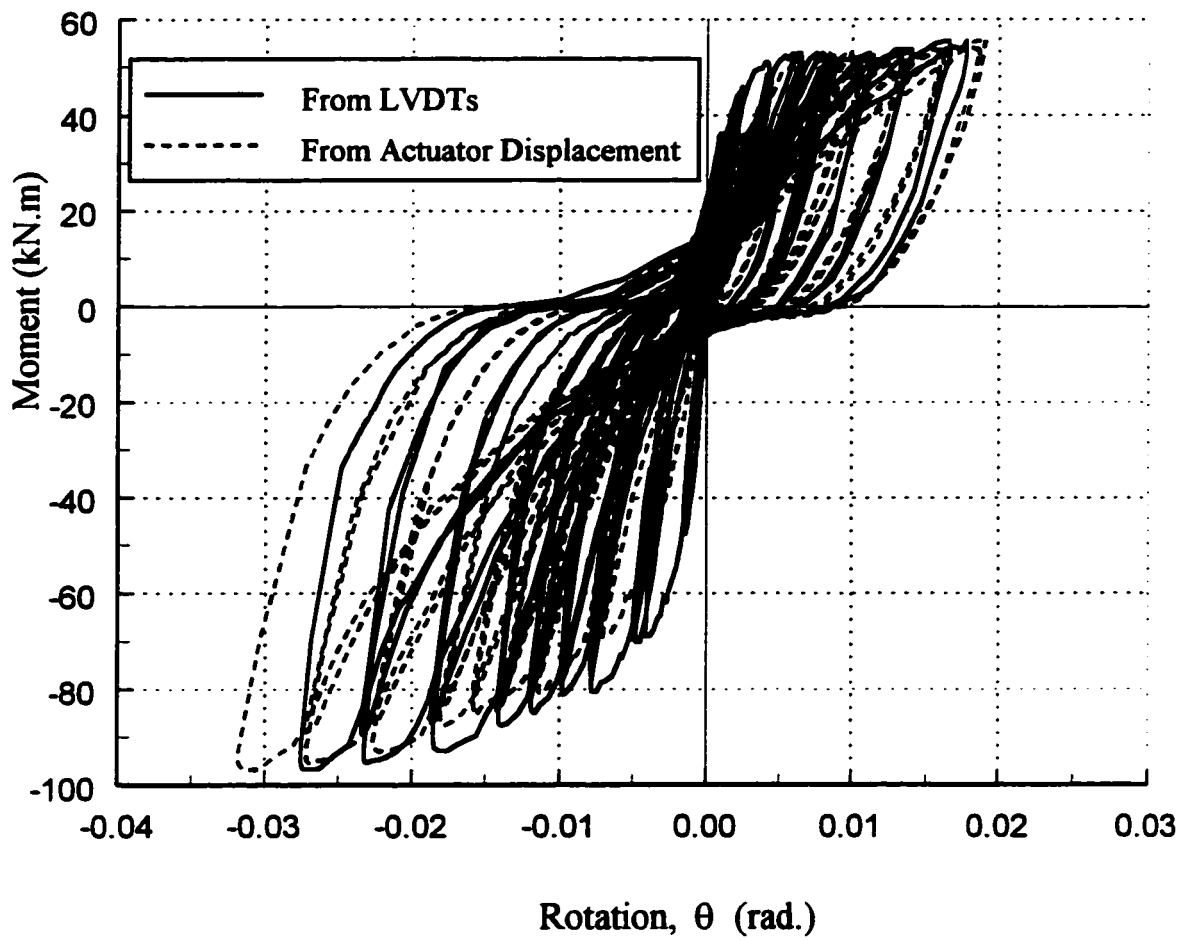
Figure 4.1 Comparison between rotations calculated using LVDTs and Actuator Displacement (to point where LVDTs were removed), specimen 1.

As described in section 3.5.2, two methods were also devised for determining beam rotations. However, in the first experiment, the LVDTs installed at the column faces eventually went out of range and had to be removed before the specimen reached failure in order to avoid damaging the instruments. Therefore the last few hysteretic loops of that first test program are not included in the recorded dataset for these instruments. When comparing the results of the rotations calculated from the LVDTs with those calculated using the actuator displacement, the correlation is very good as shown in Fig. 4.1. The slightly larger rotations measured by the actuator was found to be due to deformations of the pin-supports and some slip in the reaction buttress. Nonetheless, to present the entire range of test results as an average for both connections, the data from the actuator displacement was used to calculate the connection rotations for the first experiment.

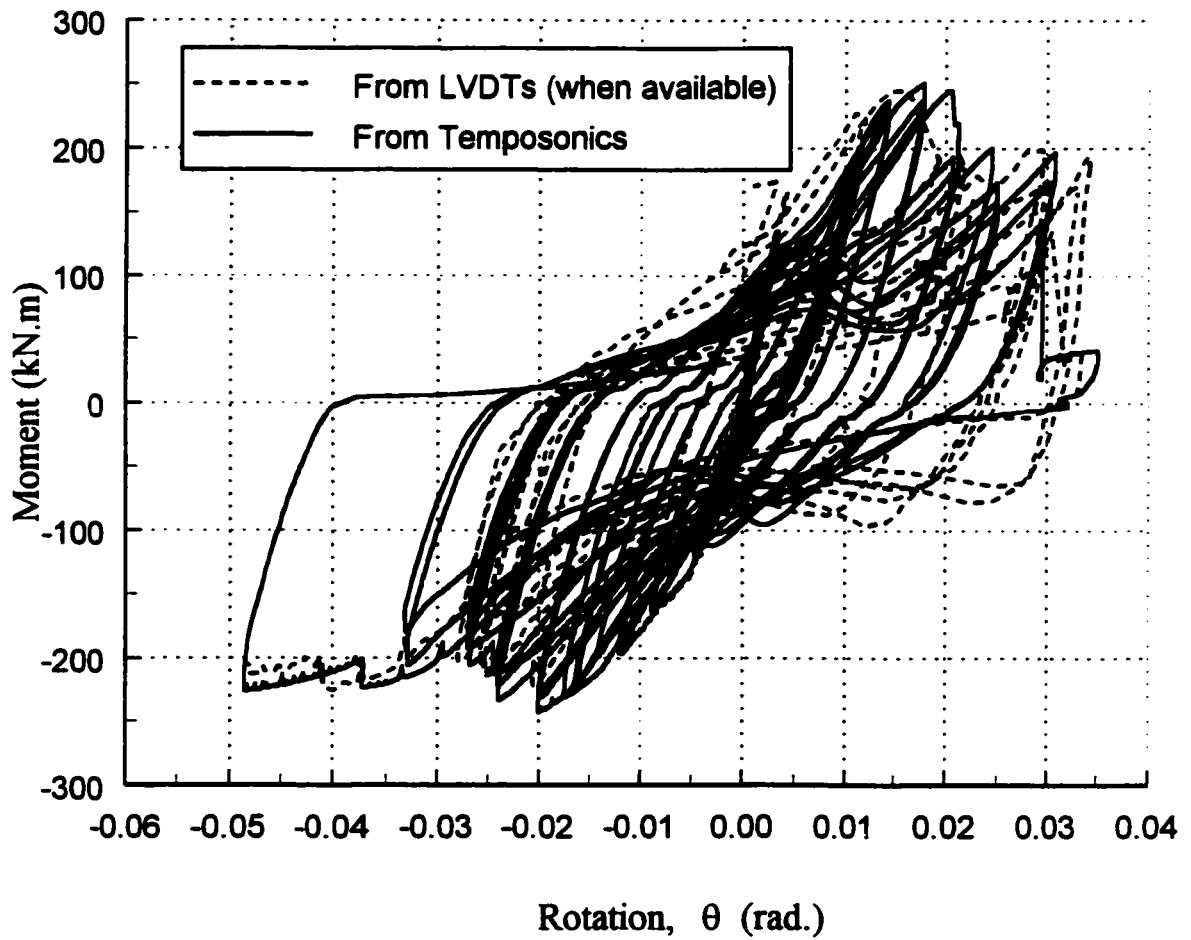
Figure 4.2 Comparison between LVDT and Temposonic data after correction, specimen 2.

During testing of the second specimen, problems developed with the Scimetric data acquisition system and only sporadic values were recorded for the LVDTs. The values of rotations obtained from the LVDTs were compared with the values calculated using the Temposonic measuring beam deflections. Once again, a good correlation was observed between the two results, as shown in Fig. 4.2, but it is important to note that the data collected by the LVDTs is not continuous and that several loops of data are missing. The data recorded by the Temposonics was chosen to present the results of the second test.

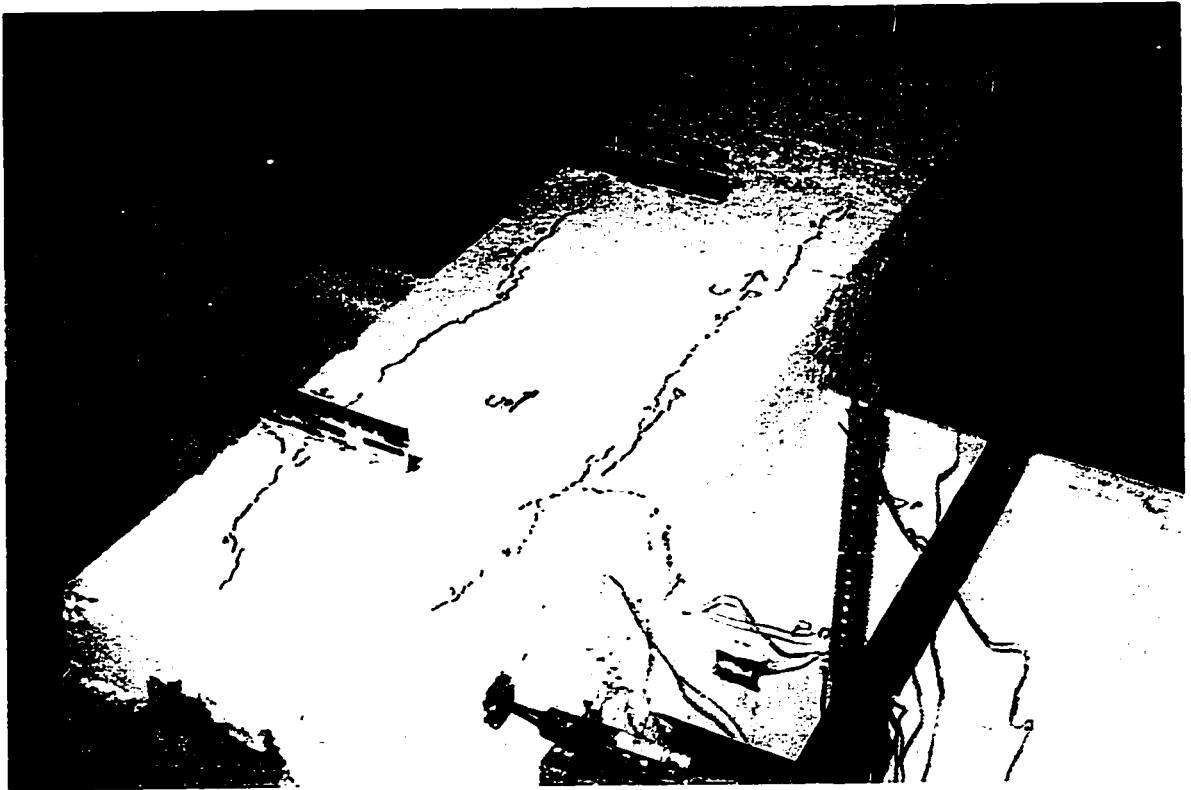
Figure 4.6 Hairline cracking of specimen 1.

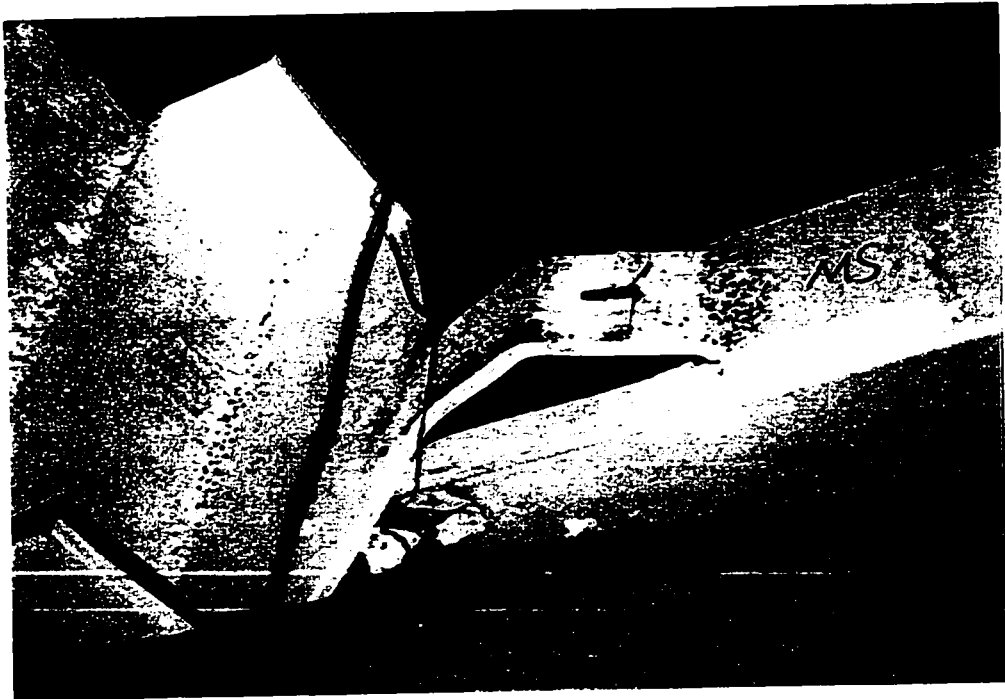
Figure 4.29 Maximum buckling deformation of South-West fuse-plate.
