# **THE EFFECT OF STEEL STRAPPING TENSIONING TECHNIQUE AND FIBRE-REINFORCED POLYMER ON THE PERFORMANCE OF CROSS-LAMINATED TIMBER SLABS SUBJECTED TO BLAST LOADS**

**America Maria Lopez-Molina**

**Master of Applied Science**

In Civil Engineering

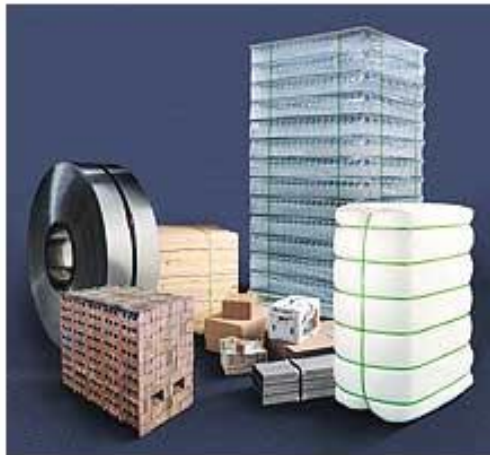
**Figure 1.7: Typical Industrial Applications (Signode, 2017)**

Steel strapping can be used as a post-tensioning technique which can serve as external confinement to a structural element. This form of steel strapping is typically seen in the packaging industry (Figure 1.7); however some attempts have been made to utilize this material in the field of structural engineering (Lloyd, 2015; Sabri, 2013; Awang et al., 2013; Pin Lee et al., 2013). The underlying reason behind the implementation of this technique is their relatively low cost, and the ease of application; in addition to their wide versatile function.

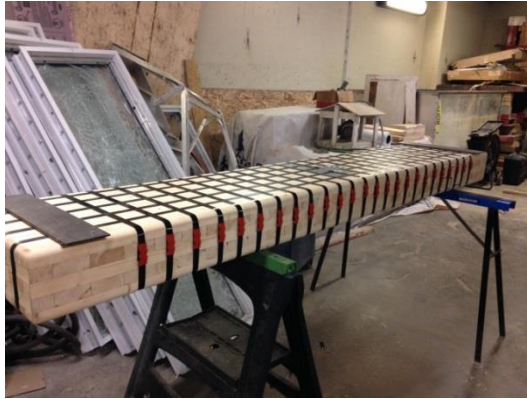
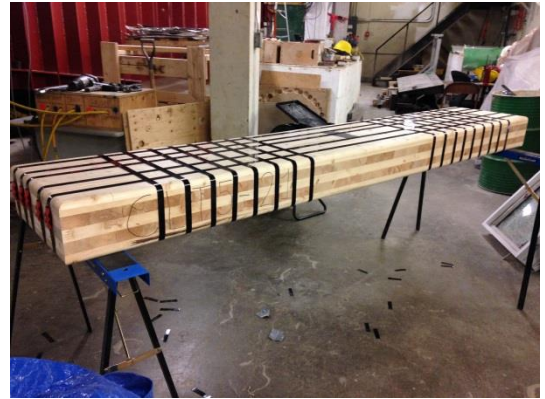
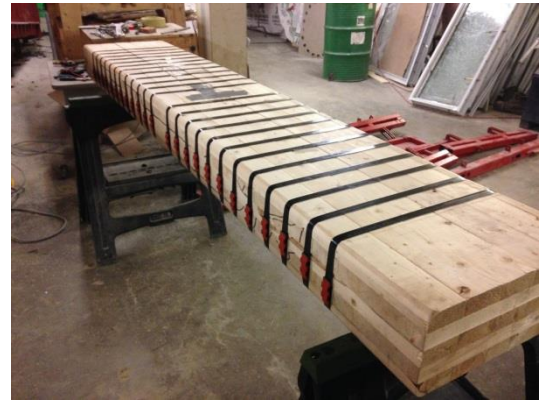
**Figure 3.3: Typical Test Configurations**

consisted of horizontal straps installed at every other transverse layer along the clear span resulting in an approximate spacing of 180 mm (7") centre to centre. Figure 3.3 shows examples of the test configurations.

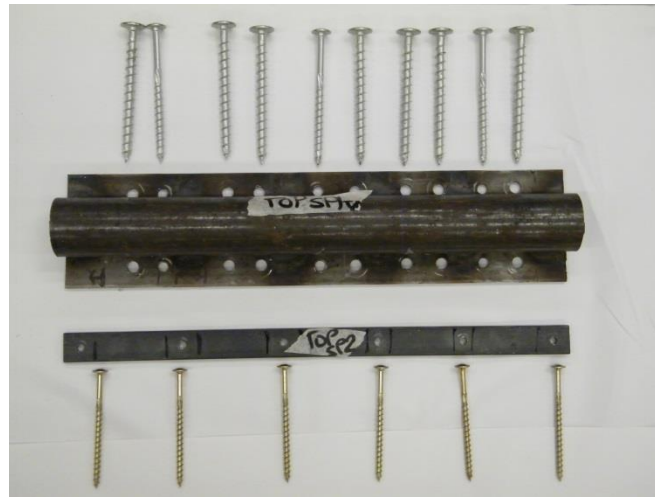
Figure 3.6: Steel Connection System

A steel plate, labelled SP2, measuring 447 mm in length and 25.86 mm in width resulting in an approximate cross sectional area of  $12,000 \text{ mm}^2$  was used to bring the steel straps closer to the specimens (Figure 3.5). This steel plate required 6 Heco-Topix screws in order to firmly secure the plate on the tension face of the panel. Figure 3.5 shows a schematic drawing including dimensions expressed in millimetres. Although the succeeding steel plates were shown separately, both of these pieces were installed adjacent to one another in order to create the steel connection system used to fasten the steel straps on the tension face of the specimen, as presented in Figure 3.6.

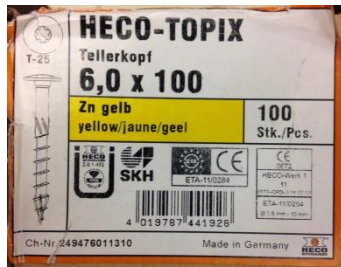
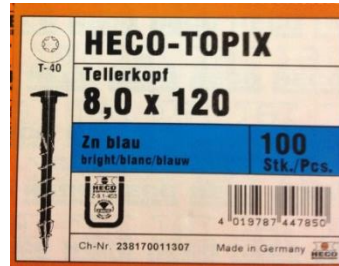
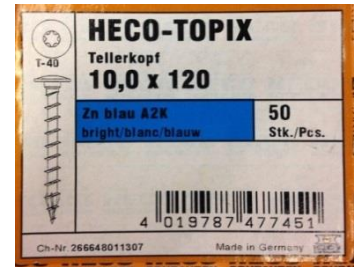
Figure 3.7: Heco-Topix Screws

CLT5-5 was a modified version of a typical vertical strap configuration as it was the only specimen where the longitudinal straps were affixed on the tension face. This specific test consisted of a steel connection system located at the top and bottom of the specimen. The connection consisted of a steel circular hollow section, labelled SP1 (Figure 3.4), with an inner and outer diameter of 43.47 mm, and 50.13 mm, respectively, welded to a steel plate which measured 443 mm in length and 101.60 mm in width resulting in an approximate cross sectional area of  $45,000 \text{ mm}^2$ . The connection plate was fastened to the tension face of the panel with six type II screws and fourteen type III screws totalling to 20 Heco-Topix screws. Additional details regarding the type of screws, dimensions, and the total number utilized are summarized in Table 3.3 and illustrated in Figure 3.7.

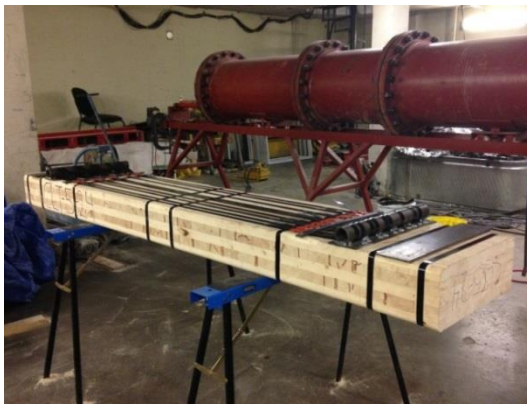
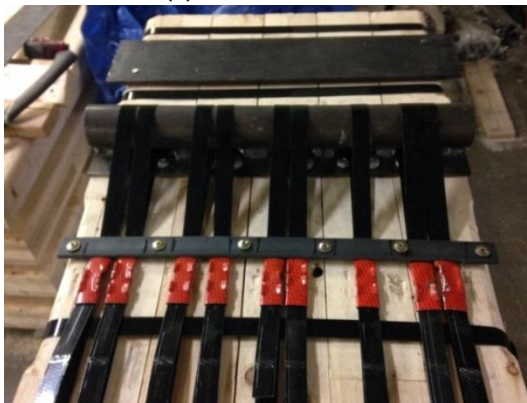
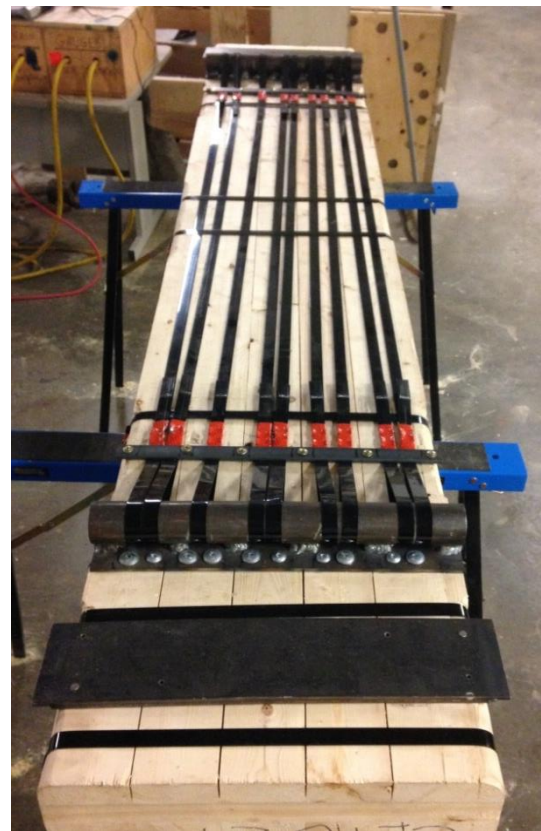
Figure 3.8: Specimen No. 7 – CLT5-5

As outlined in Table 3.2, CLT5-5 consisted of a total of nine vertical straps. Figure 3.8 illustrates this unique configuration.

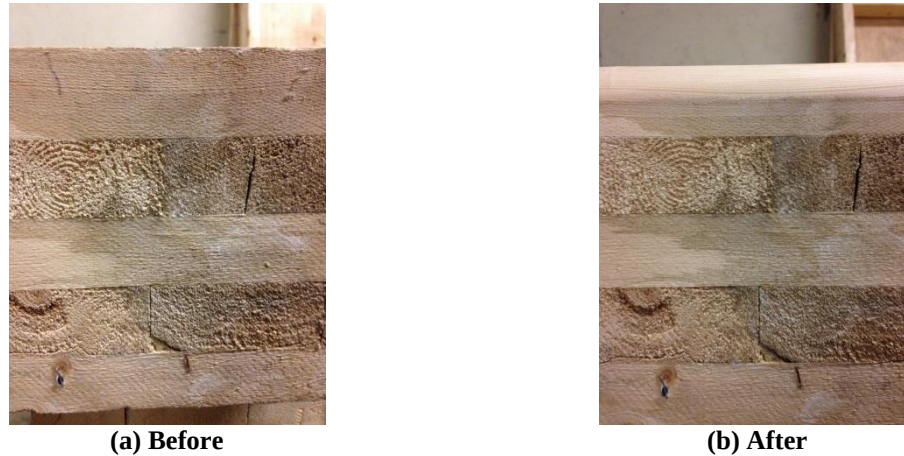
The preparation of the CLT panels was executed in two stages. Prior to the installation of either retrofitting technique, the corners of each panel were routed to a radius of 19.05 mm (3/4") as shown in Figure 3.12. This was done to reduce localized stress concentrations in these particular areas. All previously damaged specimens were also routed, sanded, and smoothed in order to remove any loose splinters.

Figure 3.12: Routing Process

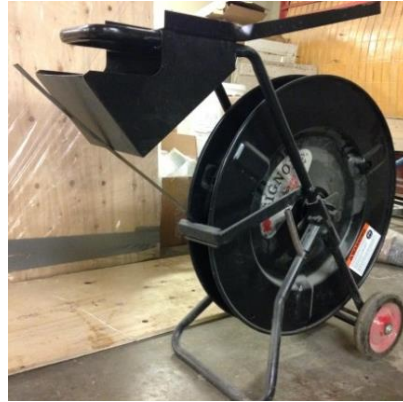
**Figure 3.13: Steel Strapping Dispenser**

1. Steel strapping was extracted from the dispenser (Figure 3.13) after which a seal was slotted through with the smooth side facing upwards.
2. The strap was then passed over top of the panel, wrapped around the panel, and fed through the seal. Approximately 50.8 mm (2") of the strap was measured and bent inwards.
3. The sag in the strapping was removed by manually tightening the strap to the panel and the strap and seal were aligned with the centre of either the transverse or longitudinal layer. A pneumatic tensioner (Figure 3.14 (a)) was used to pre-stress the strap. Once the strap was fully tensioned, a strapping tool (Figure 3.14 (b)) was used to fasten the seal to the steel strap, where two notches were formed along the length of the seal.

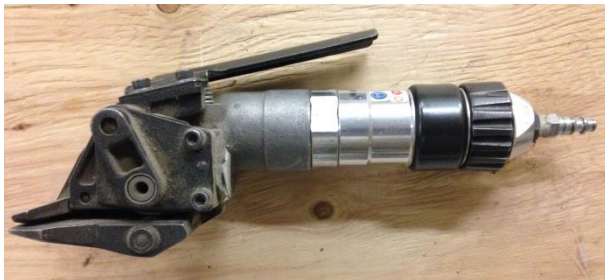
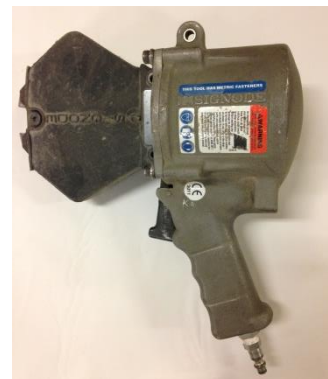
**Figure 3.14: Pneumatic Strapping Tools**

**(a) Pneumatic Tensioner PN2-114**

**(b) RCNS2-34 Strapping Tool**

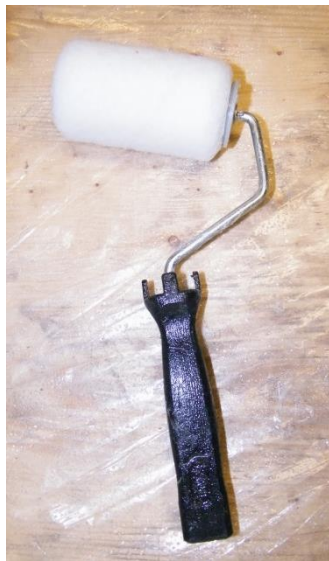
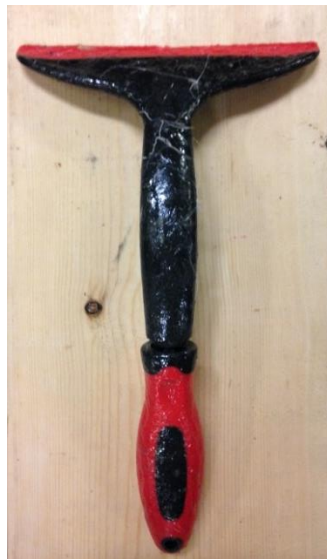
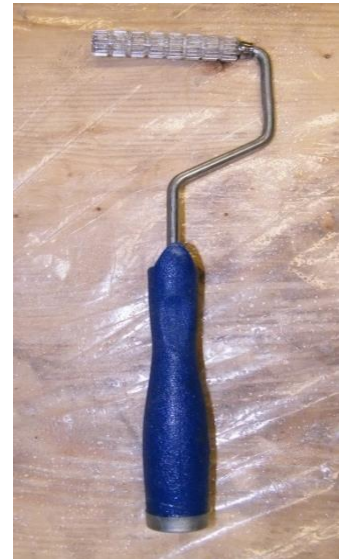
**Figure 3.16: GFRP Application Tools**

1. The GFRP fabric was cut to the correct dimensions, as per the developed test matrix and placed on a hard surface covered in plastic.
2. Prior to the application, the wooden surface was cleaned in order to remove and eliminate any dust or dirt.
3. The epoxy resin system was prepared according the manufacturers recommendation and was applied directly to both sides of a sheet with a paint roller (Figure 3.16 (a)). Once the laminate was saturated, a squidgy (Figure 3.16 (b)) was used to remove any excess epoxy.

4. A layer of epoxy was applied to the surface of the panel. After which the saturated laminate was placed directly on the wet surface.
5. Ribbed steel rollers (Figure 3.16 (c)) were used to remove air voids and excess epoxy, in addition to smoothing said surface.
6. Steps 3 – 8 were repeated for additional GFRP layers.
7. Finished specimens were left to cure for a total of 7 days.

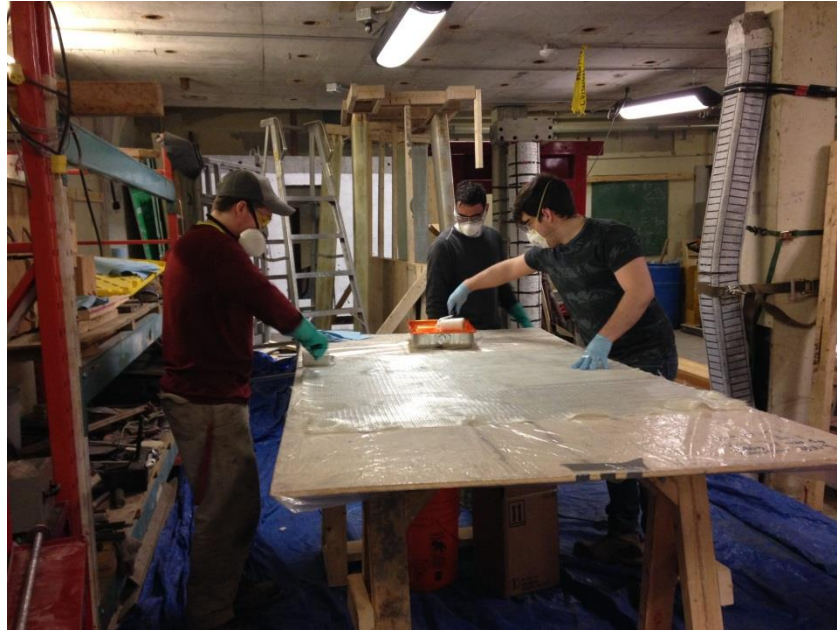
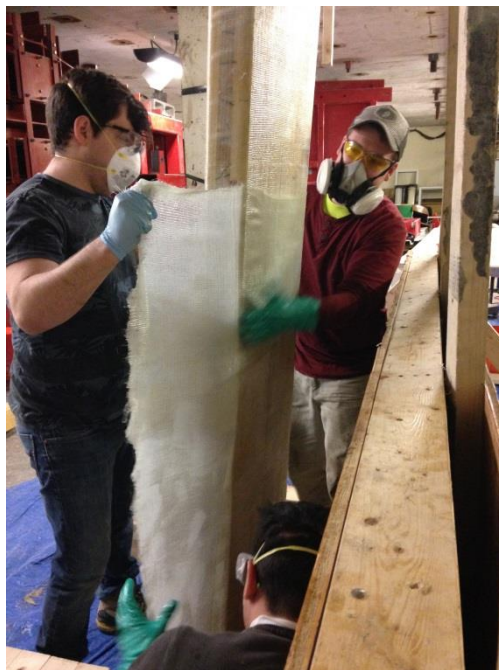
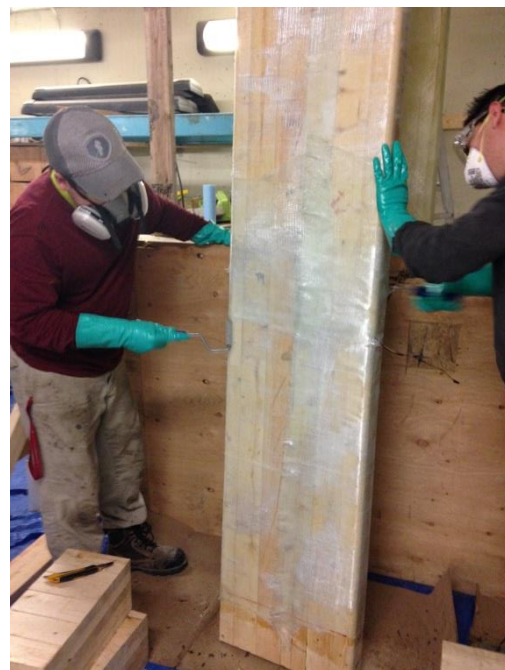
**Figure 3.17: GFRP Application Process**

The application of this retrofitting technique is shown in Figure 3.17.

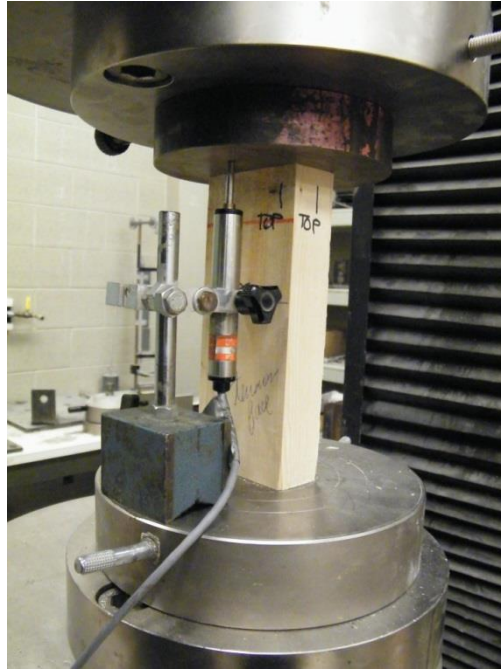
**Figure 3.18: Compression Coupon Test**

Longitudinal laminations from the cross-laminated timber panels were tested in compression and tension parallel to grain in accordance with the *Standard Test Methods for Small Clear Specimens of Timber* (ASTM D143). A total of five laminations, measuring 35 mm, 82 mm, and 200 mm in thickness, width, and in length, respectively were used for the compression coupons. Each coupon was subjected to a compressive force and an average loading rate of 1 mm/min. A typical compression coupon test is demonstrated in Figure 3.18.

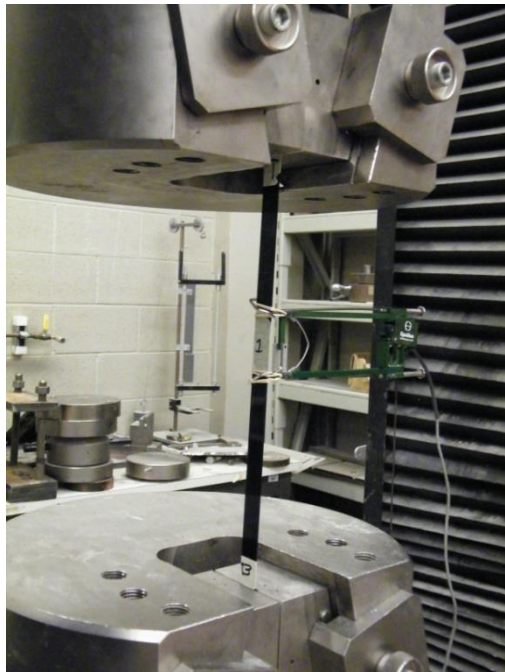
(a) Group  $SS_{NS}$

Steel straps were extracted from the dispenser and cut to the adequate length. Two tests were conducted in order to investigate the properties of the strap, and the seal respectively. Group  $SS_{NS}$  contained no seal and comprised of five steel straps measuring 406.4 mm (16") in length. Group  $SS_S$  included the seal with a notch joint and comprised of five coupons measuring 558.8 mm (22") in total length. In both cases (Figure 3.20), the coupons were subjected to an applied tensile force and a loading rate of 4 mm/min until rupture.

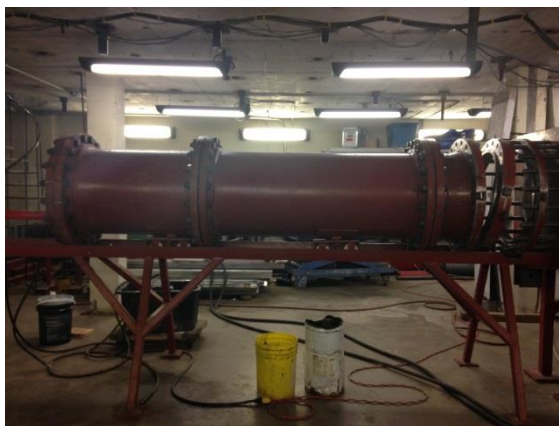
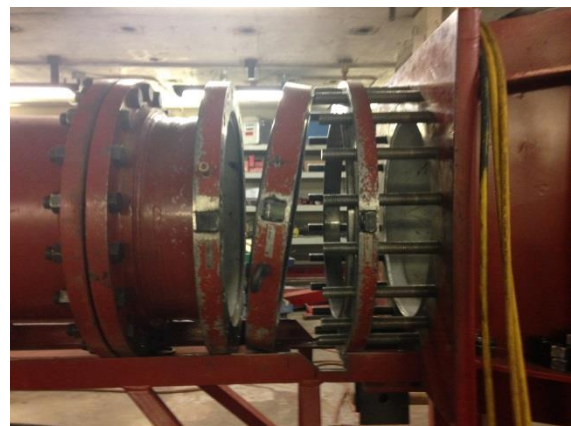
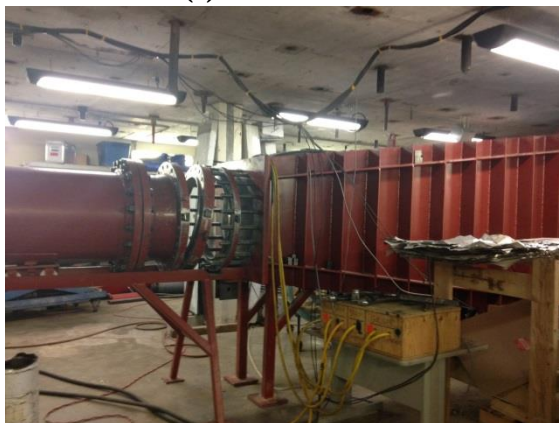
of 597 mm in diameter to a 2032 x 2032 mm<sup>2</sup> opening at the end frame, which allows for testing of large or full scale structural or non-structural elements. The end frame, along the perimeter of the opening, consists of 203 mm wide and 12.5 mm thick stiffened steel plates. In addition, a total of twenty 19 mm diameter holes have been pre-fabricated to allow for a variation in load transfer devices (LTD).

A total of twelve pressure relief vents at the end frame allow for the development of a negative pressure phase, in addition to reducing the magnitude of tertiary peaks caused by wave reflection within the shock tube.

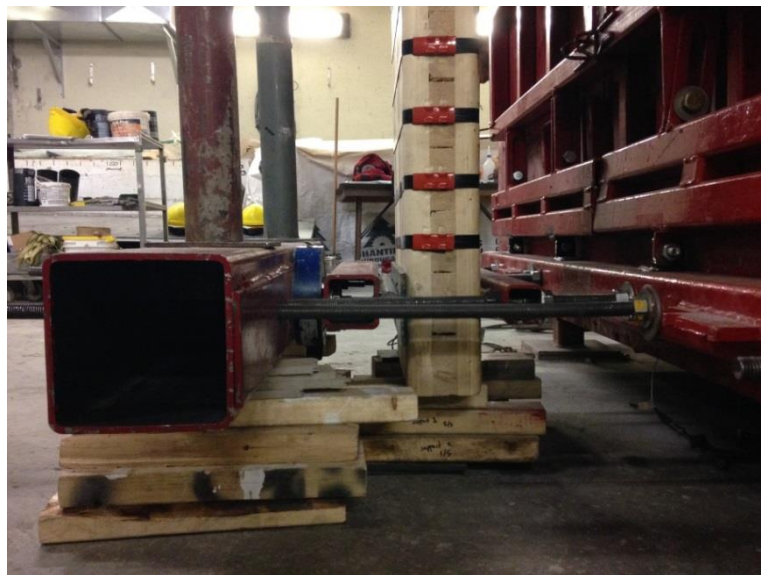
**Figure 3.27: Simply Supported End Condition Detail**

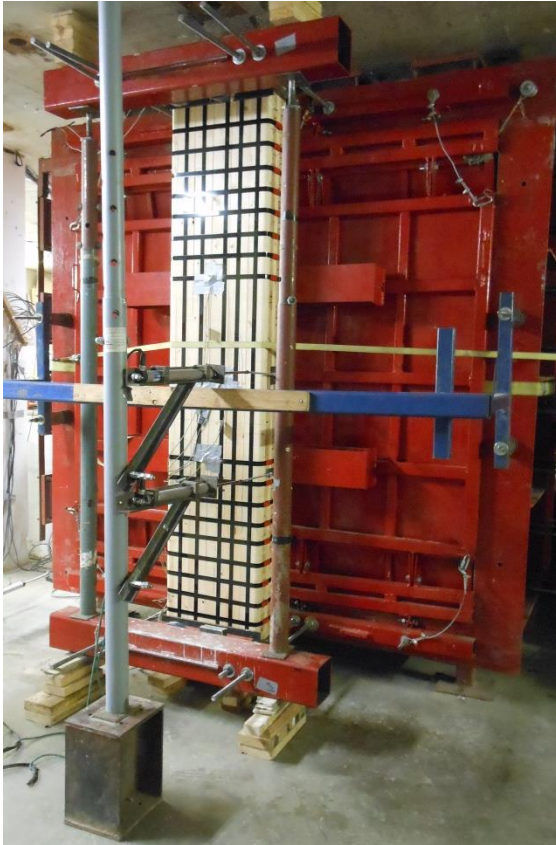
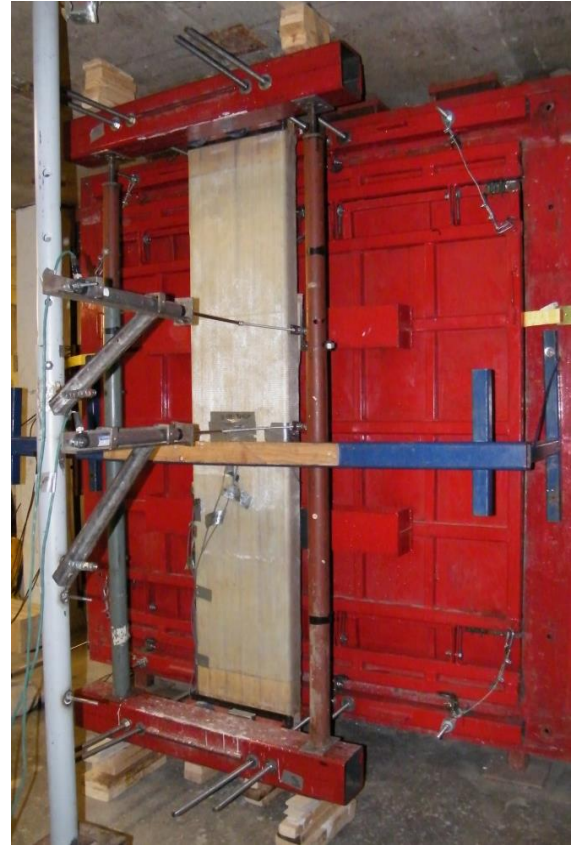
**Figure 3.28: Actual Dynamic Test Setup**

During the dynamic tests, as shown in Figures 3.28 (a) and (b), the reflected pressure acting on the test specimen was measured by two dynamic piezoelectric pressure sensors, located at the side and the bottom of the shock tube opening. The dynamic reactions of the system was measured using load cells clamped between two HSS sections, as shown in Figure 3.27. The panel displacement and shock tube movement was measured with a total of three 300 mm stroke LVDTs. The LVDTs were securely fastened to the mid-span and one-third span point, and they were encased in a steel bracket to protect them in case the specimen deflection was greater than the stroke of the LVDT.

The strain values of each material were measured by using two different types of general purpose strain gauges. The strain gauges were installed at the mid-span of the compression and tension face after sanding and cleaning any dust, debris, or splinters from the surface. A cyanoacrylate adhesive was used to glue the strain gauges onto the specimen. Electrical and duct tape was used to cover and protect the strain gauges installed on the steel strap retrofitted panels. On the contrary, the specimens retrofitted with GFRP required the use of a putty substance to ensure proper penetration of the epoxy resin system. The application of a strain gauge onto a steel strap was similar to that on a panel. The steel was sanded in order to remove the paint and wax coating, and thoroughly cleaned with an acid base mixture to remove impurities. In the case of GFRP, sanding the surface is sufficient.

The data acquisition system (DAS) has the ability to record data at a sampling rate of 100,000 samples per second. Moreover, a high speed camera capable of recording 1,000 frames per second with a resolution of 800 x 600 pixels was connected to the DAS to capture the specimen behaviour and failure. The recording process of data and video was simultaneously triggered by the shock wave travelling by the pressure sensors.

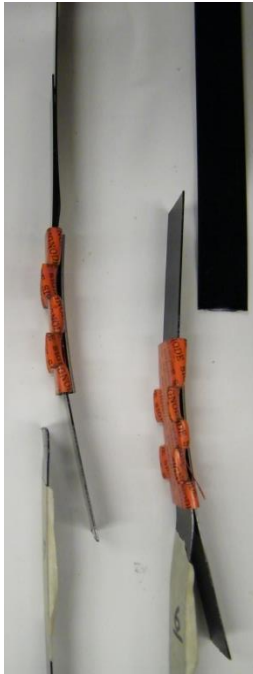
**Figure 4.4: Magnus Steel Strap with Seal Coupon Experimental Results**

The test specimens that included the seal, Group SS<sub>S</sub>, consistently failed at the location of the reverse notch joint (i.e. within the seal). Figure 4.4 (a) shows the failure mode observed at the fastened joint. Albeit this clear-cut failure mechanism, the strap steel strap snapped at the top or the underside of the seal, respectively. The stress-strain curve, as shown in Figure 4.4 (b), was developed by using the average values tabulated in Table 4.4. Unlike Group SS<sub>NS</sub>, this relationship experienced linearity until the point of ultimate tensile strength.

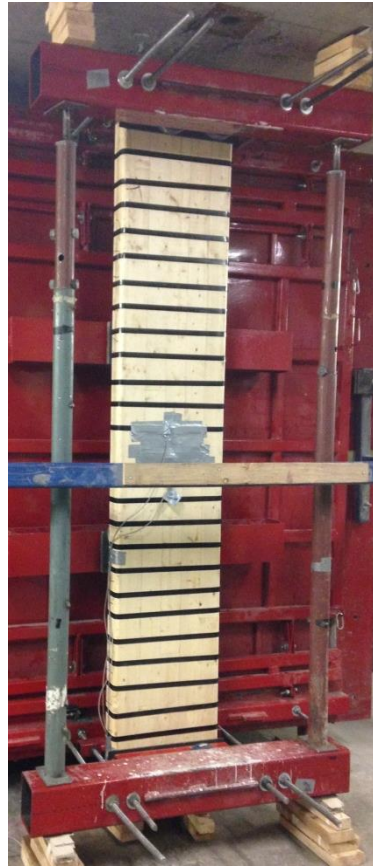
**Figure 4.13: Specimen No. 1**

Specimen 1, CLT3-1, consisted of a total of twenty-four horizontal steel straps that were installed at every transverse layer along the clear span of the panel, as shown in Figure 4.13 (a). The member was subjected to a driver pressure of 424.0 kPa, which resulted in a reflected pressure and impulse of 53.7 kPa, and 577.7 kPa-ms, respectively. The specimen reached a maximum displacement of 187.5 mm in 66.0 ms. Figure 4.13 (b) illustrates the flexural failure that occurred at the bottom third of the panel.

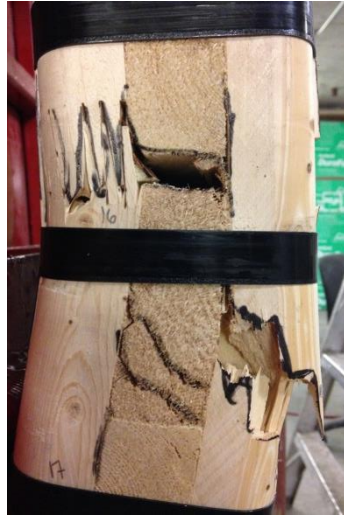
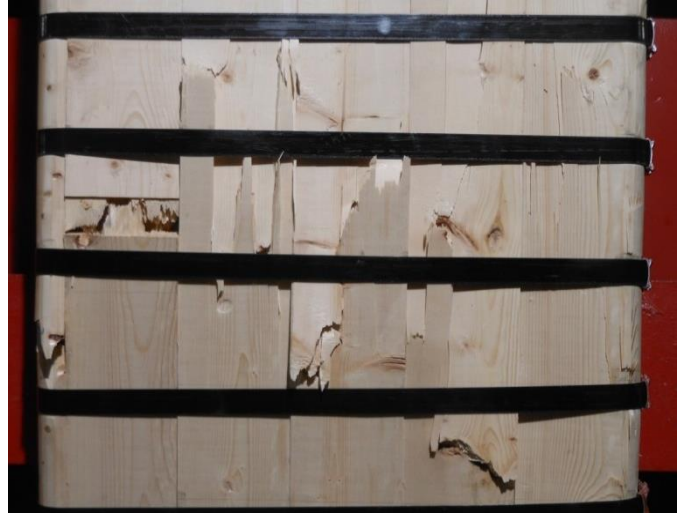
**Figure 4.14: CLT3-1 Failure Mode**

It was observed that the failure occurred at locations of finger joints (laminate 1 in Figure 4.14 (a)) or knots (laminate 3 and 4 Figure 4.14 (b)). The failure then propagated along the width of the panel, fracturing the remaining longitudinal laminates on the tension face, as shown in Figure 4.14 (b). Rolling shear failure was also observed near the support but it was very limited by the presence of the horizontal straps. There were no other indications of failure elsewhere along the CLT panel. The straps helped contain the failure mechanism within a localized region. There was minimal to no failure in the steel straps. On the contrary, the steel straps contained the panel which in turn resulted in very minimal debris and further expansion of the member.

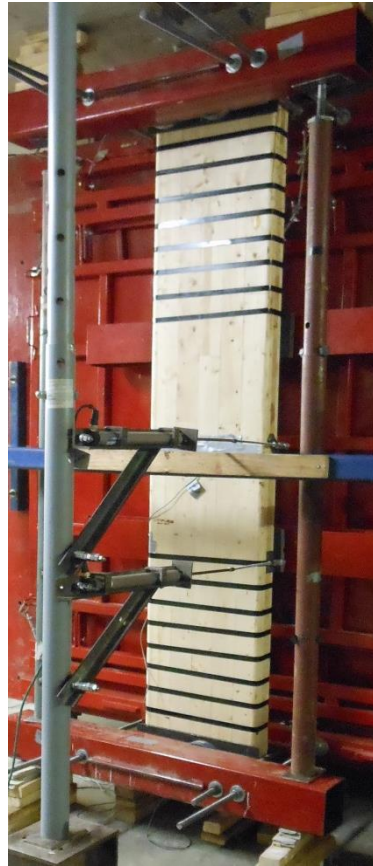
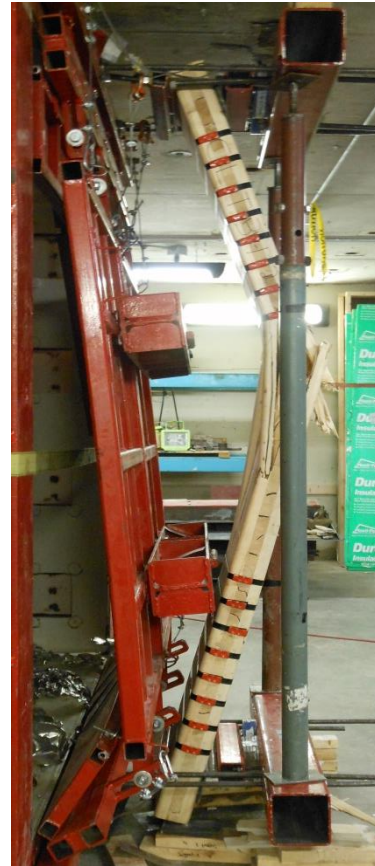
**Figure 4.15: Specimen No. 2**

Specimen 2, CLT3-2, consisted of a total of sixteen horizontal steel straps that were installed at every transverse layer along the top and bottom thirds of the panel, as shown in Figure 4.15 (a). The member was subjected to a driver pressure of 353.7 kPa, which resulted in a reflected pressure and impulse of 52.5 kPa, and 594.6 kPa-ms, respectively. The specimen reached a maximum displacement of 273.8 mm in 51.8 ms. Figure 4.15 (b) illustrates the failure that occurred at the mid-span of the panel.

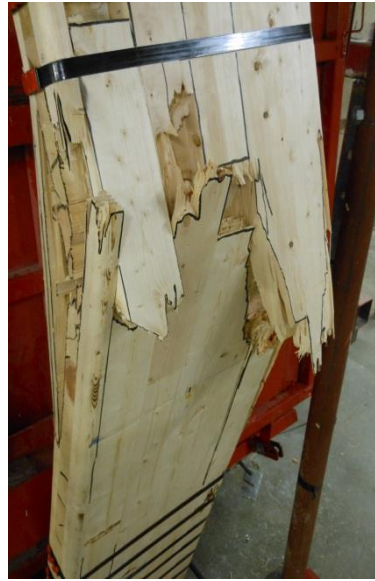
**Figure 4.16: CLT3-2 Flexural Failure**

The failure in this specimen was dominated by flexure, which initiated at a finger joint located on the right side of laminate 1. The failure then propagated along the width of the panel resulting in the rupture of all longitudinal layers on the tension face, as shown in Figure 4.16 (a). Rolling shear failure was very limited. Compression face failure was evident, as shown in Figure 4.17.

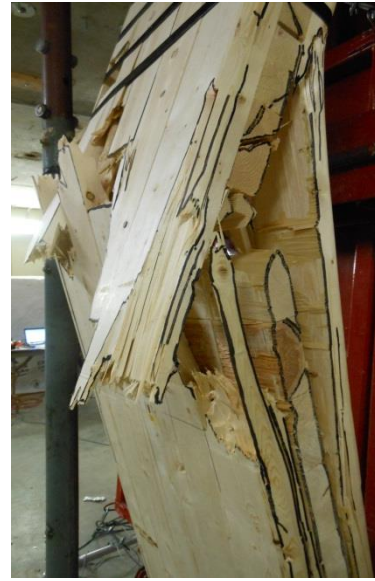
**(b) Right Face**

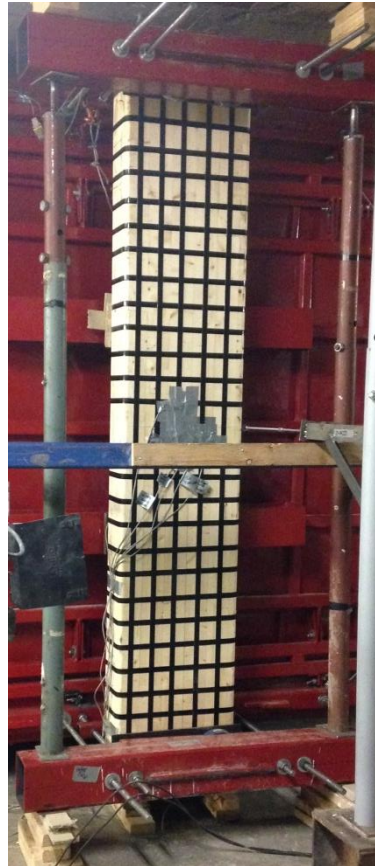
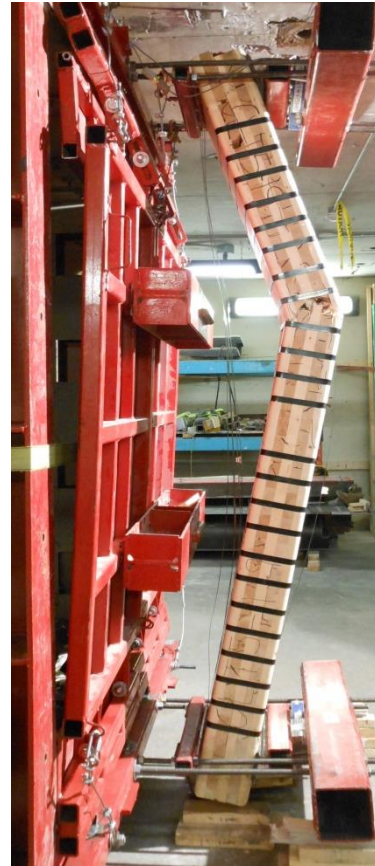
**Figure 4.19: Specimen No. 3 – Shot 2**

CLT5-1.2 was subjected to a driver pressure of 455.1 kPa, which resulted in a reflected pressure and impulse of 58.2 kPa, and 829.2 kPa-ms, respectively. The panel reached a maximum displacement of 212.1 mm in 56.4 ms. Figure 4.19 illustrates the shear and flexural failure that occurred at the top third of the panel.

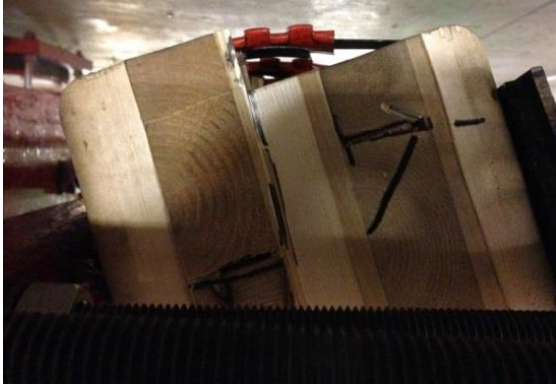
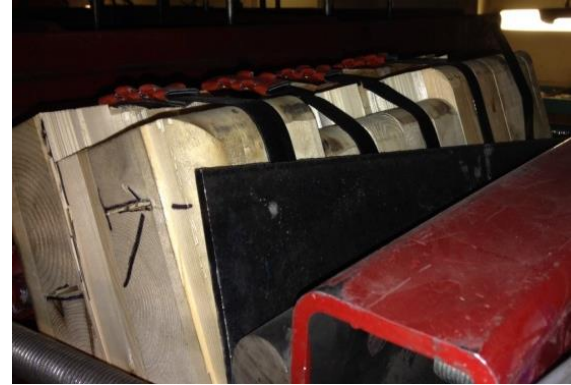
**Figure 4.20: CLT5-1.2 Shear Failure**

The specimen underwent significantly more rolling shear failure than in the first shot, where transverse laminate shear failure initiated at a time of 14.0 ms with a corresponding deflection of 32.7 mm. Longitudinal shear failure could be observed at a time and corresponding deflection of 18.0 ms, and 59.0 mm, respectively, as shown in Figure 4.20.

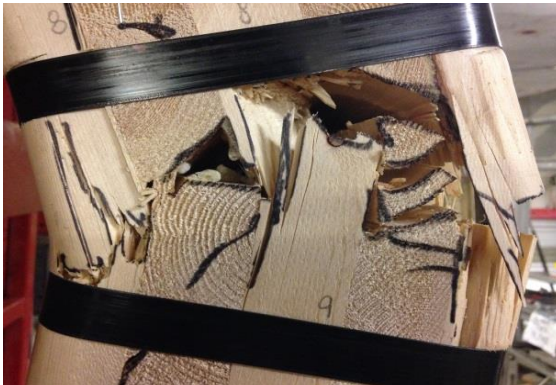
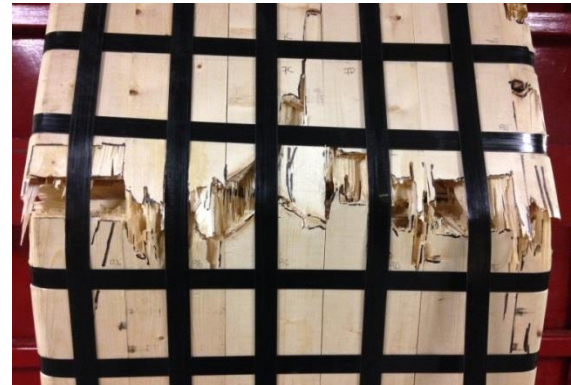
**Figure 4.21: CLT5-1.2 Flexural Failure**

The flexural failure initiated at a finger joint located on laminate 1, as highlighted in Figure 4.21. The failure then propagated through the entire width of the panel, where compression failure could also be observed, as illustrated in Figure 4.22. Such failure is favorable due to its ductile characteristics.

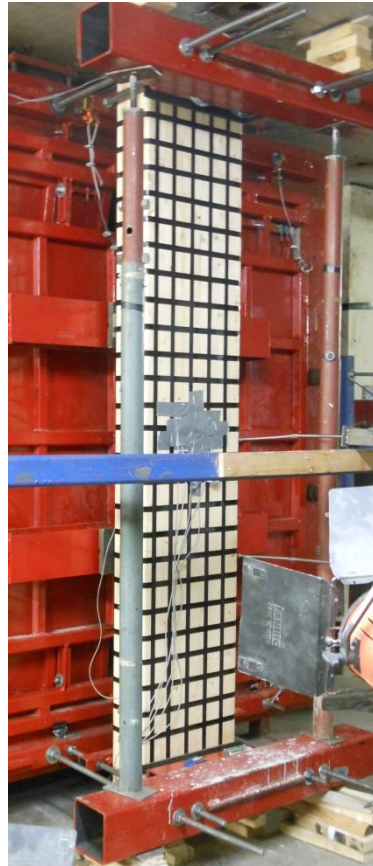
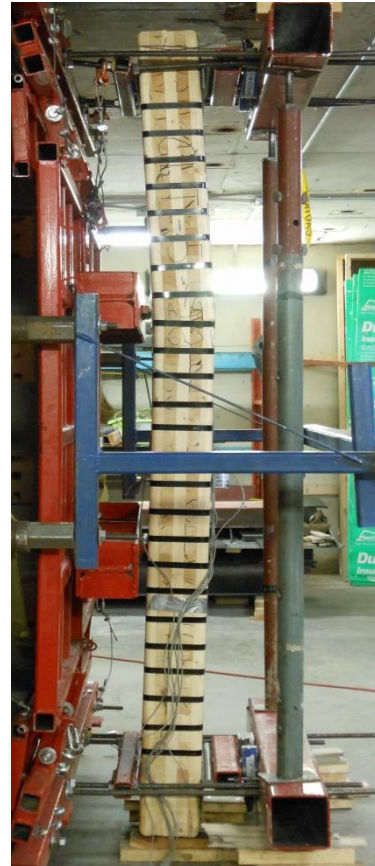
**Figure 4.23: Specimen No. 4 – Shot 1**

Specimen 4, CLT5-2, consisted of a total of five vertical steel straps followed by twenty-five horizontal steel straps that were installed at every longitudinal and transverse layer along the clear span of the span. CLT5-2.1 was subjected to a driver pressure of 537.1 kPa, which resulted in a reflected pressure and impulse of 68.6 kPa, and 983.1 kPa-ms, respectively. The specimen reached a maximum displacement of 123.9 mm in 50.8 ms. Unlike the preceding specimen, there was initial localized failure on the tension face in laminates 1 to 4. Wood crushing and finger joint failure was observed. The straps limited the amount of rolling shear expected; however, longitudinal shear failure occurred at the top end of the specimen. Through video review, it could be documented that the initial shear failure occurred at a time of 22.0 ms and a corresponding deflection of 64.6 mm followed by initial laminate separation at a time and deflection of 34.0 ms, and 106.9 mm, respectively. The vertical and horizontal steel straps remained undamaged. Due to the significantly small amount of residual displacement, as shown in Figure 4.23, the member was tested once more with the primary goal of promoting flexural failure.

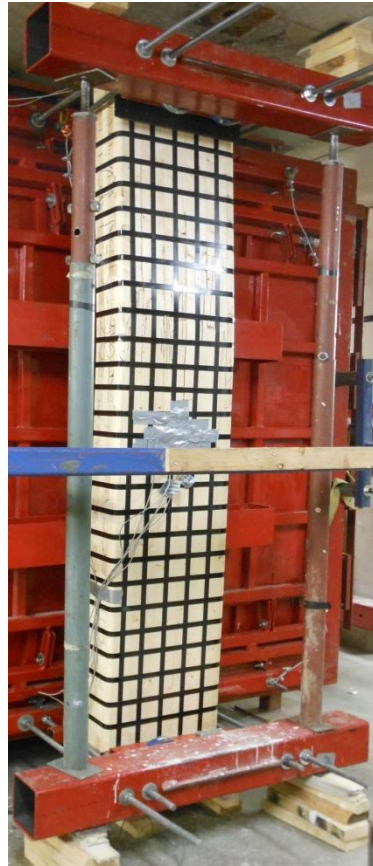
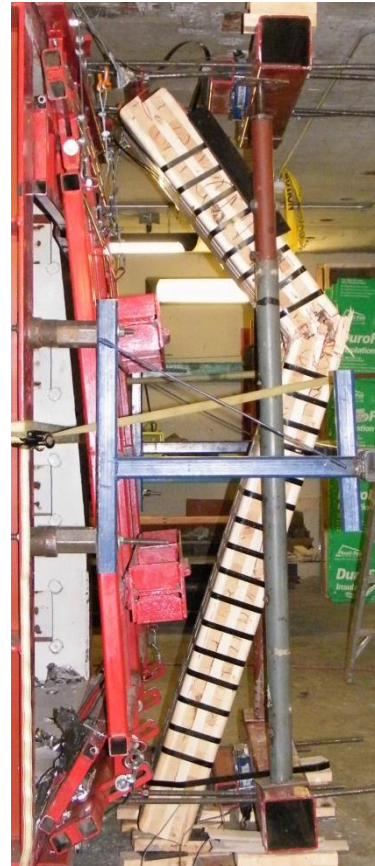
**Figure 4.24: Specimen No. 4 – Shot 2**

CLT5-2.2 represents the second shot of the specimen described above. The specimen was subjected to a driver pressure of 595.0 kPa, which resulted in a reflected pressure and impulse of 62.4 kPa, and 981.4 kPa-ms, respectively. The specimen reached a maximum displacement of 123.9 mm in 52.2 ms. Figure 4.24 (b) illustrates the shear and flexural failure that occurred at the top third of the panel.

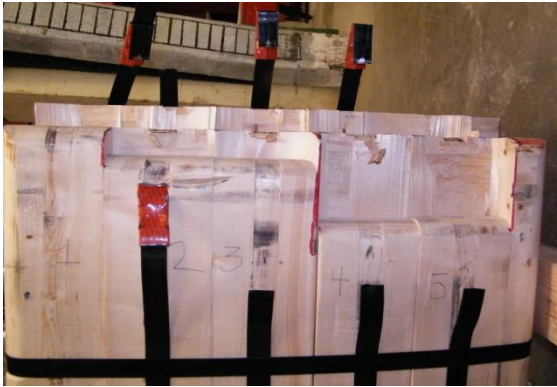
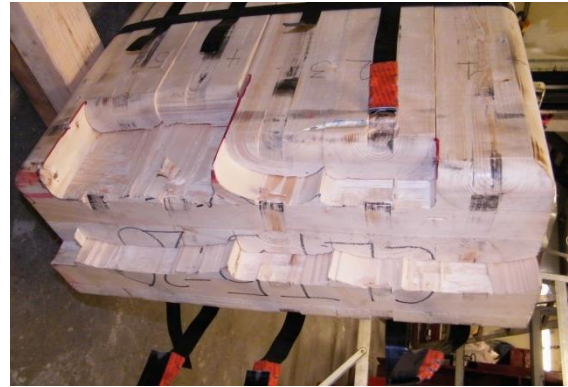
**Figure 4.25: CLT5-2.2 Shear Failure**

Shear failure was one of the predominant failure modes of this particular specimen occurring at a time and corresponding deflection of 14.0 ms and 34.1 mm, respectively, as seen in Figure 4.25.

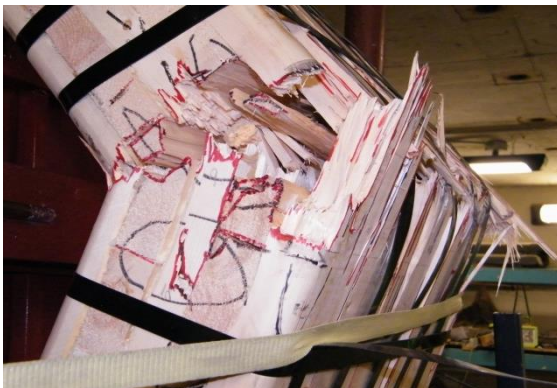
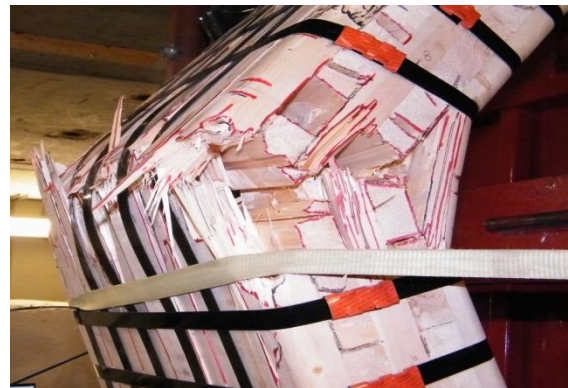
**Figure 4.26: CLT5-2.2 Flexural Failure**

Flexural failure, as shown in Figure 4.26, was limited to the top third of the panel. The failure developed at the location of a finger joint located on laminate 1, followed by a strap failure. The failure propagated through all five longitudinal laminates in addition to the compression face of the panel, as illustrated in Figure 4.27. Very little rolling shear cracks were observed.

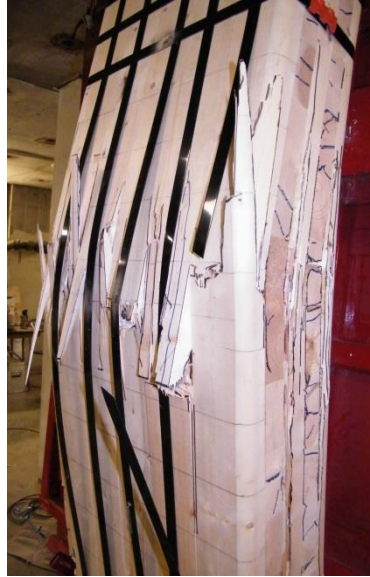
**Figure 4.29: CLT5-3 Flexural Failure**

The failure mode was very similar to that observed for CLT5-1. Flexural failure was evident at the mid-span of the panel, which initiated at a finger joint, at a time and corresponding deflection of 30.0 ms, and 133.3 mm, respectively. The absence of horizontal straps in the middle third of the specimen resulted in more deflection of the wood at that particular location. While rolling shear was suppressed at the end of the member (confined by horizontal straps) a significant amount of rolling shear was observed at the location of failure, as shown in Figure 4.29.

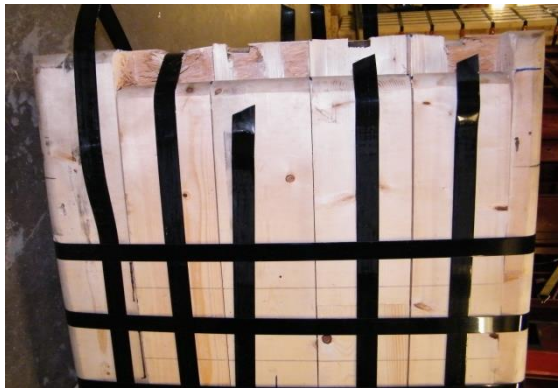
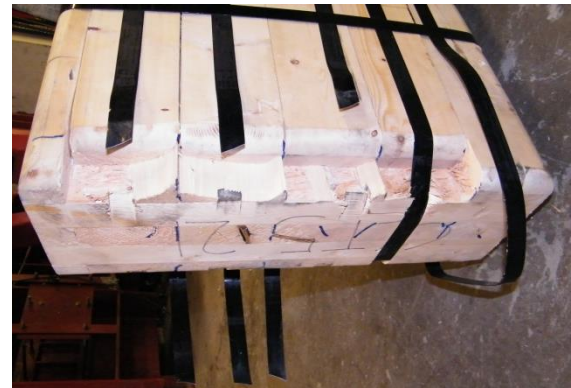
**Figure 4.30: CLT5-3 Shear Failure**

Longitudinal shear failure was also observed, as demonstrated in Figure 4.30.

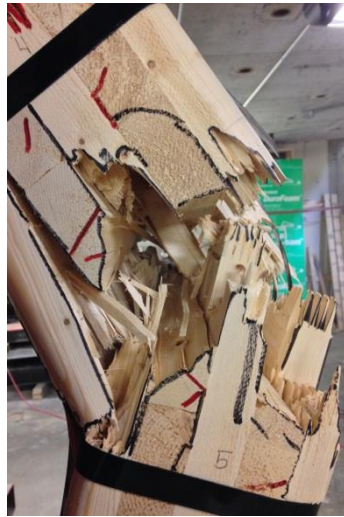
**Figure 4.32: CLT5-4 Failure Mode**

The flexure failure developed at the finger joint, as shown in Figure 4.32 (a). The failure propagated transversely through the remaining longitudinal laminates hence fracturing

the outermost layer (Figure 4.32 (b)). Laminates 1 and 2 failed precisely at a finger joint; while laminates 3 and 4 ruptured at the bottom third, and the bottom face, respectively thus creating a gap of approximately 2 cm. Rolling shear was minimal throughout the span of the panel.

flexural failure. All straps experienced some slack, as shown in Figure 4.32 (b). Strap D failed and broke towards the bottom portion of the member. Strap E, although it seems like it was in pristine condition, snapped at the seal on the compression face at the top of the specimen.

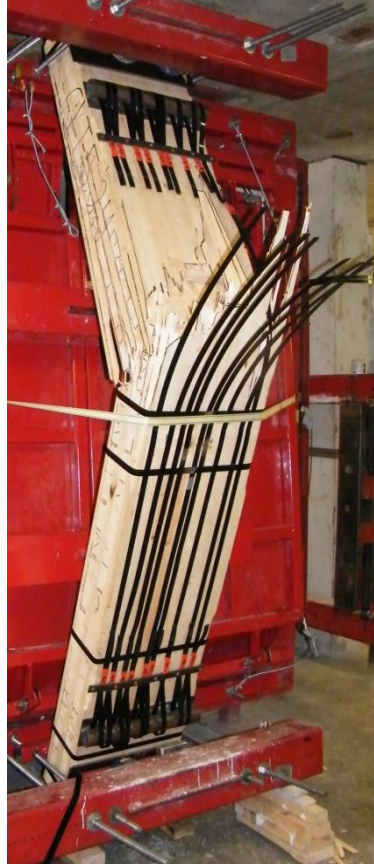
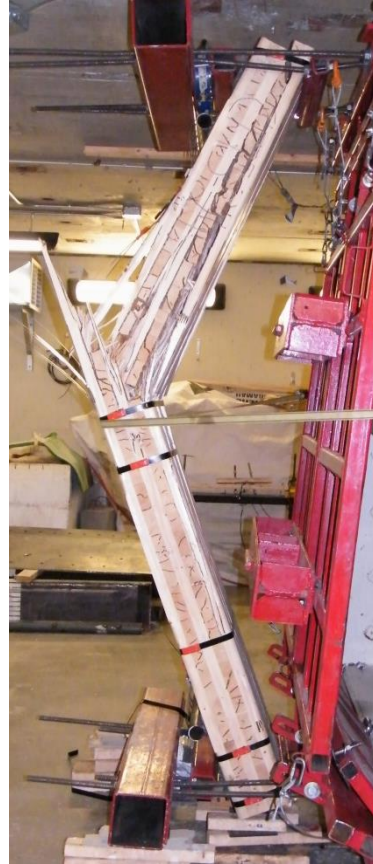
Figure 4.34: Specimen No. 7

Specimen 7, CLT5-5, consisted of vertical straps fastened directly to the tension face. This specimen consisted of a total of nine vertical straps followed by eight horizontal straps along the clear span of the panel. The aim was to install two vertical straps per longitudinal laminate but due to the fabrication process this was unattainable hence the nine straps labelled A through J. The horizontal straps were not meant to confine the panel, but rather to secure the top and bottom ends and contain the vertical straps at the mid-span and adjacent to the connections at both ends. The member was subjected to a driver pressure of 632.9 kPa, which resulted in a reflected pressure and impulse of 65.7 kPa, and 871.1 kPa-ms, respectively. The panel reached a maximum displacement of 256.2 mm in 50.0 ms. Figure 4.34 (b) illustrates the flexural failure that occurred between the top third and mid-span of the panel.

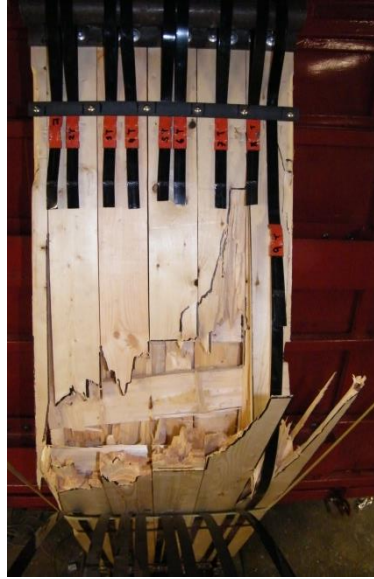
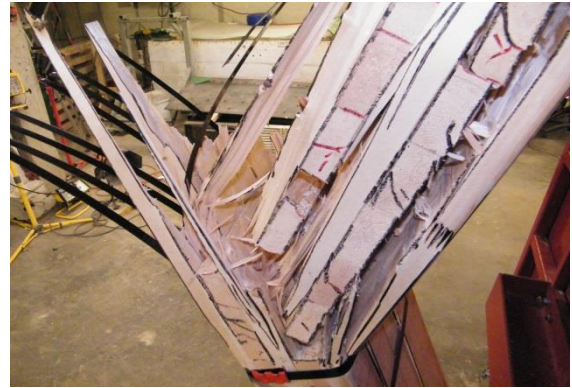
**Figure 4.35: CLT5-5 Failure Mode**

From video review, it was observed that the panel experienced initial failure at a time and corresponding deflection of 14.0 ms, and 12.9 mm, respectively. The failure propagated through the entire width of the panel, fracturing all the longitudinal laminates on the tension face. Laminates 1 through 3, as shown in Figure 4.35 (a), failed at finger joints. The failure was contained within a small region. This was also the case on the compression side where an almost horizontal failure plane could be observed, as shown in Figure 4.36. Furthermore, the development of shear failure, at the top of the panel, occurred at time of 18.0 ms and deflection of 33.0 mm. There was no sign of damage below the mid-span of the panel.

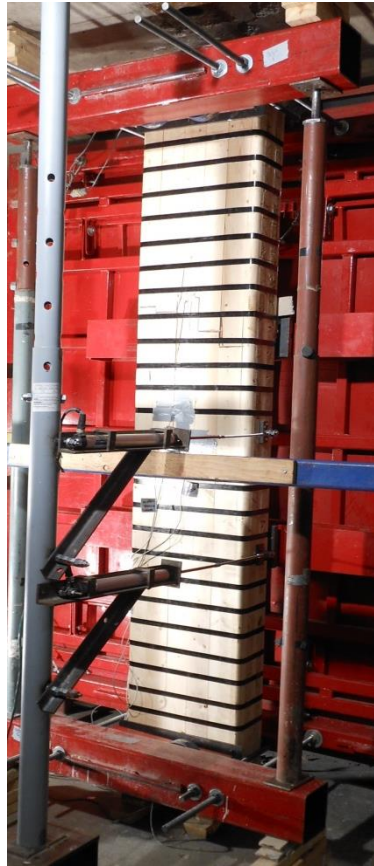
Figure 4.37: Specimen No. 8

Specimen 8, CLT5-D1, consisted of twenty-four horizontal steel straps that were installed at every transverse layer along the clear span of the panel, as shown in Figure 4.37 (a). The member was subjected to a driver pressure of 439.9 kPa, which resulted in a reflected pressure and impulse of 53.2 kPa, and 811.8 kPa-ms, respectively. The panel reached a maximum displacement of 236.8 mm in 46.6 ms. Figure 4.37 (b) illustrates the flexural failure that occurred at the top third of the panel.

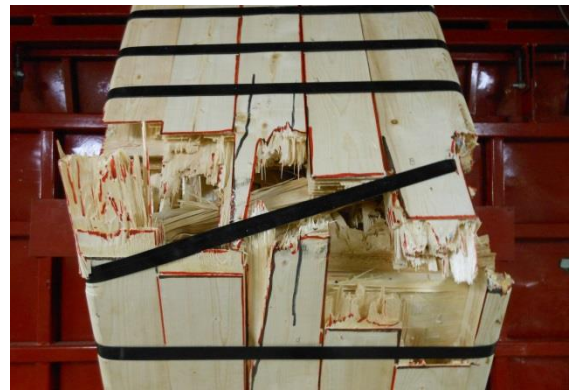
Figure 4.38: CLT5-D1 Failure Mode

Flexural failure developed at an area of existing damage (a finger joint located on laminate 1) and propagated transversely along the longitudinal laminates of the outermost layer on the tension face, as illustrated in Figure 4.38. The damage made its way across the member depth to the compression side, as shown in Figure 4.39. Only a small amount of additional rolling shear cracks were observed as the horizontal straps confined the laminations.

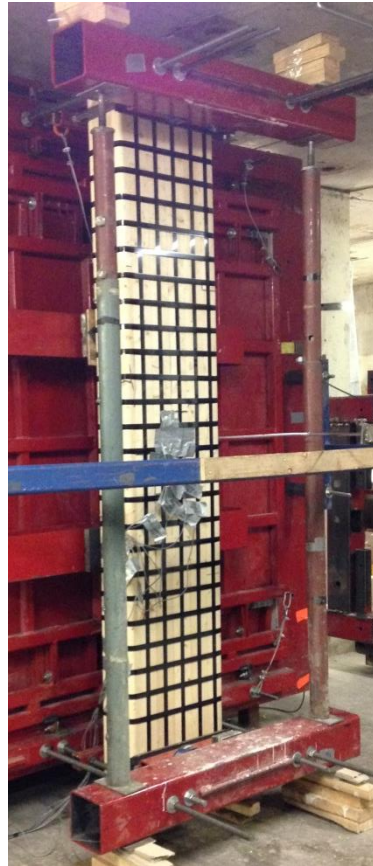
**Figure 4.40: Specimen No. 9 – Shot 1**

Specimen 9, CLT5-D2, consisted of a total of five vertical steel straps followed by twenty-four horizontal steel straps that were installed at every longitudinal and transverse layer along the clear span of the panel. CLT5-D2.1 was subjected to a driver pressure of 217.9 kPa, which resulted in a reflected pressure and impulse of 33.5 kPa, and 437.6 kPa-ms, respectively. The panel reached a maximum displacement of 64.6 mm in 41.0 ms. Initial failure occurred at a time and corresponding deflection of 14.0 ms, and 8.0 mm, respectively. Approximately 20 ms later the transverse and longitudinal layers began to open up. No additional rolling shear cracks were observed. Little residual displacement was observed following the test. The horizontal and vertical straps did not display any signs of damage; in fact they all remained intact and in place. Since the panel returned to its original position, as shown in Figure 4.40, it was decided to re-test the specimen.
