# **THE EFFECT OF STEEL STRAPPING TENSIONING TECHNIQUE AND FIBRE-REINFORCED POLYMER ON THE PERFORMANCE OF CROSS-LAMINATED TIMBER SLABS SUBJECTED TO BLAST LOADS**

**America Maria Lopez-Molina**

**Master of Applied Science**

In Civil Engineering

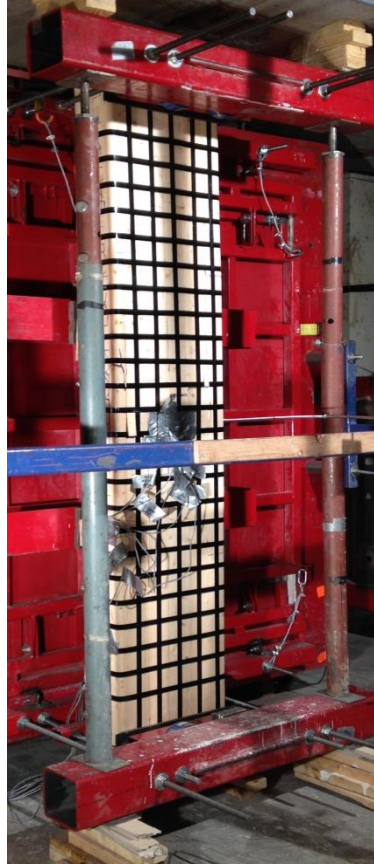
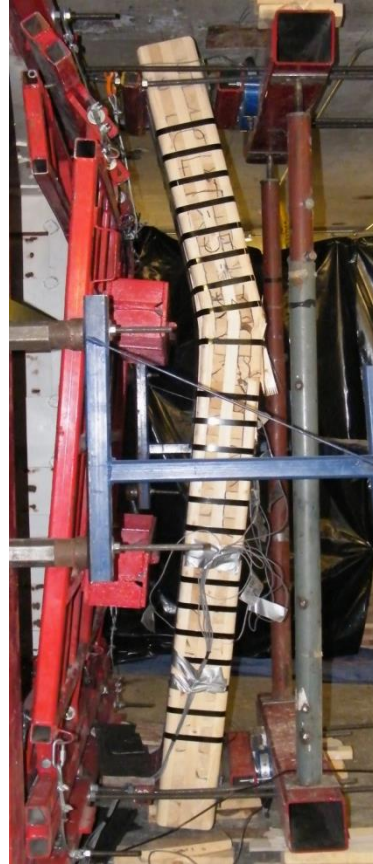
**Figure 4.41: Specimen No. 9 – Shot 2**

CLT5-D2.2 was subjected to a driver pressure of 380.6 kPa, which resulted in a reflected pressure and impulse of 51.2 kPa, and 702.8 kPa-ms, respectively. The panel reached a maximum displacement of 163.2 mm in 56.6 ms. Figure 4.41 (b) illustrates the flexural failure that occurred at the top third of the panel. Initial failure was observed at a time and deflection of 26.0 ms, and 92.8 mm, respectively. The panel failed at the exact location where, in the previous shot, had experienced initial cracking (Figure 4.42). Little damage was found on the compression face and very little rolling shear cracks were observed.

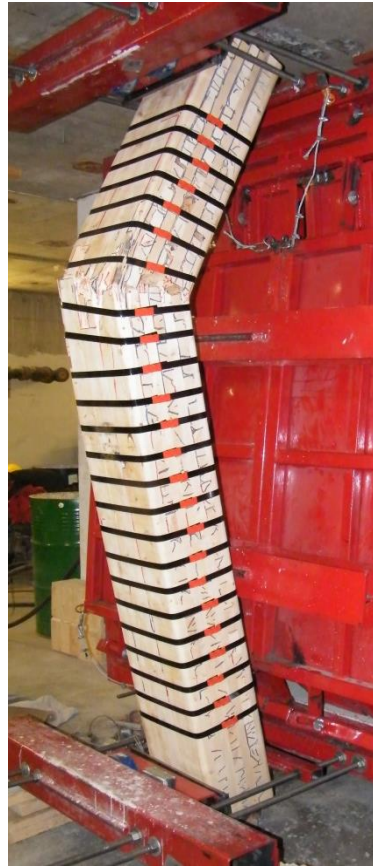
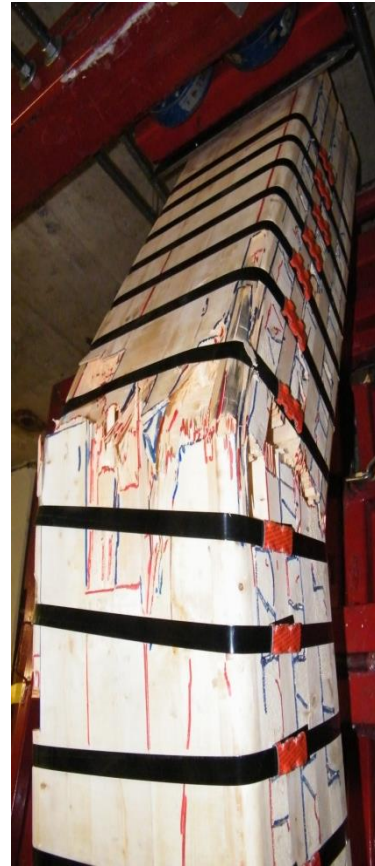
**Figure 4.43: Specimen No. 10**

Specimen 10, CLT7-D1, consisted of a total of twenty-four horizontal steel straps that were installed at every transverse layer along the clear span of the panel. The member was subjected to a driver pressure of 413.0 kPa, which resulted in a reflected pressure and impulse of 58.3 kPa, and 693.6 kPa-ms, respectively. The panel reached a maximum displacement of 234.1 mm in 84.2 ms. Figure 4.43 illustrates the flexural failure that occurred at the top third of the panel.

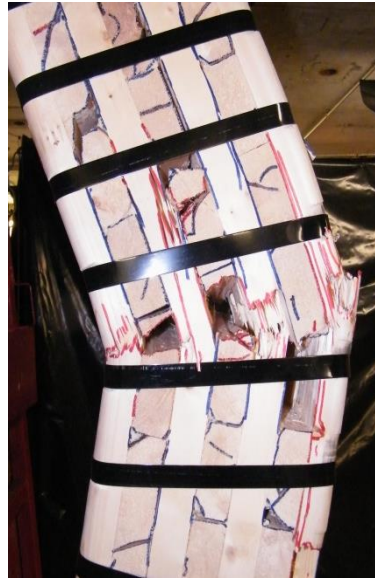
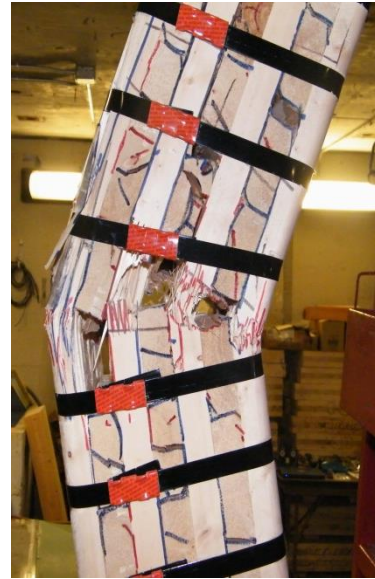
**Figure 4.44: CLT7-D1 Flexural Failure**

This member had a very similar failure mode to that observed for CLT5-D1. The failure in the panel occurred at the same location of the existing damage. The failure was contained in a small region, as shown in Figure 4.44. It was clear that the finger joints located on the left and right side of the panel were areas of weakness. Failure on the compression face was also limited to a very small area, as seen in Figure 4.45 (a). Although additional rolling shear cracks were limited, the failure shifted to longitudinal shear failure, (Figure 4.45 (b)).

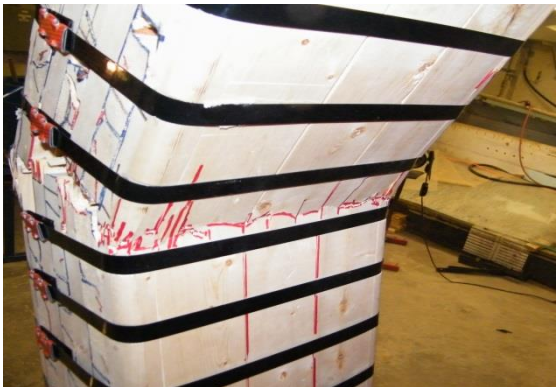
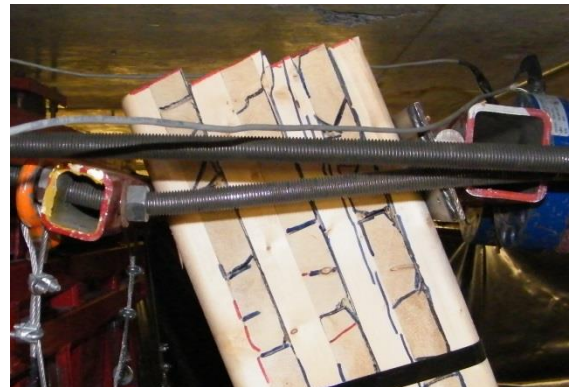
**Figure 4.45: CLT7-D1 Additional Failure Modes**

(a) Compression Failure

(b) Shear Failure

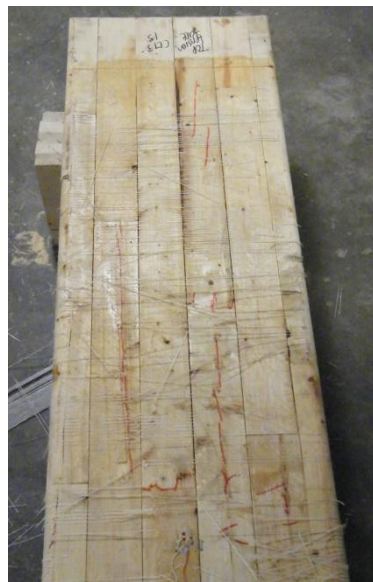
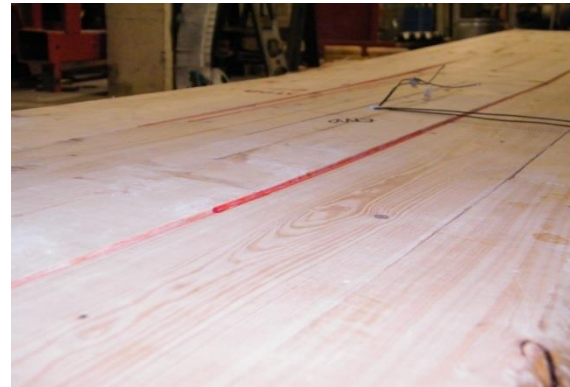
**Figure 4.51: CLT3-3 Failure Mode**

Upon removal of the GFRP, there were no apparent signs of flexural failure; however, slight longitudinal and transverse cracks had formed, particularly on laminates 3 and 4, as shown in Figure 4.51 (a). There was also no evidence of compression failure. Slight separation between the longitudinal and transverse laminates was observed, as highlighted in Figure 4.52. This was primarily a result of some rolling shear cracks and minor longitudinal shear failure, as shown in Figure 4.53.

**(a) Tension Face**

**(b) Compression Face**

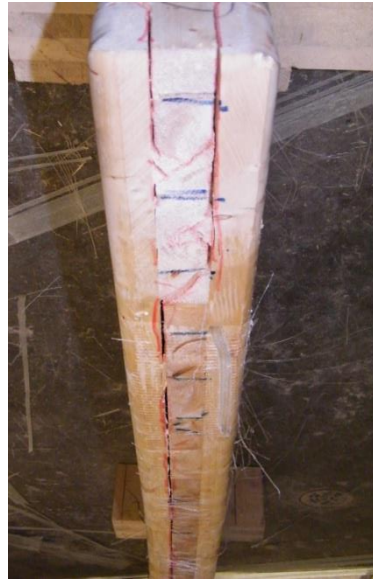
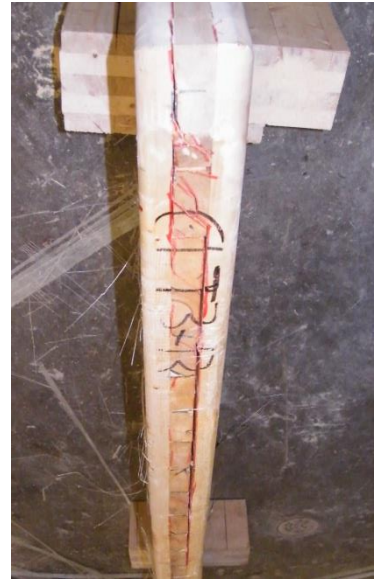
**Figure 4.52: CLT3-3 Delamination of Laminates**

(a) Left Face

(b) Right Face

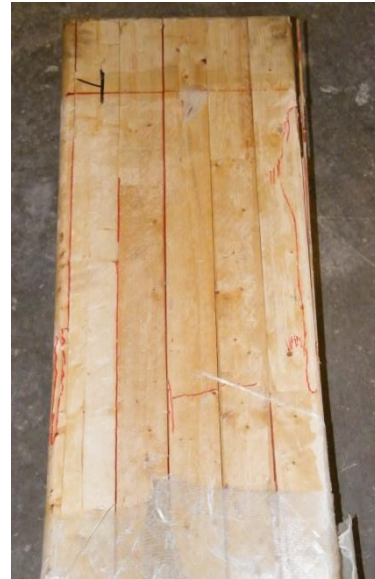
**Figure 4.58: CLT3-5 Failure Mode**

When the GFRP fabric was removed, the flexure failure was clearly visible on the tension face, as shown in Figure 4.58 (a). Significant rolling shear and separation between the longitudinal and transverse laminates were observed, as shown in Figure 4.59. Very limited failure was observed on the compression side, as highlighted in Figure 4.58 (b).

(b) Compression Face

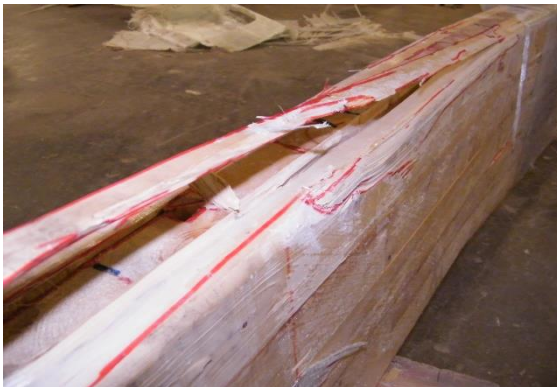
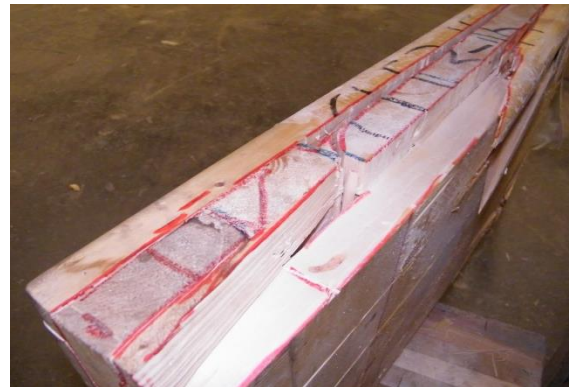
**Figure 4.59: CLT3-5 Delamination of Laminates**

(a) Left Face

(b) Right Face

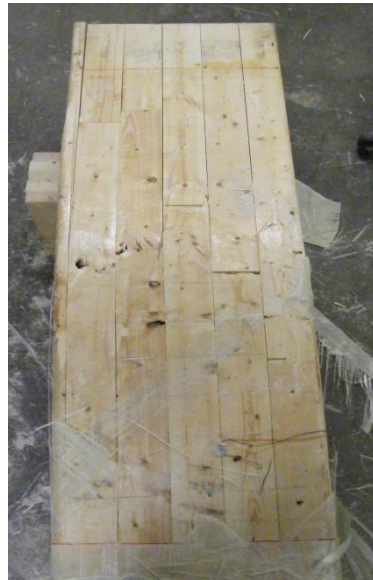
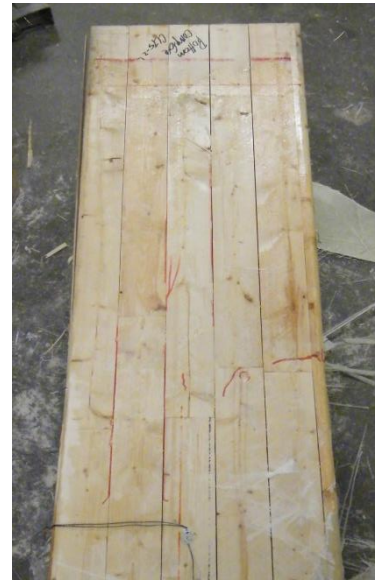
**Figure 4.63: CLT5-6 Failure Mode**

Upon removal of the GFRP, flexural failure was noticed at the bottom third, with complete failure of the five longitudinal laminations on the tension face, as shown in Figure 4.63 (a). Little damage could be observed on the compression face, as illustrated

in Figure 4.63 (b). Separation between longitudinal and transverse laminates was observed primarily due to rolling shear failure, as seen in Figure 4.64.

(a) Tension Face

(b) Compression Face

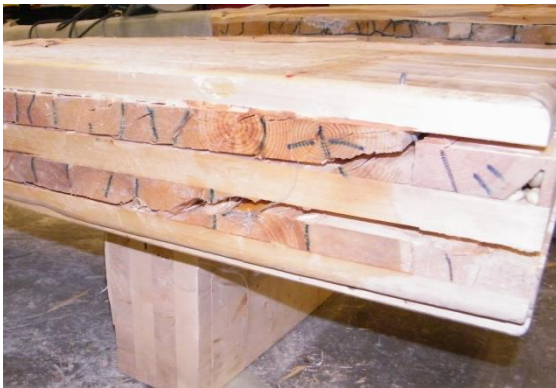
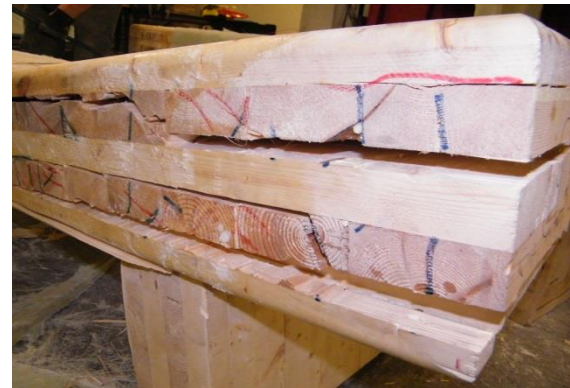
**Figure 4.64: CLT5-6 Delamination of Laminates**

(a) Left Face

(b) Right Face

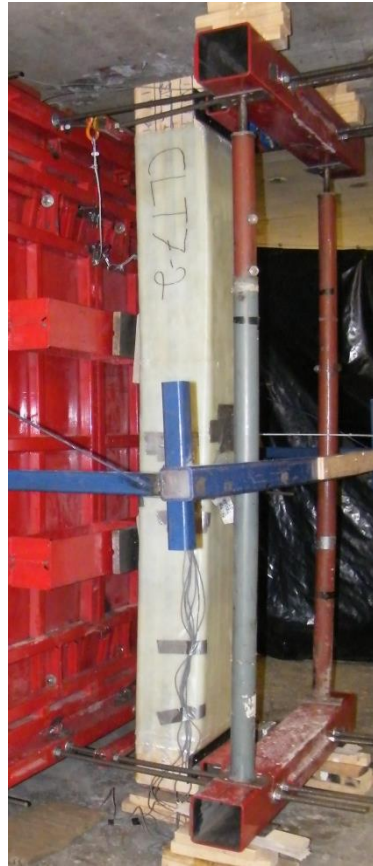
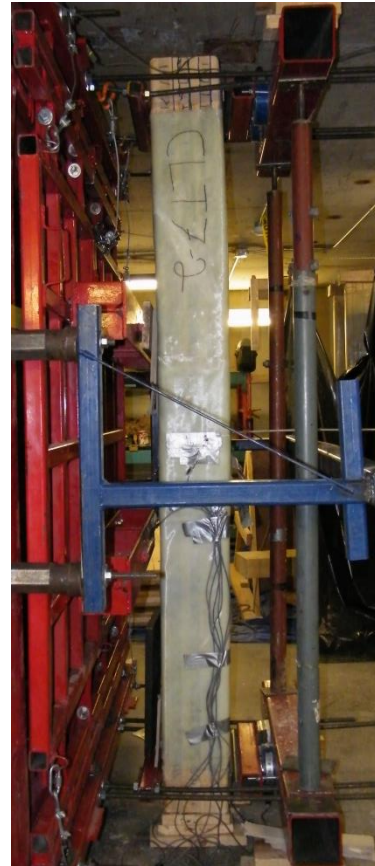
**Figure 4.67: Specimen No.17 – Shot 1**

Specimen 17, CLT7-D2, consisted of two biaxial  $[0/90^\circ]$  layers in a CM configuration followed by two biaxial  $[\pm 45^\circ]$  layers along the clear span of the panel. CLT7-D2.1 was subjected to a driver pressure of 483.3 kPa, which resulted in a reflected pressure and impulse of 59.2 kPa, and 950.7 kPa-ms, respectively. The specimen reached a maximum displacement of 44.1 mm in 26.0 ms. Minimal residual displacement was observed and the only apparent damage was slight stretching of the GFRP fabric. It was therefore deemed acceptable to re-test the specimen, as shown in Figure 4.67.

(a) Before

(b) After

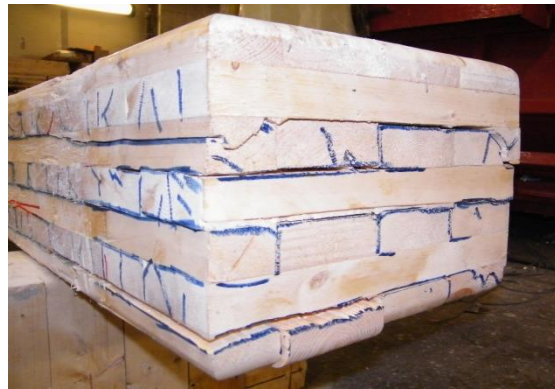
**Figure 4.70: CLT7-D2 Shear Failure**

Upon removal of the GFRP, flexural failure was evident (Figure 4.69 (a)) through the rupture of laminations 1 through 3. There was very little to no damage on the compression face, as shown in Figure 4.69 (b). Aside from the expansion of previous cracks, there were no additional rolling shear cracks observed. Limited shear failure, as presented in Figure 4.70, could be observed at the top of the panel.

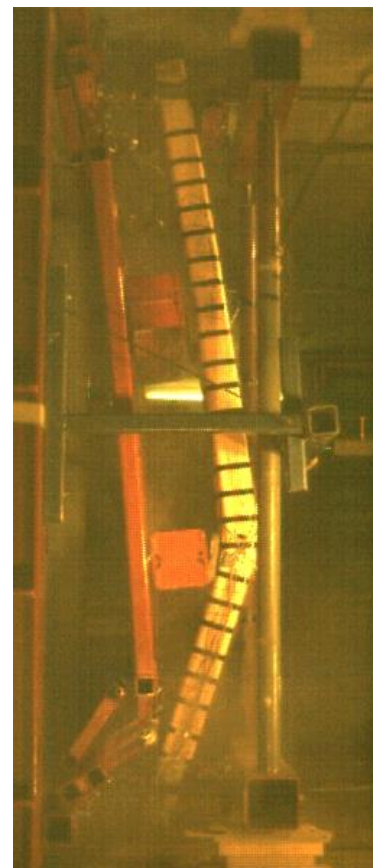
**Figure D.3: Progression of Failure of CLT3-1**

**(c) Maximum Displacement**

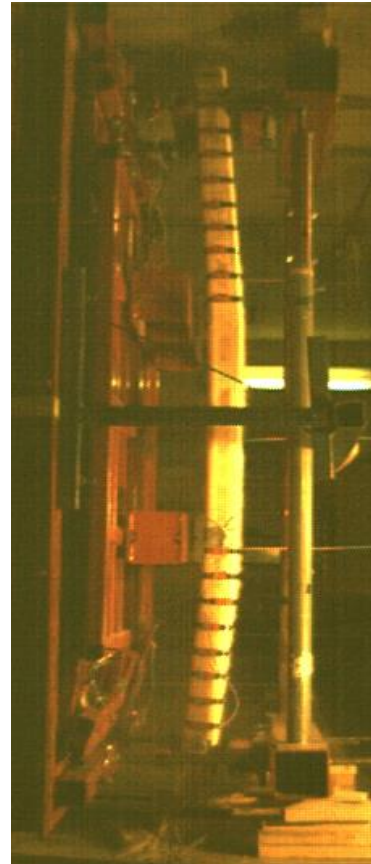
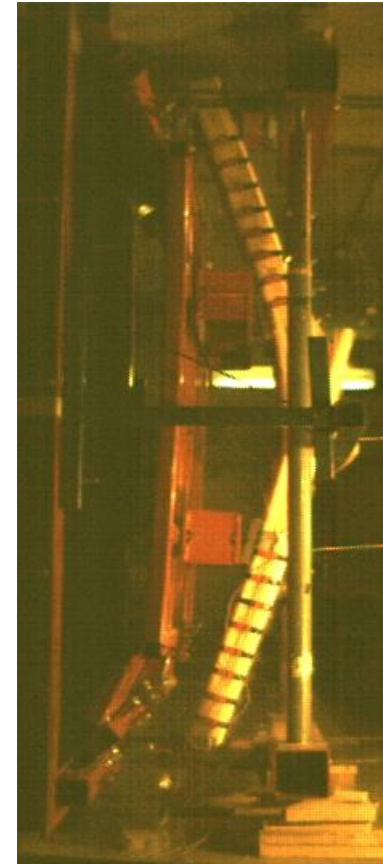
**Figure D.6: Progression of Failure of CLT3-2**

**(b) Maximum Dynamic Resistance**

**(c) Maximum Displacement**

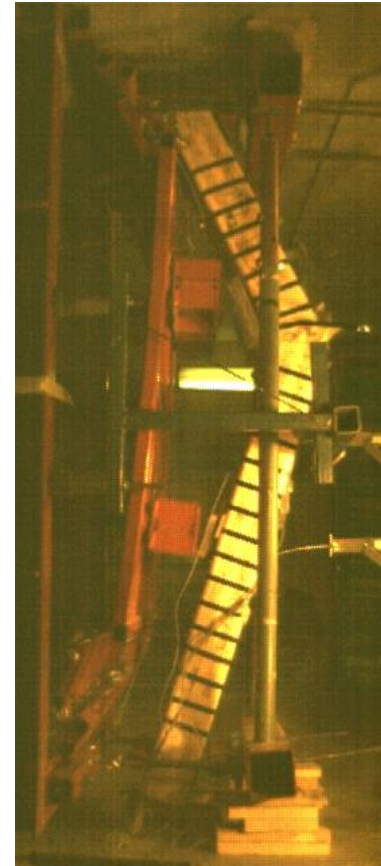
**Figure D.18: Progression of Failure of CLT5-2.2**

**(c) Maximum Displacement**

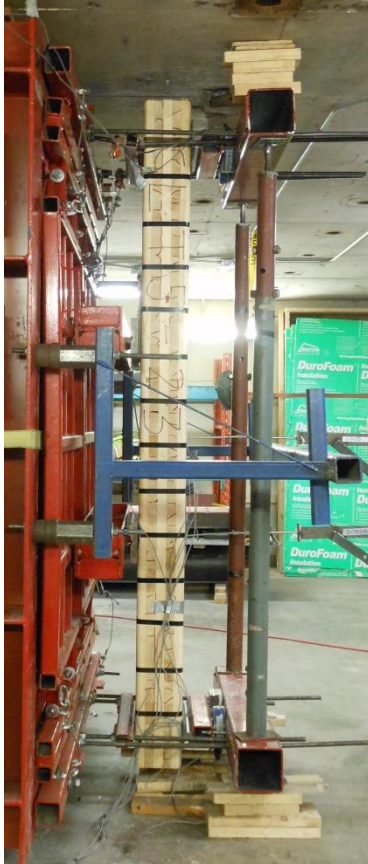
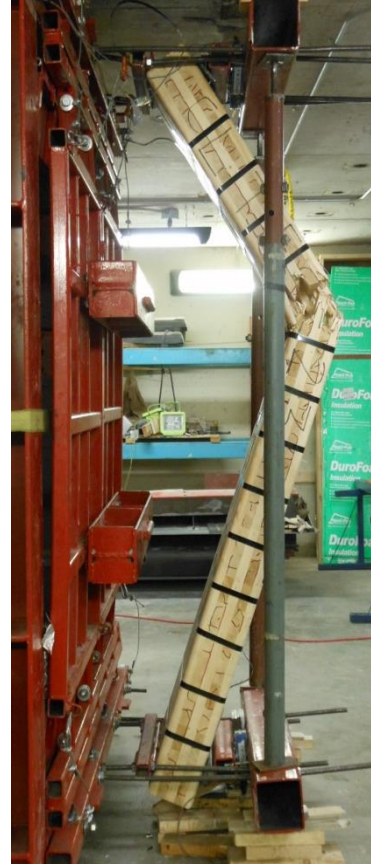
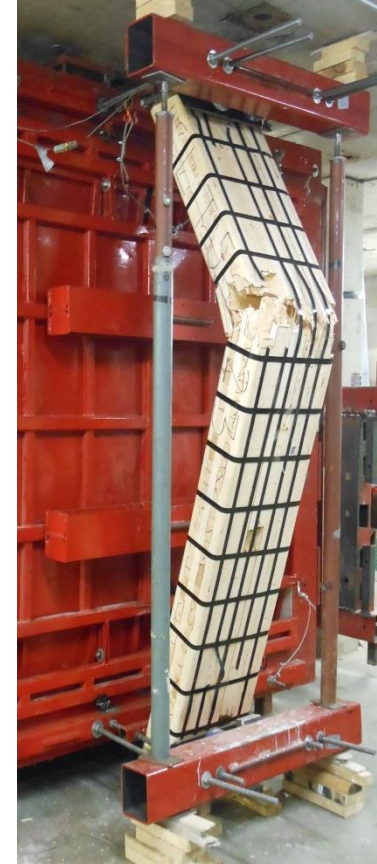
**Figure D.24: Slab Failure of CLT5-4**

**(a) Initial Position**

**(b) Final Position**

**(c) Displaced Shape**

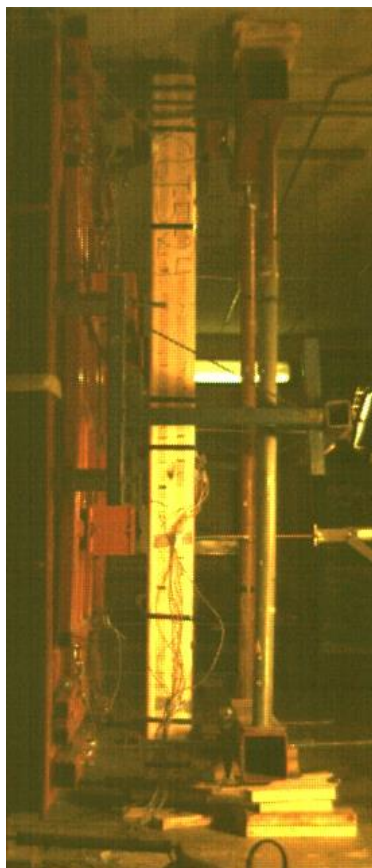
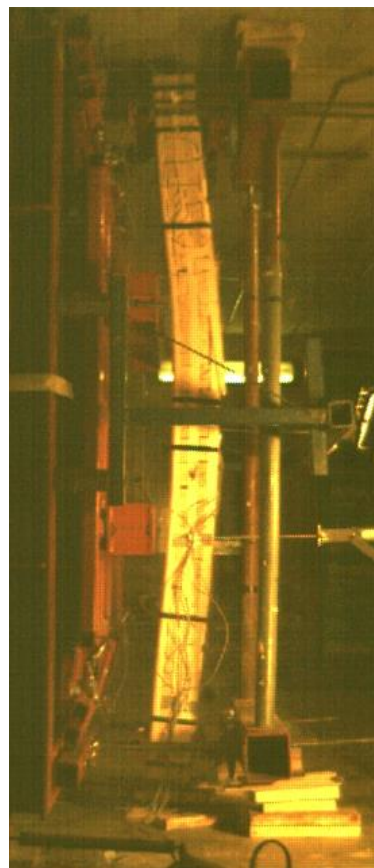
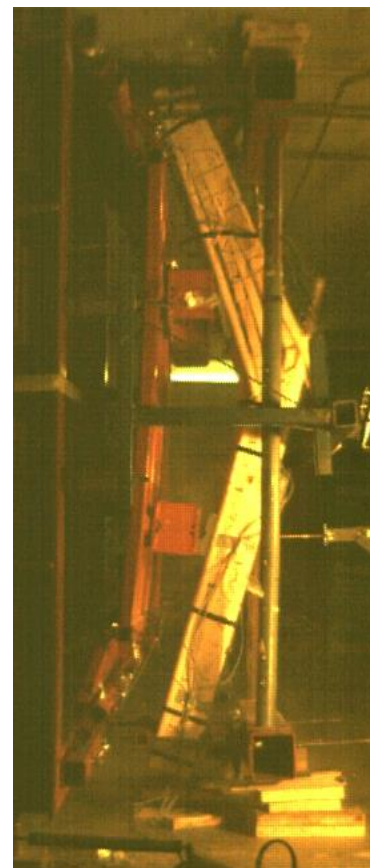
**Figure D.27: Progression of Failure of CLT5-5**

**(a) Initial Position**

**(b) Maximum Dynamic Resistance**

**(c) Maximum Displacement**

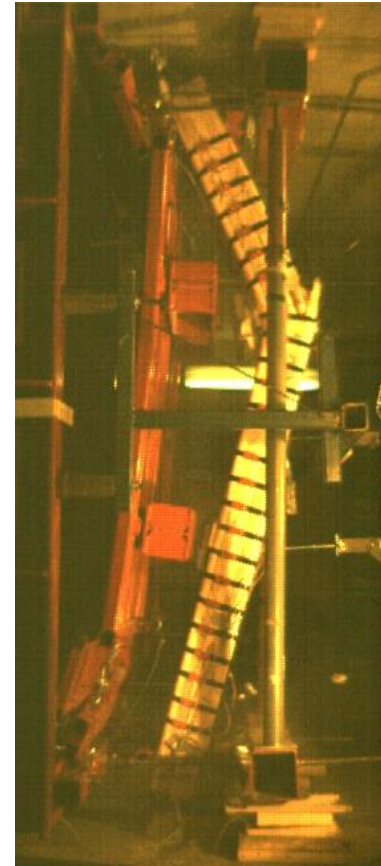
**Figure D.30: Progression of Failure of CLT5-D1**

**(c) Maximum Displacement**

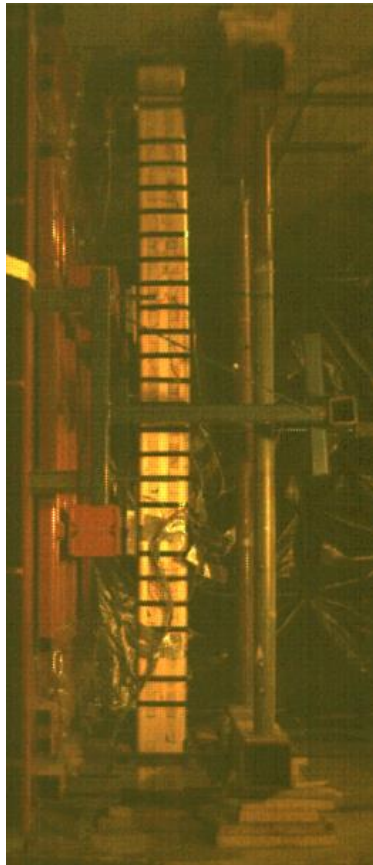
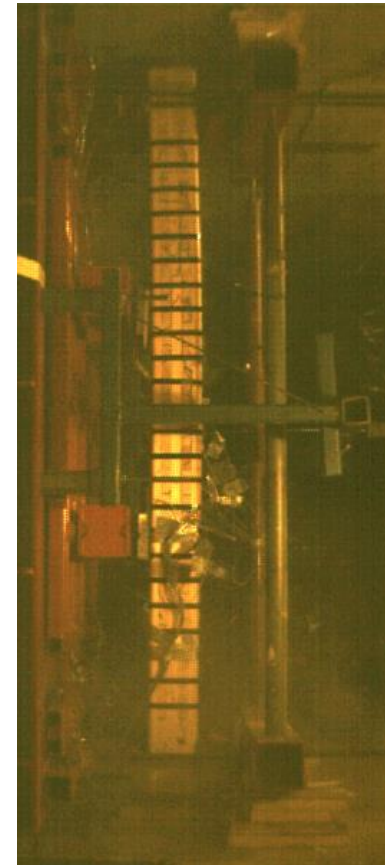
**Figure D.33: Slab Movement of CLT5-D2.1**

**(a) Initial Position**

**(d) Final Position**

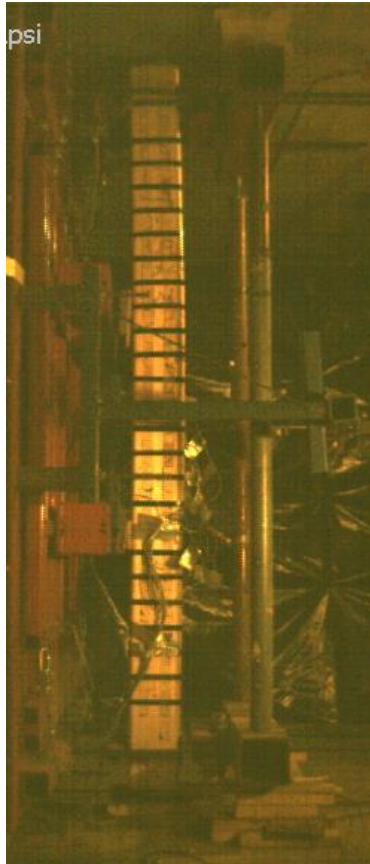
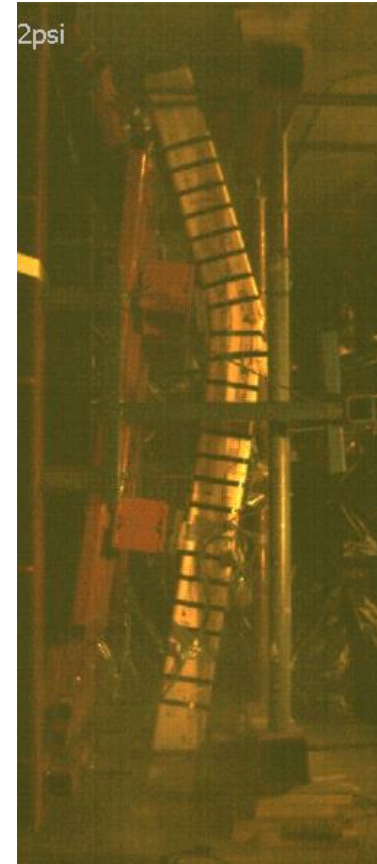
Figure D.36: Progression of Failure of CLT5-D2.2

(a) Initial Position

(c) Maximum Displacement

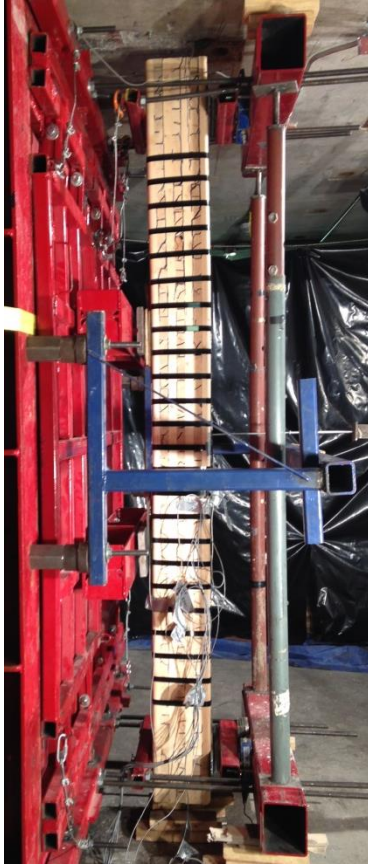
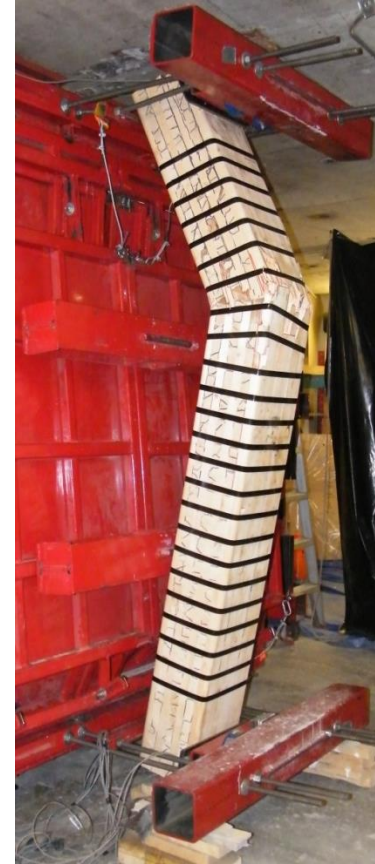
**Figure D.39: Slab Failure of CLT7-D1**

**(a) Initial Position**

**(c) Displaced Shape**

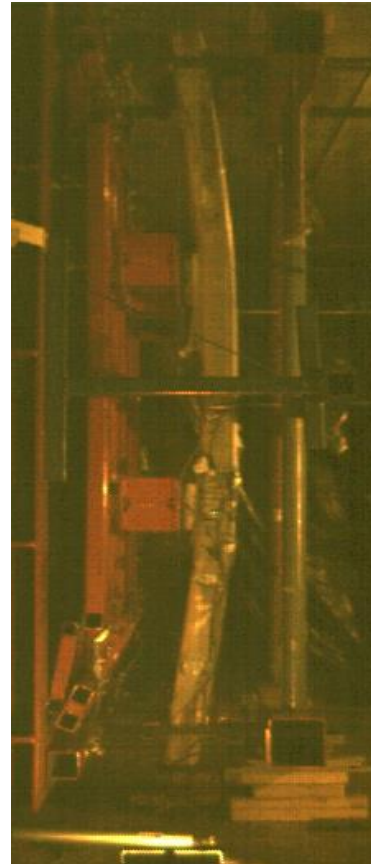
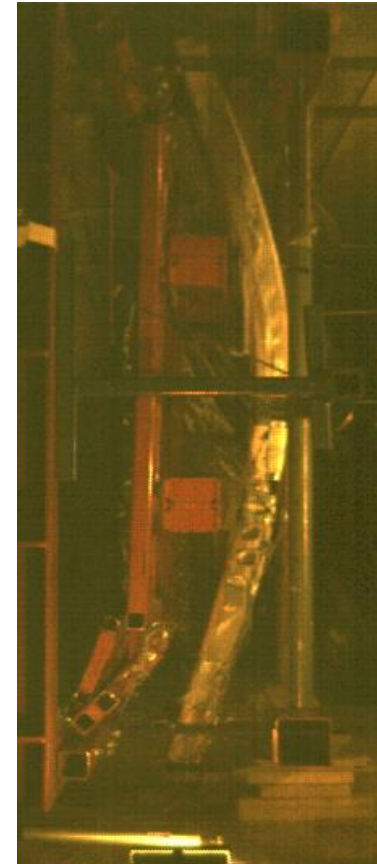
**Figure E.3: Progression of Failure of CLT3-3**

**(b) Maximum Dynamic Resistance**

**(c) Maximum Displacement**

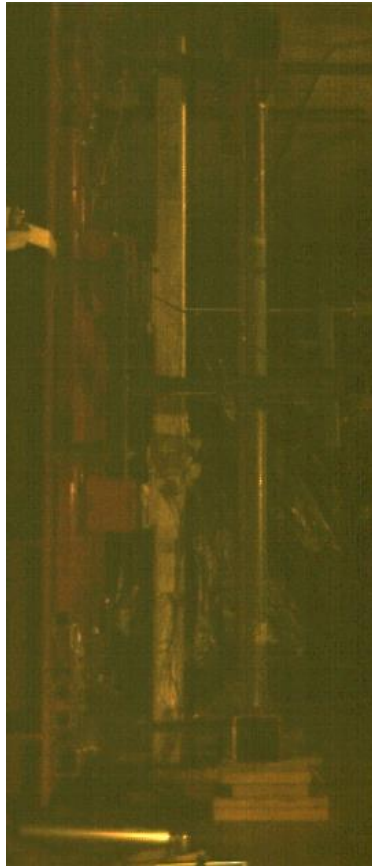
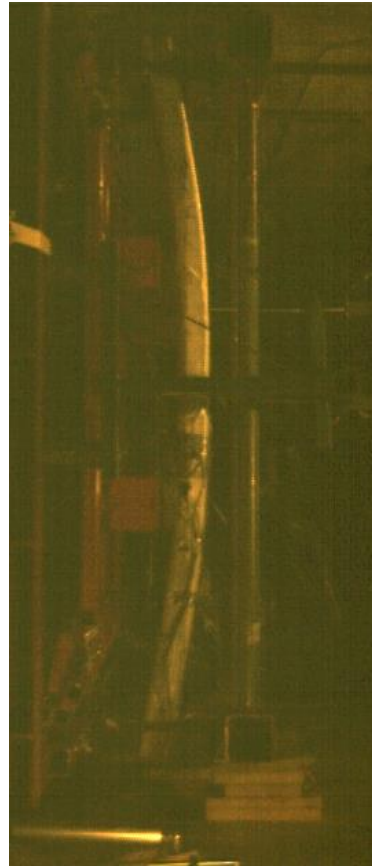
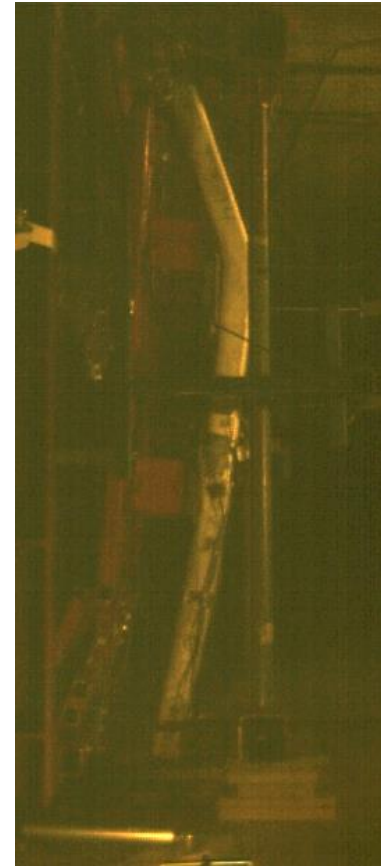
**Figure E.6: Progression of Failure of CLT3-4**

**(a) Initial Position**

**(b) Maximum Displacement**

**(c) Final Position**

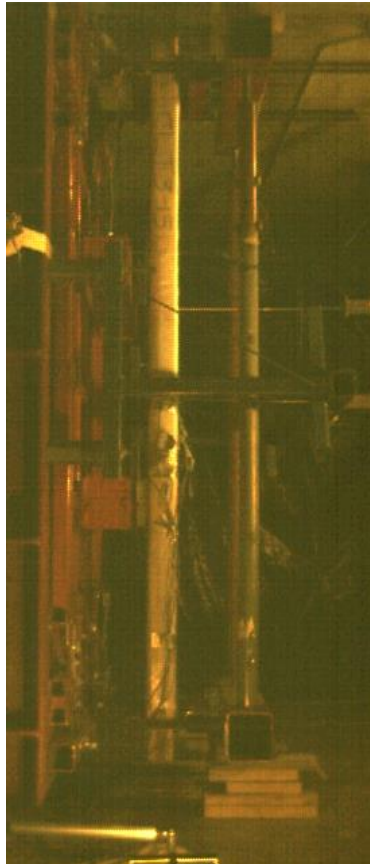
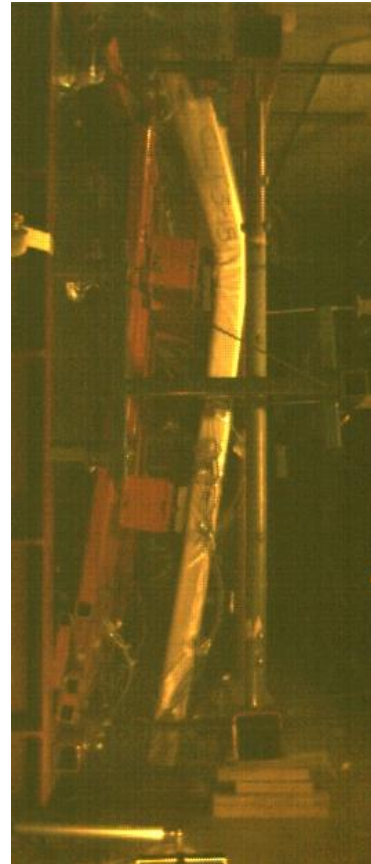
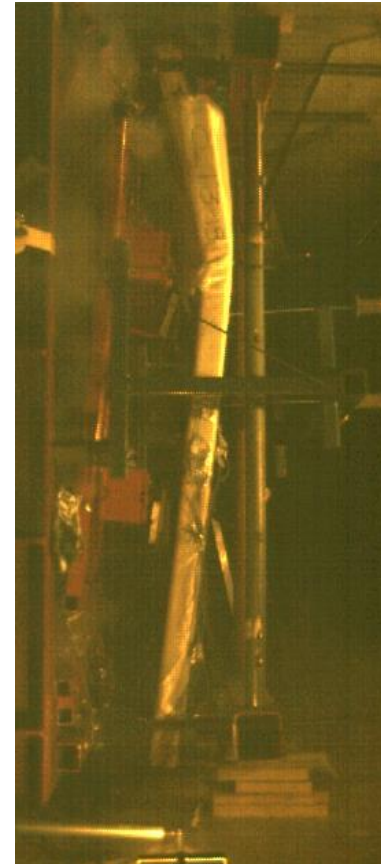
**Figure E.9: Progression of Failure of CLT3-5**

**(a) Initial Position**

**(b) Maximum Displacement**

**(c) Final Position**

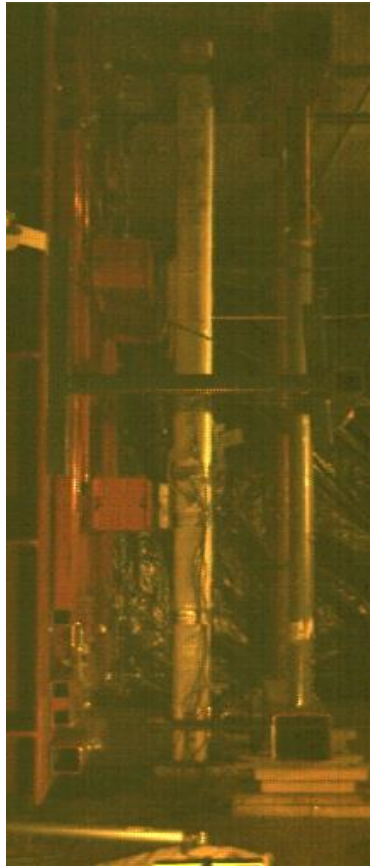
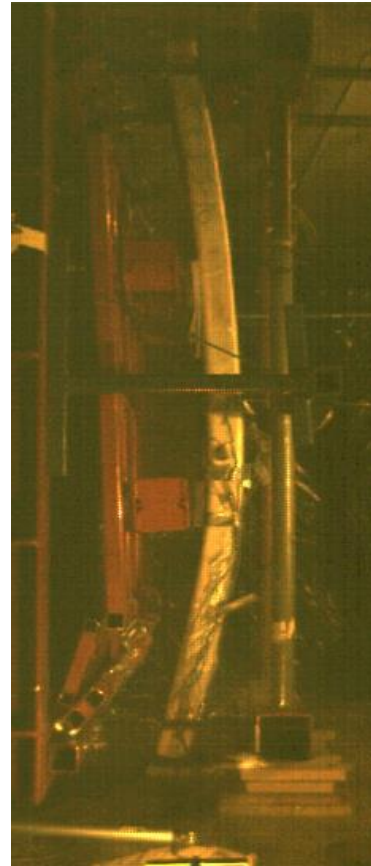
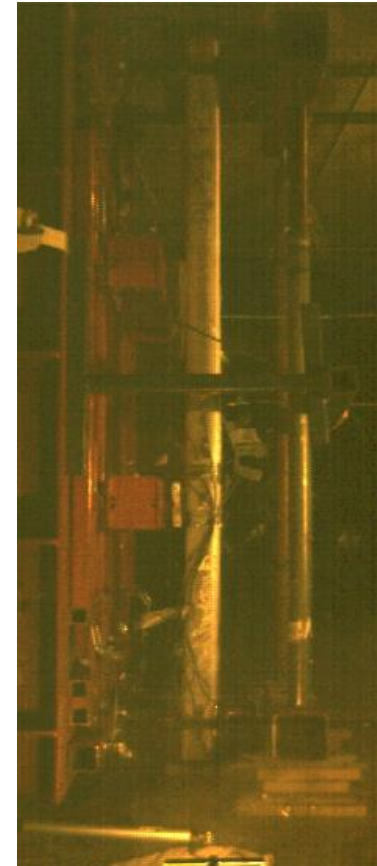
**Figure E.12: Progression of Failure of CLT3-6**

**(a) Initial Position**

**(b) Maximum Displacement**

**(c) Final Position**

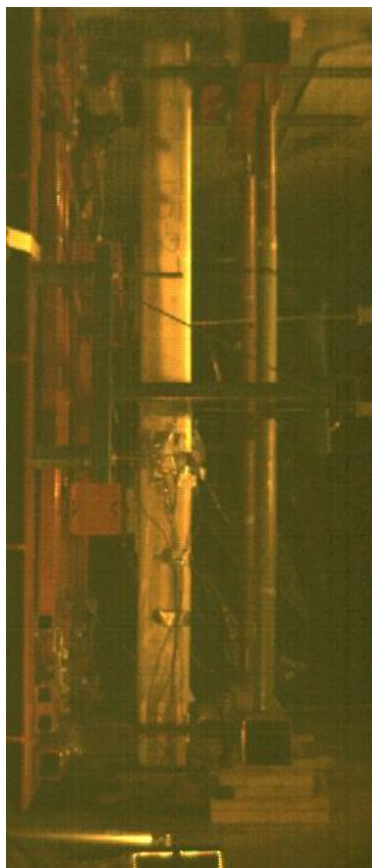
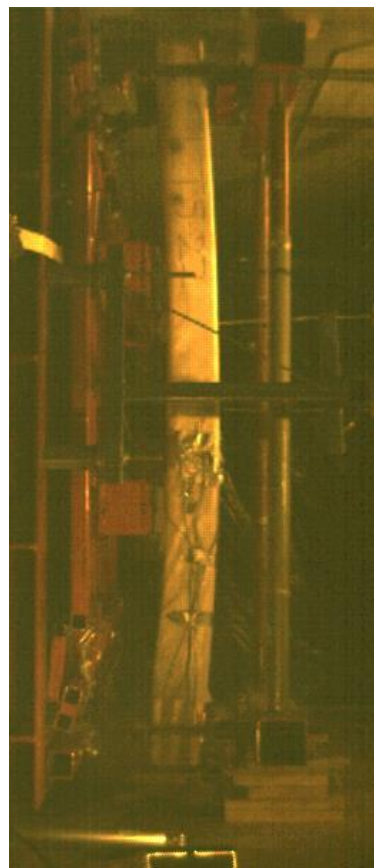
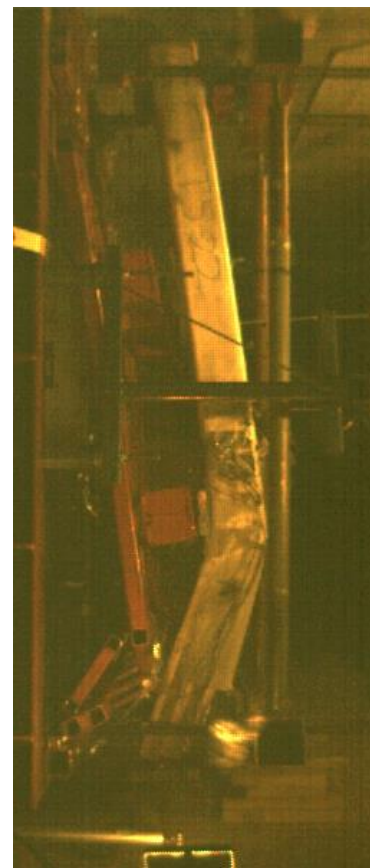
**Figure E.15: Progression of Failure of CLT5-6**

**(a) Initial Position**

**(b) Maximum Dynamic Resistance**

**(c) Maximum Displacement**

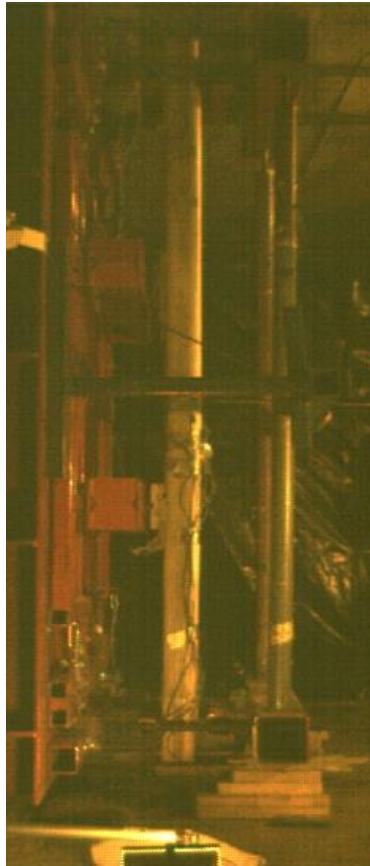
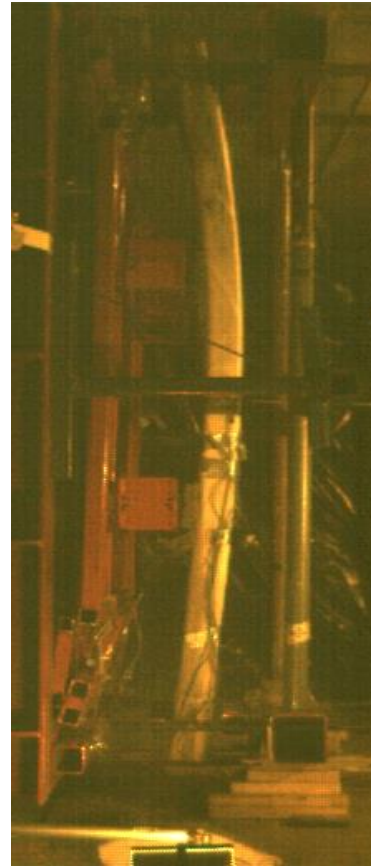
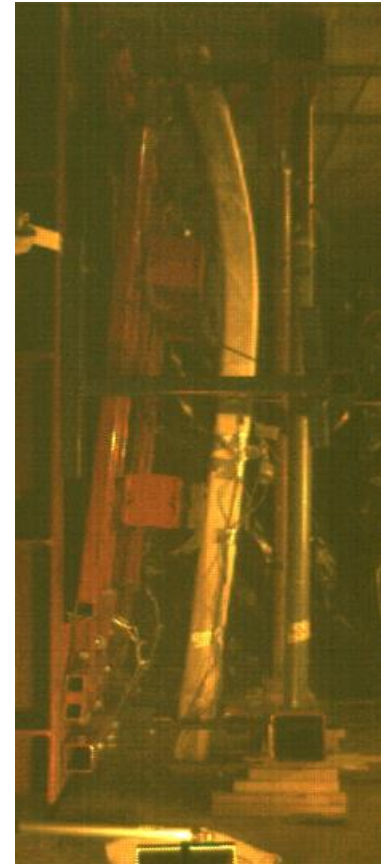
**Figure E.18: Progression of Failure of CLT3-D1**

**(a) Initial Position**

**(b) Maximum Dynamic Resistance**

**(c) Maximum Displacement**

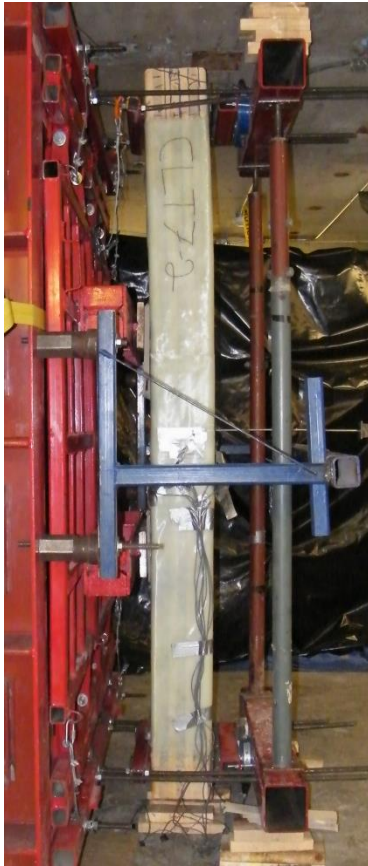
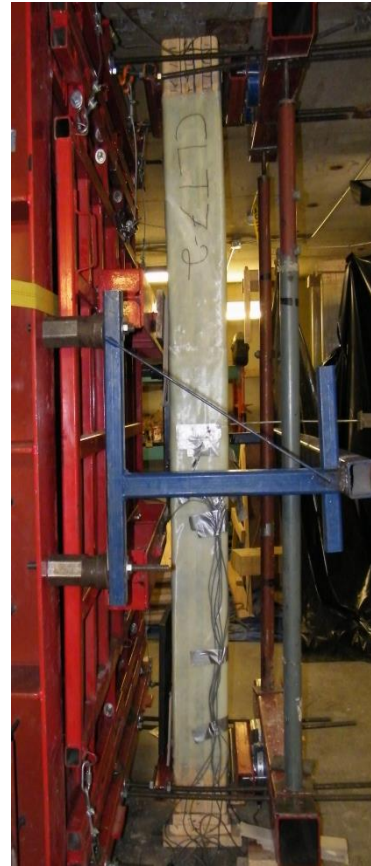
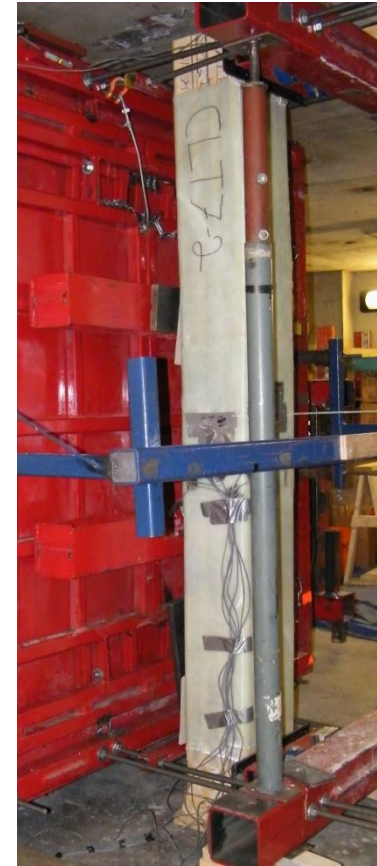
**Figure E.21: Slab Movement of CLT7-D2.1**

**(a) Initial Position**

**(b) Final Position**

**(c) Displaced Shape**

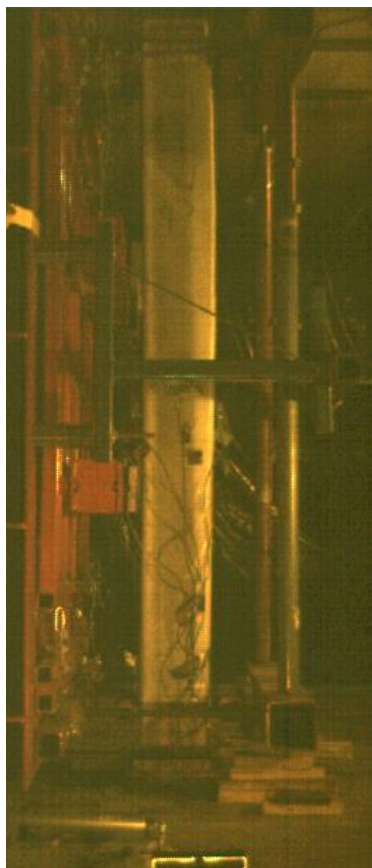
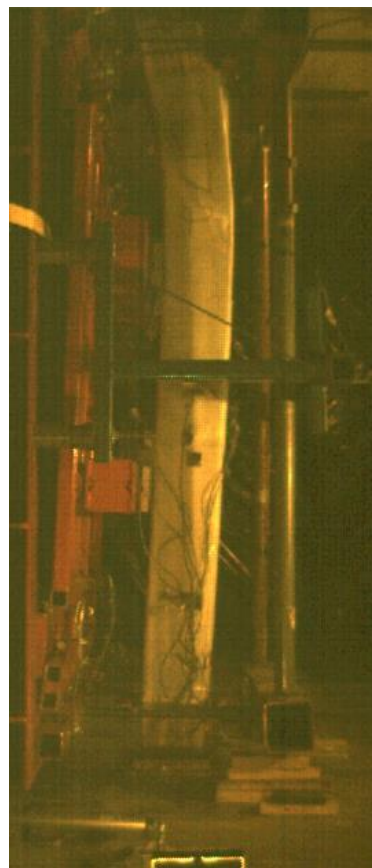
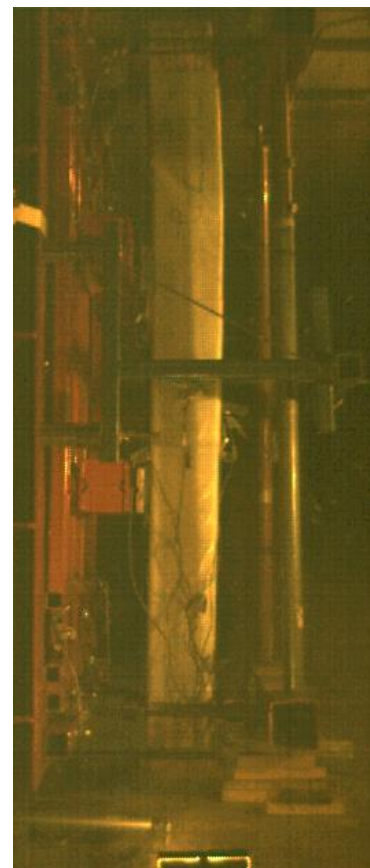
**Figure E.24: Progression of Failure of CLT7-D2.2**

**(a) Initial Position**

**(b) Maximum Displacement**

**(c) Final Position**
