**COMPREHENSIVE CONDITION ASSESSMENT OF ASR AFFECTED  
PIER CAP AND PIER SHAFT FROM MONTREAL'S CHAMPLAIN  
BRIDGE**

Thesis submitted to University of Ottawa in partial fulfillment of the requirements for the degree  
of  
**DOCTOR OF PHILOSOPHY**  
In Civil Engineering

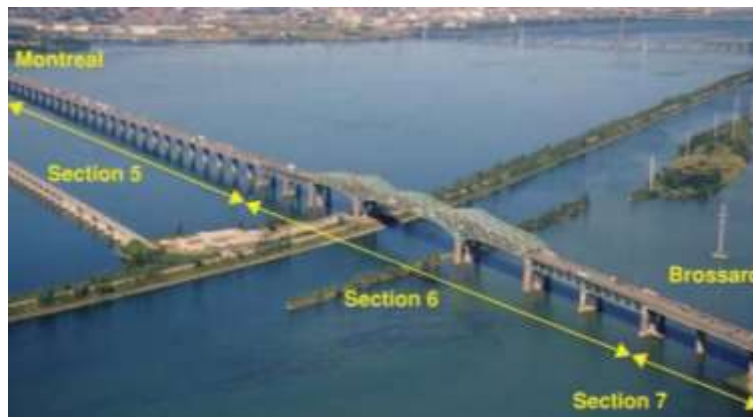
The Champlain Bridge (CB) is a 3.4 Km long six lane highway bridge which spanned the St. Lawrence River between Montreal Quebec and Brossard Quebec between June 1962 and July 2019 (Figure 2-1). The location was chosen in 1955 with construction starting in 1957 and continuing until 1964 when the final approaches to the CB were completed. The CB operated as a toll bridge until 1990 and was considered one of the busiest bridges in Canada with approximately 50 million vehicles [1] passing annually. Since 1978 the CB has been maintained by Jacques Cartier and Champlain Bridges Incorporated (JCBBI), a Canadian Crown Corporation responsible for structural health monitoring, maintenance, and management.

**Figure 2-1 Annotated image identifying key sections of the Champlain Bridge (reproduced from [2])**

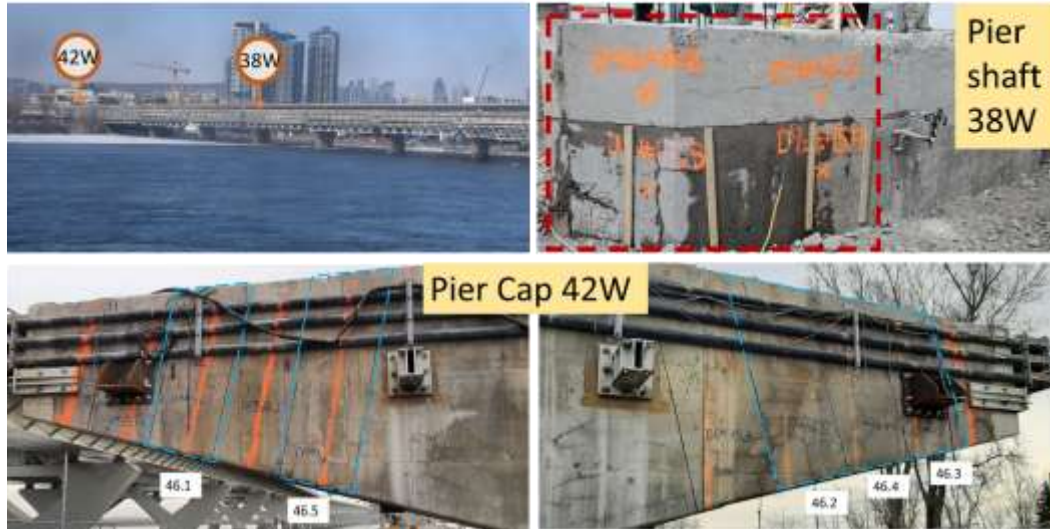
The members under investigation include five (5) segments of a pier cap and four (4) sections of a pier shaft (Figure 3-2).

**Figure 3-2 Annotated images depicting the concrete members under study and their location in the Champlain Bridge**

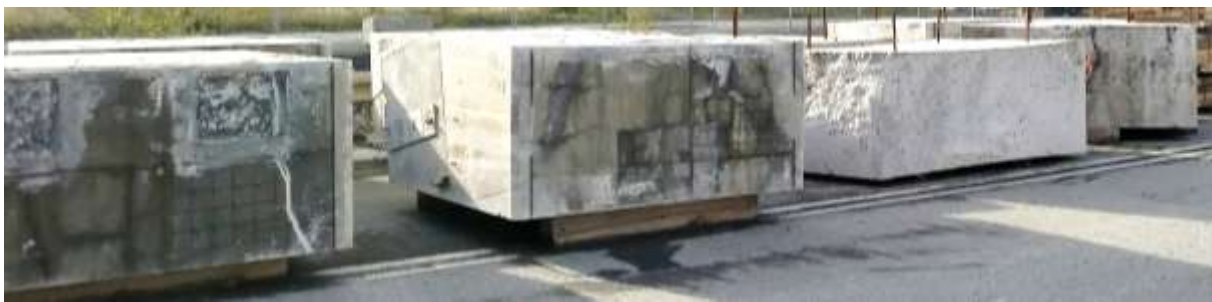
Member segments were accessed at an outdoor storage site in Montreal (e.g., Figure 3-3) with visual and non-destructive tests performed in this location followed by coring of the segments, with cores subsequently transported to the University of Ottawa laboratory.

**Figure 3-3 Image depicting segments of the pier cap (left two segments) and pier shaft (right two segments) at the Montreal storage site**

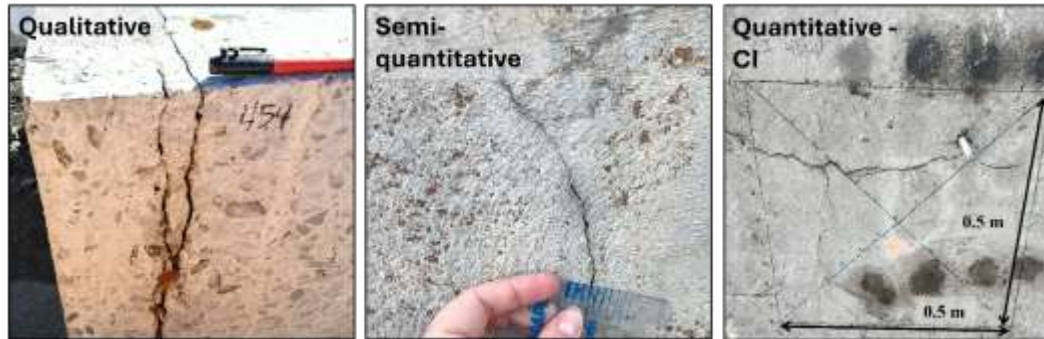
Visual assessment was performed including qualitative, semi-quantitative (using a crack comparator card) and quantitative (cracking index) assessments (Figure 3-4).

**Figure 3-4 Images depicting qualitative, semi-quantitative and quantitative visual inspection**

Qualitative assessment included photographing concrete segments and identifying points of interest such as discolouration, efflorescence, cracking, rebar corrosion, evidence of previous repairs and objects such as wires and metal plates. Since the concrete members being studied had been cut into segments, it was also possible to identify the locations of reinforcement.

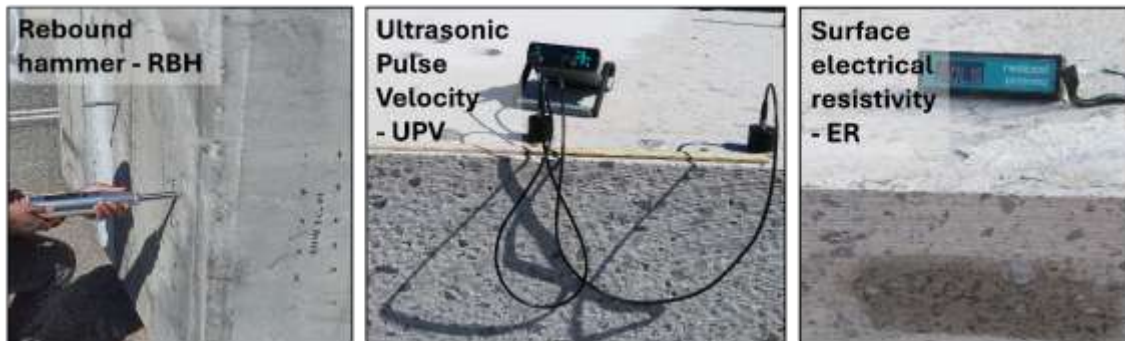
Non-destructive tests consisting of surface electrical resistivity (ER), rebound hammer (RBH) and ultrasonic pulse velocity (UPV) were conducted on the pier cap and pier shaft segments at the storage site in Montreal (Figure 3-5). These were performed over several visits with results from RBH measurements used in conjunction with CI to identify the least and most damaged segments.

**Figure 3-5 Images depicting the rebound hammer (RBH), ultrasonic pulse velocity (UPV) and surface electrical resistivity non-destructive testing techniques**

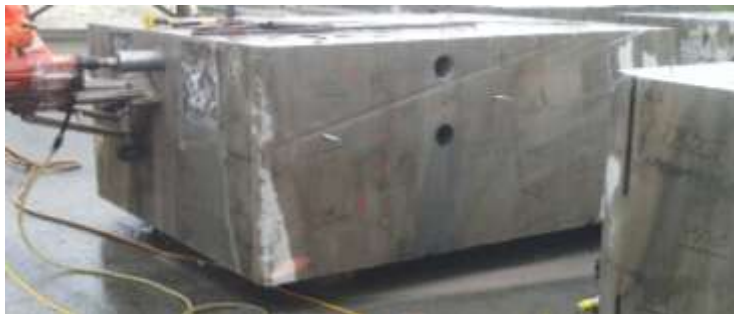
Cores were extracted from the pier cap and pier shaft segments at the storage site by a coring company using a 100-mm diameter coring bit (Figure 3-6). Cores were labeled once extracted based on an internal numbering system (segment identifier – surface identifier – number of the core extracted from the surface). Cores were then photographed and then wrapped in plastic wrap. Coring of the pier cap and pier shaft segments was performed over a four-day period and cores had a variety of moisture conditions upon wrapping in plastic wrap due to the high variation of weather during this period. Cores were subsequently stored in a temperature-controlled chamber at  $12^{\circ}\text{C}$ , as per Sanchez et al. [11], when not being evaluated.

**Figure 3-6 Image depicting core extraction from a pier cap segment at the Montreal storage site**

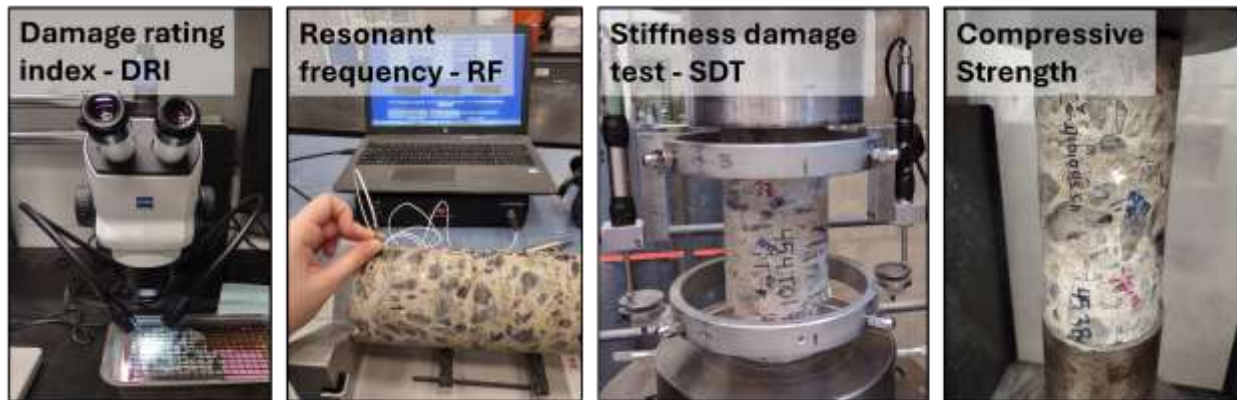
Tests performed on core specimen included resonant frequency (RF), the damage rating index (DRI), the stiffness damage test (SDT) and compressive strength (Figure 3-9). Supplemental image analysis was also conducted for both microscopic and mechanical testing. Cores extracted from the first 200 mm (i.e. from the repair concrete for the pier cap and from the surface for the pier shaft) were designated as 'surface' cores.

**Figure 3-9 Images depicting the damage rating index (DRI), resonant frequency (RF), stiffness damage test (SDT) and compressive strength tests used in analysis of core specimens**

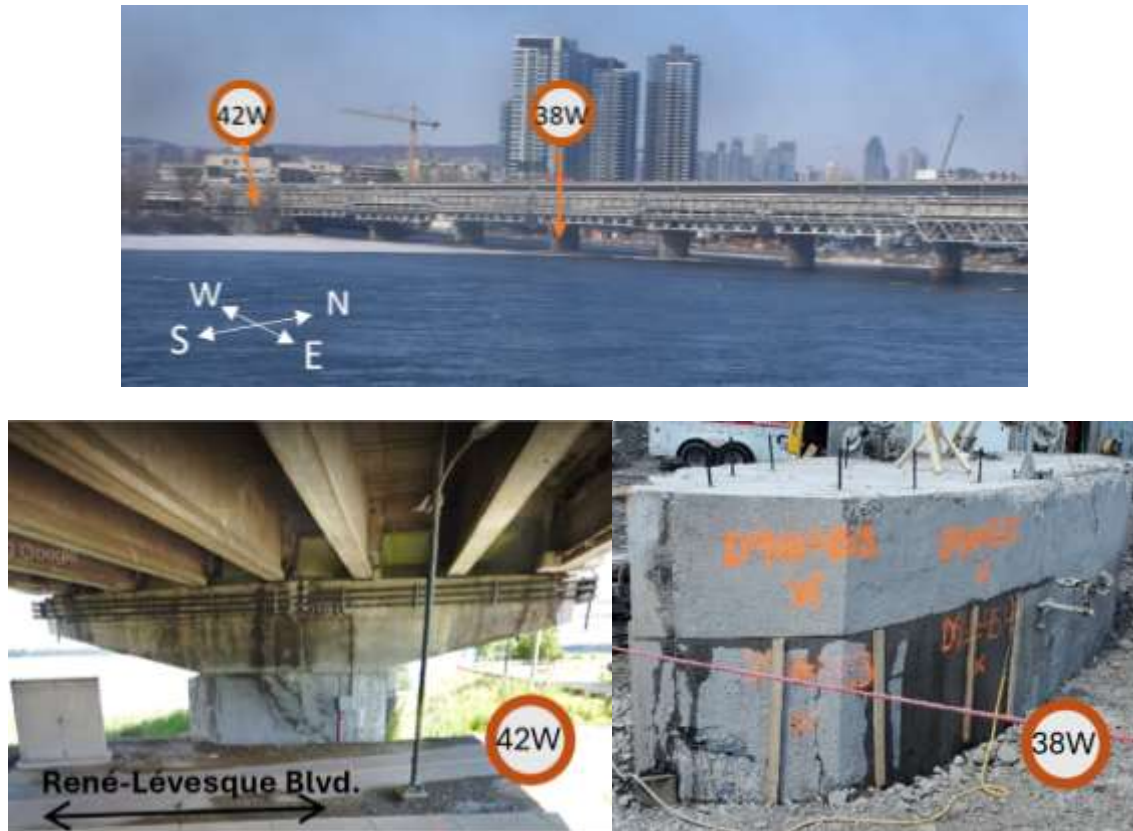
**Figure 4-1 Annotated images identifying the location of the pier cap (42W) and pier shaft (38W).**  
 (Image sources: top and bottom right images courtesy of JCCBI, bottom left image: Map data  
 ©2022 Google)

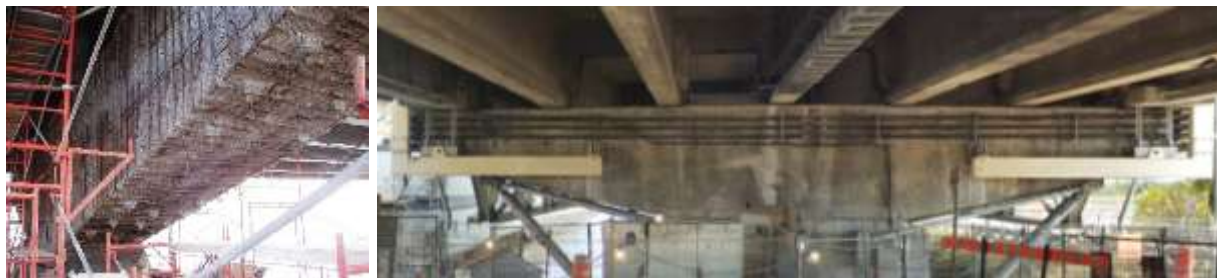
In older structures, repairs are also common. This is the case for the pier cap investigated in this work which underwent an encapsulation repair in 2004 after 42 years in service. During this repair, concrete was removed up to the outermost layer of reinforcing bars and replaced by a less permeable repair concrete [17, 18] followed by the addition of three Dywidag bars to provide additional longitudinal post-tensioning [19] in 2008 (Figure 4-2).

**Figure 4-2 Images depicting the pier cap following removal of the surface concrete in 2004 (left) and in 2018 after addition of external longitudinal reinforcement and the modular truss system in 2018 (right). (reproduced from JCCBI (left), Map data ©2022 Google (right))**

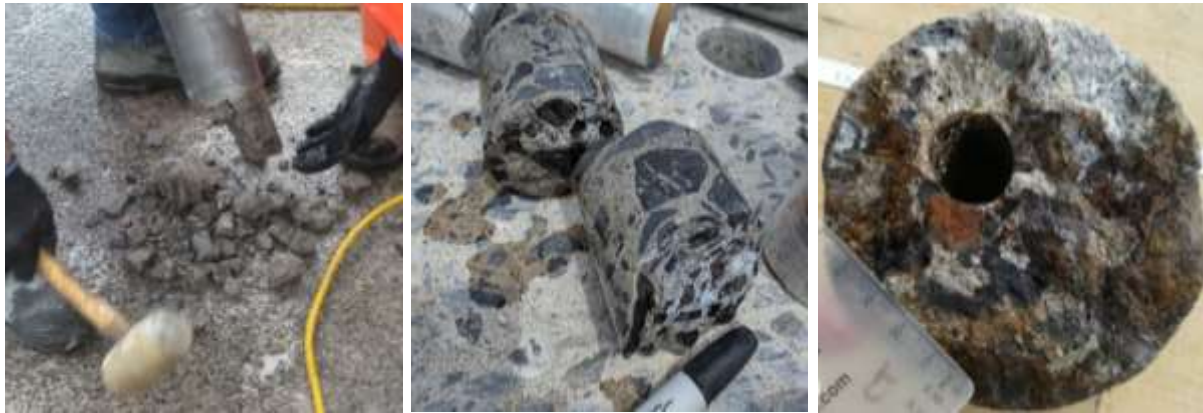
The locations for the extraction of cores were chosen to capture both the least and most damaged regions of both members, with additional cores extracted from areas exhibiting lower damage in visual and non-destructive assessments for compressive tests prior to performing SDT. The length of individual cores extracted from the PC and PS members varied. In several core locations in the PC further the maximum depth of coring was prevented by metal plates within the member. In the PS internal damage reduced the length of extracted core segments, with breaks common in extracted cores at a depth of 10 cm from the surface. General poor cohesion was additionally noted for the initial 90 cm of core L\_SE6 (left side in Figure A 9) with this section unusable for microscopic and mechanical testing.

**Figure A 9 Core specimens from the PS displaying damage**
