EVALUATION OF CFRP-CONCRETE BOND BEHAVIOUR IN FIELD CONDITIONS: A CHAMPLAIN BRIDGE CASE STUDY

ISSA FOWAI

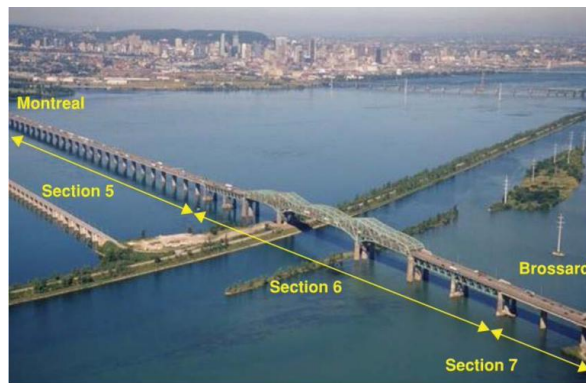
Figure 1.1- Overview of various sections (Taylor, 2013)

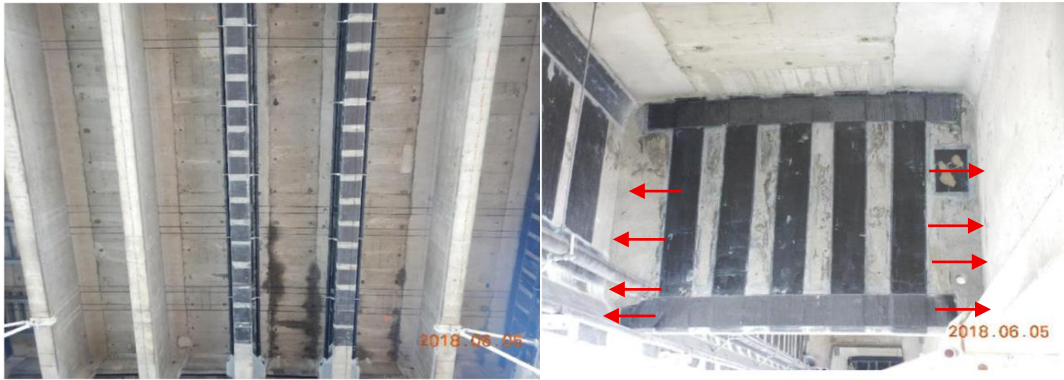
Figure 1.3 – Typical CFRP strengthening schemes a) Girders b) Diaphragm with load transfer path shown in red arrows (Stantec, 2018)

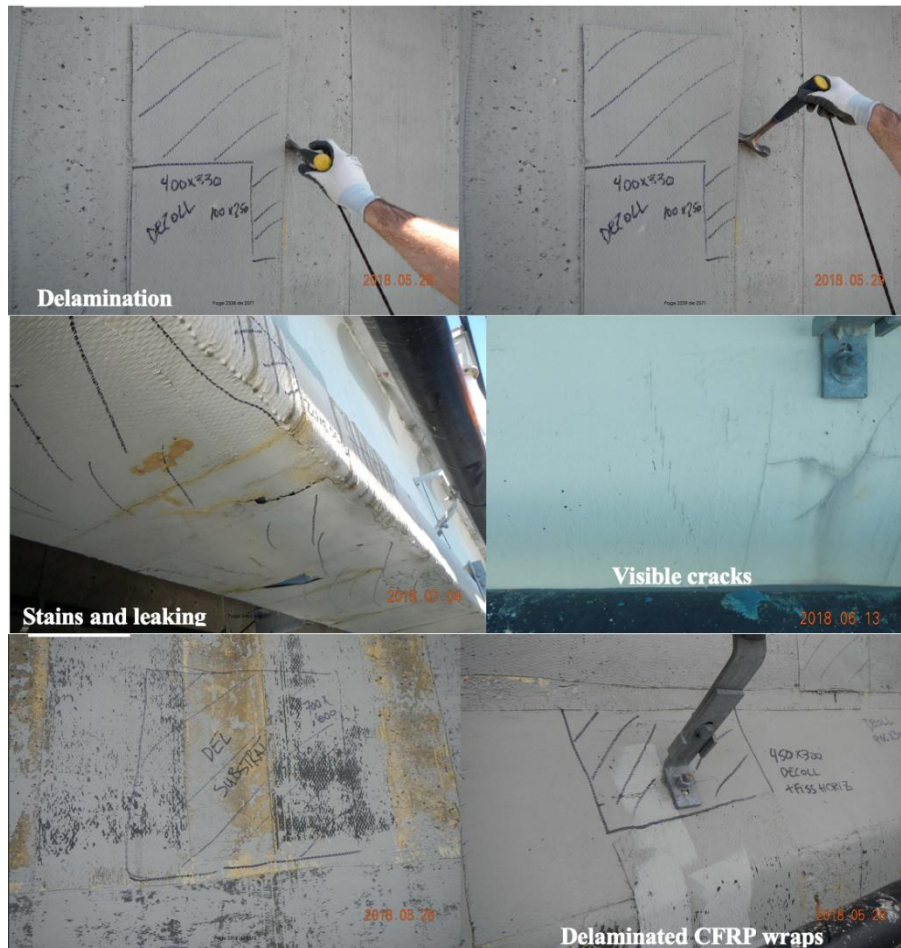
Figure 2.1-Examples of various kinds of inspected defects on CFRP-strengthened elements of the Champlain Bridge (Stantec, 2018)

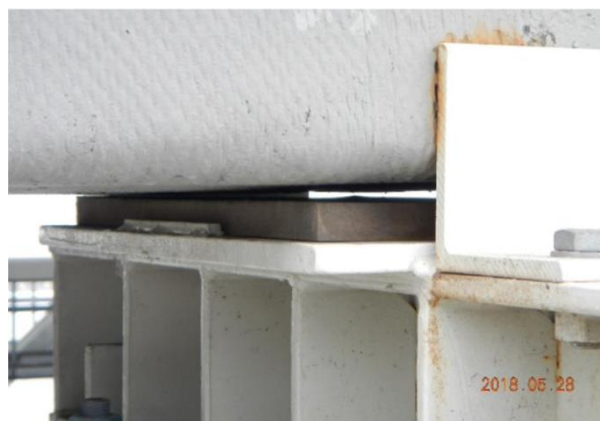
Figure 2.2 - Corrosion leading to discolouring of CFRP protective layer (4W-5W) (Stantec, 2018)

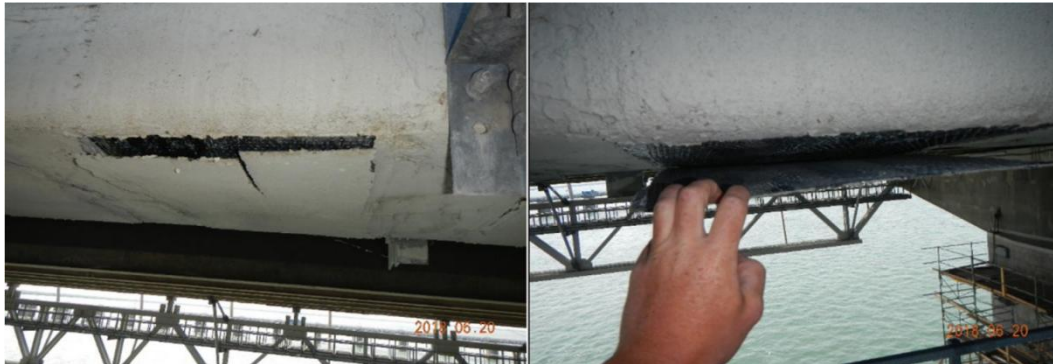
Figure 2.3 - Detachment of CFRP protective cover (Section 5; 22W-23W) (Stantec, 2018)

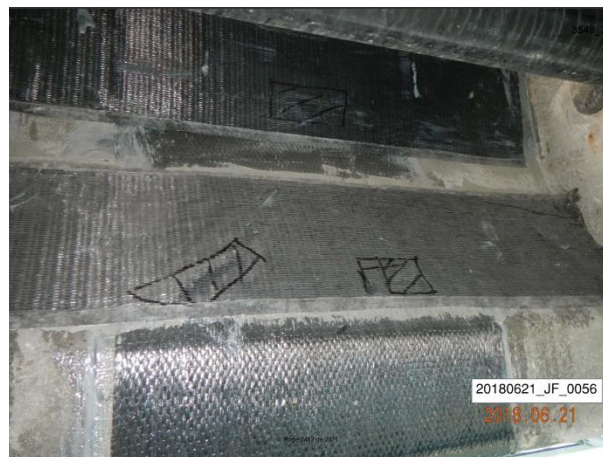
Figure 2.4 -Air bubbles observed on girder 2 of Span 23W-24W of the CB (Stantec, 2018)

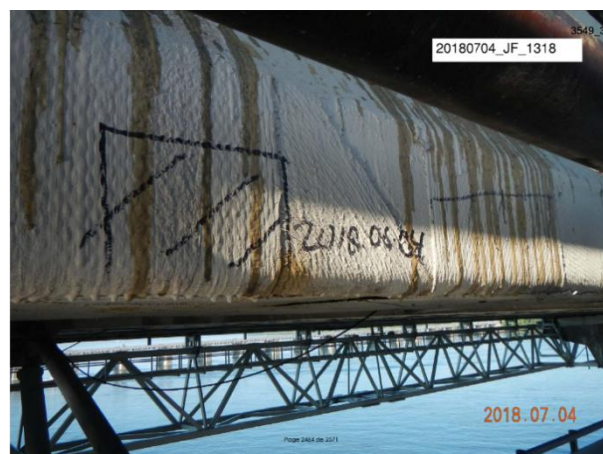
Figure 2.5-Stained protective coat due to leakage (Stantec, 2018)

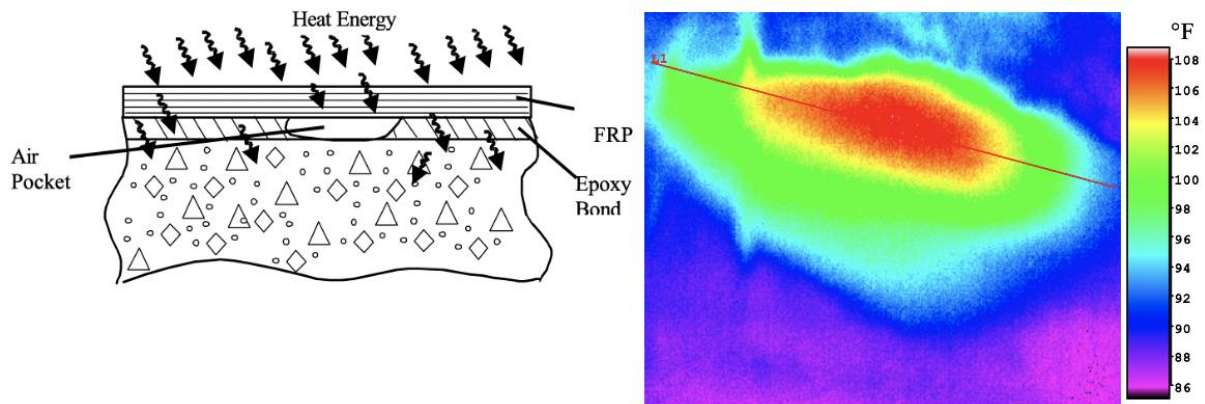
Figure 2.8 - bond line defect identification a) Typical heat transfer around subsurface defect b) Detected defect observed via thermography (Mtenga et al., 2001)

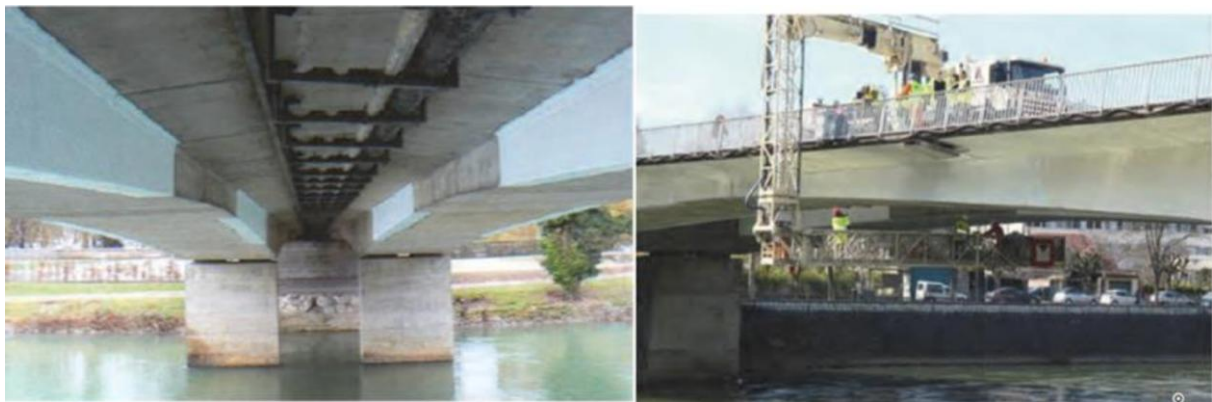
Figure 2.10 - In-situ Infrared bridge inspection a)View of strengthened regions (left), b) mounted lift-platform (right) (Taillade et al., 2012)

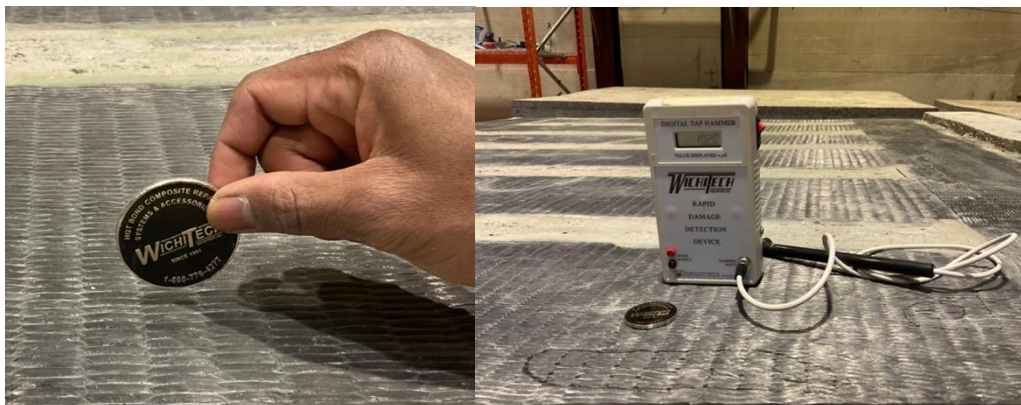
Figure 2.12- Acoustic tapping devices a) Traditional coin tap test b) Digital tap testing hammer used on the CB Diaphragms

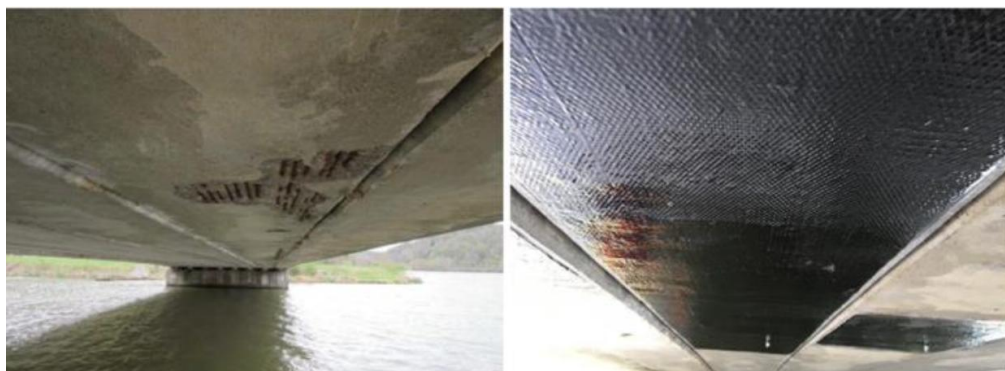
Figure 2.14 -Whiteday Creek Bridge a) before repair b) After CFRP repair (Joshi, 2018)

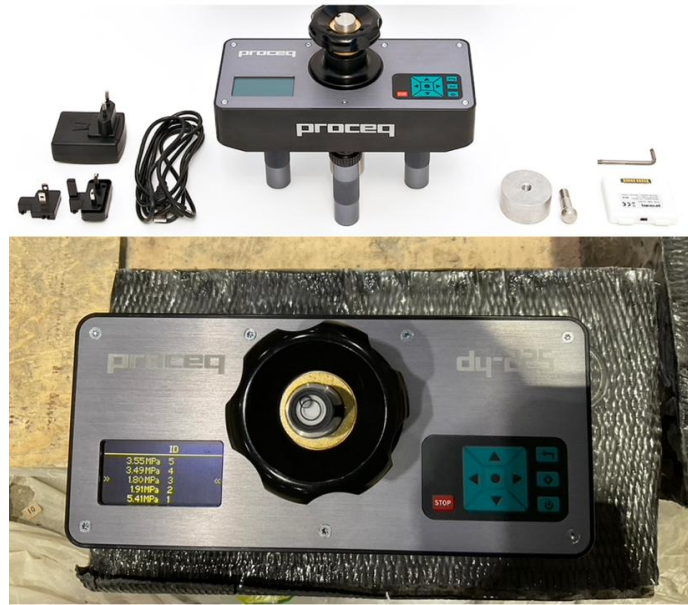
Figure 2.15 - Direct tension pull-off testing apparatus

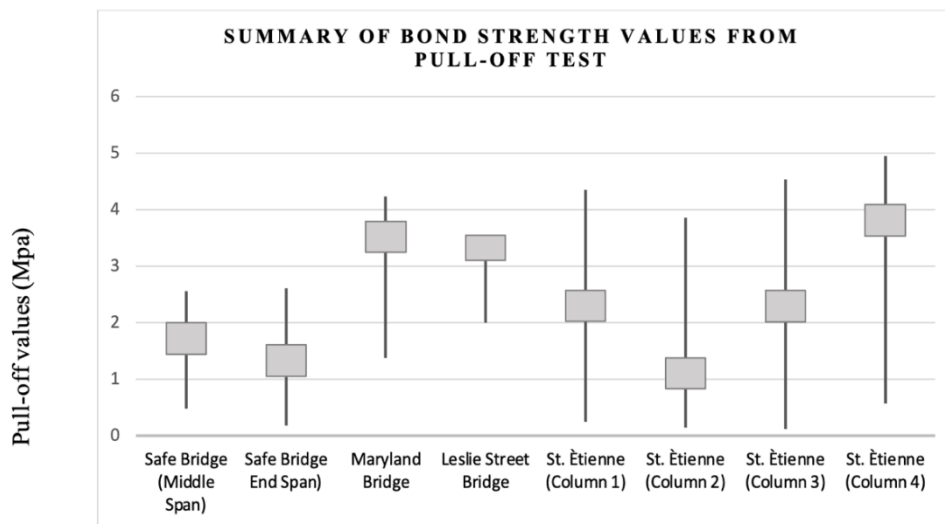
Figure 2.18 - Direct tension pull-off values obtained for various bridges (Banthia et al., 2010)

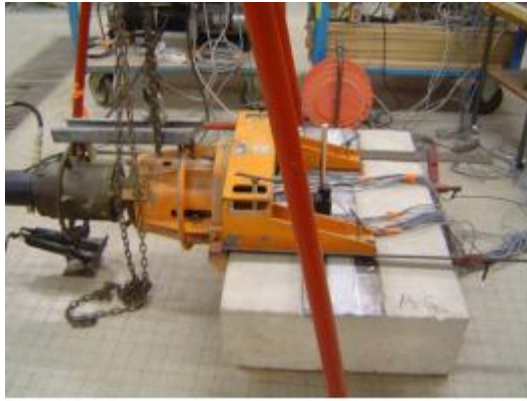
Figure 2.20 -Test set up and machine (Chataigner et al., 2011)

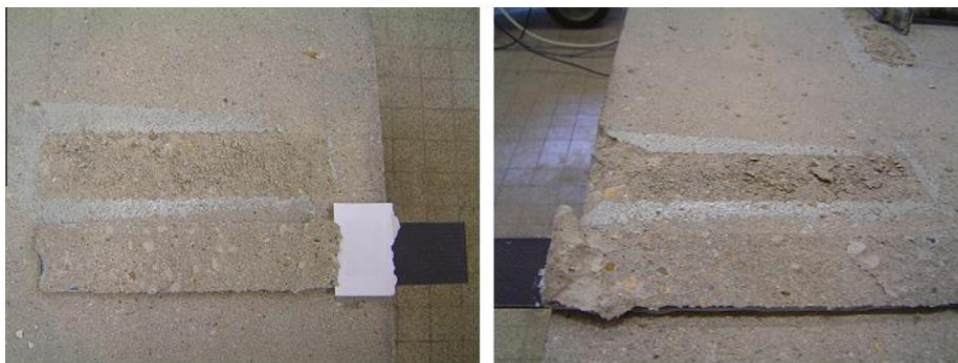
Figure 2.21 - Failure surfaces for a) 50 mm gap from the edge b) bonded to the edge (Chataigner et al., 2011)

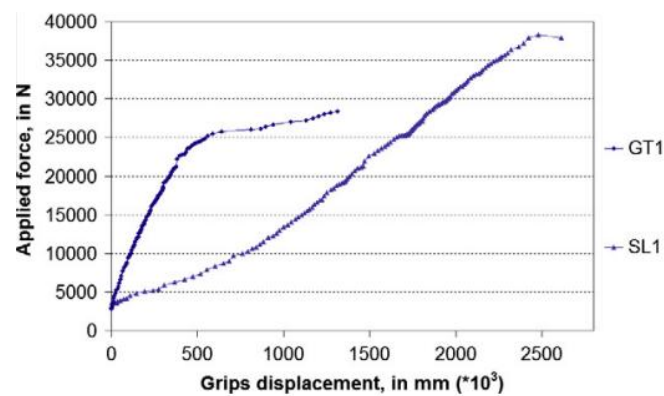
Figure 2.22 - Load-displacement curve of a typical CFRP sheet (GT1) and Plate (Chataigner et al., 2011)

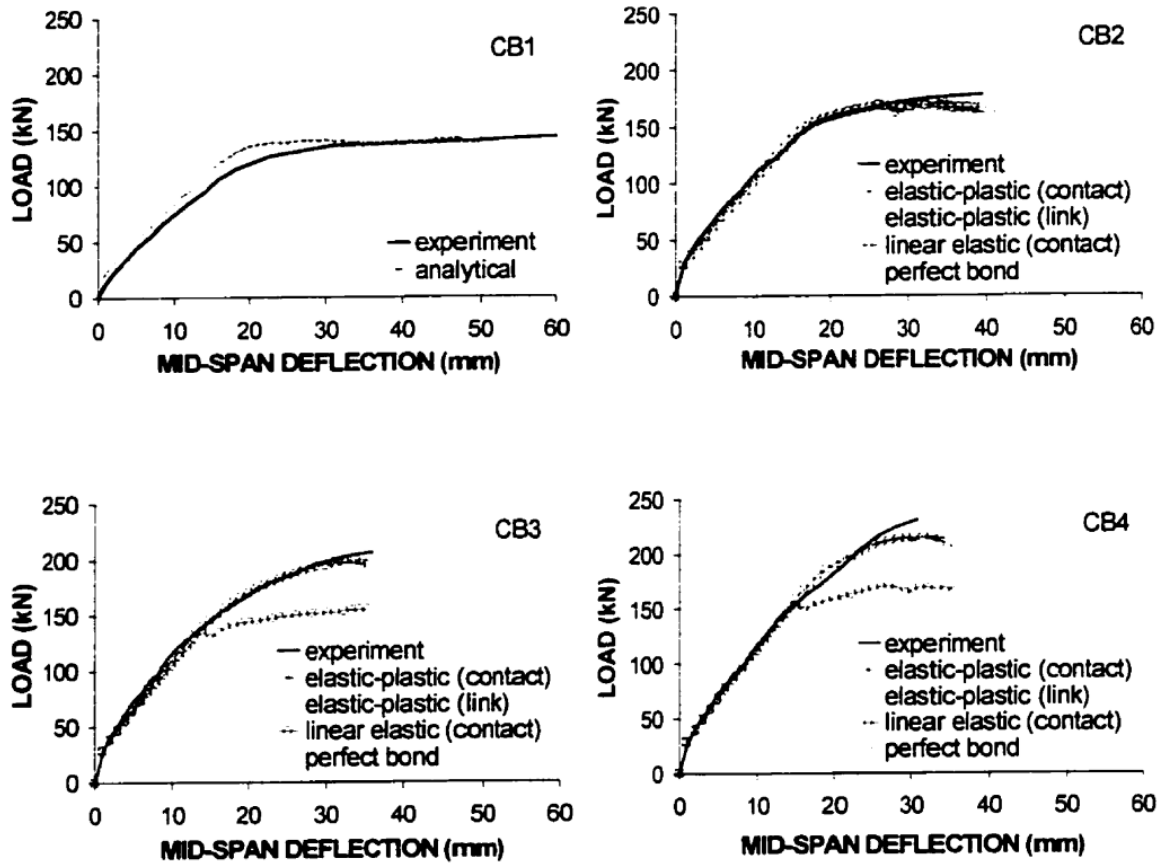
Figure 2.43 - Load-displacement for the FEM analysis of the El-Refaie beams (El-Refaie et al., 2001)

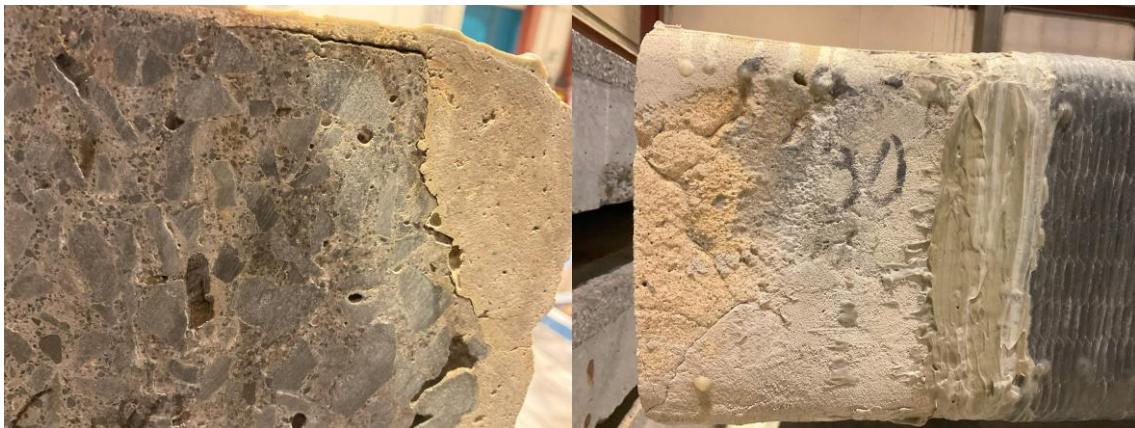
Figure 3.1-Cracks in patch materials

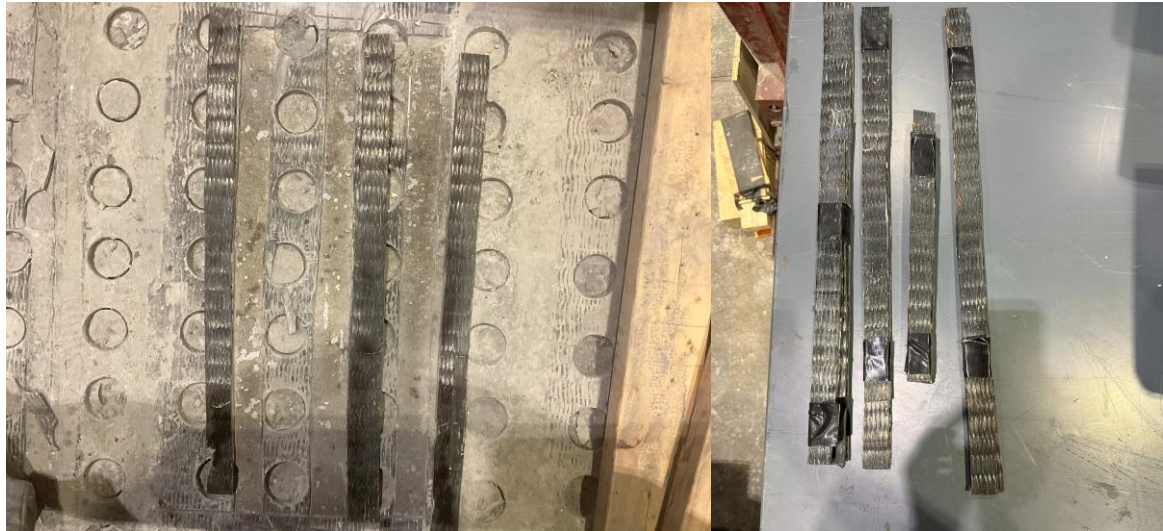
Figure 3.3-Extraction of CFRP coupon from bridge diaphragm

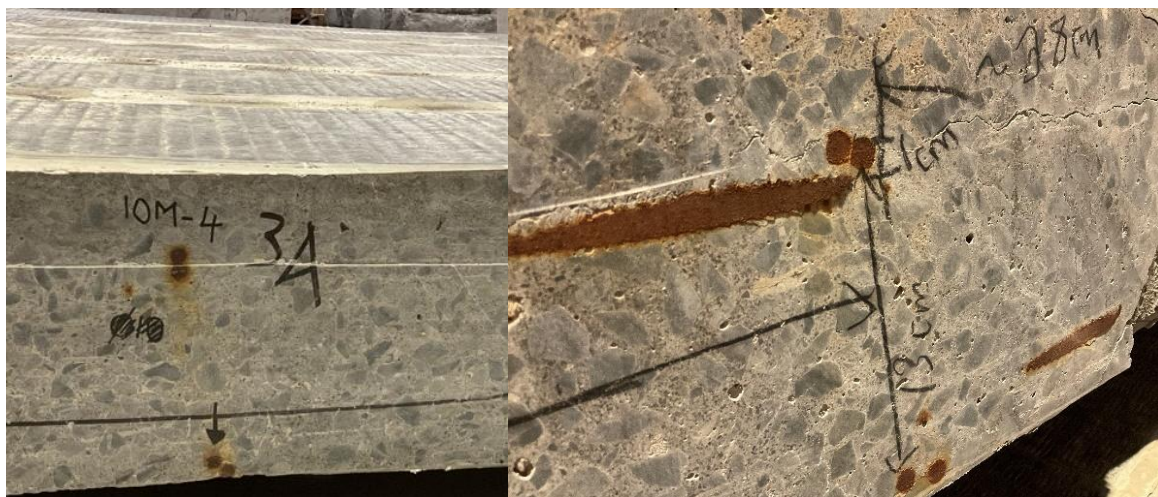
Figure 4.8-Random placement of rebar without sufficient spacing or concrete cover a) side A of diaphragm #3 b) side B of diaphragm #3

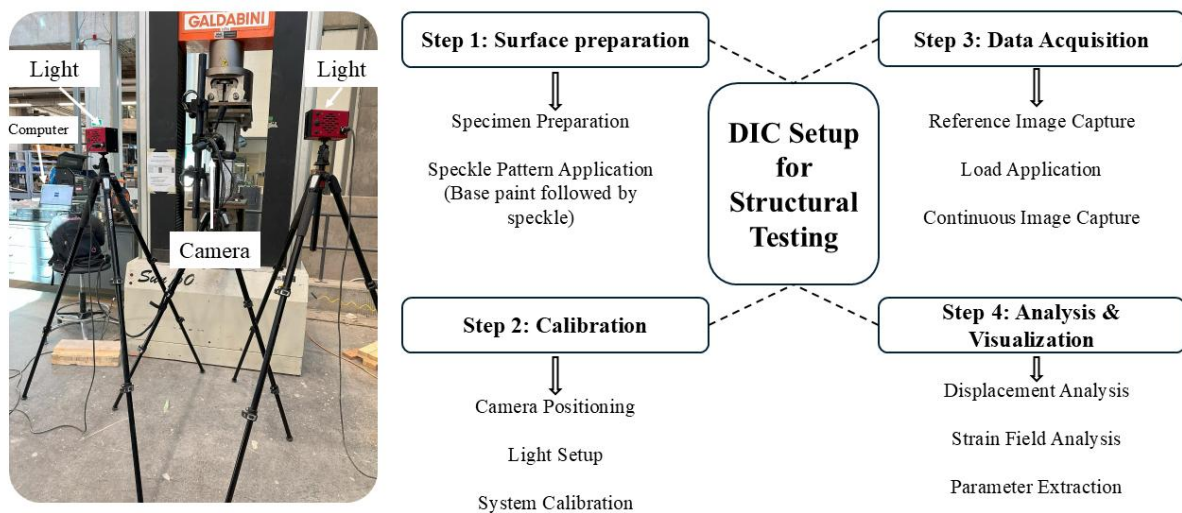
Figure. 5.5. 3D DIC setup and general steps involved in DIC measurements

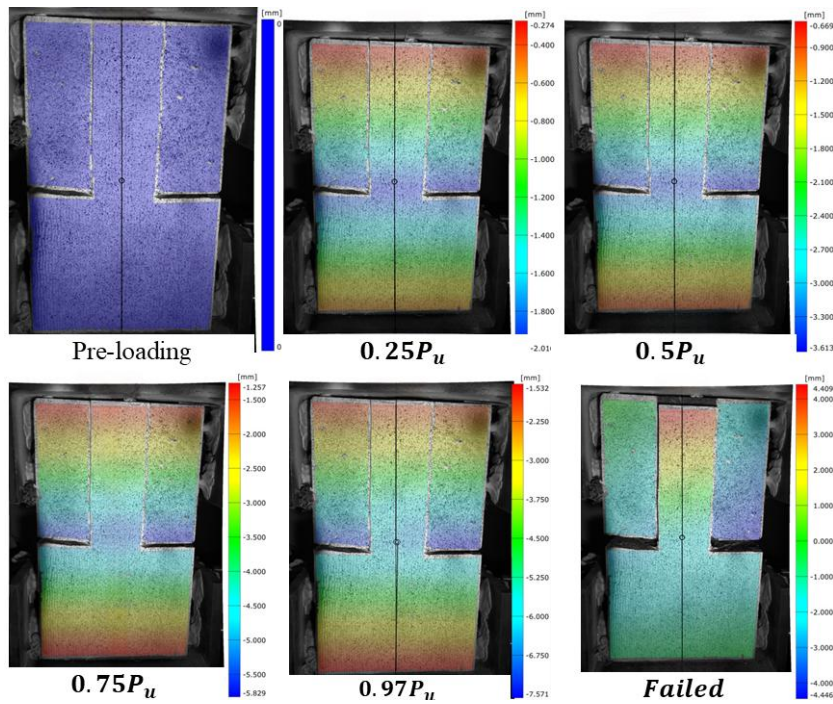
Figure 5.10-Contour of out-of-plane displacement for specimen SS-S9

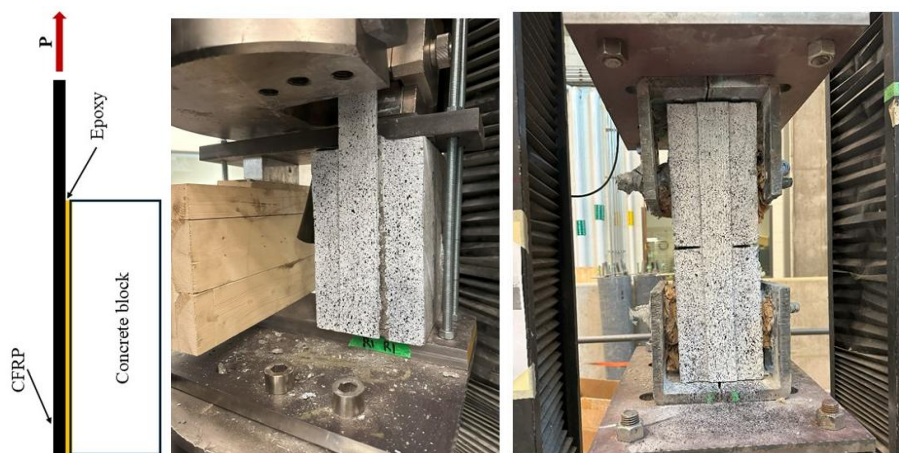
Figure 7.3- Shear-lap specimens a) Conventional single shear-lap b) Double shear-lap

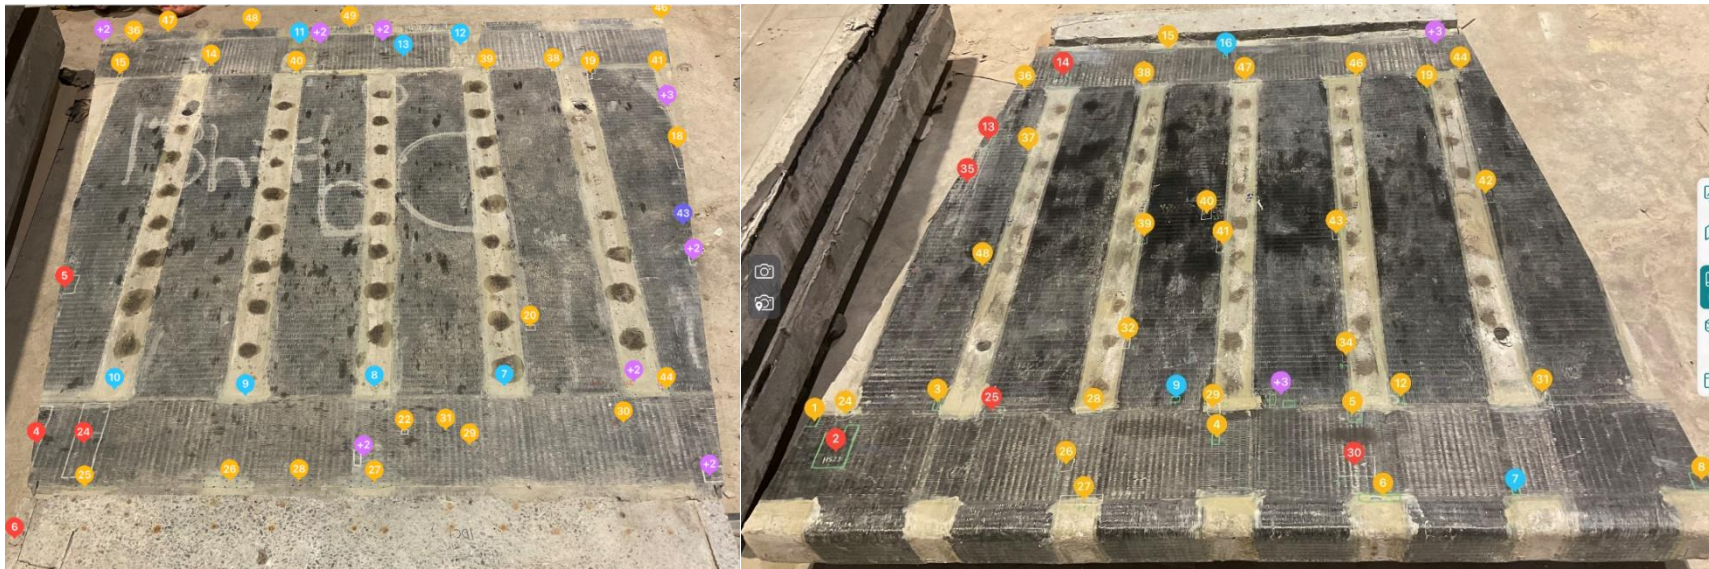
B.0.1-Defects on top surfaces of Diaphragm #1 side I (on the left) and side II (on the right)

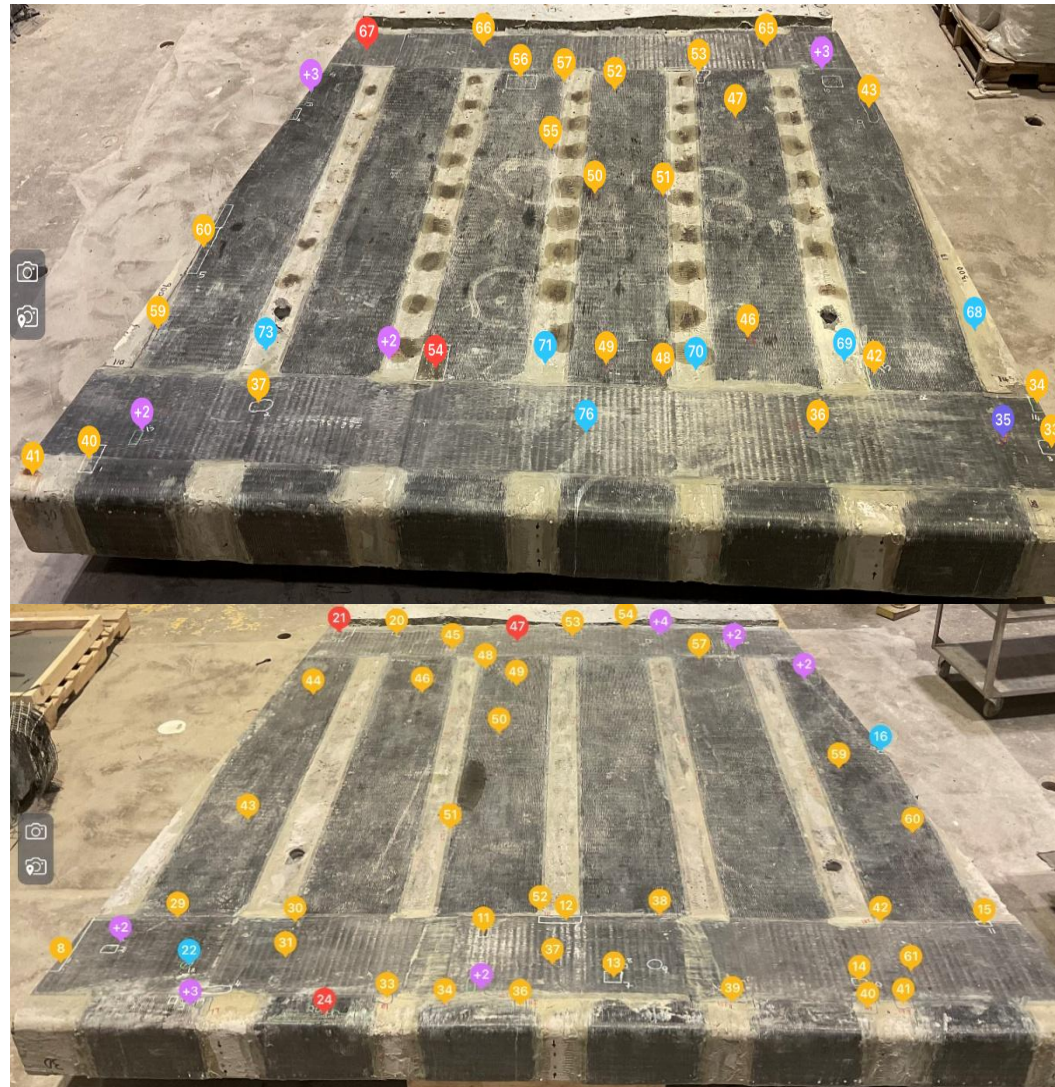
B.0.3-Defects on top surfaces of Diaphragm #3 side I (on the top) and side II (on the bottom)

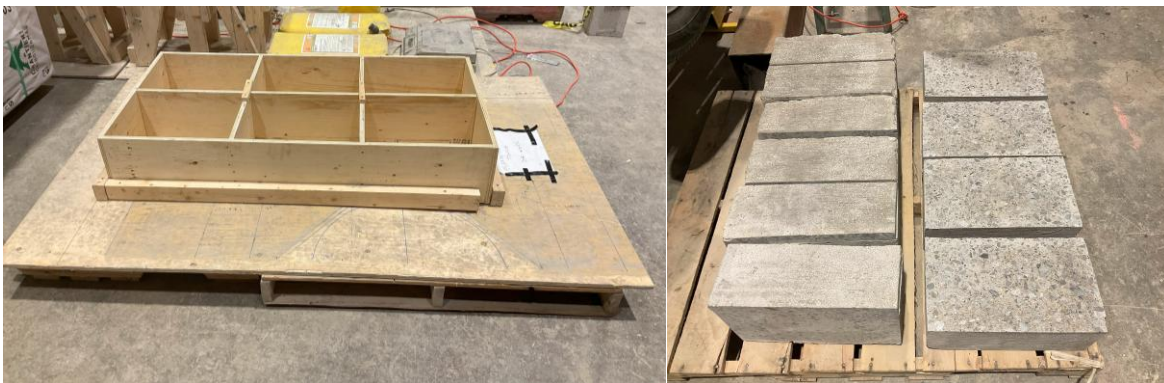
F.0.1-Formwork and laboratory specimens for direct tension pull-off tests

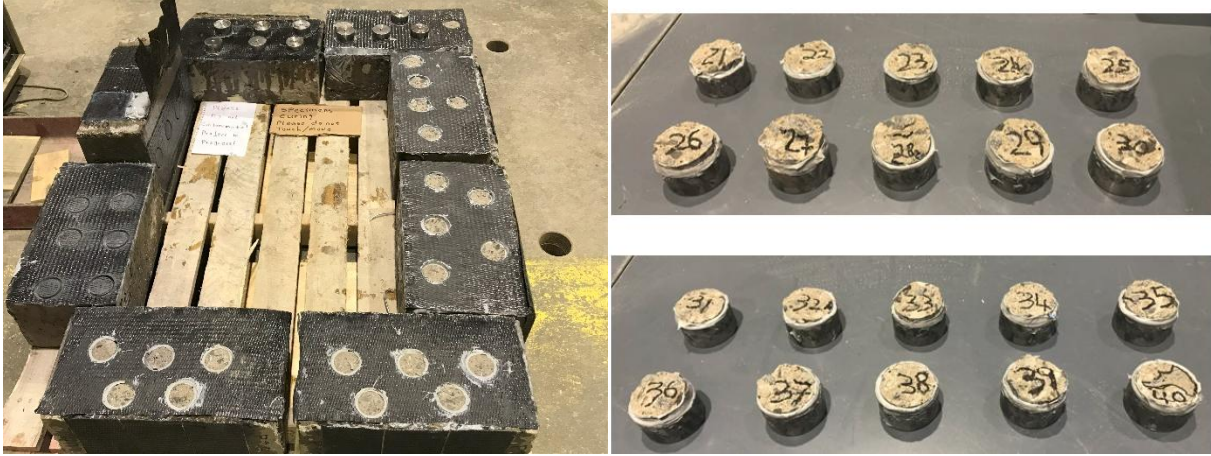
F.0.2-Mock samples for direct tension pull-off testing and concrete failure mode

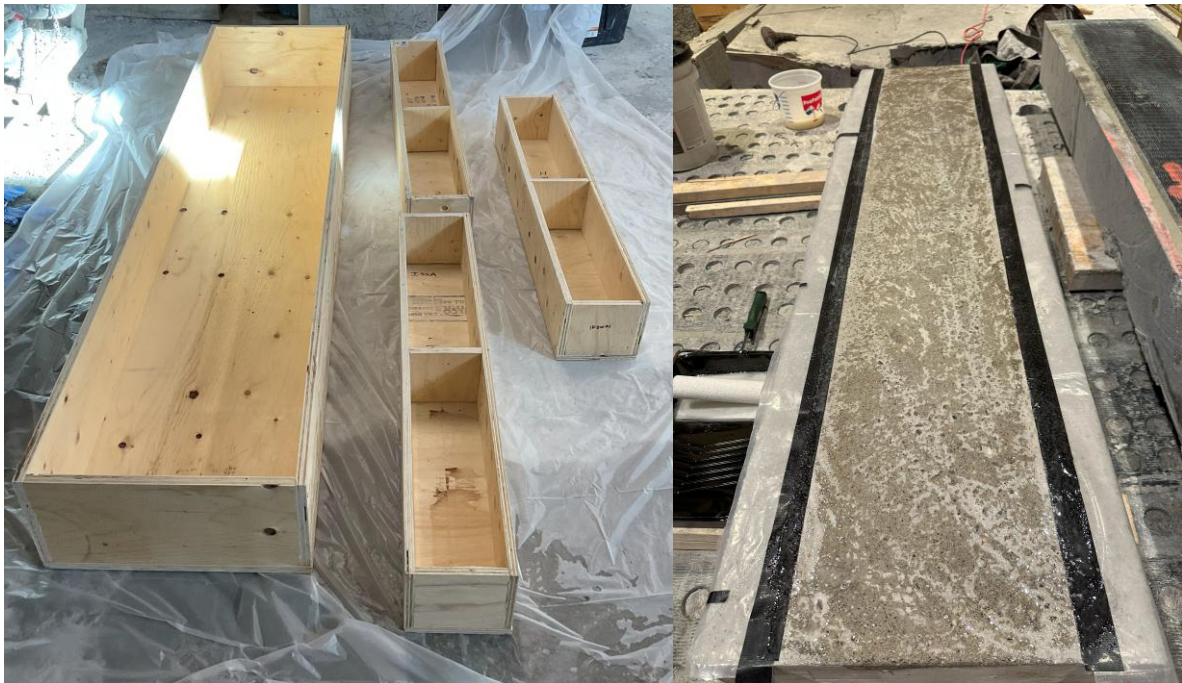
F.0.3- Laboratory specimen preparation for bending tests

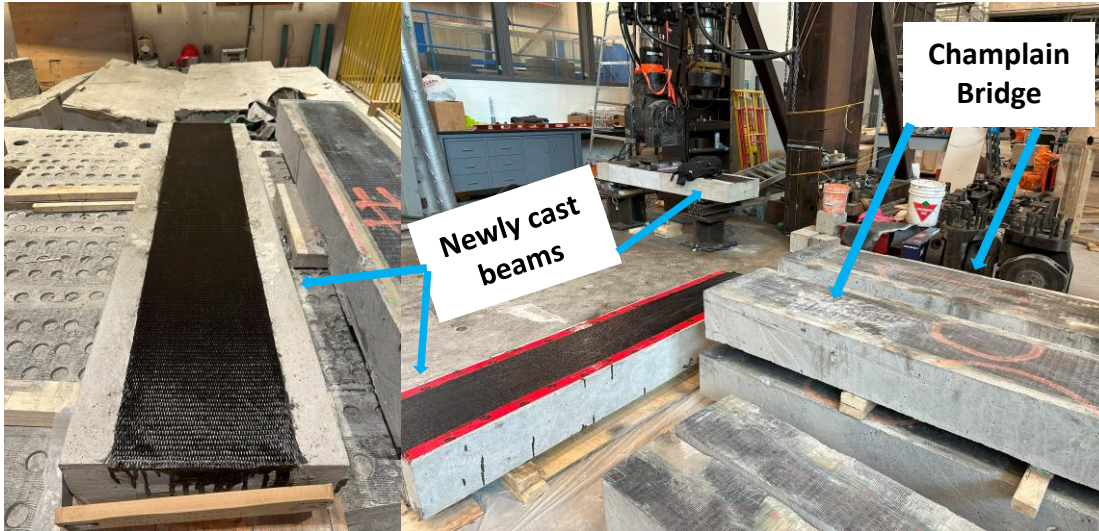
F.0.4-Laboratory prepared specimens and beams extracted from the Champlain Bridge for bending tests

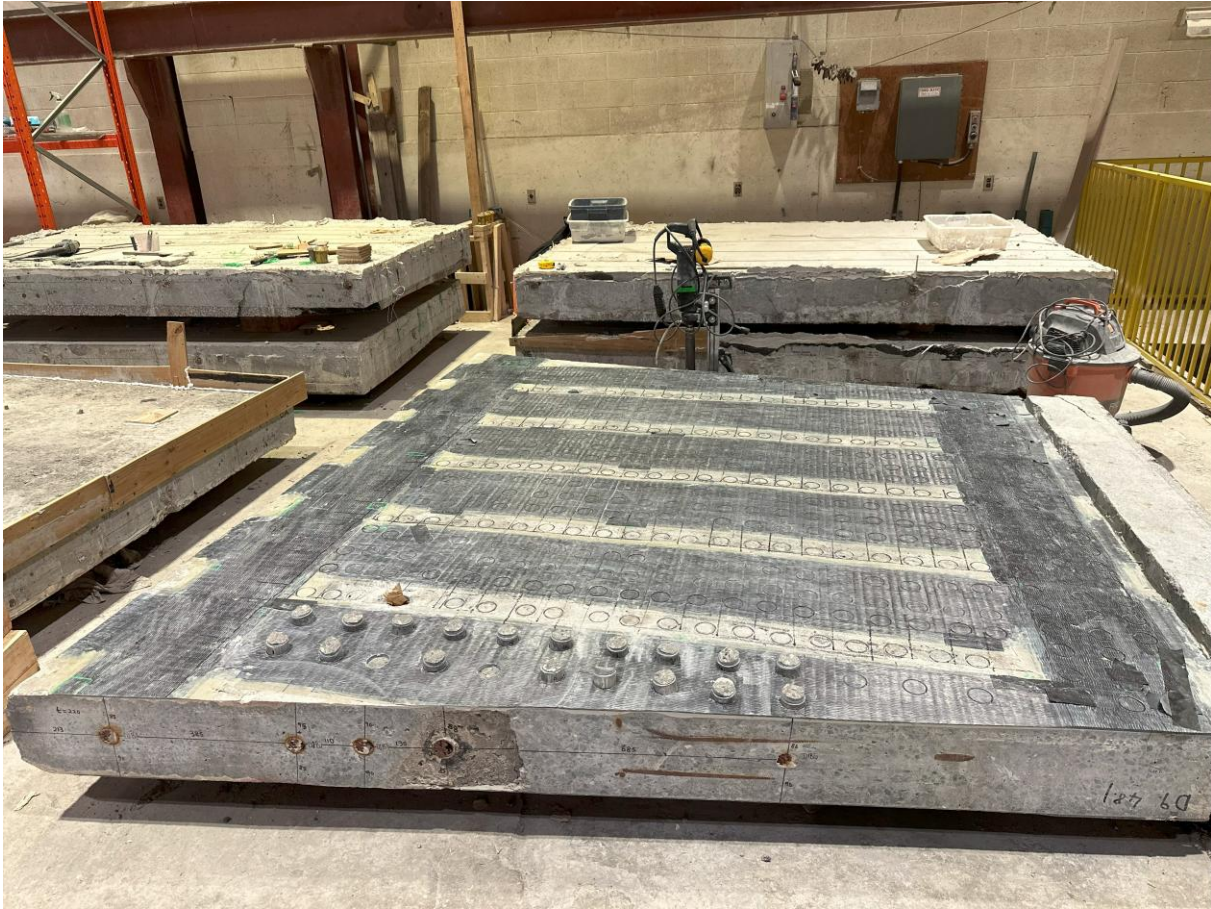
F.0.6-Pull-off specimens extracted from surface 1 of Diaphragm #

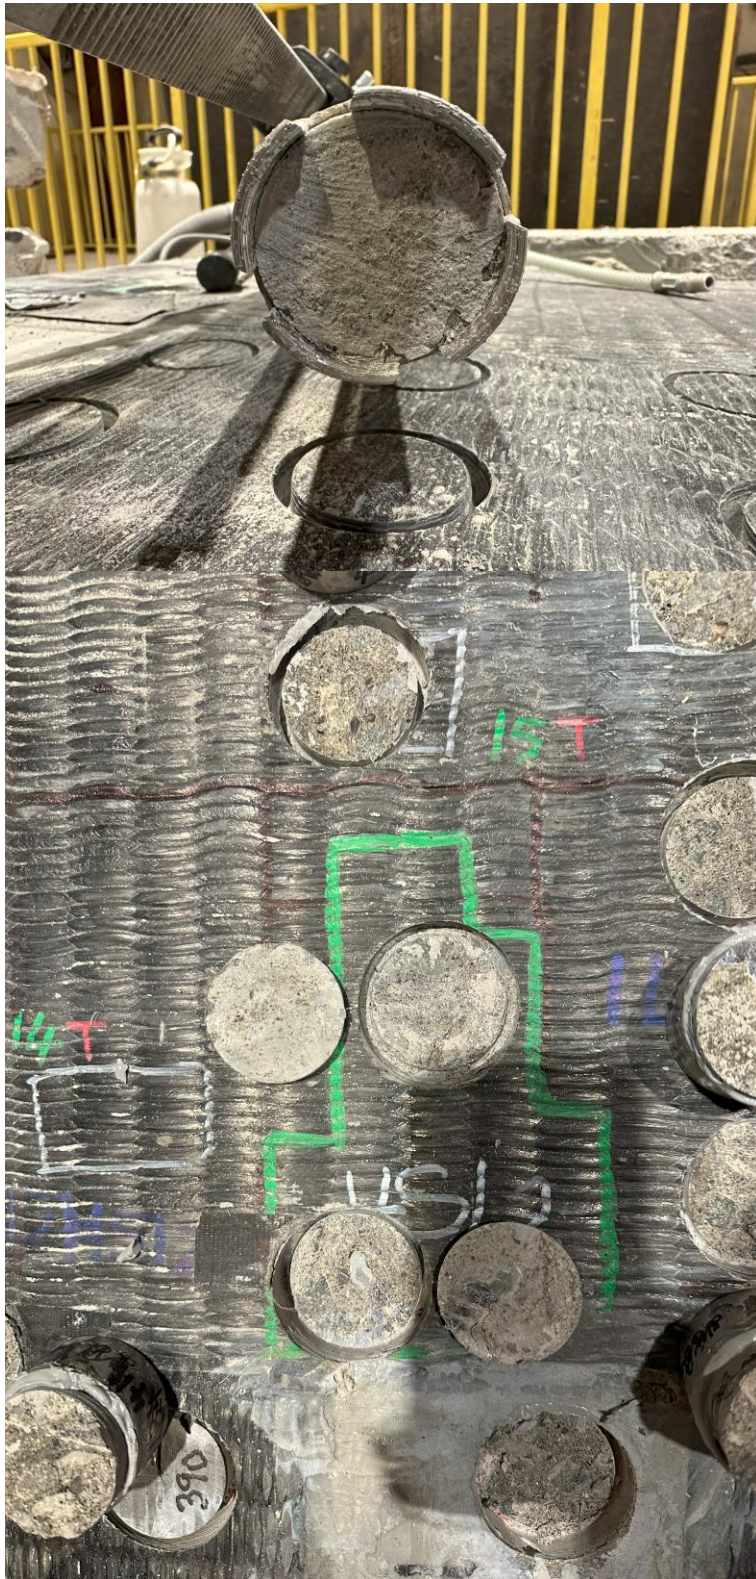
F.0.7-Detachment of defective specimens in the anchorage zone during initial scoring

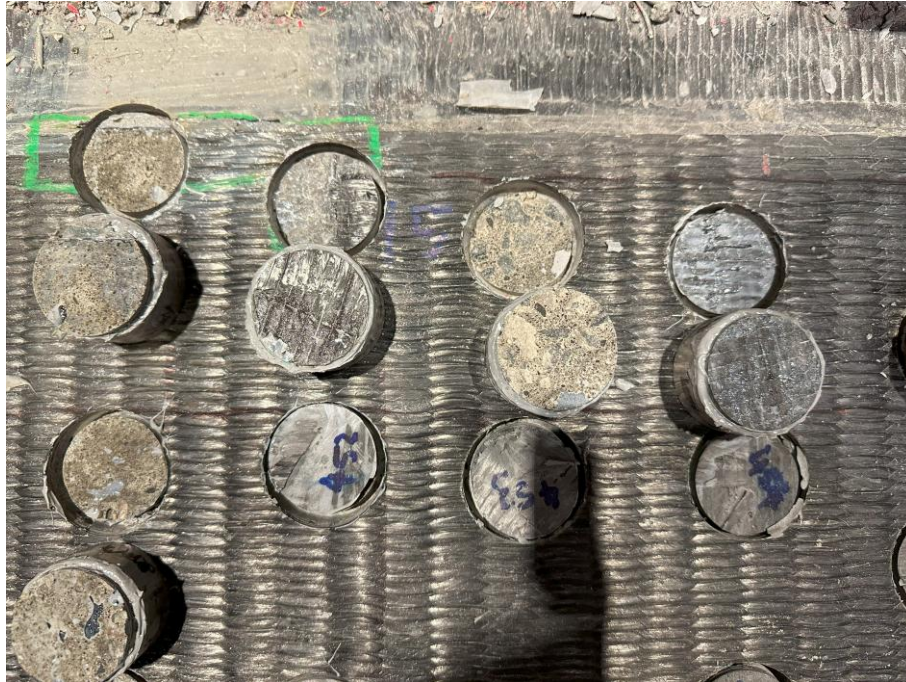
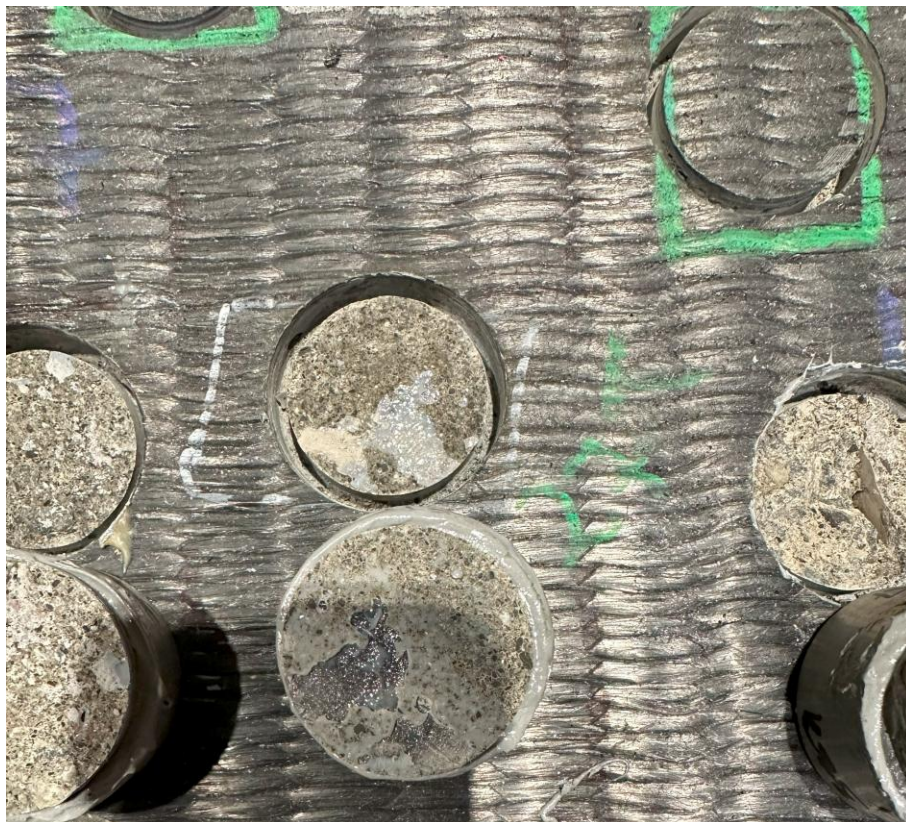
F.0.9-Bond separation between layers in defective pull-off specimens
