**The Impact of Forest Fire on Permafrost Slopes  
Klondike Area, Yukon Territory**

Thesis submitted to the  
Faculty of Graduate and Postdoctoral Studies  
In partial fulfillment of the requirements  
For the MSc degree in Physical Geography

Department of Geography  
University of Ottawa

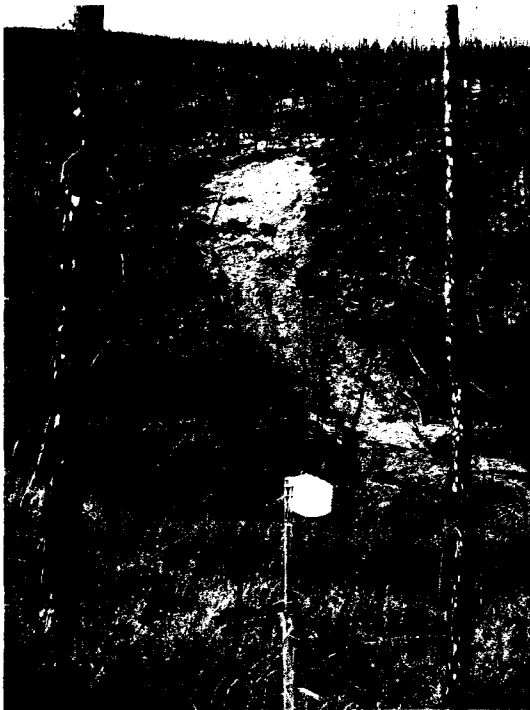
Figure 4.8: West-Facing Burned Site. June 3, 2006.

The west-facing burned site was located directly across Steele Creek from the east-facing site. Monitoring equipment was installed 20 m upslope from the creek on a 10° slope with an aspect of approximately 310° (Figure 4.8). Vegetation consisted of burned black spruce 5-10 m in height. The area had been severely burned, although there was 5-10 cm of burned organic material remaining on the surface. The remains were found downslope of a Klondike (circa 1898) dump consisting of corroded food and kerosene cans. The soil substrate consisted of sandy gravel. Permafrost was present at this site.

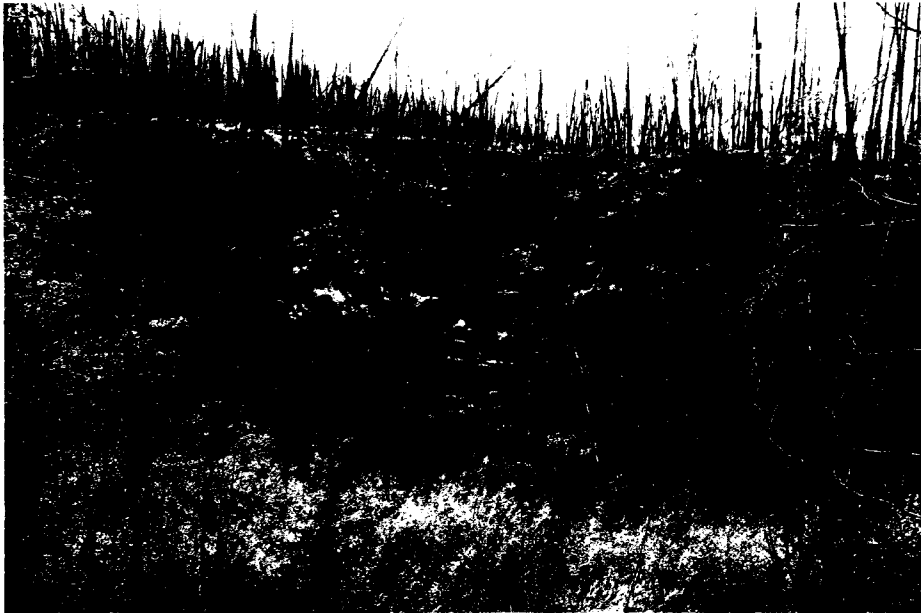
Figure 5.12: View of SC 40B. From across the valley showing displaced masses with standing trees in centre of the slope (August 15, 2005).

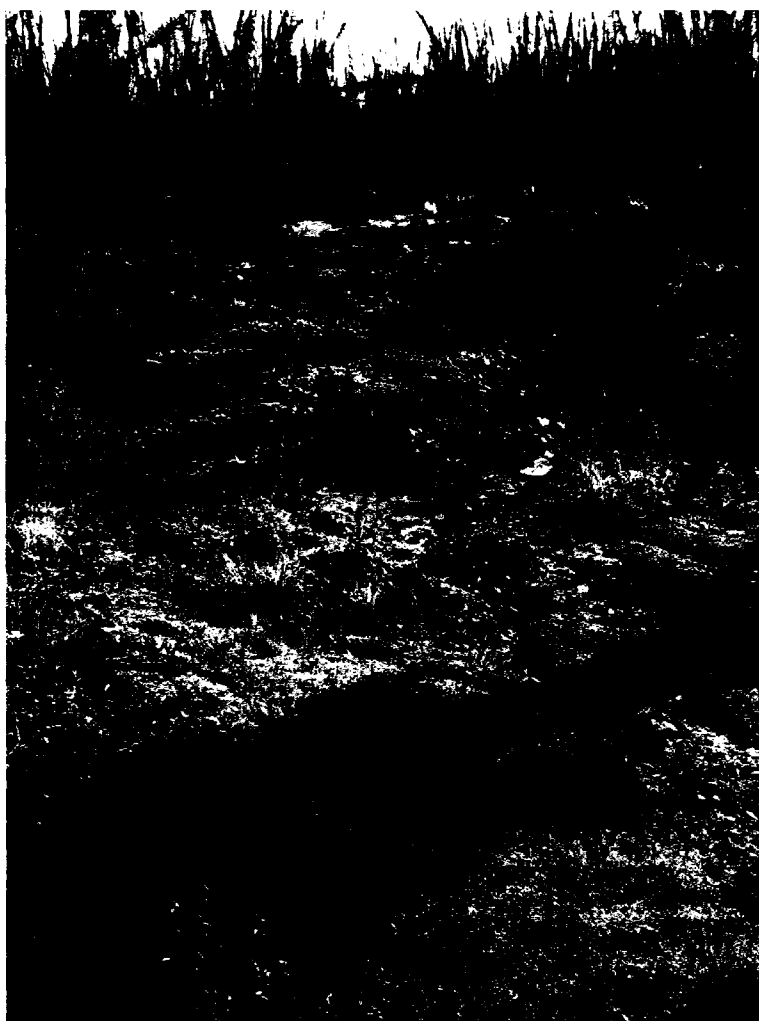
Figure 5.29: Revegetation of Scar Floor. At base of SC 21A August 2006. Note transported sections of the organic mat acting as nuclei for revegetation.

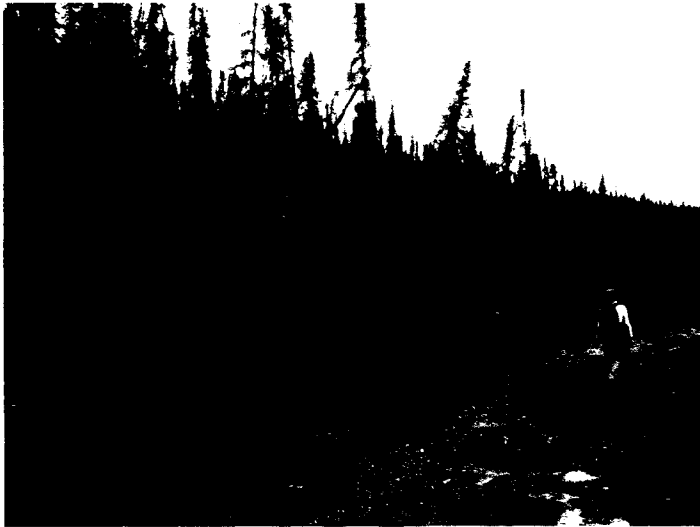
Figure 5.32. Lone Star Road Cut. Excavation approximately 5 m past people.

At the Lone Star Mine in upper Bonanza Creek (63°54'01 N, 139°15'18 W) some 50 km north of Steele Creek three pits were excavated in a road cut across the upper portion of a north-facing slope in association with soil sampling by Jeff Bond of the Yukon Geological Survey (Figure 5.32).

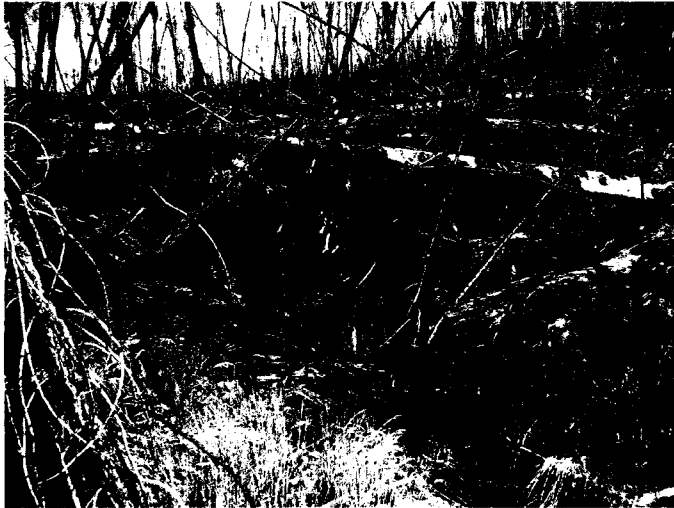
Figure 7.7: Thermokarst Collapse. ~50 m upslope of west-facing thermal logger.

The interpretation of ice-rich soils on the west-facing side of the valley is supported by thermokarst collapse observed along shallow ephemeral stream channels. These features were over 1 m deep and showed evidence of progressive development throughout the summer. Tension cracks developed into block toppling events, and muddy water was observed in the pits later in the summer (Figure 7.7).
