# **Seismic Risk Assessment of Unreinforced Masonry Buildings Using Fuzzy Based Techniques for the Regional Seismic Risk Assessment of Ottawa, Ontario**

By  
Amid El Sabbagh

**Master of Applied Science**

March 2014

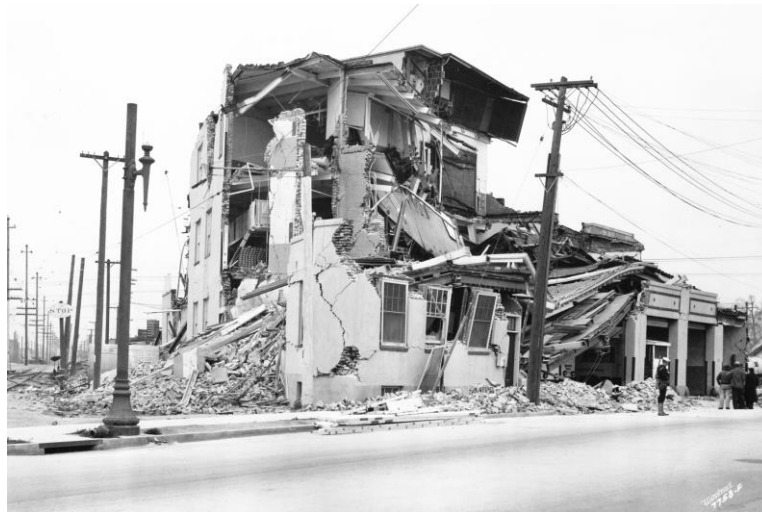
**Figure 1-1: Complete Collapse of a Commercial URM building, Long beach, California 1933**

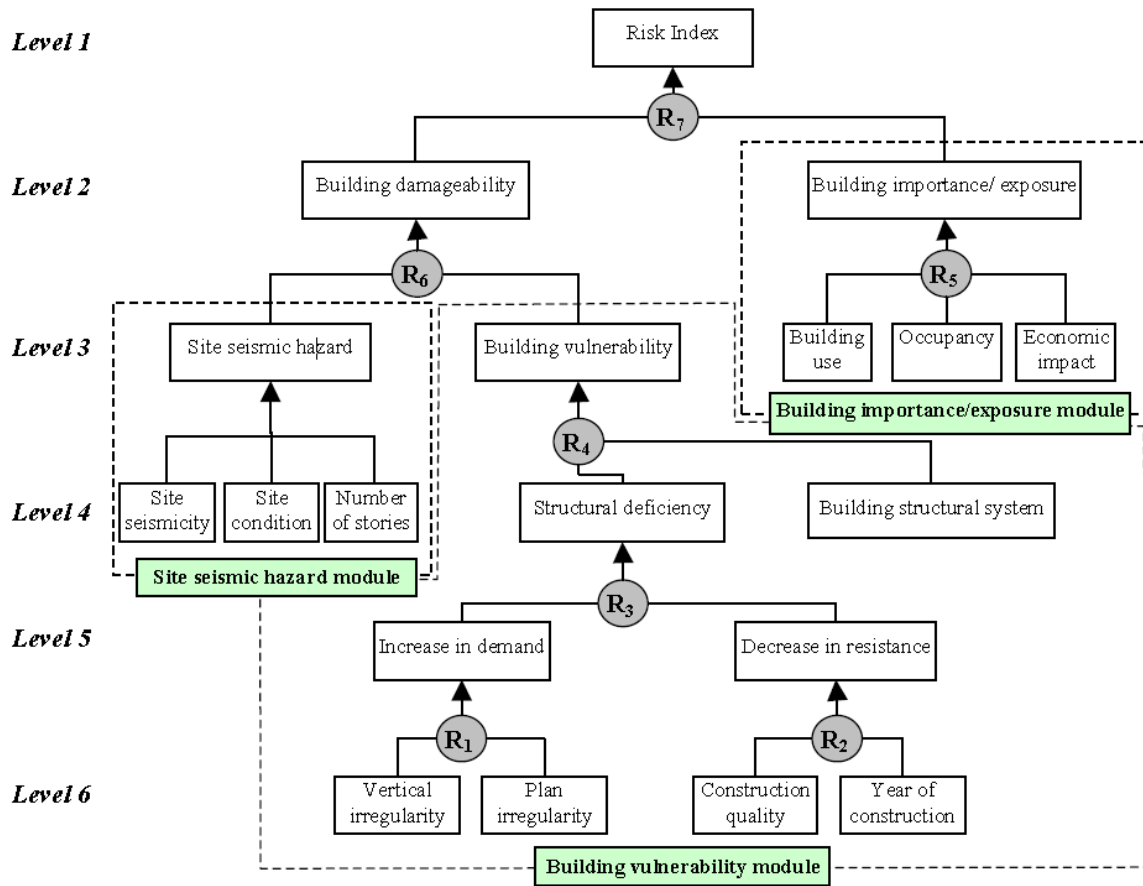
**Figure 2-1: Hierarchical seismic risk analysis of RC buildings**

D – Building Irregularity	Captures any structural irregularity within a building (vertical irregularity, plan irregularity, pounding, etc...) known to produce seismic deficiencies.
E – Building Importance	Occupancy related importance factor which incorporates occupied area, occupancy density and a duration factor. Identifies critical infrastructure, post-disaster buildings and high-occupancy buildings.
F – Non-Structural Hazards	Highlights any hazard related to non-structural elements. Considers objects that are falling hazards to life and damage to vital operations of strategic, post-disaster facilities.

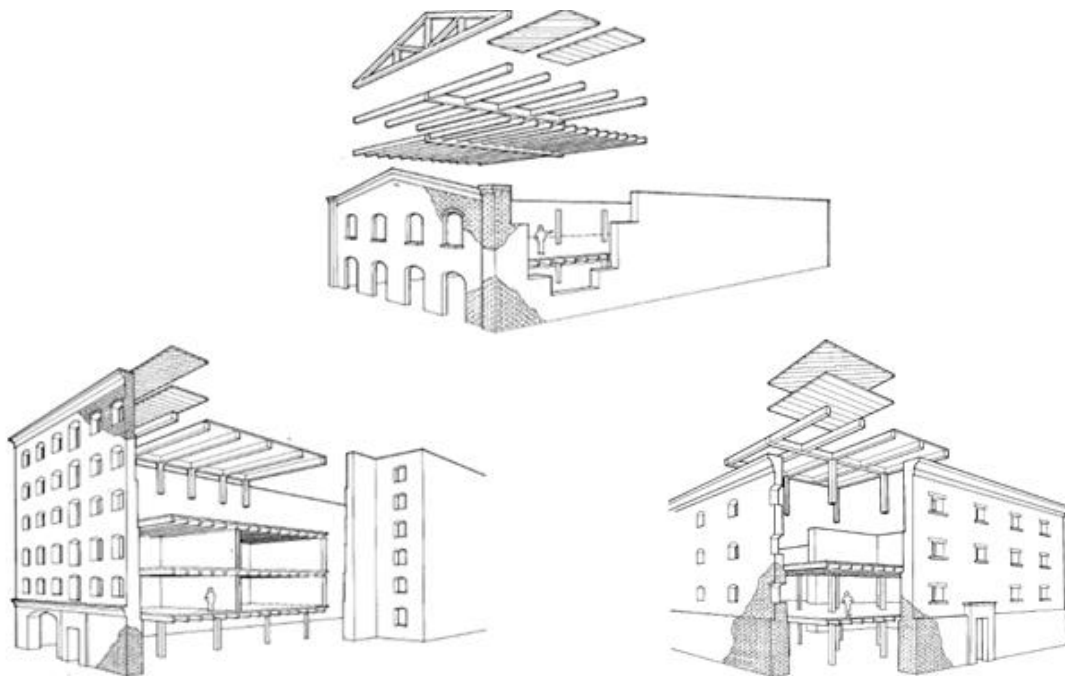
**Figure 2-4: Typical construction of URM bearing-wall buildings in North America**  
(ATC, 2002)

Unreinforced masonry buildings consist of bricks/blocks bonded together by mortar that make up the structure. URM buildings are “unreinforced” with the implication that reinforcing steel bars are not embedded within the cells of the units in comparison to more modern reinforced masonry buildings. The most common unit type is solid clay-brick, but other types of masonry units exist (concrete block and adobe). These buildings are commonly used for commercial, residential or industrial purposes, built with no greater than six stories. URM buildings are usually load-bearing wall structures (see Figure 2-4) that transfer gravity loads to the foundation of the building (ATC, 2002).

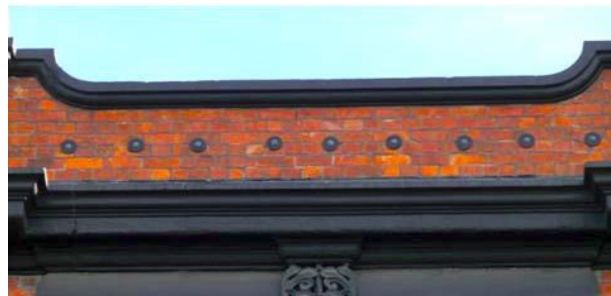
**Figure 2-8: Example of through ties connecting the roof diaphragm to load-bearing wall**  
(Ingham and Griffith, 2011a)

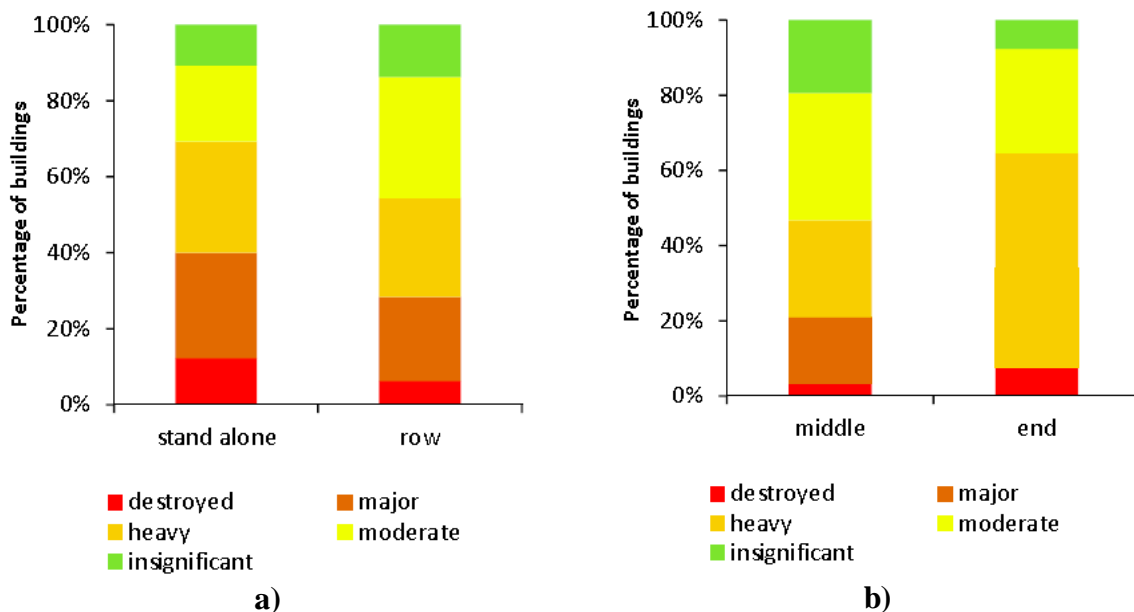
Figure 2-10: ATC-13 Damage Classification for: a) stand-alone and row URM buildings, b) position in row URM buildings

Although typology is not directly a seismic deficiency, results from post-earthquake assessments of existing URM structures demonstrate the relationship between the level of damage and a building's typology. As seen in Figure 2-10a, constructing multiple URM buildings in a row provides additional resistance to ground motion when compared to the performance of URM stand-alone buildings. This is likely due to the presence of additional load-bearing walls behaving as shear walls between buildings. In addition, Figure 2-10b shows that URM buildings positioned in the middle of a row are considered to be somewhat protected by the end-of-row URM buildings (known as “bookend behaviour”) (Ingham and Griffith, 2011b).

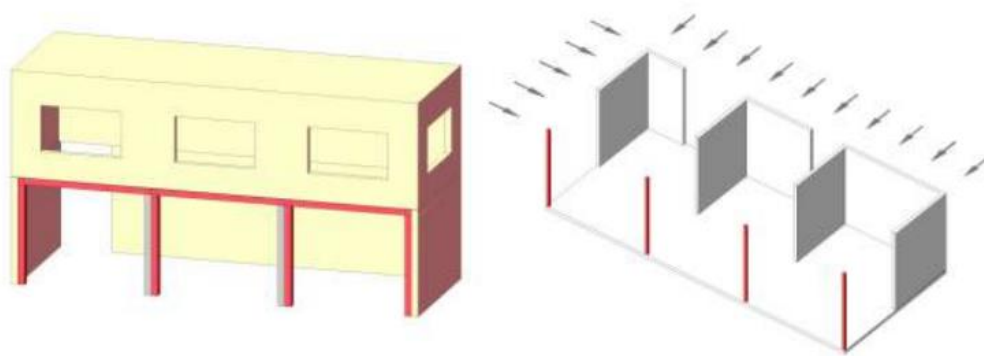
**Figure 2-11: Typical Soft Story in a URM building**

In order to increase the openness at the ground level of a URM building, often the structural elements are not continued to the foundation creating a soft/weak story in the building (ATC, 1998; Bruneau, 1994a). This type of irregularity is most commonly found in URM buildings operating as retail stores that contain open street façade fronts at the ground level parallel to the direction of the street as illustrated in Figure 2-11. Since the concentration of loads is greatest at the base of a building, a soft or weak story between the first and second floor results in a serious deficiency. A weak story results in inadequate strength when compared to stories above and can often result in failure of that story. In a soft story, the level in question has reduced stiffness or more flexibility when compared to the story above. A soft story can result if the first floor height is significantly taller than those above causing a large discrepancy in stiffness. Similarly, an open first floor that supports heavy structural or non-structural walls above can represent a special case of a soft and weak story problem (EERI, 2006).

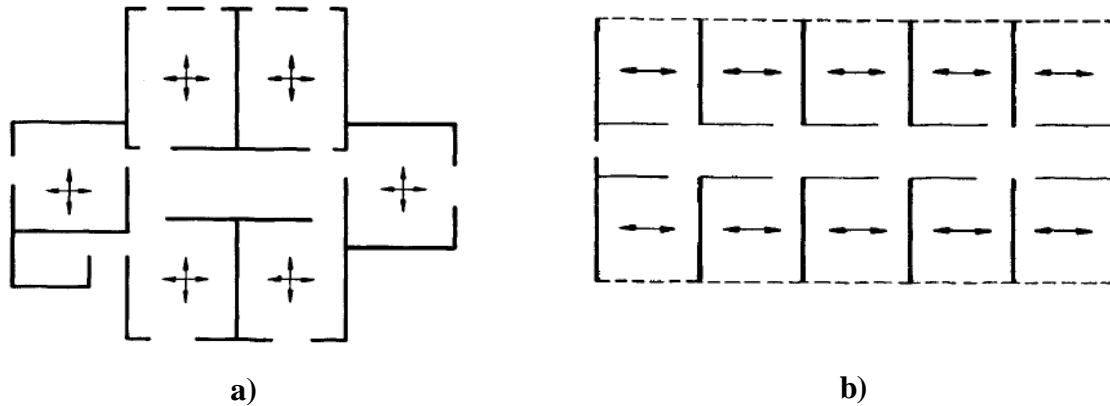
Figure 2-13: Typical wall arrangements in URM buildings: a) Two-way spanning, evenly distributed wall arrangement, b) One-way spanning, simple cross-wall structure

Torsional effects result in a lack of balance between the elements of the SFRS and the overall arrangement of the building mass. The location of walls built to form the overall structure influence the eccentricity between the center of mass and the center of resistance. A large eccentricity can result in undesirable concentrations of stress and torsion causing twisting action in the building. A reasonable balance between the distributions of walls in the principal directions of the building is essential in order to provide adequate resistance to lateral forces in both directions as illustrated in Figure 2-13a. URM buildings with square or rectangular configurations with well distributed walls will generally have a greater torsional resistance than buildings with less evenly distributed lateral force resisting walls or buildings with walls only distributed in one principal direction as seen in Figure 2-13b (Ingham and Griffith, 2011a; Hendry et al., 1997). In addition, URM buildings located at the corner of an intersecting street often with asymmetrical wall arrangements and plan configurations may exhibit a large torsional response due to a large eccentricity.

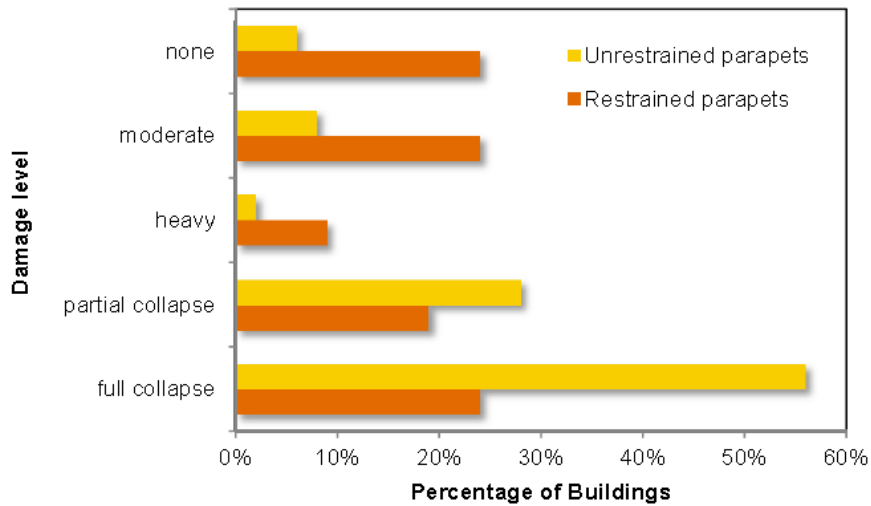
**Figure 2-14: Performance of unrestrained and restrained parapets**

Non-structural elements in a URM building pose a major falling hazard to passers-by. These elements often project above and beyond the building roof such as parapets and chimneys. As Figure 2-14 demonstrates for URM parapets of 238 buildings in the 2011 Christchurch earthquake, non-structural elements behave poorly if inadequately anchored/restrained to the overall structure which consequently fail out-of-plane in a brittle, flexural manner when subject to lateral force (FEMA, 2006; Ingham and Griffith, 2011b). In order to diminish the risk of damage or injury these URM elements are properly braced or completely removed from the structure as often they only serve architectural/decorative purposes. Failure of non-structural elements can result from excessive seismic accelerations which cause connection failures between the non-structural elements and the structure; the vulnerability of non-structural elements include cracking, spalling and pounding against adjacent buildings and can lead to localized falling hazards (ATC, 2011; FEMA, 2006).

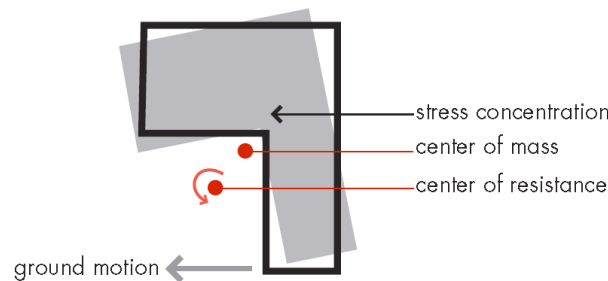
**Figure 2-15: Re-entrant corner plan configuration**  
(EERI, 2006)

Irregular plan configurations of a building, such as L, H or U shaped configurations, where different wings may oscillate out-of-phase may result in major shear stresses in diaphragms. This deficiency is known as a re-entrant corner irregularity (EERI, 2006). The re-entrant corner is a major irregularity problem found in older URM buildings (ATC, 2002). Large demands at the setback of a building tend to pull apart the diaphragms at the corners conditions. The longer and larger the wings are, the higher torsion and stress concentration. The variations in rigidity between the wings cause differential motion between the two parts of the building, resulting in torsional effects and stress concentrations as seen in Figure 2-15.

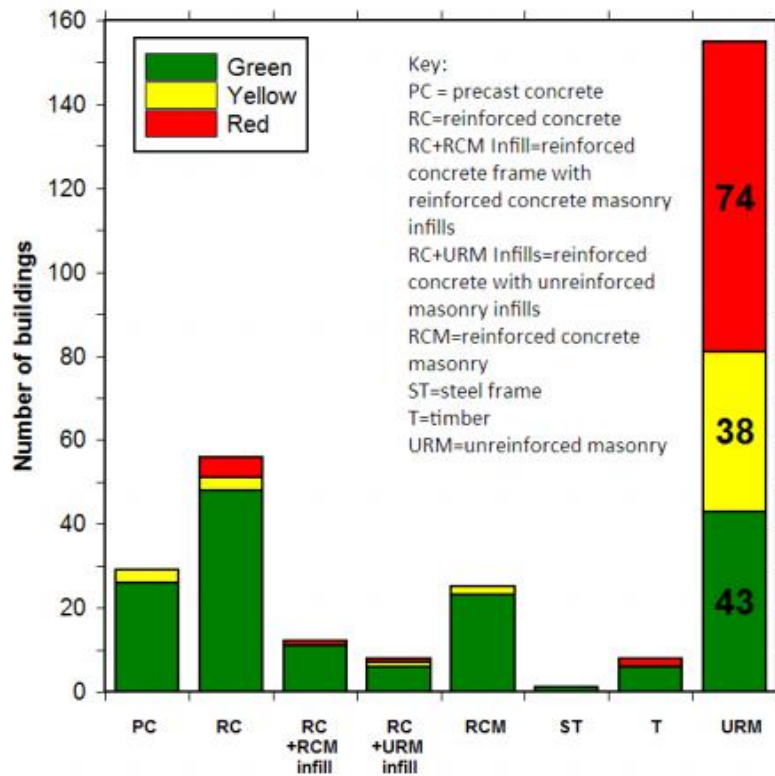
**Figure 2-16: Summary of Building Observations in the 2011 Christchurch Earthquake**

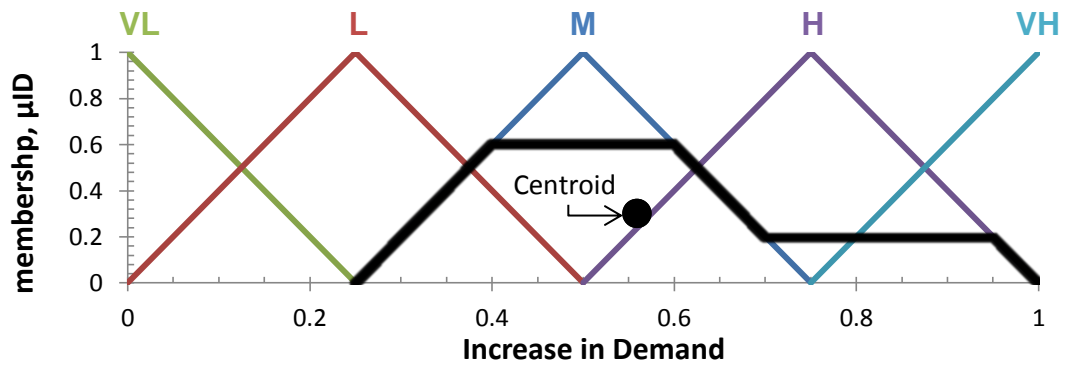
**Figure 3-4: Center of Area Calculation for Increase in Demand from resulting VI and PI Input variables.**

Continuing the example conducted using the Mamdani type inference engine, the resultant fuzzy values for the increase in demand (ID) are ( $\mu_{VL}^{ID} = 0.00$ ,  $\mu_L^{ID} = 0.00$ ,  $\mu_M^{ID} = 0.60$ ,  $\mu_H^{ID} = 0.20$ ,  $\mu_{VH}^{ID} = 0.00$ ) as depicted in Table 3-2. Thus, the resultant shape of the fuzzified values for the ID is outlined in Figure 3-4.

Therefore, the increase in demand of the evaluation has a value of 0.56 as represented in Figure 3-4, where the value of the ID will be continued in the hierarchical evaluation process.

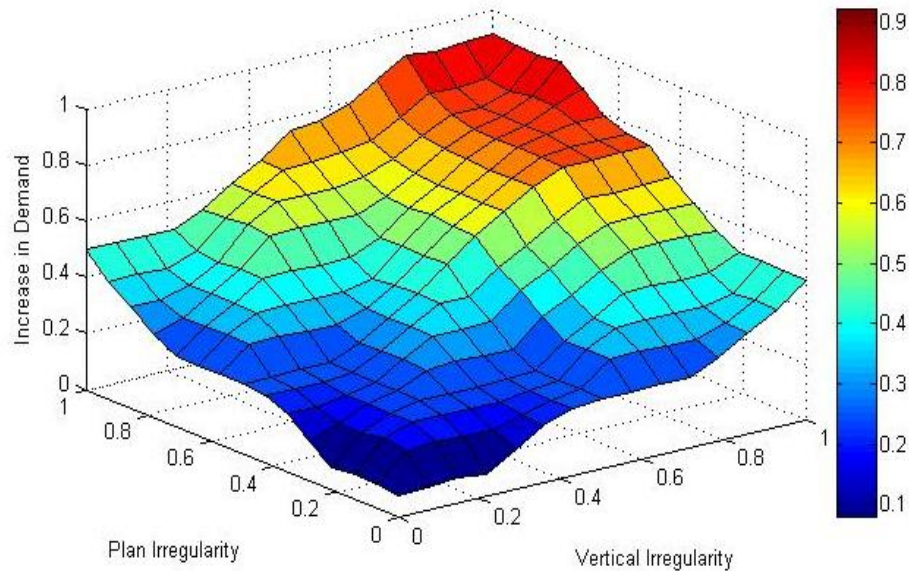
**Figure 3-5: 3D Surface for the Increase in Demand Evaluation of a Building**

A 3D surface can be generated for the above fuzzy mathematical procedure in order to visualize the variation of an output value from two input values. Figure 3-5 illustrates the 3D surface for the evaluation of the increase in demand (ID) of a structure.

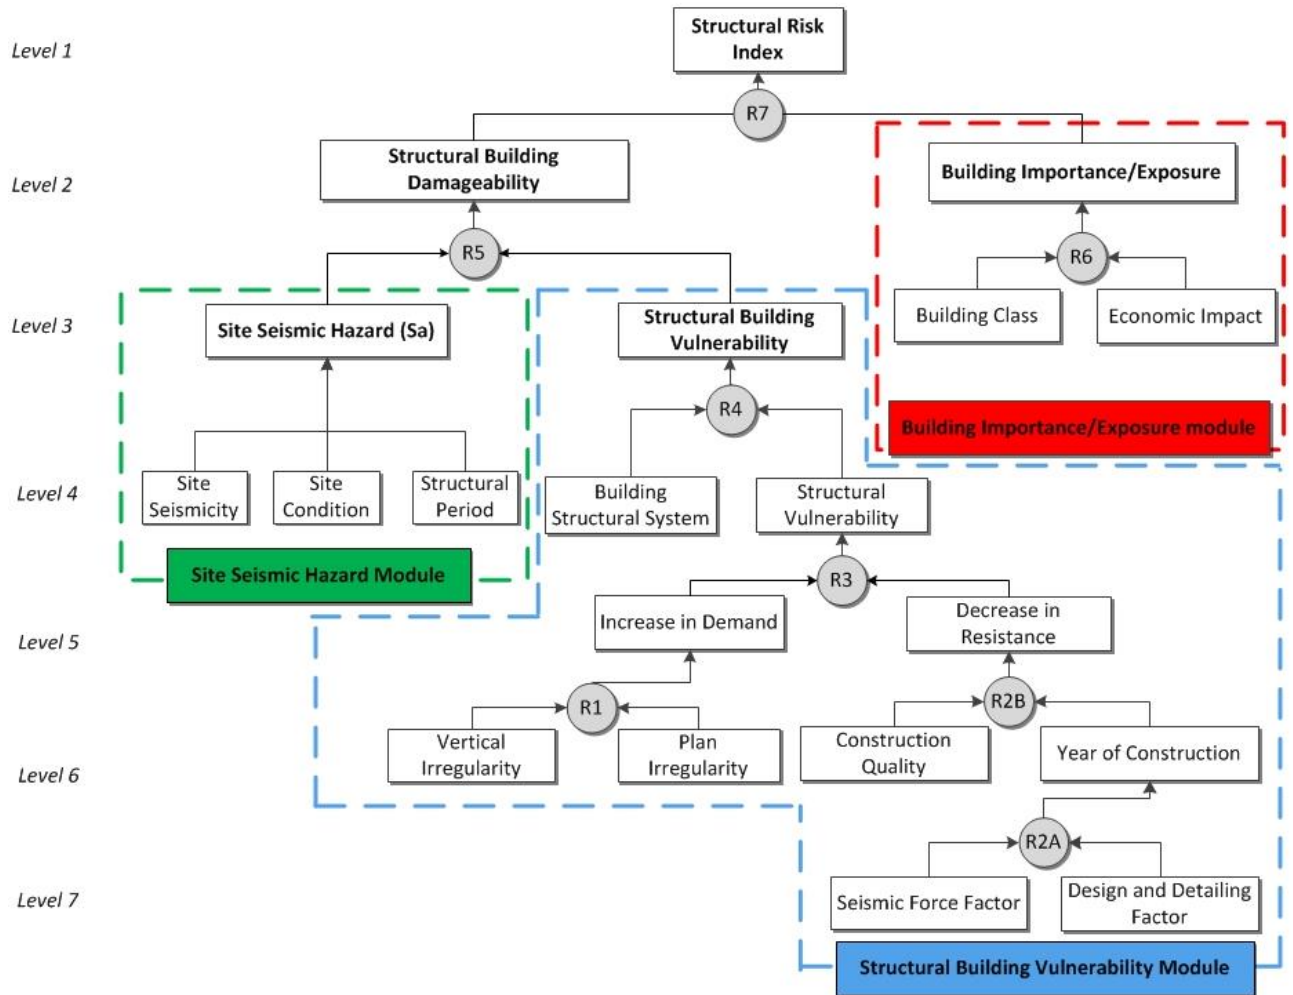
Figure 3-6: Hierarchical Structural Seismic Risk Analysis of URM/RC Buildings

As mentioned previously, fuzzy logic deals with mathematical modeling of vague concepts such as evaluating seismic risk. The complex problem of risk-based inspection is handled through a simple manageable hierarchical structure as illustrated in Figure 3-6 and Figure 3-7. Each pair of parameters are evaluated using the fuzzy synthetic evaluation (FSE) outlined in Section 3.3 where membership functions are established for each parameter and a rule base is created for the combination of parameters. The hierarchy follows a logical order where the casual relationship for each supporting argument is further subdivided into specific contributors (Tesfamariam, 2008). The hierarchy incorporates three main modules in order to quantify seismic risk: site seismic hazard, building vulnerability (structural and non-structural) and building importance. The building vulnerability contains two new different module types in comparison to the original CanRisk hierarchy for concrete structures as illustrated in Figure 2-1 . The first for the hierarchical structural seismic risk analysis as seen in Figure 3-6 and the second hierarchy representing the non-structural seismic risk analysis as shown in Figure 3-7.

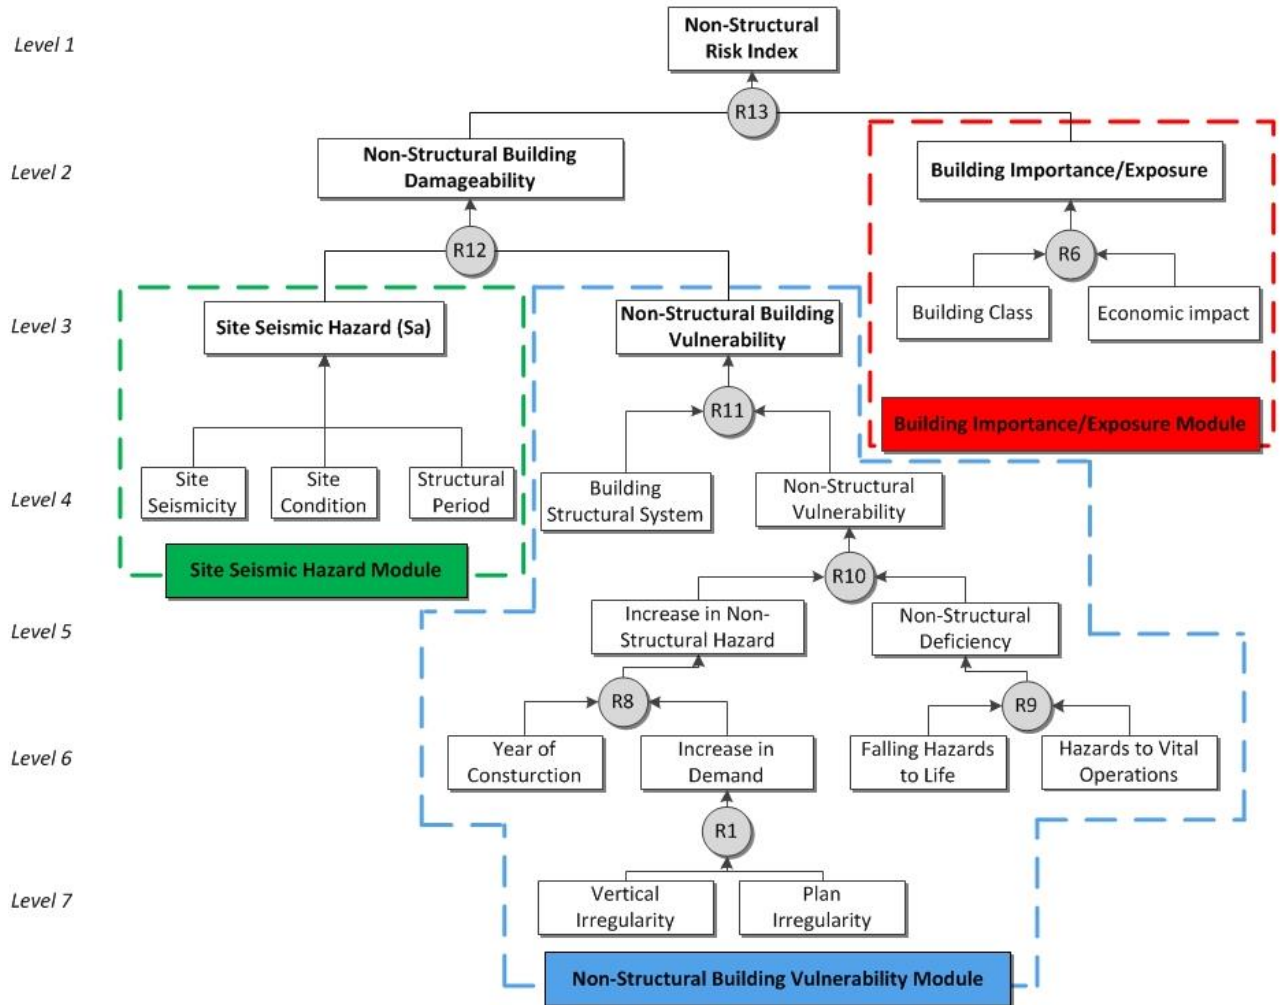
**Figure 3-7: Hierarchical Non-structural Seismic Risk Analysis of URM/RC Buildings**

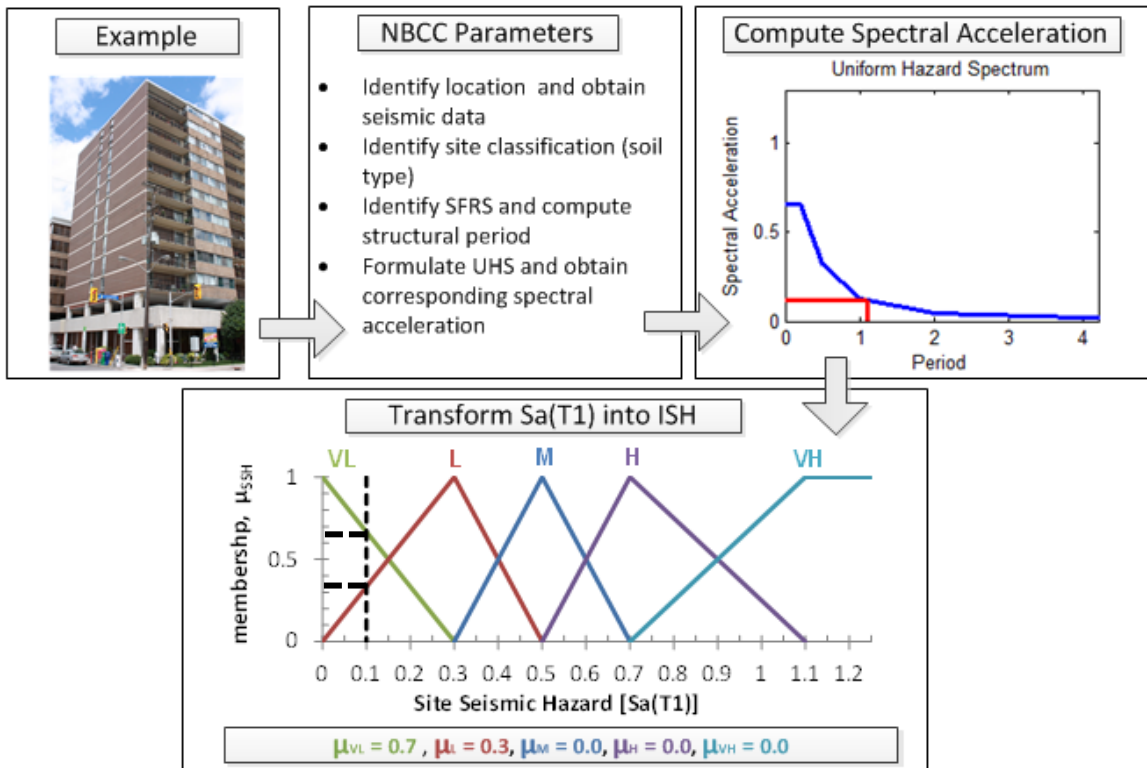
Figure 3-8: Fuzzification Process of Site Seismic Hazard using Spectral Acceleration

Site seismic hazard pertains to the ground motions generated due to earthquakes and the affects they pose on existing built infrastructure. One way of establishing site seismic hazard is to adopt design spectra specified in buildings codes established based on seismic hazard values. In Canada, the design level of earthquake is expressed in terms of the Uniform Hazard Spectra (UHS) defined in the 2010 edition of the NBCC with 2% probability of exceedance in 50 years. The UHS is determined directly as a function of geographical location and site condition and is defined by intervals of structural periods calculated at the same probability of exceedance (Heidebrecht, 2003). In order to formulate the UHS of a specific building, three main parameters are considered, consisting of site seismicity, site condition and the fundamental period of vibration of a structure. The overall fuzzification process of a building's spectral acceleration is briefly summarized in Figure 3-8.

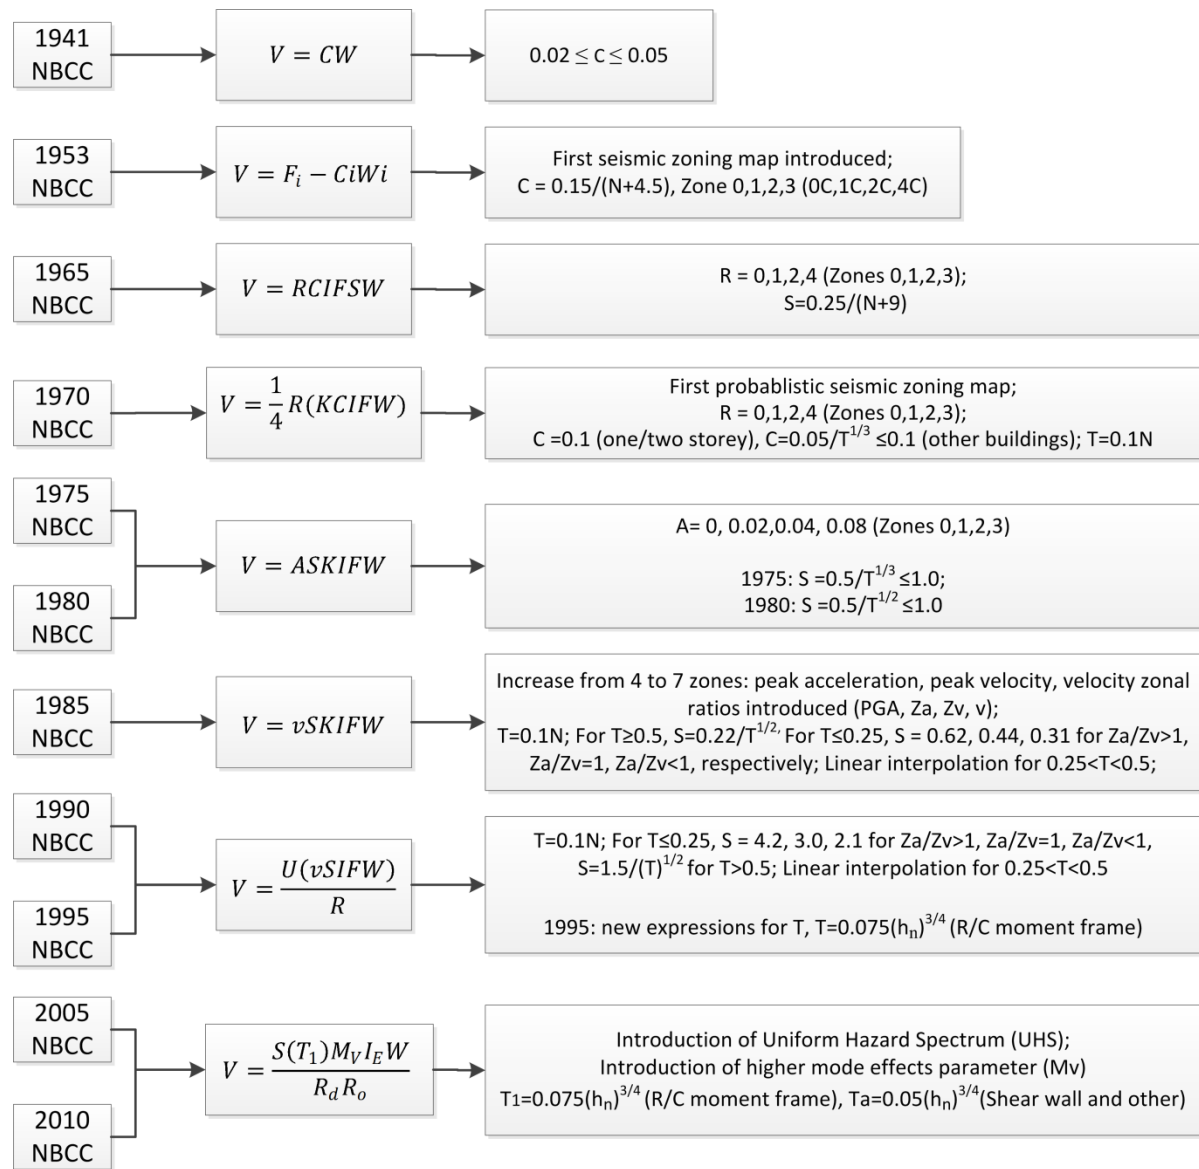
**Figure 3-9: Historical Development of Base Shear Equation of the NBCC**

In addition to introducing the effect of seismicity of the region, a set of cut-off values are also assigned to the Seismic Force Factor to control its sensitivity to the base shear ratio. The cut-off values, shown in Table 3-9, are introduced using the seismicity ranges used in Table 4.1.8.9 of the 2010 NBCC based on spectral accelerations at 0.2 sec.

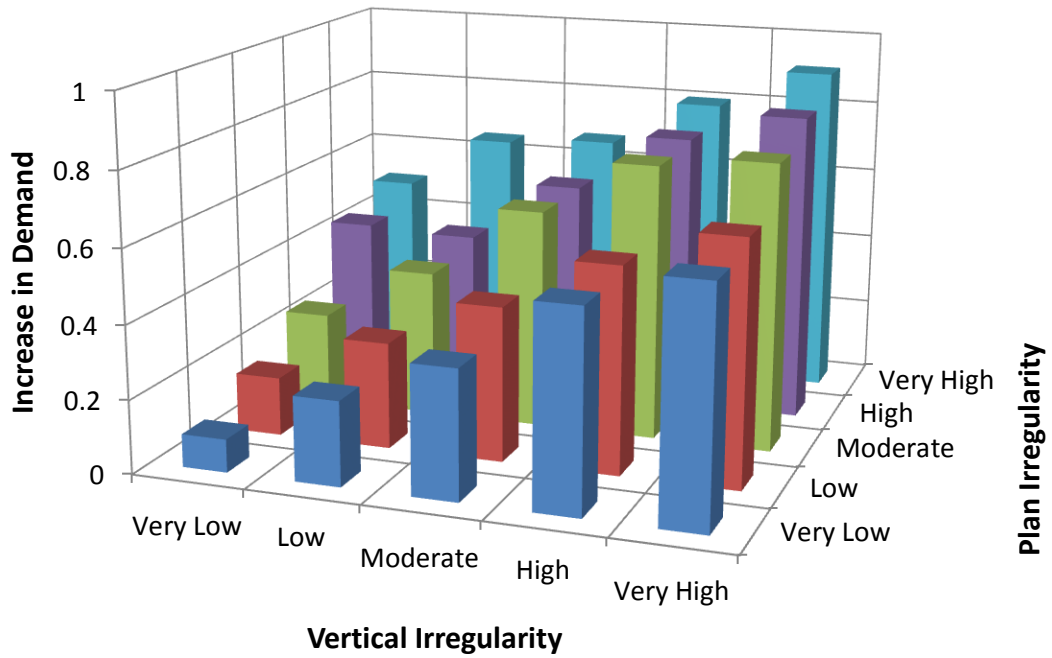
Figure 4-1: Increase in Demand of a Building

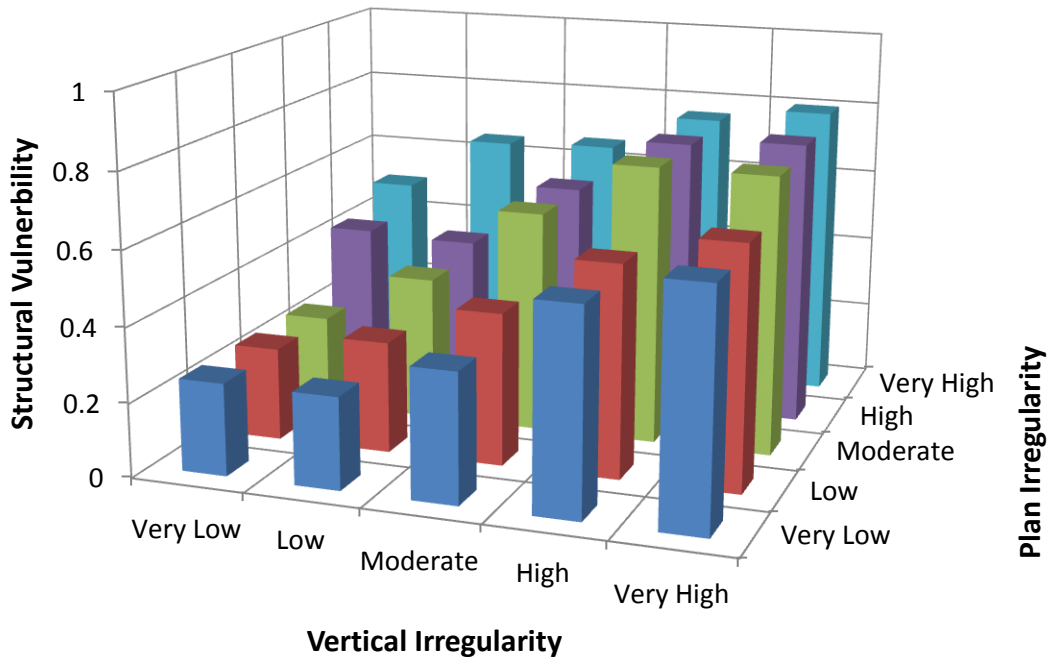
Figure 4-2: Structural Vulnerability of a Building built prior to 1940 with poor construction quality

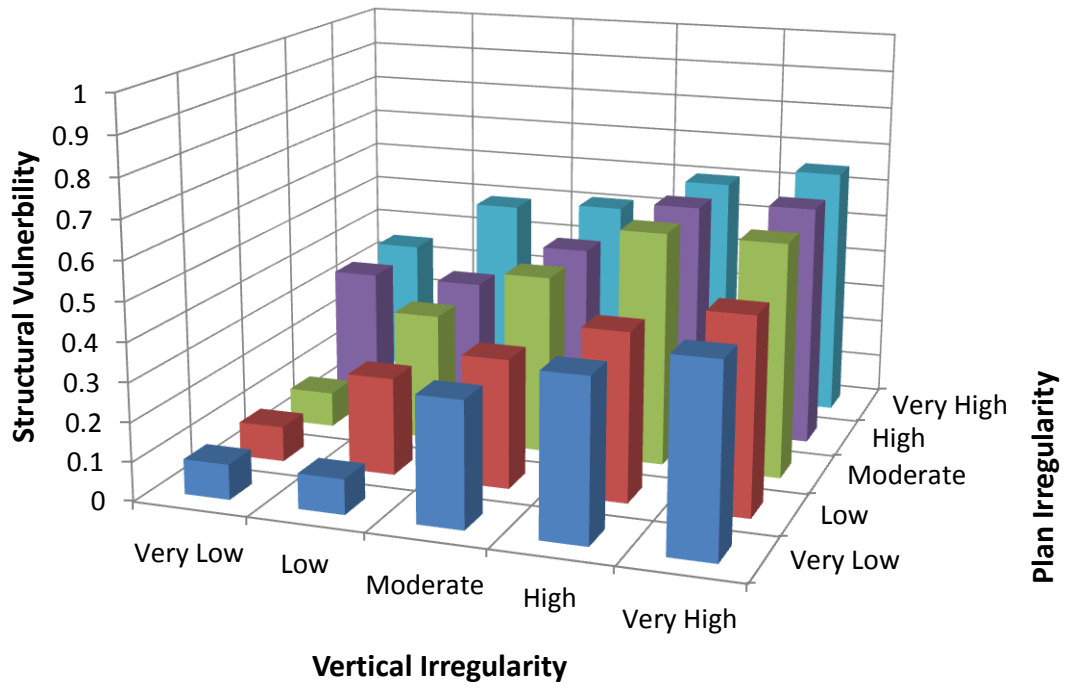
Figure 4-3: Structural Vulnerability of a Building built in 2010 with good construction quality

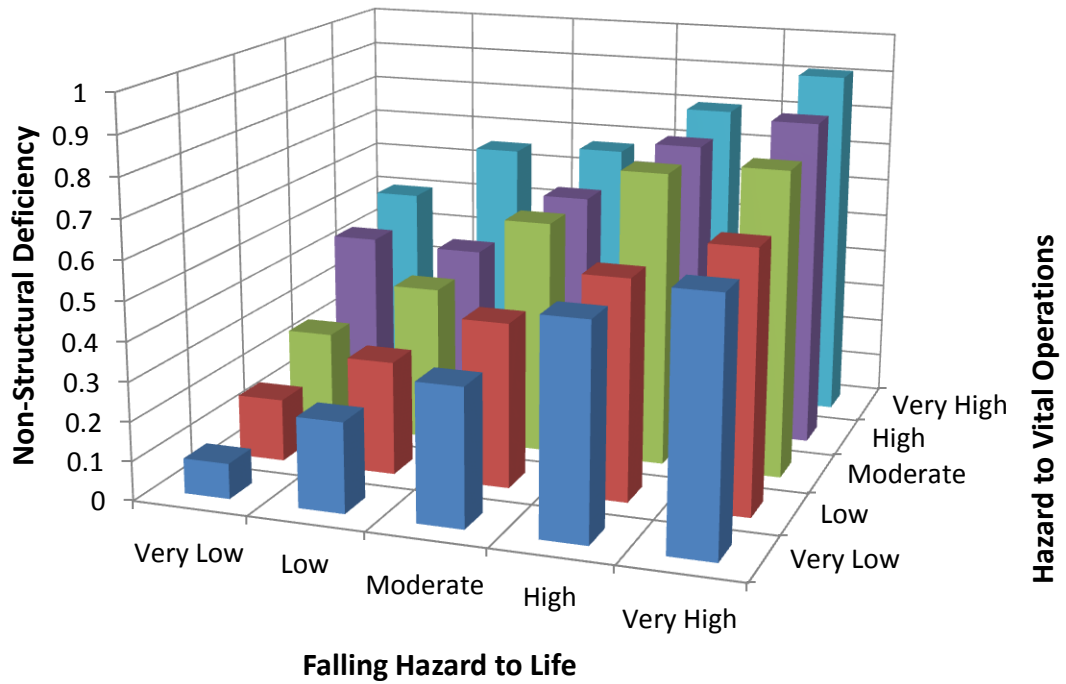
Figure 4-4: Non-structural deficiency of a Building

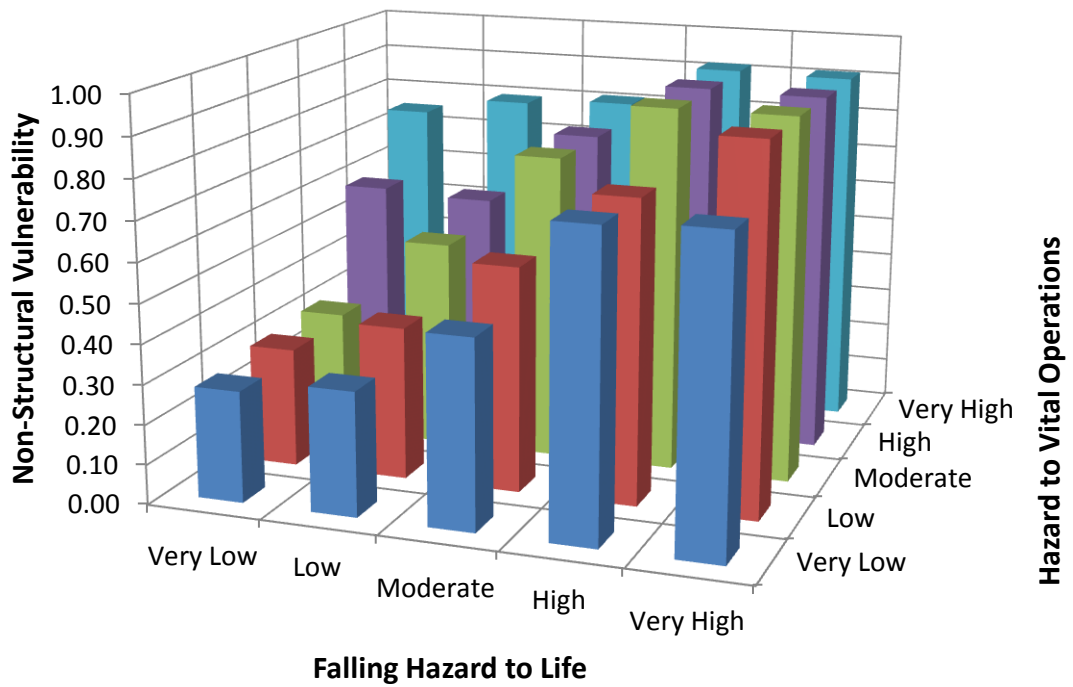
Figure 4-5: Non-Structural Vulnerability of a Building built prior to 1970 with very high ID

1970 with very high *increase in demand* result in larger *non-structural vulnerability* values when compared with buildings built in 2010 with very low *increase in demand*.

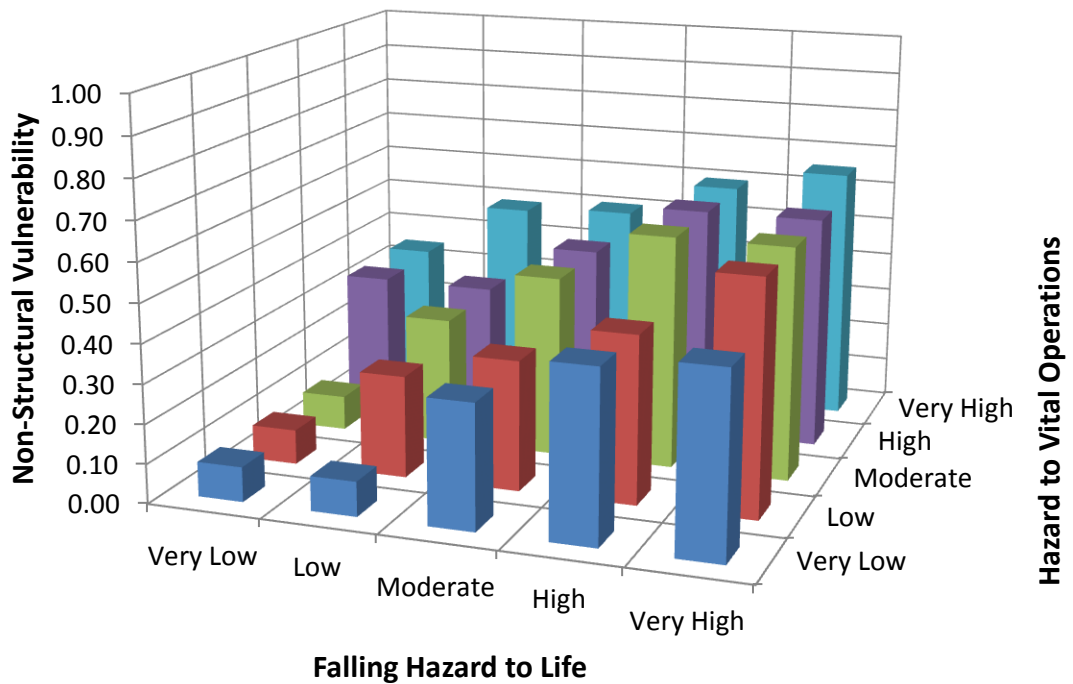
Figure 4-6: Non-Structural Vulnerability of a Building built in 2010 with very low ID

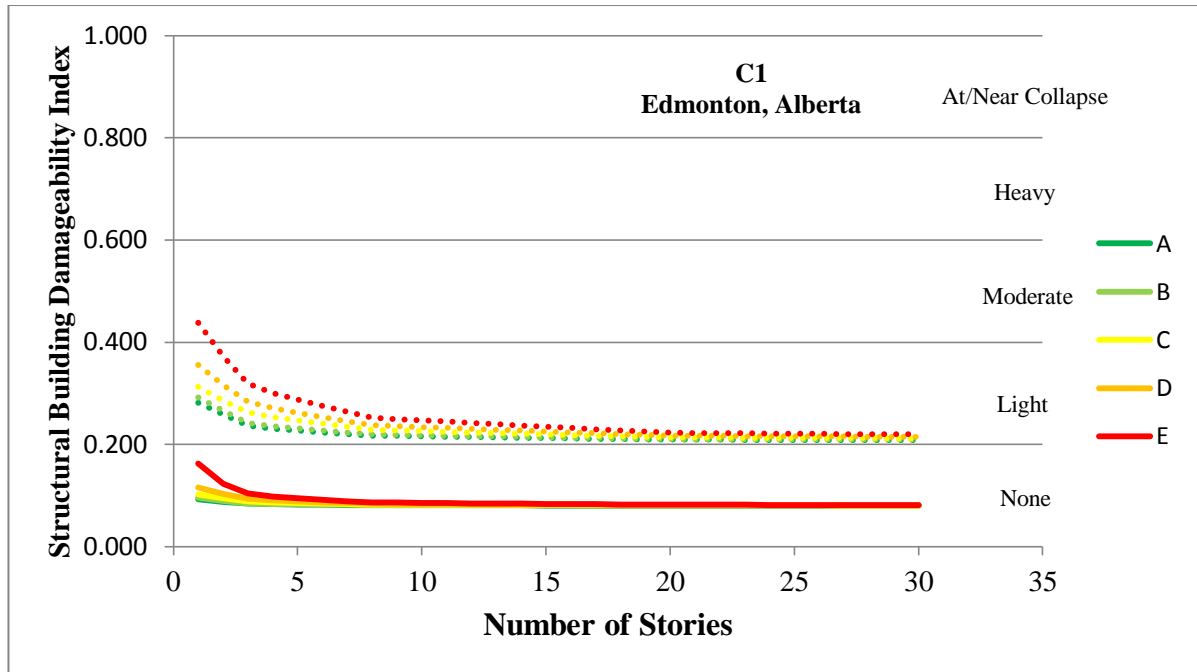
Figure 4-7: Upper and lower bound limits of  $I_S^{BD}$  for C1 structures resting on various soil conditions in Edmonton, Alberta

Overall, the sensitivity of *structural building damageability index* ( $I_S^{BD}$ ) illustrates the poor performance of buildings on softer soil profiles, in comparison with buildings on hard rock soil profiles. In addition, C1 and C2 buildings perform generally the best, followed by C3 buildings. It is evident that URM buildings perform the poorest among the structural types considered. Finally, URM stand-alone buildings perform generally poor in comparison to URM buildings in a row configuration.

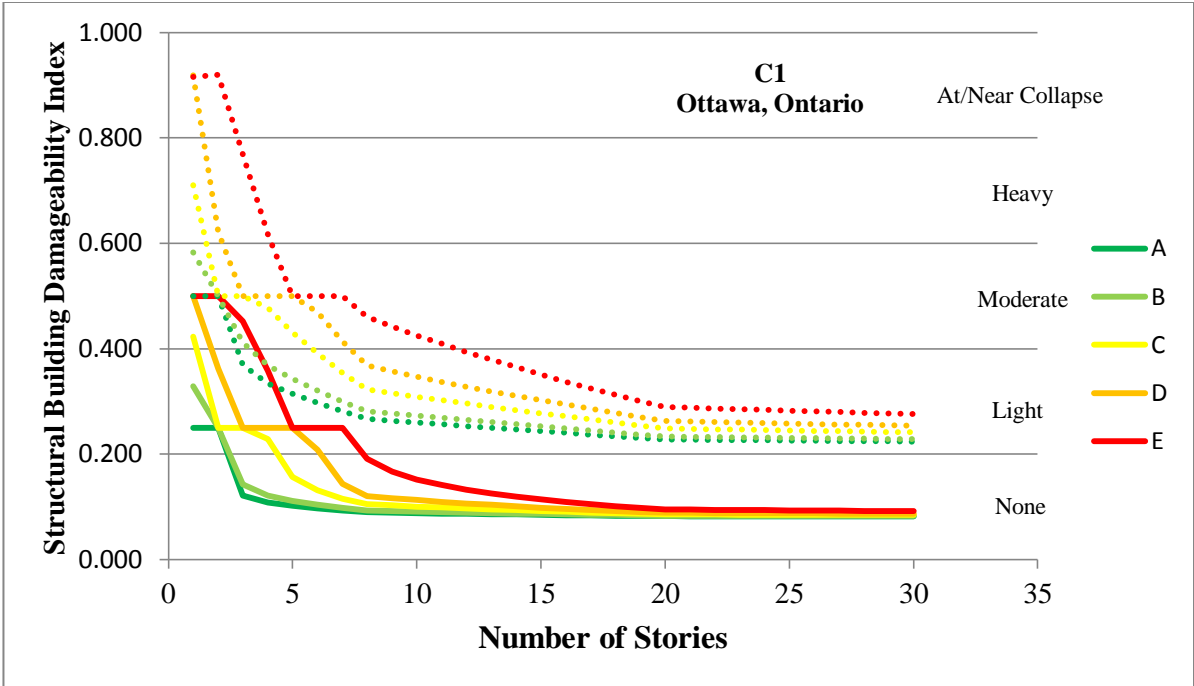
**Figure 4-8: Upper and Lower Bound Limits of Building Damageability for C1 Structures resting on various soil conditions in Ottawa, Ontario**

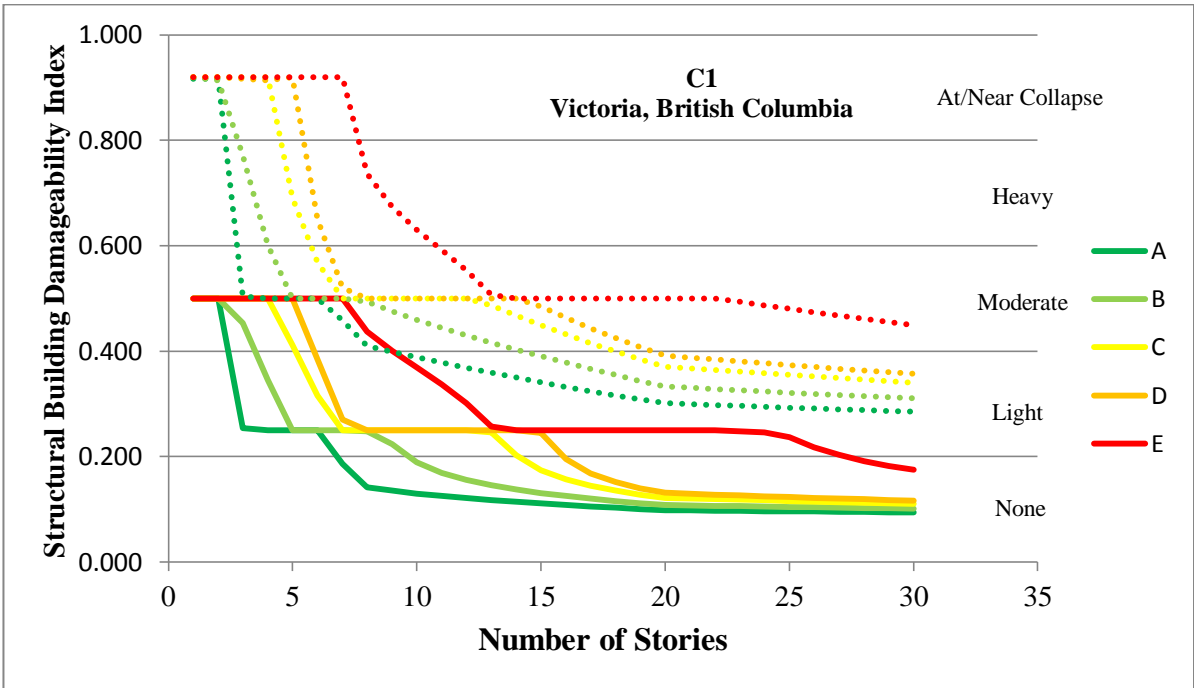
**Figure 4-9: Upper and Lower Bound Limits of Building Damageability for C1 Structures resting on various soil conditions in Victoria, British Columbia**

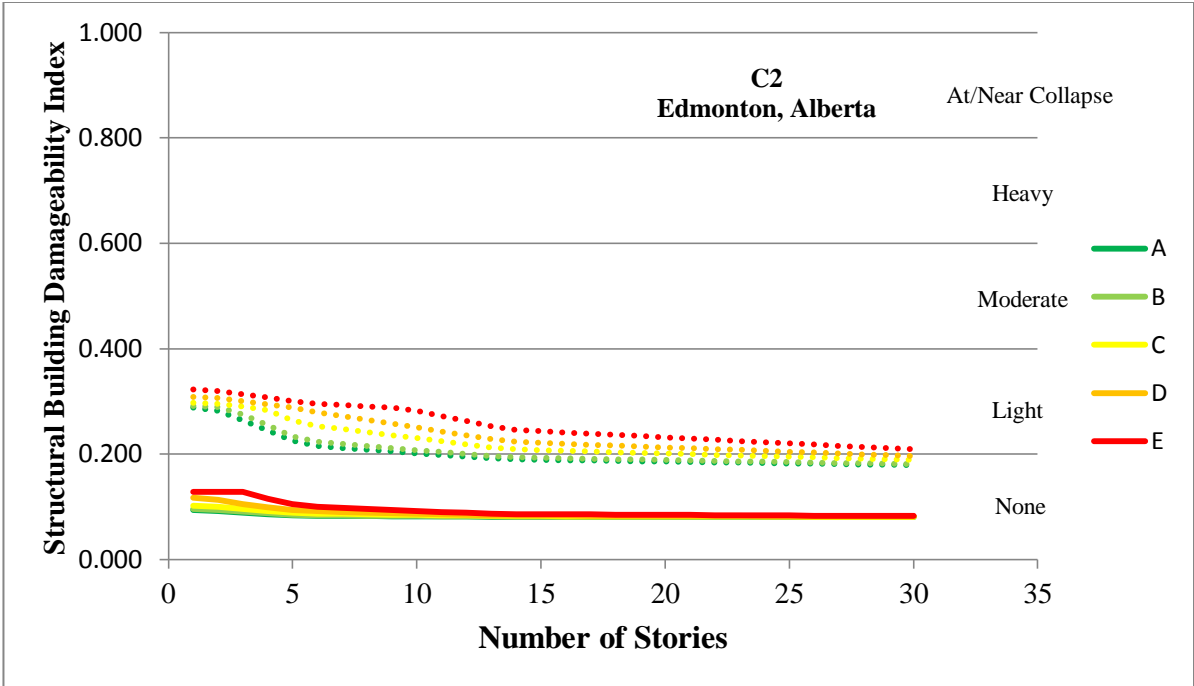
**Figure 4-10: Upper and Lower Bound Limits of Building Damageability for C2 Structures resting on various soil conditions in Edmonton, Alberta**

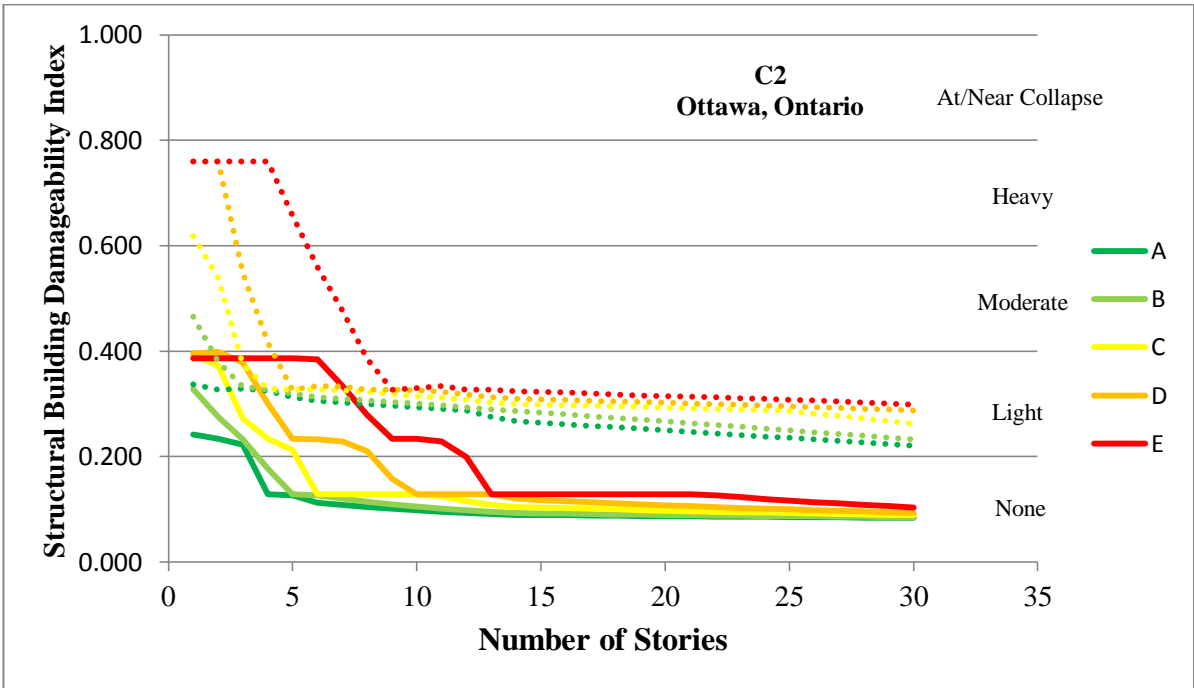
**Figure 4-11: Upper and Lower Bound Limits of Building Damageability for C2 Structures resting on various soil conditions in Ottawa, Ontario**
