# **Seismic Risk Assessment of Unreinforced Masonry Buildings Using Fuzzy Based Techniques for the Regional Seismic Risk Assessment of Ottawa, Ontario**

By  
Amid El Sabbagh

**Master of Applied Science**

March 2014

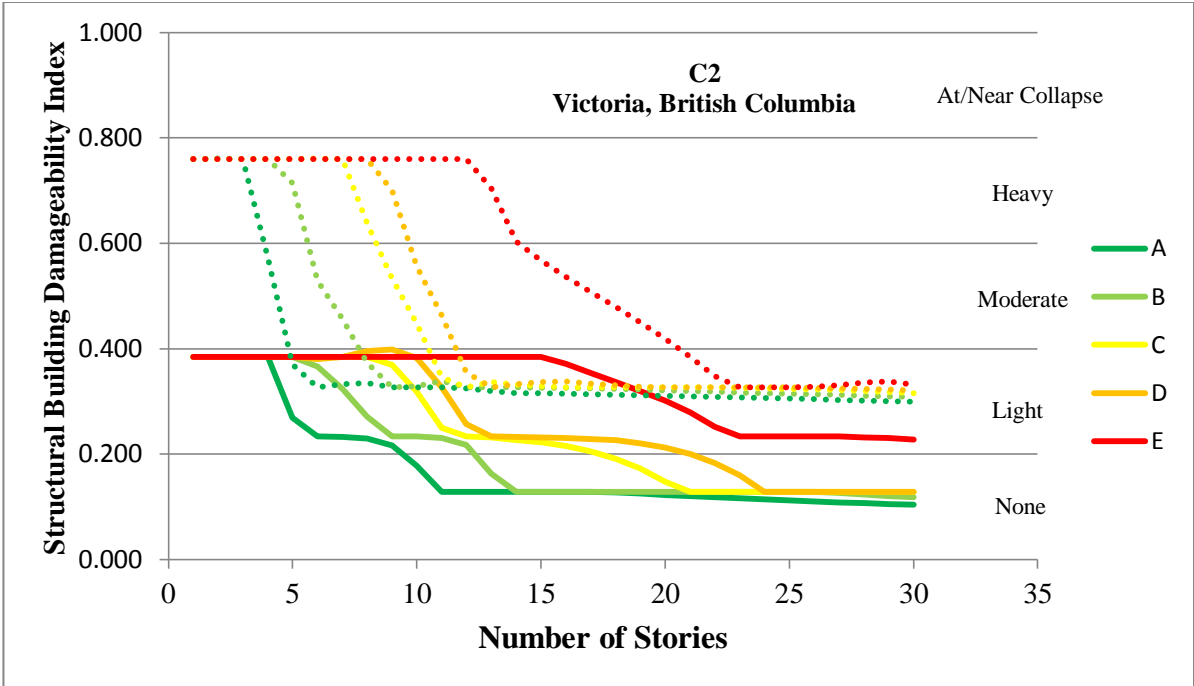
**Figure 4-12: Upper and Lower Bound Limits of Building Damageability for C2 Structures resting on various soil conditions in Victoria, British Columbia**

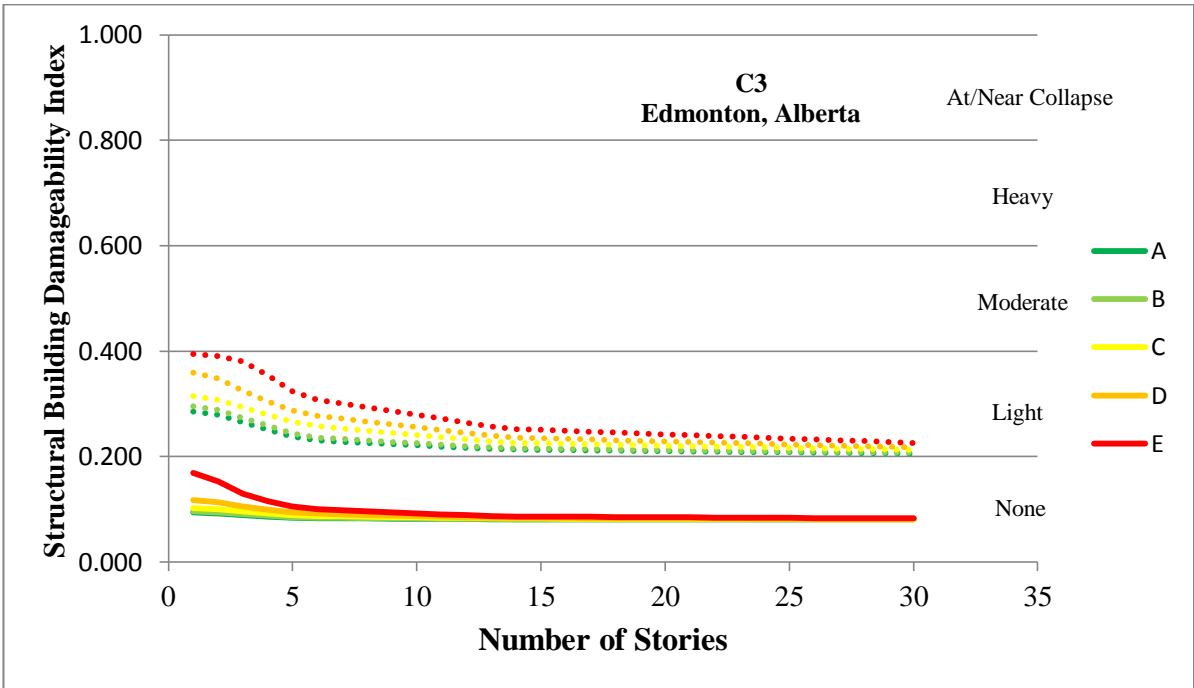
**Figure 4-13: Upper and Lower Bound Limits of Building Damageability for C3 Structures resting on various soil conditions in Edmonton, Alberta**

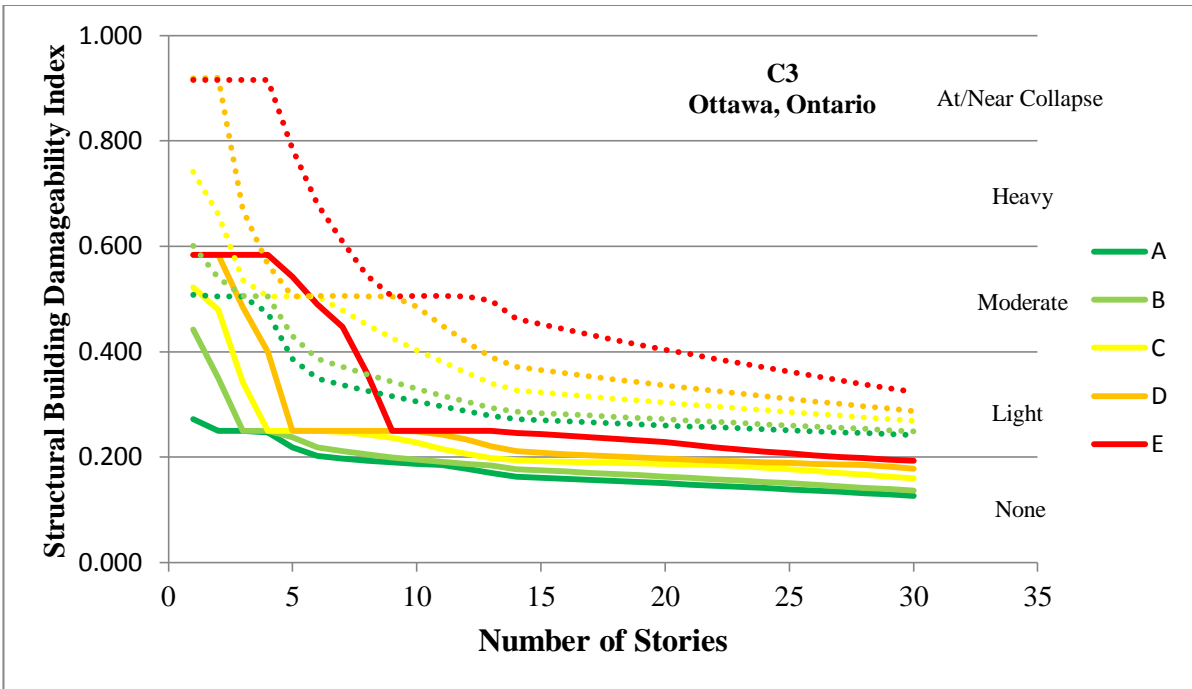
**Figure 4-14: Upper and Lower Bound Limits of Building Damageability for C3 Structures resting on various soil conditions in Ottawa, Ontario**

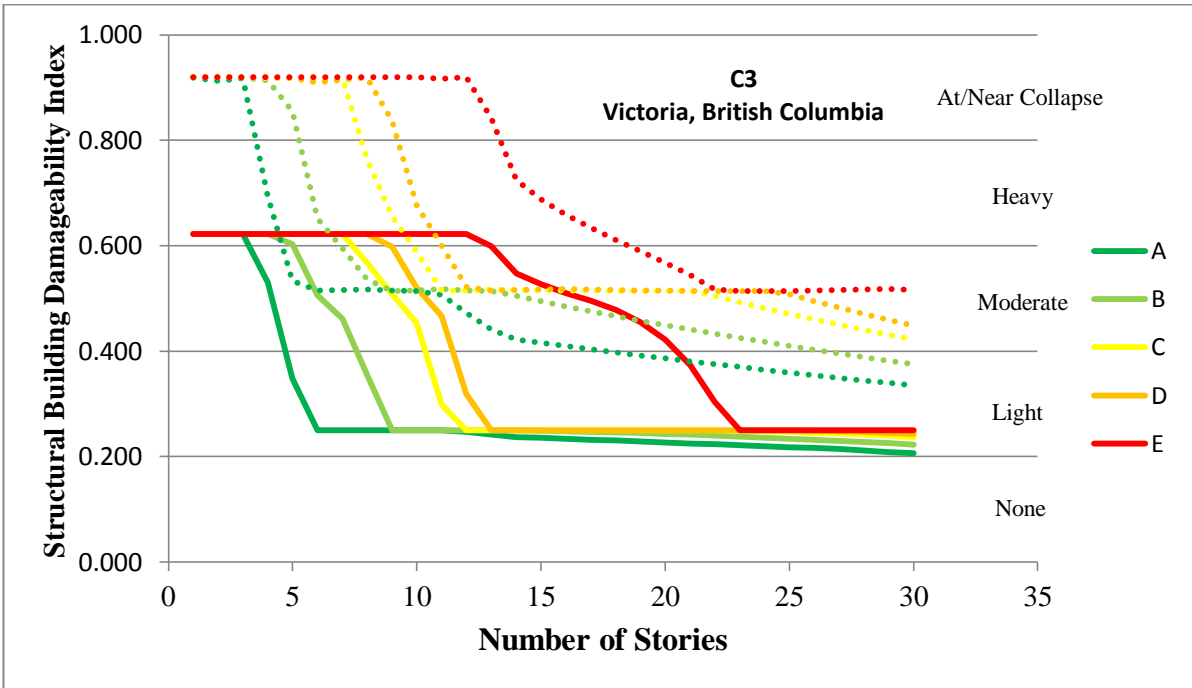
**Figure 4-15: Upper and Lower Bound Limits of Building Damageability for C3 Structures resting on various soil conditions in Victoria, British Columbia**

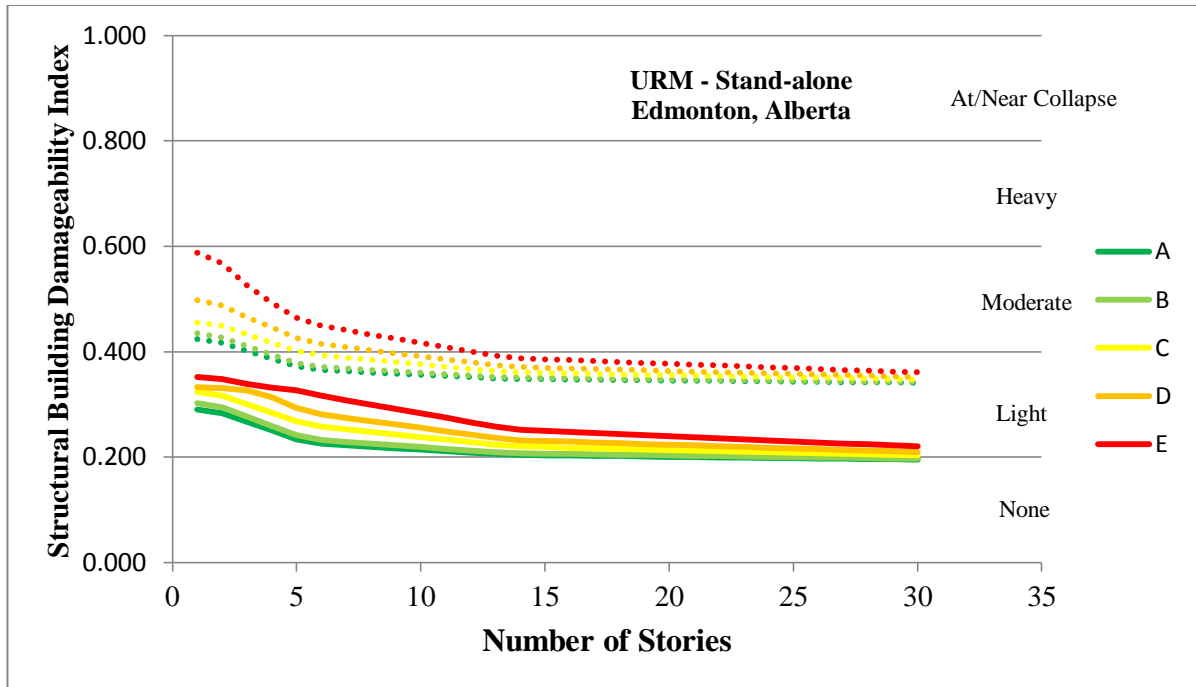
**Figure 4-16: Upper and Lower Bound Limits of Building Damageability for URM (Stand-alone) Structures resting on various soil conditions in Edmonton, Alberta**

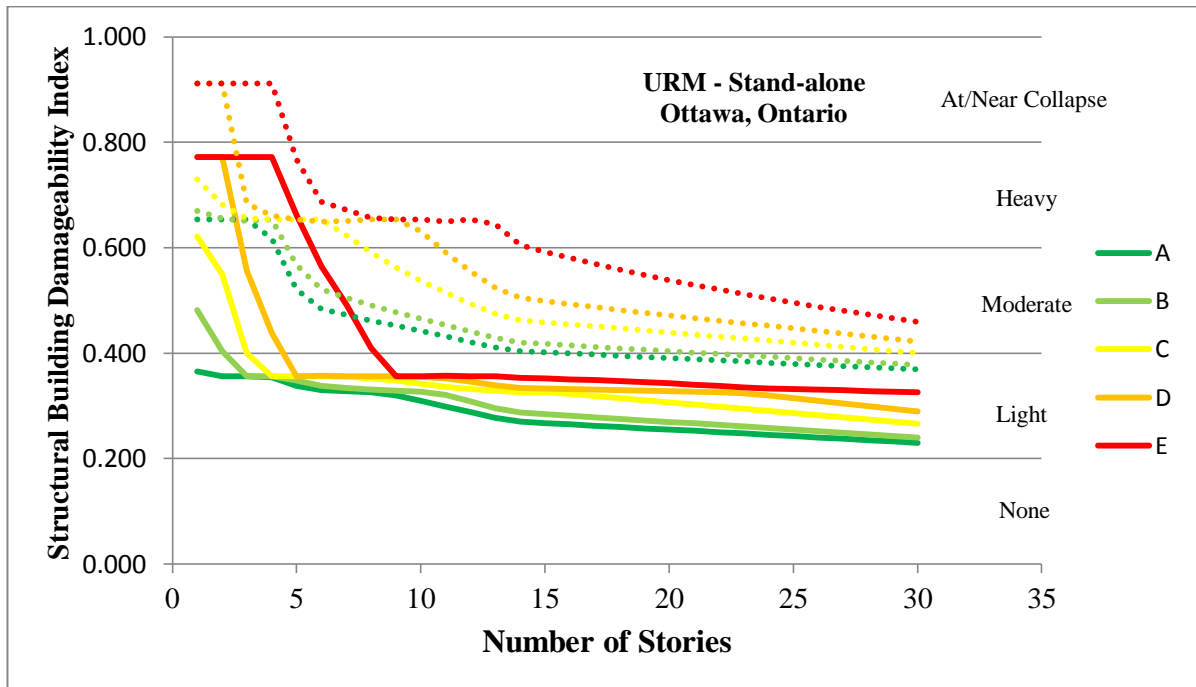
**Figure 4-17: Upper and Lower Bound Limits of Building Damageability for URM Structures resting on various soil conditions in Ottawa, Ontario**

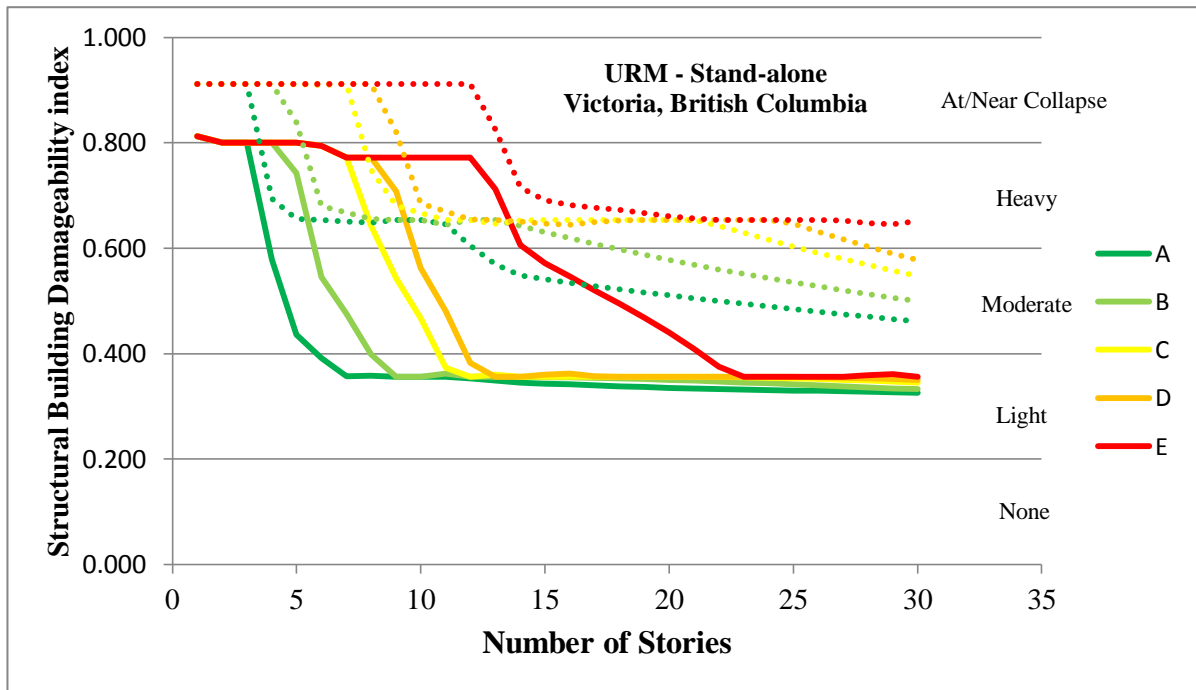
Figure 4-18: Upper and Lower Bound Limits of Building Damageability for URM Structures resting on various soil conditions in Victoria, British Columbia

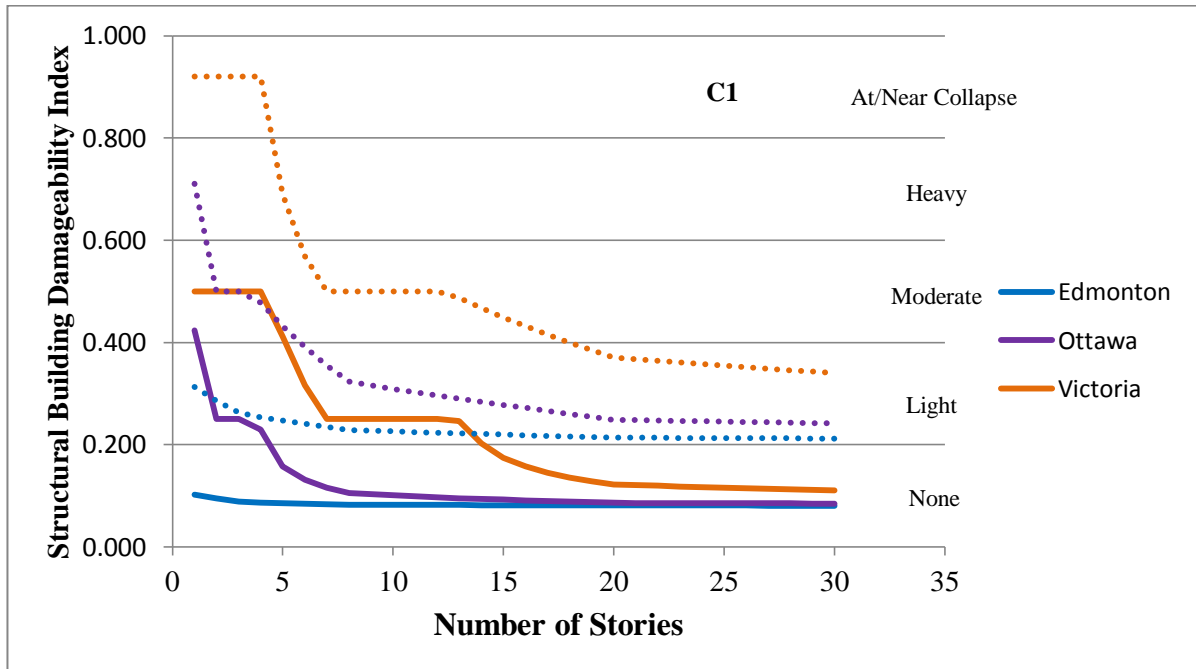
Figure 4-19: Comparison of Upper and Lower Bound Limits of Building Damageability for C1 Structures Resting on Reference Site Soil Class C

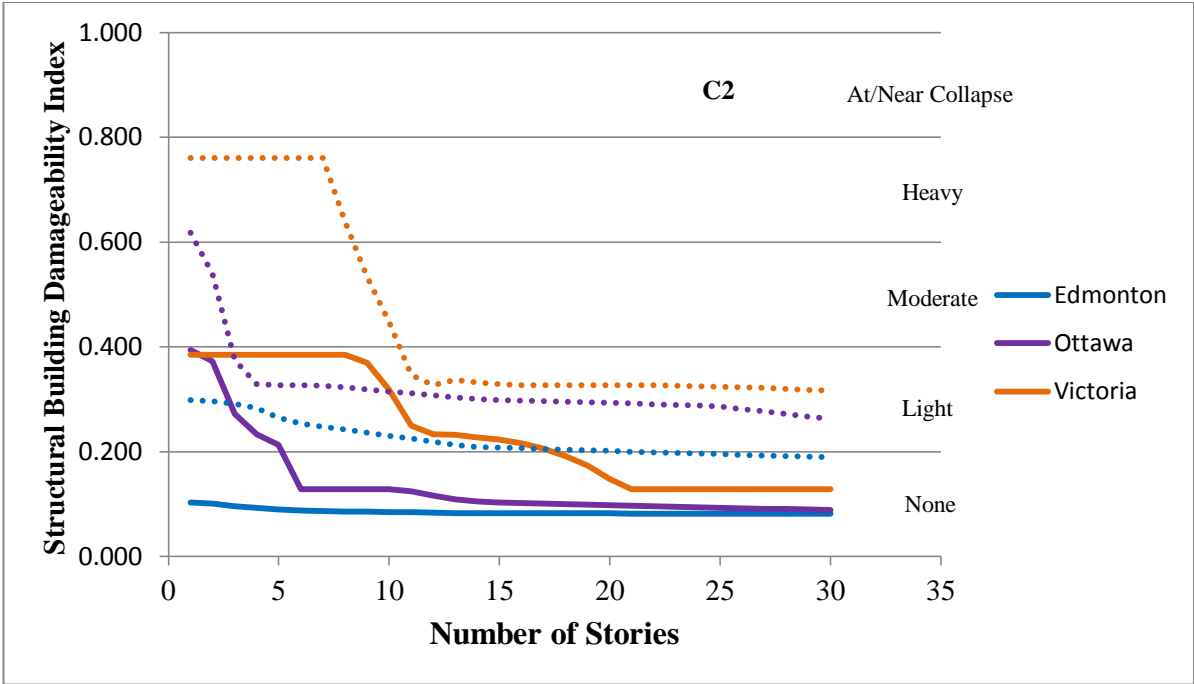
**Figure 4-20: Comparison of Upper and Lower Bound Limits of Building Damageability for C2 Structures Resting on Reference Site Soil Class C**

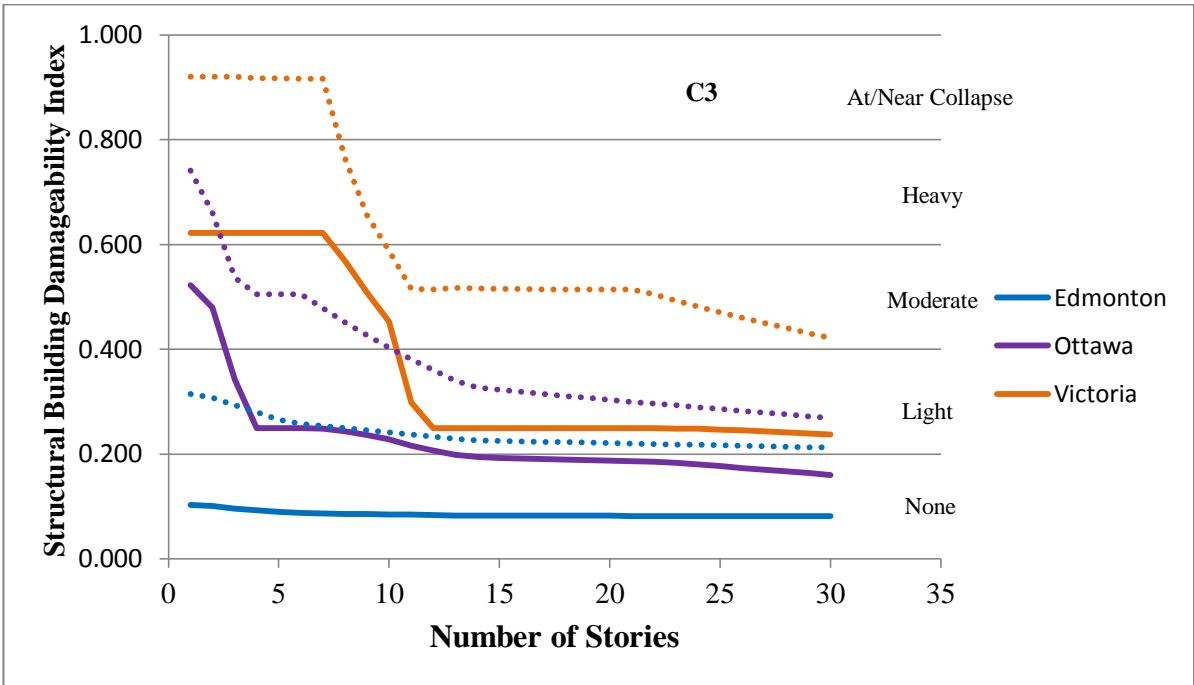
**Figure 4-21: Comparison of Upper and Lower Bound Limits of Building Damageability for C3 Structures Resting on Reference Site Soil Class C**

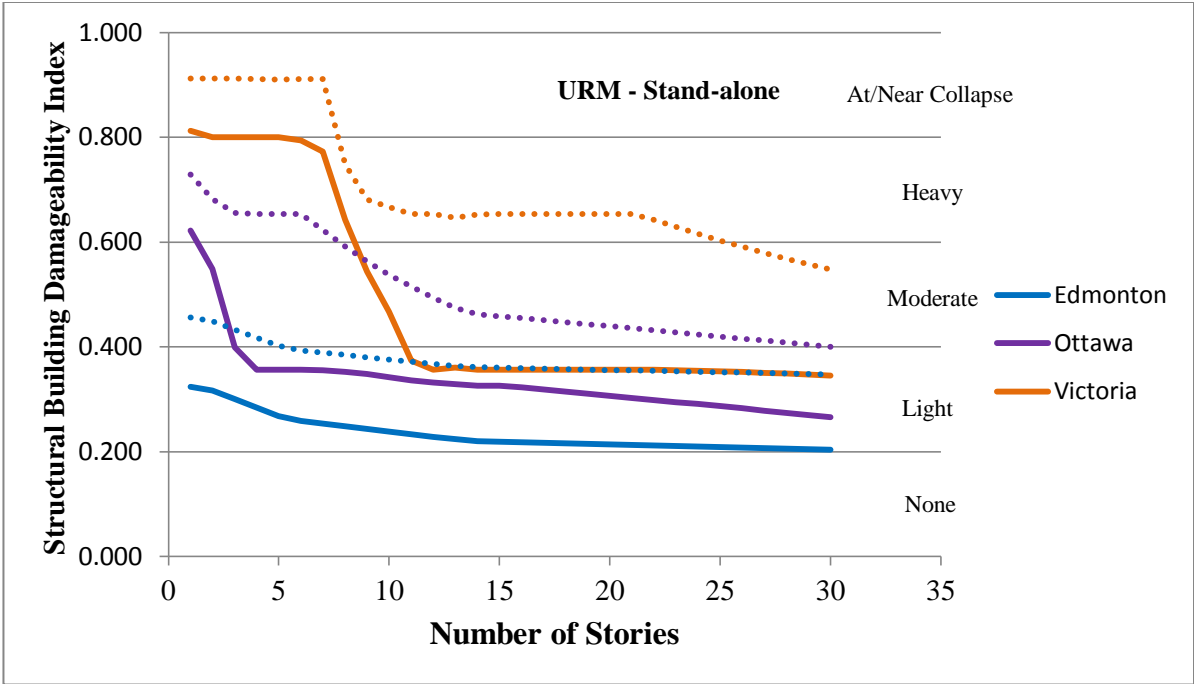
**Figure 4-22: Comparison of Upper and Lower Bound Limits of Building Damageability for URM Structures Resting on Reference Site Soil Class C**

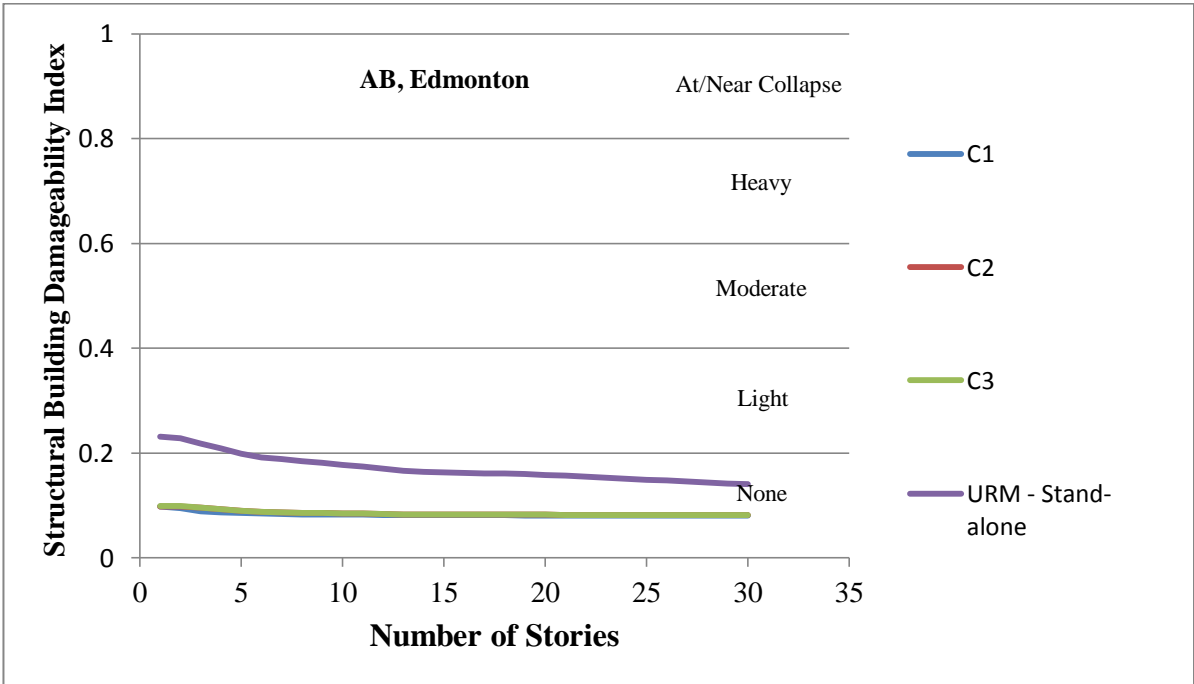
**Figure 4-23: Comparison of Building Type for Structural Building Damageability of Structures Resting on Reference Site Soil Class C in Edmonton, AB**

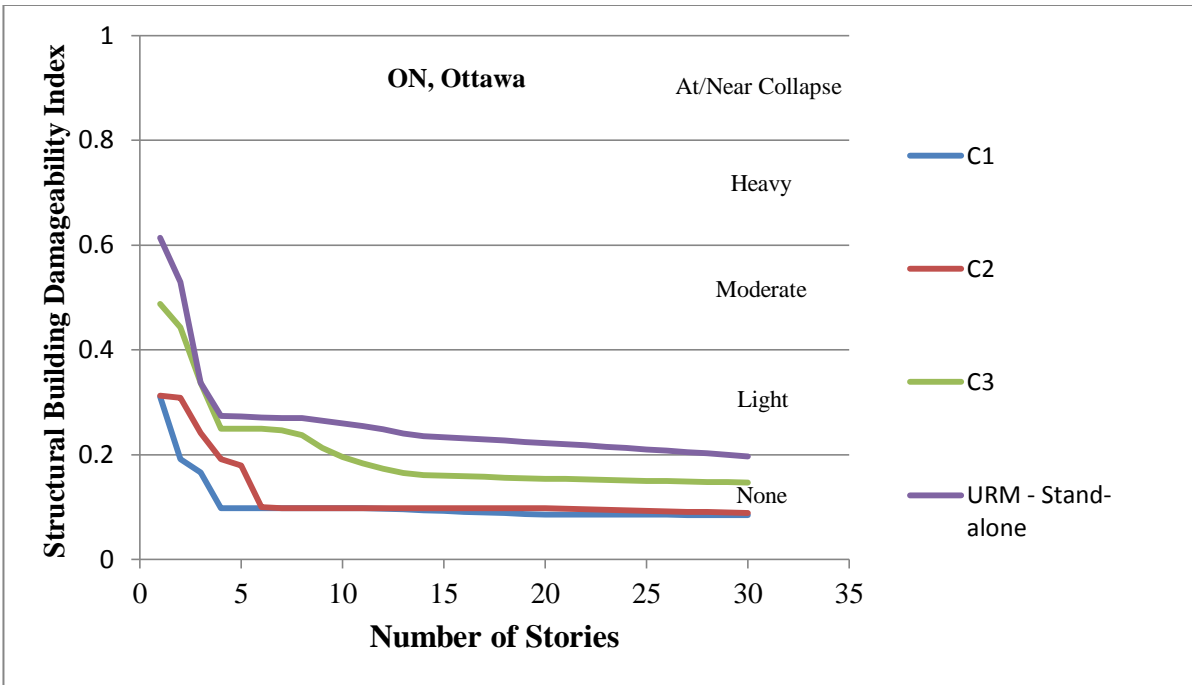
Figure 4-24: Comparison of Building Type for Structural Building Damageability of Structures Resting on Reference Site Soil Class C in Ottawa, ON

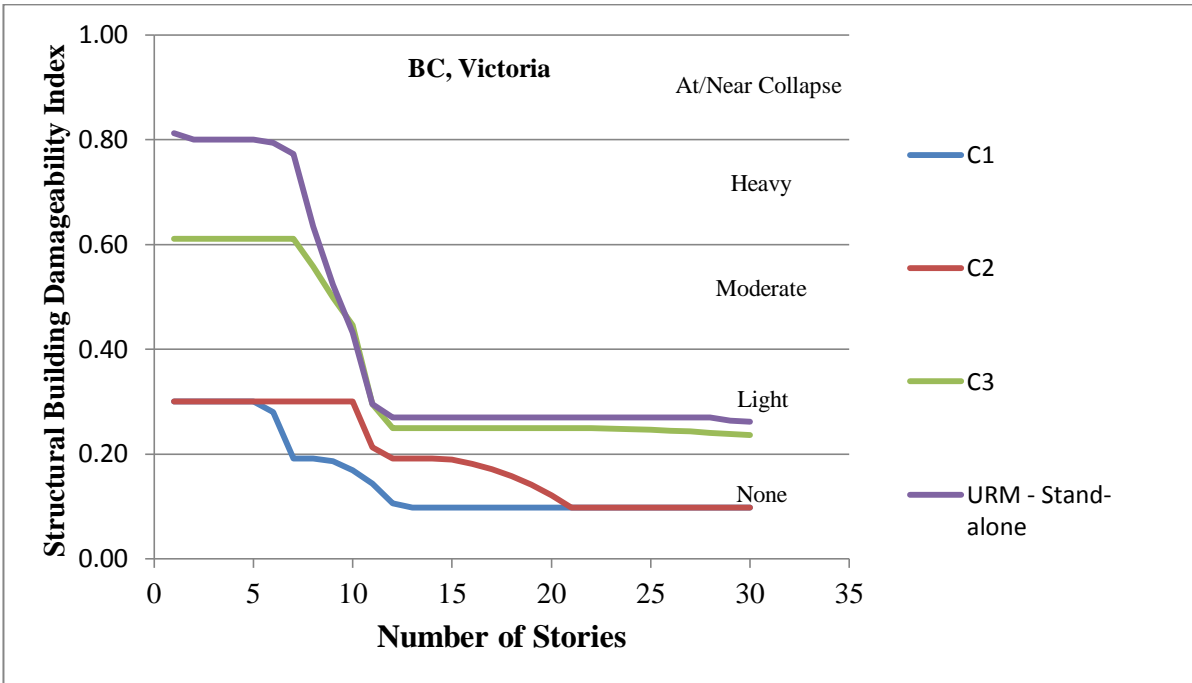
Figure 4-25: Comparison of Building Type for Structural Building Damageability of Structures Resting on Reference Site Soil Class C in Victoria, BC

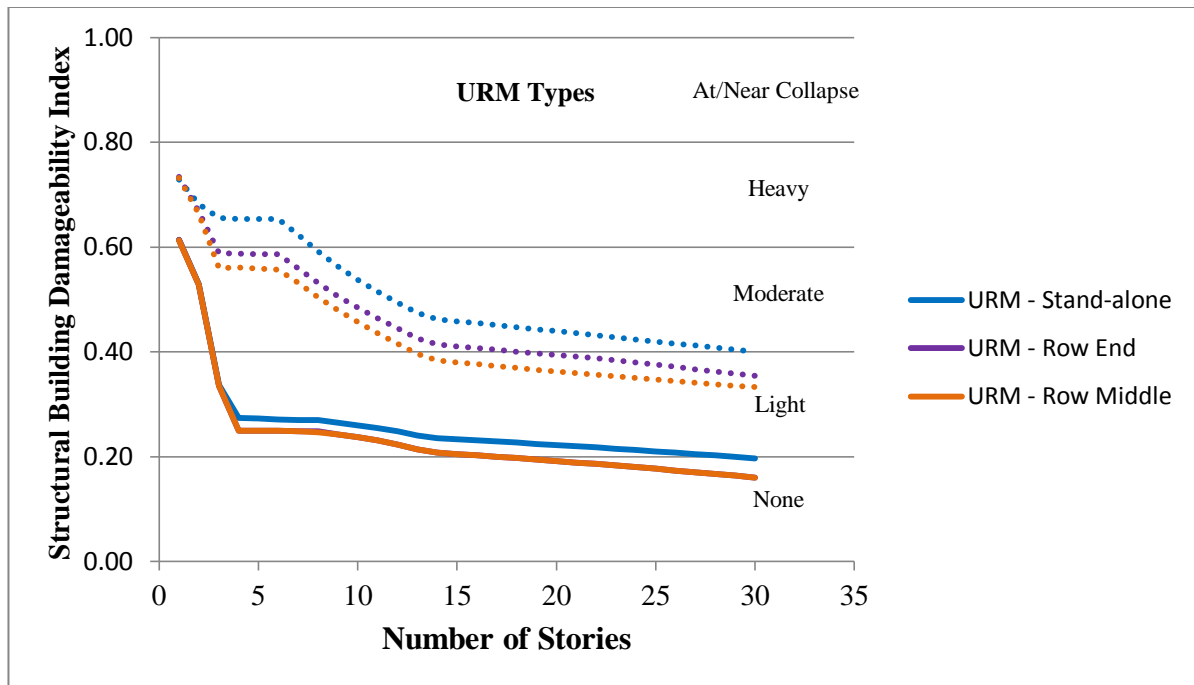
**Figure 4-26: Comparison of URM Building Type for Structural Building Damageability of Structures Resting on Reference Site Soil Class C in Ottawa, ON**

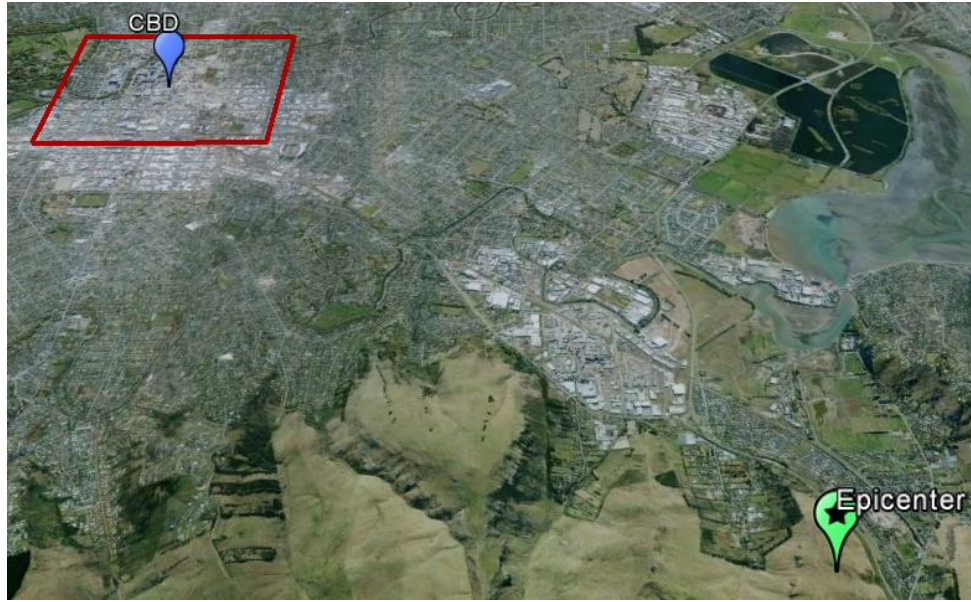
**Figure 4-27: Epicentre Distance to the Central Business District (CBD) of the 2011 Christchurch Earthquake in New Zealand**

On February 22<sup>nd</sup>, 2011, New Zealand was struck by an earthquake of moment magnitude  $M_w = 6.2$ , resulting in 185 deaths (Elwood, 2013). The earthquake caused extensive damage in a large number of URM buildings located in the Central Business District (CBD) as summarized in Table 2-4 of Section 2.5.6. The aftermath of the earthquake resulted in the demolition of many URM buildings which were tagged as unsafe to enter (Ingham and Griffith, 2011a). Although the building stock in Christchurch had been subjected to previous large magnitude earthquakes, the Christchurch Earthquake was one the most catastrophic on record, with the URM building stock suffering wide-scale damage (Moon et al., 2012). The epicenter of the earthquake was located less than 10 km south-west of the CBD as illustrated in Figure 4-27.

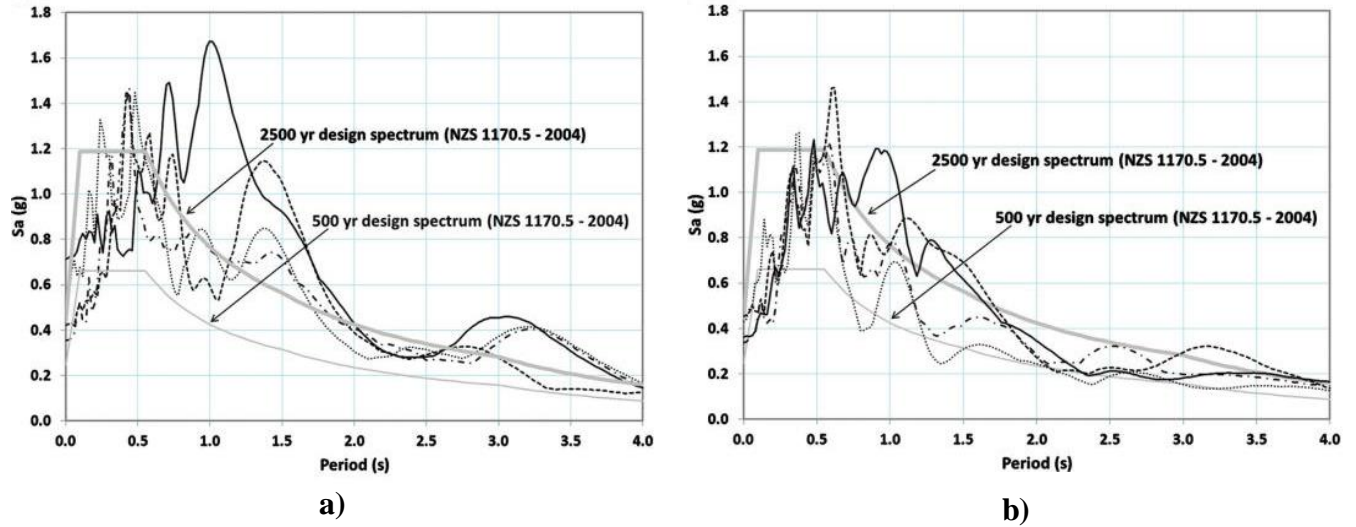
Figure 4-28: 5% damped spectra for ground motions recorded of the February 2011 Christchurch Earthquake in New Zealand for: a) East-West Direction b) North-south Direction

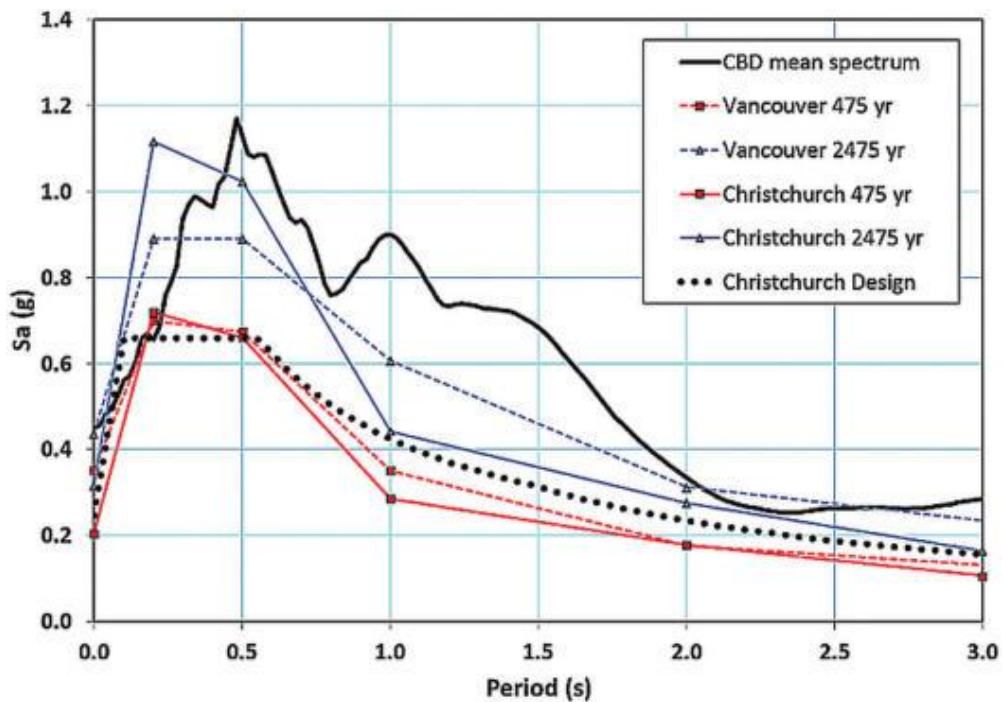
Figure 4-29: Comparison of mean spectrum for all horizontal ground motions of the February 2011 Christchurch Earthquake to the UHS design spectrum for Vancouver and Christchurch (soil class D assumed).

The mean earthquake spectrum of the four stations is illustrated in Figure 4-29 and compared to the UHS and design spectrum of Vancouver and New Zealand for two different return periods. It is clearly illustrated in Figure 4-29 that the mean earthquake spectrum sits fairly close to, and for the most part exceeds, the spectral acceleration of the UHS and the design spectrum. Although, the mean spectrum does not represent the spatial variability of seismic hazard, the spectral acceleration corresponding to a specific period can be used to quantify the site seismic hazard (Tesfamariam, 2008) and will be used in the analysis that follows.

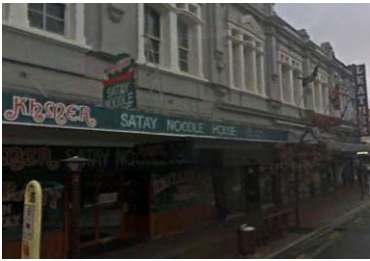
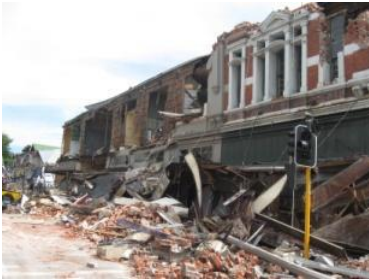
#	Pre-earthquake photo	Post-earthquake photo	ATC-13 Classification
1

Heavy
2

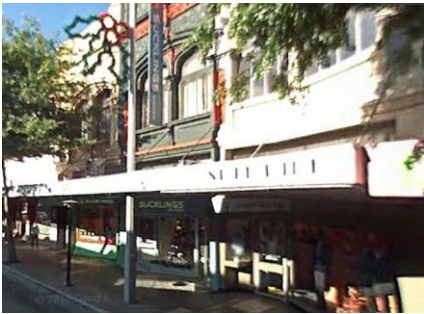
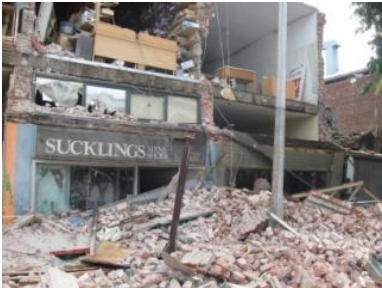
Major
3

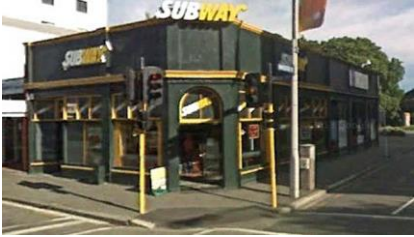
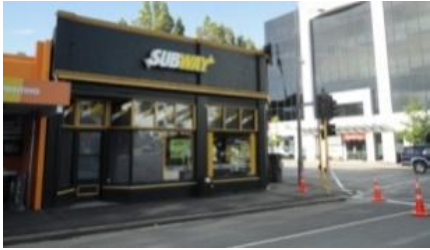
Light
5

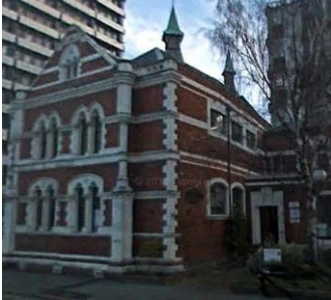
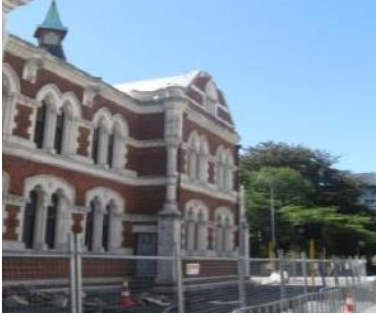
Moderate
6

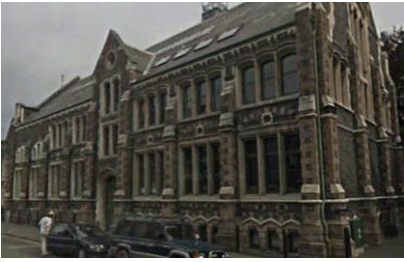
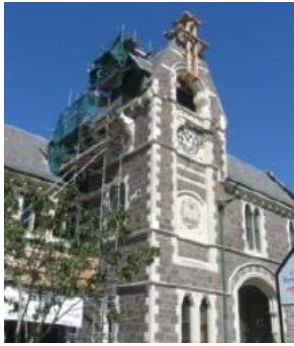
Heavy
9

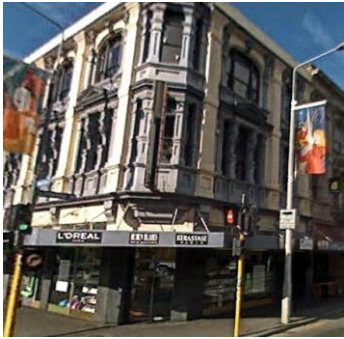
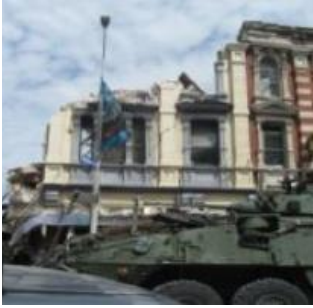
Destroyed
10

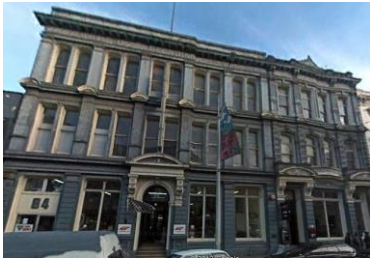
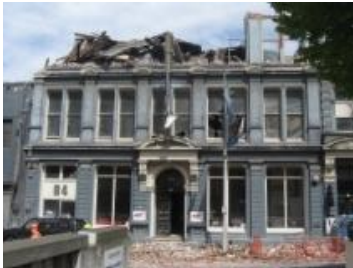
Destroyed

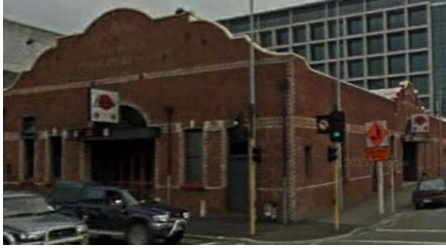
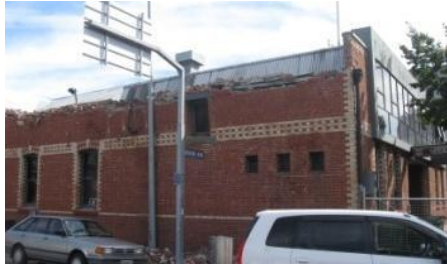
Moderate
13

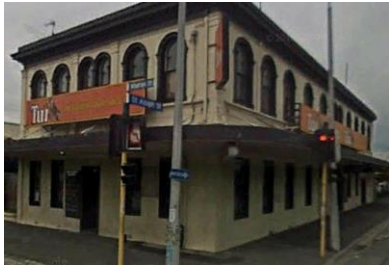
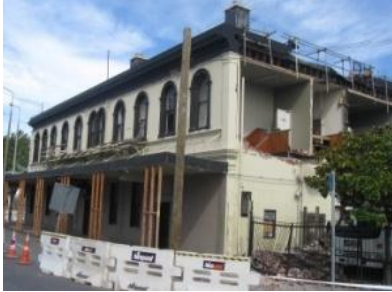
Heavy

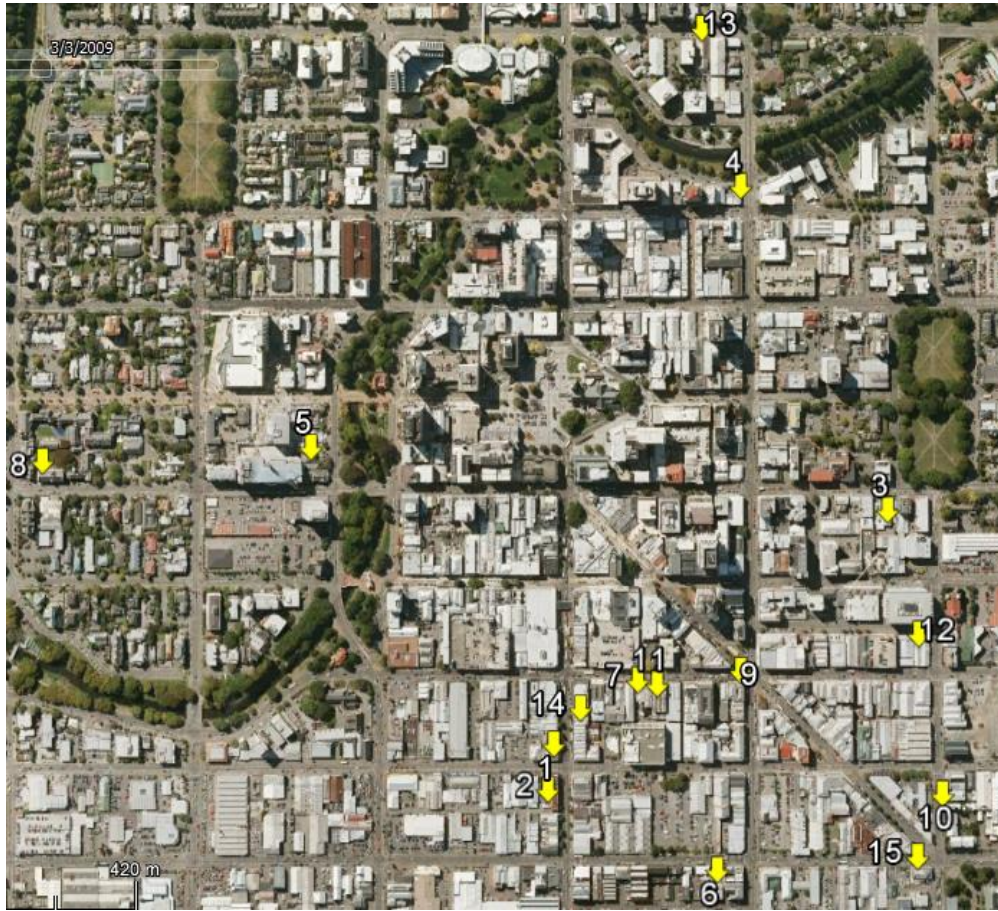
**Figure 4-30: Evaluated URM buildings in the CBD**

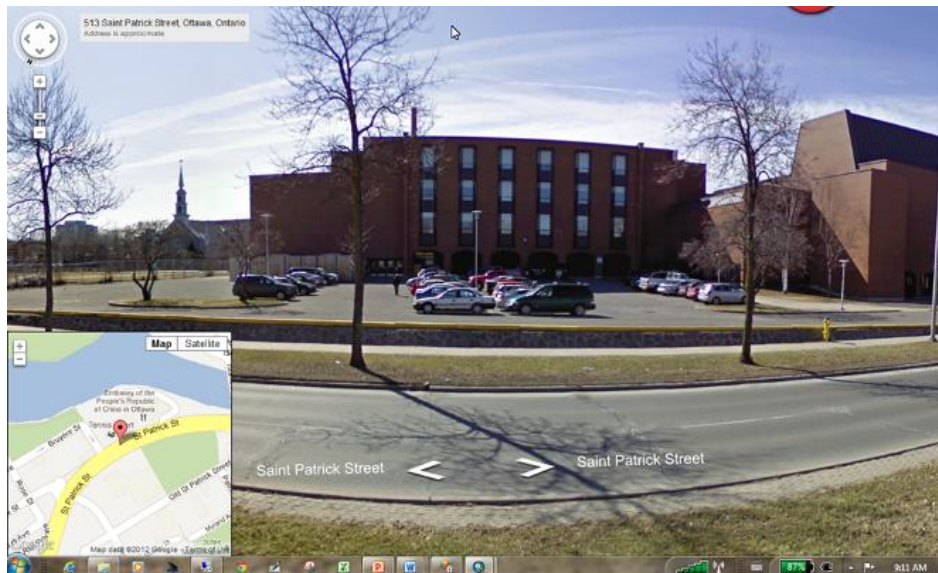
**Figure 5-2 a) Building assessment form in Urban RAT; b) Google StreetView within Urban RAT and within ArcGIS open at location of building to be assessed**

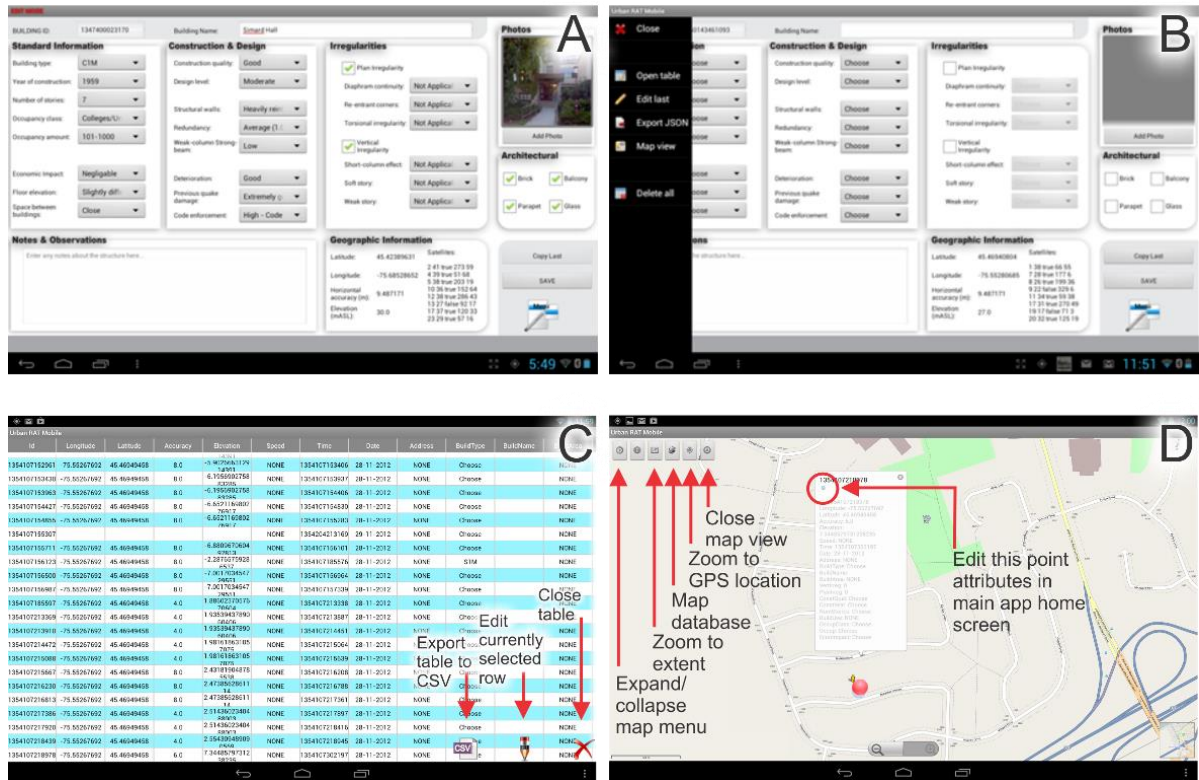
Figure 5-3: Urban RAT mobile: a) Main assessment screen, variables as in Table 1; b) Main menu used to switch between data entry screen, map and data table; c) Data table of stored assessment locations. User can edit or export to comma separated values file (CSV); d) Map of assessment area. User can plot all assessed points, select individual points for editing and see current location on map using GPS receiver in tablet.

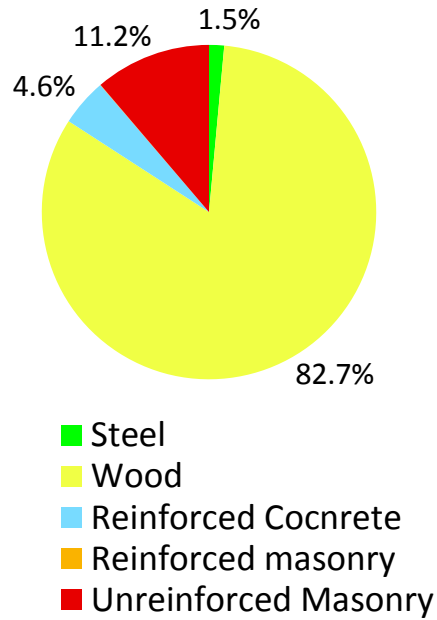
**Figure 5-6: Percent Breakdown of Construction Type of Buildings in Ottawa, Ontario**

non-engineered. As shown in Figure 5-6, the majority of buildings assessed in this study can be classified as non-engineered buildings while approximately 6.1% of the building stock can be categorized as engineered. Of particular concern is the large inventory of unreinforced masonry buildings (11.2%), a structural material which has consistently demonstrated poor performance in past earthquakes. In addition, it is noted that a large inventory of residential single family dwellings built of wood were included in the assessment (82.7%).

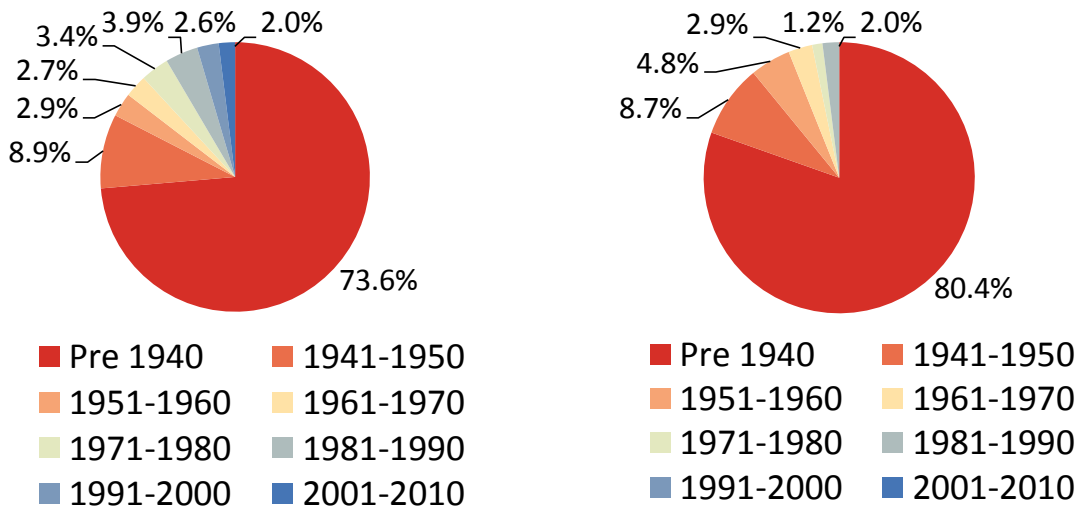
a) Total Inventory

b) URM Inventory

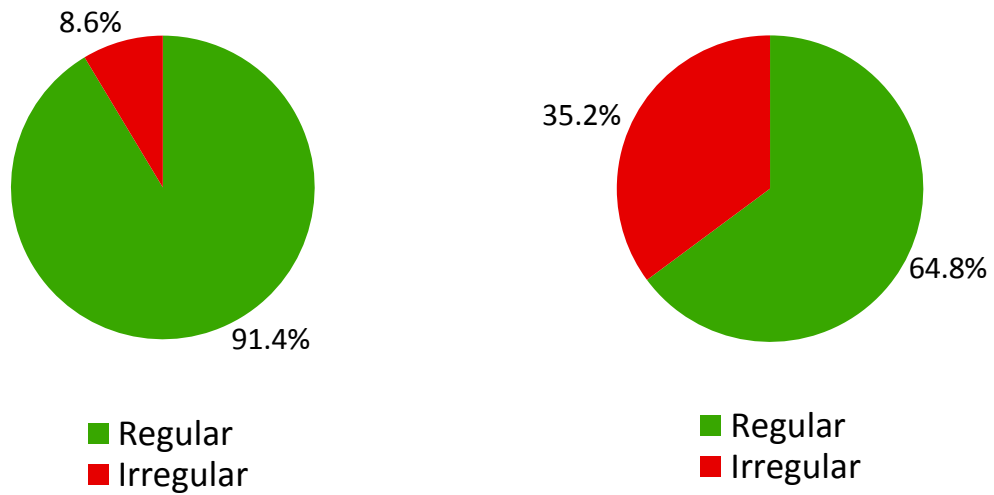
a) Total Inventory

b) URM Inventory

Performance of buildings in past earthquakes has demonstrated that buildings with irregular configuration or irregular distribution of structural properties can cause an increase in seismic demand, leading to a greater degree of damage and greater risk of failure of a building (Tesfamariam & Saatcioglu 2008). Therefore, in the development of the NBCC seismic provisions, rules have provided for the classification of buildings into various building irregularity categories as a function of asymmetries (NRCC 2010). Accordingly, these parameters that evaluate structural irregularities have been accounted for in the building inventory and buildings within the inventory have been classified as regular and irregular in terms of configuration as seen in Figure 5-13. The two principal types of irregularity assessed include plan and/or vertical irregularities of a structure with 8.6% of the downtown building stock classified as containing irregular configurations (Figure 5-14a). The most common type of irregularity found in URM buildings are re-entrant corners caused by asymmetrical plan configurations and setbacks. In addition, a number of URM buildings contain first floor retail stores with one or two levels of family dwellings located above, particularly buildings along Bank Street – a street that is considered historical, a major shopping and business district in the City of Ottawa. This building configuration typically results in a soft story effect due to large display windows and storefront openings. Figure 5-14b illustrates that approximately 35% of the URM building stock contain an irregular structural configurations which include plan irregularity, vertical irregularity or a combination of the two aforementioned irregularity types. The presence of irregularities in this hazardous construction type results in increased seismic demand and can result in increased seismic vulnerability and the overall likelihood of failure.

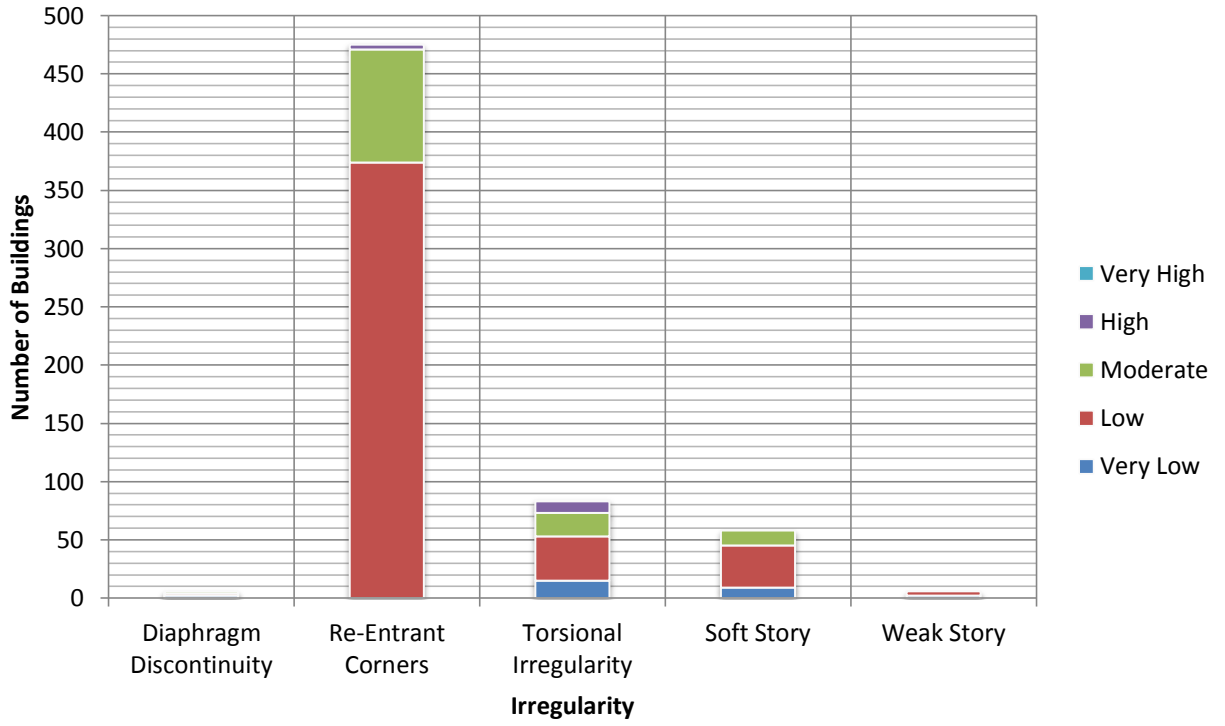
**Figure 5-15: Detailed breakdown of URM irregularities**
