# **Seismic Risk Assessment of Unreinforced Masonry Buildings Using Fuzzy Based Techniques for the Regional Seismic Risk Assessment of Ottawa, Ontario**

By  
Amid El Sabbagh

**Master of Applied Science**

March 2014

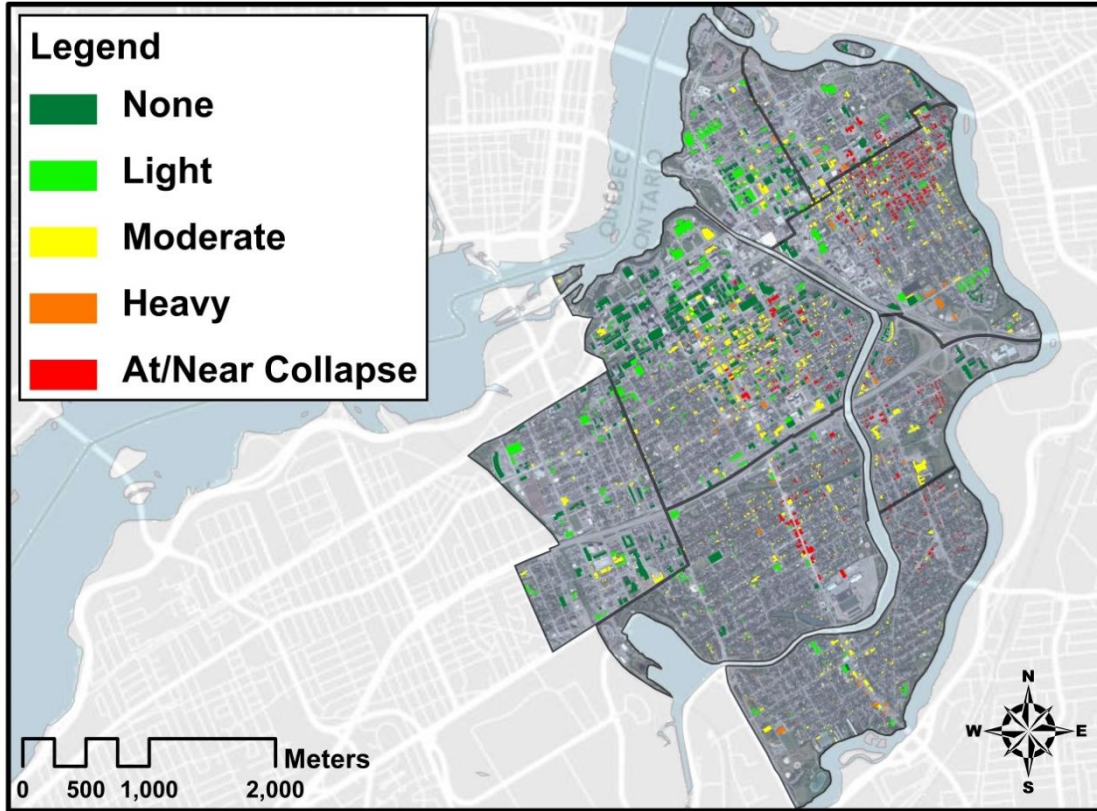
Figure 6-3: Spatial Distribution of Expected Structural Building Damageability of Buildings in Ottawa, Ontario

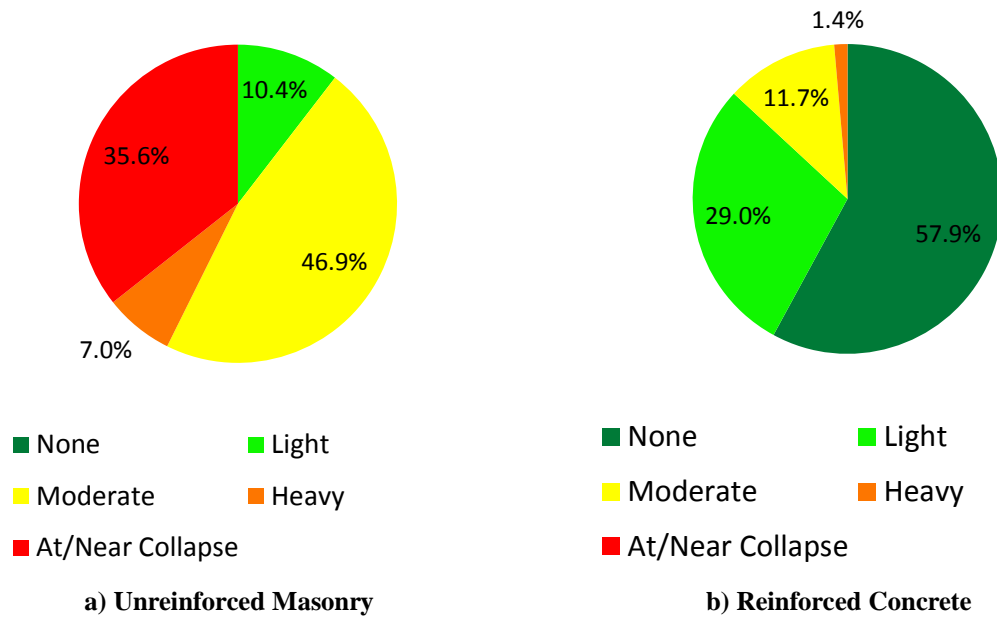
Figure 6-4: Percent Breakdown of Structural Building Damageability: a) URM, b) RC

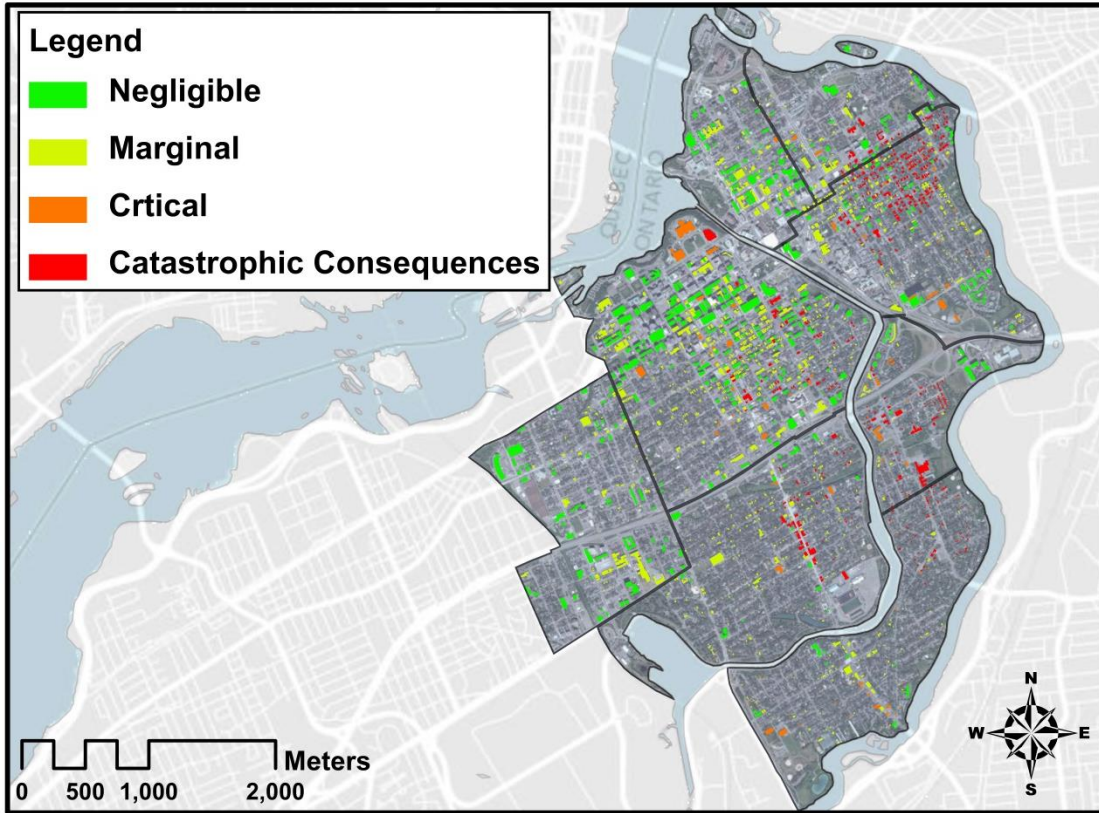
Figure 6-5: Spatial Distribution of Expected Structural Risk of Buildings in Ottawa, Ontario

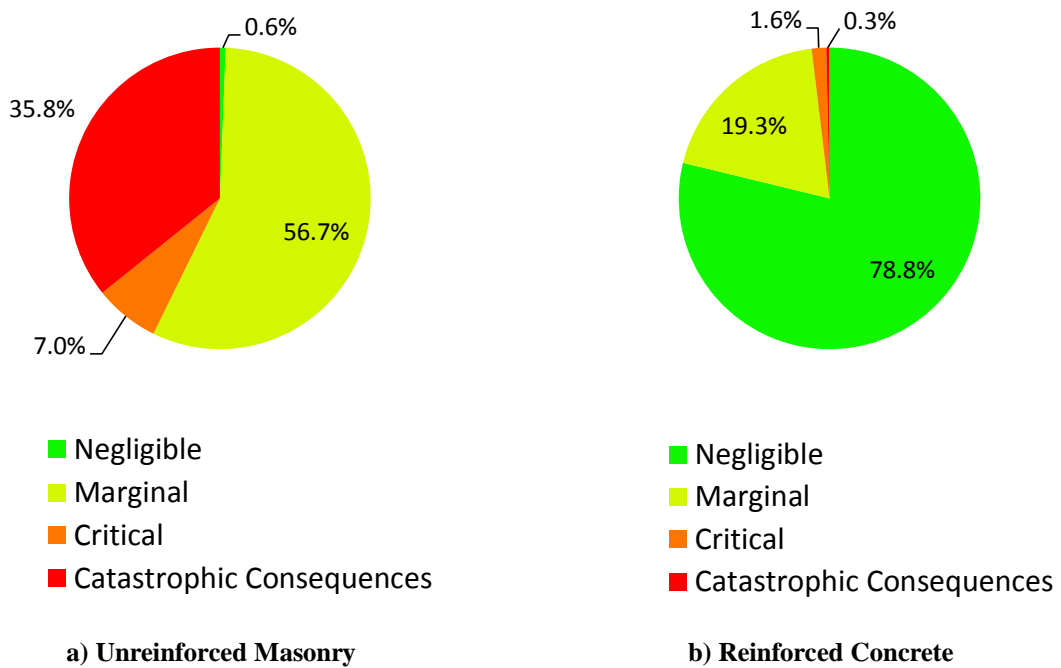
Figure 6-6: Percent Breakdown of Structural Risk: a) URM, b) RC

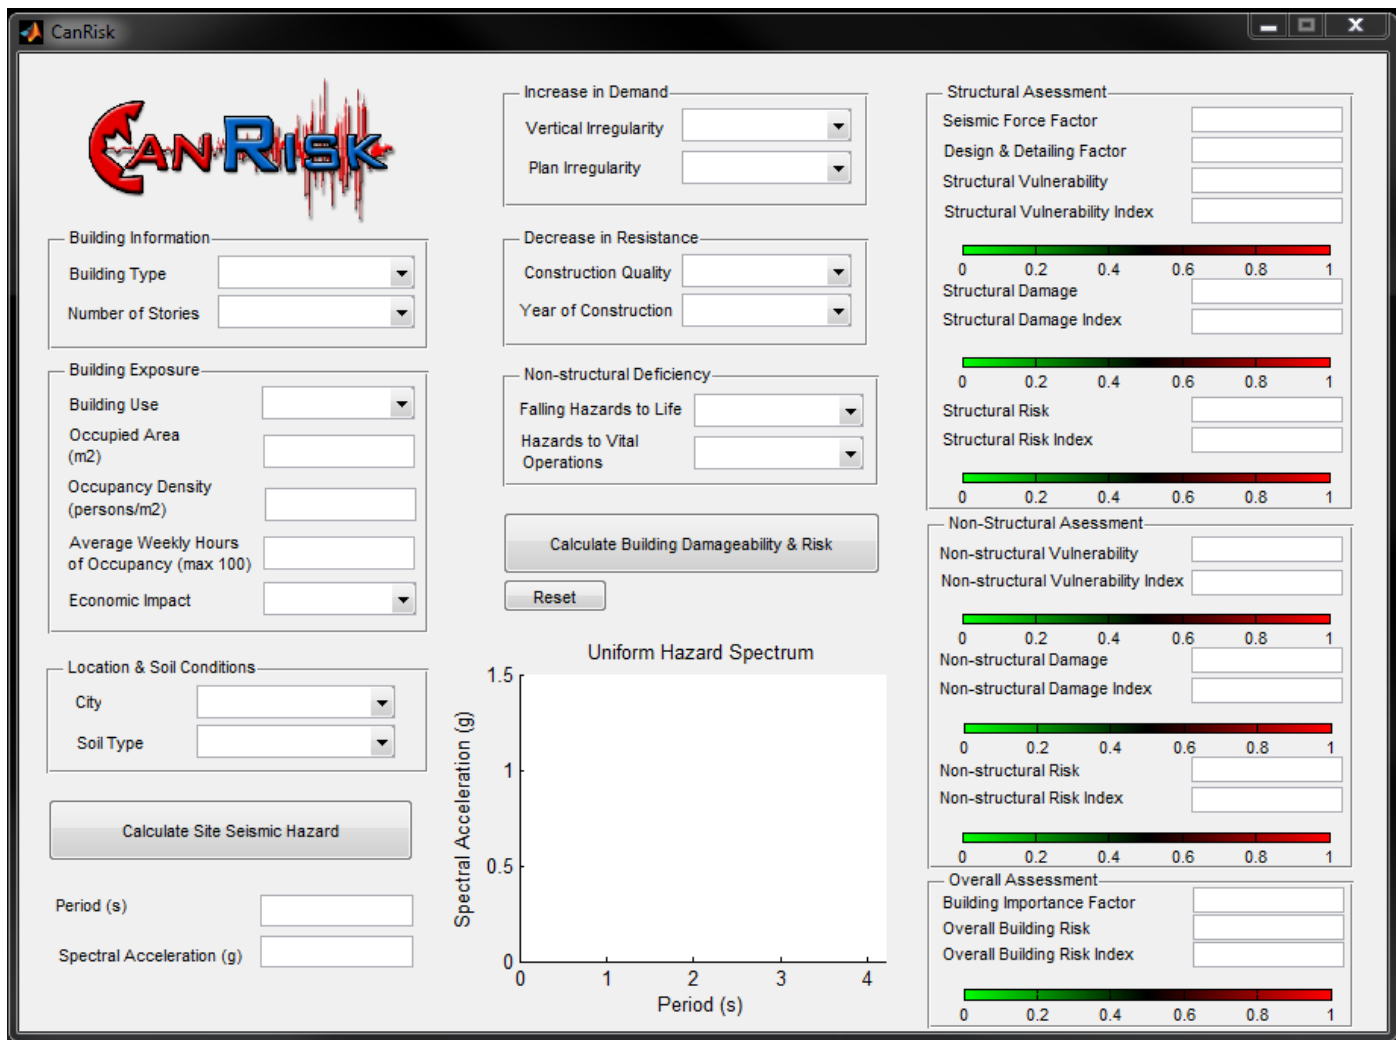
Start the *CanRisk* program by double clicking the CanRisk.exe file. Once the program is opened, the input data is inserted manually by the user by selecting various options of the graphical user interface (GUI) of *CanRisk* as seen below.

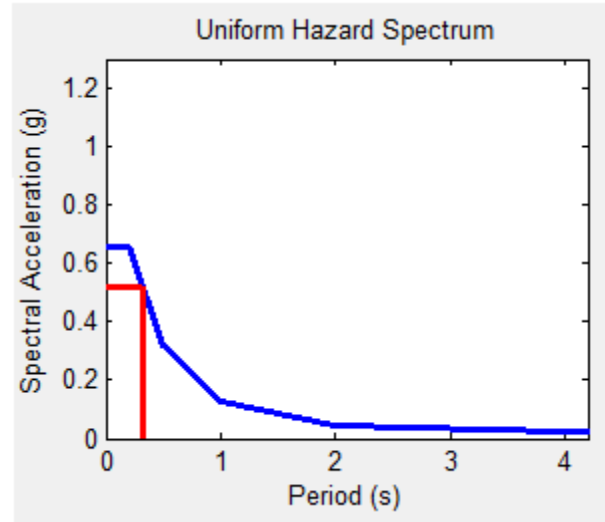
Therefore, the URM building has a period of 0.322 seconds and a spectral acceleration of 0.521g. The value obtained for spectral acceleration will be used in order to quantify SSH.

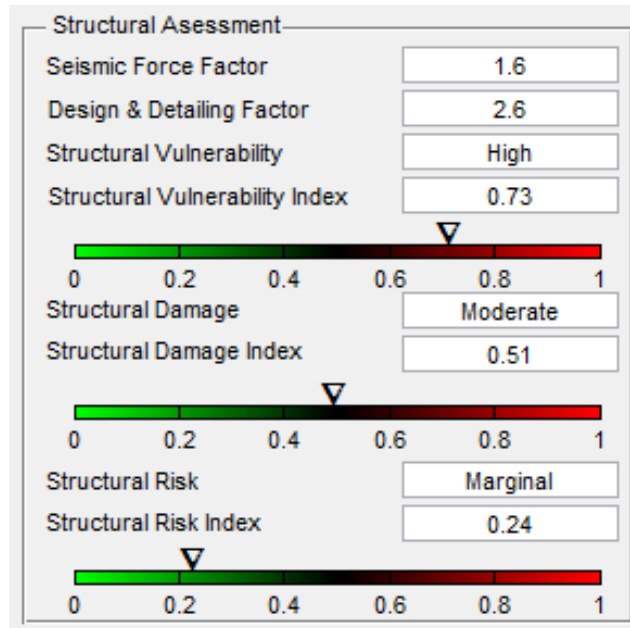
The **Structural Assessment** panel displays the Seismic Force Factor (SFF), the Design & Detailing Factor (DDF), Structural Vulnerability (SV), Structural Damageability (SD) and the Structural Vulnerability Index (SVI). Thus, the results of the example above are:

- **High** Structural Vulnerability
- **Moderate** Structural Damage (function of SSH and SV)
- **Marginal** Structural Risk (function of SD and Building Exposure)

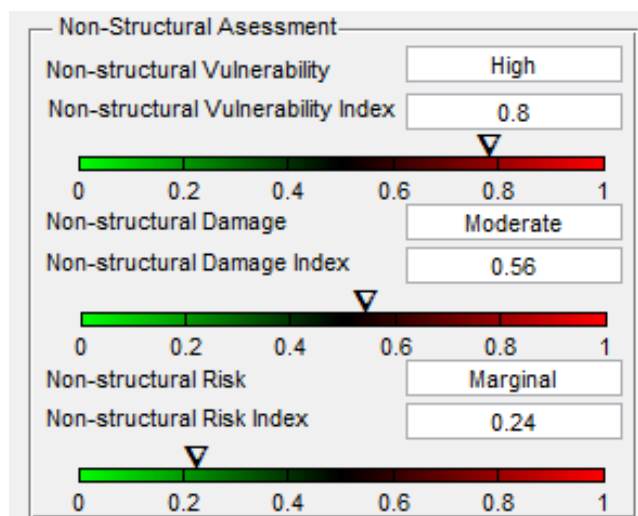
The **Non-structural Assessment** panel displays the Non-structural Vulnerability (NSV), Non-structural Damageability (NSD) and the Non-structural Vulnerability Index (NSVI). Thus, the results of the example above are:

- **High** Non-structural Vulnerability
- **Moderate** Non-structural Damage (function of SSH and NSV)
- **Marginal** Non-structural Risk (function of NSD and Building Exposure)

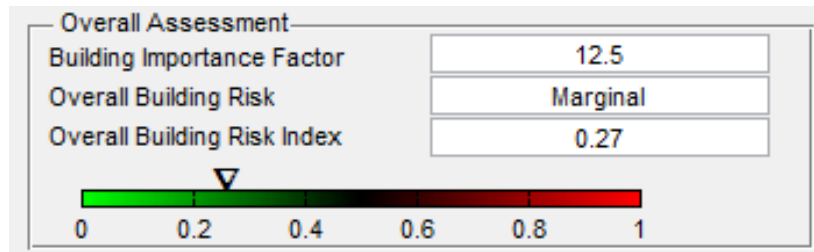
Finally, the Structural Risk and Non-structural Risk are aggregated to give an Overall Building Risk level and index. Thus, the results of the example are:

- **Marginal** Overall Building Risk
