**Seismic Retrofit of Reinforced Concrete Frames with
Diagonal Prestressing or FRP Strips**

Fathalla Shalouf

A thesis presented to the School of Graduate Studies and Research of the
University of Ottawa in partial fulfillment of the requirements for the degree
of Doctor of Philosophy in Engineering

July 2005

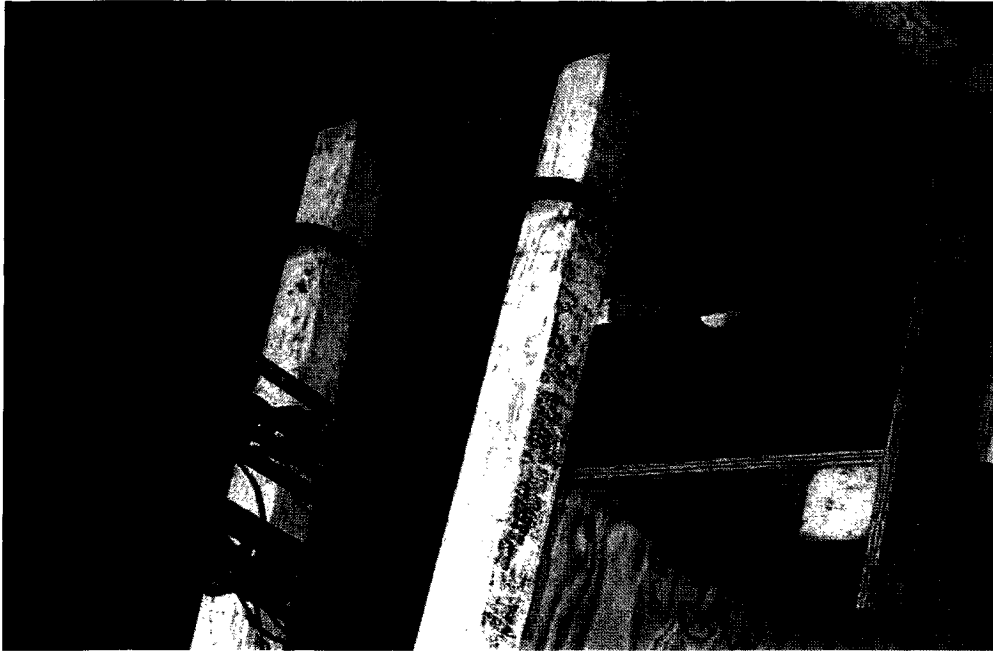
Figure 3.9: Foundations ready to cast

Each frame was built on an I-shaped foundation which was secured on the laboratory strong floor to provide fixity. They were heavily reinforced as shown in Figure 3.1. Figure 3.9 illustrates the construction of two foundations side by side. Four plastic tubes were embedded in each foundation to allow for holes, through which the specimens were secured on the laboratory strong floor by steel bolts. Four steel hooks were provided to be cast in concrete so that the specimen could be lifted and positioned for testing, as shown in Figure 3.10.

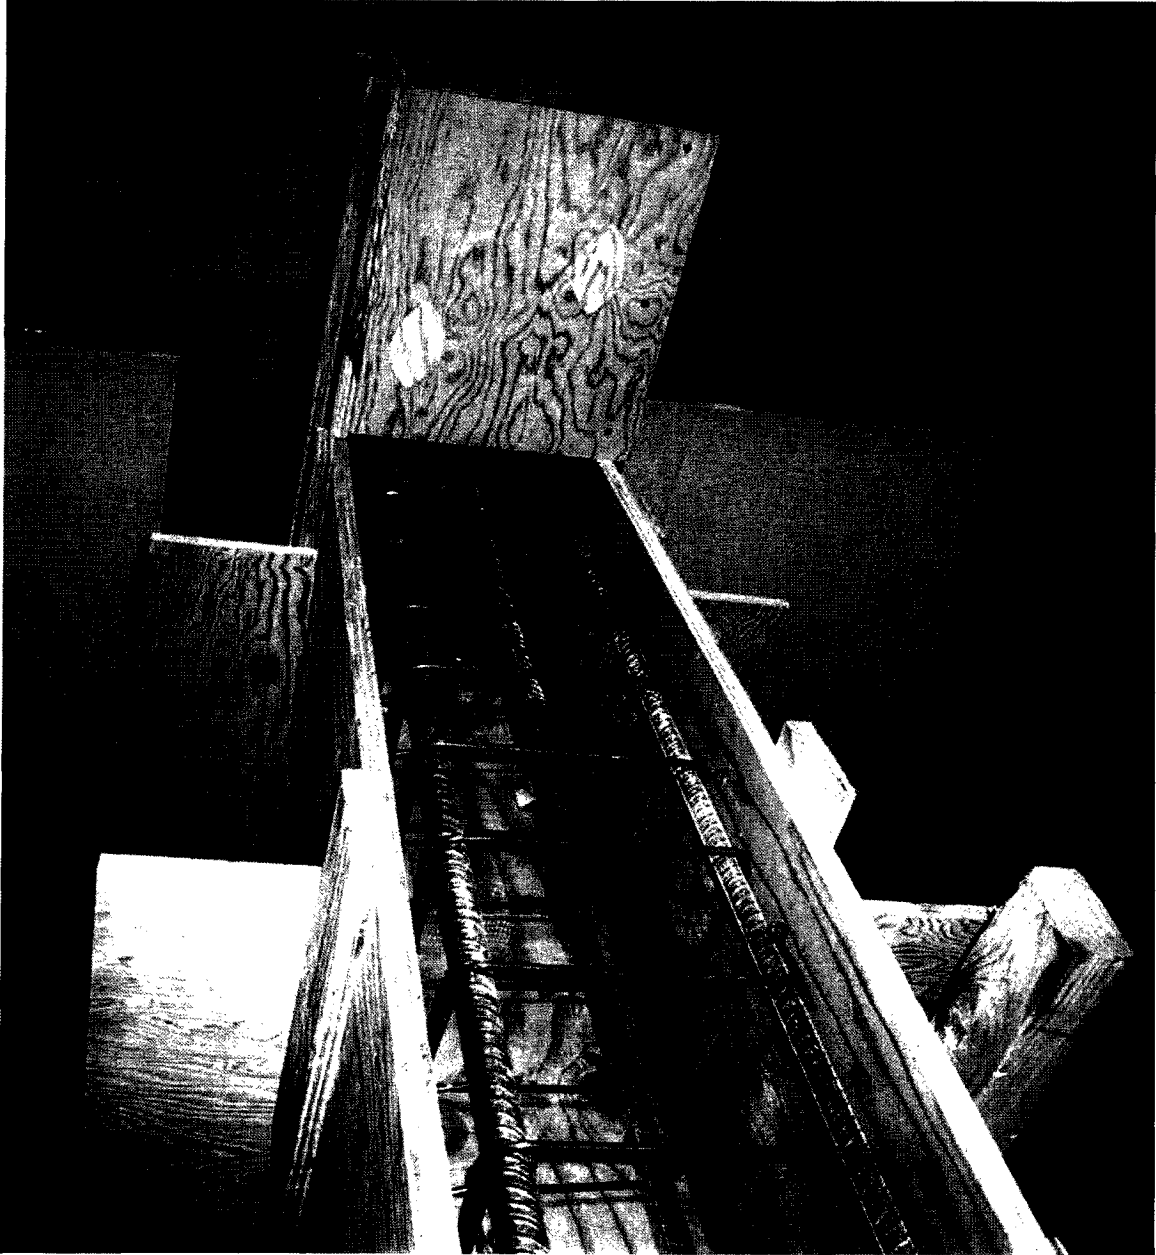
Figure 3.12: Complete frame formwork

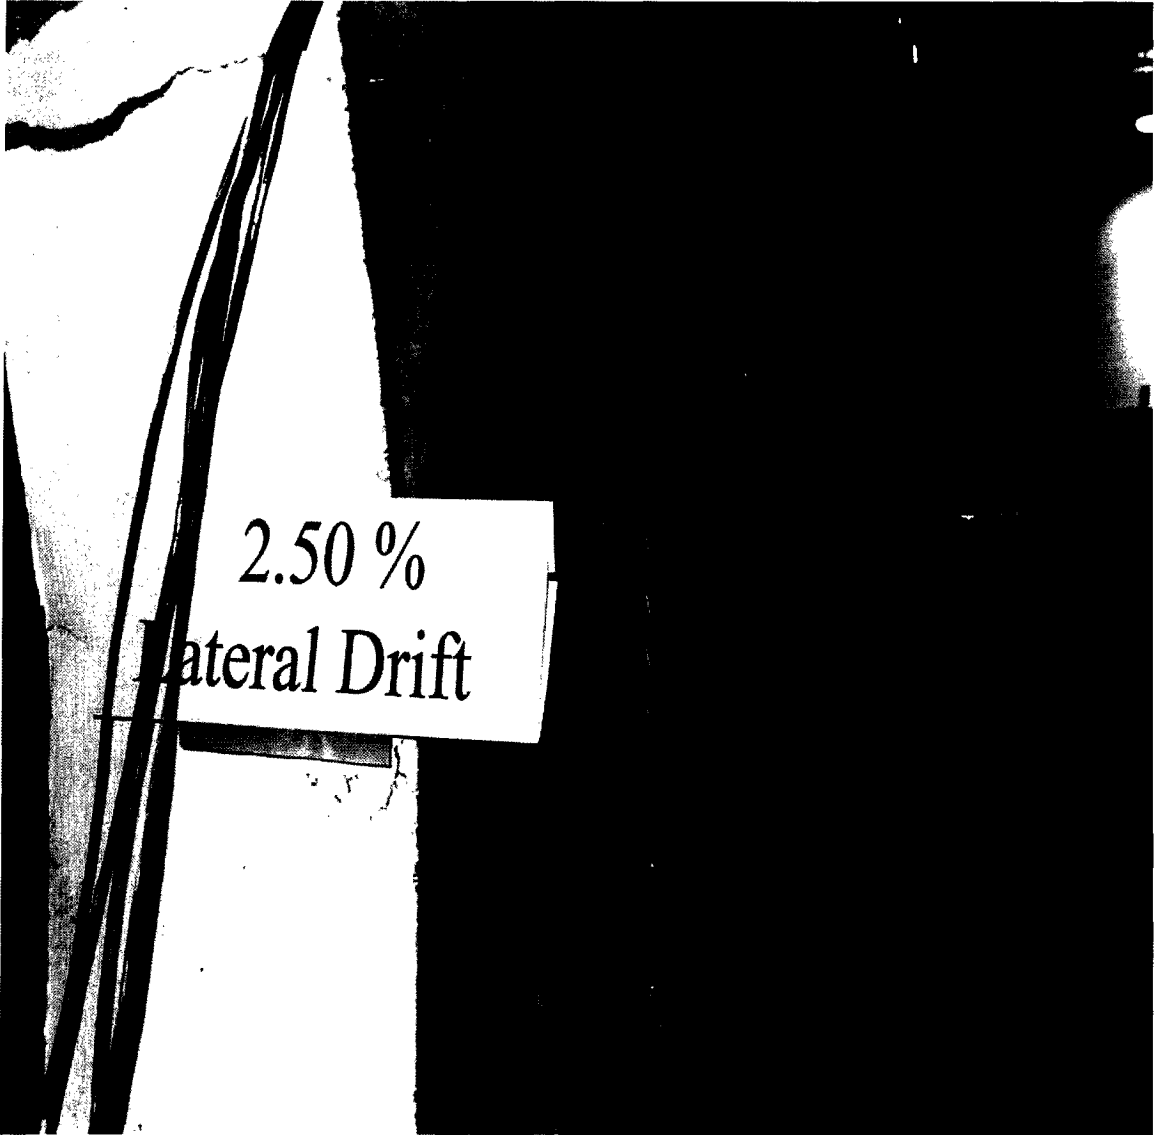
Figure 4.13: Failure of masonry and buckling of column bars at 2.5 % lateral drift (BR-1)

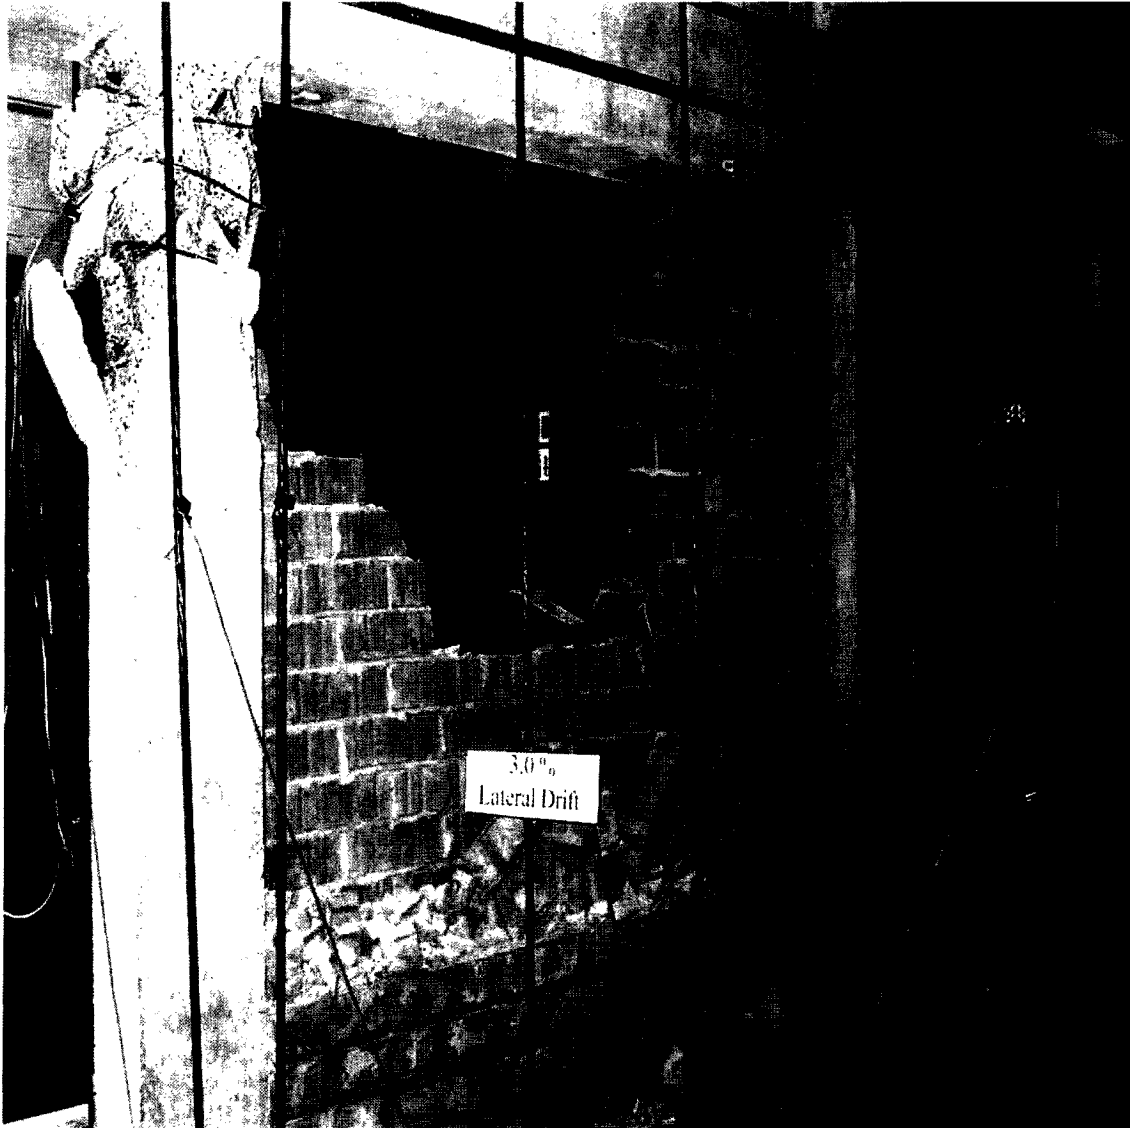
Figure 4.15: Deterioration of specimen BR-1 at 3 % lateral drift (front view)
