**An Integrated Framework for Image Acquisition, Processing, and Analysis  
Procedure for Automated Damage Evaluation of Concrete Surface**

**MASTER OF APPLIED SCIENCE**

in Civil Engineering

**University of Ottawa**

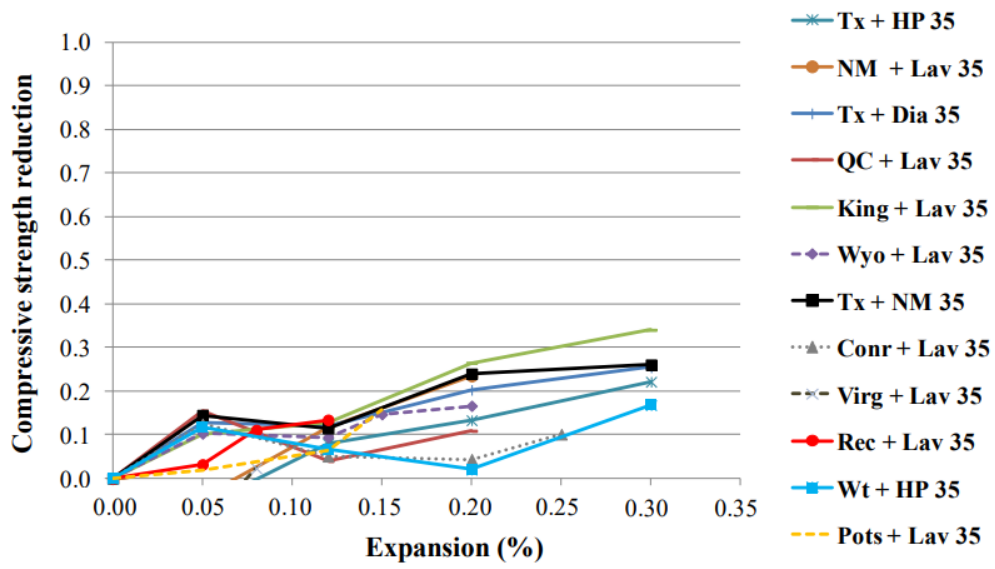
In Figure 2.4, Sanchez et al. (2014) presented the result of mechanical properties reduction under free expansion condition for different 35 MPa mixtures combinations [1]. The compressive strength loss is approximately 10% at an expansion of 0.05%, rising to between 10% and 20% at

These findings evidence that concrete exposed to ASR-induced expansion experiences a severer reduction in tensile strength and elastic modulus, especially at medium to low expansion levels (0.05% and 0.12%) when compared to the reduction in compressive strength. At high expansion levels (0.30% and above), all mechanical properties witness a substantial reduction yield to 60%. Moreover, the results above insights that mixtures containing different types of aggregate present a distinct influence (up to 30%) on mechanical properties under the same expansion level [1].

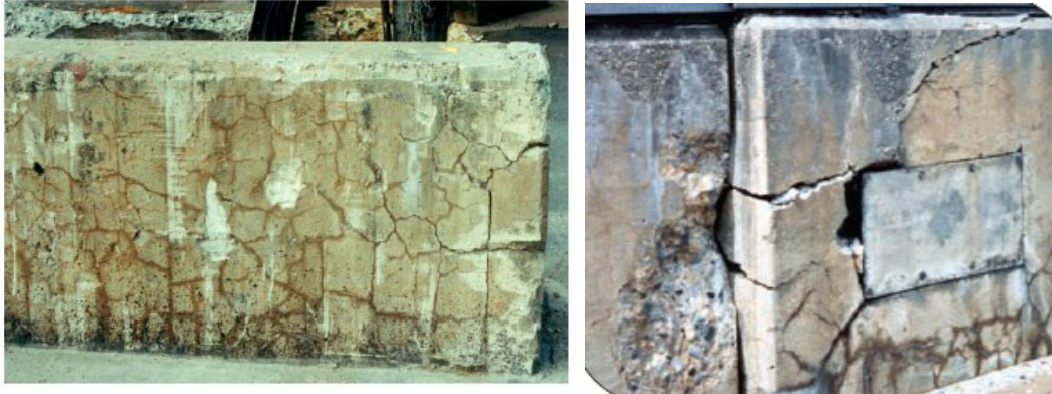
ASR has become a typical threat to many existing concrete structures in terms of long-term durability [3,18]. Figure 2.5 [3,15] depicts damaged concrete elements severely affected by ASR. In addition to affecting the mechanical properties of concrete elements, ASR also can cause permanent deformation, cracking, spalling, extrusion of joint materials, and 'ASR gel' exudation. According to CSA A864-00 (2005) [21], ASR begins with the presence of a minimal amount of 'ASR gel'. As ASR progresses to moderate or significant levels, surface-level cracking and micro-cracking become evident, along with the darkening of the cement paste around known reactive aggregate particles. In severely affected concrete, expansion induced by swelling pressure can be positively identified at locations ASR-gel emanates from aggregates that have reacted and cracked, extending into the adjacent cement paste, significant amount of gel can be observed in cracks

*Figure 2.5: Typical ASR damaged concrete element with presence of spalling, deformation, joint closing, map cracking with the presence of gel product [3].*

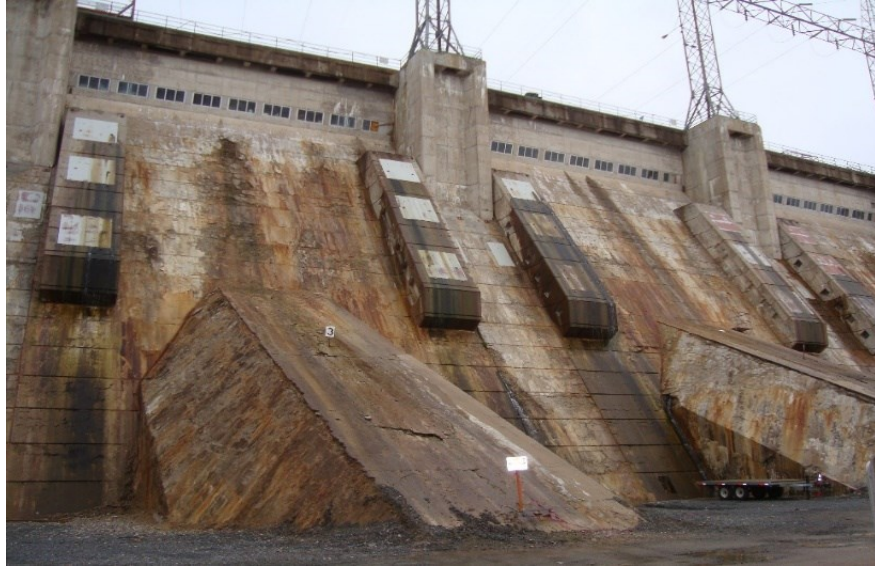
*Figure 2.6 : Mactaquac Dam in New Brunswick, Canada affected by ASR [24].*

Recent studies have specifically focused on the impact of ASR on critical infrastructure elements, including concrete dams and bridges [18,22,23]. In the mid-1980s, both Canada and the United States discovered that the Mactaquac Dam in New Brunswick, Canada, which had been commissioned for hydroelectric power generation in the 1960s, had been adversely affected by ASR. Millions of dollars are spent annually to reduce the expansion and prolong the service life of the dam since the discovery of ASR in the concrete material of the dam [24]. Consequently, the decision was made to decommission the dam due to the prohibitive cost of repairs. Notably, the Mactaquac Dam has experienced an expansion in height of approximately 230 mm since its initial construction in early 1980s, and extensive cracks can be observed throughout the entire structure (Figure 2.6). The dam has since been the subject of the “Life Achievement” project aiming to achieve its intended 100-year service life [24].

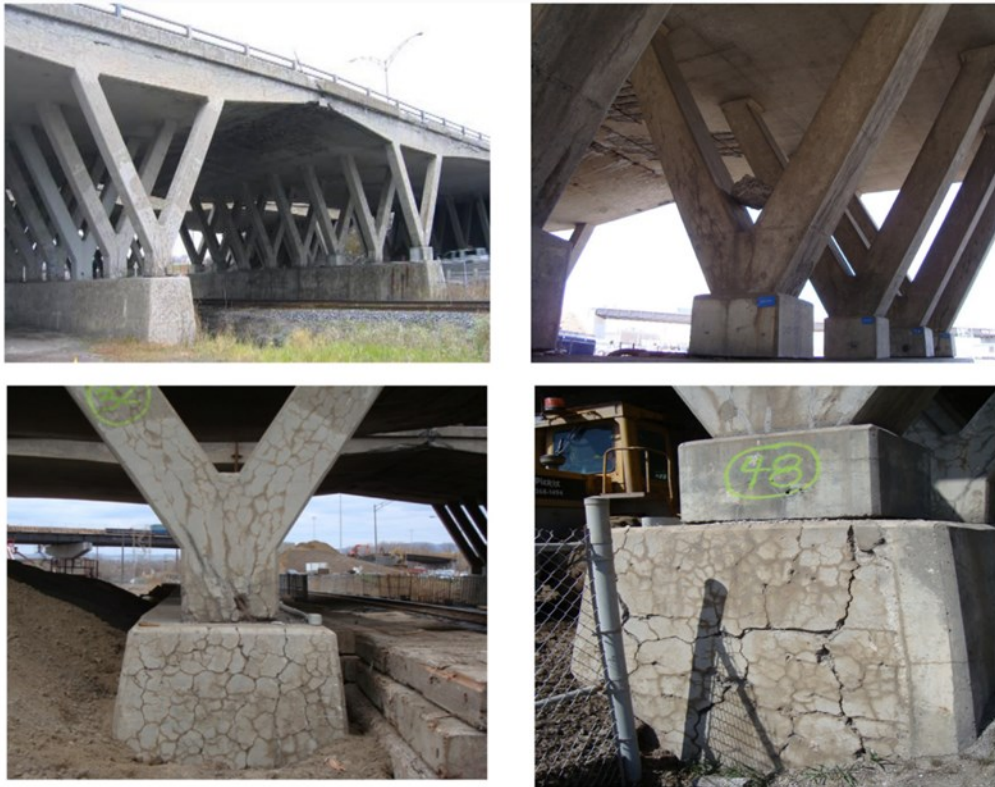
The Robert-Bourassa/Charest (RBC) overpass, located in Quebec, Canada (*Figure 2.7*), was a highway bridge constructed in 1966 using alkali-silica reactive limestone aggregate. Over the past 50 years, the RBC's structural elements exhibited numerous damages, largely attributed to the effects of ASR and freeze-thaw cycles, including extensive steel corrosion and concrete delamination/spalling on the bridge deck, as well as map cracking, scaling, disintegration, and pop-outs on the massive concrete foundations of the reinforced concrete supporting columns. The overpass was commissioned for demolition in 2010/2011.

*Figure 2.7: Robert-Bourassa/Charest (RBC) overpass affected by ASR in 50 years of service [3].*

Researchers have conducted a multi-level assessment of the damage extent to various concrete elements demolished from RBC [3]. Compressive strength tests showed that a significant number of samples from foundation blocks and bridge decks had strength results lower than the expected design values, with stiffness loss up to 50%, compress strength loss up to 20%, and tensile strength

loss up to 60%, raising concerns about the overpass's integrity to bear service loads as designed and in accordance with Canadian standards and safety protocols.

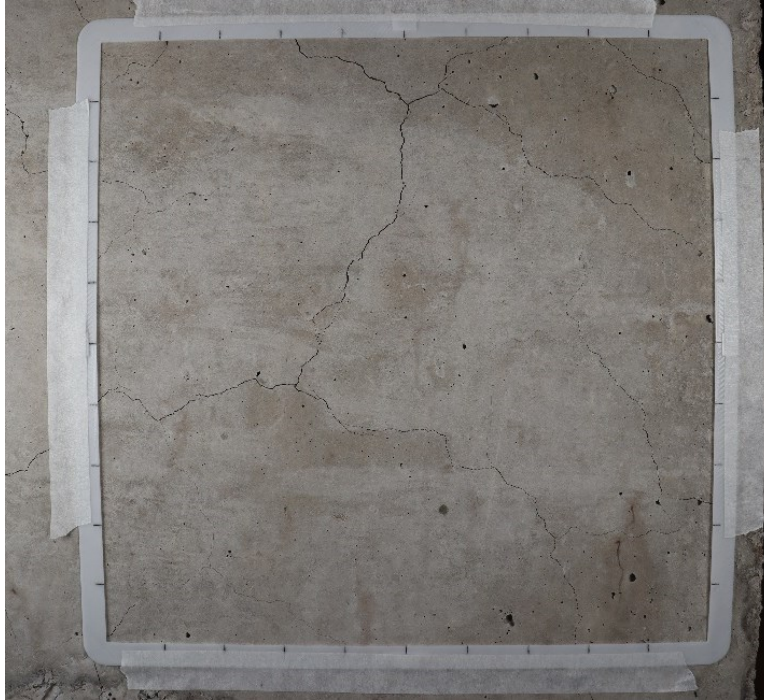
As shown in Figure 2.8, each CI reference grid should contain a “measurable amount of cracking”. These grids serve as visual reference points for quantifying and documenting the extent of cracking in the concrete structure. By strategically placing the reference grids on the most affected areas, a quantifying evaluation can be conducted to assess the severity of cracking. To measure the width of cracks on the surface of the investigated element, a magnifying lens with a plastic crack comparator card is required for precision. Each line drawn on the surface should be divided by 10 intervals as reference points and tabulating the crack amount and width in 10 steps for each side, this is to help the measurement can be documented correctly and efficiently.

*Figure 2.8: A typical cracking index layout on a concrete surface using a 3D-printed reference grid.*

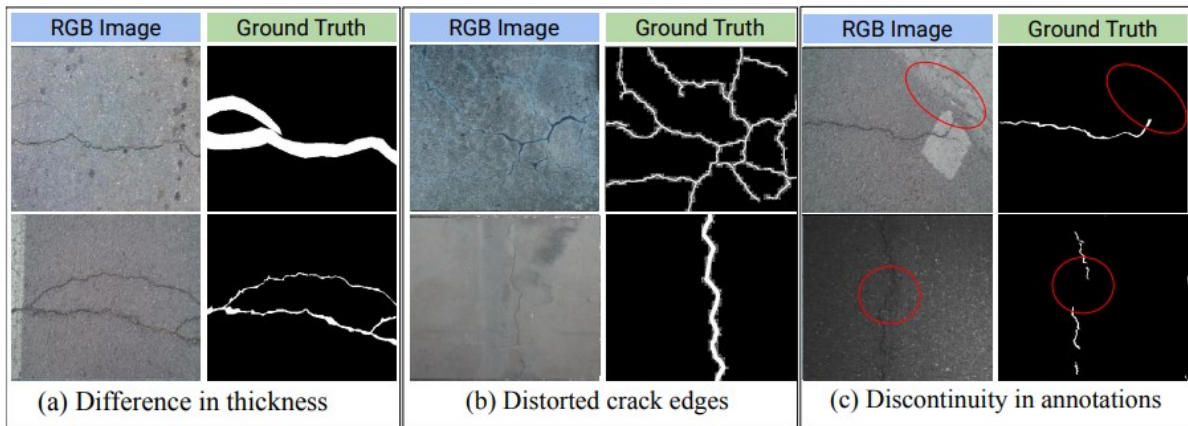
are not available to public). As depicted in Figure 2.12 [42], the results highlight the inaccuracies that stem from training on unannotated images, potentially compromising the precision of damage estimation. Consequently, datasets enriched with crack annotations become a potential asset to address this limitation.

Figure 2.12: Inconsistent crack detection result through a trained R-CNN model [43].

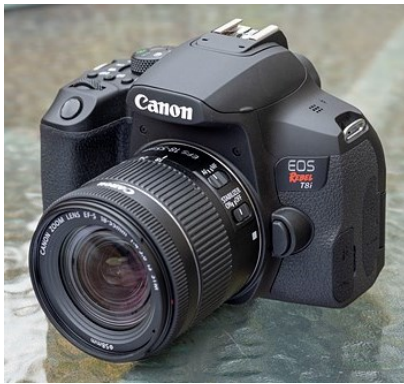
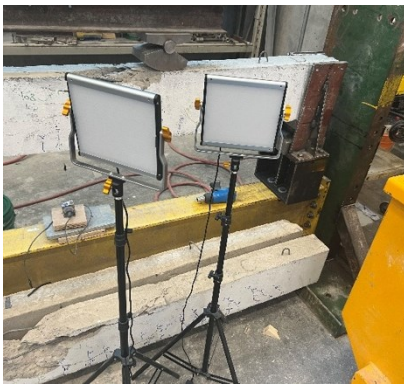
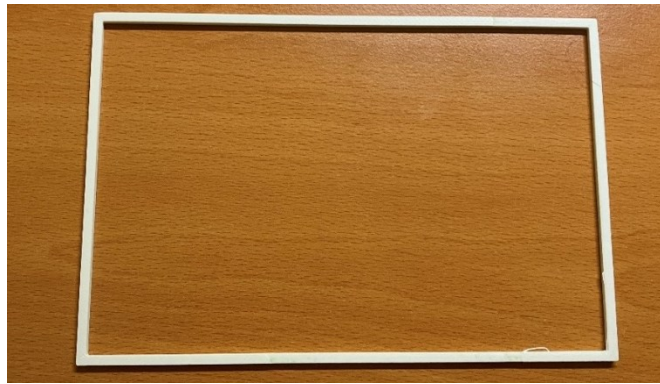
Figure 3.2: (a) A typical photographic DSLR camera with lens; (b) EOS utility software, remote shooting interface; (c) LED light Kits; (d) 3D Printed Reference Frames.

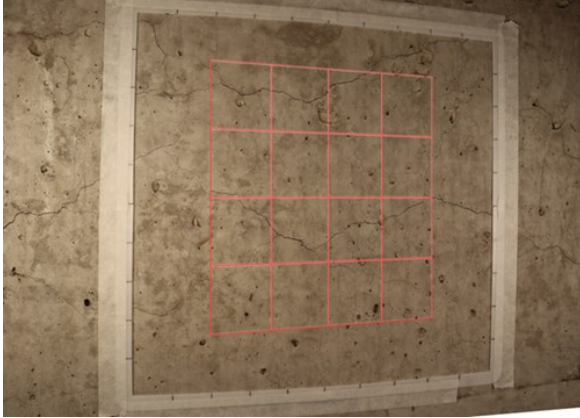
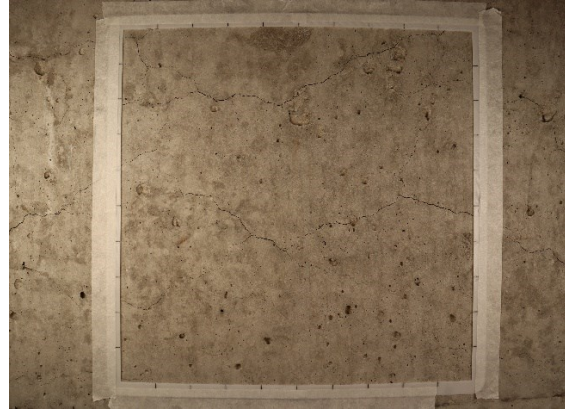
*Figure 3.3: (a) Image with perspective distortion, (b) image after perspective correction. Image (a) has the left side boarder wider than the right side, resulting in scale inconsistency for the whole image.*

Perspective distortion occurs when the imaging frame of the camera cannot remain parallel to the target plane when taking a photo. As shown in figure 3.2a, this distortion results in the image taking on a trapezoidal shape instead of retaining a square shape as it appears, hence the image fails to display the correct measurement. There are many approaches to

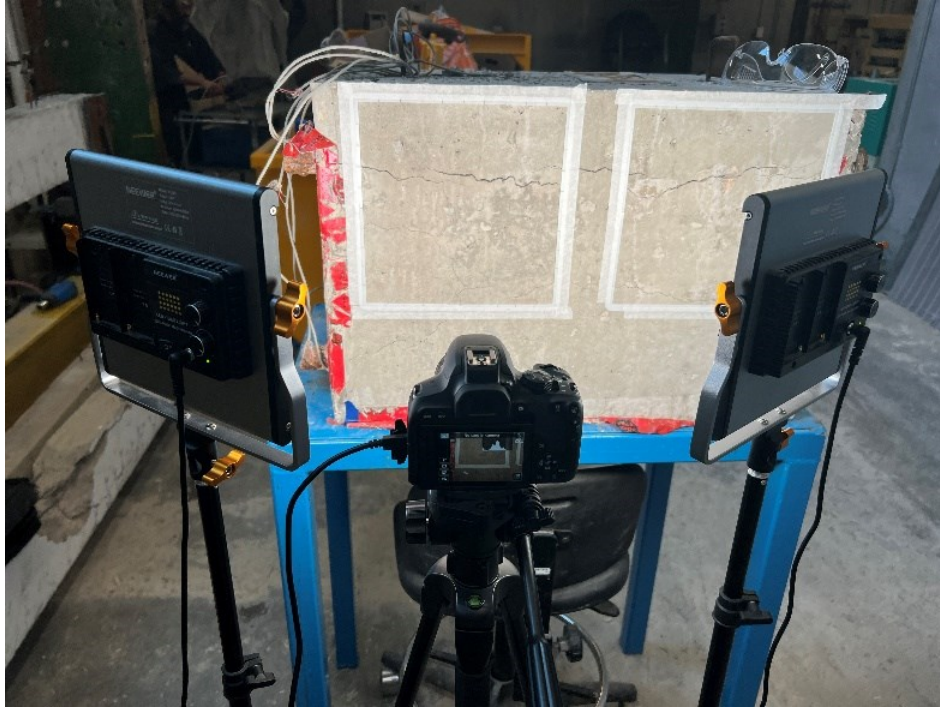
The image acquisition procedure involved setting up the equipment (Figure 3.4) capturing images under different lighting conditions: white (cold, 5600K), maximum yellow (warm 3200k), and white-yellow (daylight, 4800k). Nonetheless, camera settings and positioning for each image captured were kept consistent.

*Figure 3.4: Image acquisition setup.*

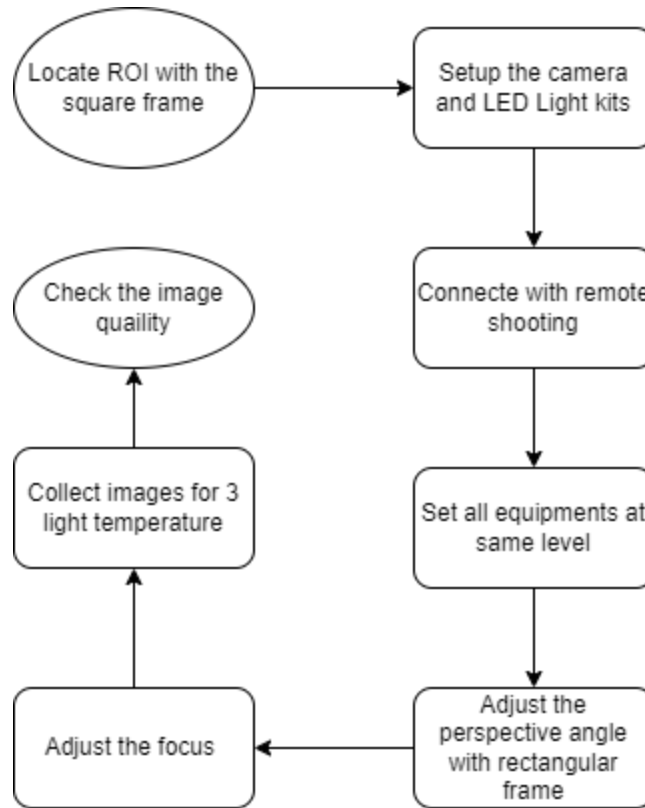
Figure 3.4 represents the flowchart regarding the step-by-step procedure for image acquisition. It is worth mentioning that the concrete blocks were lifted onto a table to allow for a comfortable working height thus, minimizing human error. The lights were placed on either side of the camera and the camera brought close to the surface of the concrete block until only the reference frame was brought into the field of view. The procedure will ensure that each image captured by camera can be fulfilled by the region of interest (ROI) with the maximum quality.

Figure 3.5: Image acquisition procedure flowchart.

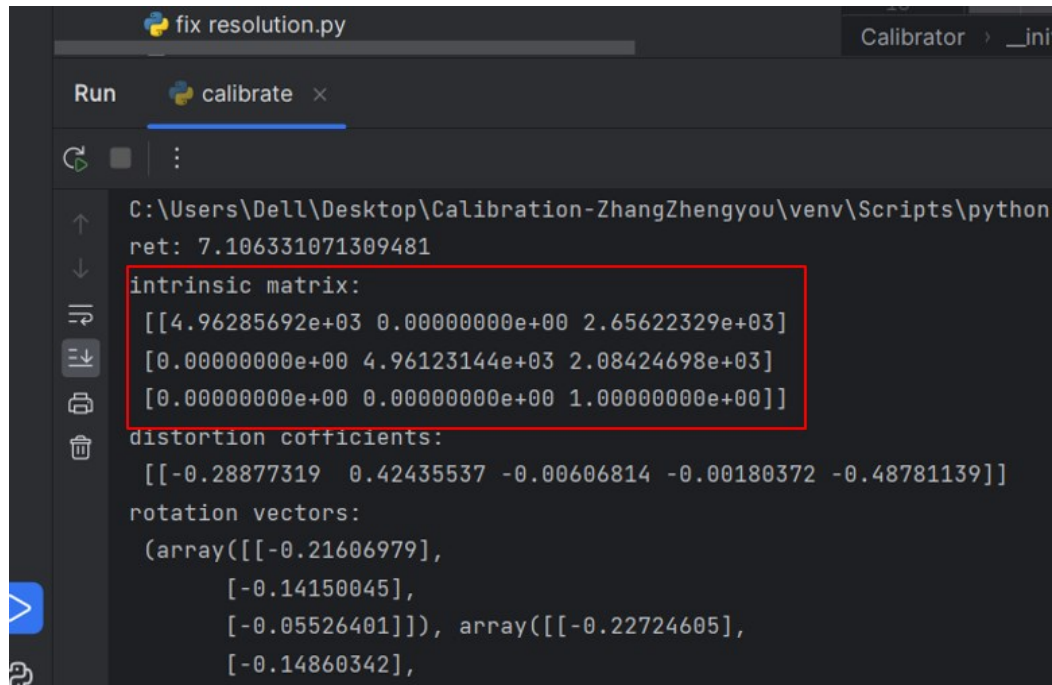
3. **Calculate camera parameters:** Calculating camera parameters involves utilizing the calibration algorithm to estimate intrinsic camera parameters as shown in Figure 3.10 (such as focal length, distortion coefficients and principal points) as well as extrinsic parameters (comprising rotation and translation vectors). These estimations are derived from the identified corners within the calibration images.

```
fix resolution.py
Run calibrate x
C:\Users\Dell\Desktop\Calibration-ZhangZhengyou\venv\Scripts\python
ret: 7.106331071309481
intrinsic matrix:
[[4.96285692e+03 0.00000000e+00 2.65622329e+03]
 [0.00000000e+00 4.96123144e+03 2.08424698e+03]
 [0.00000000e+00 0.00000000e+00 1.00000000e+00]]
distortion coefficients:
[[-0.28877319 0.42435537 -0.00606814 -0.00180372 -0.48781139]]
rotation vectors:
(array([[ -0.21606979],
        [ -0.14150045],
        [ -0.05526401]]), array([[ -0.22724605],
        [ -0.14860342],
```

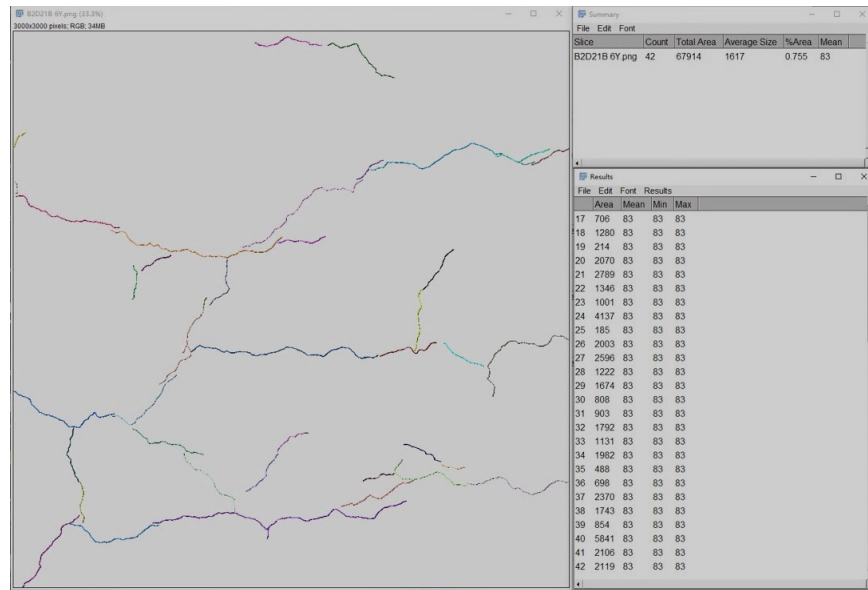
Figure 3.15: Generating result for crack area in pixel wise. (a) Transform the image to 8-bit grayscale, (b) adjust the threshold bar to encompass the relevant color range in the image, (c) Perform particle analysis, spreadsheet will be generated.

The results exported entail the number of cracks along with their length after which the calculation for the Total Crack Length can be applied (i.e., total crack length over analyzed area). The results are not limited to lengths but can also describe preferential crack orientation and lengths, etc. which will be further shown in the “Results” and discussed in the “Discussion” section. Figure 3.16 summarizes the essential steps used in this study. Crack counts may also be selected for output however, due to the length of cracks, the counts were not part of the metrics used in this study. Nevertheless, this study's methodology aims to enhance the accuracy of crack assessment through image analysis as opposed to manual measurement.

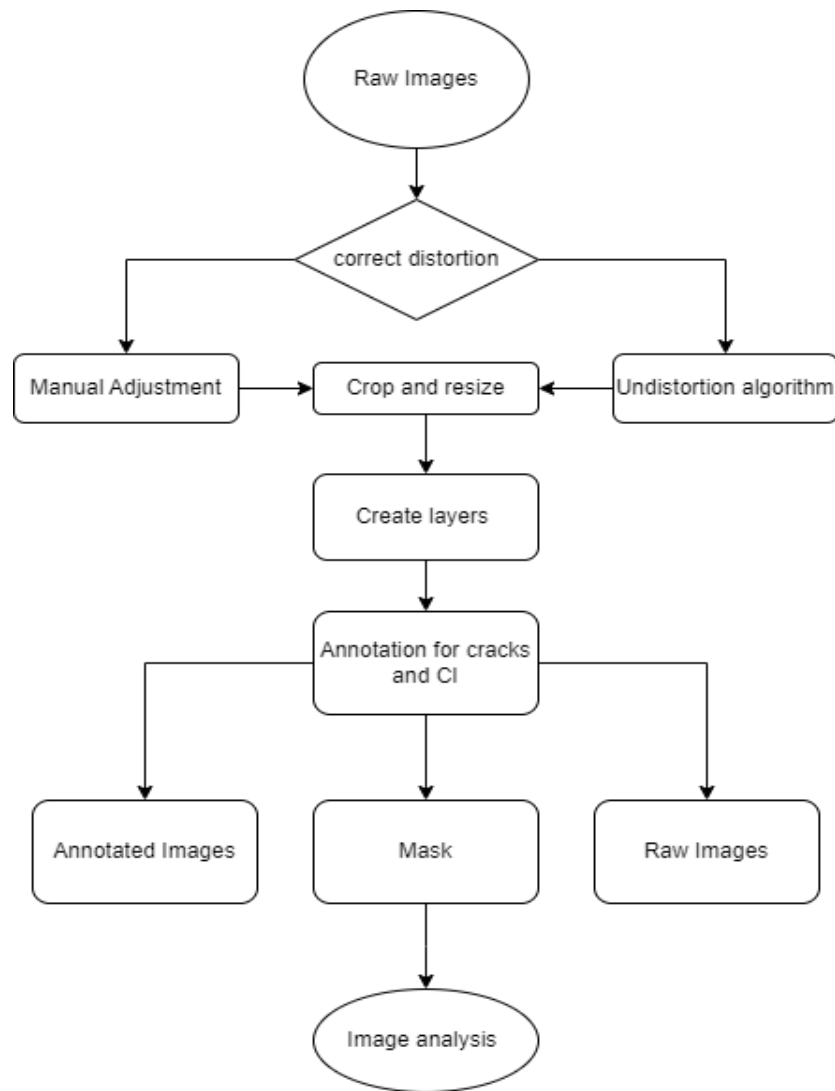
Figure 3.16: Image processing flowchart.

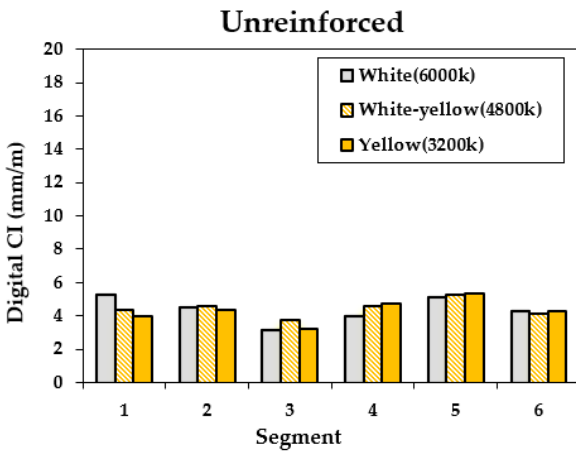
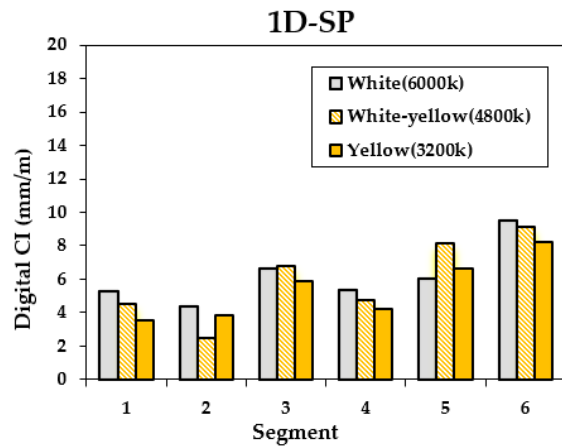
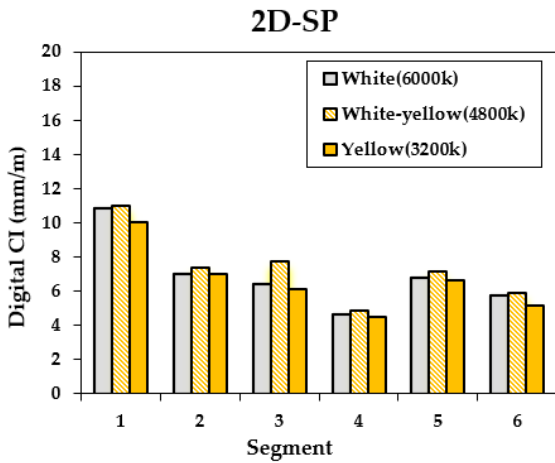
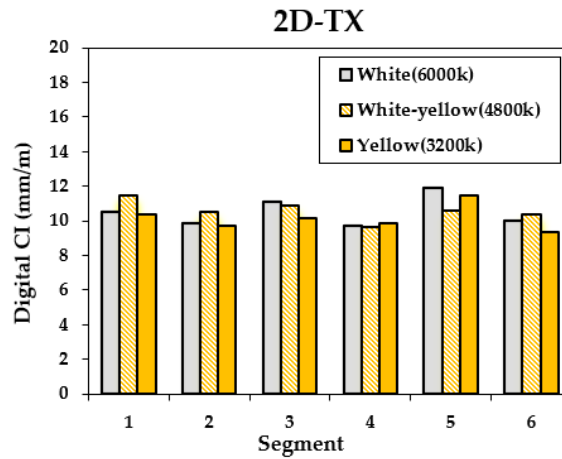
Figure 3.17: Comparison for 3 light conditions among 24 image segments. a) Cracking index (mm/m), and b) Cracking density (mm/m<sup>2</sup>).
