Ph.D. (Civil Engineering)

Department of Civil Engineering

**Seismic Retrofit and Repair of Existing Reinforced Concrete Bridge Columns by Transverse
Prestressing**

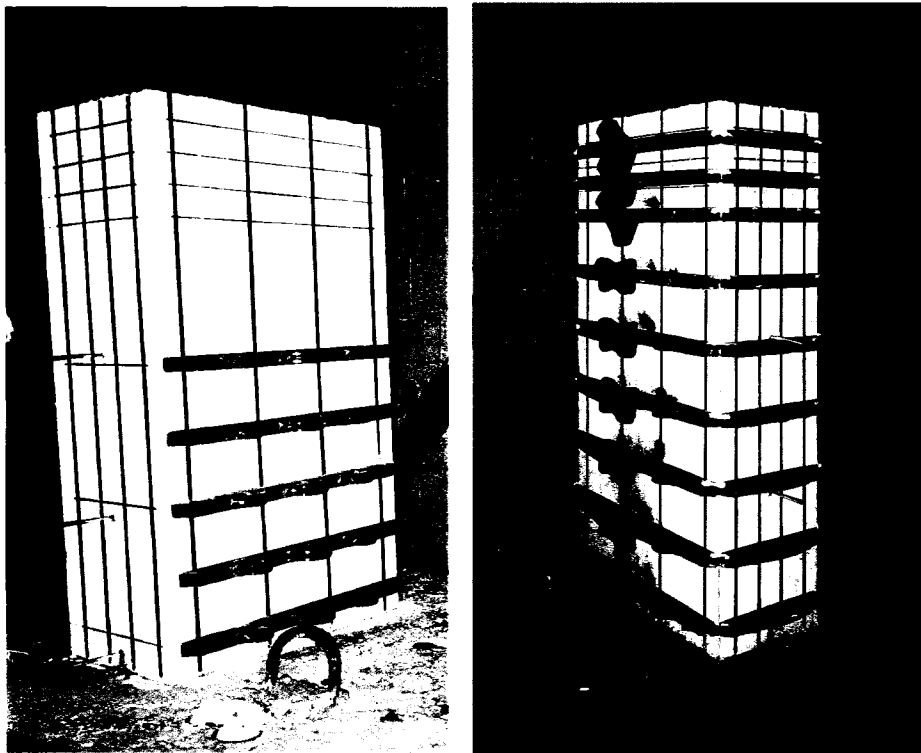
Figure 2.3 Installation of Retro-belt on rectangular and square columns

a) Retrofitting a rectangular column

b) Repairing a square column

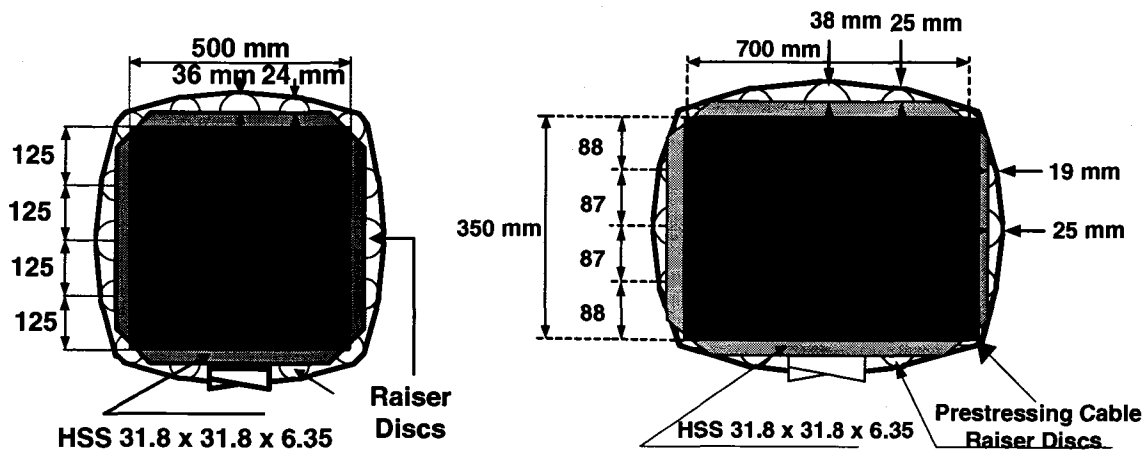
Figure 2.10 Details of raiser frames

b) Repair columns

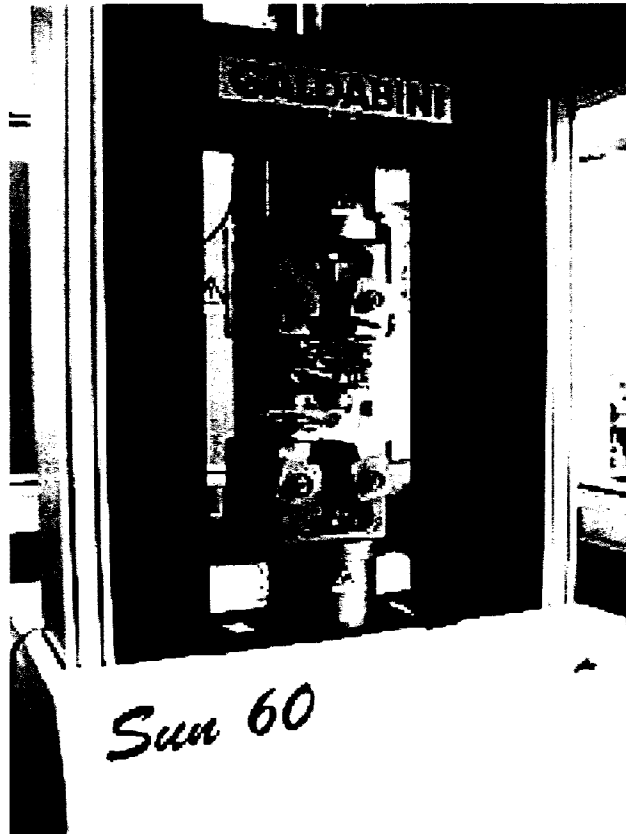
Figure 2.20 Standard coupon tests for longitudinal and transverse reinforcement

a) Galdabini universal testing machine

b) Steel coupons prior to testing

c) Steel coupons after testing

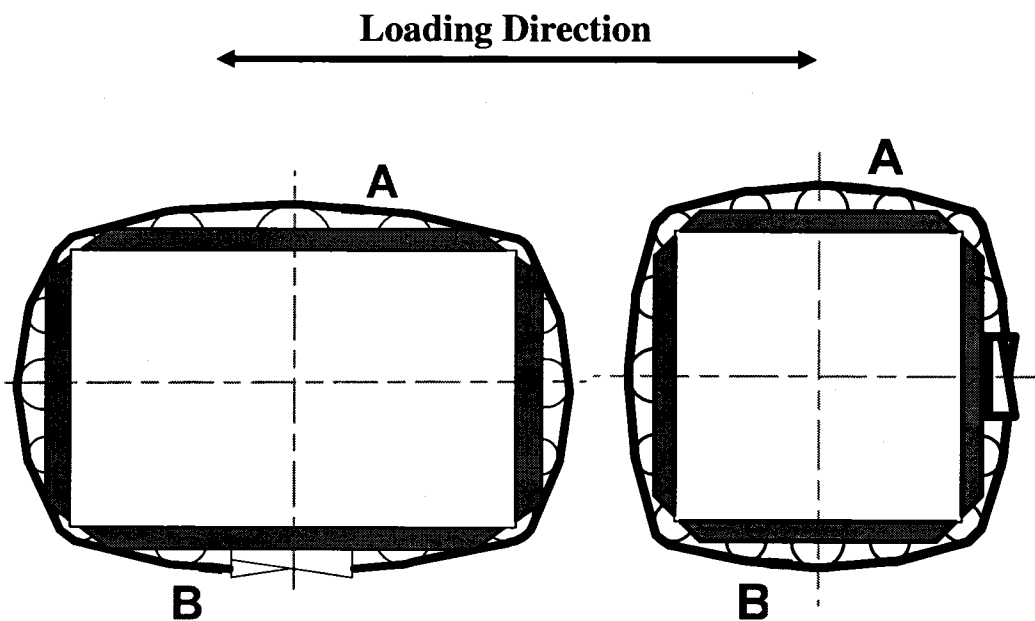
Figure 2.34 Strain gauge locations on prestressing strands

b) Repaired Columns

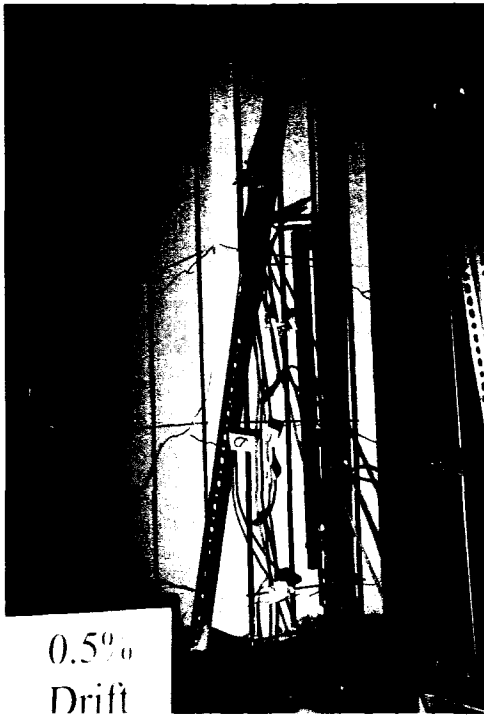
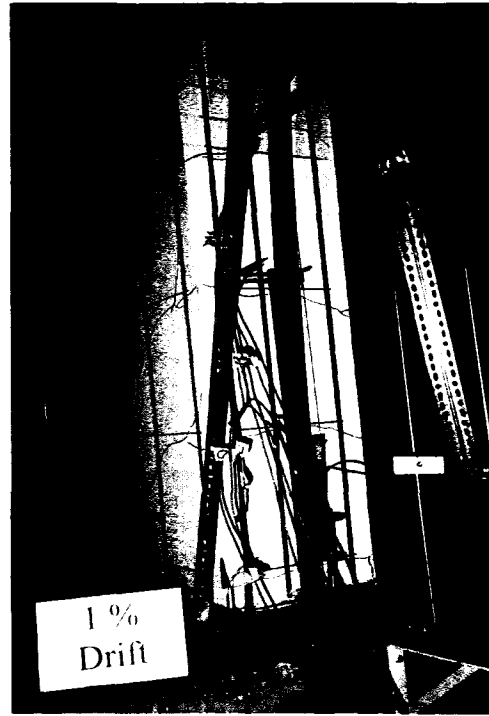
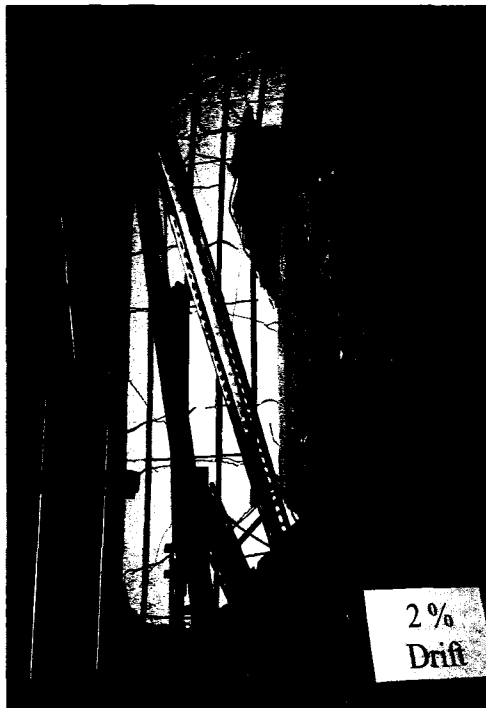
Figure 3.1 Behaviour of Column SR-C

a) 0.5% Drift

b) 1% Drift

c) 2% Drift

d) After the test

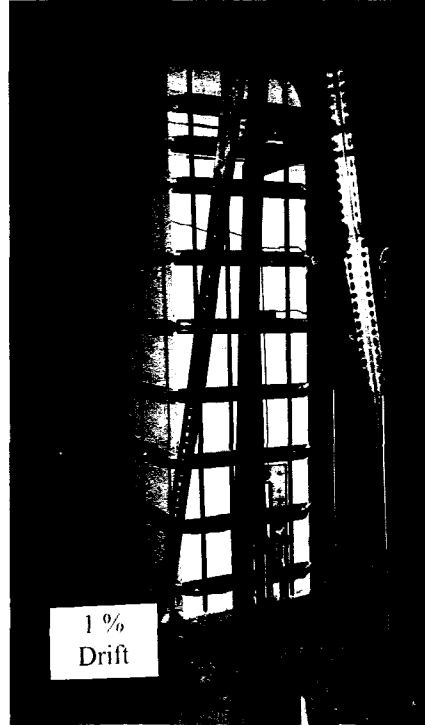
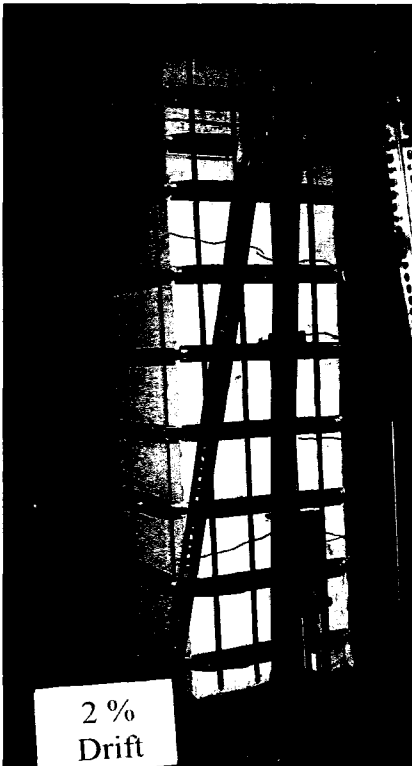
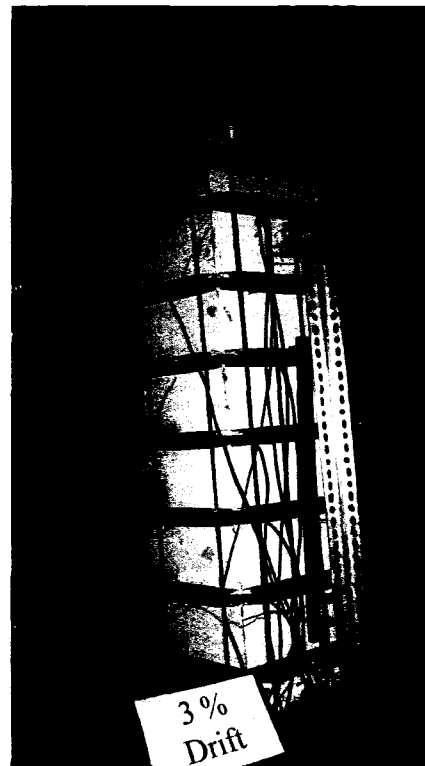
Figure 3.5 Behaviour of Column SR-R

b) 1% drift

c) 2% drift

d) 3% drift

Figure 3.5 illustrates the column behavior with photographs taken during various stages of loading. It also shows the column at the end of 3% drift cycles with virtually no damage. The hysteretic force and moment-lateral drift relationships are plotted in Figure 3.6 showing stable loops until after 4% lateral drift ratio.

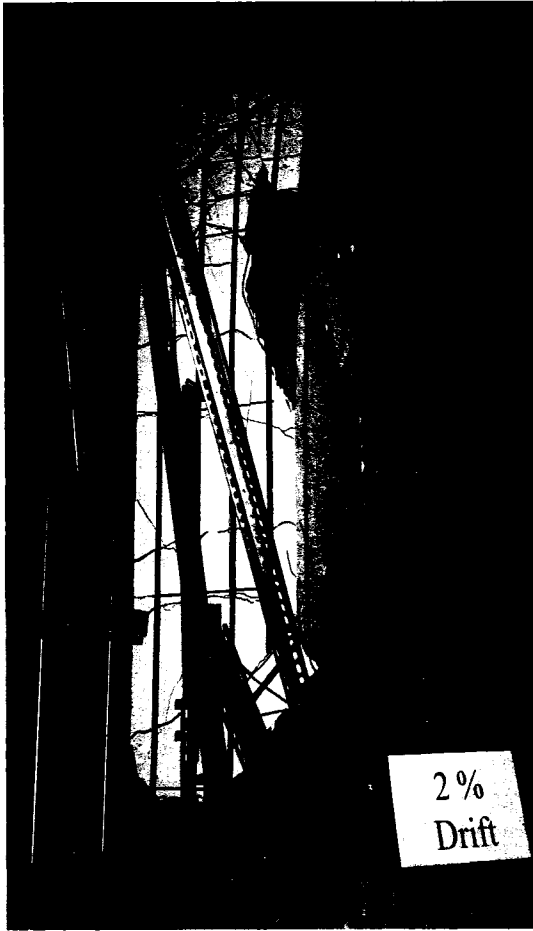
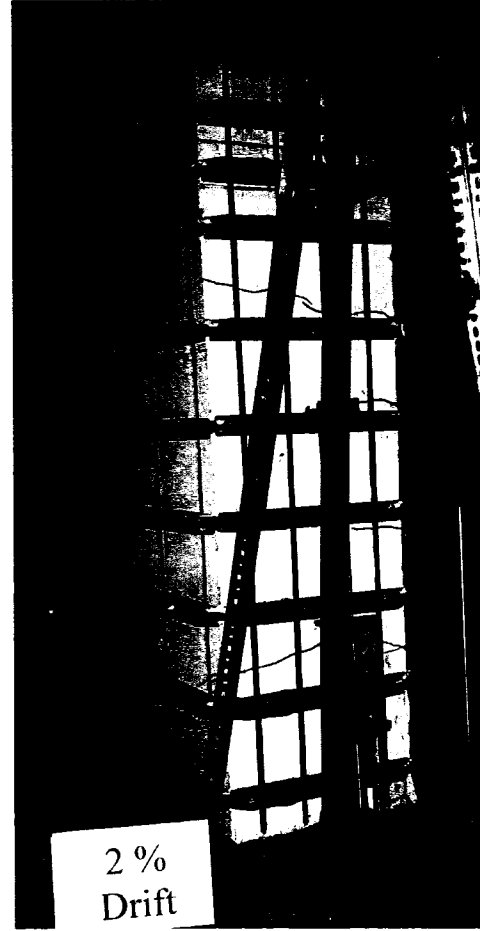
Figure 3.9 Comparison of columns SR-C and SR-R after the test (Pictures)

a) SR-C at 2% Drift Level

b) SR-R at 2% Drift Level

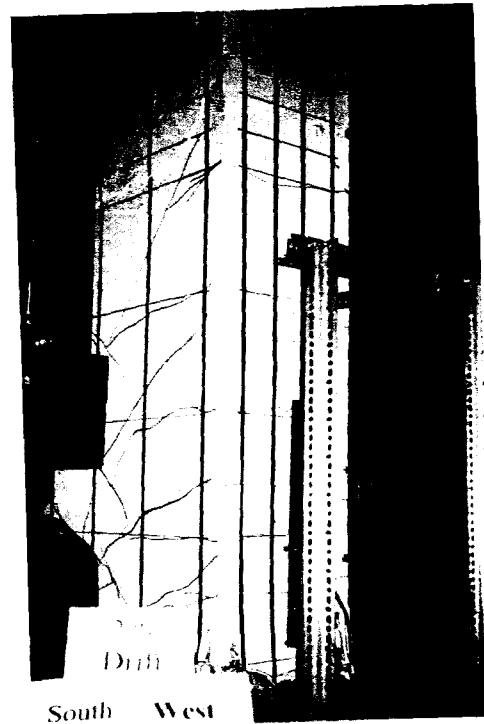
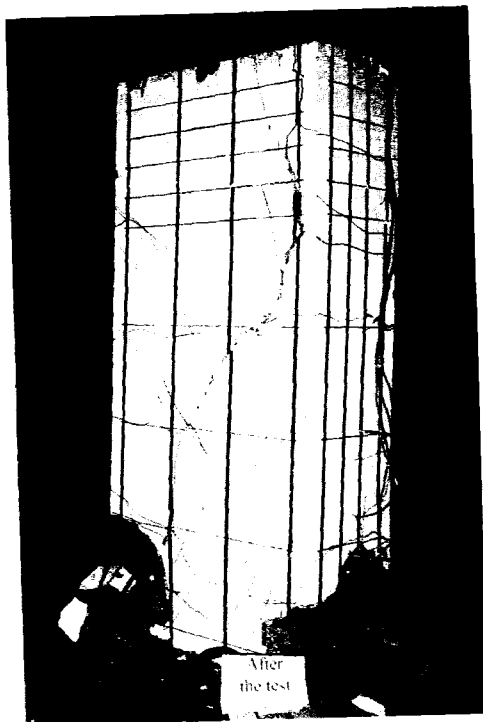
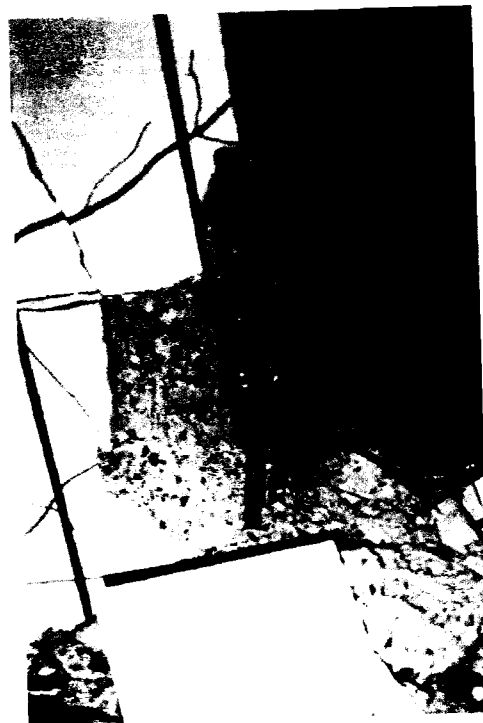
Figure 3.10 Behaviour of Column LR-C

b) 2% drift

c) After the test

The performance of Column LR-C during various stages of loading is demonstrated in Figure 3.10. Initial flexural cracks perpendicular to the loading direction and shear cracks on the side faces formed as early as the second cycle of 0.5% drift ratio mainly in the lower half of the column. The longitudinal reinforcement started yielding at this drift level while the hoops did not yield until 2% drift ratio. Lateral load resistance at this stage of loading was 319 kN, which was increased to 415 kN during the first cycle at 1% drift ratio. During this cycle, the strains in longitudinal reinforcement increased well beyond the yield strain(ϵ_y), as the number of flexural cracks increased and widened. The number of shear cracks also increased during this level of deformation on the side faces. The lateral load resistance was 402 kN during the first cycle at 1.5 % drift ratio. Visible signs of cover crushing and spalling were observed on the compression side near the base. During the third cycle of the same drift level, vertical cracks were noticed along the longitudinal reinforcement. These cracks propagated towards the top, within the lower half of the column, signifying the onset of further cover spalling. The flexural cracks also propagated further towards the compression zone as the column was deformed to 2% lateral drift. The cover spalled off completely at the second hoop level, 375 mm above the column-footing interface, exposing the reinforcement cage. Strength decay was observed as the column was deformed to 2.5% drift ratio. The load resistance dropped from 388 kN during the first cycle to 287 kN during the third cycle. Finally, the longitudinal reinforcement buckled in compression and the test was discontinued. Figure 3.10(c) shows a picture taken after the test, illustrating the buckling of all the bars between the first and second ties. One of the

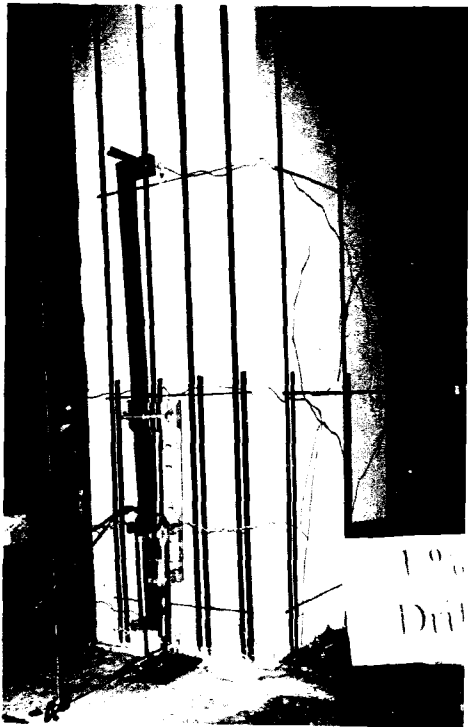
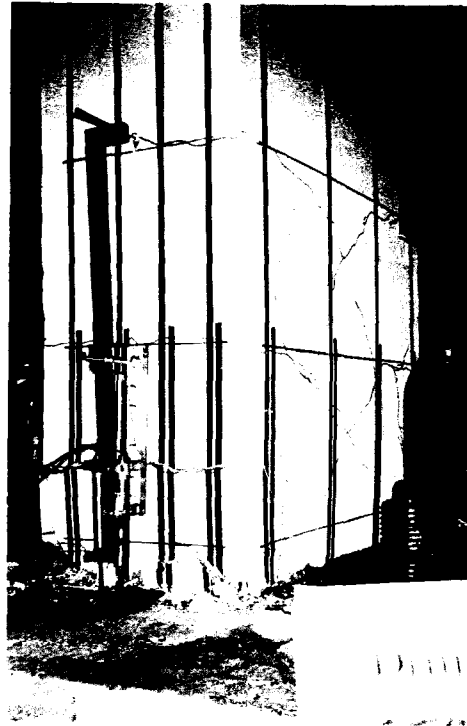
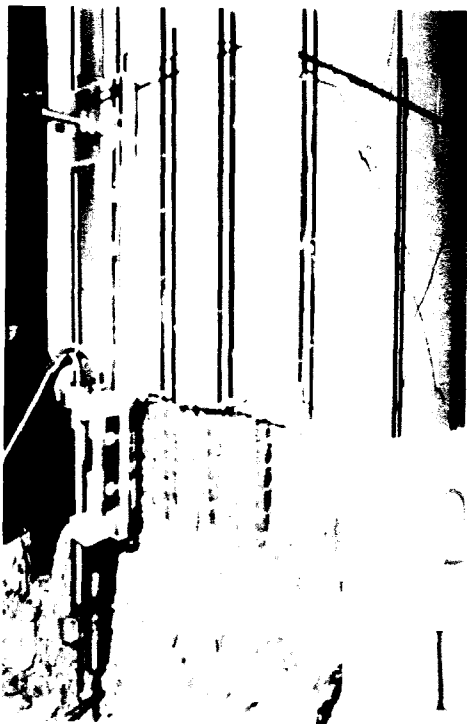
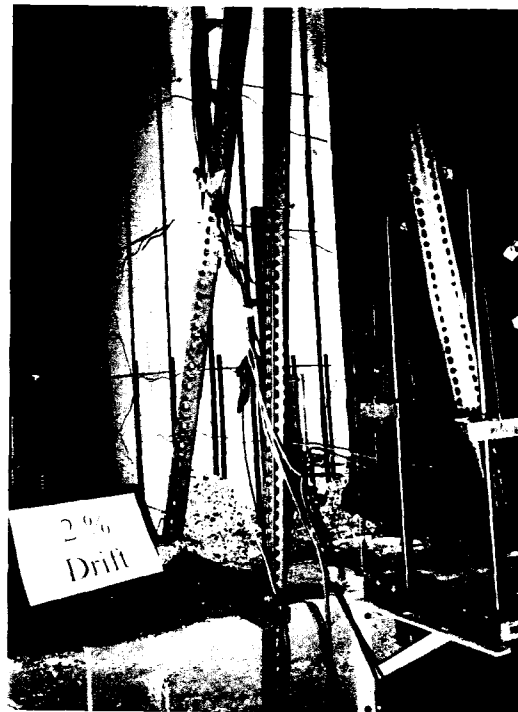
Figure 3.18 Behaviour of Column LS-C

a) 1% drift

b) 1.5% drift

c) 2% drift

d) 2% drift

Column LS-C was representative of a flexural dominant rectangular column with lap splices in the potential hinging region. It was the control column which reflected non-seismic design practices utilized in existing bridge columns. The shear span was long enough to promote flexure dominant response with spliced reinforcement subjected to critical flexural tension near the column base. The observed damage during testing is illustrated in Figure 3.18, showing the slippage of reinforcement as the failure mode.

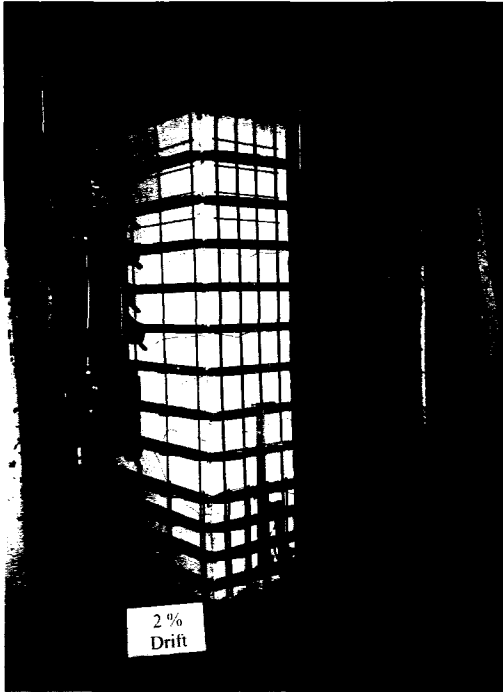
Figure 3.22 Behaviour of Column LS-R

a) 2% drift

d) 6% drift

Column LS-R was the companion column to LS-C with identical geometric and material properties. However, this column was retrofitted by external prestressing in transverse direction, as explained earlier. The same loading scheme that was used for the former column was also used for this column. Damage observed at various stages of testing is shown in Figure 3.22.

The first flexural hairline crack was observed during the third cycle of 0.5% drift. The number of flexural cracks increased during deformation cycles at 1% drift ratio. A crack formed at the column footing interface during the second cycle at 1% drift ratio. The first shear crack was also observed on one of the side faces during the same load stage, at the 2nd deformation cycle, when the lateral force was 460 kN. The third cycle at 1% drift ratio resulted in more hairline shear cracks on the side faces. Strain gauges located on dowels showed that they started yielding at the first cycle of 1% drift ratio. This is illustrated in Figure A.13. The crack at the column-footing interface widened and became longer during the 2nd cycle at 1.5% drift ratio. During the cycles of 2 % drift, more hairline shear cracks formed on the side faces while the previous cracks became longer. Flexural cracks widened up to 1 mm indicating an increase in the anchorage slip, as demonstrated in Figure 3.25. One of the LVDT’s used to measure anchorage slip reached its stroke limit and could not record displacements beyond 20 mm, as shown in Fig. 3.25, resulting in error in data beyond this level of slippage. Some crushing of cover concrete was observed near the base at 3% lateral drift ratio and the longitudinal reinforcement started yielding at this drift ratio. Increased diagonal shear cracks were observed during the 4% drift cycles, with the widening of one

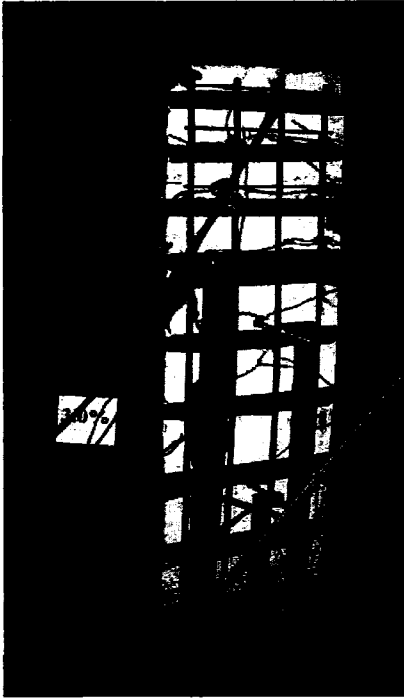
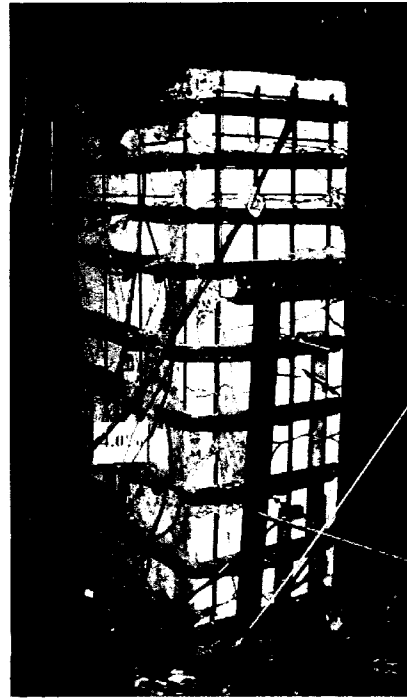
Figure 3.43 Behaviour of Column RR-R

a) 3% drift

b) 4% drift

a) 5% drift

b) 6% drift

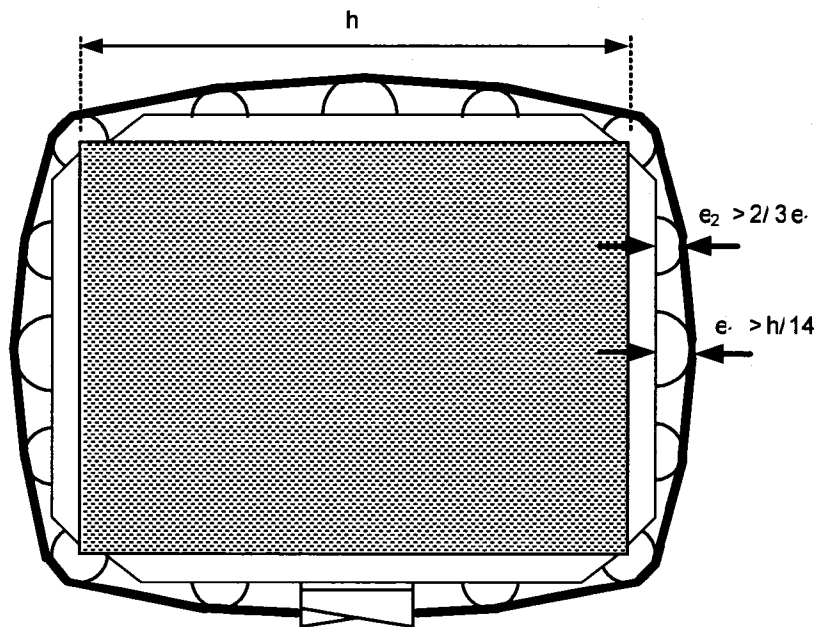
Figure 4.13 Recommended design dimensions for prestressing hardware

Layout for Shear and Confinement
