BLAST RETROFIT OF UNREINFORCED MASONRY WALLS USING ECC SHOTCRETE

Thesis submitted to the
Faculty of Graduate Studies and Research
in partial fulfillment of the requirements for the degree of
Master of Applied Sciences
in Civil Engineering

Department of Civil Engineering
Faculty of Engineering
University of Ottawa

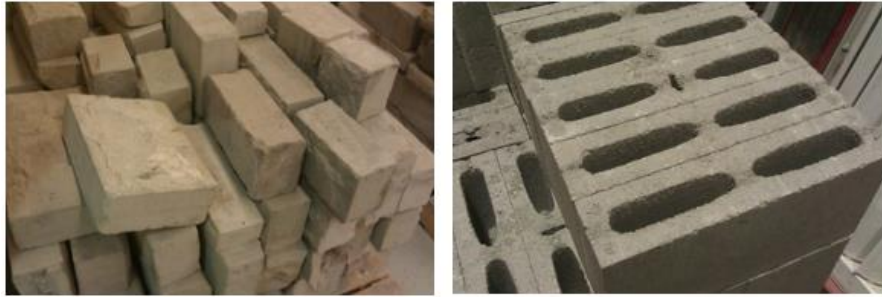
Figure 2-2. A) Stone Blocks and B) CMU blocks

industry, they are commonly found in older or historical buildings. **Figure 2-2** shows an example of the stone and CMU blocks used in this research.

Stone blocks are available “in a virtually limitless range of sizes and shapes, varying from brick-size units to storey-height panel” (Drysdale and Hamid, 2005). The stones used in this research were sedimentary in origin and came in three different sizes: small (90x60x600mm), medium (90x135x600mm), and large (90x200x600mm). While stone blocks are still being used in the

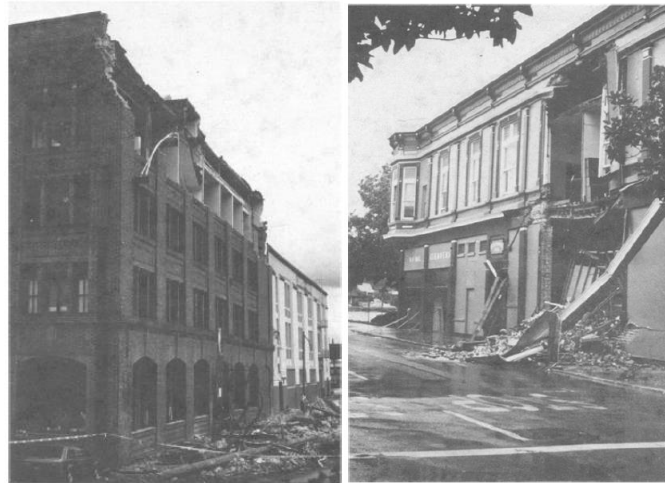
Figure 2-4. Examples of Out-of-plane failure of URM walls caused by earthquakes (Bruneau, 1994)

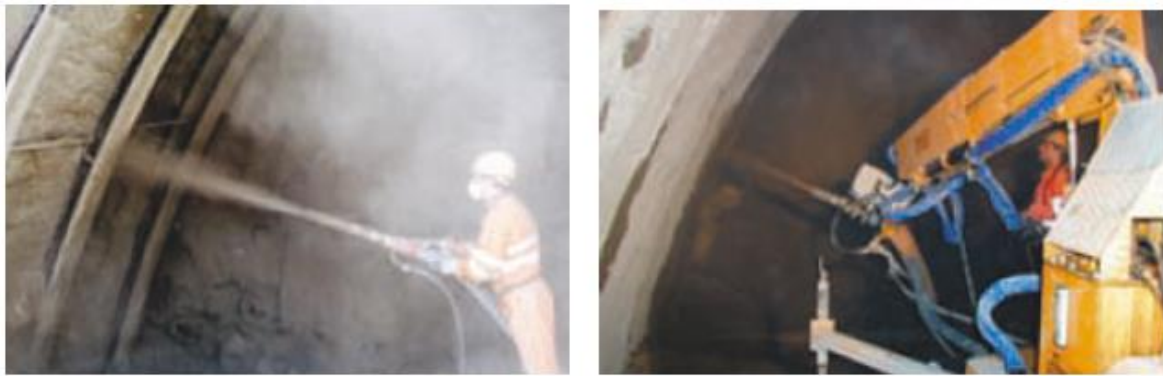
A) B)
Figure 2-10. A) Dry spray and B) wet spray shotcrete (Hofler and Schlumpf, 2004)

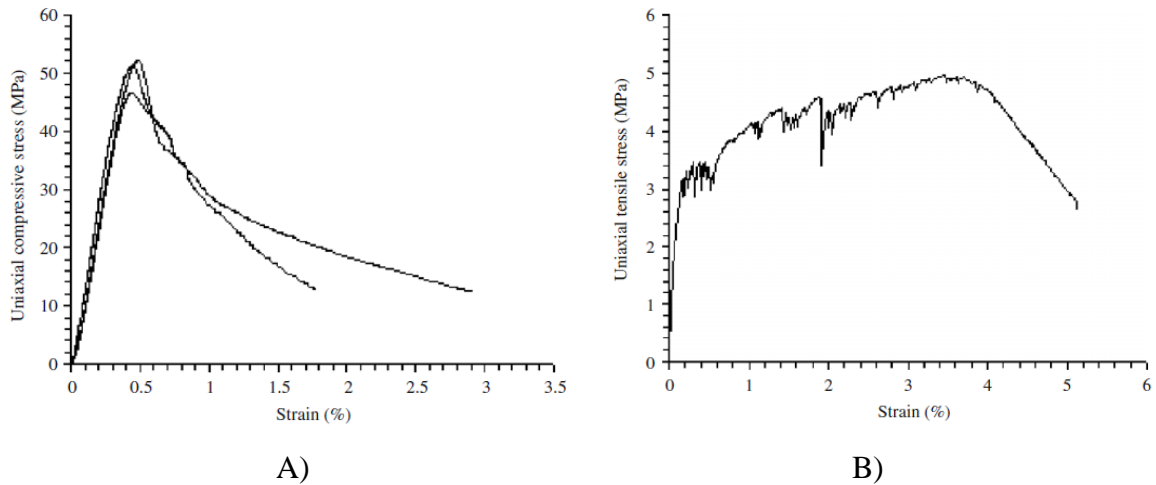
Figure 2-11. A) Typical Compression Response of ECC. B) Typical Tension Response of ECC (Maalej et al., 2010)

strain hardens after it cracks, and “demonstrates a strain capacity 300 to 500 times greater than normal concrete”. Furthermore, Sahmaran et al. (2009) states that even at large deformations, the crack widths remain small. **Figure 2-11** shows the typical compression and tension response of ECC and **Figure 2-12** shows multiple cracking that characterizes ECC composites. These properties of ECC make it an ideal solution for the blast retrofit of URM walls.

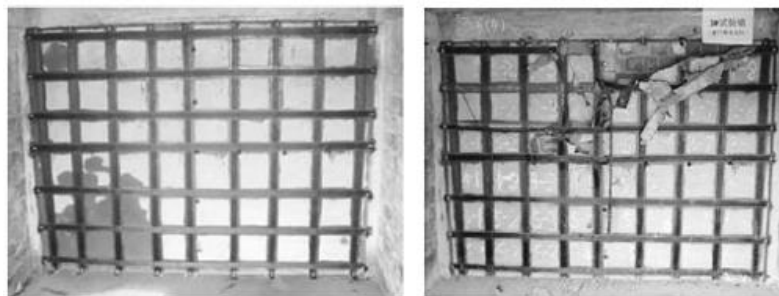
Figure 2-15. Retrofit setup and results for FRP reinforcement. (Chen et al., 2014)

Chen et al. (2014) tested 4 masonry walls under increasing and repeated live blast loads. The walls were built with a Flemish bond and were reinforced with carbon fibre reinforced polymer (CFRP) strips, steel wire mesh, and steel bar. The CFRP strips and steel bar were applied vertically and horizontally and were anchored to the reinforced concrete (RC) frame surrounding the wall. The setup and results of a CFRP wall are shown in **Figure 2-15**. The retrofit walls performed significantly better than the control walls, which showed signs of spalling at the fourth detonation. At the sixth detonation, the control wall was destroyed, while the wall with CFRP strips showed signs of shear rupture and delamination. According to post-test observations, the steel mesh performed the best, with little damage. Next in performance was the CFRP, which showed delamination. The steel bars performed slightly worse than the CFRP, due to more fragmentation and less energy dissipation. The authors conducted a Finite Element analysis and found that the results reflected those of the live tests. It was concluded that the retrofit techniques notably increased the blast resistance of URM walls.

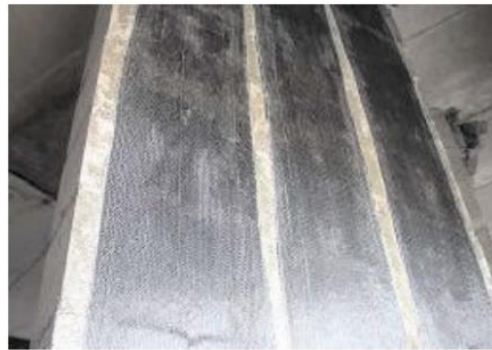
Figure 2-16. Retrofit setup (Urgessa and Maji, 2010)

Urgessa and Maji (2010) tested 8 masonry walls reinforced with two or four layers of FRP with a live explosive. The FRP was unidirectional carbon fiber applied as three side by side vertical sheets along the height of the wall, as shown in **Figure 2-16**. The wall and FRP fabric were restrained at the supports with steel angles. Two different matrix polymers were used to adhere the FRP to the wall: a geopolymer containing of liquid potassium silicate and amorphous silica powder, and an

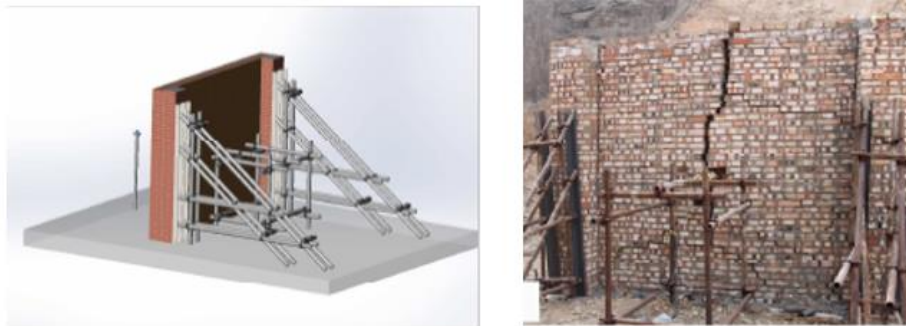
Figure 2-21. Test setup and result of wall retrofit with one side of polyurea (Wang et al., 2016)

Wang et al. tested six clay brick masonry walls reinforced with spray on polyurea under live explosives. The walls were built with a Flemish bond and were supported at the sides with the top of the wall unsupported. The polyurea was either applied to the front face, or to both faces. The polyurea retrofit improved the blast performance of the walls. The wall with polyurea applied to the front face only failed in tension (see **Figure 2-21**). The walls with polyurea applied to both sides decreased the deflection of the wall and prevented the tension crack from growing. When the blast charge was increased, the wall with both sides retrofitted failed through rotation along the bottom support, since the top was unsupported. However, even though the wall completely failed, the polyurea adequately contained fragmentation. When comparing the walls built with normal clay brick and aerated clay brick, the normal bricks performed much better.

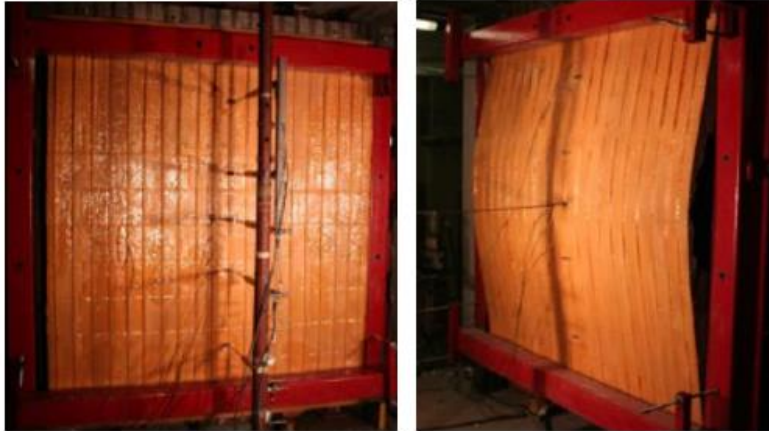
Figure 2-22. Wall reinforced with polyurea and steel rebar. (Ciornei, 2012)

Ciornei tested 4 URM walls retrofit with spray on polyurea using a shock tube. The blast loading was increased and repeated until failure for each wall. The four walls were split in two groups: load bearing and non-load bearing. Each group had a retrofit wall and a control. The retrofit wall in the load bearing group was also reinforced with 6.3mm rebar applied vertically and attached to the steel frame (see **Figure 2-22**). The walls were built with CMU blocks in running bond and were supported at the top and bottom to allow one way bending. The polyurea retrofit was found to be successful in preventing fragmentation and increasing the strength of the walls. The retrofit caused the walls to fail in a ductile manner instead of failing due to a brittle hinge at the mid mortar joint. The load bearing walls performed better than the non-load bearing walls due to the activation of a stronger arching mechanism. The arching mechanism was found to increase the strength of the unreinforced wall significantly. It is noted that arching action can be activated by reducing the gap between the top support and the wall for non-load bearing walls. Ciornei (2012) concludes that polyurea is excellent at absorbing the energy of blast loads for URM walls.

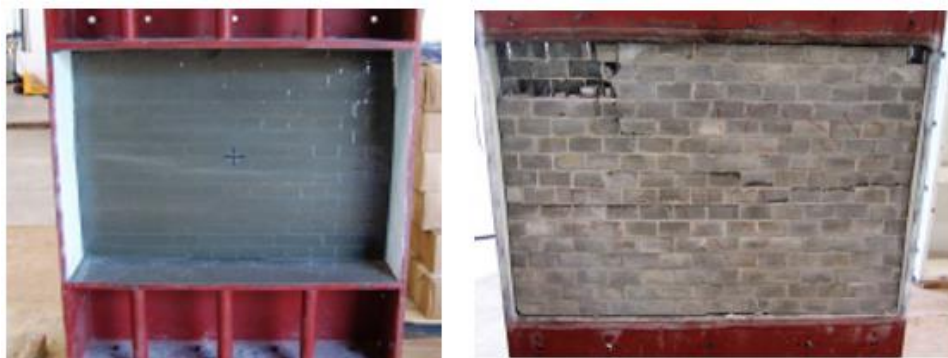
Figure 2-23. Wall 3 retrofit with polyurea and POSS. (Irshidat et al., 2011)

Irshidat et al. (2011) tested with a shock tube three walls retrofitted with polyurea and two different nanoparticles, polyhedral oligomeric silsesquioxane (POSS) and exfoliated graphene nano platelets (XGnP). The walls were built with quarter scale CMU bricks. The control wall was retrofitted only with polyurea and failed in tension at a pressure of 208kPa with horizontal cracks at every mortar line. The wall retrofitted with polyurea and XGnP also suffered horizontal cracking at every mortar joint, and completely failed at pressure of 224kPa. For the first two walls, the polyurea layer failed in tension, but helped to prevent complete fragmentation of the wall. The third wall that was retrofitted with polyurea and POSS resisted a blast pressure of 218kPa. The top left corner sustained shear damage, but the wall remained standing (**Figure 2-23**). The authors conclude that polyurea retrofit systems increase the flexural resistance of the wall, with the POSS system performing the best.

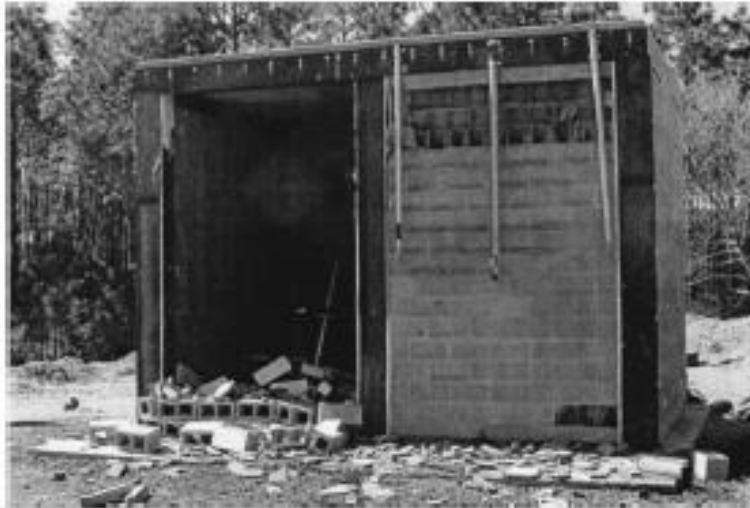
Figure 2-25. Comparison of control and retrofit wall for Test 1. (Davidson et al., 2004)

the charge weight was doubled, and the distance reduced by 14%. Both walls failed during this test, with the control being destroyed and the repaired wall failing in shear at the supports. For the third test, two additional walls were built in cubicles for a total of four walls. The charge remained the same as in test 2, but the distance was 30% larger than in test 1. All retrofitted walls sustained significant damage but remained intact. The walls repaired with polyurea were in much better condition than the control. The wall with polyurea on both compression and tension sides did not have a significant increase in capacity. The authors conclude that the application of polyurea greatly increased the flexural resistance of the wall.

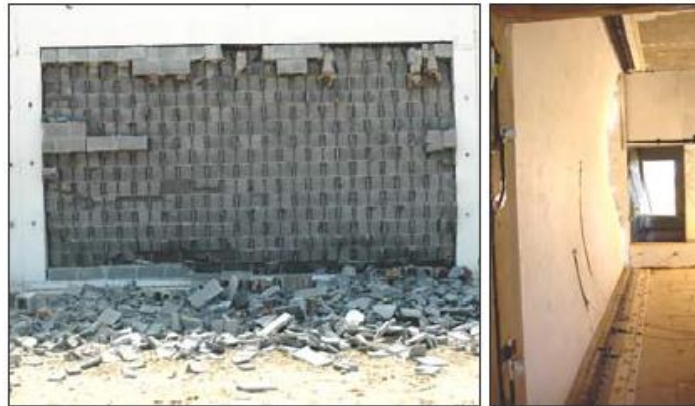
Figure 2-27. Results of wall retrofit with spray on polyurea. (Johnson et al., 2004)

The first full scale wall had spray on polyurea with +/-45 orientated fabric, the second only had trowelled on polyurea, and the last was retrofit with trowelled on polyurea and thermoplastic film. While the faces of the walls were destroyed, there was no debris on the tension side of the wall (**Figure 2-27**). The full-scale tests demonstrated that the quarter scale tests achieved valid results. The authors conclude that spray on or trowelled polyurea is an effective solution for blast loading.

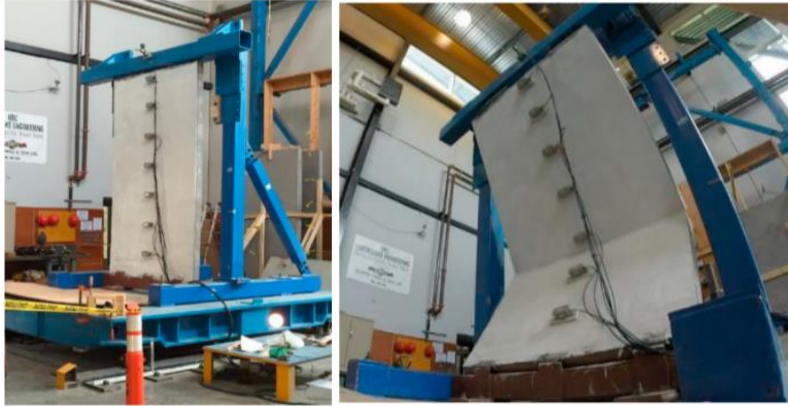
Figure 2-29. Test setup and Results (Soleimani-Dashtaki et al., 2017)

Soleimani-Dashtaki et al. (2017) tested six full scale URM walls retrofit with sprayed Eco-Friendly Ductile Cementitious Composite (EDCC) to out-of-plane loads caused by variable earthquake load intensities. Half the walls were tested with a double-sided retrofit, while the other half was tested with only a single side of EDCC. The specimens were 2m wide by 3m high, and the retrofit was 20mm in thickness. The results indicate that a single layer of retrofit changes the behaviour of the wall from a rocking mechanism to beam bending. The added level of energy dissipation increased the performance of the wall before failure. While a single sided retrofit was found to be satisfactory for earthquakes in the BC area, a double-sided retrofit was recommended for walls where drift should be limited. **Figure 2-29** shows the test setup and results of one of the walls.

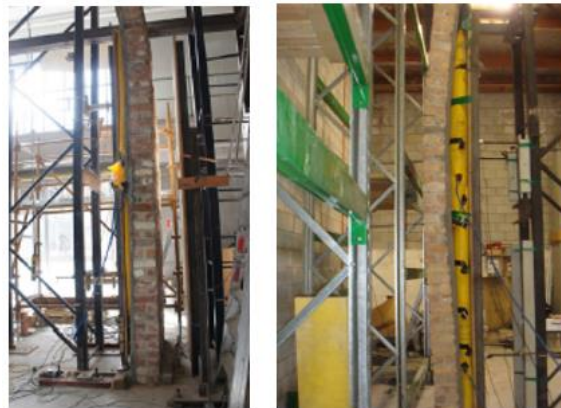
Figure 2-30. Test setup and results. (Lin et al., 2016)

Lin et al. (2016) tested 6 walls retrofitted with fiber reinforced ECC shotcrete and near surface mounted rebar under cyclic and monotonic out-of-plane loading. The walls were built with clay bricks laid in common bond configuration (**Figure 2-30**). The authors also tested the effect of thickness of the ECC overlay. While ECC applied to either side of the wall increased its capacity, layers of ECC on the tension side showed a greater improvement than layers applied to the compression side. The addition of near surface mounted rebar further increased the load capacity of the wall but changed the mode of failure to debonding of the rebar. The walls with thicker ECC layers were shown to have increased capacity than the thinner specimens. It was concluded that ECC shotcrete is a feasible option for retrofitting URM walls for out-of-plane seismic loads.

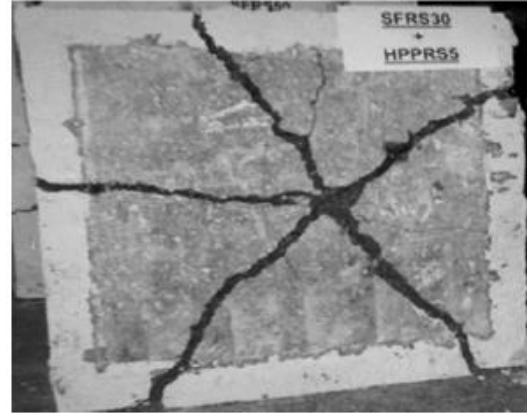
Figure 2-34. Test setup and results of the panel with a mixture of fibers (Cengiz et al., 2004)

Cengiz and Turanli tested 18 dry-mix shotcrete panels under quasi-static loading to determine the behaviour of FRS and steel mesh reinforced shotcrete used in tunnel linings. The panels were reinforced with steel mesh, steel fibers, high performance polypropylene fibers (HPP) and a mixture of the two fibers. The test setup is shown in **Figure 2-34**. For each type of fiber, two different fiber amounts were used. When comparing the average load deflection curves for each panel, all panels had similar initial peak loads. However, the steel mesh panels had a second peak load greater than the first which greatly increased energy absorption when compared to the fiber reinforced panels. For the panels with steel fibers, the increase in energy absorption and peak load was found to be proportional to the increase in the amount of steel fibers. Conversely, increasing the polypropylene fiber content decreased the peak load but did not affect the energy absorption. The panel that had a mix of steel and polypropylene fibers had the second highest energy absorption of all panels (second to the steel mesh). The results of this panel can be seen in **Figure 2-34**. It should be noted that the polypropylene fibers had a higher fiber content per volume when compared to the steel fiber panels. The usage of the HPP fibers was noted to be advantageous due to the reduced amount of rebound when compared to the steel fibers. The authors conclude that the shotcrete panels adequately reached a toughness class required for tunnel repair jobs.

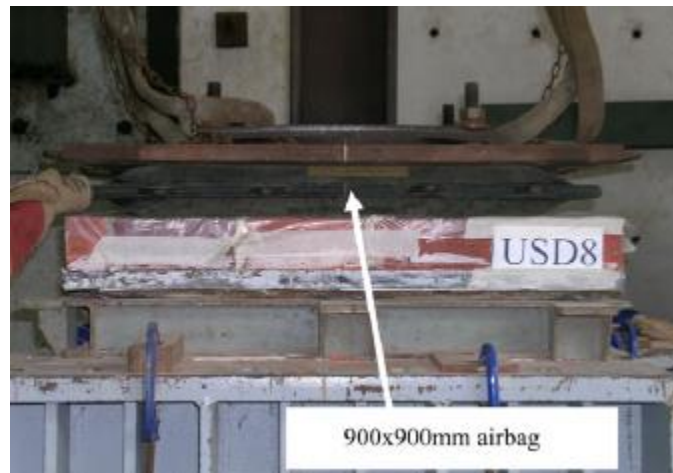
Figure 2-36. UDL testing setup (Maalej et al. 2010)

To prevent out-of-plane failure of unreinforced masonry walls, Maalej et al. (2010) tested 18 masonry wall panels retrofitted with engineered cementitious composite (ECC) overlay. The panels were tested under patch loads, UDL, and impact loads. Each panel was 1000x1000x100mm and rested horizontally with simple supports on all sides. The solid clay bricks used were 215x100x70mm in dimension and were laid in a running bond layout with 10mm of mortar. The ECC mix contained 0.5% steel fibers and 1.5% high performance polyethylene fibers with 200 μm diameters. The 18 panels were split into three series. Each series tested a) two control panels, b) one 34mm thick ECC layer single sided, c) one 34mm thick ECC layer double sided, d) one 34mm thick ECC layer single sided with 8 mm diameter steel mesh, and e) one 34mm thick ECC layer double sided with 8mm diameter steel mesh. The first series focused on quasi-static patch load of 100mmx100mm applied in the centre of the panel. In addition to the above panels, the first series also tested a single face ECC layer with a thickness of 20mm. The second series tested quasi static uniformly distributed loads applied via air bags over an area of 780x780mm at the center of the panels (see **Figure 2-36**). The third series tested impact loading by releasing a drop weight of 51 kg from a 4m height to the center of the panel. Only one control was tested for the third series.

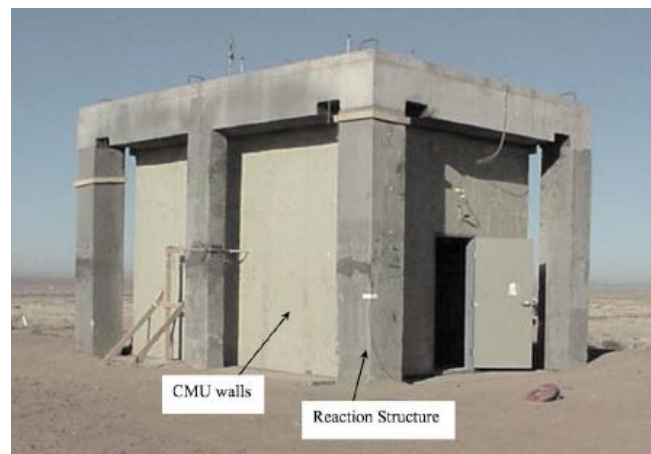
Figure 2-42. Test setup (Maji et al., 2008)

Maji et al. (2008) set up a rectangular room (6.1mx3.7m, 4m high in dimension) with masonry walls on each side and set a charge 0.76m above the center of the room. **Figure 2-42** shows the setup of the experiment. The walls were constructed using hollow masonry units set in running bond. The walls were restrained by a reinforced concrete frame. All the walls were retrofit with GFRP on the tension face, but the north and south walls (the two larger walls) were also reinforced with two inches of shotcrete on the compression face. Two GFRP laminates were used, a unidirectional fabric that was applied vertically, and a ply that ran 0/90 in direction. Iron angle connections were attached to the bottom of the walls to simulate simple support conditions.

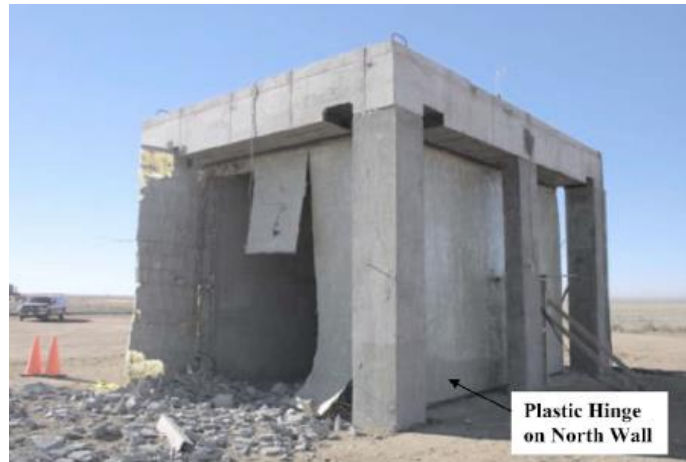
Figure 2-43. Results of the test. The north and south walls remained intact. (Maji et al., 2008)

The north and south walls, which were retrofit with shotcrete, remained intact and standing after the test (**Figure 2-43**). The GFRP remained bonded to the wall and to the supports, and the shotcrete received minor damage in the form of spalling.

The authors conducted an analytical examination of the walls supported with shotcrete and GFRP and GFRP only. It was found that the models agreed with the experimental results adequately. The additional mass and resistance to bending that the shotcrete provides allowed the north and south walls to withstand the blast. The authors conclude that GFRP retrofit is an effective solution for URM walls subjected to blast.

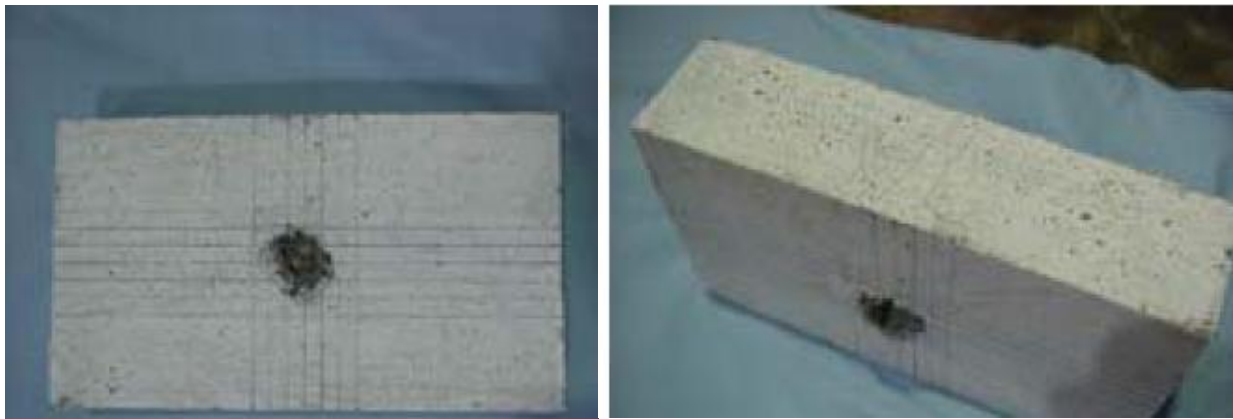
Figure 2-46. Ballistic Tests (Maalej et al., 2004)

Ballistic tests were performed with 15-gram projectiles with an impact velocity of 800m/s to evaluate damage done to panels 300mmx170mm of varying thickness (55,75,100,120,150mm). The recorded data included depth penetration, crater size, cracking, spalling, scabbing, and fragmentation. There was no correlation of impact velocity to crater size. The thicker ECC specimens had a reduced penetration depth compared to the thinner ones, but not much improvement over normal concrete. There was no fragmentation or scabbing on the opposite face in the ECC panels, and very little spalling on the impact face. There was significant improvement to crack distribution in the ECC panels with respect to normal concrete panels. Upon impact, the ECC panels produced thin micro-cracks as opposed to larger cracks leading to failure (**Figure 2-46**). Furthermore, the integrity of ECC panels remained intact after impact.

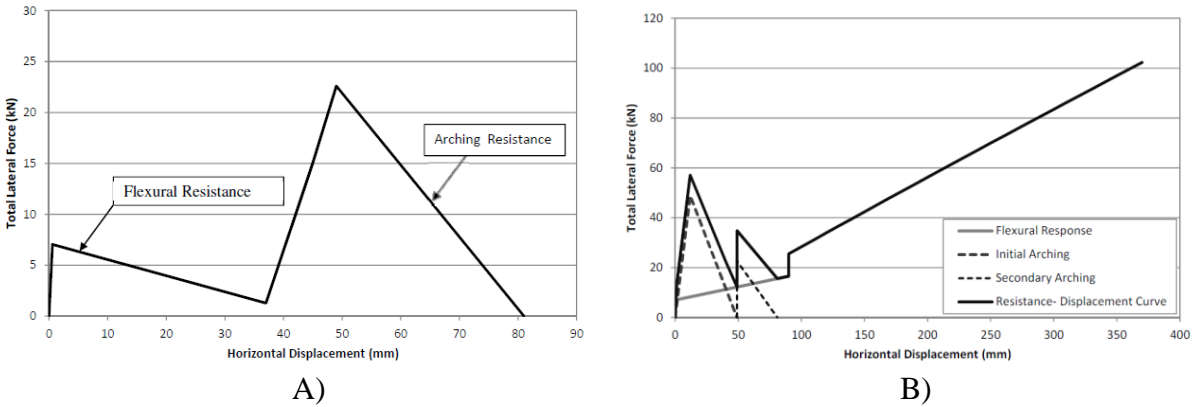
Figure 2-49. A) Sample Restoring force-displacement relationship for sample URM wall. B) Sample Restoring force-displacement relationship for retrofit URM wall (Ciornei, 2012)

of arching action would occur as the top edge of the wall pressed against the top support (Ciornei, 2012). The resistance increases until over a deflection of 350mm and a force of 100kN due to the membrane action of the polyurea.

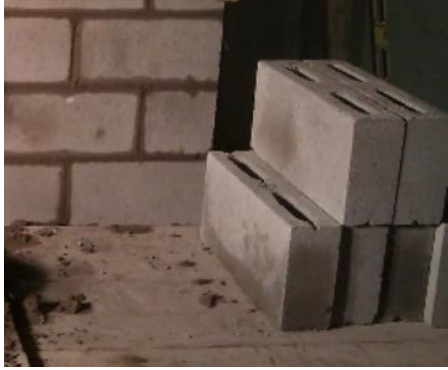
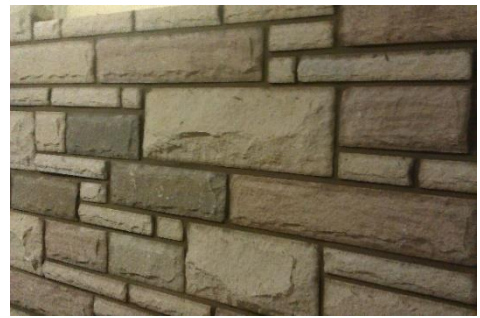
Figure 3-2. Typical CMU and Stone blocks

The CMU walls were built with architectural concrete blocks that were 100 mm (4") thick (**Figure 3-2** shows the dimensions and properties of the standard 100 x 200 x 400 concrete masonry unit blocks used in this study). The blocks were built in running bond (as pictured in **Figure 3-1 A**). The thickness was the same for the stone walls. The height of the stone blocks varied from 63.5mm (2.5"), 127mm (5") and 203.2mm (8"). Type S mortar was used for each wall. High early strength grout was placed at the top of each wall to fill in the gap between the wall and the top HSS support to promote arching action. **Figure 3-3** shows some of the CMU and stone walls that were constructed.

Modular Size (mm)	100
Actual Overall Width (mm)	90
Minimum Faceshell Thickness (mm)	20
Minimum Web Thickness (mm)	20
Equivalent Thickness (mm)	66
Percentage Solid	74
Approximate Mass of Wall in Place (kg/m^2)	140

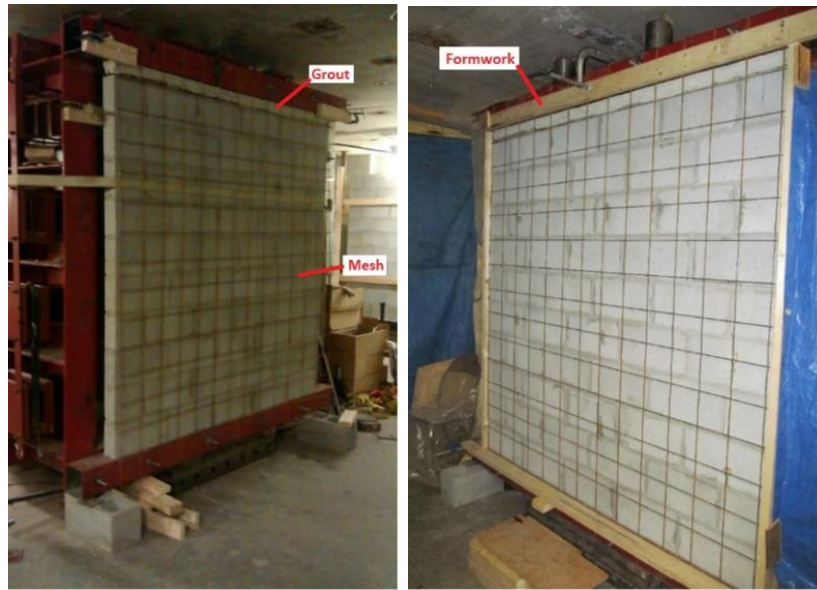
Figure 3-9. A) Wall is placed in the shocktube frame. Grout and top HSS are placed, as well as mesh. B) Formwork is placed in preparation for the shotcrete

The wall was placed in the shocktube frame, and a layer of high strength non-shrink grout was placed on top of the wall. The purpose of the grout was to even out the top of the wall so loads would be applied equally over the wall, and to fill the space between the wall and the top HSS beam to promote arching action. After the grout had set, the HSS beam was installed at the top and fixed to the shocktube frame. It should be noted that for every wall after RMW-C-N, the grout was placed after the shotcrete was applied. **Figure 3-9** shows how the wall was prepared for retrofit.

The 152mmx152mm (6inx6in) steel mesh was placed flushed and tack welded to the top and bottom HSS beams. The mesh was kept at 13mm (1/2 in) from the face of the wall with small wooden spacers that were glued to the wall. A wooden formwork was installed around the face of the wall for the placement of the shotcrete.

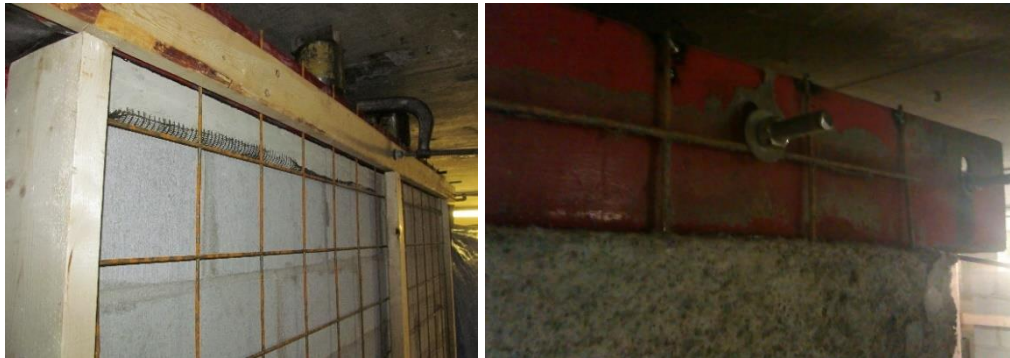
Figure 3-10. Before and After shotcrete was applied.

Before the shotcrete was applied by a professional nozzleman, the wall was sprayed with water to prevent the dry CMU blocks from absorbing the moisture from the shotcrete. Next, the shotcrete was applied in a layer about 51mm thick (2 in). Due to the nature of shotcrete, the layer was not completely the same thickness, but was satisfactorily uniform for the scope of this research. Please see section 3.3.4 for more information of how the shotcrete was applied. **Figure 3-10** shows the top support of the wall before and after the shotcrete was applied.

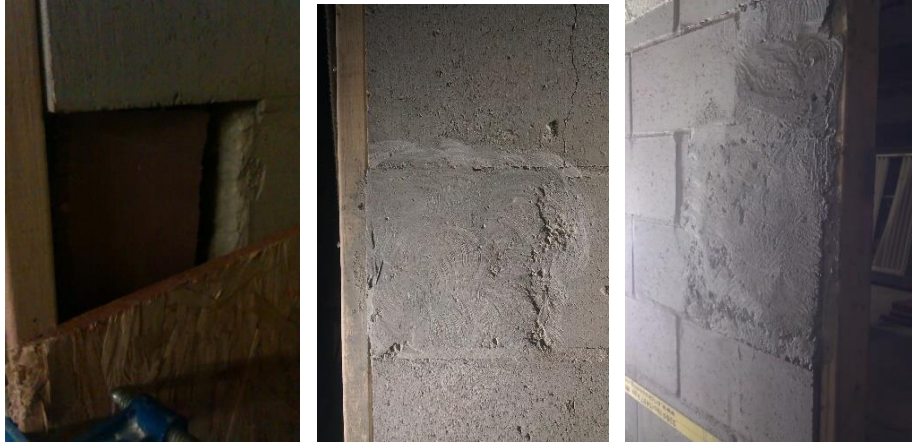
Figure 3-11. Damage and Repair of RMW-C-L

When moving RMW-C-L, the wall experienced some damage on the compression side. A total of 4 blocks at the edges were cracked and the faces of the blocks fell out. To repair this, Styrofoam was placed where the CMU block would be hollow, and the space was filled with repair concrete. The damage and repair can be seen in **Figure 3-11**. A few vertical cracks remained along the edges after the repair was completed. It should be noted that the shotcrete sustained no damage.

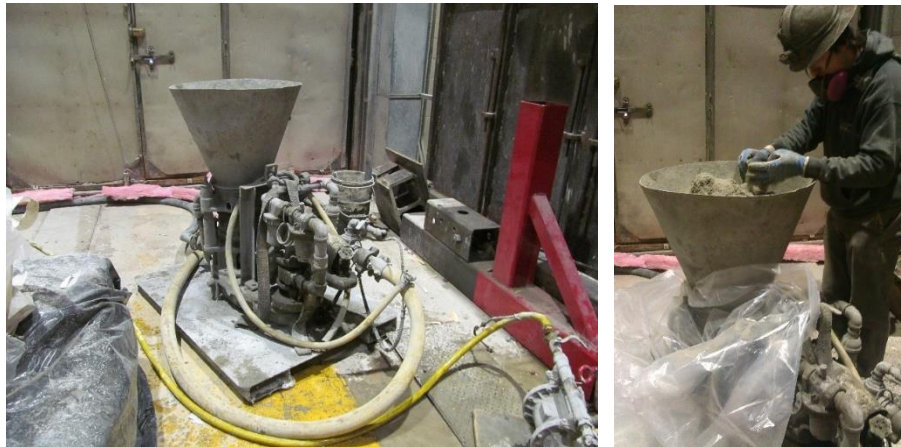
Figure 3-12. Cement Intake Machine

The shotcrete was placed using a dry mix system. The air pressure was supplied by a Doosan P600 air compressor that can operate at 400-450 cfm with a pressure of 100-125 psi. The air pressure powered the dry cement intake machine, which pressurized the dry cement through the hose. A worker ensured that enough cement was placed into the intake, and that it was not clumped together. **Figure 3-12** shows the worker operating the cement intake machine.

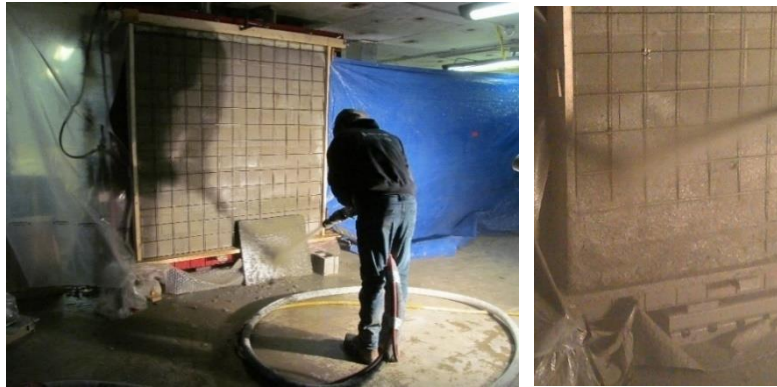
Figure 3-13. Nozzleman tests the consistency of the shotcrete before applying it to the wall

At the same time, water was pumped through a separate hose. Both hoses lead to the nozzleman, who oversees mixing the desired amount of water and cement while spraying them onto the walls. **Figure 3-13** shows the nozzleman testing the shotcrete mix on a wooden panel, and the application

of shotcrete onto the wall. Due to the nature of shotcrete application, the material properties of the shotcrete are variable, as seen with the shotcrete material test results in Section 3.4.2.

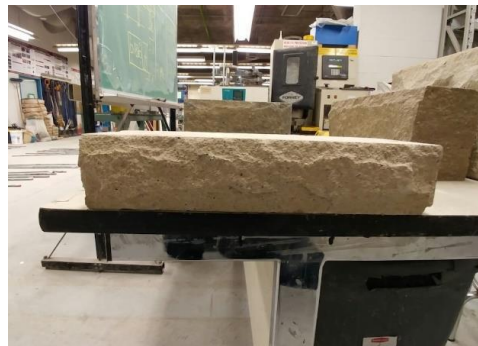
Figure 3-16. One of the stones tested by Saatcioglu et al. (2018)

Stone Masonry Tests: The stone masonry was tested by Saatcioglu et al. (2018) (**Figure 3-16**). The stone blocks were one of three different sizes, small (300x90x60mm), medium (300x90x135mm), and large (300x90x200mm). According to Saatcioglu et al. (2018) the strength of the small blocks were: 33.3MPa; 32.4MPa; 32.0 MPa, with an average of 35.6MPa. The strengths of the medium blocks were: 27.5 MPa; 30.5 MPa; 28.0 MPa, with an average of 28.7MPa (Saatcioglu et al., 2018). The strengths of the large stones were: 23.2 MPa; 23.7 MPa; 24.5 MPa, with an average of 23.8MPa (Saatcioglu et al., 2018).

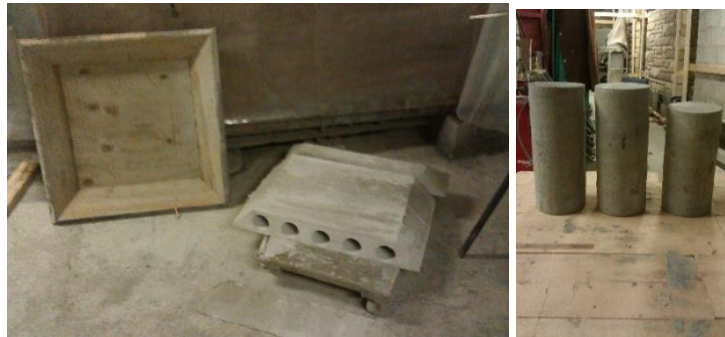
Figure 3-20. The shotcrete panel is cored for the cylinders. The smaller core represents the size for the first set of shotcrete cores

Preparation of Shotcrete: (ASTM C1140) One shotcrete panel was prepared for the first two walls, and one for the last two walls. Alongside the panels, shotcrete was also applied into prism molds for flexural tests. The panels and molds were cured in the same manner as the shotcrete on the walls, with sprayed water onto burlap sheets. The panels and molds were covered with plastic sheets. The sides of the panel were cut with a concrete saw, and cores were drilled from the panels (**Figure 3-20**). Care was used to ensure that the cores were perpendicular to the application of the shotcrete, like the tests performed by Ginouse et al. (2015). The tension and compression tests would therefore be in the same plane as tension and compression is experienced for the shotcrete on the walls. The diameter of the cored cylinders was taken to be the largest permissible by the shotcrete panel. The cylinders were cut to the desired length (2X the diameter) with a concrete saw and were dried before being placed into individual plastic ziplock bags.

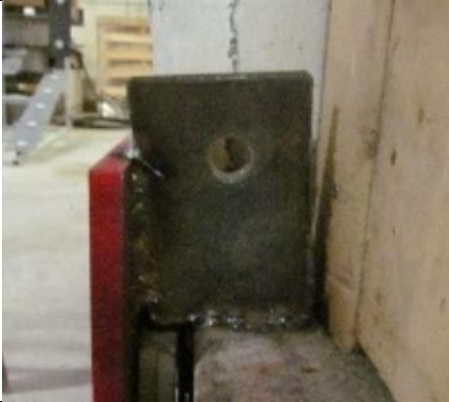
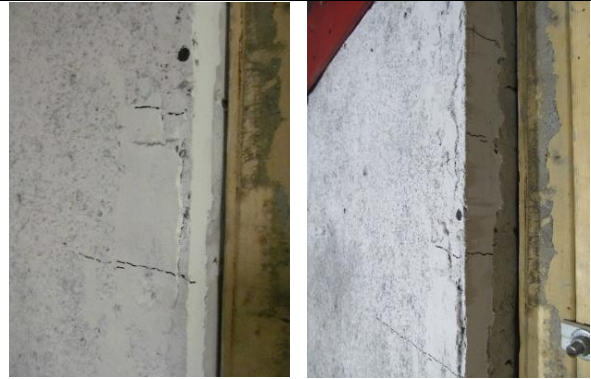
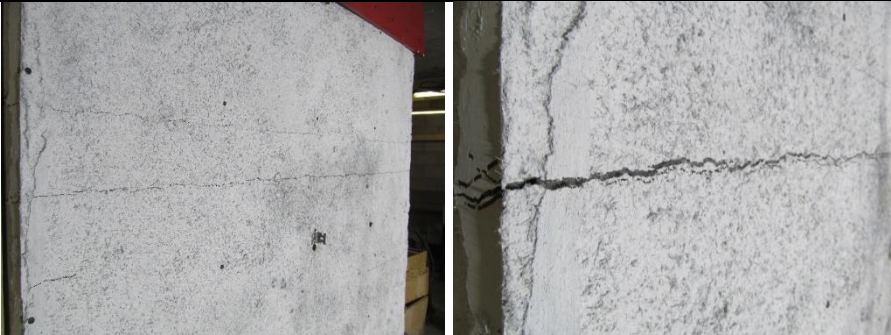
Figure 4-3. RMW-C-N

The residual damage for each shot is shown in **Figure 4-1**. The wall did not experience any damage from the first shot. The second shot created a small crack at the bottom right corner of the wall. The crack can be explained due to arching action. Due to the support displacement, the plates at the top and bottom were strengthened with a stiffener at each corner of the wall (**Figure 4-3 B**). For each subsequent wall tested, these stiffeners were used. Over the next two shots, the wall sustained hairline cracks beginning and elongating at the front face edges of the wall at the mortar joints (**Figure 4-3 C**). The cracks were roughly spaced at 152mm (6") apart, likely caused by the horizontal mesh. At the fifth shot (Blast 7), the wall sustained significantly more damage than previously. A main crack formed along the length of the wall above mid-height. The crack was measured to be 0.3mm in thickness at this point. Other minor cracks were lengthened as well. The sixth shot (Blast 9) produced no extra cracking but widened the main crack up to 4mm in thickness (**Figure 4-3 D**). The PVA fibers in the shotcrete could be seen spanning the crack.

The wall completely failed during the seventh shot (**Figure 4-3 E**). The failure occurred along the main crack from the previous tests. The wall completely sheared along that crack, and the top and bottom portions of the wall acted as cantilever members. The steel mesh spanning the crack was completely cut. Since the shotcrete held both pieces strongly, and the mesh was welded to the top and bottom supports, the wall did not fall over, but remained almost upright.

RMW-C-N was the first wall tested for this thesis. It was a retrofitted infill masonry wall, built with CMU blocks. The shotcrete overlay was from the same batch as RMW-C-L and was applied in an overlay 51mm thick, and the mesh used was gage 6 in thickness. **Table 4-5** details the blasts, deflections and main events for each shot. **Figure 4-2** shows the pressure, impulse and displacement time histories of each blast, while **Figure 4-3 A)** displays the wall setup. **Figure 4-4** shows the failure mode captured by the camera.

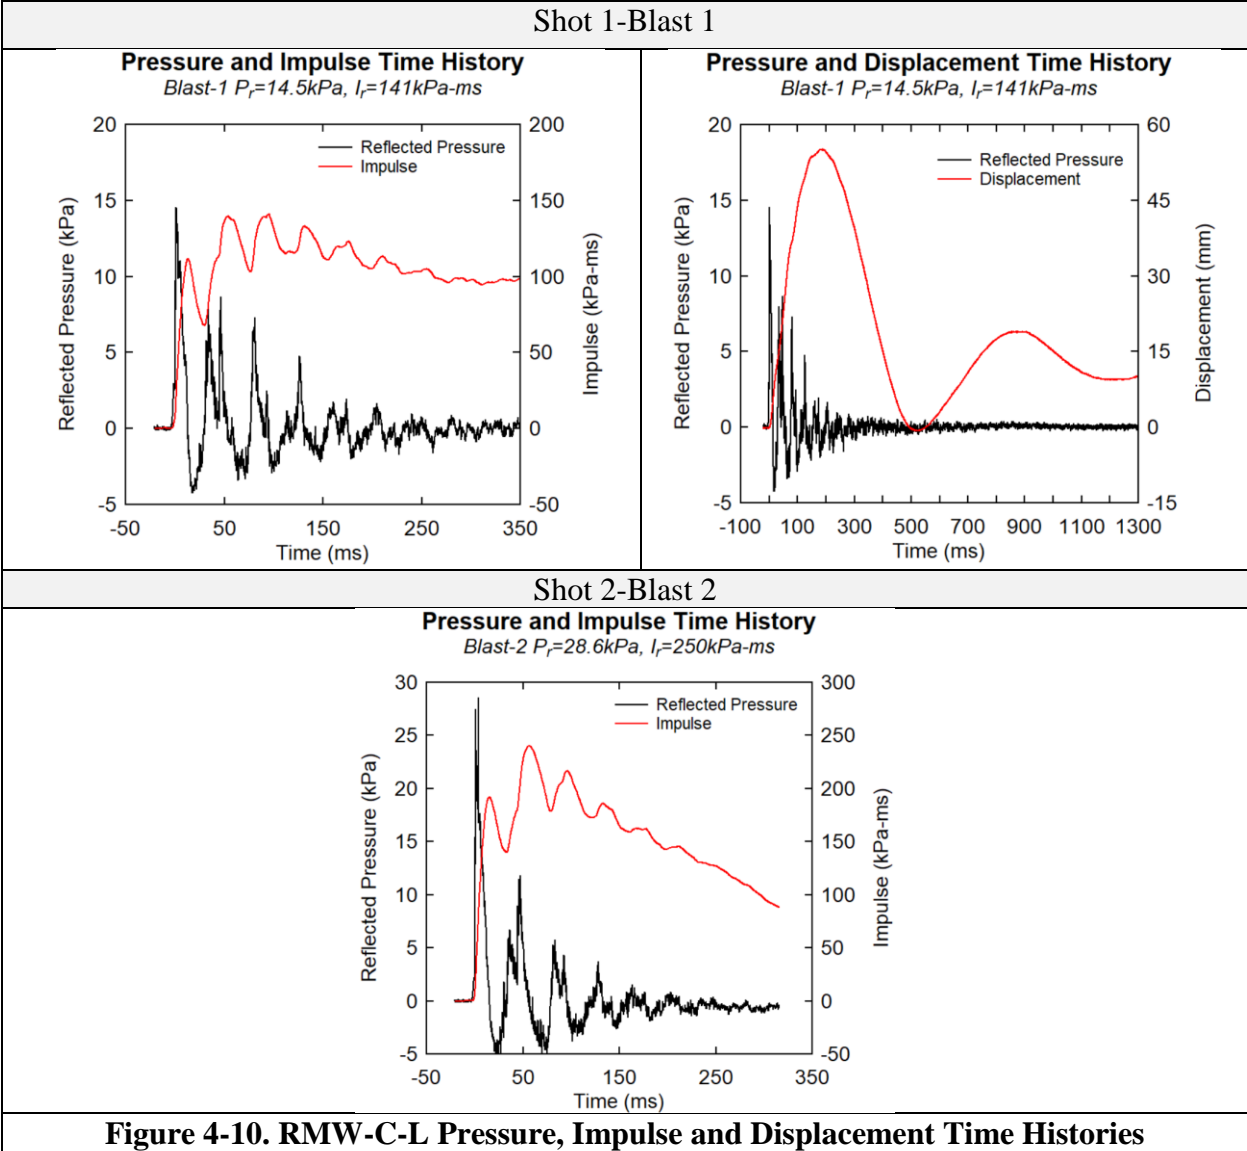
Figure 4-10. RMW-C-L Pressure, Impulse and Displacement Time Histories

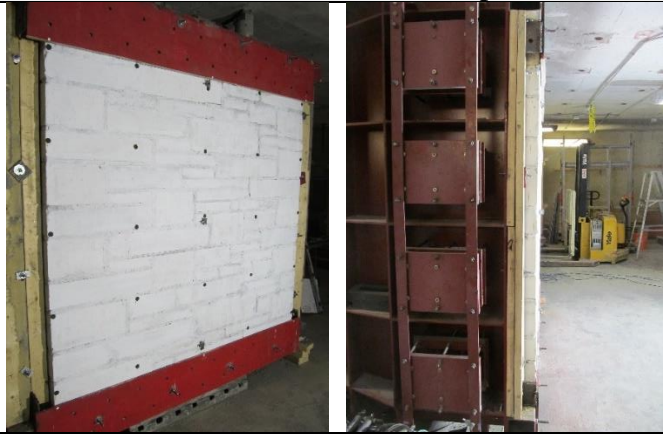
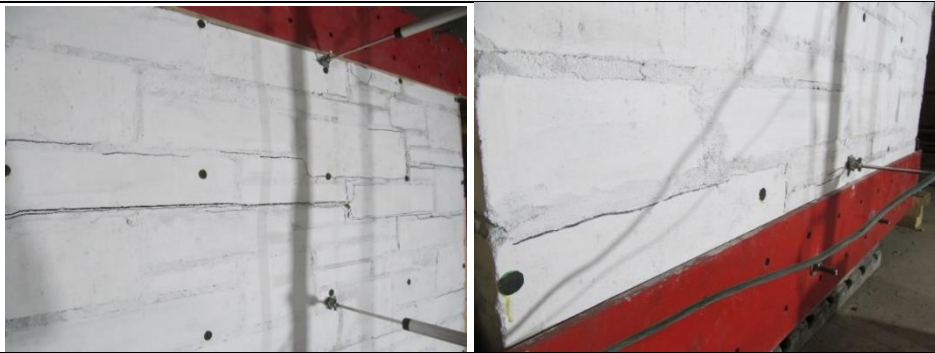
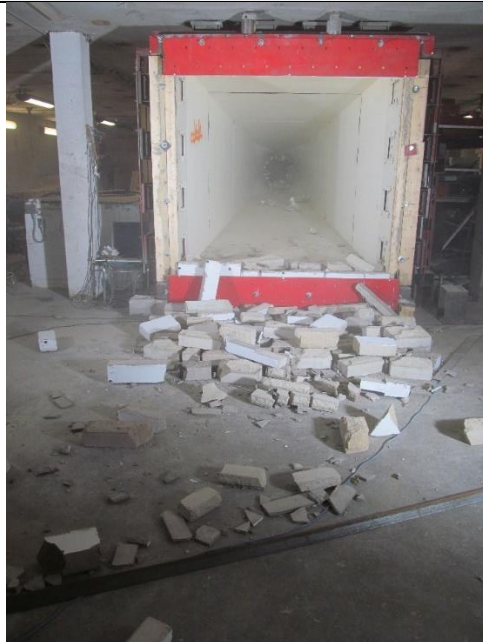
Figure 4-11. URM-S-N

The residual damage sustained by URM-S-N is shown in **Figure 4-9**. Extensive cracking was observed after the first test, with the formation of a main crack at 2.5mm wide. Two horizontal mortar joints above the midpoint of the wall had cracks almost spanning the entire length of the wall. One reason that cracking occurred at that point may be that those mortar joints were more continuous and straighter than the ones at the midpoint of the wall. Cracking can be seen at the top and bottom of the wall near the supports (**Figure 4-11 B**). This is due to hinges forming at those locations.

The wall experienced three hinges at failure (Blast 2), one at each support, and one above midpoint of the wall (**Figure 4-12**). The middle hinge formed at the cracks that appeared during the first shot. The wall fragmented into many pieces, creating projectiles that landed up to 4.5m away from the wall (**Figure 4-11 C**).

URM-S-N was the third wall tested for this thesis. The wall was a stone infill wall with no retrofit. **Table 4-7** details the blasts, deflections and main events for each shot. **Figure 4-10** shows the pressure, impulse and displacement time histories of each blast, while **Figure 4-11 A)** displays the wall setup. **Figure 4-12** shows the failure mode captured by camera.

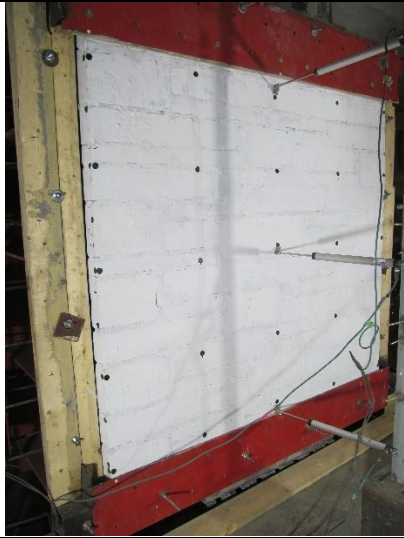
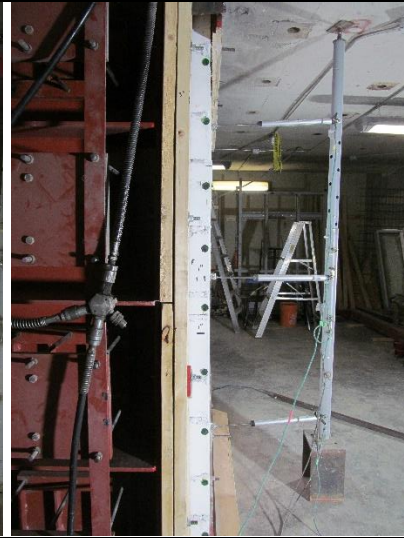
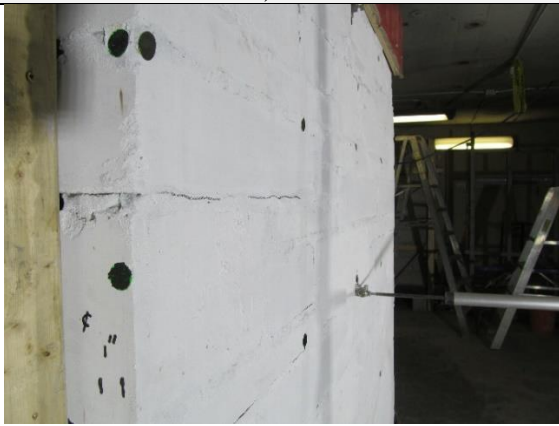
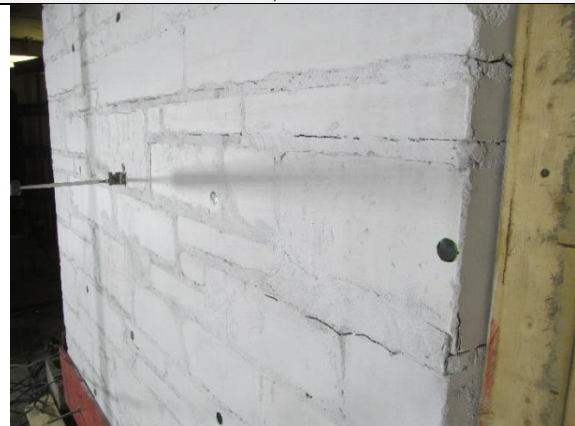
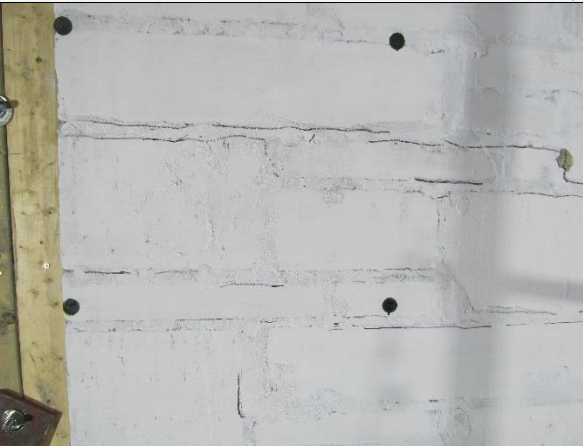
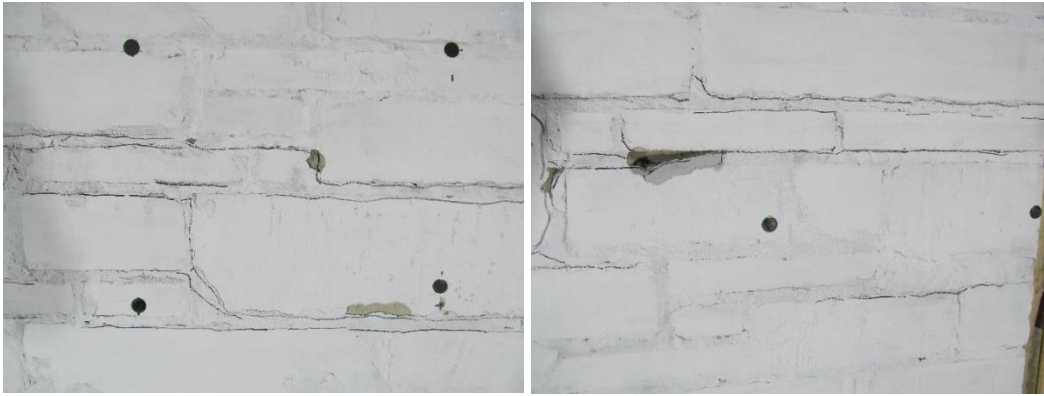
URM-S-L was the fourth wall tested for this thesis. It was a stone load-bearing wall. As with URM-S-N, this was a control wall, so no retrofit was applied. The load axial applied was 171kN, which was about 4% of the total axial resistance of the wall. A value of 4% was chosen to compare the stone walls tested by Saaticioglu et al. (2018). **Table 4-8** details the blasts, deflections and main events for each shot. **Figure 4-14** shows the pressure, impulse and displacement time histories of each blast, while **Figure 4-15 A)** displays the wall setup. **Figure 4-15 H)** shows the displacement profile for each blast and **Figure 4-16** shows the failure mode captured by camera.

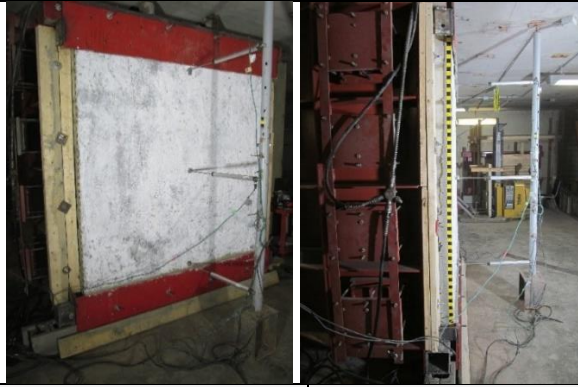
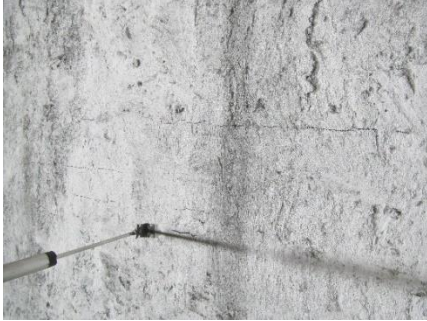
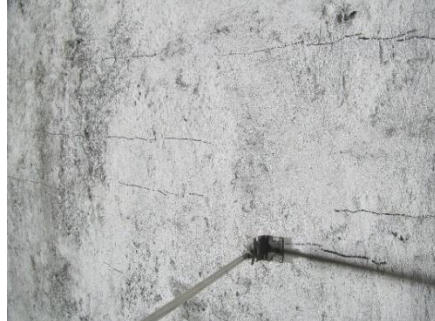
RMW-S-N was the fifth wall tested for this thesis. It was a retrofit stone infill wall. The mesh used was gage 2 in thickness and was welded to the top and bottom HSS supports. The shotcrete was applied in a thickness of 51mm from the same batch as RMW-S-L. **Table 4-9** details the blasts, deflections and main events for each shot. **Figure 4-18** shows the pressure, impulse and displacement time histories of each blast, while **Figure 4-19 A)** displays the wall setup. **Figure 4-19 G)** shows the displacement profiles for each blast. **Figure 4-20** shows the failure mode captured by camera.

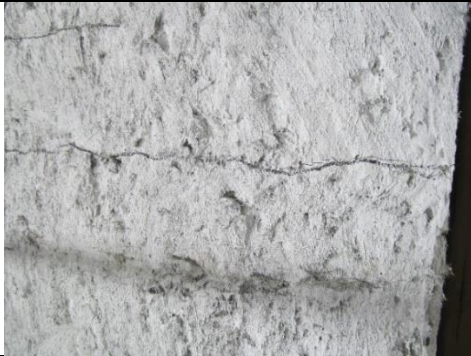
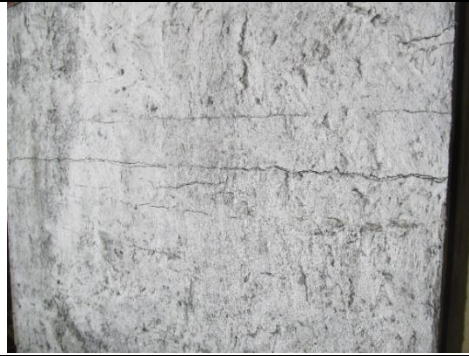
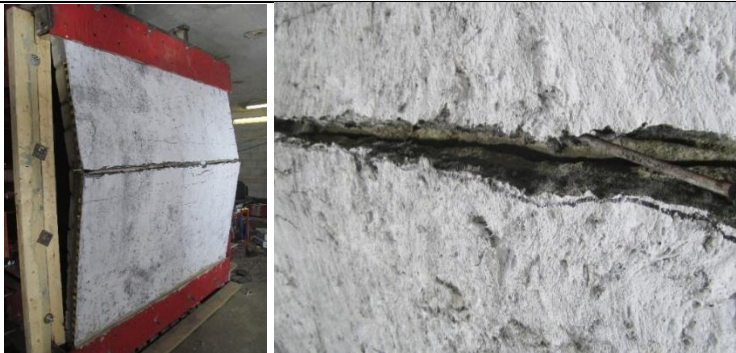
D) Shot 5. Main Crack appears

E) Shot 6

F) Shot 7 Failure
