BLAST RETROFIT OF UNREINFORCED MASONRY WALLS USING ECC SHOTCRETE

Thesis submitted to the
Faculty of Graduate Studies and Research
in partial fulfillment of the requirements for the degree of
Master of Applied Sciences
in Civil Engineering

Department of Civil Engineering
Faculty of Engineering
University of Ottawa

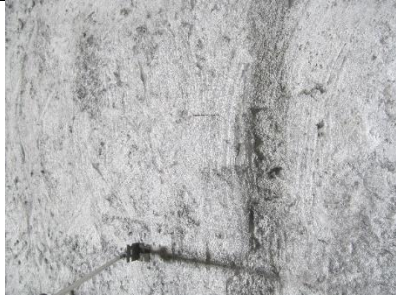
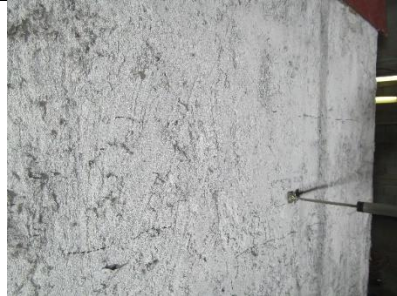
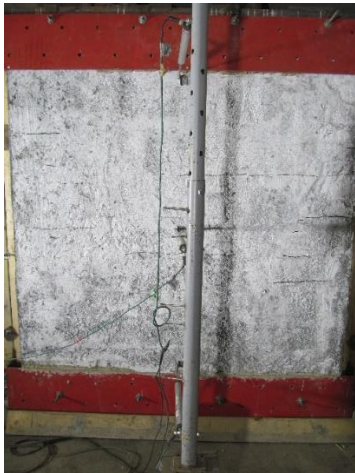
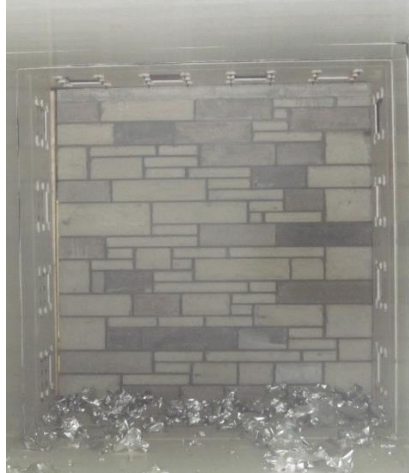
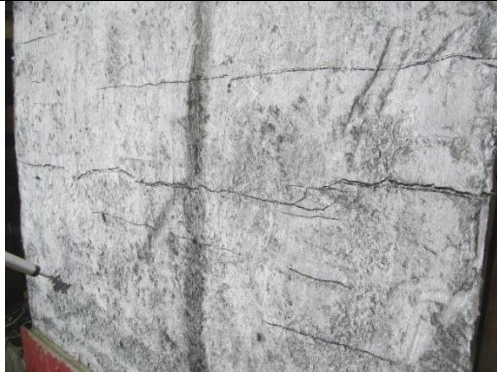
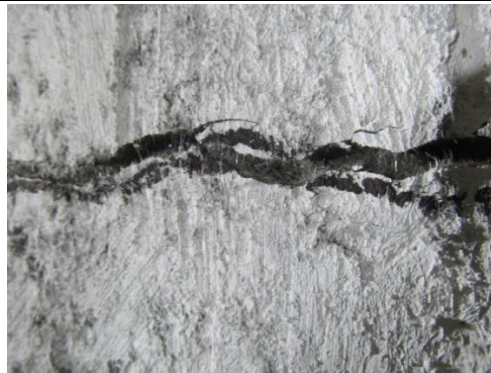
B) Shot 5

C) Shot 6

D) Shot 7

E) Shot 7 Failure

Table 4-10 details the blasts, deflections and main events for each shot. **Figure 4-23** shows the pressure, impulse and displacement time histories of each blast, while **Figure 4-24 A)** displays the wall setup. **Figure 4-25** shows the failure mode captured by camera. **Figure 4-26** shows the strain data time histories for each blast and strain gage.

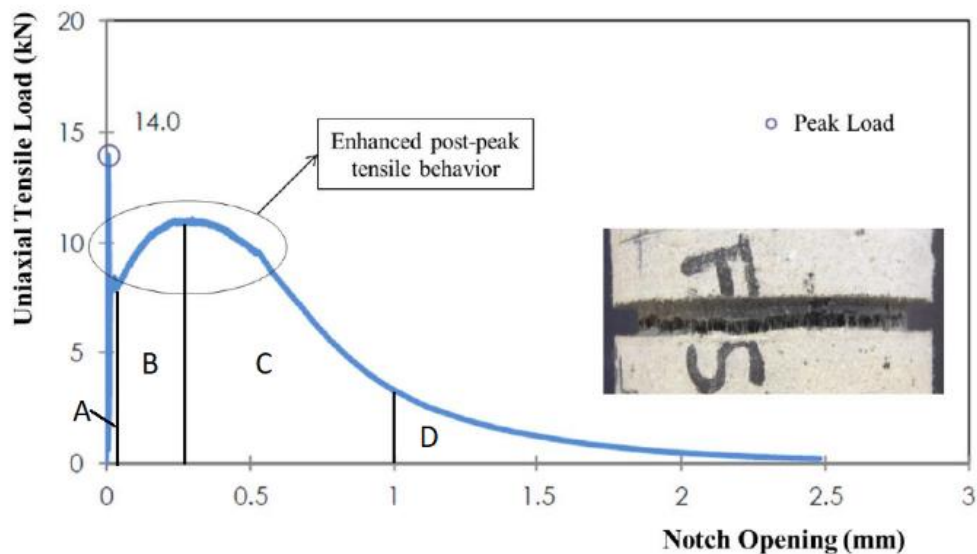
Figure 5-1. Tensile Load Displacement Relationship, emphasis mine (Ginouse et al., 2015)

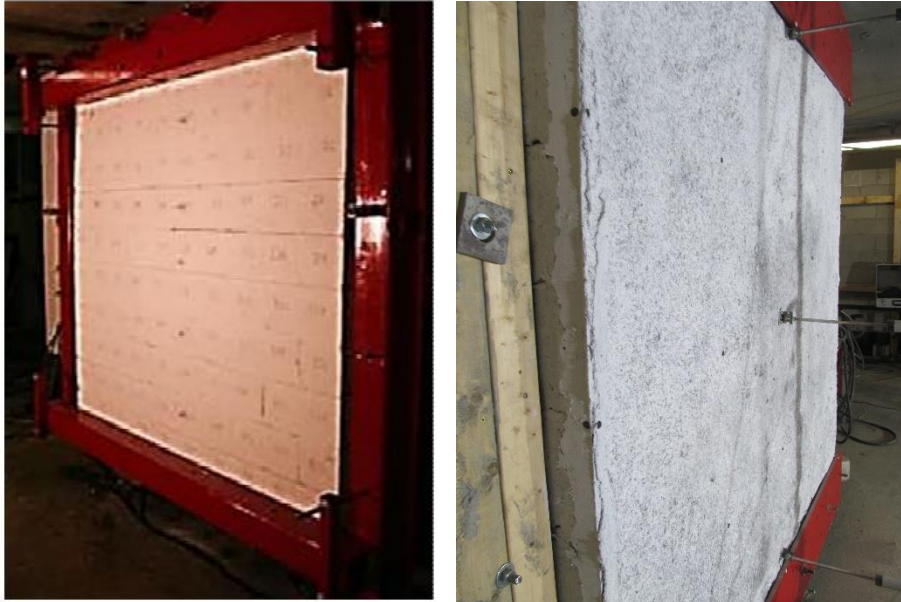
Blast 2 Damage Comparison (Left: Ciornei, 2012)

Blast 3 Damage Comparison (Left: Ciornei, 2012)

Figure 5-3 compares the displacements sustained by the walls over the course of testing and shows selected displacement time history graphs and maximum/residual displacement comparisons. **Figure 5-4** shows photos of the walls during testing.

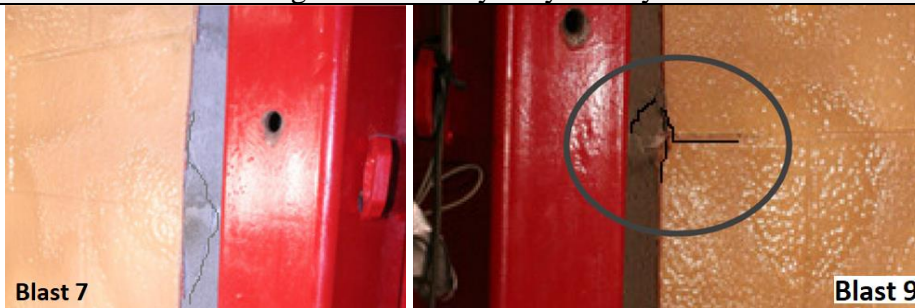
Damage Sustained by Polyurea System

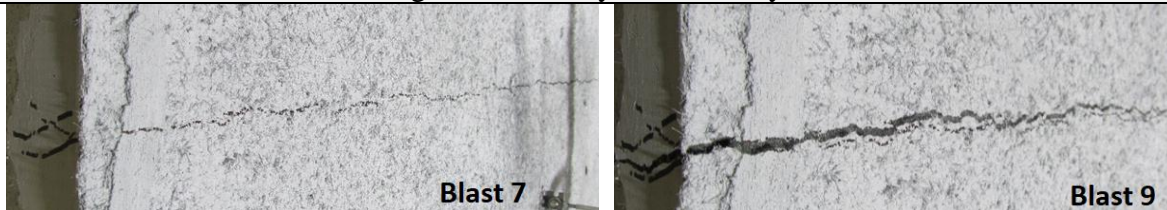
Damage Sustained by Shotcrete System

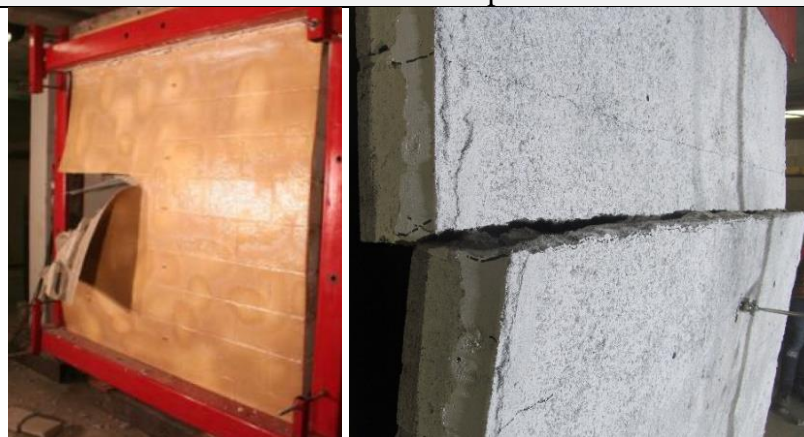
Figure 5-27. Polyurea Retrofit Comparison (Polyurea photos from Ciornei, 2012)

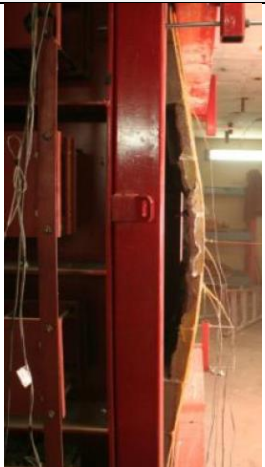
Figure 5-28. Polyurea and Shotcrete Retrofit Comparison (Polyurea from Ciornei, 2012)

Failure Mode Comparison: Polyurea (left) and Shotcrete (right)

The effect of retrofit method is further examined by comparing the performance of wall URM-4, tested by Ciornei (2012), and wall RMW-C-L from the current study. Both walls were made of concrete masonry units and were tested under axial load corresponding to 10% P_o , 122kN and 146kN, respectively. **Figure 5-28** compares the maximum and residual displacements over the course of testing, as well as select photos of tests.
