# Seismic Retrofit of Load Bearing URM Walls with Internally Placed Reinforcement and Surface-Bonded FRP Sheets

Thesis submitted in partial fulfillment of the requirements  
for the degree of Doctor of Philosophy  
in  
Civil Engineering

Department of Civil Engineering  
University of Ottawa  
Ottawa, Ontario

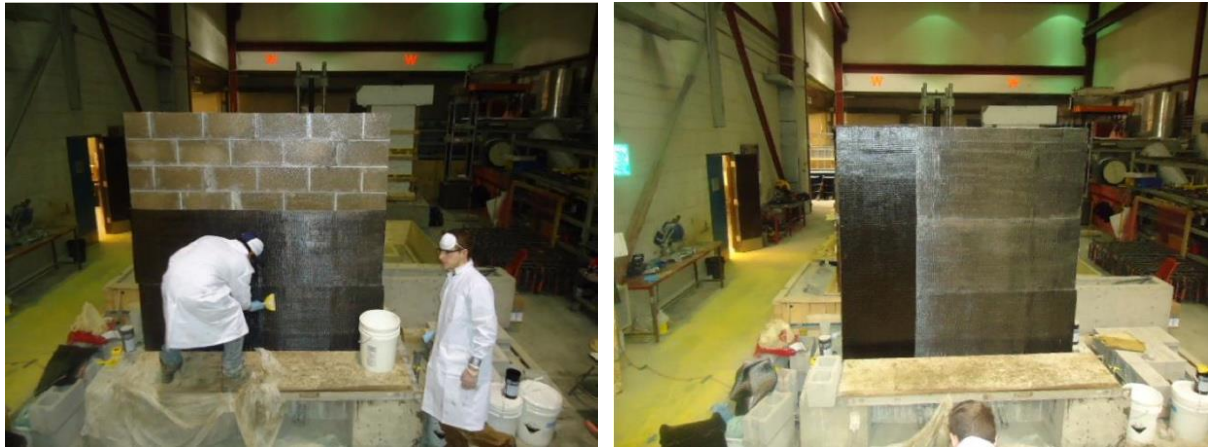
**Figure 2.25 Application of FRP sheets on masonry wall**

earlier. The vertical FRP sheet extended to the foundation and epoxy glued to the foundation concrete. In addition, the FRP anchors were used to prevent debonding of the FRP sheet from the foundation.

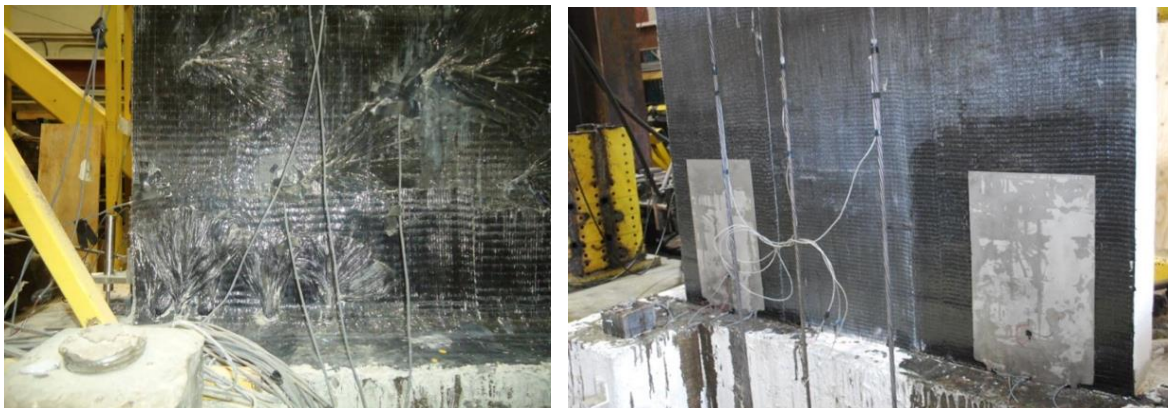
**Figure 2.26 Installed FRP and ductile steel sheet anchors on PRM and URM walls, respectively**

The URM wall was built using concrete blocks without any longitudinal reinforcement. Truss type reinforcement was placed horizontally at mortar joints. The two boundary cells were grouted at both ends to provide additional compressive strength, which was required after retrofitting the wall. This time a different type of anchor system was used to connect the FRP sheets to the foundation. Ductile anchors made from stainless steel sheets that had been evaluated earlier was applied. Two vertical slots were cut in the foundation at two locations at wall ends, adjacent to the wall. The steel sheet anchors were epoxy glued inside the slots while the portions above were epoxy glued to the wall FRP. Figure 2.25 shows the FRP and steel anchors on PRM and URM walls.

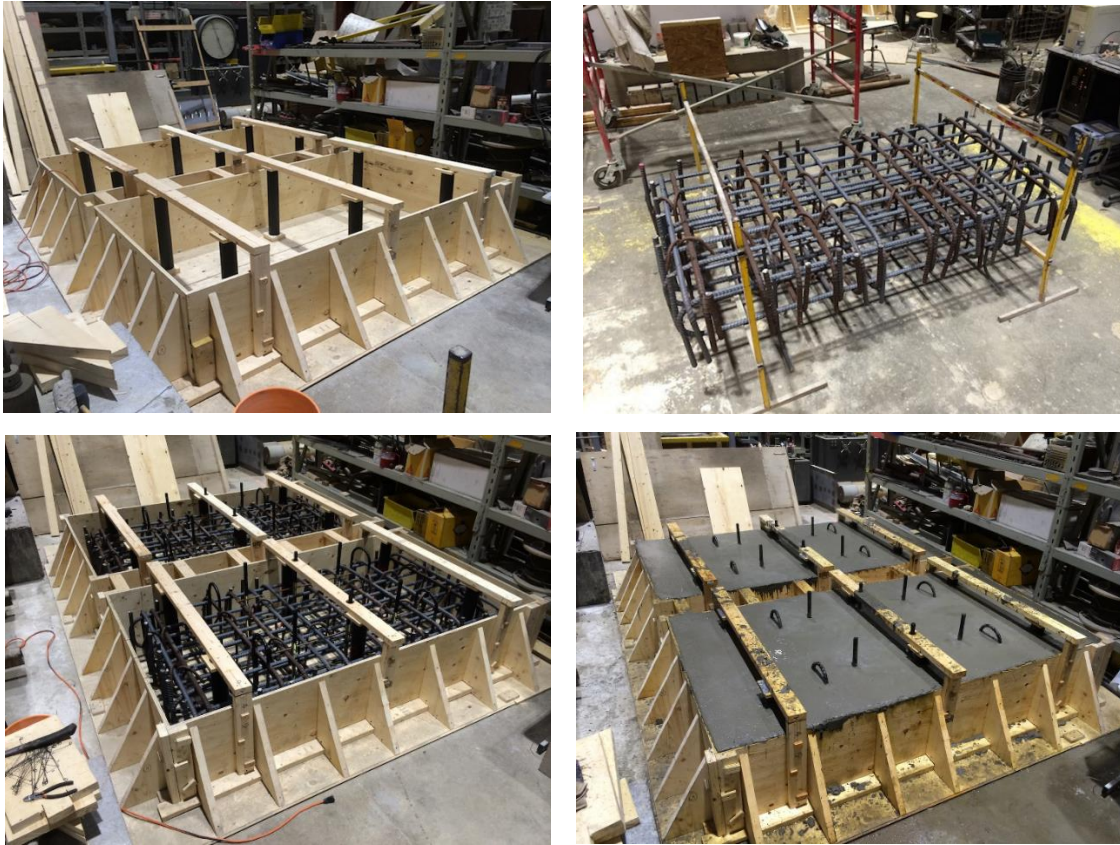
**Figure 103.25 Construction process of footings**

Two reinforced concrete footings were constructed as foundations for the masonry walls. The construction of footings involved the preparation of formwork, the assembly of steel reinforcement cage, and the casting of concrete. Figure 3.25 illustrates selected stages of construction.

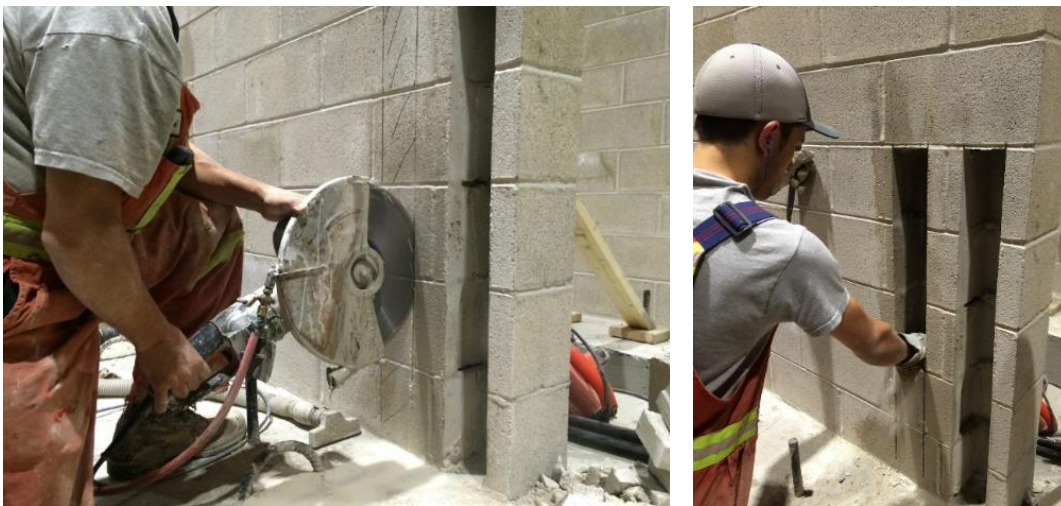
**Figure 105.27 Cutting of masonry walls to create open ducts**

for the placement of eight 15 M steel rebars, four at each end (Figure 3.28). SDS rotary hammer drill was used for this purpose. The hole size was established based on the bar size and the specifications of the epoxy that was used for anchorage. Figure 3.29 illustrates the wall prior to the placement of reinforcement bars. Sika Anchorfix 3 was used as a two-compound epoxy to anchor the steel bars inside the foundation (Figure 3.30). Wooden formwork was built with plywood and studs to cover the exposed parts of the ducts on the wall. The formwork was secured to its place by means of through bolts that were tightened on both sides of the wall with washers and nuts (Figure 3.31). A batch of self-leveling concrete was mixed. The concrete was cast inside the ducts from a concrete bucket that was lifted with crane. A wooden cone was placed on top of the wall to direct the concrete inside the ducts. The formwork was removed 24 hrs after casting (Figure 3.32).

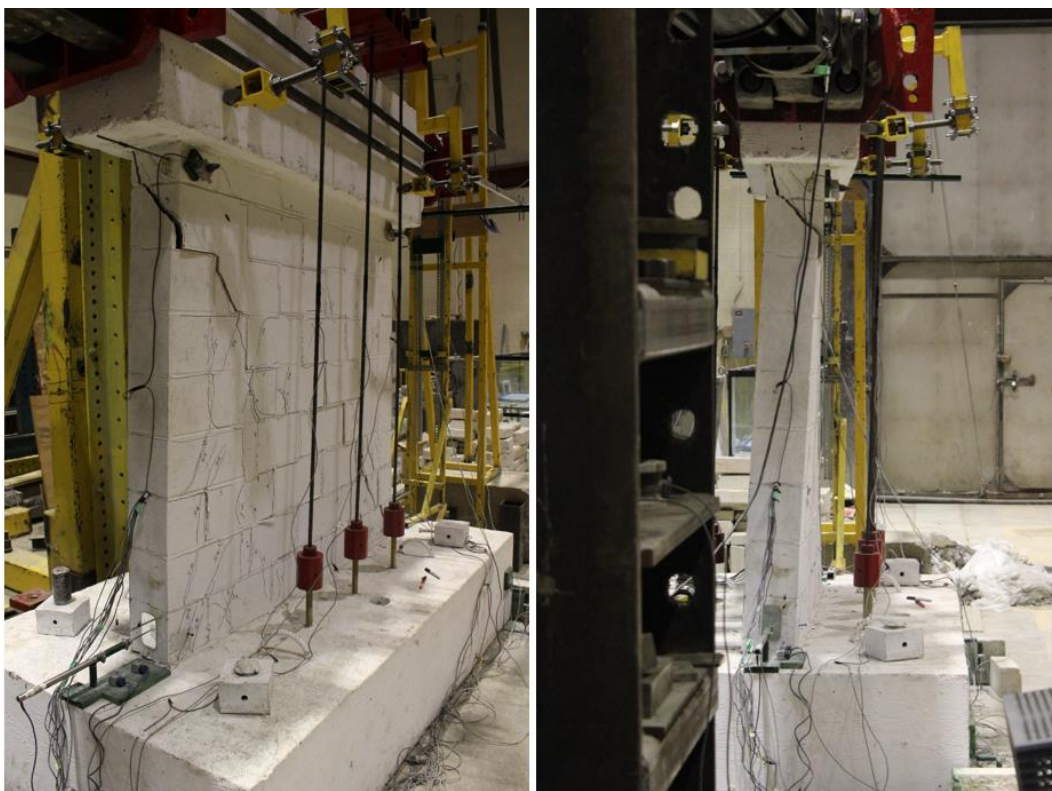
**Figure 141.6 Twist of the wall at 0.5% drift**

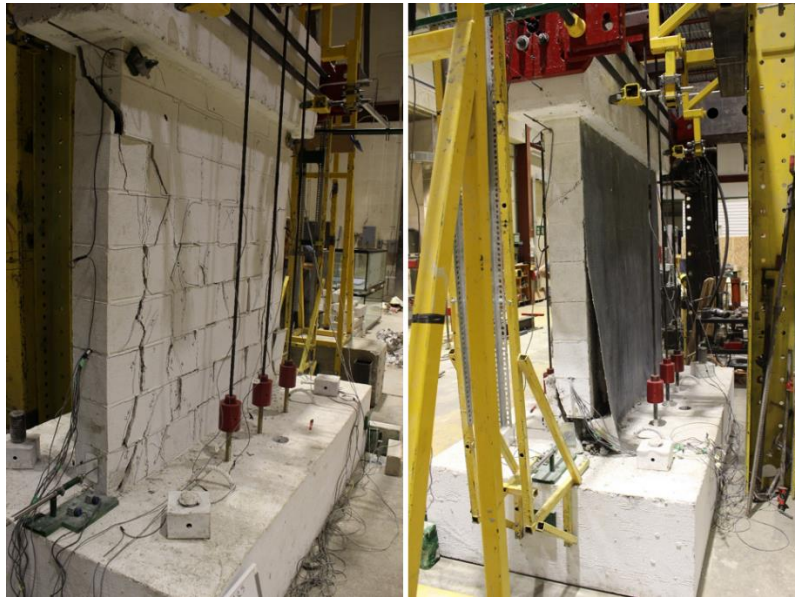
**Figure 147.12 Damage of the wall at 1.25% drift ratio**

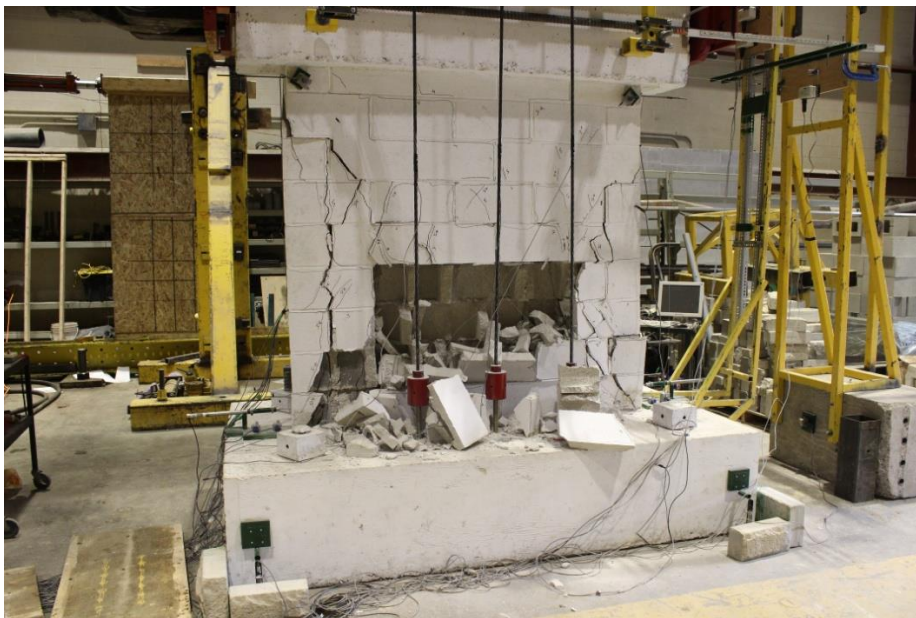
**Figure 149.14 Final stage of the experiment for Wall 1**

The wall was displaced to -31.02 mm, corresponding to -1.5% drift level, as the final stage of testing. The load resistance was -54 kN during the first pull. It was also pulled the second time towards the same displacement. The centre of the wall fully deteriorated at this final stage of loading, as can be seen in Figure 4.13. The actuator was pushed back to zero displacement to stop the test. At this stage the concrete blocks at the lower middle half of the wall collapsed as illustrated in Figure 4.14 shows the wall at the final stage of the experiment.

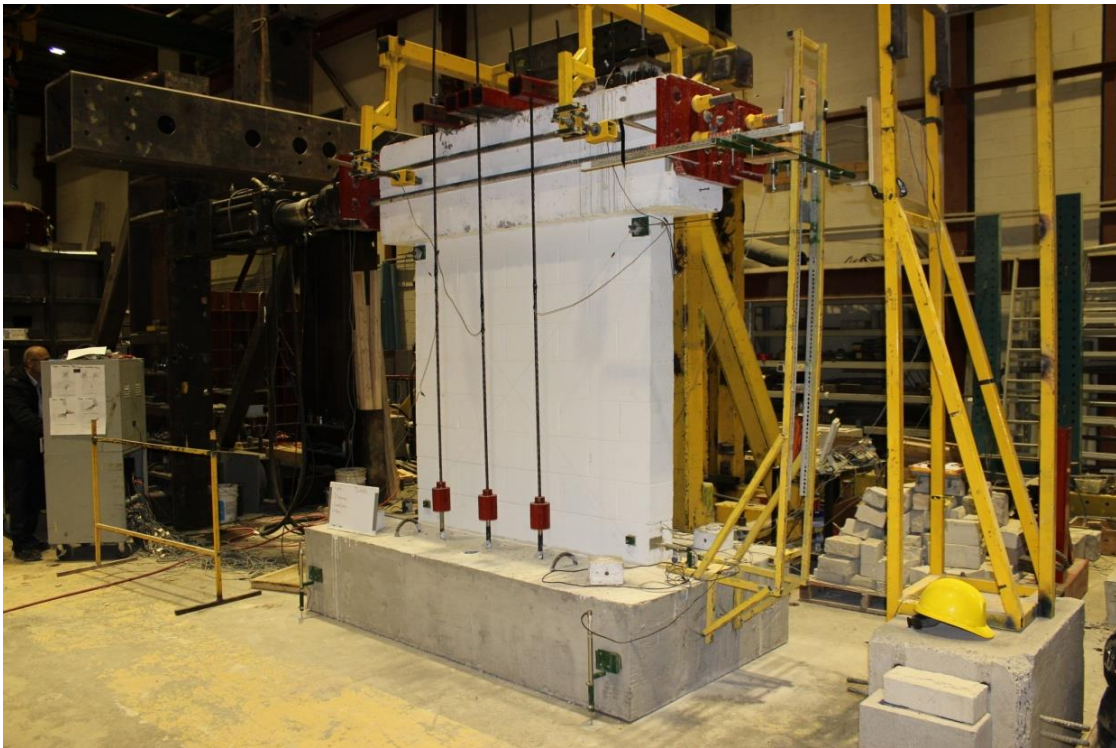
**Figure 152.17 Retrofitted masonry wall 2 test setup**

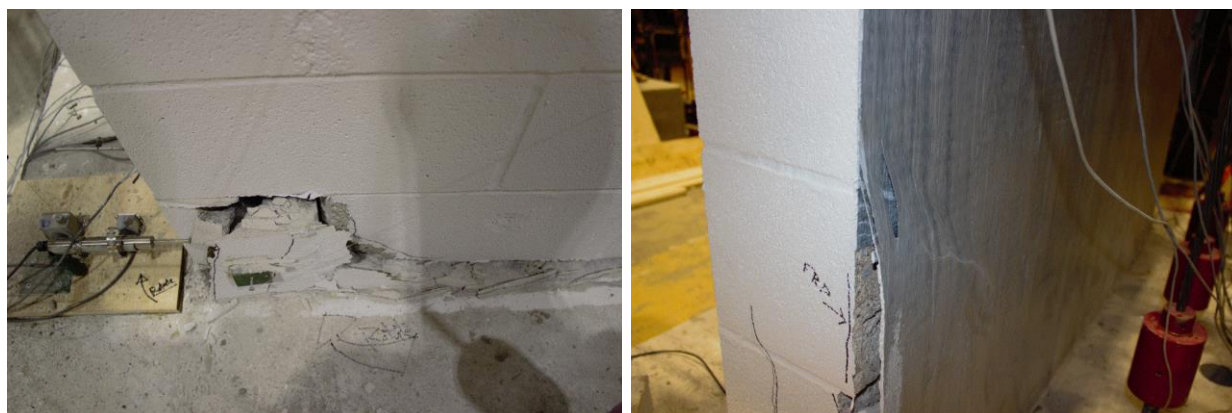
(a) Rotation of east end towards north

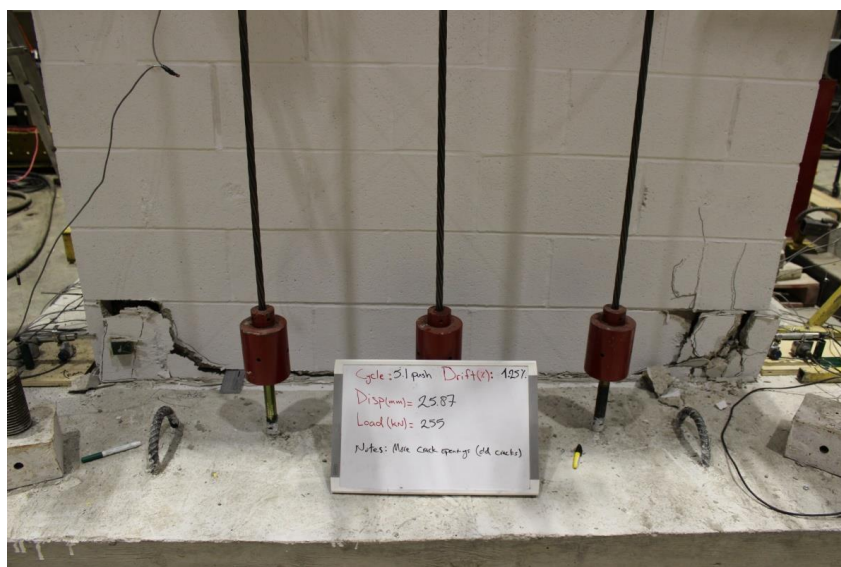
Figure 162.27 Wall 2 at -1.25% drift push
