# **EFFECT OF REALISTIC BOUNDARY CONDITIONS ON THE BEHAVIOUR OF CROSS-LAMINATED TIMBER ELEMENTS SUBJECTED TO SIMULATED BLAST LOADS**

**Dominic Cote**

**Master of Applied Science**

University of Ottawa

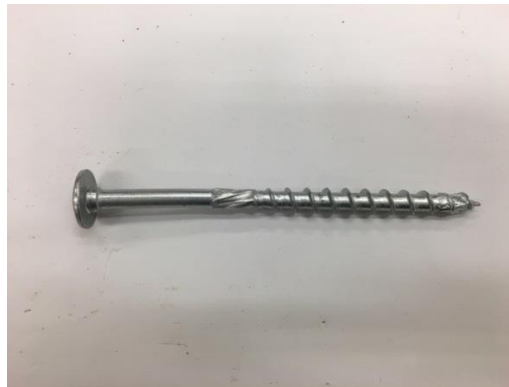
**Figure 3.2: Screw A – 8x120 Heco-Topix Zn Blau**

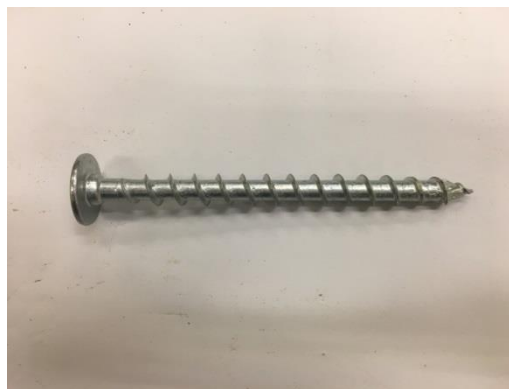
**Figure 3.3: Screw B – 10x120 Heco-Topix Zn Blau A2K**

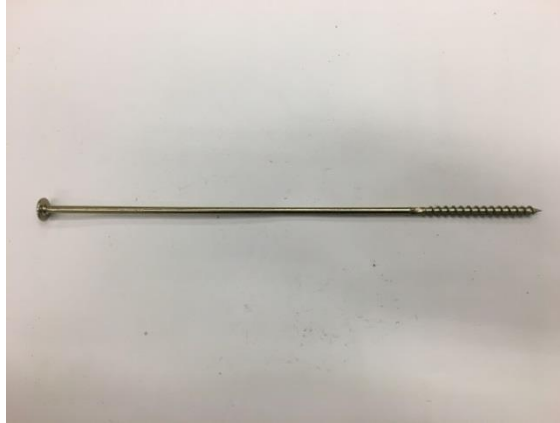
**Figure 3.4: Screw C – 6x300 Heco-Topix Zn Gelb A2L**

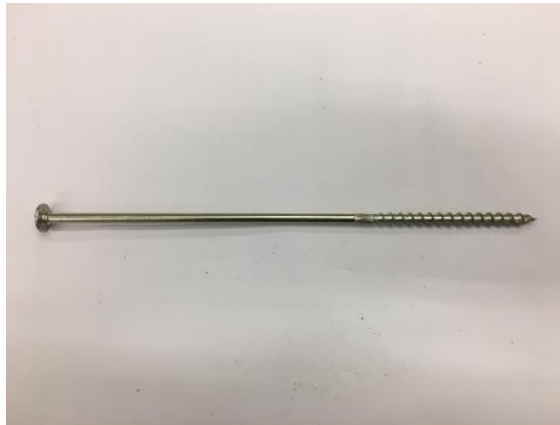
**Figure 3.5: Screw D – 8x300 Heco-Topix Zn Gelb A2L**

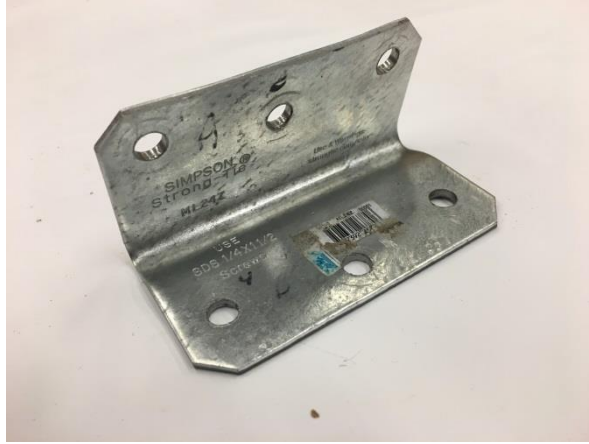
**Figure 3.7: Angle A – ML24Z angle**

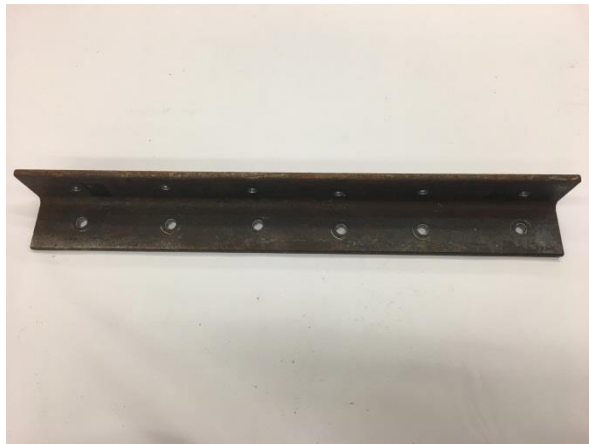
**Figure 3.8: Angle B – Stiff Manufactured Angle**

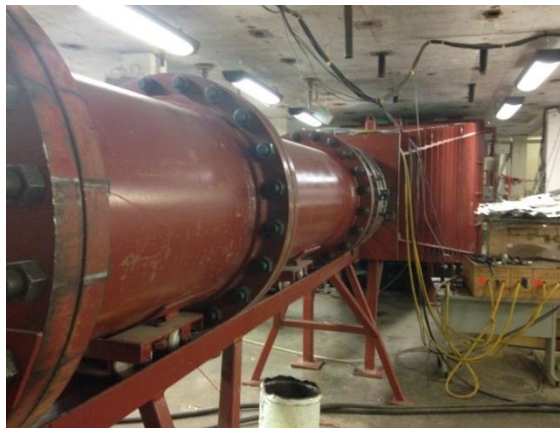
**Figure 3.11: Shocktube Driver and Diaphragm Section**

The load transfer device consists of hinged steel panels which allow it to bend out of plane, while transferring the load to the test specimen. Reinforced steel I-beams with welded rollers were implemented such that the load was applied as a four-point bending with the load application points located at the third points of the test specimens (694 mm apart). Based on preliminary analysis, a 2743 mm (9 ft) driver section was found suitable for all the pressure and impulse ranges needed in the current project.

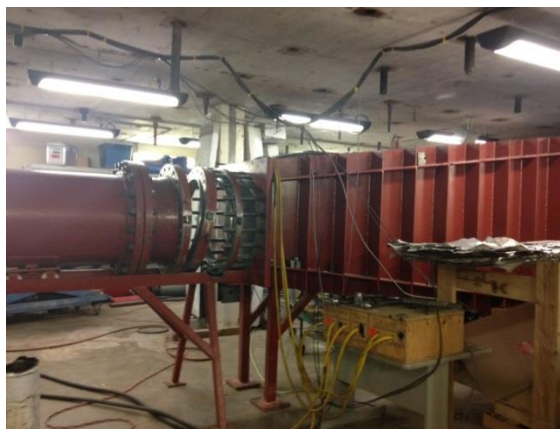
**Figure 3.12: Shocktube Expansion Chamber**

The shocktube simulates blast loads by compressing air and releasing it almost instantaneously. This is possible due to the three main components of which the shocktube comprises: the driver section, the diaphragm section, and the expansion chamber. The way the air interacts with a specimen could either be direct if the specimen is produced in the same size as the end frame, or through a load transfer device (LTD) when the test specimen is smaller in width than the end frame. Figures 3.11 to 3.13 show the various components of the shocktube facility.

A safe and predictable double-diaphragm firing mechanism is used to build up and release the pressurized air onto the test specimen. As seen in Figure 3.12, aluminum foils are placed between the driver and diaphragm, as well as between the diaphragm and expansion chamber. The thickness and quantity of foils are selected to produce the desired pressure and ensure that premature trigger does not occur. The driver length can be varied in order to produce different pressure-impulse combinations for each shot. Pressure is built up in the driver section until the desired level is achieved. The pressure in the diaphragm is controlled such that the differential pressure between the driver and diaphragm, as well as between the diaphragm and atmospheric pressure found in the expansion chamber, does not exceed the capacity of the foils in between various sections. Once the desired pressure is reached in the driver, the diaphragm pressure is reduced, causing the difference in pressure between the driver and diaphragm to be more than the foil capacity between these two sections. It is at this point that the foils rupture and the pressure wave travels through the 6096 mm (20 ft) expansion chamber and interacts with the specimens mounted at the end frame. The 2032 x 2032 mm<sup>2</sup> opening of the shocktube allows for the testing of large or full-scale structural elements. The expansion section also

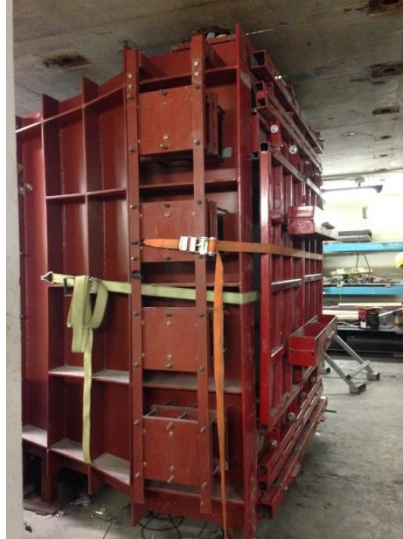
**Figure 3.13: Shocktube Load Transfer Device Description of the Test Setup**

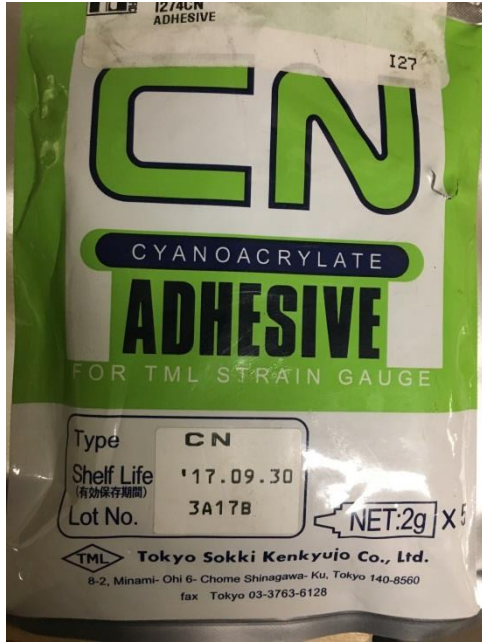
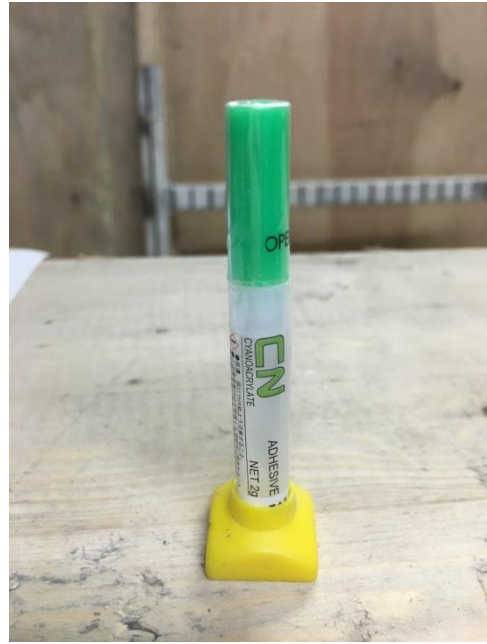
A) Packaging

B) Adhesive

Figure 3.16: Cyanoacrylate Adhesive

Strain on the compression and tension faces of the slab at mid-span was also measured using 350 Ohm strain gauges. The CLT face was sanded and cleaned prior to adhering the strain gauges to the face of the specimens using cyanoacrylate adhesive, shown in Figure 3.16. Typical test setup, including the equipment used, can be seen in Figures 3.17 to 3.18.

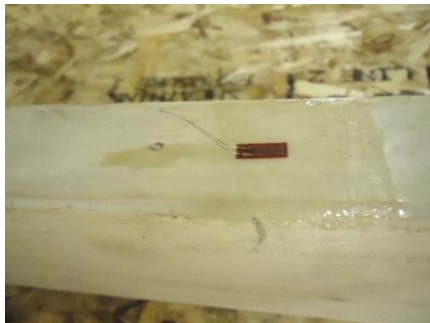
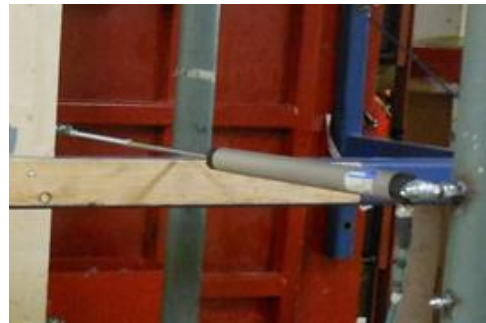
A) Strain Gauge

B) LVDT

Figure 3.17: Measurement Devices

The reflected pressure acting on the CLT slabs was measured using two piezoelectric pressure sensors, located at the side and bottom of the shocktube opening. Once the initial blast wave passed these pressure sensors, the recording of the different devices was triggered. The data acquisition system (DAS) was capable of recording data at 100,000 readings per second continuously for the duration of the test. The slab displacement was measured using 300 mm stroke linear variable displacement transducers (LVDT). The LVDT was attached to a steel post enabled the measurement of the slab deflection at mid-span. To protect the LVDTs, a steel encasement was devised and installed at the steel bracket. This encasement had the goal to protect the LVDT when the deflection of the specimen was larger than the maximum stroke of the LVDT.

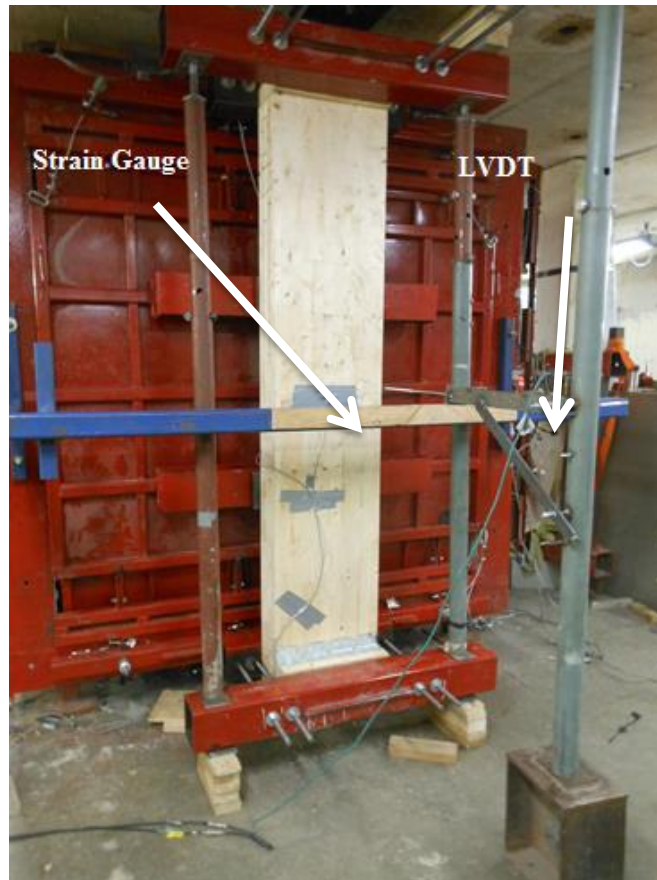
**Figure 3.18: Measurement Device Placement**

To capture the behaviour of the specimens during the investigation, readings of the pressure, displacement, and strain were documented. Also, a high speed camera, recording at a rate of 500 frames per second and with a resolution of 800 x 600 pixels was used to capture the motion of the specimens during the tests. This was essential in order to review the sequence of failures and displacements leading up to the overall failure of the test specimen.

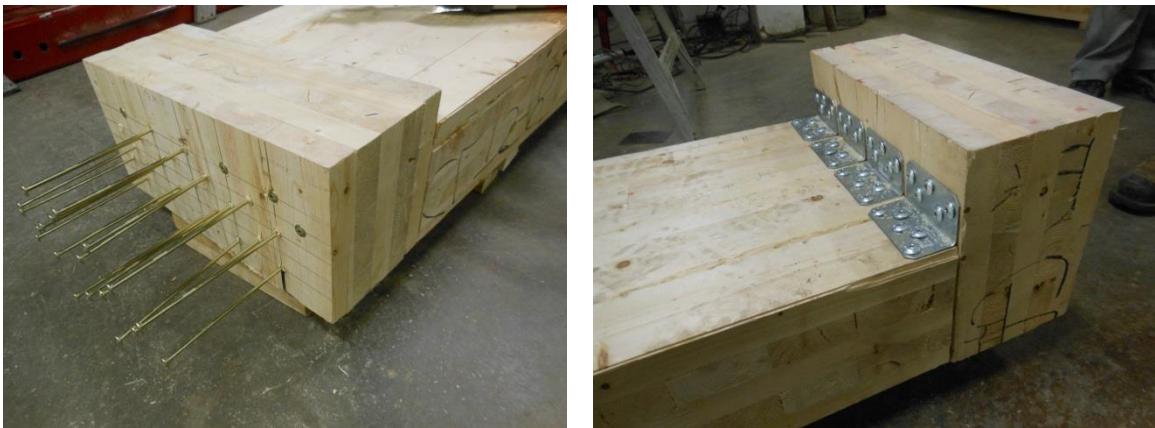
A) Top Connection

This test configuration consisted of CLT connections typically used in construction to resist gravity loads. The purpose of this test was not only to investigate whether typical connections have any inherent blast resisting capabilities but also to document whether the failure mode is suitable for blast design (i.e. possesses some level of ductility). The joint capacity was calculated using the blast standard requirements. The top connection consisted of twenty-five screws driven straight through the top supporting block (simulating CLT floor slab) and into the end grain of the CLT wall. The fasteners consisted of Heco-Topix Zn Gelb A2L screws, with a diameter of 6 mm and a length of 300 mm. The bottom connection comprised of four ML24Z steel angles (2.77 mm thick L-shaped) representing angle brackets. This joint was fastened using Heco-Topix Zn Blau screws, with a diameter of 8 mm and a length of 120 mm. A total of forty screws (twenty on each side) were used. Figure 4.1 displays the top and bottom connections for this test.

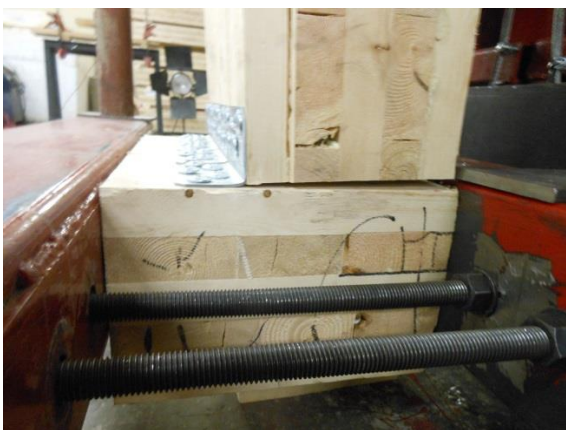
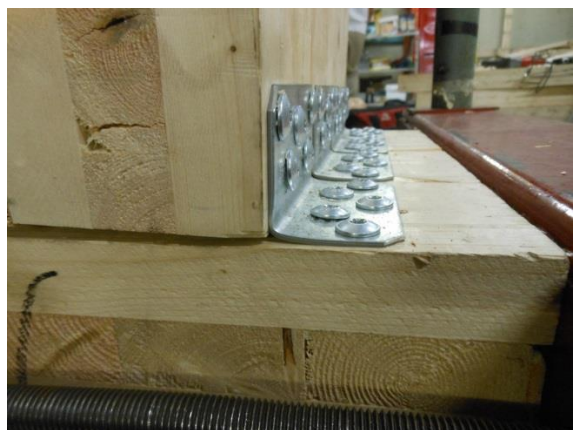
Rotation at the bottom support and bending in the steel plate was observed. However, no significant yielding in the screws occurred. As rolling shear began to form at both ends of the slab, tension perpendicular to grain failure dominated the top joint. The failure occurred at the row of screws closest to the tension face. Some of the top connecting screws were fastened into end-grain, but the transverse layers did not seem to help reinforce the region and restrict the failure from occurring. Figure 4.4 and Figure 4.5 show the failure modes described above for both the top and bottom connections.

A) Rotation at Bottom Support

B) Close-Up of Steel Angles

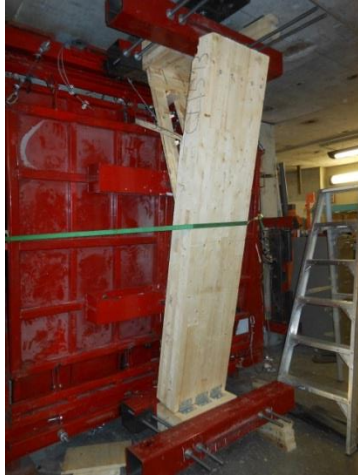
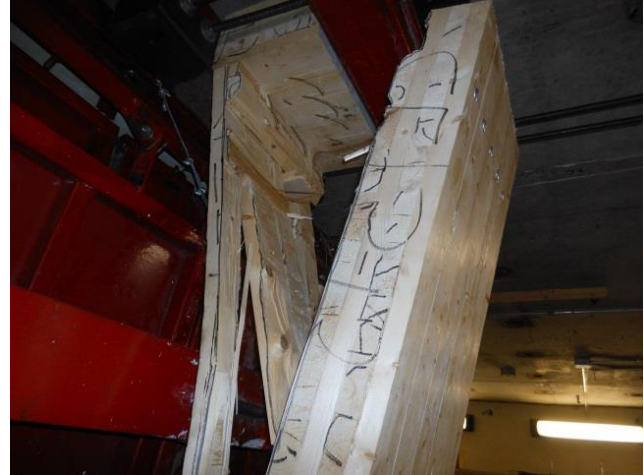
**Figure 4.7: CLT 5-2 Top Connection Failure Pictures**

Rotation at the bottom support was observed due to bending of the steel angles connecting the support block to the test specimen, with little to no yielding in the screws. As for the top connection, failure perpendicular to grain was also observed. However, the reinforcing screws shifted the surface of splitting towards the compression face. The splitting occurred at the tips of the reinforcing screws. Figure 4.7 and Figure 4.8 show the failure modes for both the top and bottom connections.

**A) Overall Failure**

**B) Top Tension Perpendicular to Grain Failure**

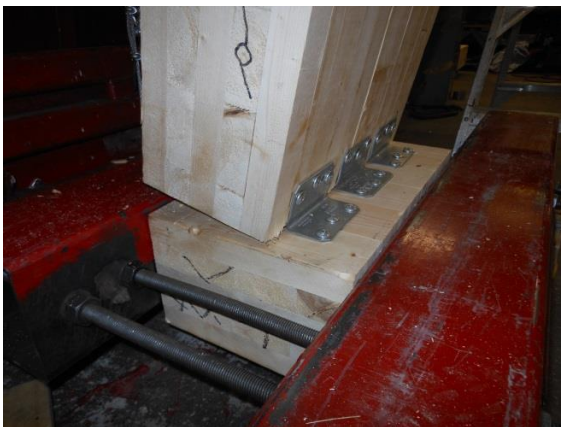
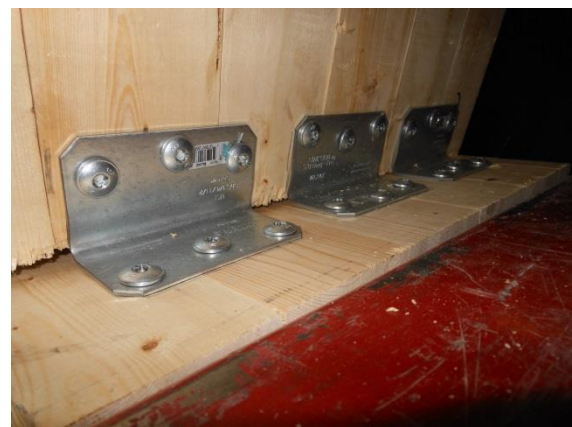
**A) Bottom Support Rotation**

**B) Close-Up of Bottom Steel Angles**

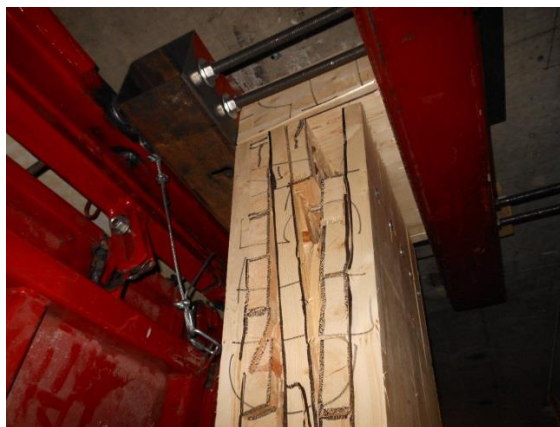
**Figure 4.10: CLT 5-3 Top Connection Failure Pictures**

Tension perpendicular to grain was observed at the first row of vertical screws on the tension side, which coincided with the first transverse layer where rolling shear occurs and further weakened the slab. Figure 4.10 and Figure 4.11 show the failure modes described above for both the top and bottom connections.

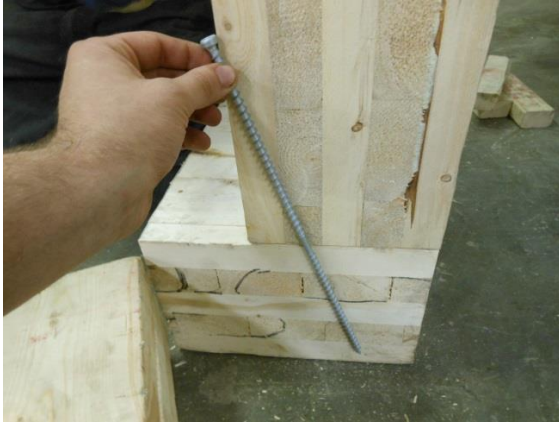
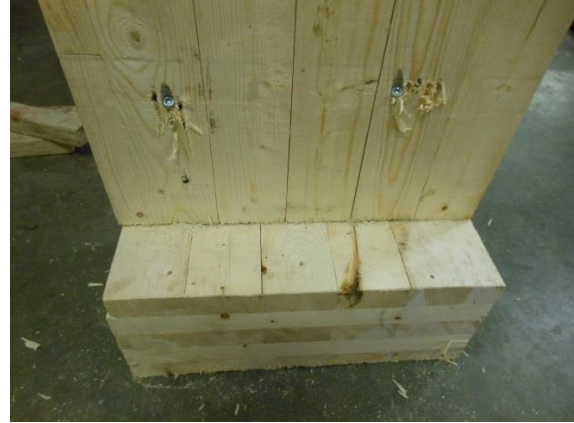
**A) Screw Installation Angle**

**B) Top and Bottom Connection**

**Figure 4.12: CLT 5-4 Connection Details**

The top and bottom connections for this test were identical and consisted of another common connection type used in CLT construction for exterior wall to floor connection. Two double-threaded ZnA2K+DS-Beschichtet screws, measuring 8.5 mm in diameter and 350 mm in length, were installed at 60° from horizontal. In this test, the number of screws was selected based on the seismic design considerations described at the beginning of the chapter. It was ensured that the point where the screw thread changes was located at the interface between the slab and support block as shown in figure 4.12 A in order to pull the two wood pieces together. Figure 4.12 displays the top and bottom connections for this test.

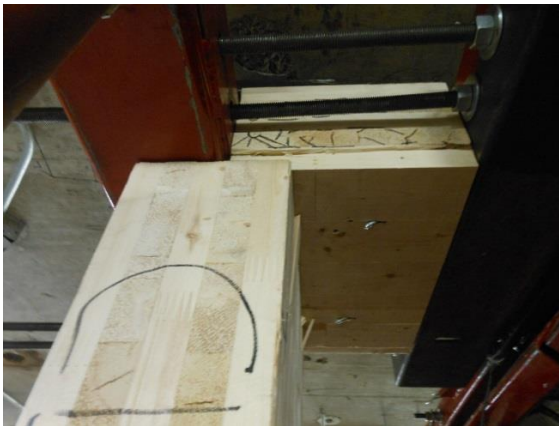
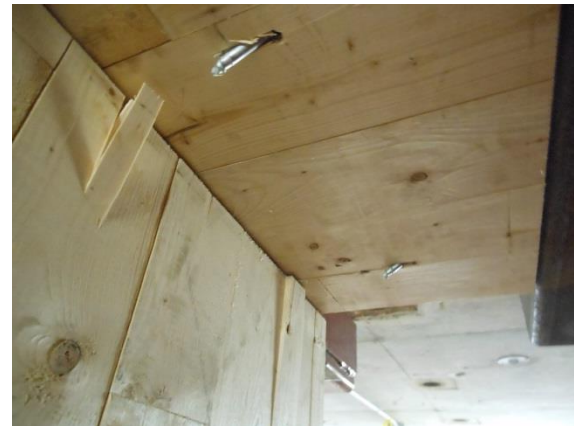
**Figure 4.13: CLT 5-4 Top Connection Failure Pictures**

There was no observable damage to the CLT test specimen itself. However, the screws at the top and bottom connections all failed in combination of shear and withdrawal. This caused the slab to slide 23 cm until friction between the slab and blocks stopped the test specimen from moving any further. Figure 4.13 and Figure 4.14 show the failure modes.

**A) Displacement Relative to Top Support**

**B) Failure of Top Connection Detailing**

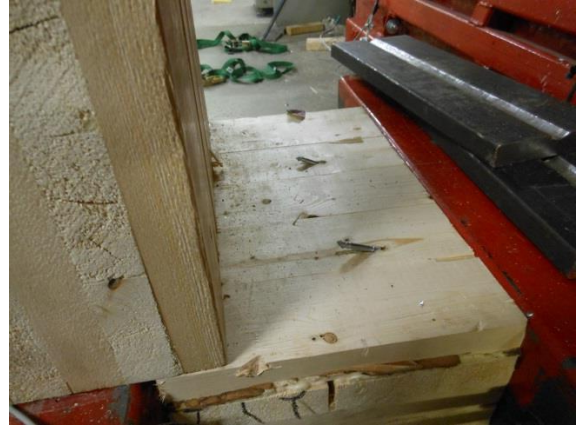
**A) Displacement Relative to Bottom Support**

**B) Failure of Bottom Connection Detailing**

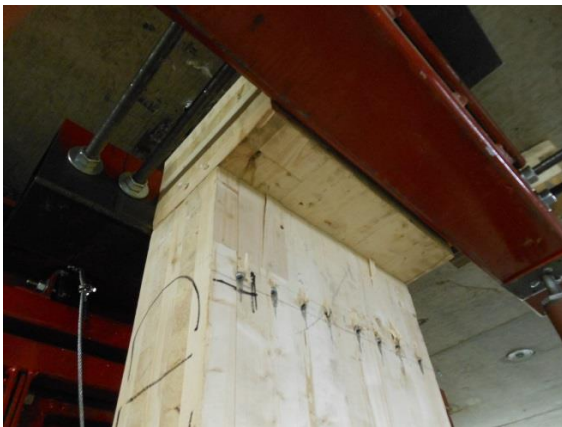
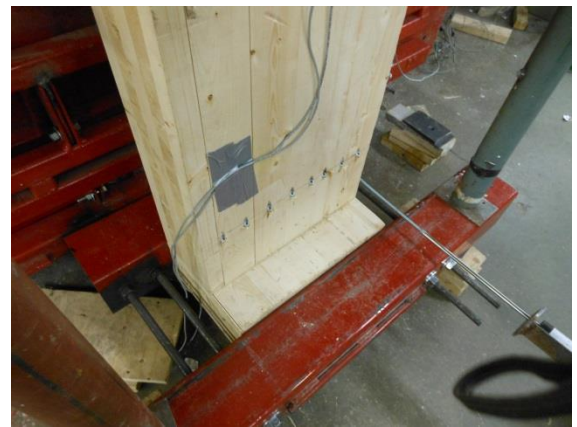
**A) Top Connection**

**B) Bottom Connection**

**Figure 4.15: CLT 5-5 Connection Details**

This test specimen is identical to CLT 5-4; however, eight double-threaded ZnA2K+DS-Beschichtet screws were used based on dynamic design following the blast design standard (2012). This was an attempt to increase the connection capacity beyond what was deemed adequate for the purpose of lateral in-plane design of the slab. Figure 4.15 displays the top and bottom connections for this test.

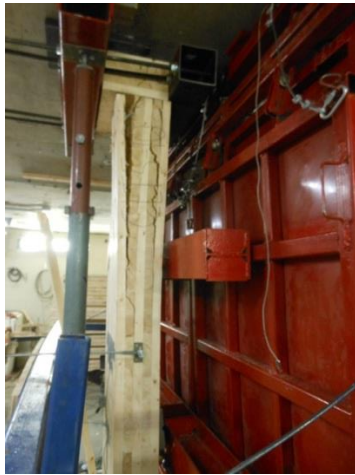
**A) Perpendicular to Grain Failure**

**Figure 4.16: CLT 5-5 Top Connection Failure Pictures**

The increased connection capacity resulted in little sliding being observed. Significant rolling shear and tension perpendicular to grain failure was observed. Figure 4.16 and Figure 4.17 show the failure modes described above for both the top and bottom connections.

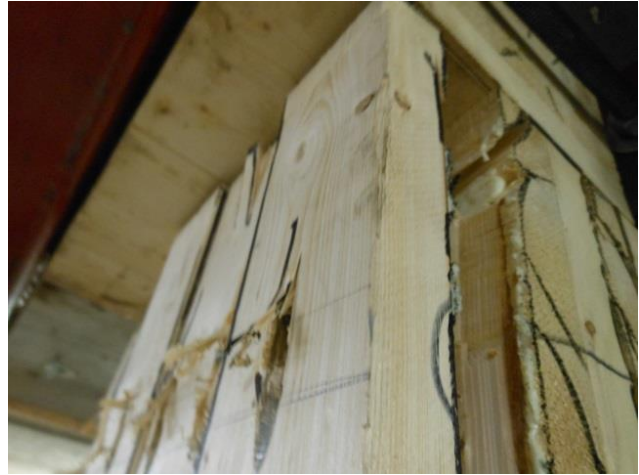
**B) Close-Up of Top Failure Mode**

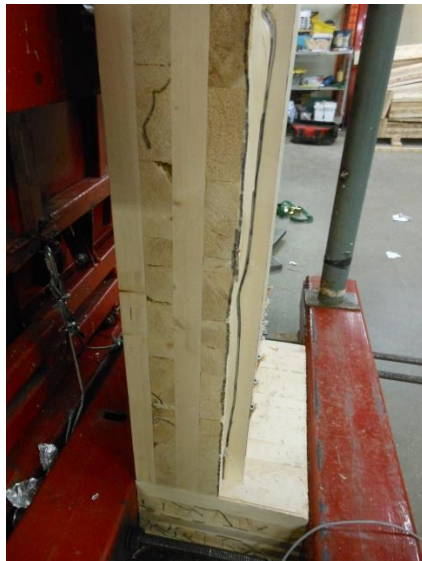
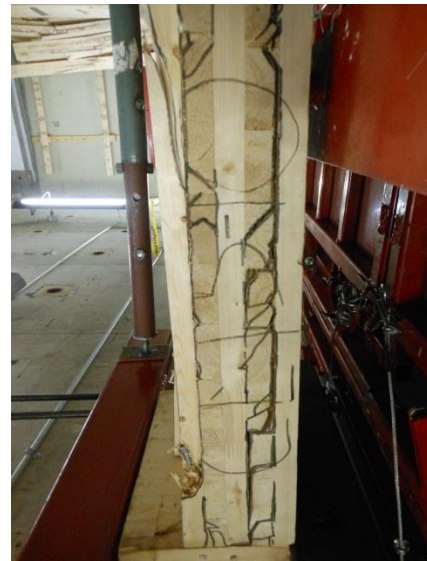
**A) Left Side Rolling Shear**

**B) Right Side Rolling Shear**

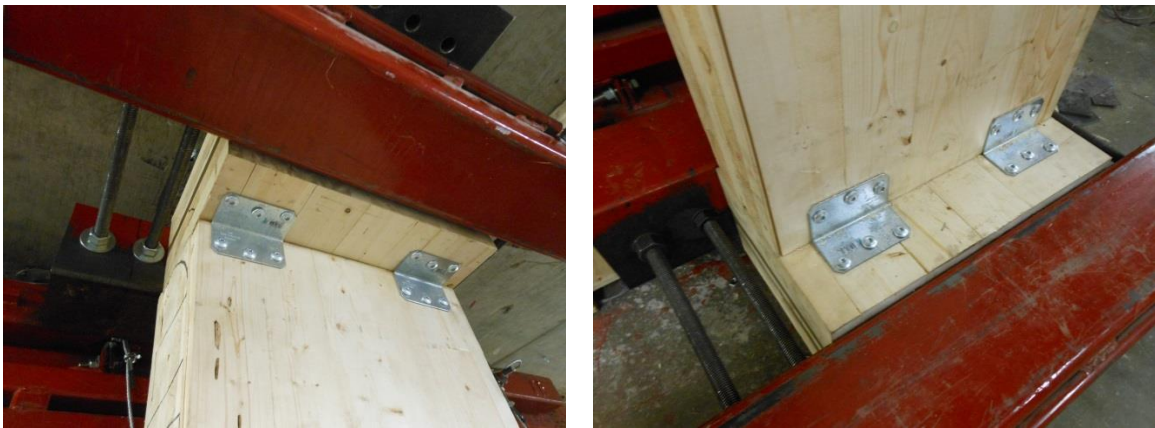
A) Top Connection

Due to wood's inherent poor tension perpendicular to grain capacity and its high compression capacity, the remainder of the tests performed in this experimental program were performed on bearing type connection details. This was done to limit and prevent the premature failure modes observed in the previous tests. In this test, the connection at both the top and bottom floors consisted of ML24Z thin steel angle brackets with Heco-Topix Zn Blau screws. Only two angle brackets were used and three screws per angle face. The capacity of this connection represented sufficient capacity per unit length of panel for seismic detailing. The connection was under-designed based on dynamic capacity considerations (70% reduced capacity compared to dynamic capacity of the panel), thus promoting failure in the connection. The purpose of this test was to achieve ductile damage in the connection without causing complete failure in the slab or connections. Figure 4.18 displays the top and bottom connections for this test.

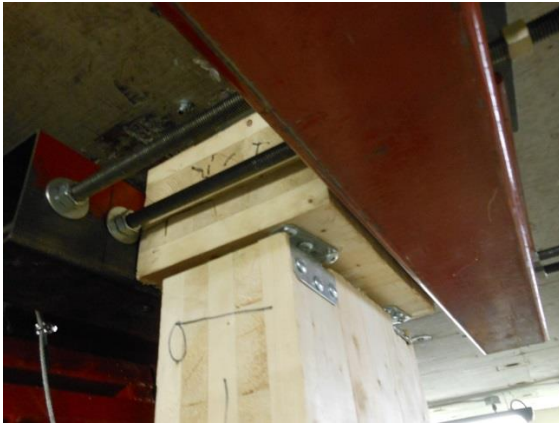
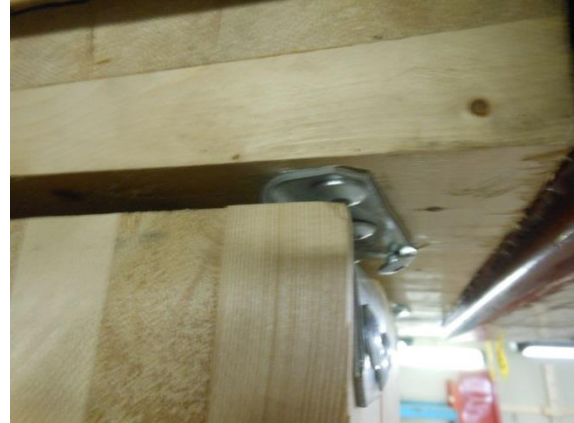
**Figure 4.19: CLT 5-6 Top Connection Failure Pictures**

The slab deflected approximately 40 mm and had very little to no visible damage. All four angle brackets deformed significantly and in a similar manner. The screws remained embedded into the wood with little to no withdrawal failure observed. Figure 4.19 and Figure 4.20 show the failure modes for both the top and bottom connections.

**A) Embedding of Top Steel Angles**

**B) Close-Up of Top Angles**

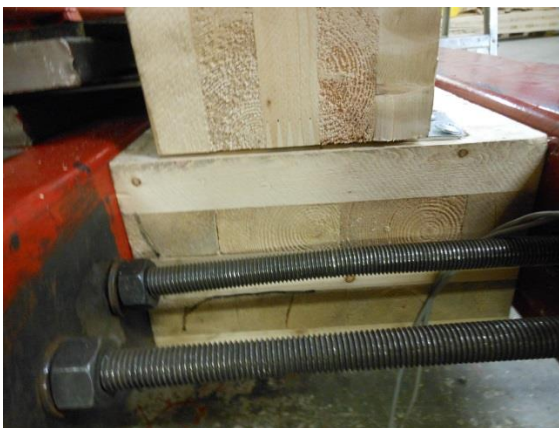
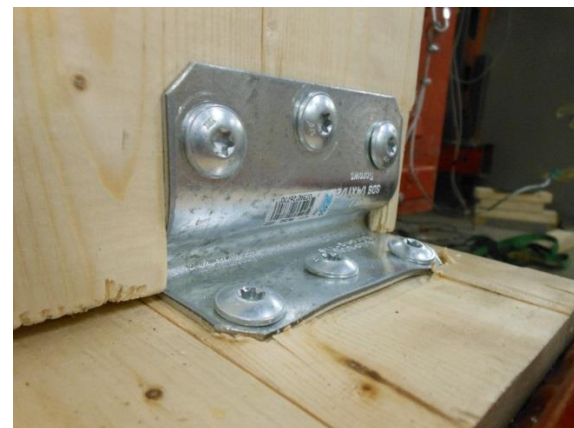
**A) Displacement Relative to Bottom Support**

**B) Close-Up of Bottom Angle**

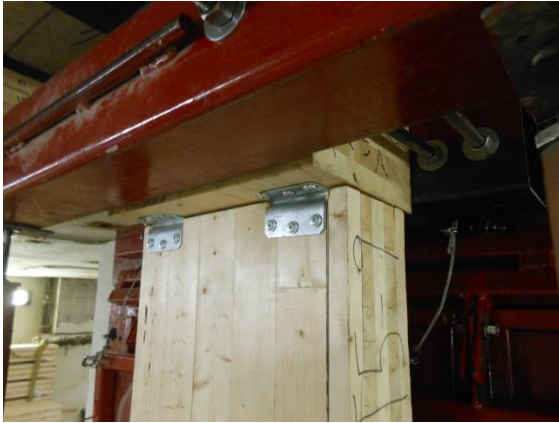
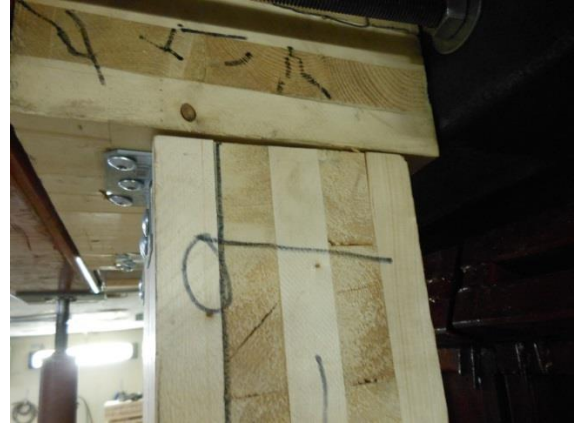
**Figure 4.21: CLT 5- 7 Top Connection Failure Pictures**

indicating initial signs of flexural failure. Figure 4.21 and Figure 4.22 show the failure modes for both the top and bottom connections.

**A) Embedding of Top Steel Angles**

**B) Displacement Relative to Top Support**

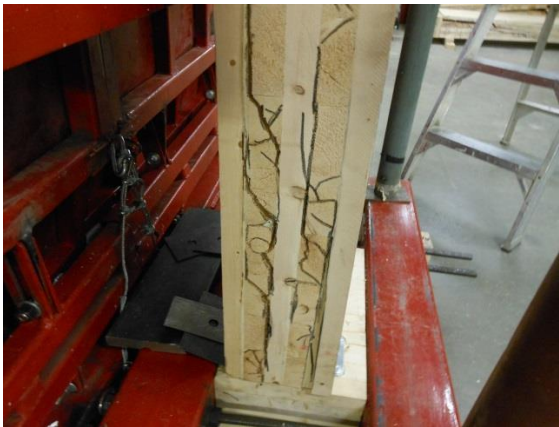
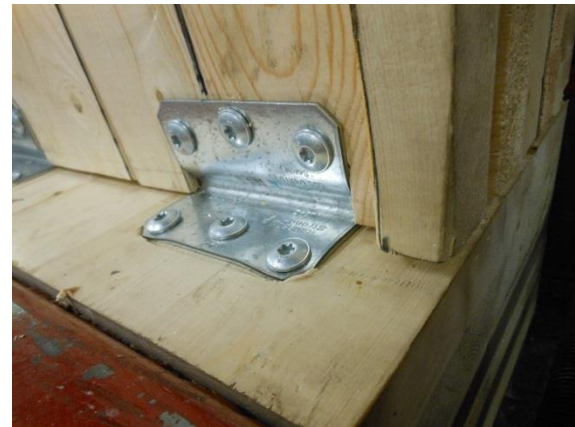
**A) Rolling Shear at Bottom Support**

**B) Embedding of Bottom Steel Angles**

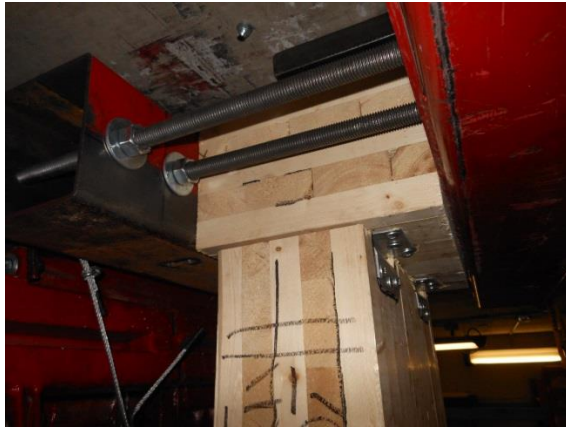
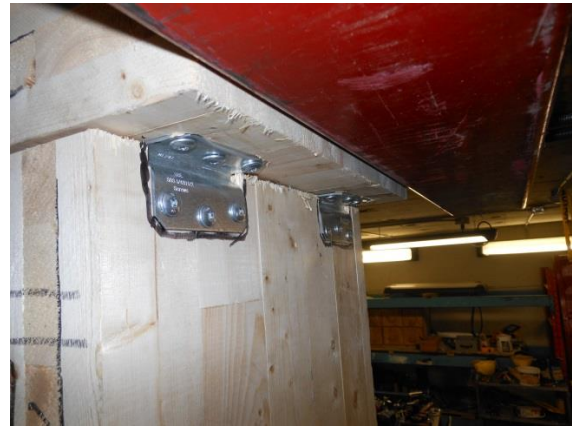
Figure 4.23: CLT 5-8 Top Connection Failure Pictures

the slab to slide forward. Some bending as well as pullout of the screws connecting the angles to the blocks was observed. Figure 4.23 and Figure 4.24 show the failure modes.

A) Displacement Relative to Supports

B) Embedding of Top Angles

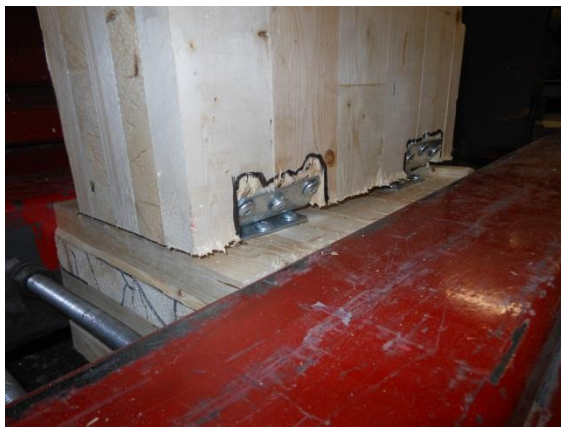
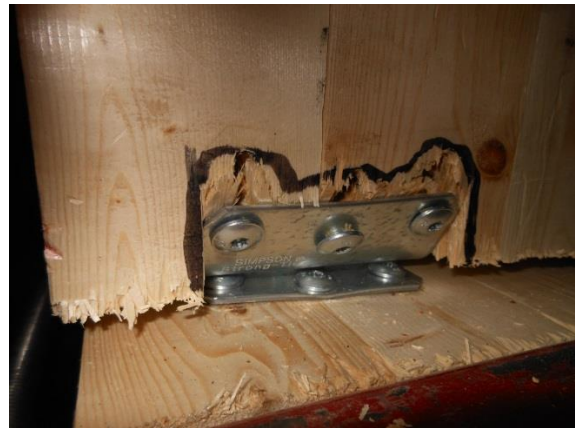
A) Embedding of Bottom Angles

B) Close-Up of Bottom Angles

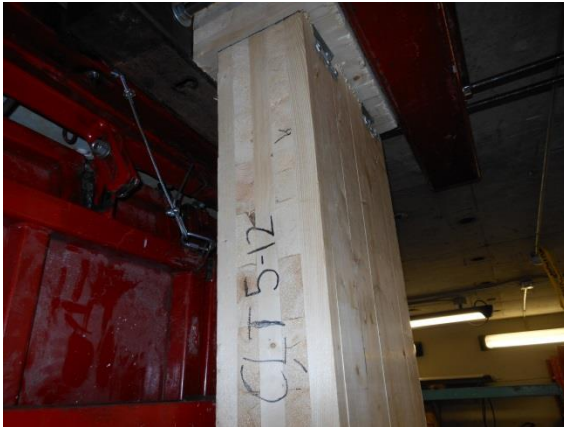
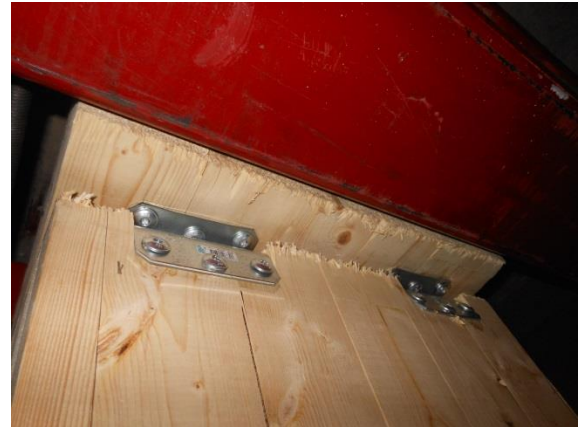
**Figure 4.25: CLT 5-9 Top Connection Failure Pictures**

supports. Significant bending in the steel bracket and crushing in the wood tension face was observed. Additionally, some of the screw heads at the bottom support were pulled out. Figure 4.25 and Figure 4.26 show the failure modes the top and bottom connections.

**A) Displacement Relative to Top Support**

**B) Embedding of Top Steel Angles**

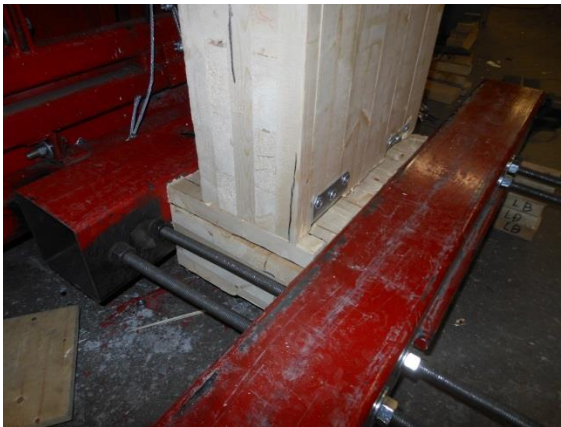
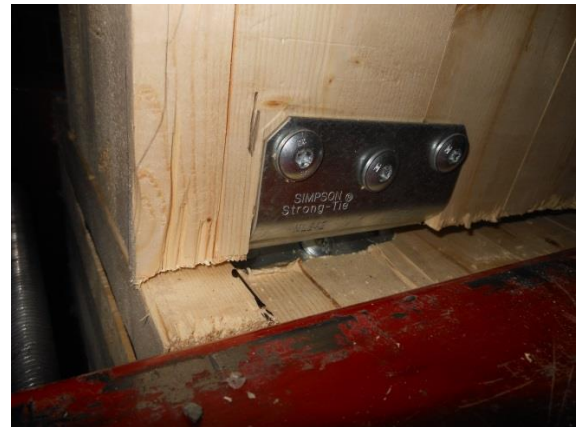
**A) Displacement Relative to Bottom Support**

**B) Embedding of Bottom Angle**

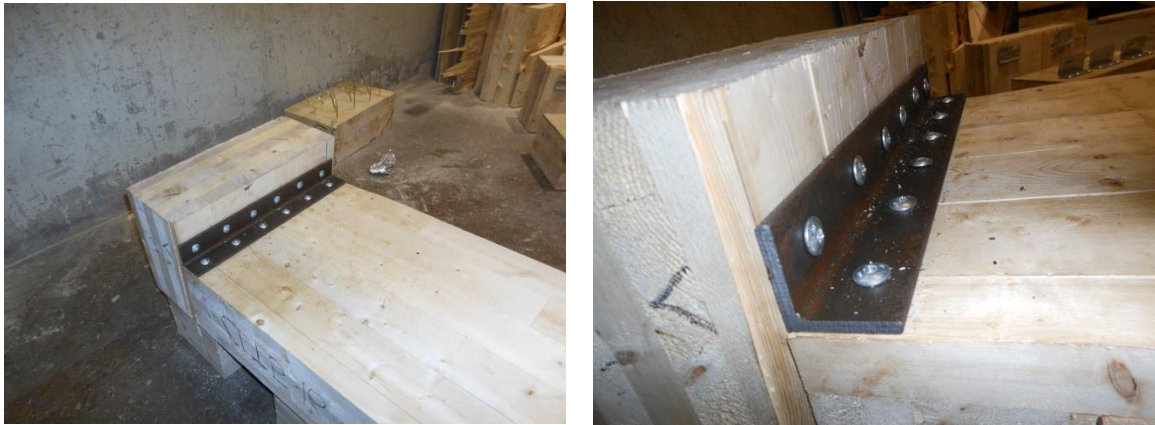
A) Bottom Connection

The connection detailing using thin steel angles (e.g. 5-6, 5-7, 5-8, and 5-9) resulted in a ductile behaviour of the angles themselves, absorbing the energy of the blast. Failure of the screws in those tests rarely occurred. Therefore, in order to investigate the possibility of attaining flexural failure in the CLT slabs, a 6.6 mm thick steel angle bracket was manufactured, and six Heco-Topix Zn Blau screws (8 mm diameter and 120 mm length) were used per angle face. The same connection detail was used for both the top and bottom end conditions. Figure 4.27 shows the connection detail.

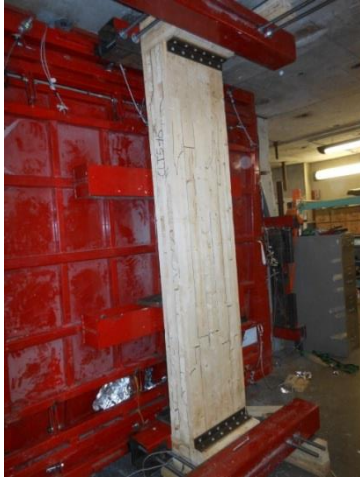
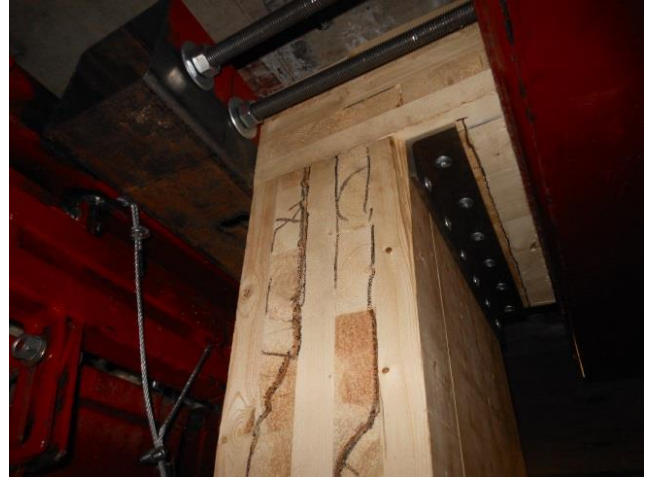
Figure 4.28: CLT 5-10 Top Connection Failure Pictures

No bending in the angles occurred, but screw deformation and wood crushing allowed for the ends of the slab to rotate without displacing. Rolling shear developed near the end supports. Flexural failure was initiated, as indicated by the spreading of the finger joints on the tension face of the slab, shown in Figure 4.28A. Figure 4.28 and Figure 4.29 show the failure modes described above for both the top and bottom connections.

A) Overall Failure

B) Top Rolling Shear

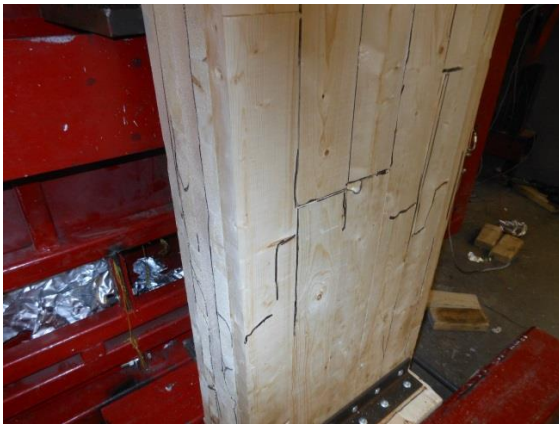
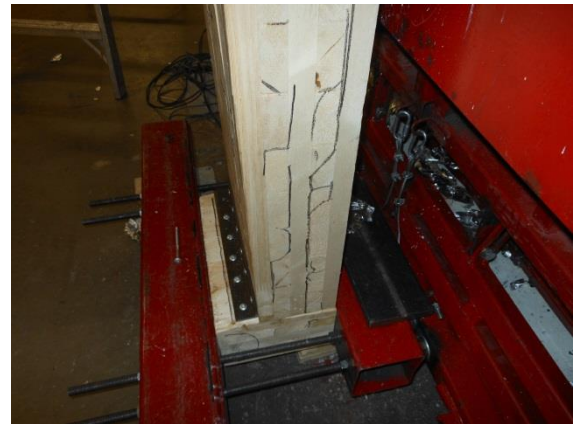
A) Initial Flexural Failure

B) Bottom Rolling Shear

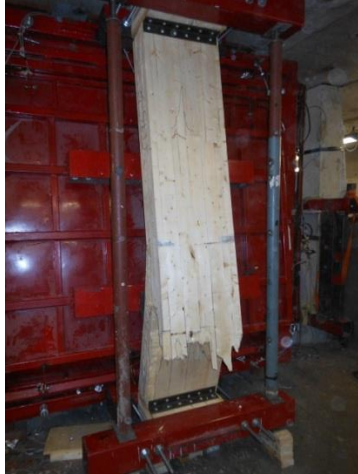
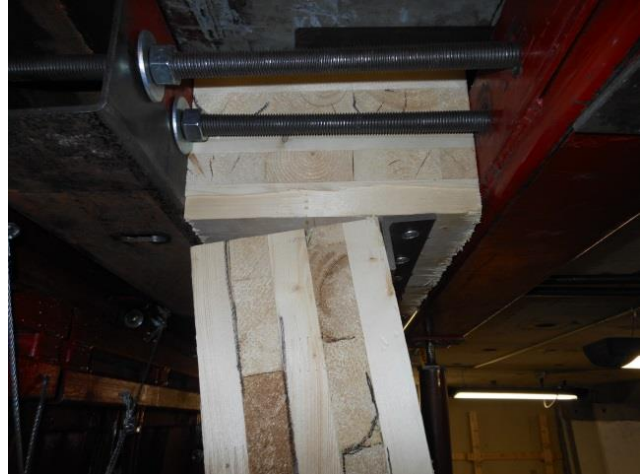
**Figure 4.30: CLT 5-11 Top Connection Failure Pictures**

failure was observed near the bottom third point with no significant damage in the connections. Figure 4.30 and Figure 4.31 show the failure modes.

**A) Overall Failure**

**B) Top End Rotation**

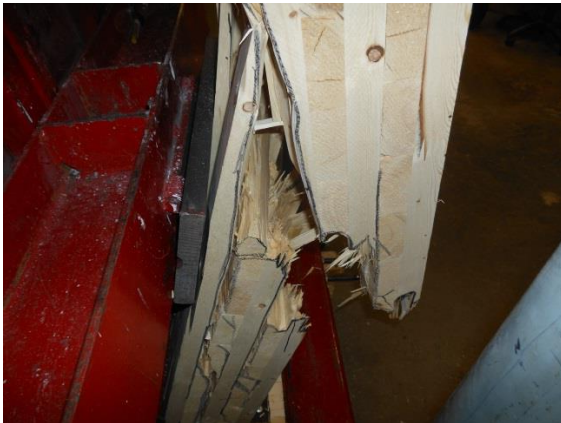
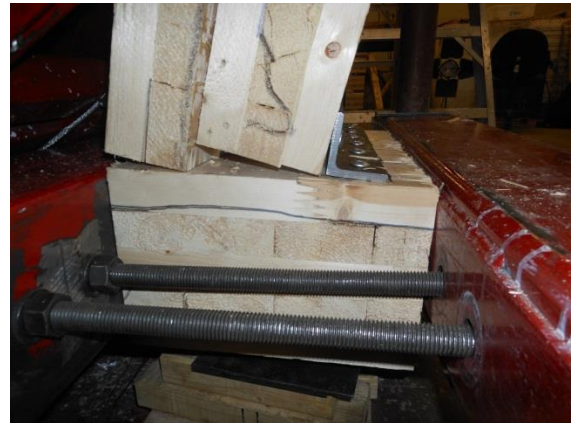
**A) Left Side Flexural Failure**

**B) Bottom End Rotation**

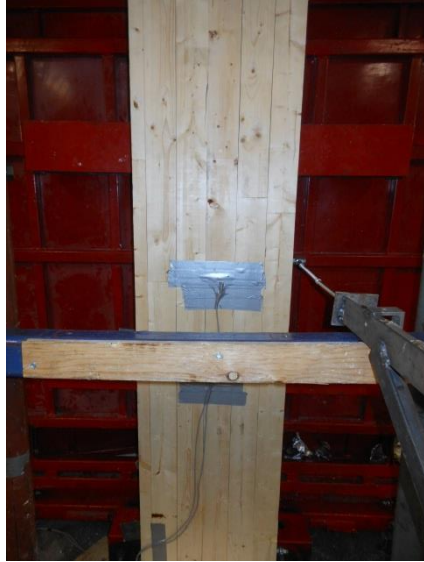
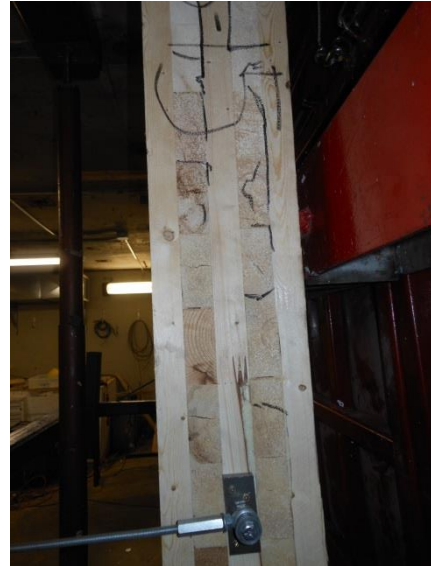
Figure 4.33: CLT 5-12 Top Connection Failure Pictures

Although bending occurred in the middle of the slab, the applied pressure was not sufficient to cause complete flexural failure in the test specimen, as shown in Figure 4.33 A. Instead, rolling shear near the supports occurred. Very little damage occurred in the longitudinal laminates. Figure 4.33 and Figure 4.34 show the failure modes for both the top and bottom connections.

A) Tension Face

B) Right Side Rolling Shear

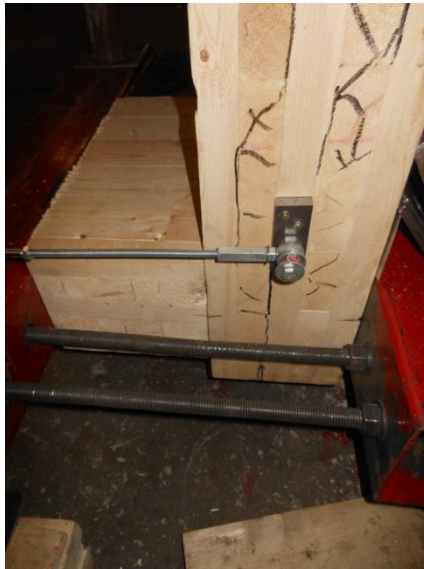
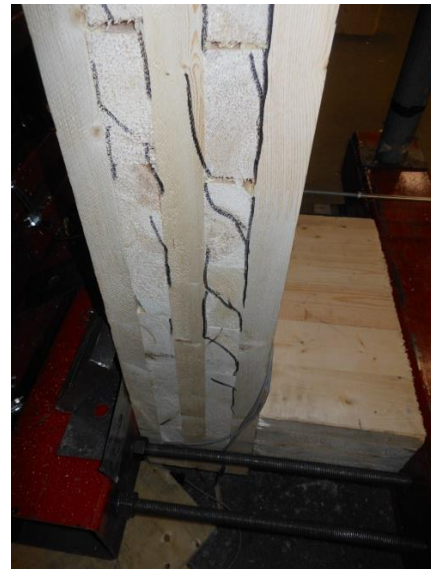
A) Right Side Rolling Shear

B) Left Side Rolling Shear

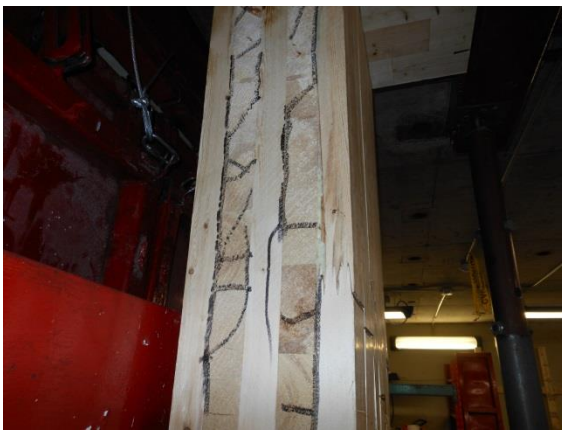
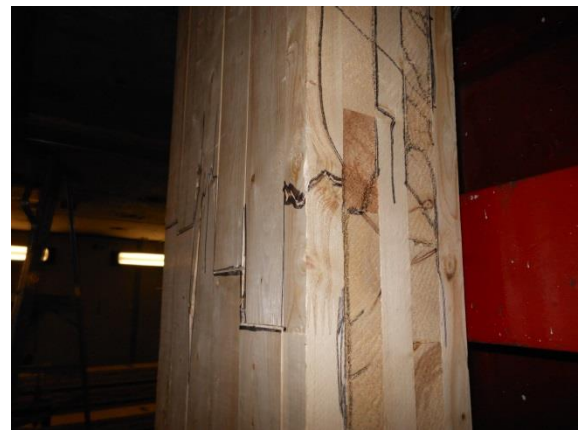
Figure 4.35: CLT 5-13 Top Connection Failure Pictures

In an attempt to fail an undamaged specimen in flexure a 12% higher pressure and 4% higher impulse combination was employed in this test. The specimen experienced significant amounts of rolling shear. The magnitude of the applied load was sufficient to separate the finger joints, but the applied shot was not enough to cause a flexural failure through the entire cross-section. Figure 4.35 and Figure 4.36 show the failure modes for the top and bottom connections.

A) Left Side Flexural Failure

B) Right Side Flexural Failure

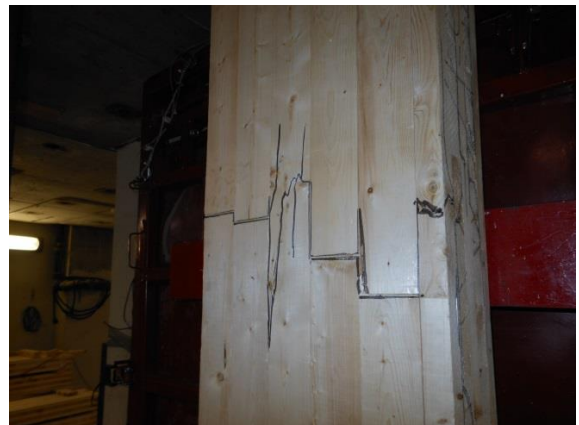
A) Bottom Left Side Rolling Shear

B) Tension Face Flexural Failure

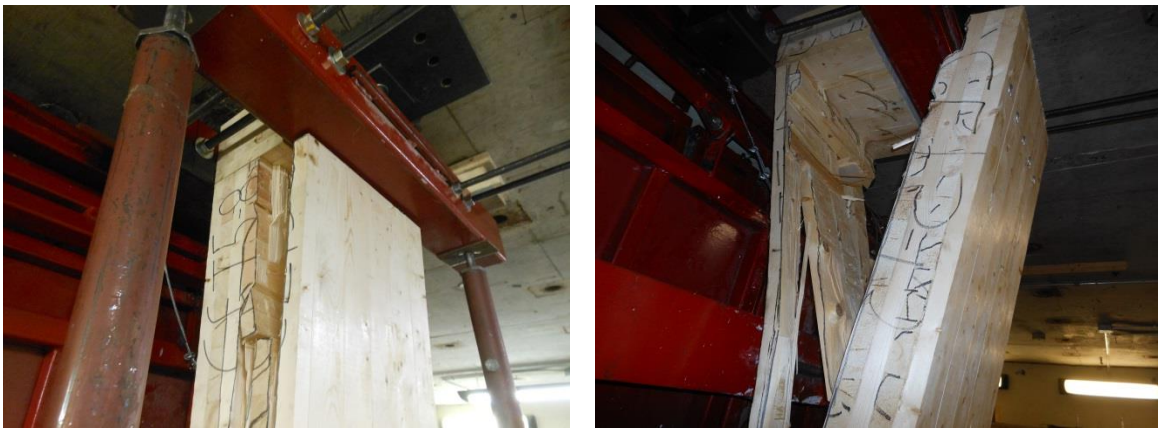
A) CLT 5-1

Reinforcement of tension perpendicular to grain splitting has in recent years been researched and designed for using self-tapping screws installed in the perpendicular direction to the wood fiber and near the location of the end grain screws (e.g. Trautz and Koj, 2009). In an attempt to improve the behaviour observed in specimen CLT 5-1, screws were installed from the tension face to reinforce the joint. The number of screws in the end grain was reduced to further emphasize the positive effect of the reinforcing screws. Without the reinforcing screws, this connection would be under-designed according to the Canadian blast design standard (CSA 2012). The pressure and impulse were increased by 23% and 16%, respectively, compared to the shot specimen CLT 5-1 was subjected to. Although the connection was under-designed, the failure shifted towards the compression face, engaging more wood material and thereby increasing the splitting capacity. Figure 5.2 shows this shift in failure plane.
