# **EFFECT OF REALISTIC BOUNDARY CONDITIONS ON THE BEHAVIOUR OF CROSS-LAMINATED TIMBER ELEMENTS SUBJECTED TO SIMULATED BLAST LOADS**

**Dominic Cote**

**Master of Applied Science**

University of Ottawa

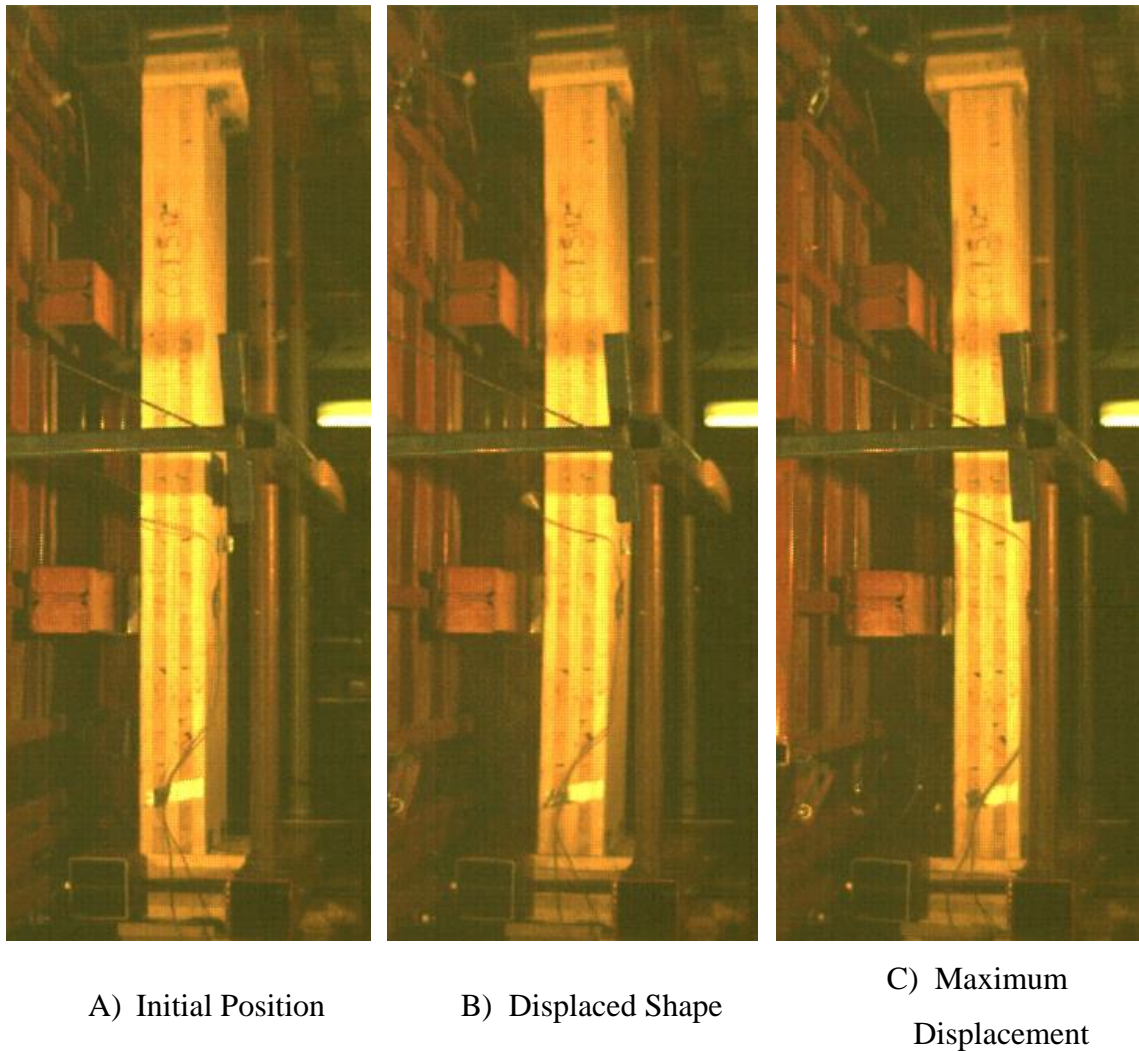
**Figure 5.4: CLT5-9 Displacement Progression (Max at 90 mm at 42ms)**

An important point to mention is that although both the angle and the screws were under-designed based on the requirements in the blast design standard (CSA 2012), the overall performance of the wall slab was significantly improved due to the ductile failure.

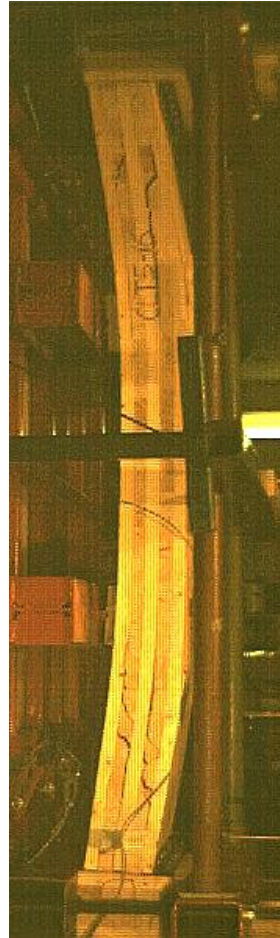
**Figure 5.7: CLT5-10 at Maximum Displacement (85 mm at 41ms)**

between the slab and the block simulating floors. As will be shown in Section 5.3 this will have some implication on the modeling aspect of the CLT wall system.
