INFORMATION TO USERS

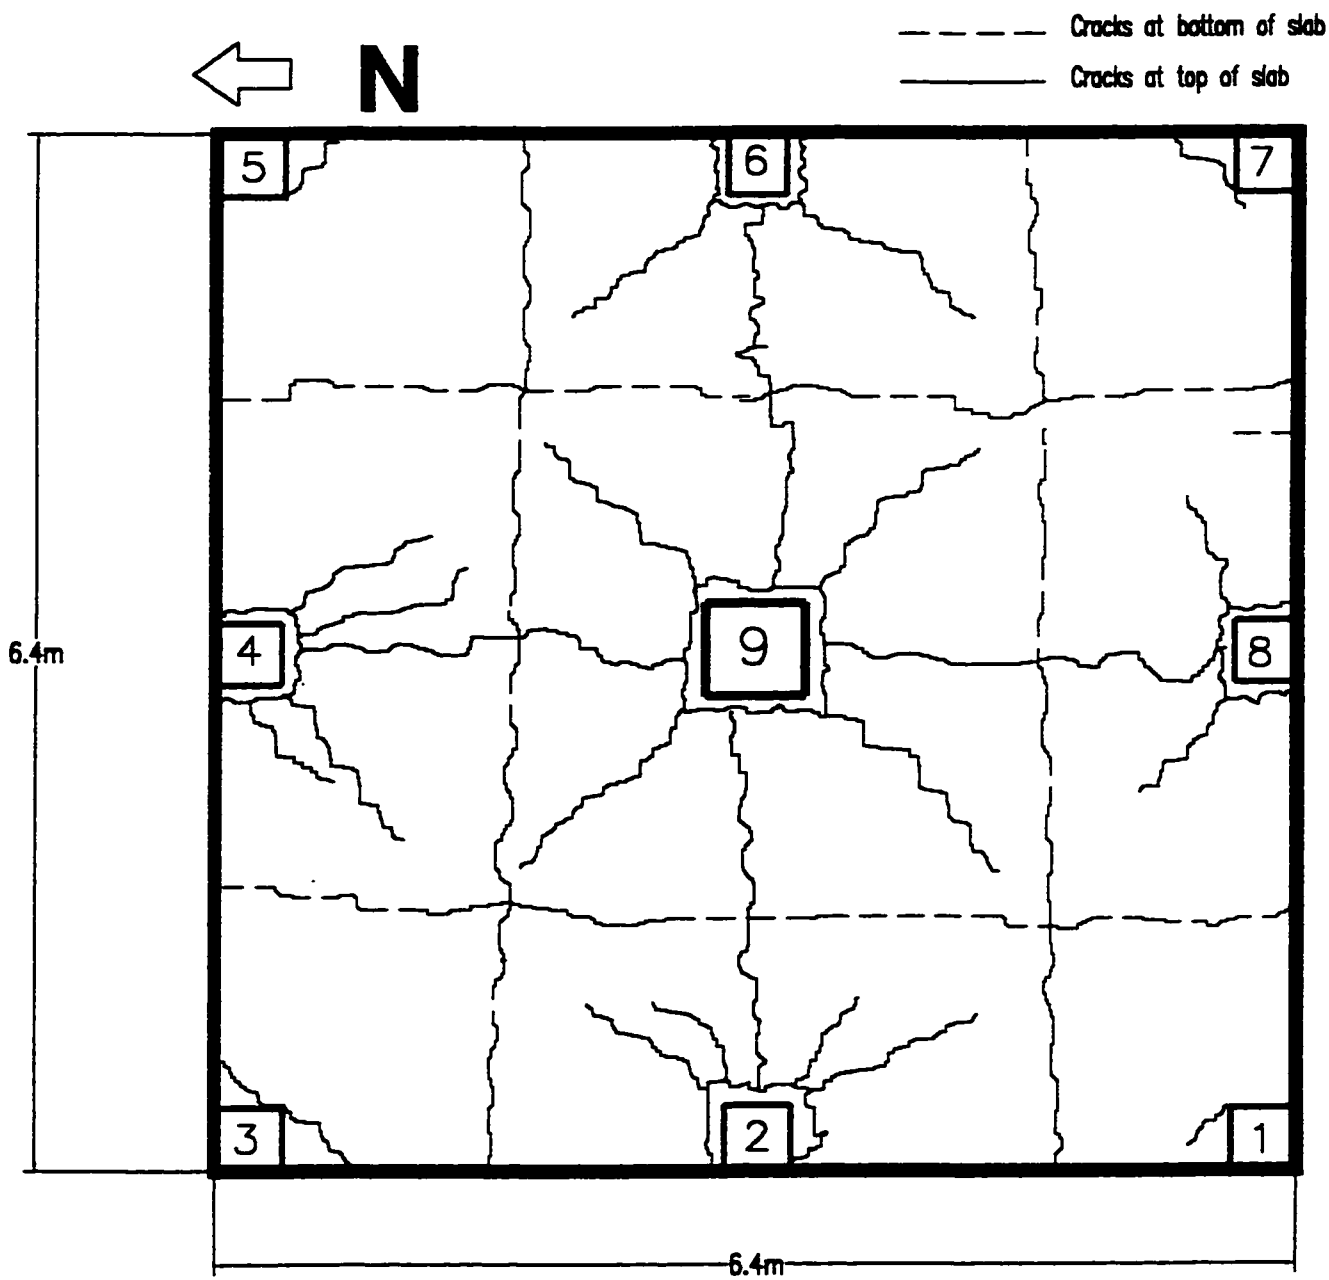
Fig. 4-3 Distribution of cracks immediately prior to failure in Test no. 1

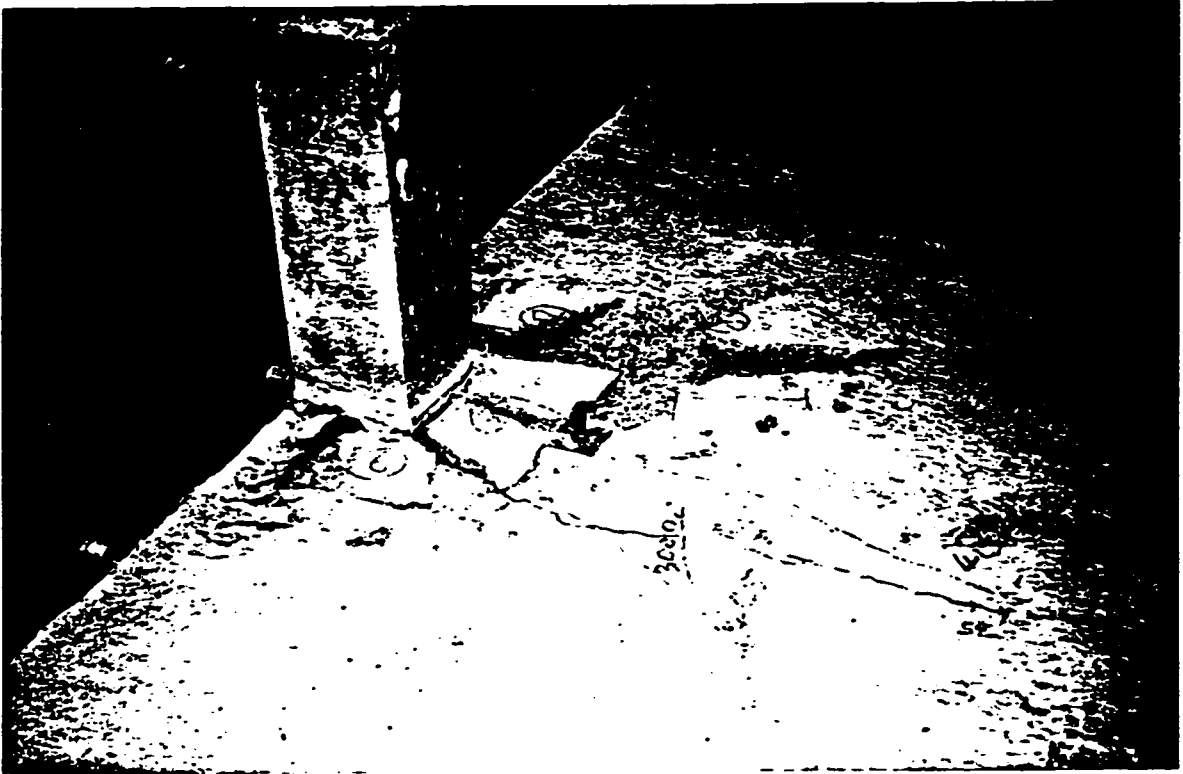
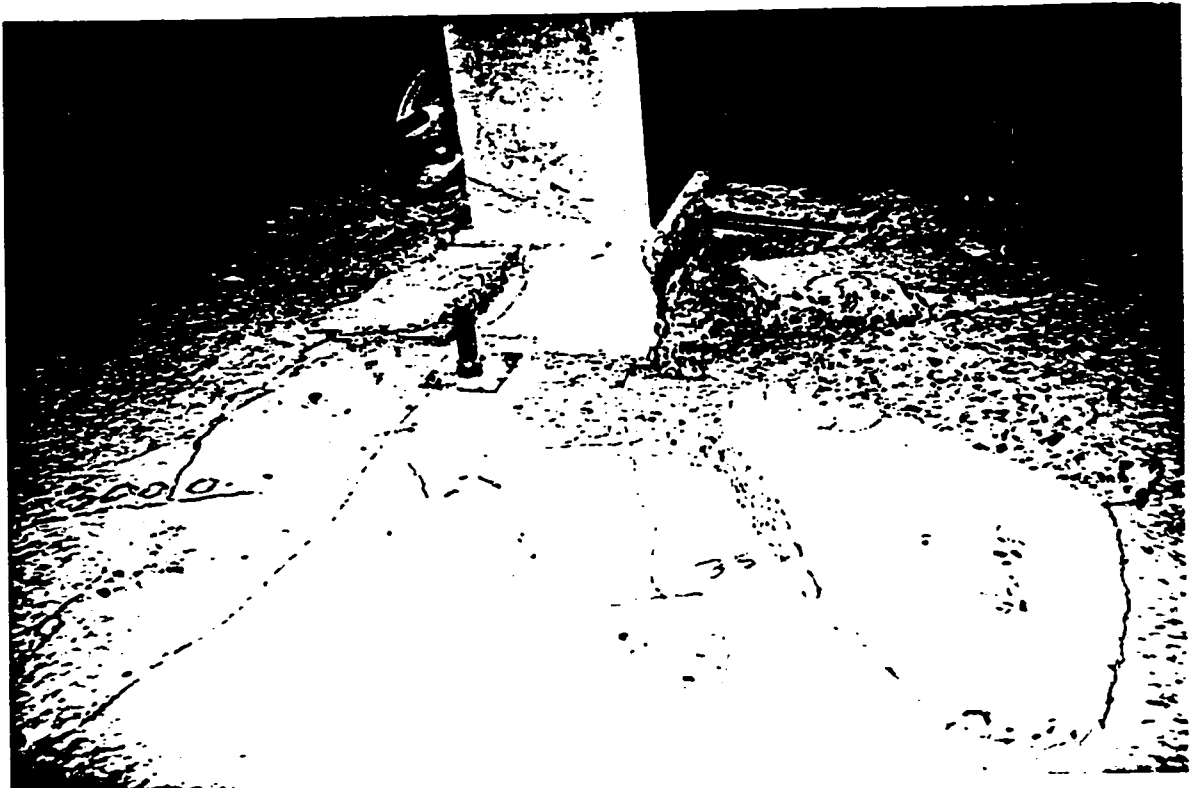
Fig. 4.4 Punching shear failure zone at column no. 2 in Test no. 1

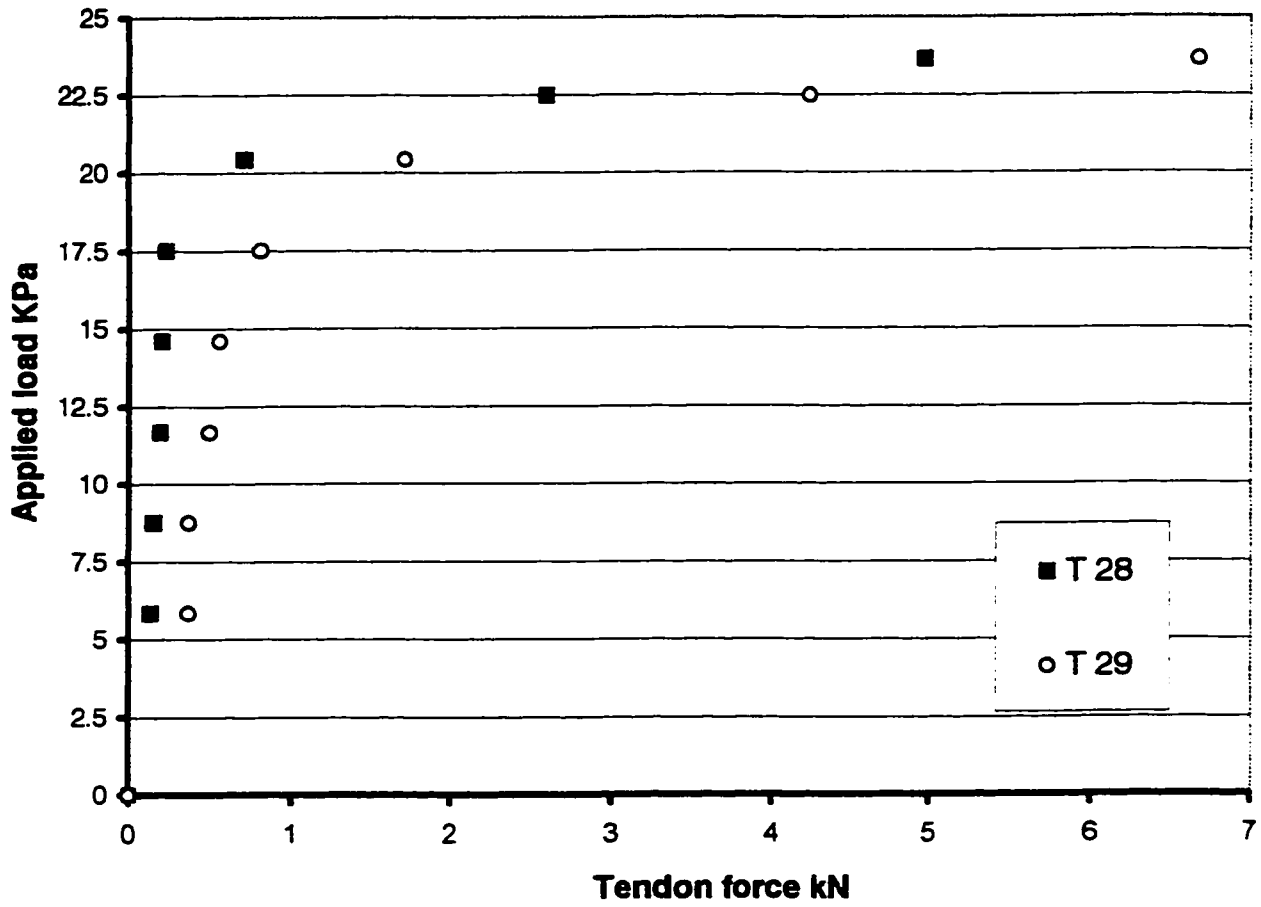
Fig. 4-5 Changes in force in the tendons passing through column 2 in the east-west direction in Test no. 1

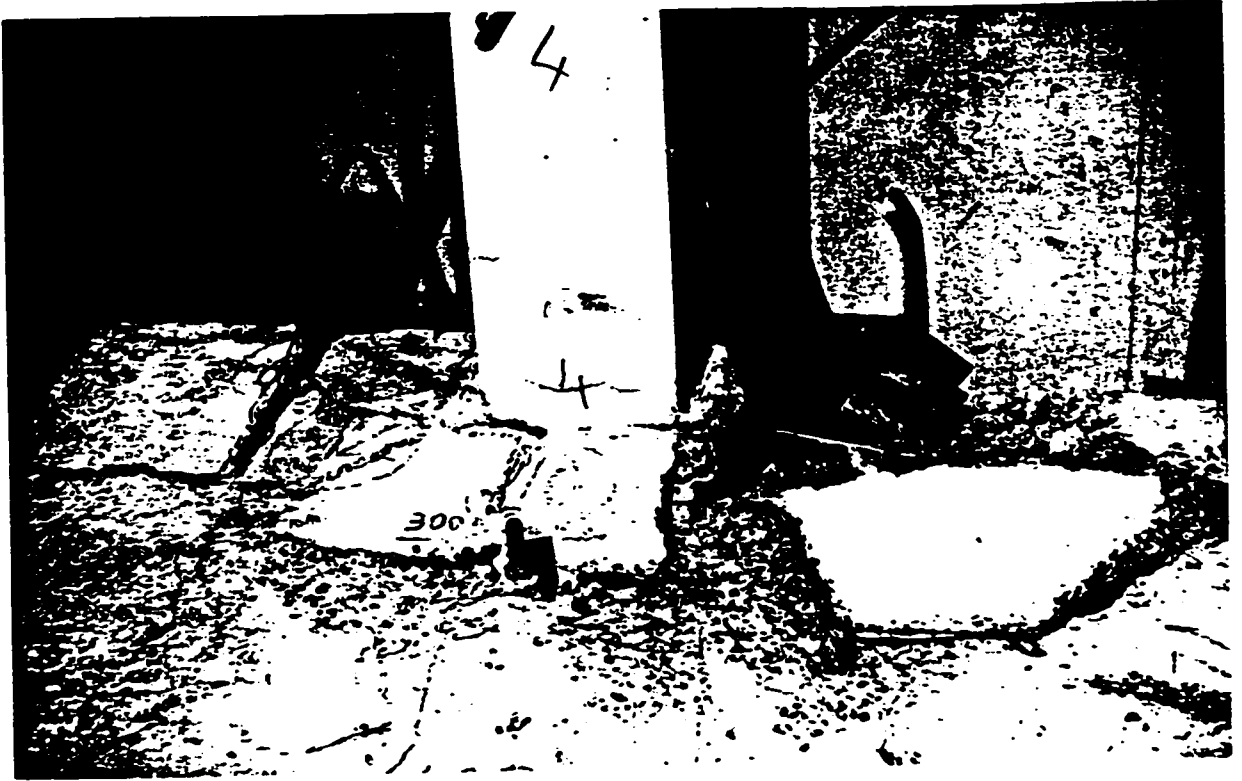
Fig. 4.25 The severe damage of connection no. 4 due to punching shear failure in Test no. 4

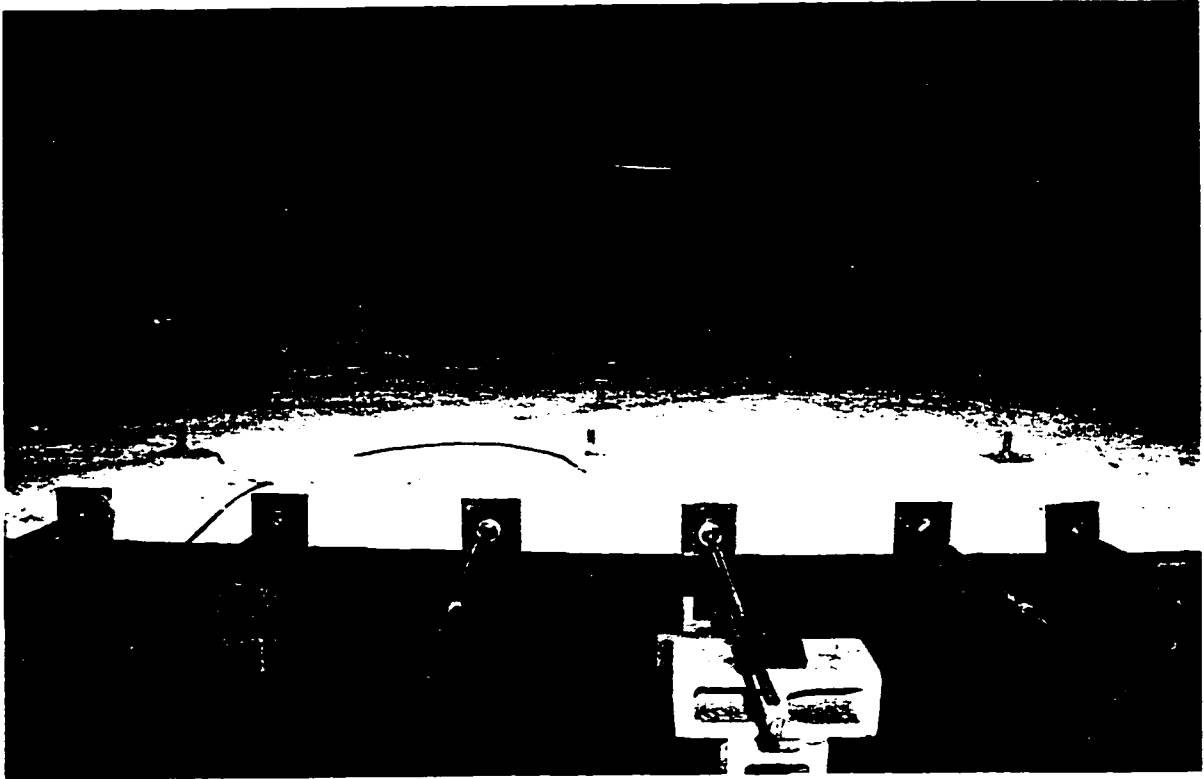
Fig. 4.32 View of the two zones failure in Test no. 5

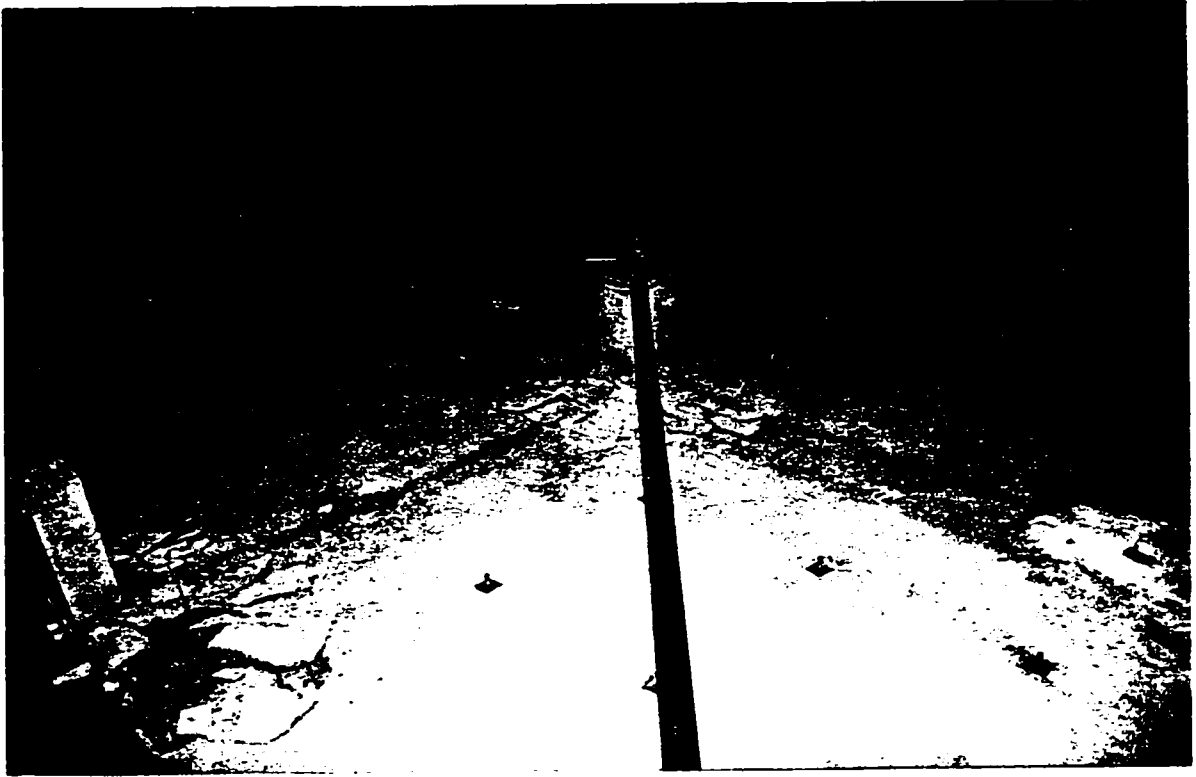
Fig. 4.33 Column 9 and 2 connections after failure
