**SEISMIC TESTING OF
UNREINFORCED MASONRY
BUILDING WITH FLEXIBLE
DIAPHRAGM**

Jocelyn Paquette

Thesis submitted to the Faculty of Graduate and Post Doctoral Studies
in partial fulfillment of the requirements for the
Doctor of Philosophy Degree in Civil Engineering
under the auspices of the
Ottawa-Carleton Institute for Civil Engineering

February 2002

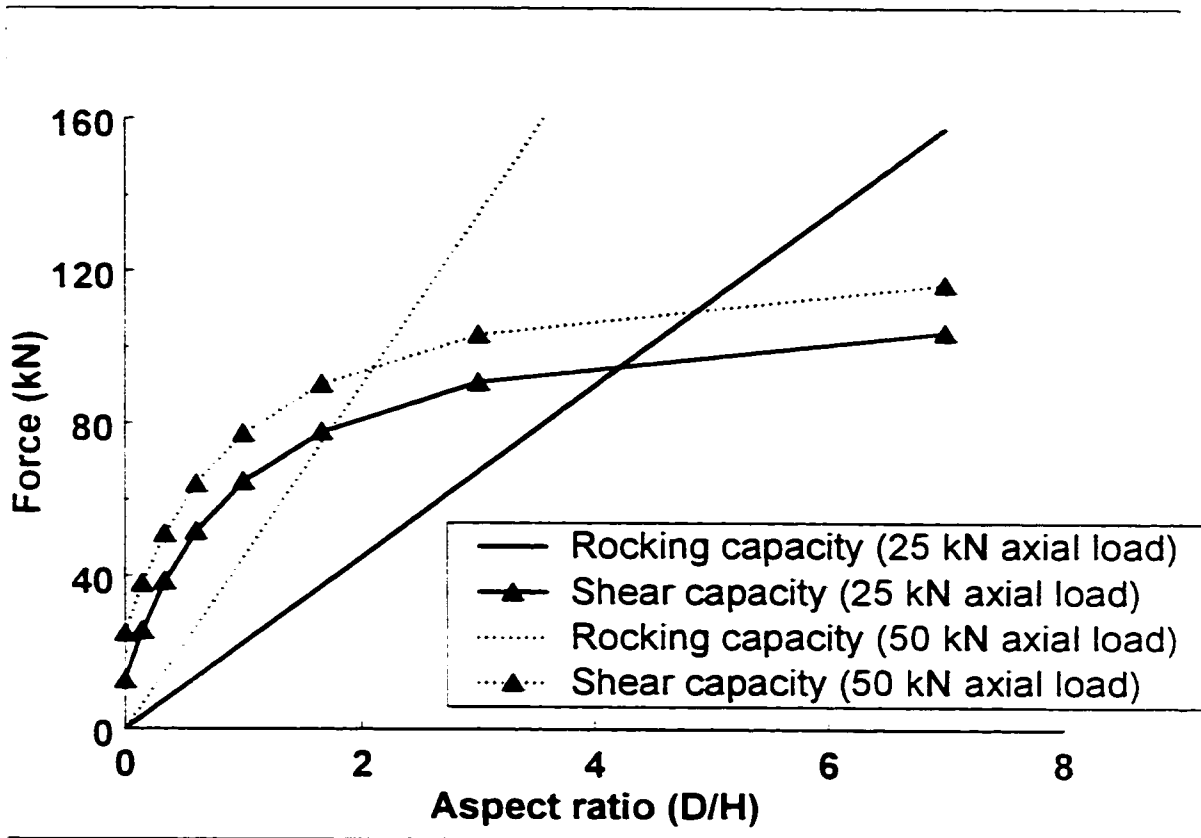
Figure 3.1 Piers rocking and shear capacity for different aspect ratios and axial loads, where D is the in-plane width dimension of masonry, and H is the least clear height of opening on either side of pier.

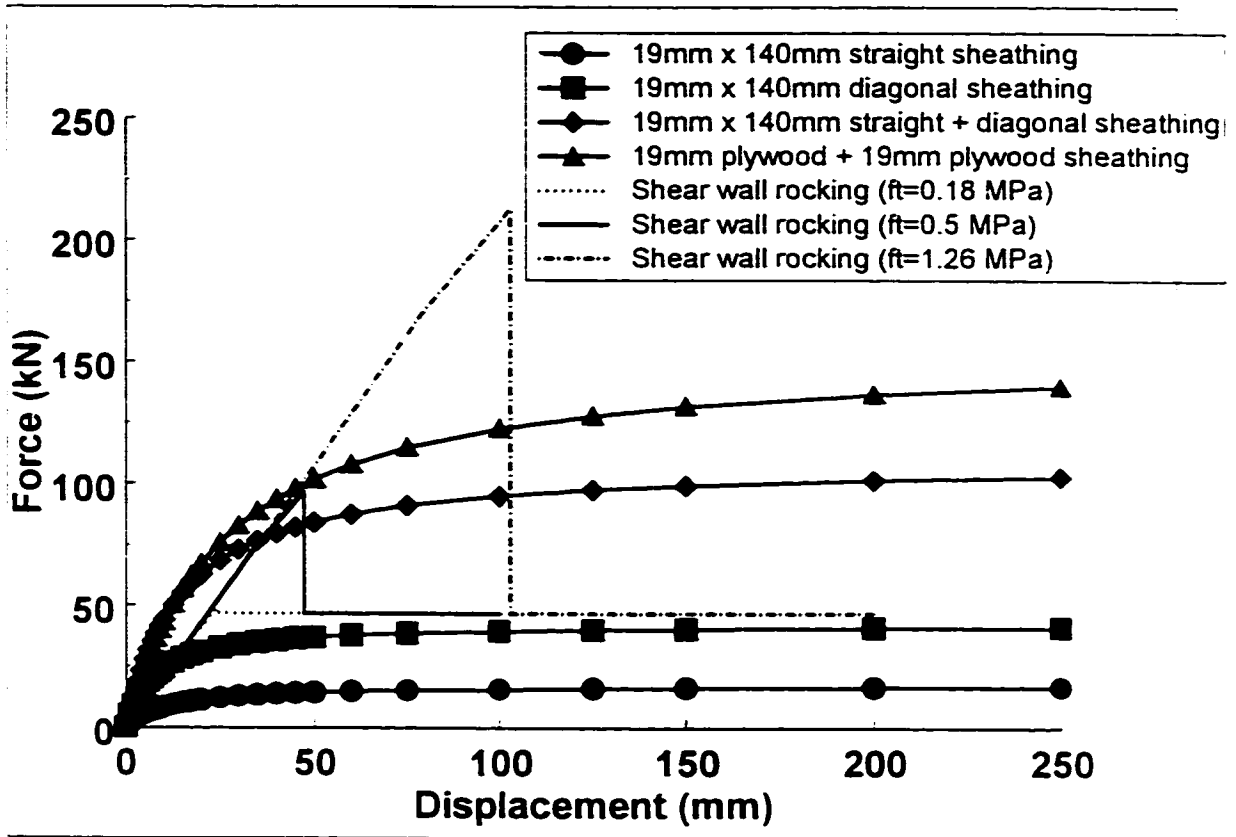
Figure 3.2 Force-deformation curves for a 3.66 m x 5.28 m diaphragm for different types of sheathing, and wall cracking/rocking behavior considering gravity on specimen's piers. Note that the shear wall rocking displacements have been magnified by 1000 to be visible on the same graph.

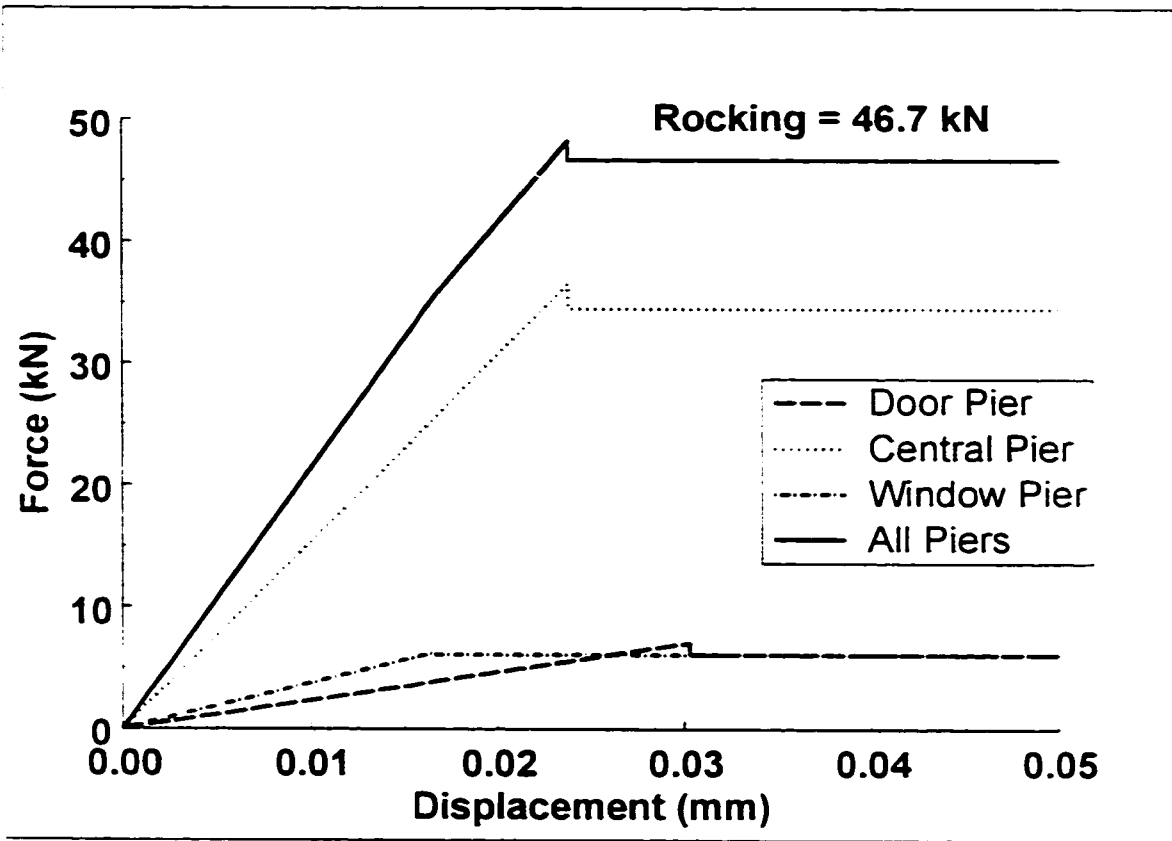
Figure 3.6 Pier rocking resistance based on CGSEEB.

Shear walls were designed such that all piers would successively develop a pier-rocking behavior during seismic response, as shown in Fig. 3.6. The initial portion of the curve is the linear elastic stiffness of the shear wall, while the second portion has a zero slope representing the rocking behavior of the piers in the shear wall. This rigid-body mechanism is recognized by the UCBC to be a favorable stable failure mechanism.

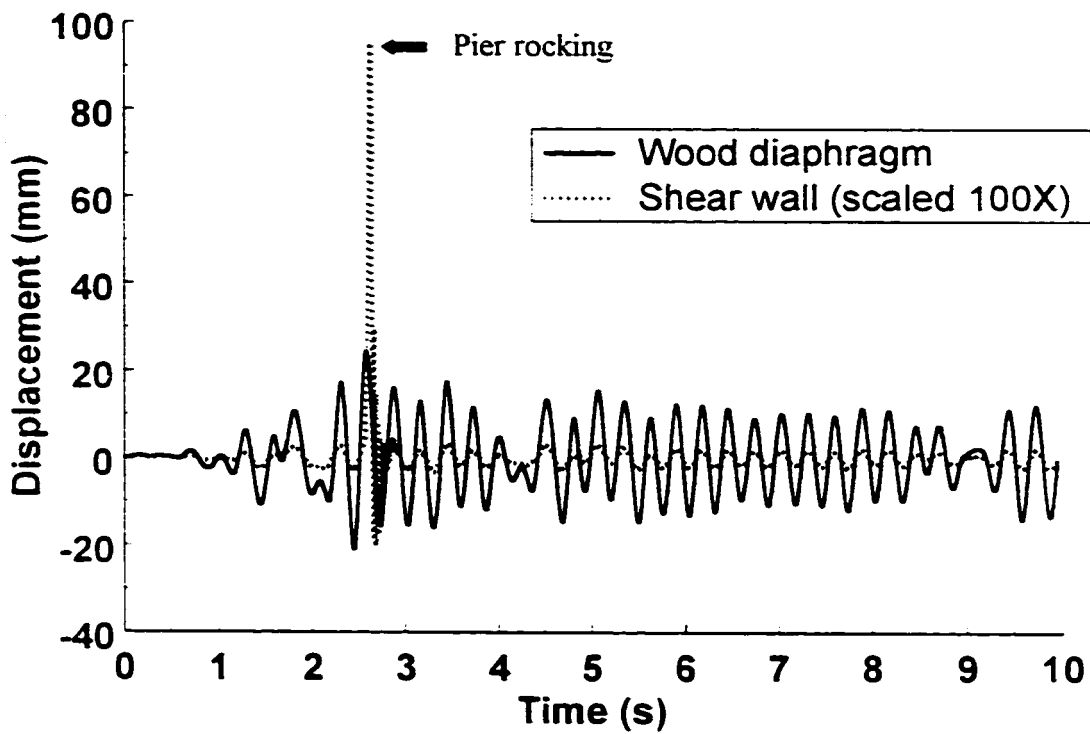
Figure 3.7 Comparison of wood diaphragm center-span response with magnified (100X) end-wall response for El Centro earthquake scaled to 0.5g.

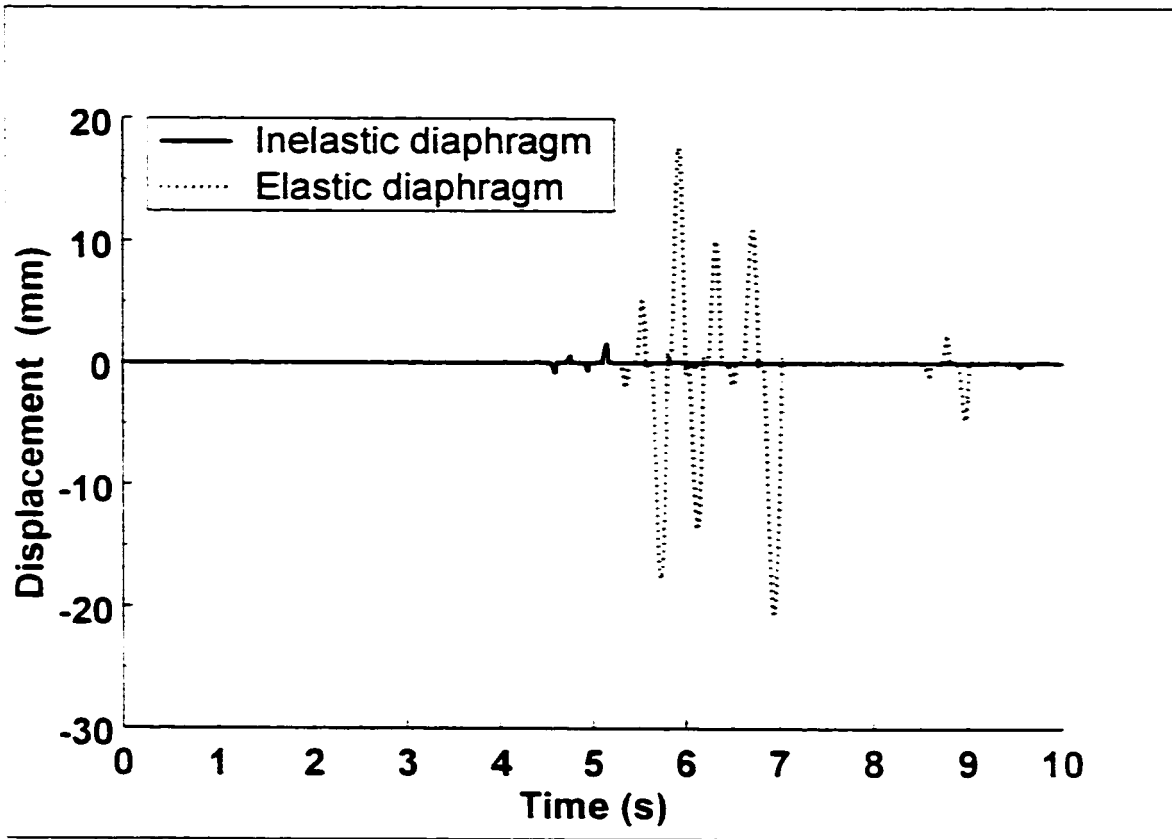
Figure 3.8 Comparison of end-wall response considering elastic or inelastic wood floor diaphragms for the Northridge earthquake Newhall fire station (peak ground acceleration of 0.583g).

Similarly, inelastic nonlinear analyses were performed using the "stick" model with DRAIN-2DX. Spring elements were used at the top and bottom of the frame modeling the shear walls to model rotational flexibility at joints, as shown in Fig. b.4. The rotational stiffness of the springs used bilinear force-displacement curves as in the FORTRAN program from Costley and Abrams. A first series of analysis was performed with a linear elastic diaphragm. Excellent agreement was found with the results obtained from the Costley and Abrams program. Then, inelastic response of the diaphragm was considered using an inelastic force-displacement relationship as shown in Fig. b.5. Results showed that yielding of the diaphragm reduces the peak displacements of the shear walls during rocking, (for example, see Fig. 3.8).

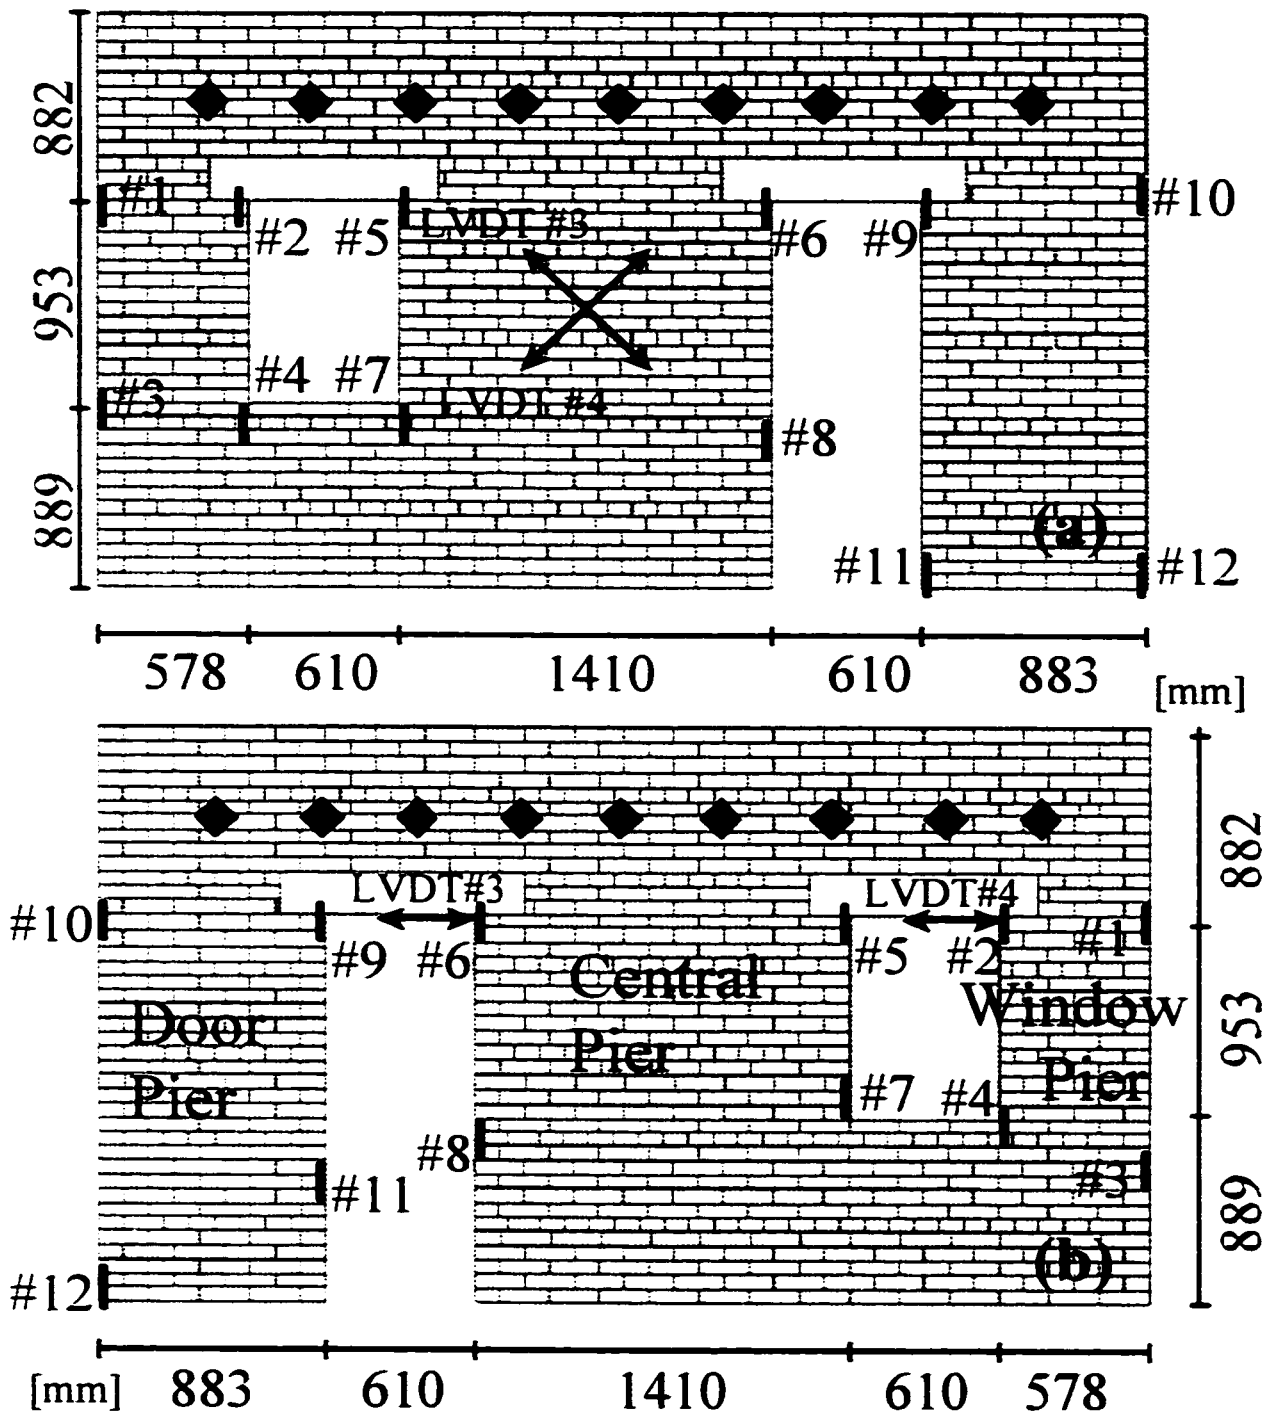
Figure 3.28 Location of LVDTs and clip gages: (a) West wall elevation; (b) East wall elevation.

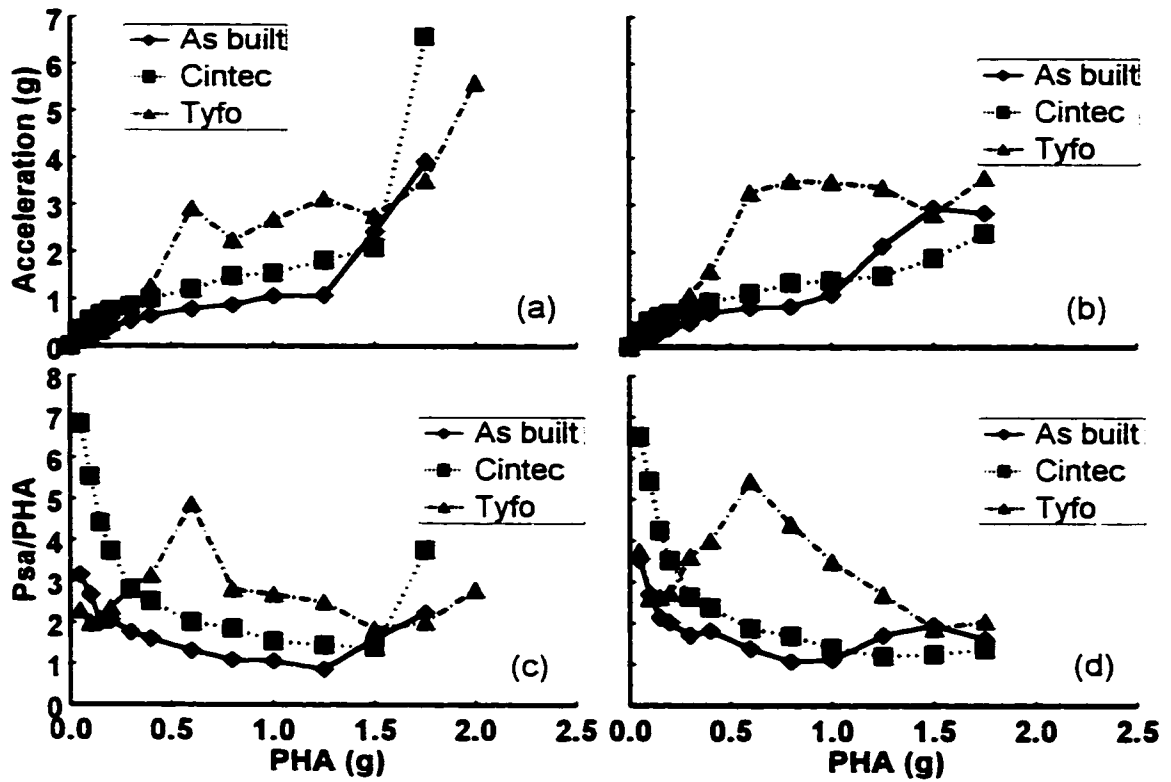
Figure 5.13 Peak acceleration at center of wall: (a) Brick side, (b) Wood side, and; Dynamic amplification factor at center of wall: (c) Brick side, (d) Wood side.

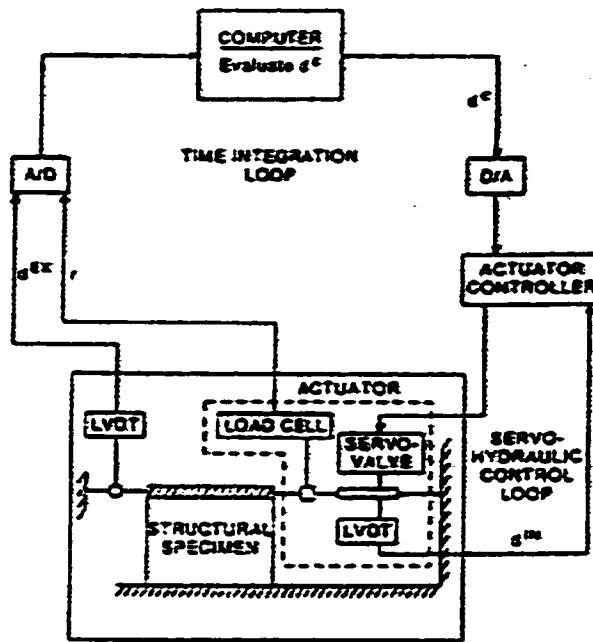
Figure d.1 Schematic of the Pseudo-dynamic test method (Shing et al. 1991).

It is possible to perform a simulated free vibration test with the pseudo-dynamic algorithm. When entering the initial conditions, a non-zero starting position for which the values of initial displacements and velocities must be specified, and when entering the load type, the free vibration option should be selected. Then, upon starting the test, the actuators will impose on the specimen the specified displacements and the resulting simulated free vibration response as per the pseudo-dynamic algorithm.
