In-Situ Measurement of Wind Loads for Roof Edge Metal Configurations

Master of Applied Science in Civil Engineering

Department of Civil Engineering
University of Ottawa
Ottawa, Ontario, Canada
June 2015

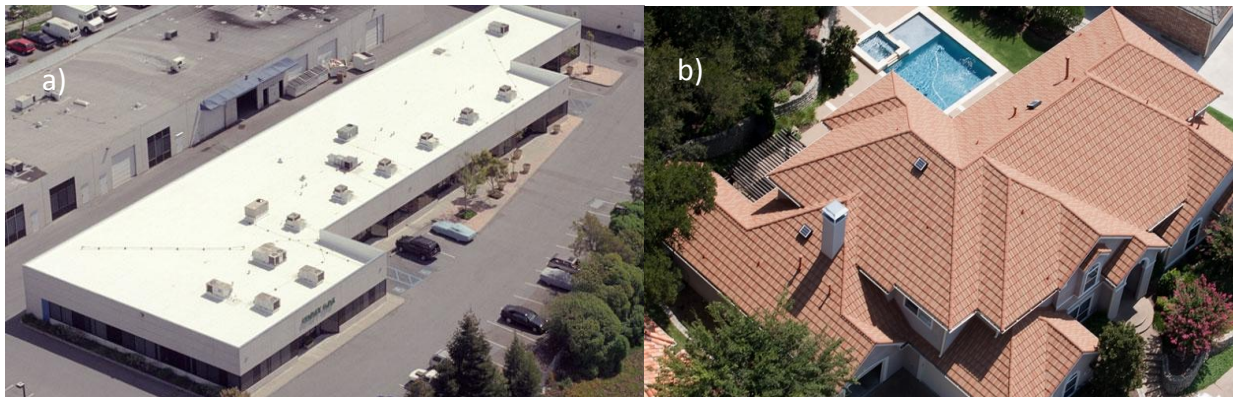
Figure 1.1: Low-slope roofs: (a) commercial roof and (b) residential roof

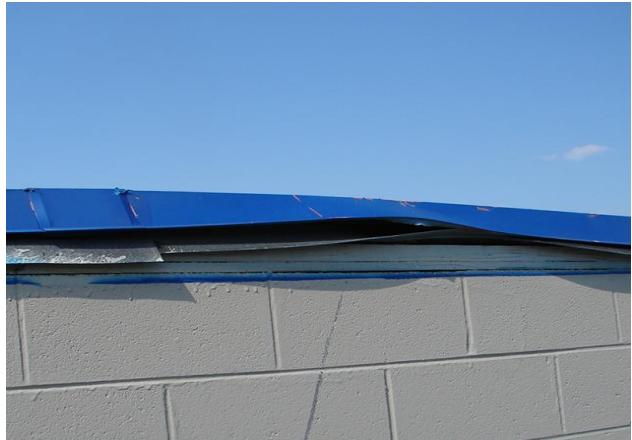
Figure 1.3: Typical roof edge failures during high wind conditions: (a) complete failure, (b) partial failure, (c) cleat failure and (d) coping failure. (Courtesy of NRCC)

Changes in the Earth's climate can lead to extreme weather events such as hurricanes and tornadoes, which cause flooding and high wind speeds. These events can severely damage the roof edge systems of low-rise buildings and result in failure. In October of 2012, Hurricane Sandy caused severe damage to building and the roof envelope, leading to several total roofs collapses (CBC News 2012). Figure 1.3 shows various failures for roof edge system for different components that have been seen in the field.

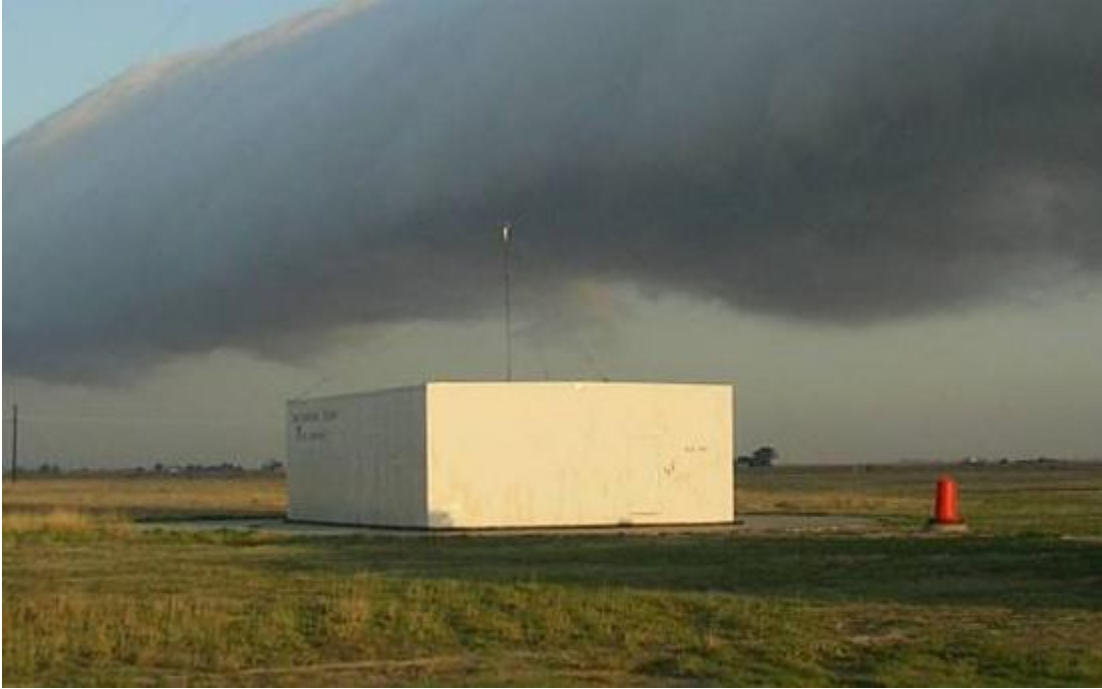
Figure 2.8: Wind Engineering Research Field Laboratory (WERFL) test building
(<https://www.depts.ttu.edu/nwi/facilities/WERFL.php>.)

Jiang (1995) conducted several field tests at the Texas Tech Wind Engineering Research Field Laboratory (WERFL), located on the university campus in Lubbock, Texas (Figure 2.8). The WERFL building is 3,300-ft (1,000 m) above sea level, and the terrain around the building is flat and open with a 160-ft (48.8 m) meteorological tower. The test building is a full-size steel frame building with dimensions of 30 x 45 x 13-ft (9.1 x 13.7 x 4.0 m). It is not anchored to the ground, but to a rigid frame undercarriage with wheels at the corners. It can rotate 360° to the desired angle of attack (Figure 2.10).

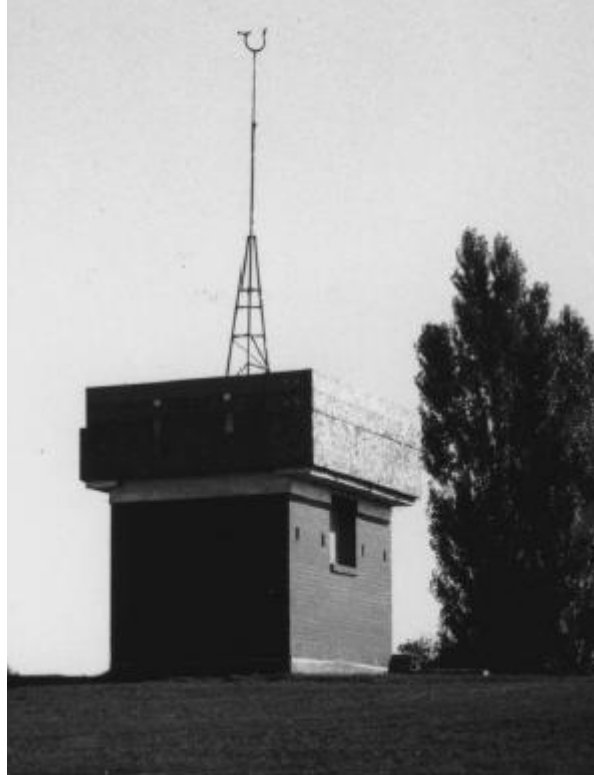
Figure 2.13: Field site at Concordia University (Stathopoulos et al., 1999)

The building dimensions are 3.3 x 3.7 x 2.6 m, with a low-slope roof with dimensions of 4.0 by 3.2 m. The building was equipped with retractable panels on the corners, each with 12 pressure taps. The study investigated three cases: (i) no parapets, (ii) 0.10 m wide and 0.25 m high parapet installed in the corner, and (iii) 0.10 m wide and 0.50 m high parapet installed in the corner. The terrains around the building are of two types, suburban and open country, each one surrounding two corners of the building. The strongest winds came from the open country terrain, in the South and West directions. A 3-cup anemometer and a wind vane were used to measure the wind speed and direction, with a minimum wind speed requirement to start the data collection of 5.5 m/s. The data collection at the field site used 12 channels with a maximum sampling rate of 1 Hz, run times of 15-min, and 900 samples. Pressure coefficients were calculated using the mean pressure and the 15-min mean wind velocity, and Stathopoulos et al. (1999) presented the pressure coefficients as average values corresponding to a 5°-interval of the wind direction.

Stathopoulos et al. (1999) conducted a full-scale experiment in a low-rise building located in the Loyola campus of Concordia University, Montreal (Figure 2.13). In this study, the wind-induced pressure along the roof parapet was evaluated to investigate its effect on the flat roof. No metal edges were installed on the roof parapets.

Bedair (2009) conducted full-scale testing on a low-rise building in order to examine the wind-induced pressure acting on the surface of the parapet, using the same site used by Stathopoulos et al (1999) (Figure 2.13). Field data was collected between the months of May and November for three consecutive years, in which the strongest wind direction in Montreal came from the South-West. The parapet that was installed on site had a height of 0.5 m and a width of 0.16 m and was fixed to the roof by plates. Pressure taps were installed in the interior, exterior, and top of the parapet. Data was collected for wind speeds higher than 5.6 m/s with a sampling rate of 1 Hz.

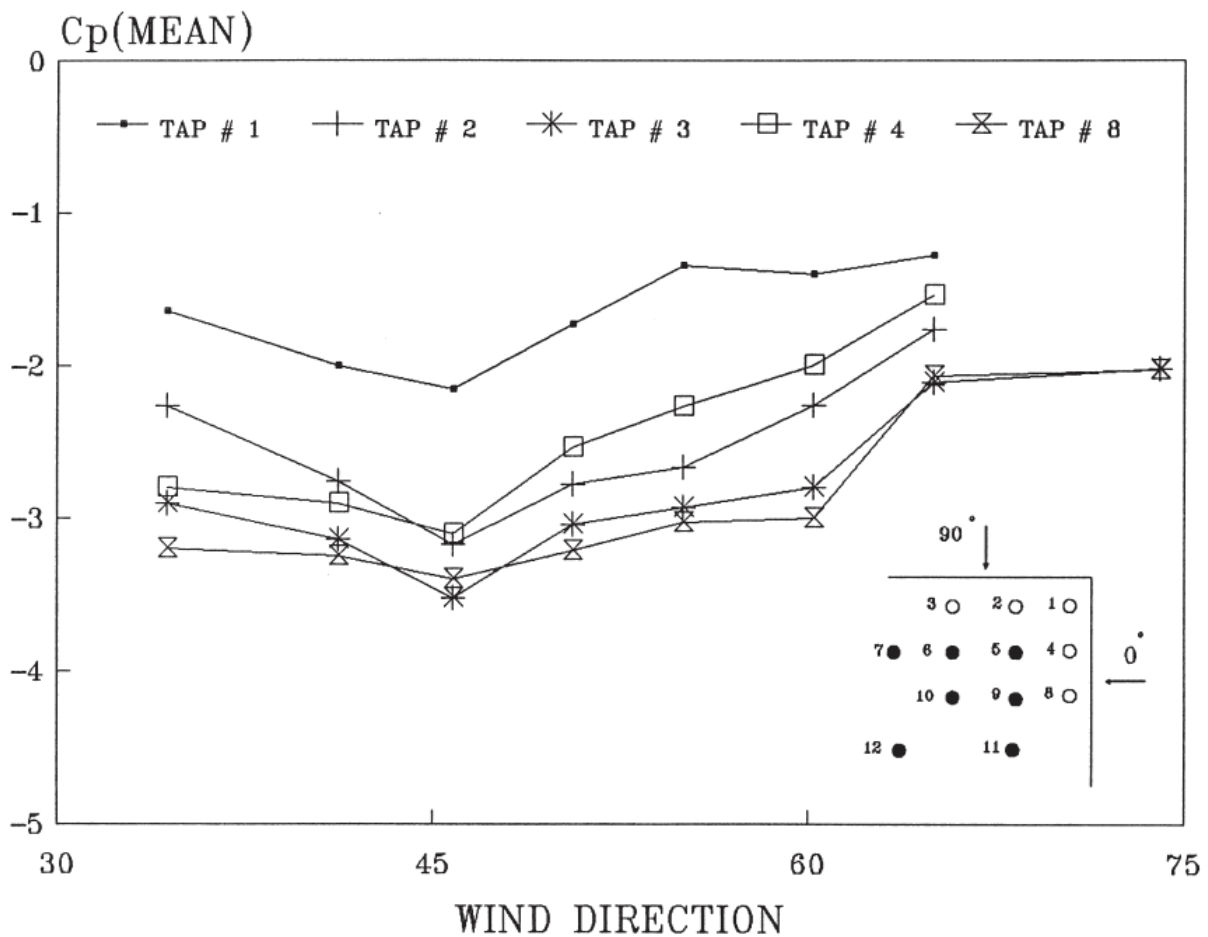
Figure 2.14: Mean pressure coefficients measured along roof edges (Stathopoulos et al., 1999)

In the first phase of the experiment, there were no parapets installed on the roof of the building. Figure 2.14 shows the calculated mean pressure coefficients along the roof edge due to wind directions in the range of 35° to 70°. The data shows that the edge pressure taps had the highest suction for a wind direction between 35° and 60°. It can be seen that taps #2, #3, #4 and #8 experienced near identical mean pressure coefficient values at 45° and more negative than tap #1. The pressure taps along the diagonal direction on the roof, pressure taps #5, # 10 and #12, show that the suction the roof experiences decreases as it moves further away from the corner (Figure 2.15).

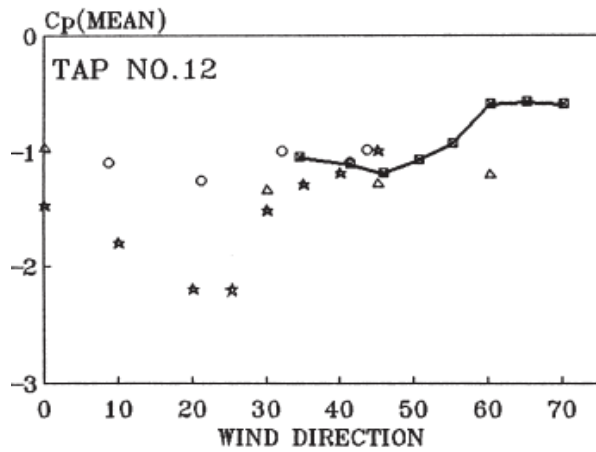
Figure 2.15: Comparison of full-scale results with other studies—flat roof without parapets (Stathopoulos et al., 1999)

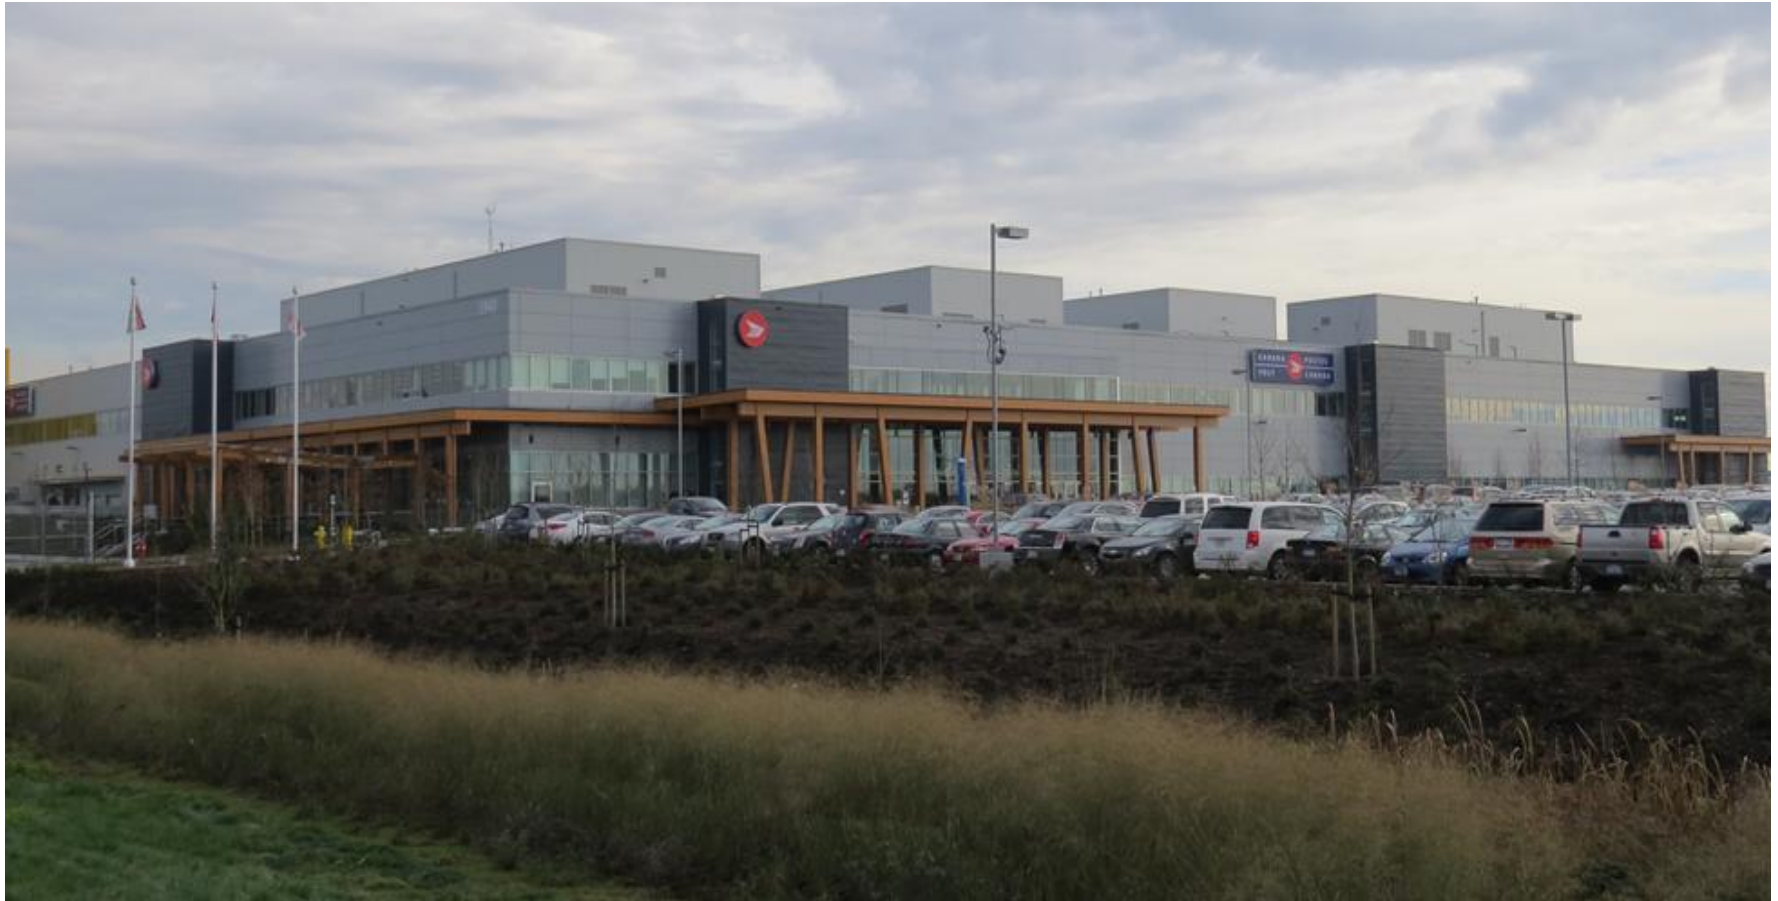
Figure 3.1: Canada post building in Vancouver, Canada (Courtesy of NRCC)

The Canada Post building in Vancouver, Canada, met this requirement and was thus selected as the site for field monitoring of wind-induced pressure on roof edge systems (Figure 3.1). The building is located in the Richmond area of Vancouver, on the north side of the airport, surrounded by open terrain (Figure 3.2). The building has two roof levels (Figure 3.3), with the lower roof elevated at 38-ft (11.6 m) and upper roof elevated at 58-ft (17.7 m). A 16-ft (4.9 m) tall wind tower was installed on the upper roof level, to record wind data (Figure 3.4).

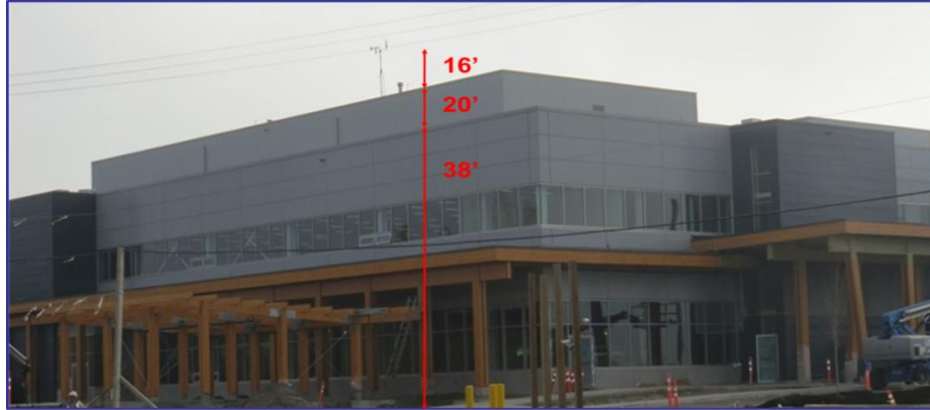
Figure 3.3: Elevations of the lower and upper roofs, and of the wind tower (Courtesy of NRCC)

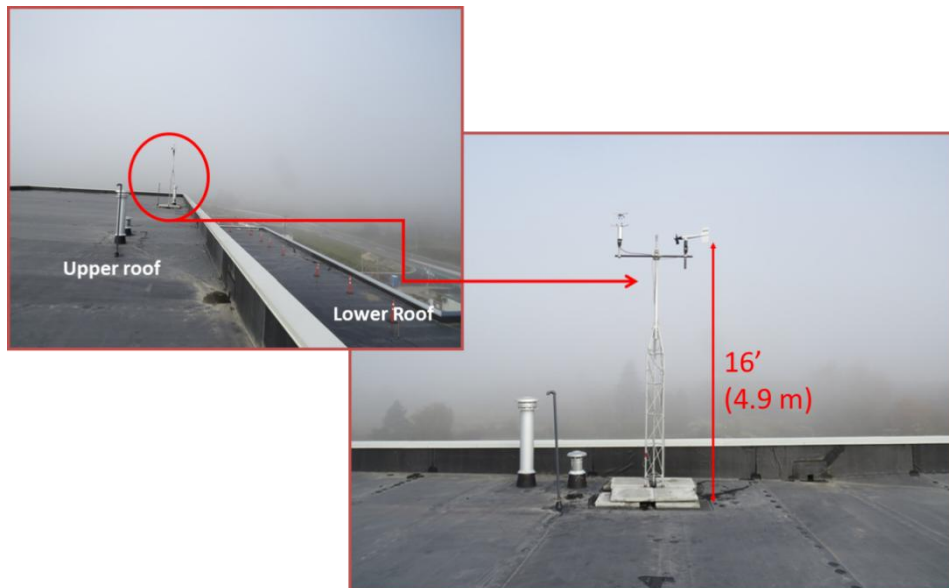
Figure 3.4: Wind tower installation at the upper roof level (Courtesy of NRCC)

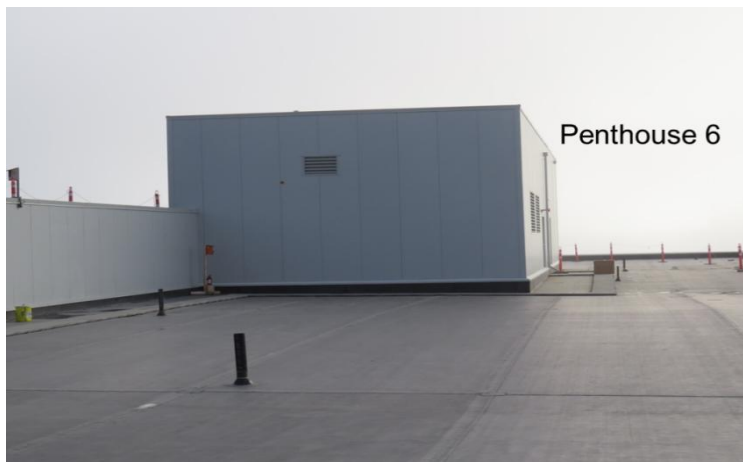
Figure 3.6: Close up of Penthouse 6 (Courtesy of NRCC)

Figure 3.5 shows the overall dimensions of the building: 433-ft (132 m) wide by 1440-ft (439 m) long. The roof edge configurations were installed on Penthouse 6, located on the West side (Figure 3.5). Penthouse 6 is 96-ft (29 m) long by 28-ft (8.5 m) wide (Figure 3.6). The wind data was obtained from the wind tower (Figure 3.4), which revealed that the predominant wind direction ranged from south-west to north-west. Figure 3.7 shows the building orientation and the critical wind direction.

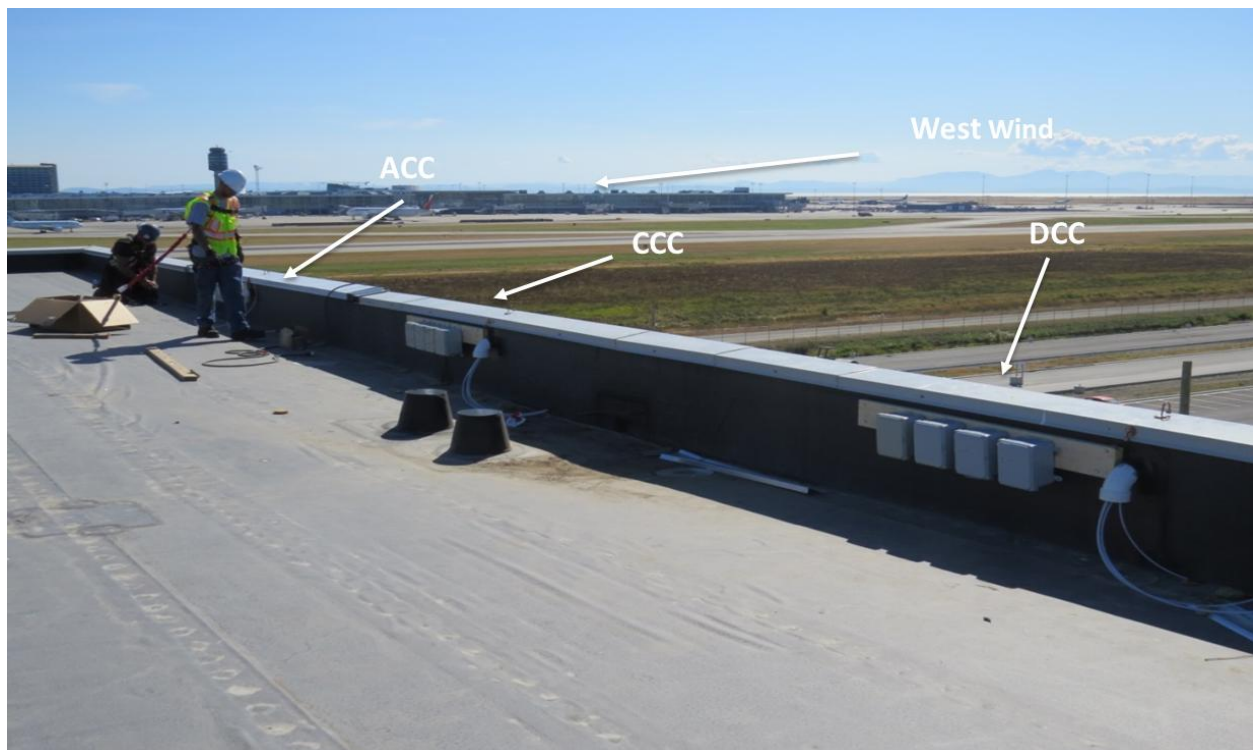
Figure 3.8: Instrumented edge configurations (Courtesy of NRCC)

The metal roof edges were placed along the 96-ft (29 m) long segment of Penthouse 6 in order to be exposed to the perpendicular and oblique wind flow conditions (Figure 3.7). The roof edge configurations used were the same as those tested by Alassafin (2013), namely the ACC, CCC and DCC. The three types of edge configurations were designed and installed on the field site by the participating industrial partners. Instrumentations (pressure transducers and wind sensors) were designed, selected, calibrated and installed in collaboration with NRCC.

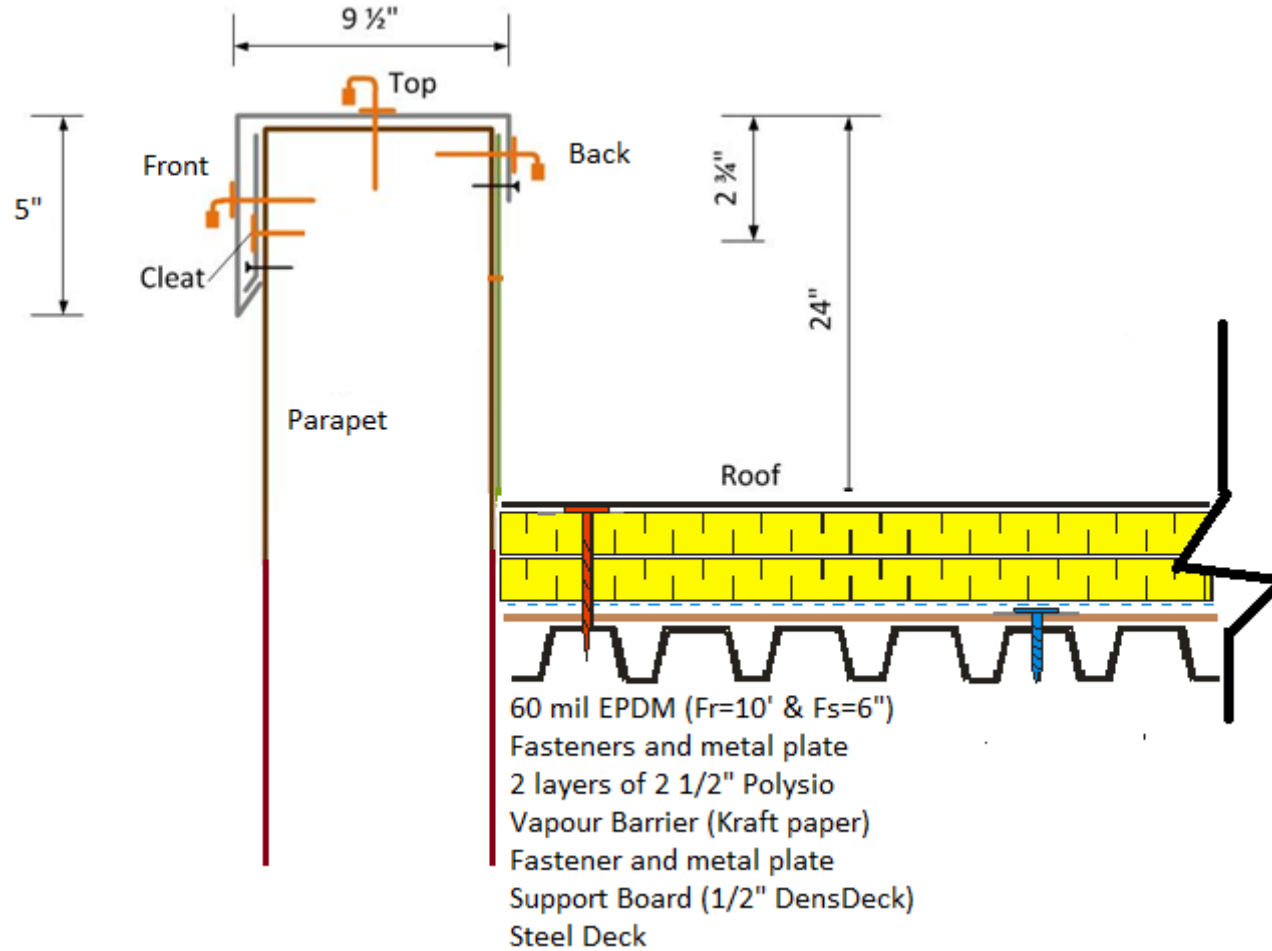
Figure 3.10: Roof edge, pressure tap profile layout, and roof detail

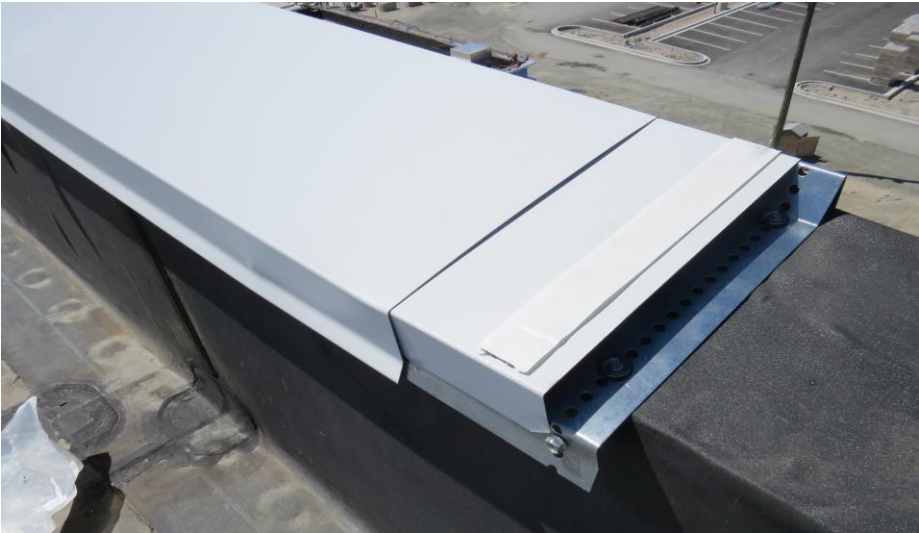
Figure 3.12: Anchor Clip splice plates with pre-applied adhesive tapes (Courtesy of NRCC)

The ACC is built from 24 gauge galvanized steel and has no cleat component, but instead uses anchor clips placed 4-ft (1.22 m) apart (Figure 3.11). The ACC's anchor clips were fastened to the substrate at the top of the parapet, and splice plates with pre-applied adhesive tapes (Figure 3.12) were placed at the joints to secure the coping segment. The coping segments were then clipped to the anchor clips. The ACC was installed on the parapet located on the windward side of Penthouse 6 (Figure 3.8 and Figure 3.9).

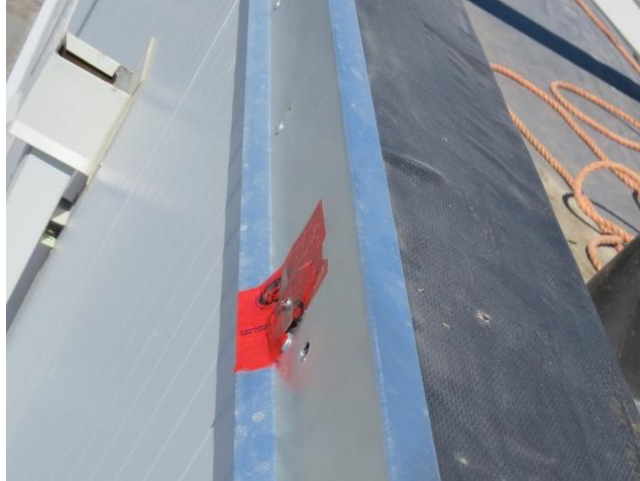
Figure 3.17: Cleat pressure tap (Courtesy of NRCC)

For the installation of the pressure taps on the cleat, a hole was first drilled through the cleat and parapet through which the pressure tap was inserted and secured by duct tape (Figure 3.17). To install the pressure taps on the coping front, top and back, a hole was drilled through the coping and parapet (Figure 3.18), and pressure taps were inserted and fixed to the coping faces with epoxy (Figure 3.19).

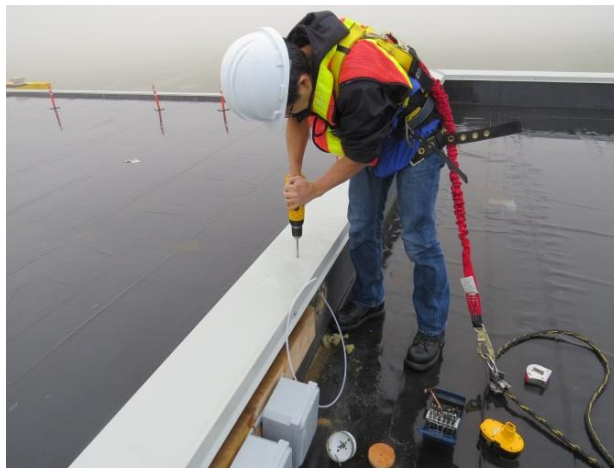
Figure 3.18: Drilling the hole for the pressure tap on the top face (Courtesy of Laith Hajsaid, University of Ottawa)

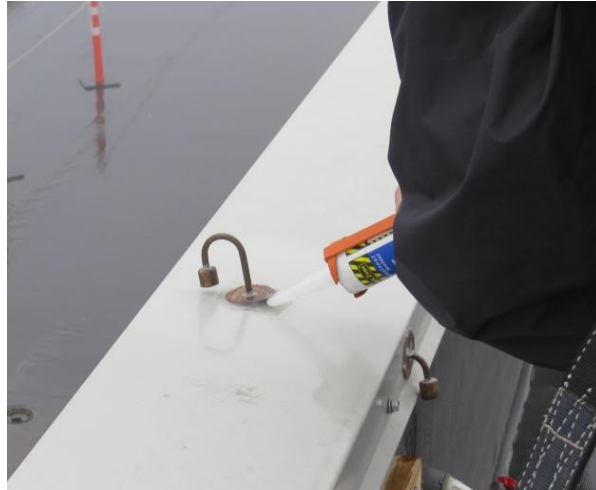
Figure 3.19: Applying epoxy to the pressure tap on the top face (Courtesy of Laith Hajsaid, University of Ottawa)

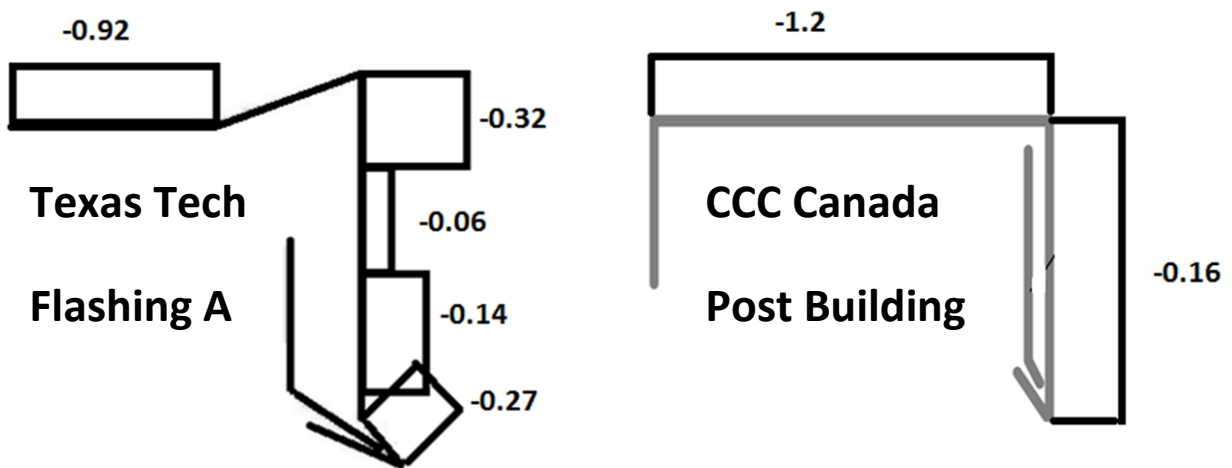
Figure 5.6: McDonald et al (1997) flashing A vs CCC pressure coefficients
