# **DEVELOPMENT OF ANCHOR SYSTEMS FOR FRCM RETROFITS**

Thesis submitted to the University of Ottawa  
in partial Fulfillment of the requirements for the degree of  
Master of Applied Science in Civil Engineering

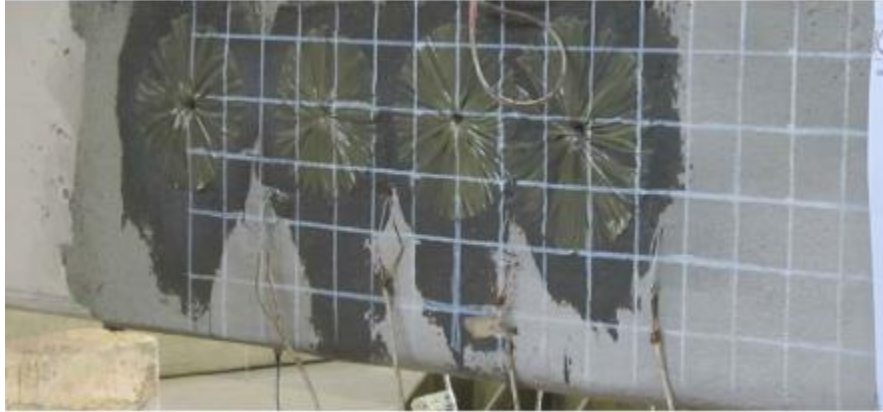
Figure 2.4: Spike anchors installed into the beams (Gonzalez-Libreros et al., 2017)

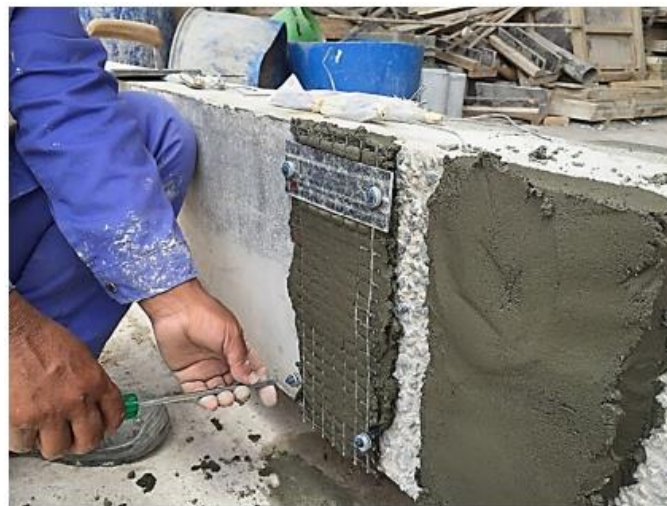
*Figure 2.6: Mechanical FRCM anchorage (Younis et al., 2017)*

Following previous studies, Younis et al. (2017) investigated the efficiency of three different FRCM systems for the strengthening of RC beams which were critical in shear, but focused on the orientation of the FRCM strips and the effect of the end-anchorage of the FRCM strips. Sixteen shear-critical RC beams without stirrups were shear-strengthened using FRCM with different configurations within the shear-critical span and tested under three-point loading. Four different test variables were considered; FRCM type (carbon, PBO, and glass), strengthening scheme (full/continuous FRCM plate or a set of spaced FRCM strips), strengthening orientation (vertical or 45°), and FRCM anchorage by mechanically fixing two FRP plates on top and bottom of the strip as shown in Figure 2.6.

Younis concluded that FRCM anchorage had an insignificant effect on the strength enhancement of the strengthened beams. The average gain in the load carrying capacity was 51% for the strengthened beams when compared to the non-strengthened reference. More ductile behaviour was generally observed as well for all strengthened beams, where deflection at failure reached up to 2.4 times that reported for the reference specimen. While debonding of the strengthening layer was the common type of failure mode for all specimens, crack width values were noticed to be smaller for carbon-FRCM systems than those reported for the PBO- or glass-FRCM systems. Crack widths corresponding to the continuous FRCM systems were smaller than those reported for the intermittent counterparts. Younis stated that reasonable agreement was achieved between the experimental and the theoretically (ACI 549-driven method) predicted values for load carrying capacity.

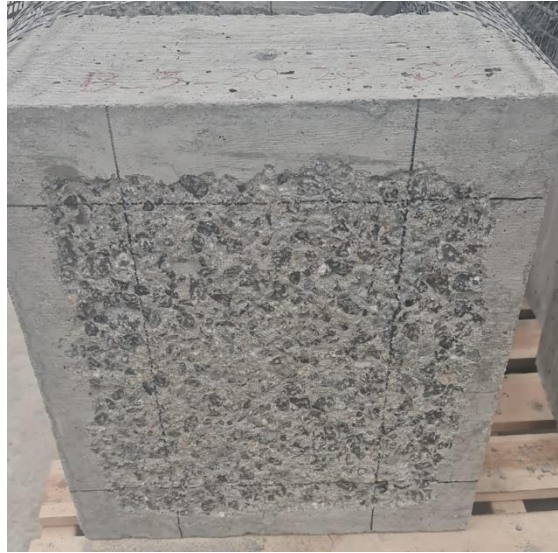
*Figure 3.4: Prism surface roughened to a CSP 9*

The surface of the concrete prisms was prepared before mixing the cementitious matrix. The surface of each prism was crushed using a bush hammer to reach a minimum amplitude of 6 mm (0.25 in) or Concrete Surface Profile (CSP) 6-9 as recommended by the manufacturer as presented in Figure 3.4. Only one face of each prism was prepared for composite installation, except for wrap anchored specimens where all faces were roughened all around the prism in order to install the wrap anchor. All corners were rounded to a 19 mm (0.75 in) minimum radius using a grinder. After crushing the concrete surface and grinding the corners, compressed air was used to clean the surface of any debris and dust. Then, following the manufacturer's installation guide, all prepared surfaces were wetted to a Saturated Surface Dry (SSD) condition prior to FRCM application.

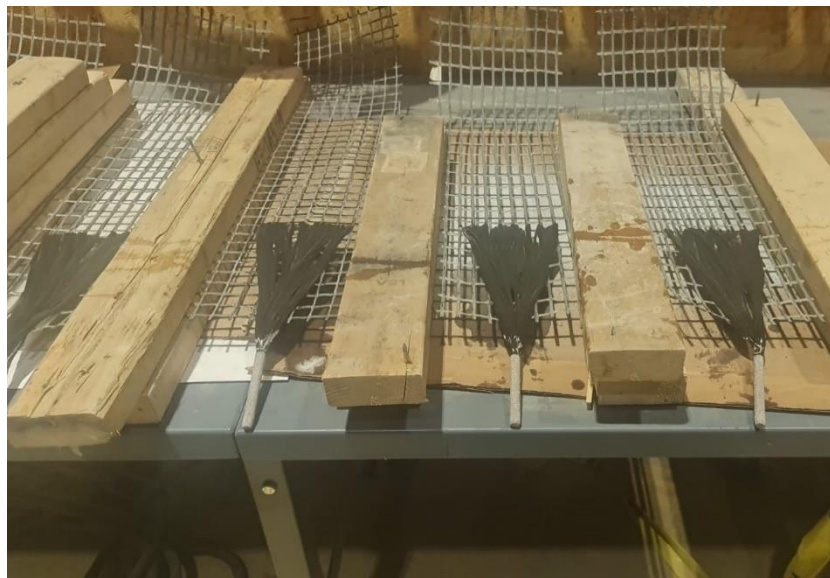
*Figure 3.5: Carbon spike anchors installation*

Preparation of the spike anchored specimens was a little different compared to the latter two types. A two-component epoxy resin was mixed in a clean mixing container and was paddled for approximately 5 minutes until uniformly blended. The fan part of the carbon spikes was anchored to the fabric grid using the epoxy resin and was left to cure for 72 hours prior to FRCM application. The fan part of the spike anchor was spread at a 45° angle to cover the fabric strands after being

embedded in epoxy while ensuring full fibre saturation was achieved. The prefabricated part was left dry to be anchored to the concrete prism later. Figure 3.5 displays the spike anchors during the installation process. After the epoxy resin cured, the FRCM was applied to the prism following the same procedure for non-anchored specimens. However, after the FRCM cured, a 12.7 mm (0.5 in) -wide, 100 mm -deep hole was drilled for each spike anchor. The edge of the hole opening was curved and smoothened to avoid stress concentrations. After cleaning them, the holes were filled with the same epoxy resin used for the fan section, and the prefabricated sand-coated section of the carbon spike anchor was inserted immediately afterwards.

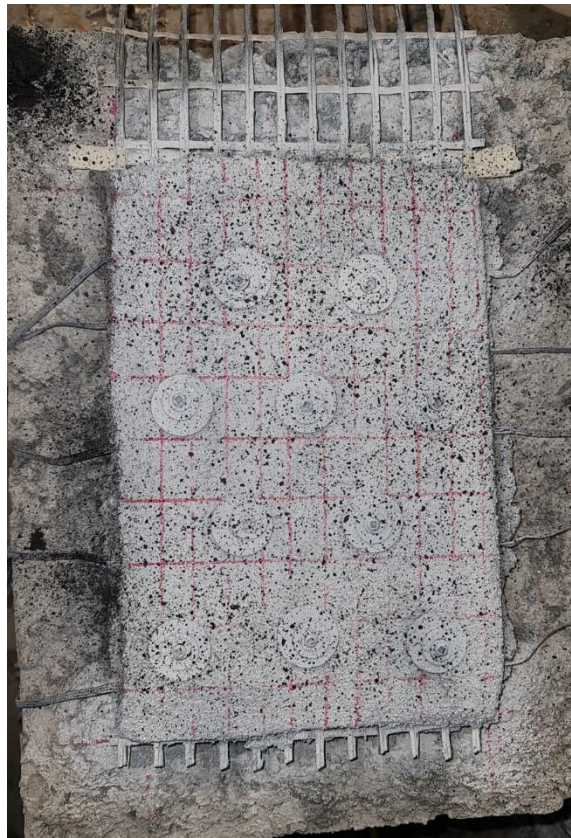
The last step of specimen preparation before testing was spray painting. To create a speckle pattern for the DIC, a flat white paint was sprayed on top of the FRCM covering the whole surface of the specimen. Then a flat black paint was sprayed on top creating small random dots or a speckle pattern. These two colors were chosen in order to create a contrast to make it easier for the software to recognize the dots and follow the deformation. Two pieces of white paper tape were attached, from both sides of the specimen, and were sprayed with a random speckle pattern to be tracked using the software to record the global displacement (i.e., slip) of the fabric as illustrated in Figure 3.6.

*Figure 3.6: Tapes with speckle pattern to track global displacement*

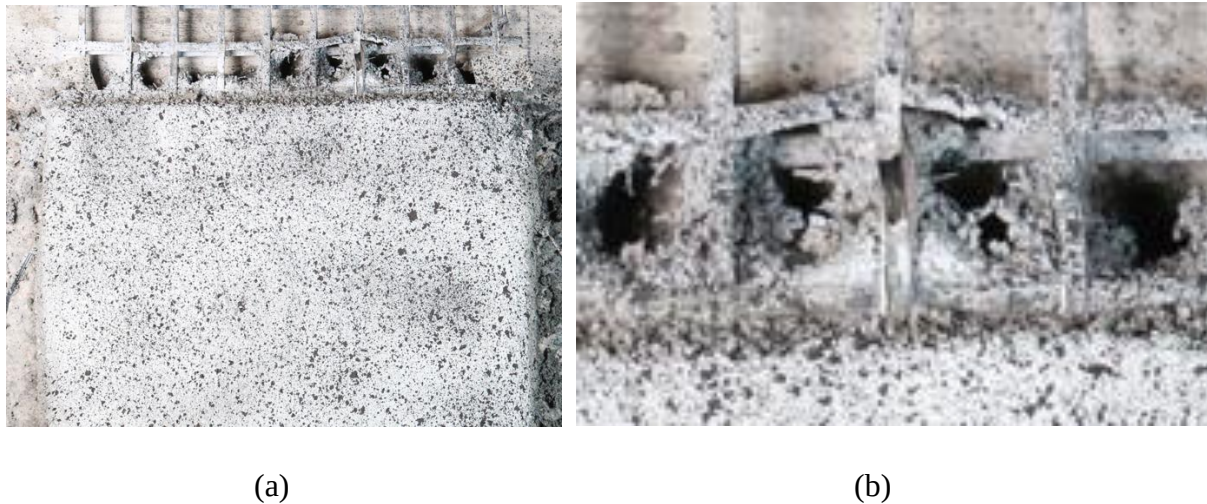
This specimen was fabricated using two layers of bidirectional carbon fabric, anchored using a carbon spike anchor, with a composite length and width of 300 mm and 200 mm, respectively. Similar to the previous specimen, no cracking nor delamination were observed on the composite. At the failure load, some of the fabric strands ruptured at both the composite loaded end and at the grip as can be seen in Figures 4.5a & 4.5b. Failure stress was significantly lower than the theoretical one. The failure stress of this specimen was 348.2 MPa at a load of 6.13 kN.

*Figure 4.5: front view of the fabric (a) and close-up to the ruptured strands (b)*

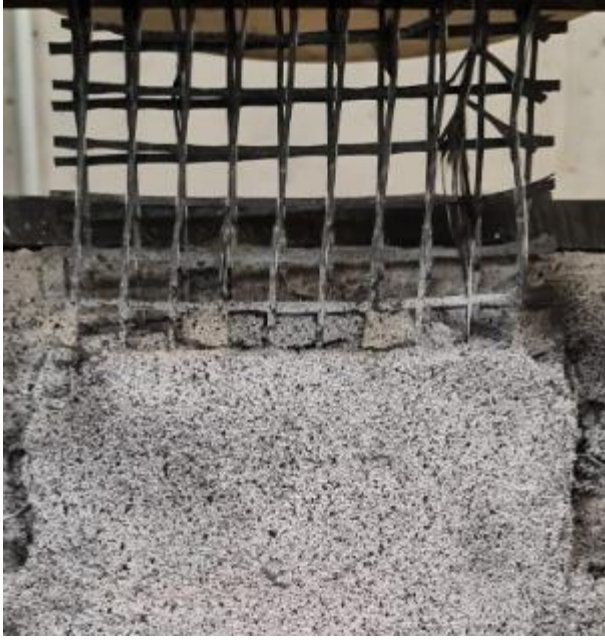
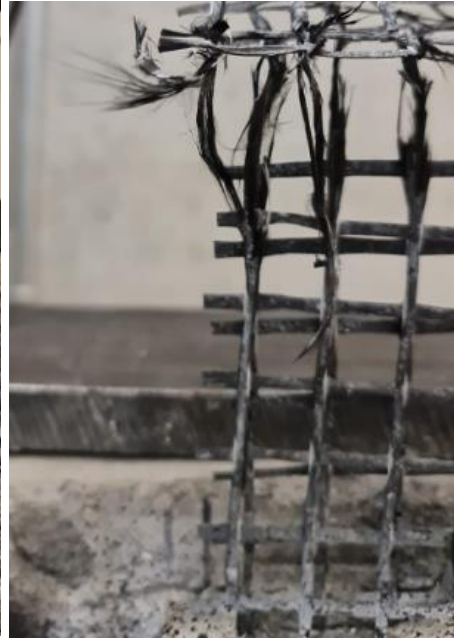
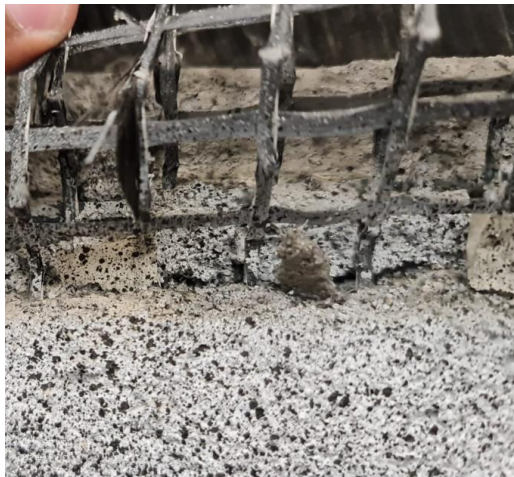
*Figure 4.9: (a), (b), (c) and (d) different spots of ruptured fabric*

of the fabric as can be seen in Figures 4.9a, 4.9b, 4.9c and 4.9d. Failure stress for this specimen was significantly lower than the theoretical one although it performed better than other bidirectional ones with two layers. First rupture of this specimen occurred at a load of 5.7 kN and the fabric started picking up the load again up to a stress of 523.1 MPa at a load of 9.2 kN.

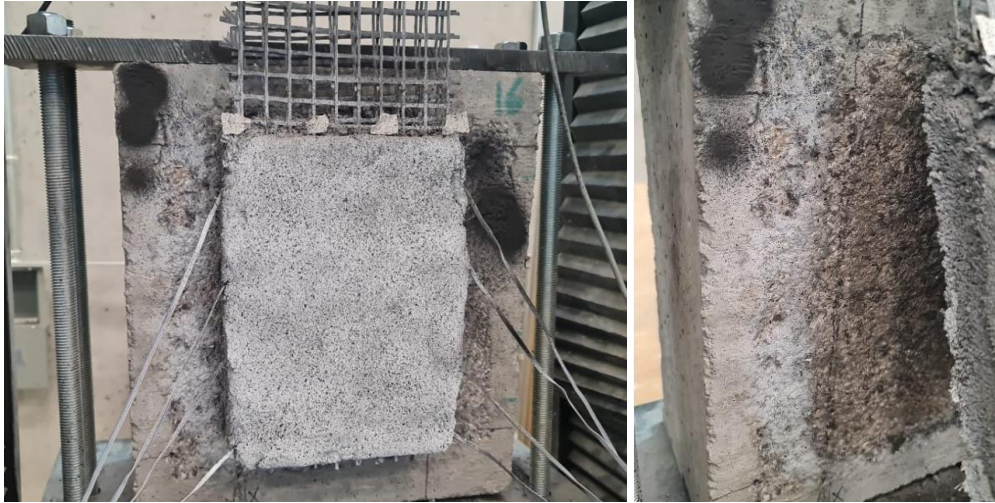
This specimen was fabricated using three layers of non-anchored bidirectional carbon fabric, with a composite length and width of 300 mm and 200 mm, respectively. Similar to the previous specimen, no cracking nor delamination were observed on the composite. At the failure load, no damage was observed in the dry fabric nor on the composite surface. The composite fully debonded from the concrete block (the substrate), as shown in Figures 4.13a & 4.13b, in a brittle manner. The tensile stress at failure was 354.6 MPa in the fabric and the average composite-substrate bond stress was 0.16 MPa at the peak load of 9.36 kN.

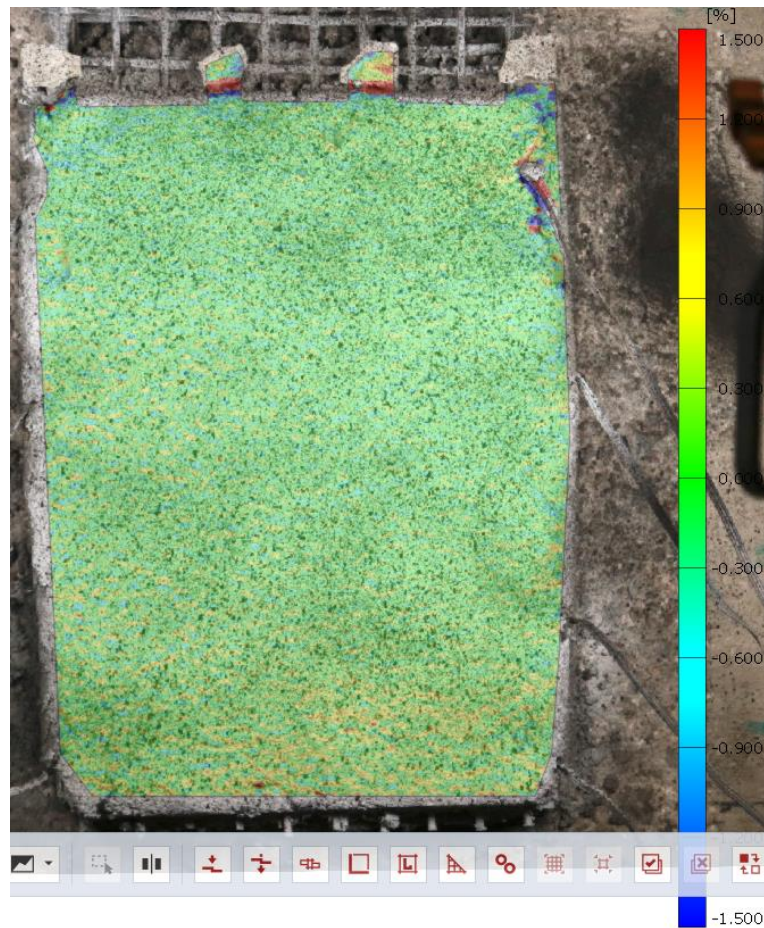
Figure 4.17: DIC generated 2D strain contour map

The 2D strain map of this specimen created using DIC is presented in Figure 4.17. Just like the DIC generated strain profile, no significant strain is visible on the surface of the composite with the whole surface covered in green indicating 0% strain.

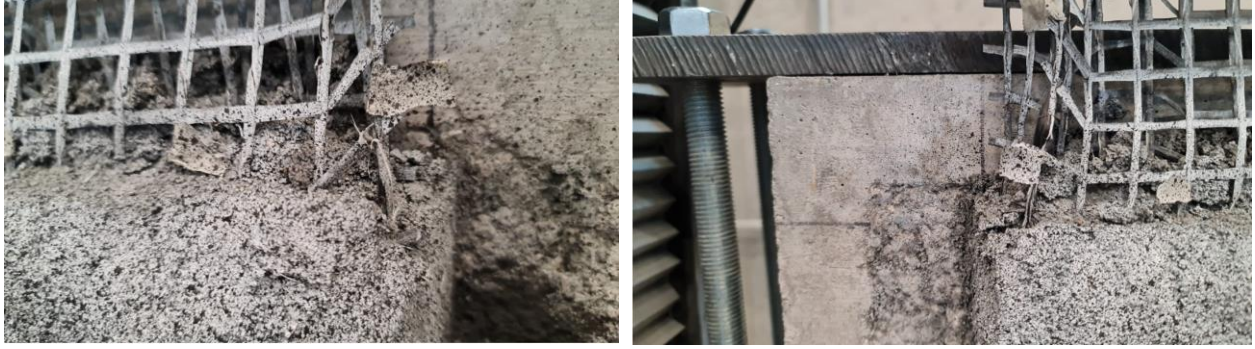
This specimen was fabricated using three layers of bidirectional carbon fabric, anchored using 2 carbon spike anchors, with a composite length and width of 300 mm and 200 mm, respectively. Like all previous specimens, no cracking nor delamination were observed on the composite. However, slip was observed in this specimen during the test before the fabric ruptured. The slipped fabric strands were on both edges of the composite as shown in Figures 4.18a & 4.18b in addition to the ruptured fabric. The stress at the full rupture was 678.3 MPa in the fabric at a load of 17.9 kN which the highest among the specimens with bidirectional fabric.

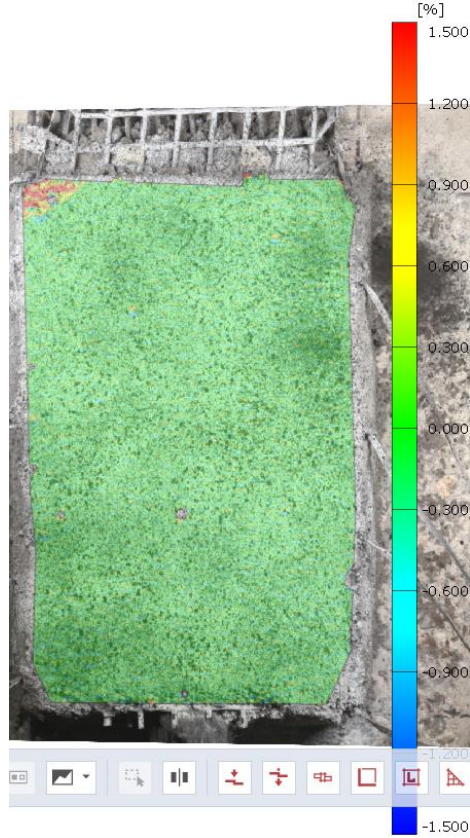
Figure 4.22: DIC generated 2D strain contour map

The 2D strain map of this specimen created using DIC is shown in Figure 4.22. Similar to the DIC generated strain profile, no significant strain is visible on the surface of the composite with the whole surface covered in green indicating 0% strain. The excessive strain that can be seen at the corner of the specimen is not actual because the surface at this corner is tilted and not on the same plane of the DIC.

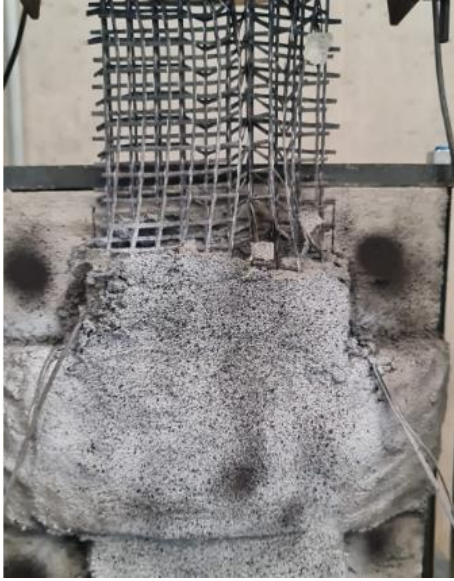
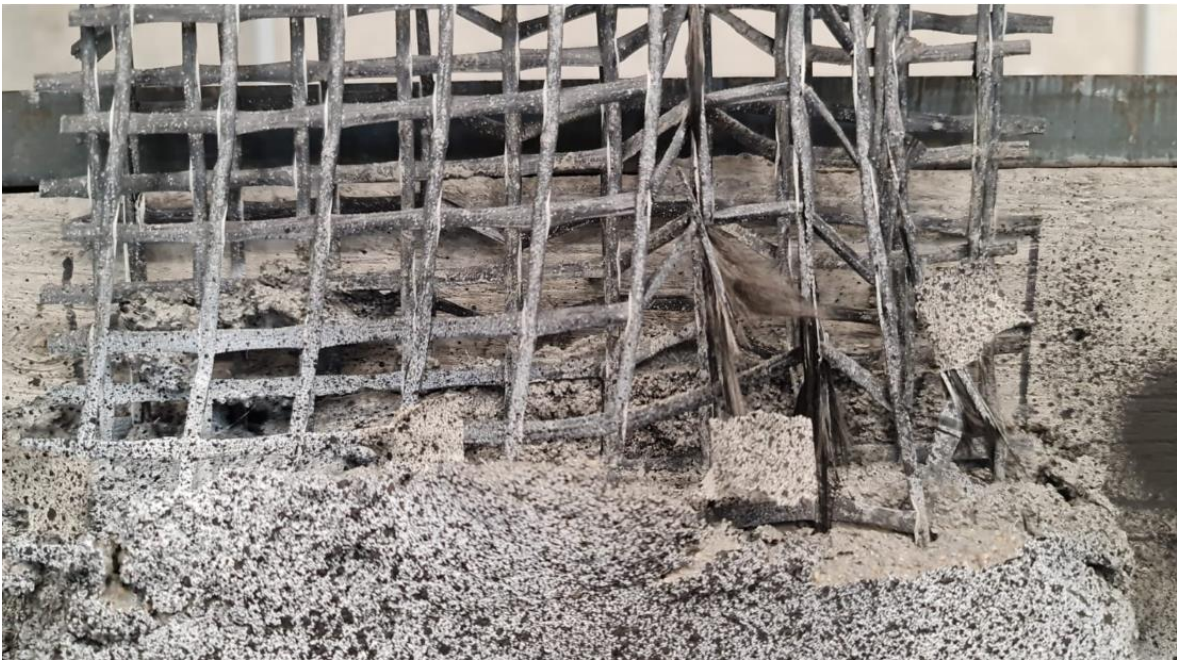
*Figure 4.23: front view of the fabric (a), close-up to a ruptured fabric spot (b) and close-up to another ruptured fabric spot (c)*

This specimen was fabricated using three layers of bidirectional carbon fabric, anchored using a wrap anchor, with a composite length and width of 300 mm and 200 mm, respectively. Unlike previous specimens, cracking was observed on the composite and fabric rupture at failure as can be seen in Figures 4.23a, 4.23b and 4.23c. Despite the matrix cracking and the fabric rupture, no visible fabric slip was observed during the test. The stress at the rupture was 364 MPa in the fabric at a load of 9.61 kN.

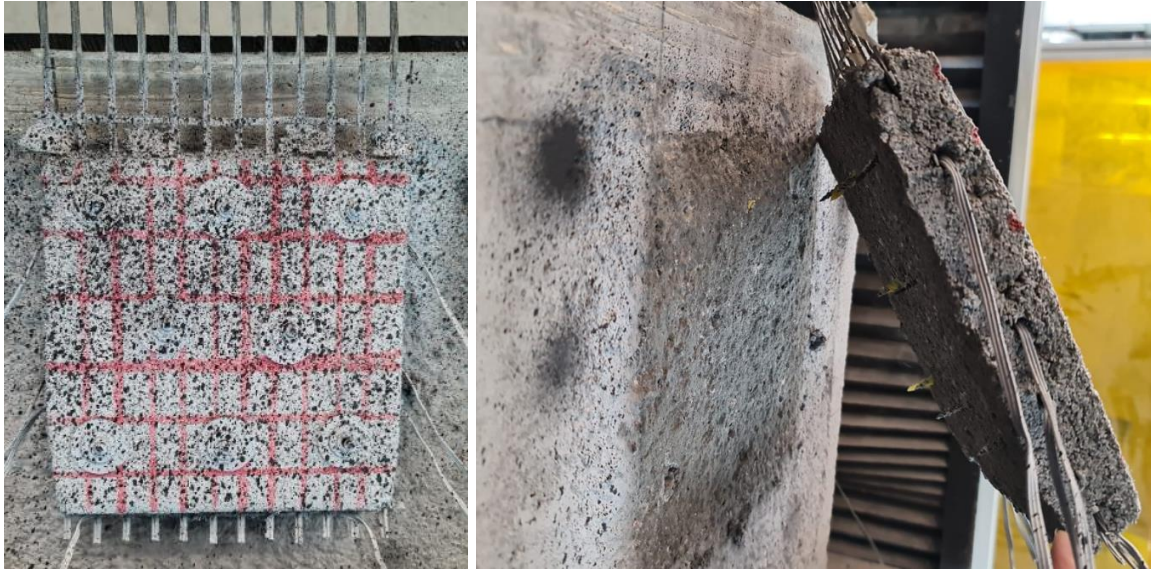
This specimen was fabricated using one layer of unidirectional carbon fabric, anchored using a mechanical anchor (screws), with a composite length and width of 200 mm. No cracking nor delamination were observed on the composite during the test. Moreover, no damage was observed on the dry fabric strands. The initial failure observed was the debonding at the composite – substrate interface while the screws were still attached to the concrete block. At the second failure, the screws were pulled out of the concrete block completely as shown in Figures 4.28a & 4.28b. Failure stress was significantly lower than the theoretical one. The failure stress of this specimen was 343.7 MPa at a load of 10.77 kN.

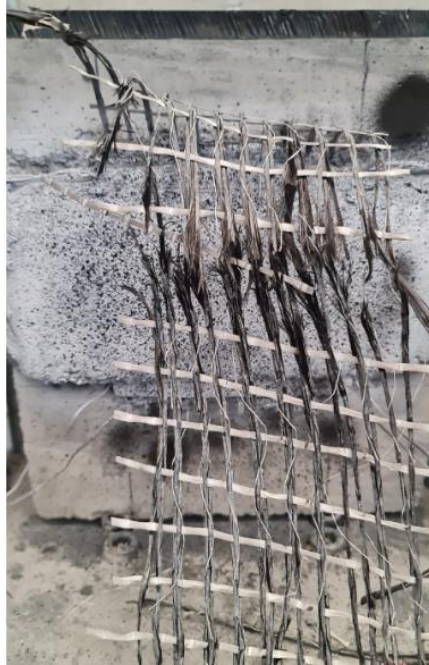
Figure 4.33: ruptured fabric

This specimen was fabricated using one layer of unidirectional carbon fabric, anchored using a wrap anchor, with a composite length and width of 200 mm. No cracking nor delamination were observed on the composite during the test. However, the fabric strands were worn out at various spots at the failure load before fully rupturing shortly as shown in Figure 4.33. This specimen presented the second highest stress in the fabric among the unidirectional specimens although failure stress was still lower than the theoretical one. The failure stress of this specimen was 504.7 MPa at a load of 15.81 kN.

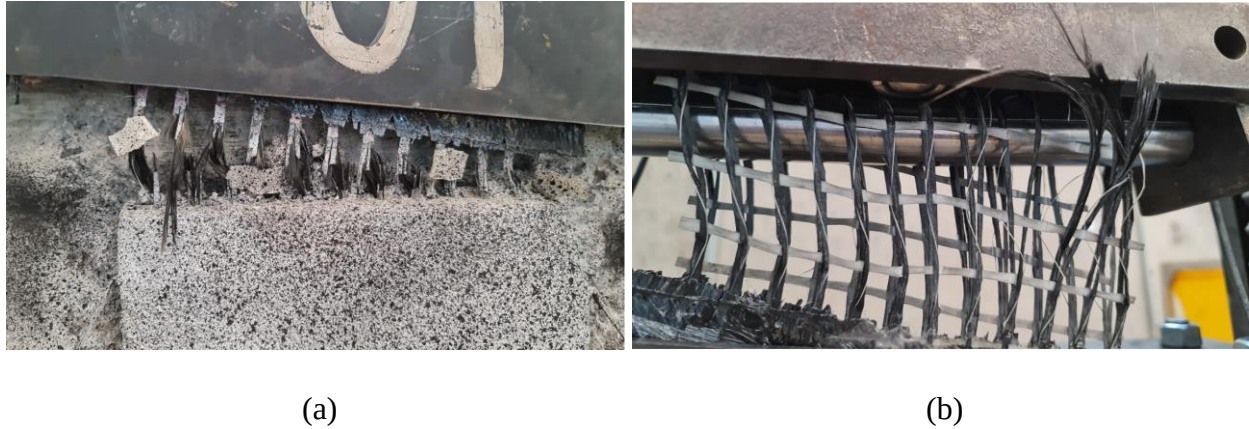
*Figure 4.38: fabric rupture near the composite edge (a) and fabric rupture near the grip (b)*

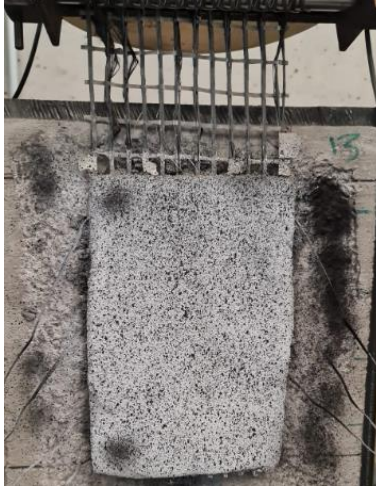
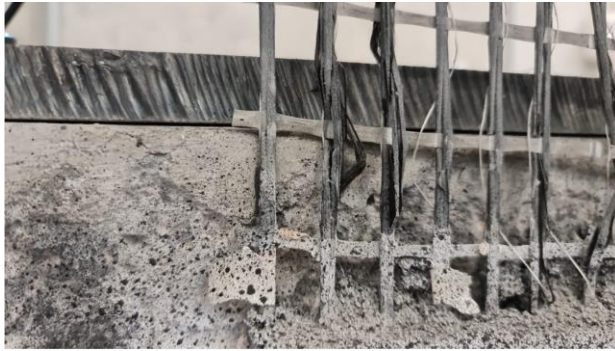
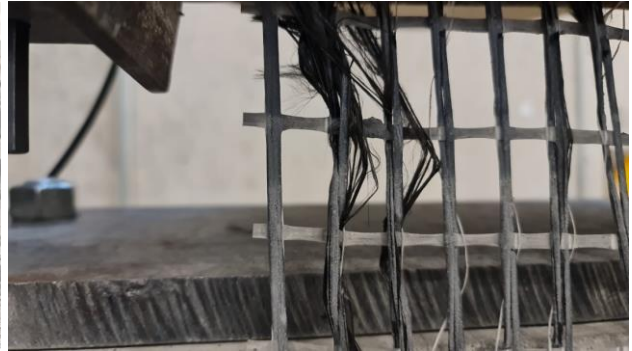
*Figure 4.41: front view (a), fabric rupture near the composite (b), fabric rupture near the edge (c), fabric rupture near the grip (d)*

This specimen was fabricated using one layer of unidirectional carbon fabric anchored using one spike anchor, with a composite length and width of 300 mm and 200 mm, respectively. No cracking nor delamination were observed on the composite surface during the test. However, the fabric strands near the edges ruptured at both sides of the fabric as presented in Figure 4.41. As most of the other specimens, the failure stress was significantly lower than the theoretical one. The failure stress of this specimen was 341.9 MPa at a load of 10.71 kN.

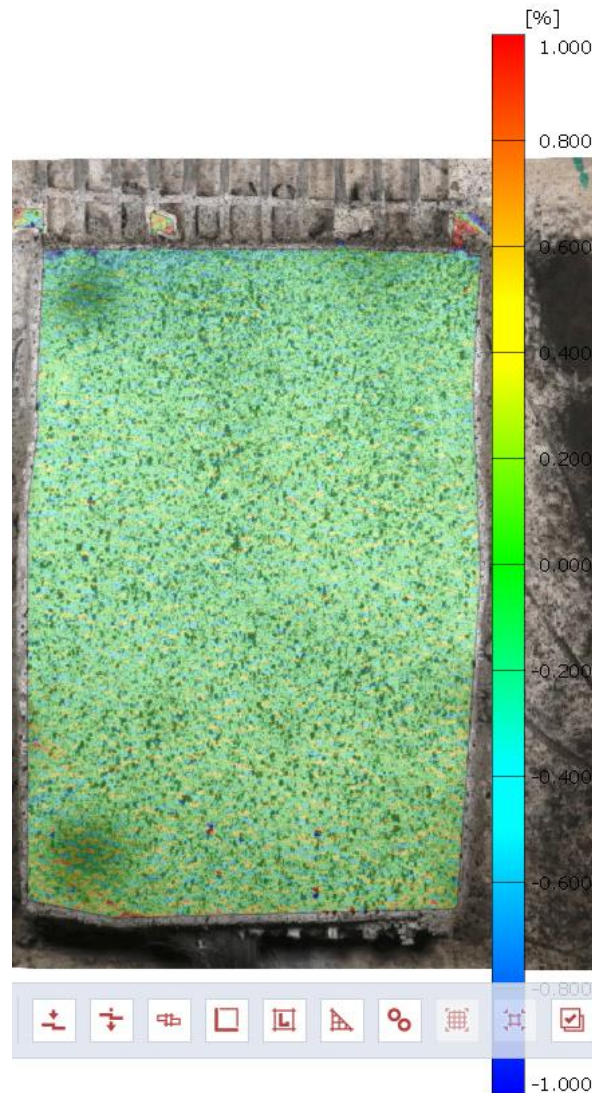
Figure 4.45: DIC generated 2D strain contour map

The 2D strain map of this specimen created using DIC is shown in Figure 4.45. This map shows that there is no cracking or any significant strain on the surface of the composite with the whole surface covered in green indicating 0% strain.

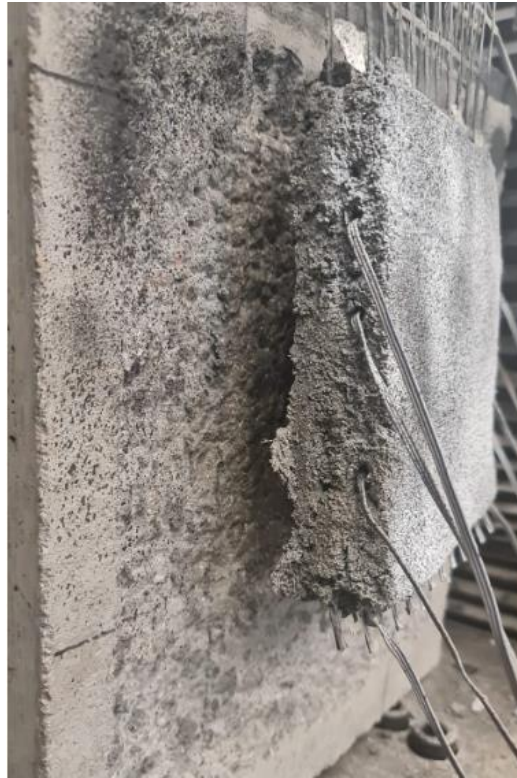
*Figure 4.46: debonded composite*

This specimen was fabricated using two layers of non-anchored unidirectional carbon fabric, with a composite length and width of 200 mm. No cracking nor delamination were observed on the composite surface before the composite-substrate debonding took place as shown in Figure 4.46. Moreover, the fabric strands did not rupture. This specimen did not perform well compared to

other specimens as the failure stress was amongst the lowest. The failure stress of this specimen was 225 MPa in the fabric and 0.35 MPa at the composite-substrate interface at a load of 14.1 kN.

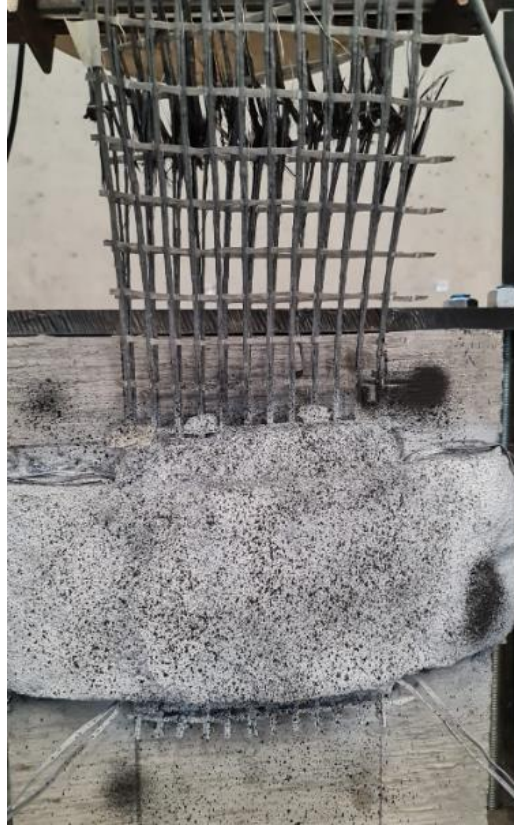
*Figure 4.54: ruptured fabric*

This specimen was fabricated using two layers of unidirectional carbon fabric, anchored using a wrap anchor, with a composite length and width of 200 mm. Neither cracking nor delamination were observed on the composite surface before the fabric ruptured as can be seen in Figure 4.54. Most of the ruptured fabric was in one layer which means the two fabric layers were not loaded equally. The failure stress of this specimen was 233.6 MPa in the fabric at a load of 14.6 kN.

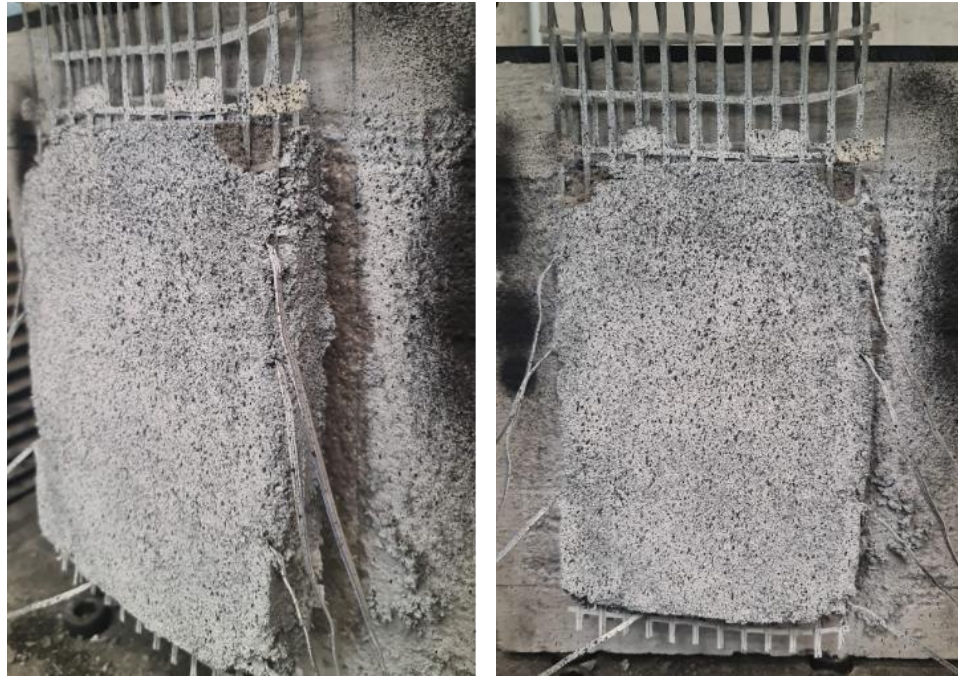
*Figure 4.58: side view (a) and front view of the debonded composite (b)*

This specimen was fabricated using two layers of non-anchored unidirectional carbon fabric, with a composite length and width of 300 mm and 200 mm, respectively. Cracking and delamination were observed at the top corners of the composite surface just before the composite-substrate

debonding took place as shown in Figure 4.58. Moreover, the fabric strands did not rupture and no visible fabric slip was observed in spite of the surface cracking. This specimen was one of the worst performing in terms of fabric stress due to the premature debonding. The failure stress of this specimen was 203.2 MPa in the fabric and 0.21 MPa at the composite-substrate interface at a load of 12.7 kN.

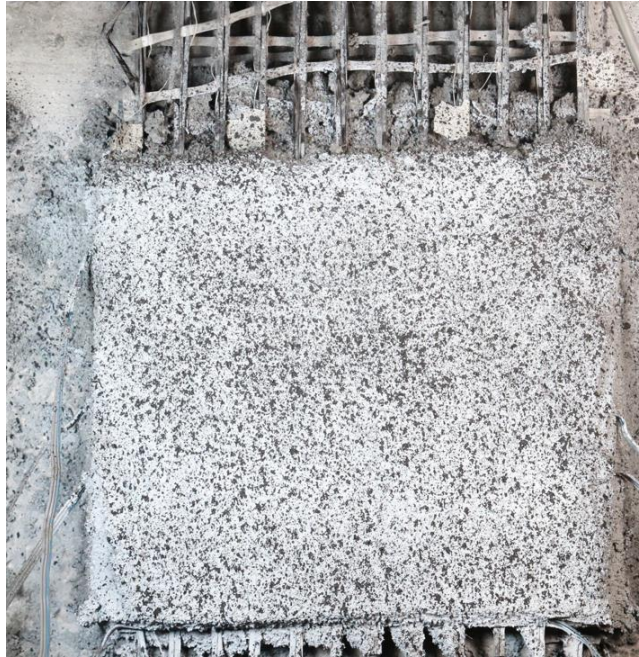
*Figure 4.63: ruptured fabric*

This specimen was fabricated using three layers of non-anchored unidirectional carbon fabric, with a composite length and width of 200 mm. No cracking nor delamination were observed on the surface of the composite during the test as presented in Figure 4.63. However, the fabric strands ruptured at the failure load. The failure stress of this specimen was 199.2 MPa in the fabric at a load of 18.7 kN.

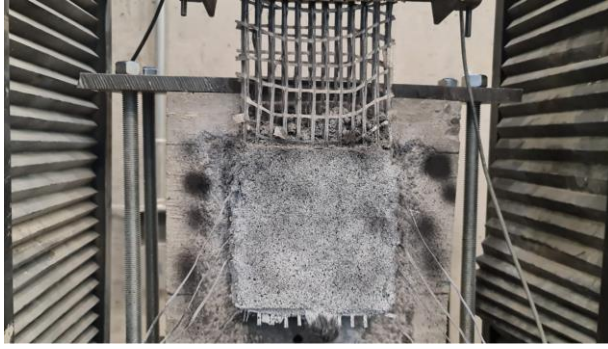
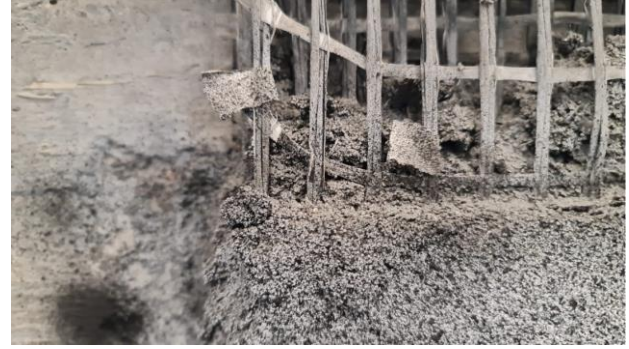
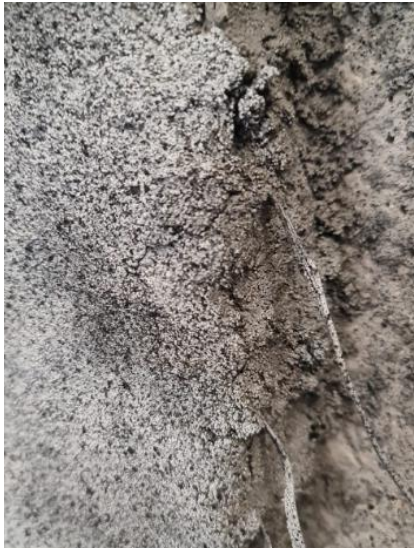
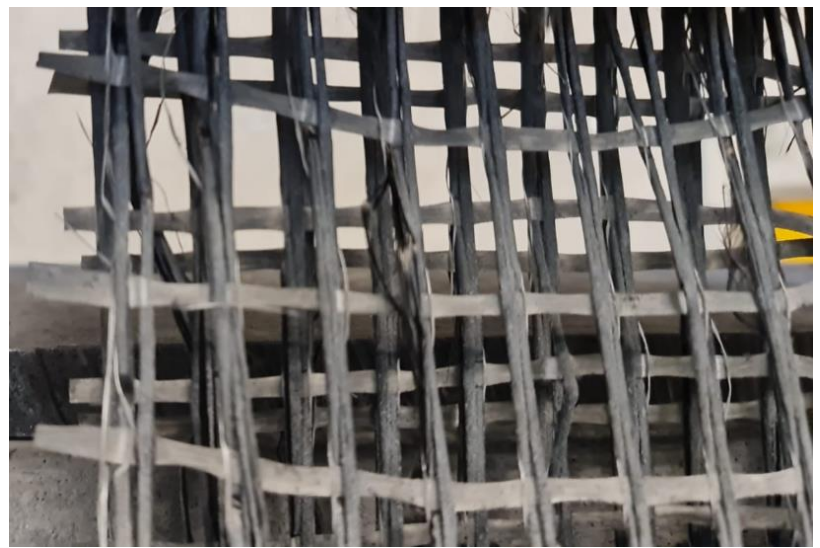
*Figure 4.65: front view (a), cracking (b), splitting (c) and fabric rupture (d)*

This specimen was fabricated using three layers of unidirectional carbon fabric, anchored with two spike anchors, with a composite length and width of 200 mm. Cracking was observed near the top corners of the composite surface during the test, in addition to the matrix splitting from the sides at the closest fabric layer to the external surface of the composite, before the final rupture as shown in Figure 4.65. Moreover, few minor ruptures in the fabric were observed throughout the test before the final major one. The failure stress of this specimen was 409.9 MPa in the fabric at a load of 38.5 kN.

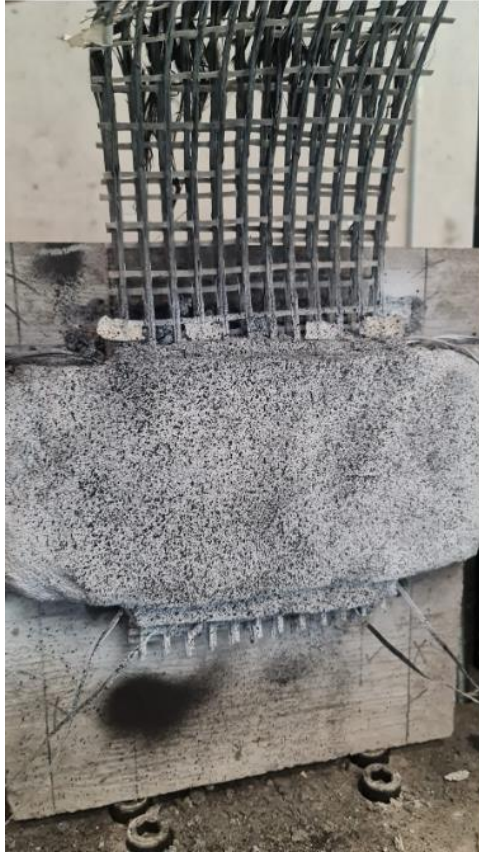
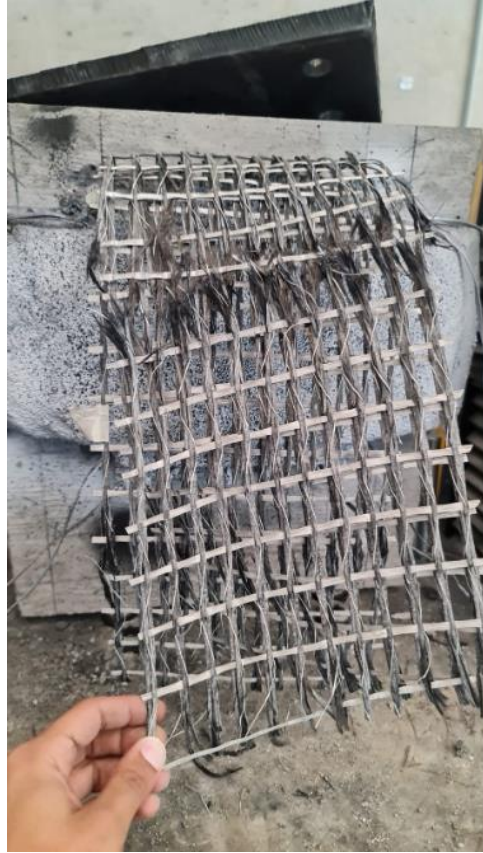
*Figure 4.70: front view (a) and ruptured fabric (b)*

This specimen was fabricated using three layers of unidirectional carbon fabric, anchored using a wrap anchor, with a composite length and width of 200 mm. No cracking or delamination were observed on the surface of the composite during the test before the final rupture in the dry fabric as shown in Figure 4.70. The failure stress of this specimen was 250.6 MPa in the fabric at a load of 23.5 kN.

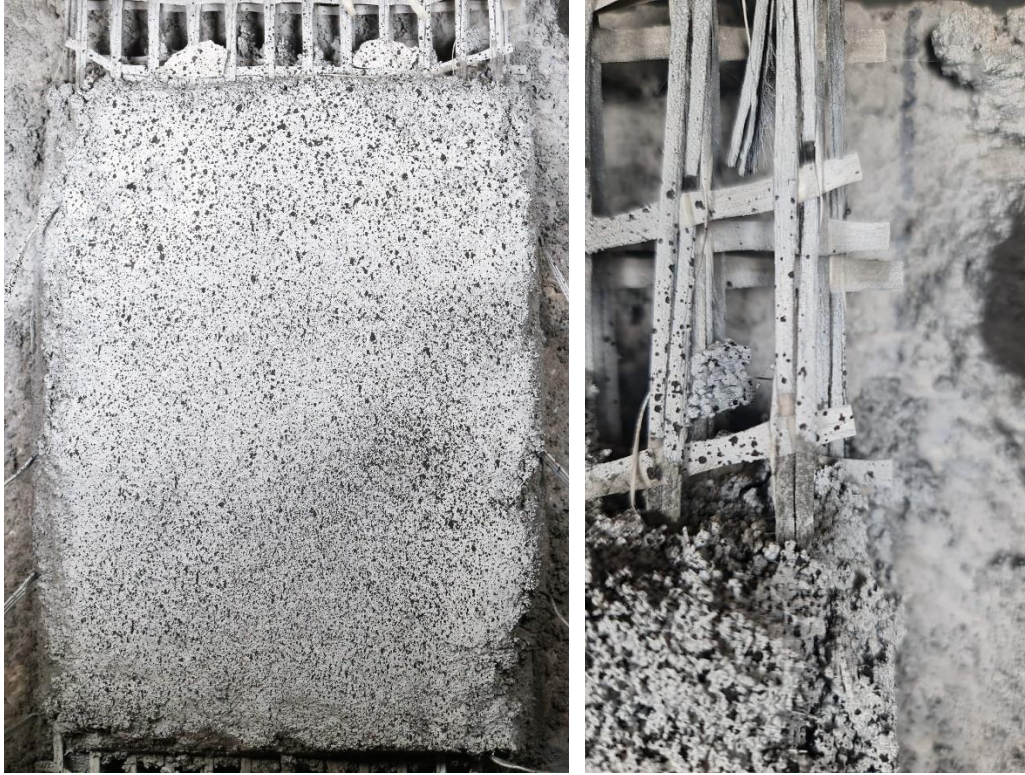
This specimen was fabricated using three layers of non-anchored unidirectional carbon fabric, with a composite length and width of 300 mm and 200 mm, respectively. No cracking or delamination were observed on the surface of the composite during the test. However, a series of ruptures in the fabric took place during the test, in addition to slip of the fabric strands near the edges as shown in Figure 4.74. Just like specimen U\_3\_20\_20\_S2, the difference in slip between the fabric strands closer to the edges of the composite and the middle ones was significant. The failure stress of this specimen was 314.5 MPa in the fabric at a load of 29.5 kN.

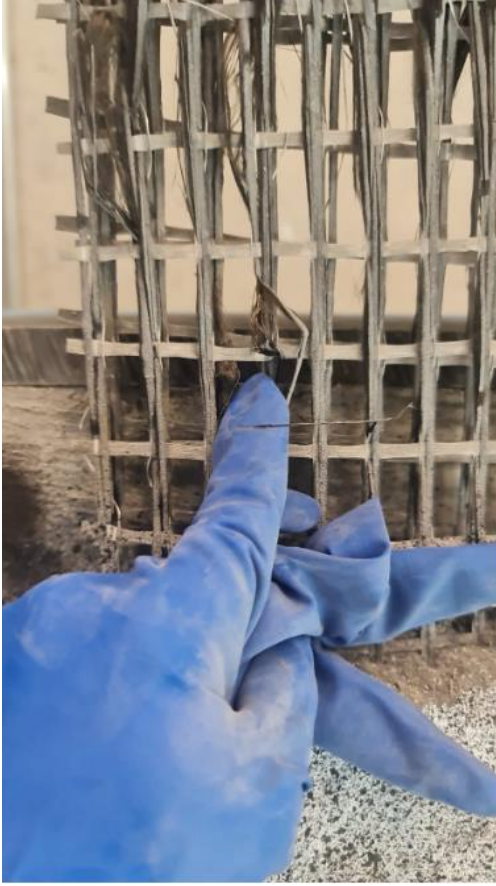
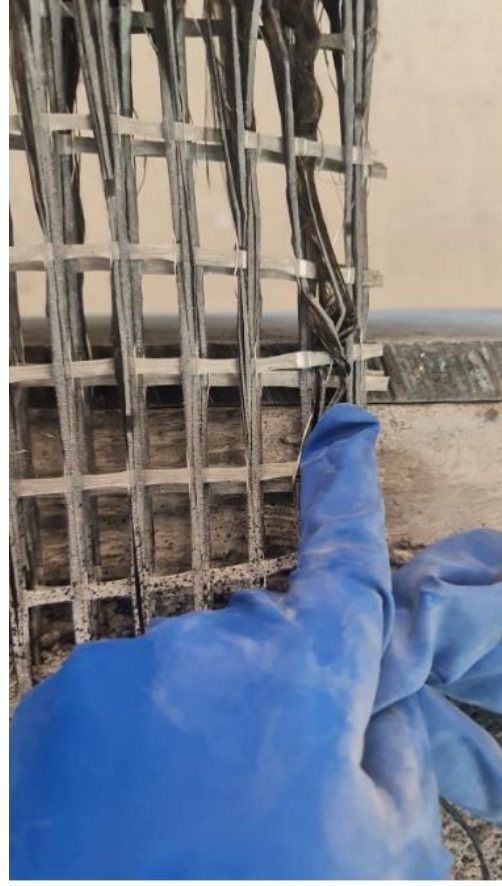
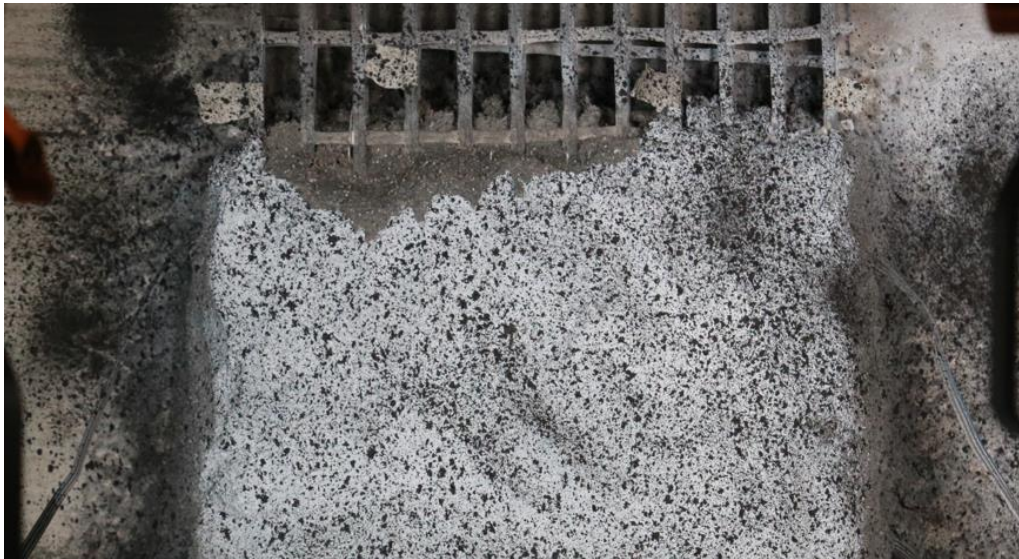
*Figure 4.79: fabric rupture close-up (a) and (b) and matrix cracking (c)*

This specimen was fabricated using three layers of unidirectional carbon fabric, anchored with two spike anchors, with a composite length and width of 300 mm and 200 mm, respectively. Cracking that propagated from the top left corner of the composite was observed which led to delamination and spalling later during the test. Moreover, fabric strands near the edge started slipping before the fabric rupture took place at the failure load as shown in Figure 4.79. The failure stress of this specimen was 310.6 MPa in the fabric at a load of 29.2 kN, which is close to that of unanchored specimen U\_3\_30\_20\_N.
