# **Blast Retrofit of Reinforced Concrete Columns**

Thesis submitted to the  
Faculty of Graduate and Postdoctoral Studies  
in partial fulfillment of the requirements  
for the Doctorate in Philosophy degree in Civil Engineering

Department of Civil Engineering  
Faculty of Engineering  
University of Ottawa

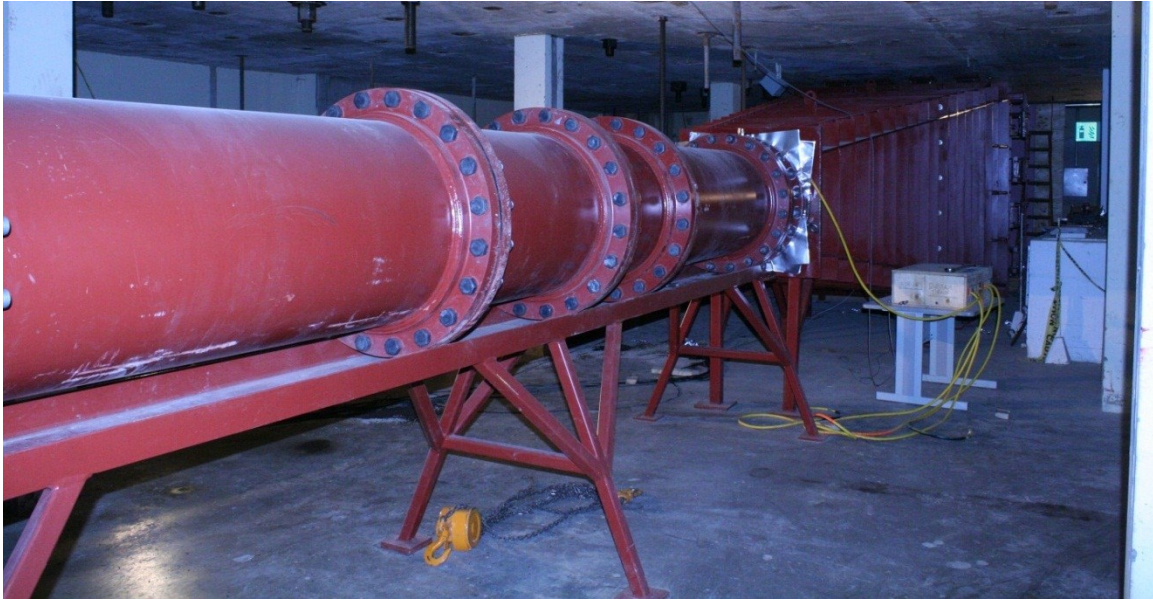
**Figure 3-10: Driver Section, Diaphragms, and Expansion Section of Shock Tube**

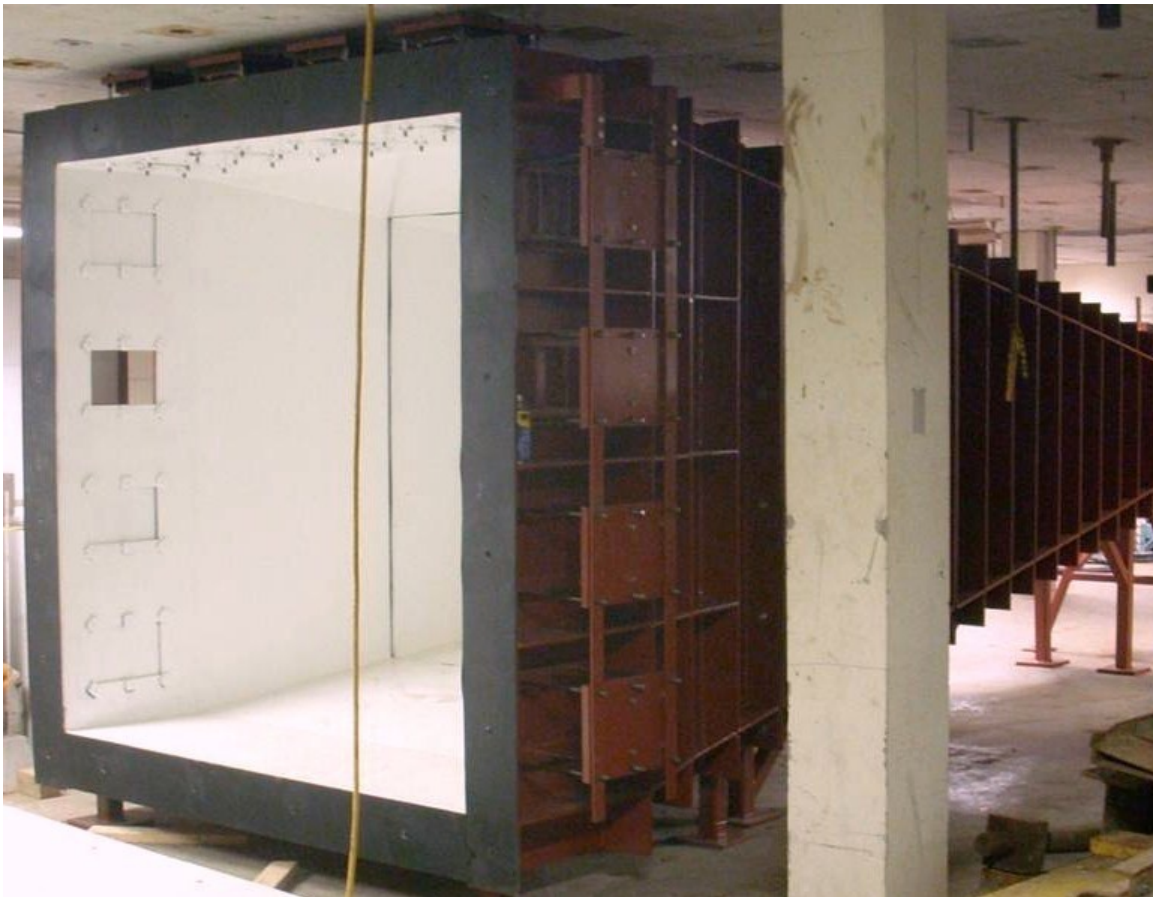
**Figure 3-11: Shock Tube Opening, Test Frame and Expansion system**

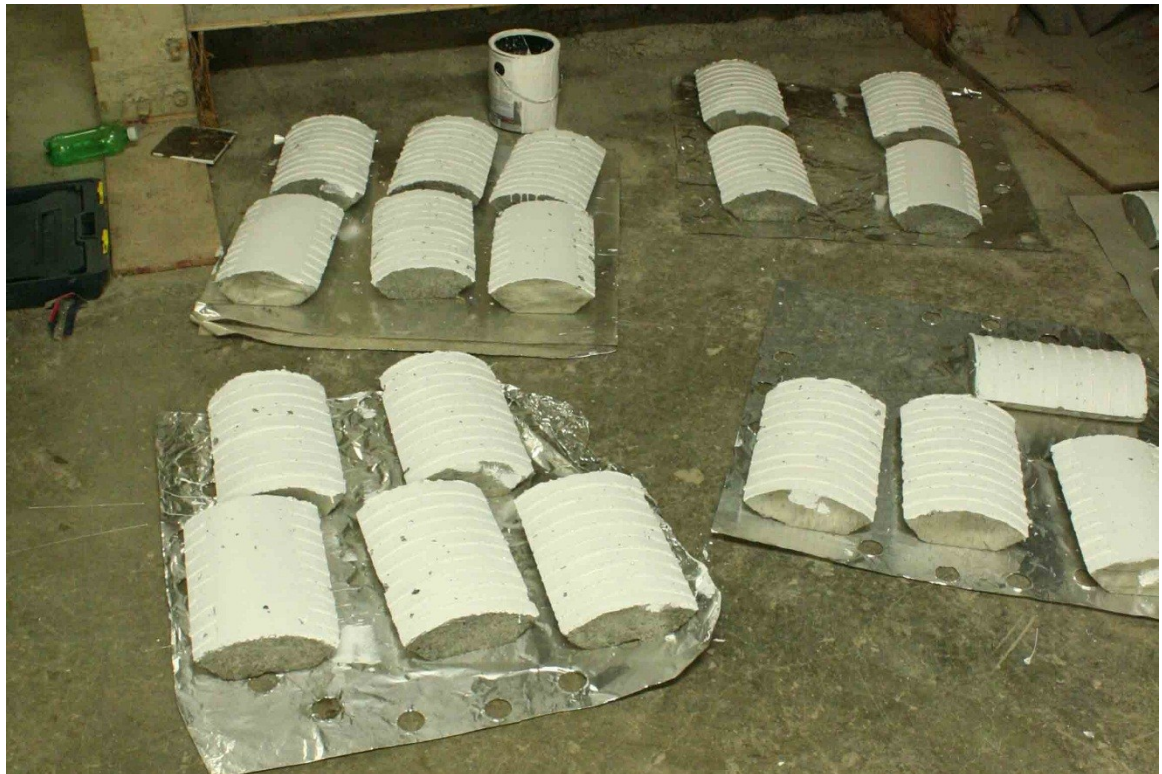
**c) Prior to Installation**

**Figure 3-28: Construction of Fibre Reinforced Concrete Wedges**

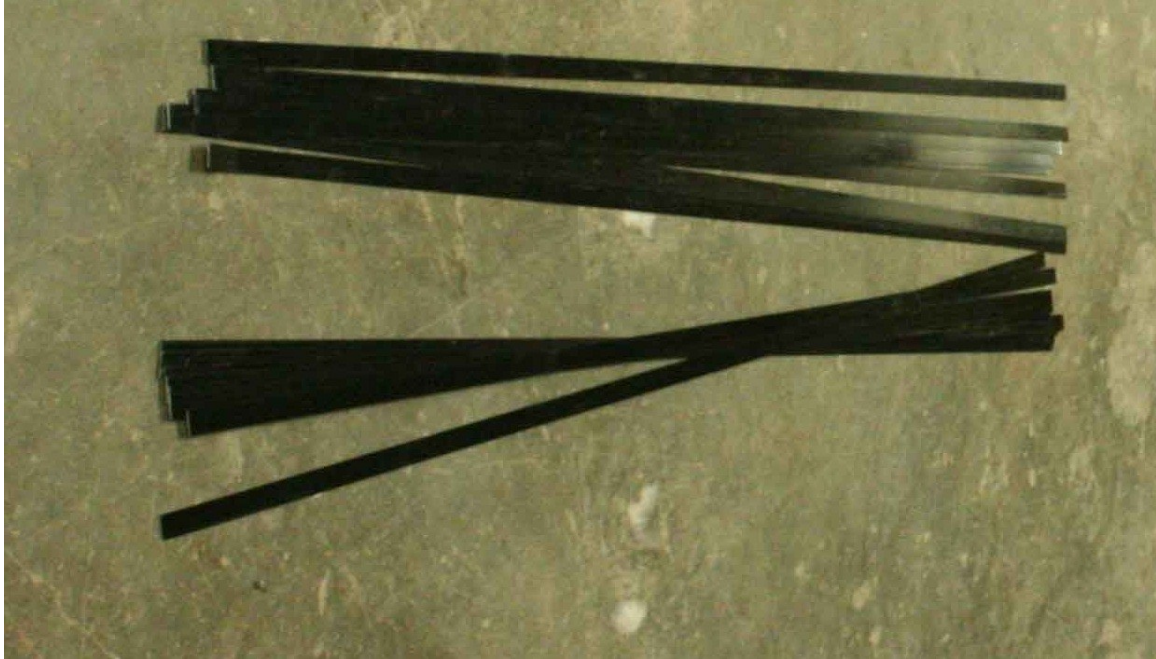
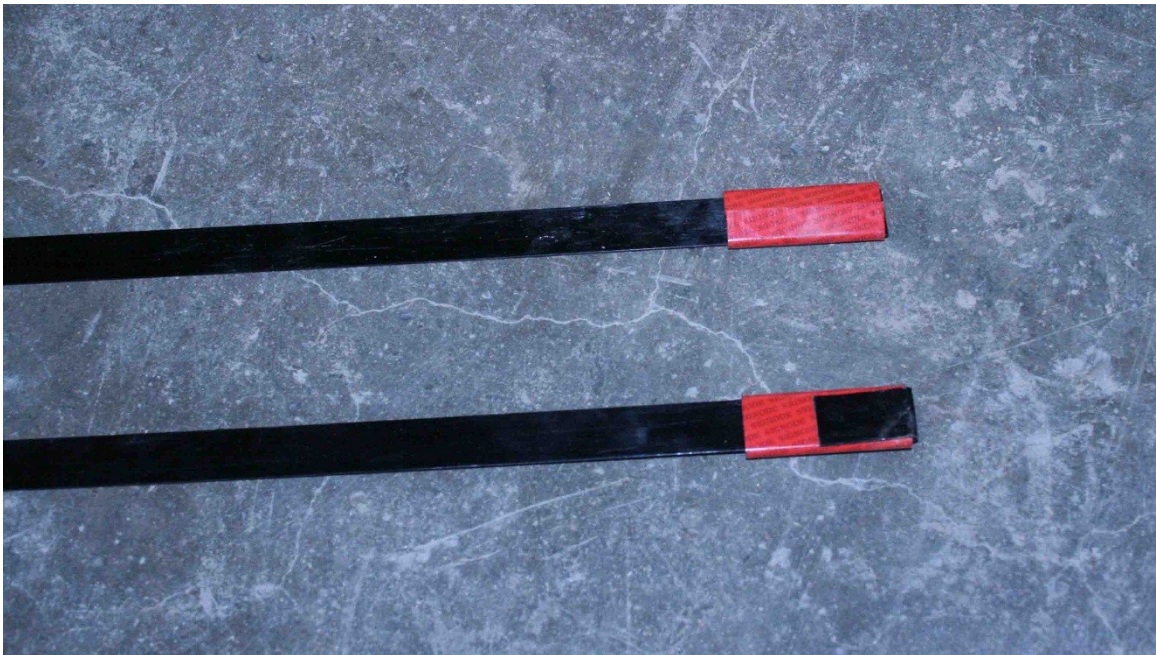
**a) Straps Cut to Length**

**b) Straps with Couplers**

**Figure 3-29: Prestress Straps Prior to Installation**
