**INVESTIGATING THE RESPONSE OF LIGHT-FRAME
WOOD STUD WALLS WITH AND WITHOUT
BOUNDARY CONNECTIONS TO BLAST LOADS**

Thesis submitted to the
Faculty of Graduate and Postdoctoral Studies
in partial fulfillment of the requirements for the degree of

in Civil Engineering

University of Ottawa

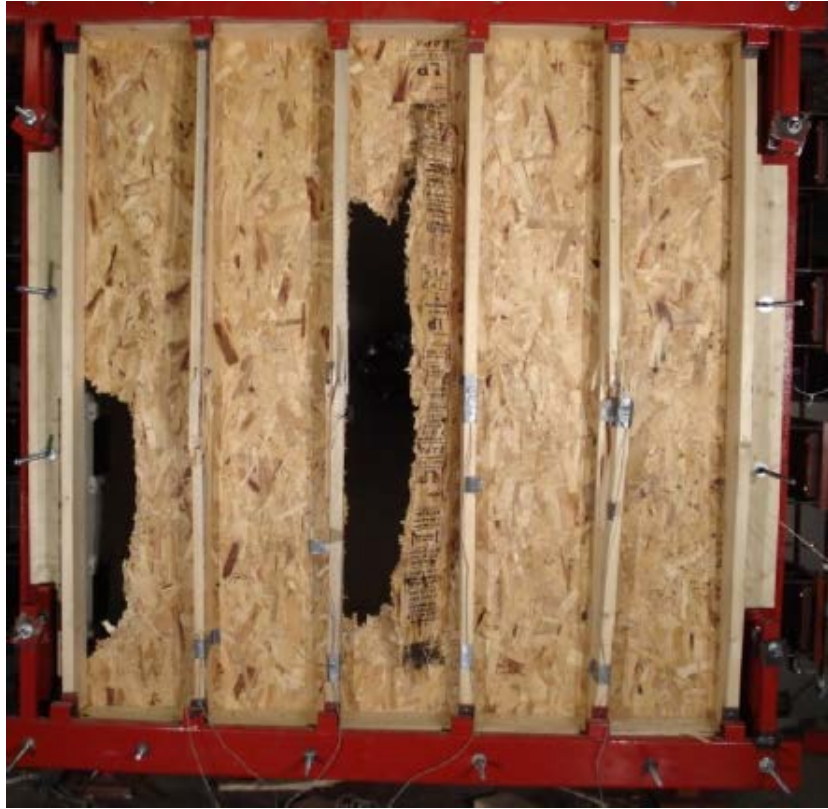
Figure 2.3 : Damaged OSB sheathing (Lacroix, 2013)

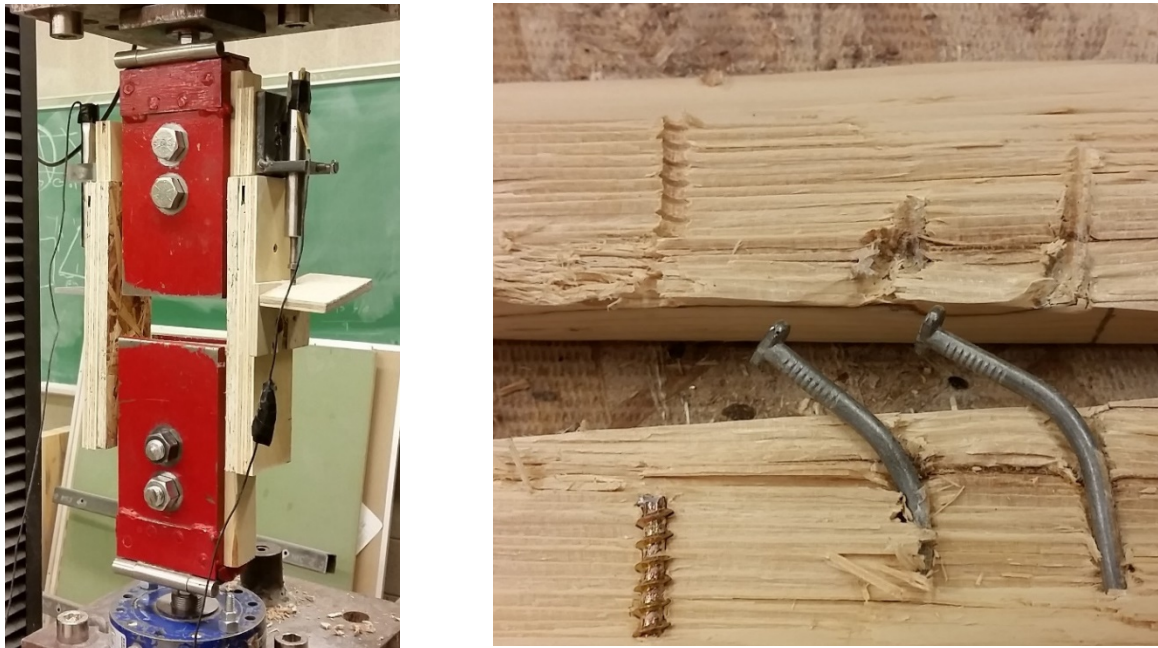
Figure 3.9 : Typical test setup and failure mode for load-slip tests

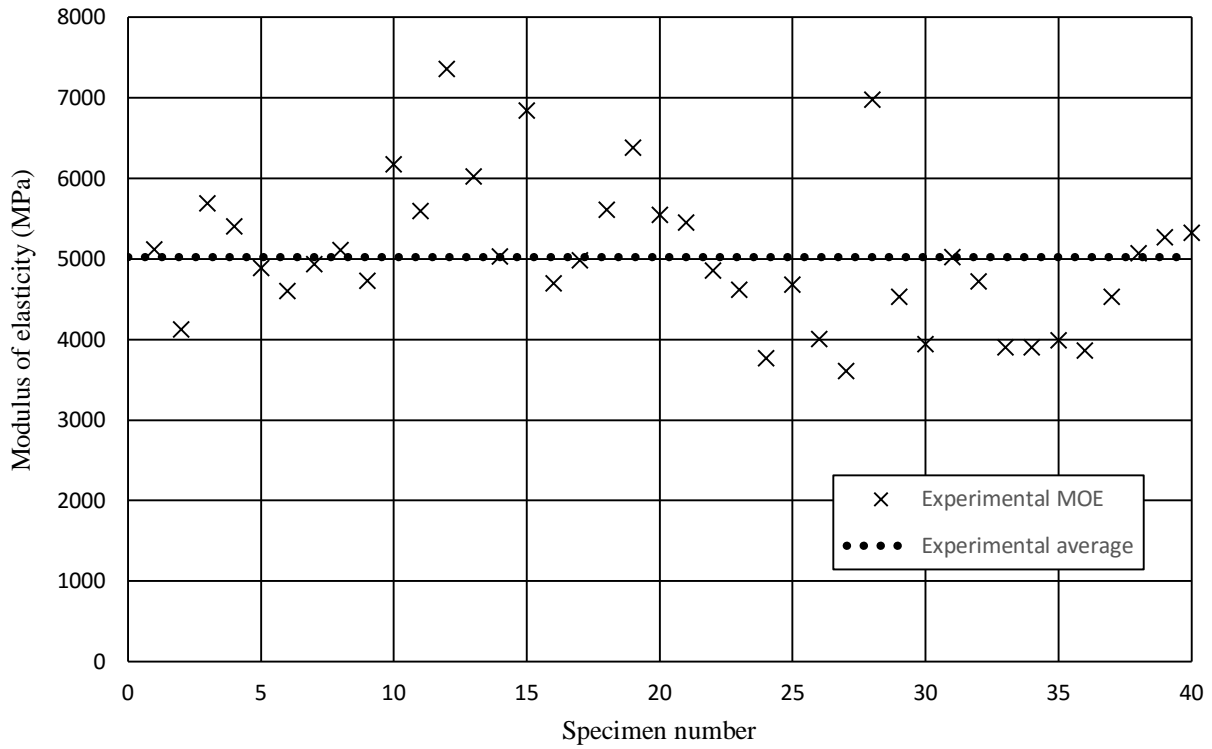
Figure 4.1 : Experimental MOE for OSB coupons

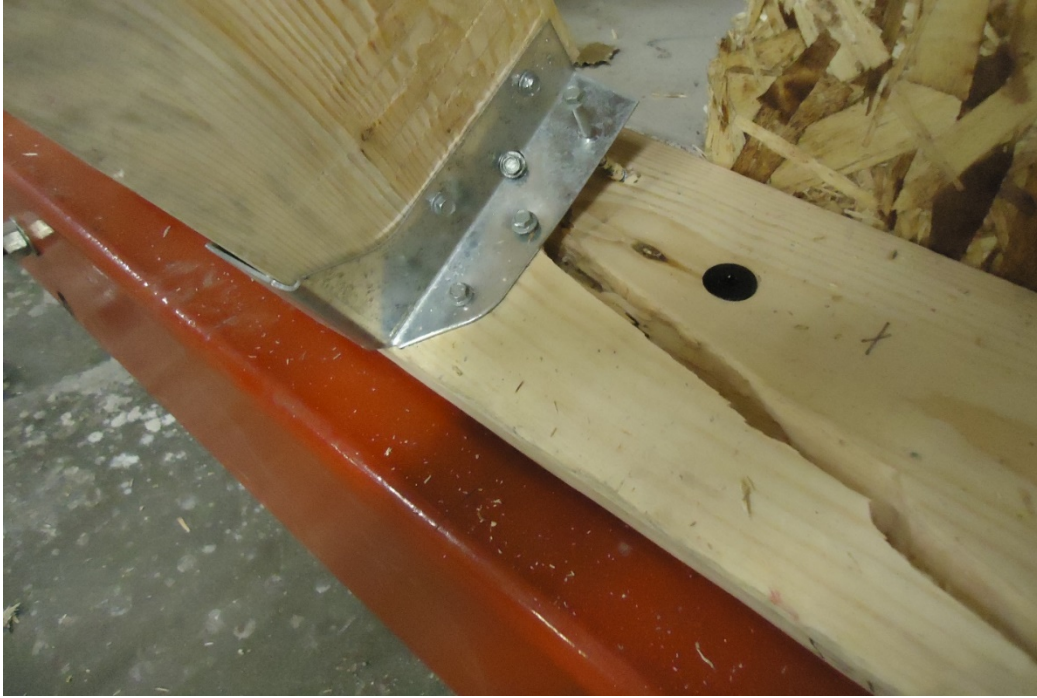
Figure 6.16 : Typical connection damage for HU28 connections

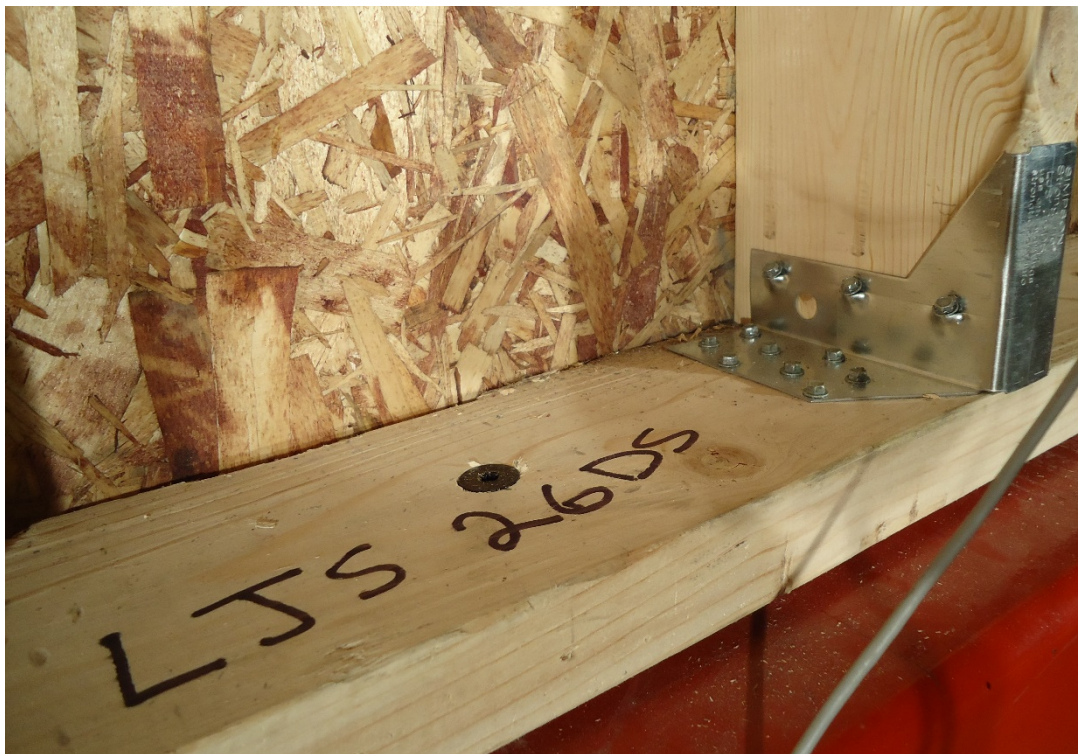
Figure 6.17 : LJS26DS connection detail

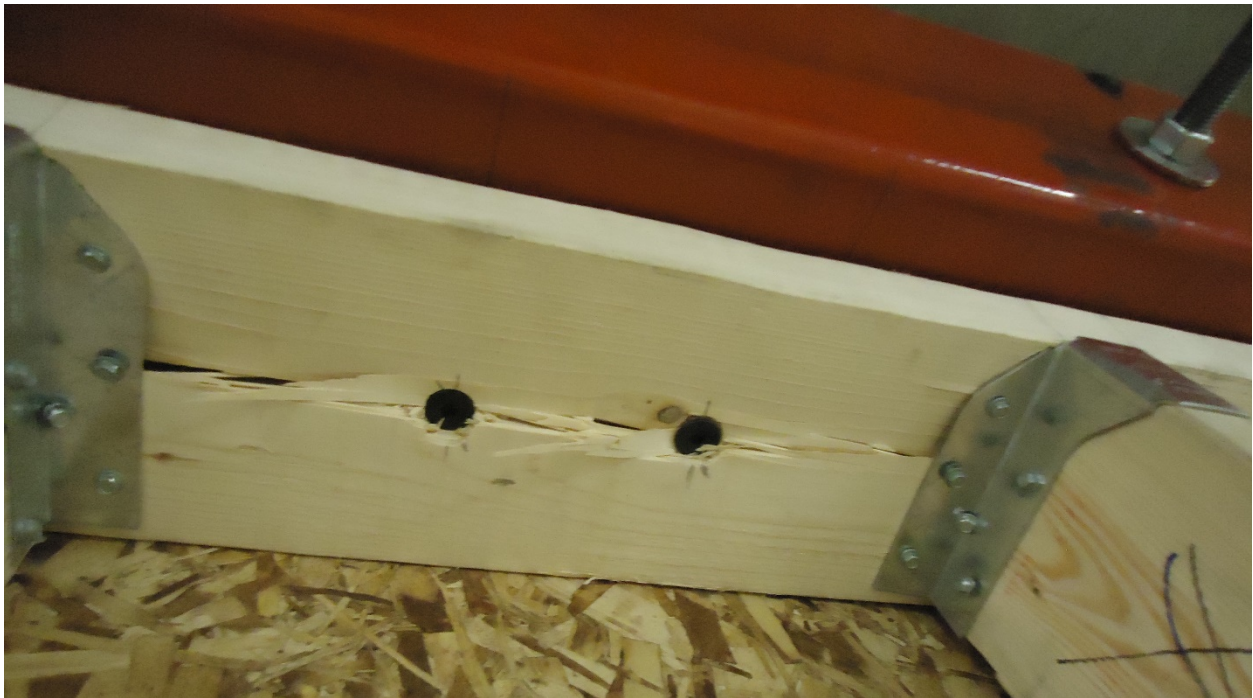
Figure 6.19 : Damage in top plate in wall with LJS26DS
