M.A.Sc. (Civil Engineering)

Department of Civil Engineering

**An Experimental Study on the Non-Destructive Evaluation of
Corroded Bridge Steel**

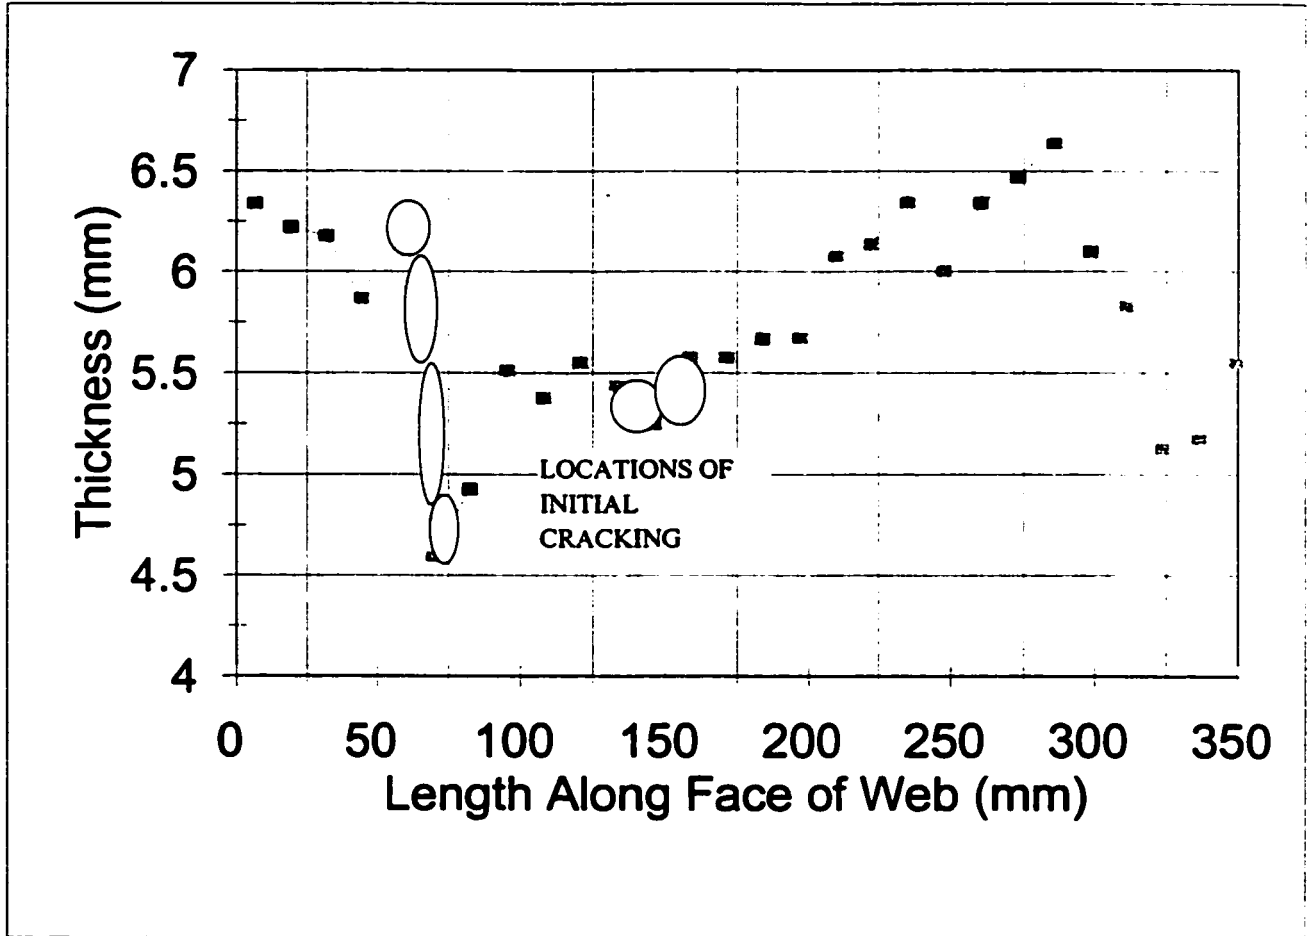
Figure 5.7 Initial Crack Location for Test 3

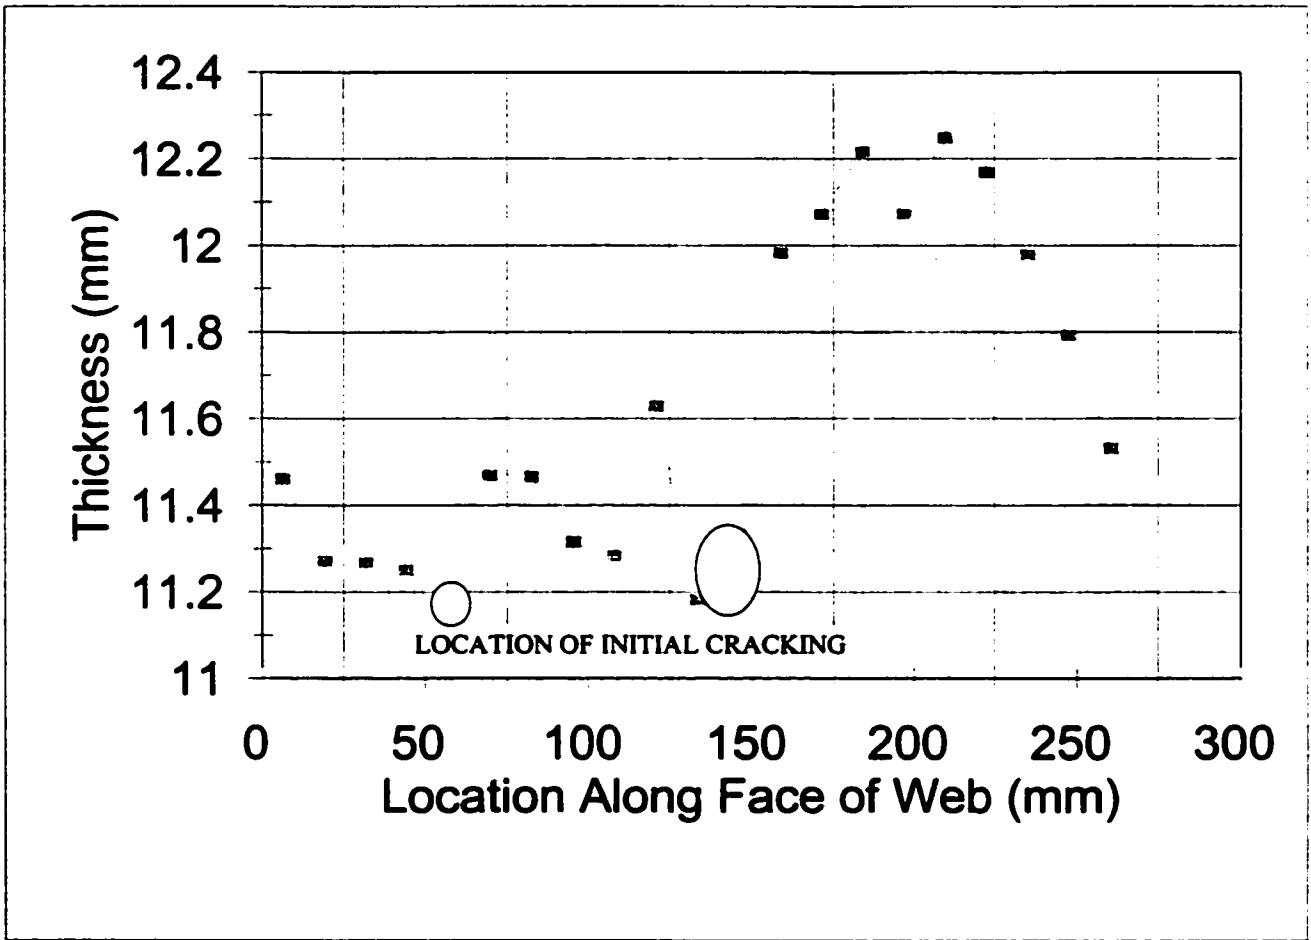
Figure 5.10 Initial Crack Location for Test 6
