Does Corrosion Affect the Bond Between Steel and Concrete?

Rahim Moosavi and Dr. Beatriz Martin-Perez
Department of Civil Engineering

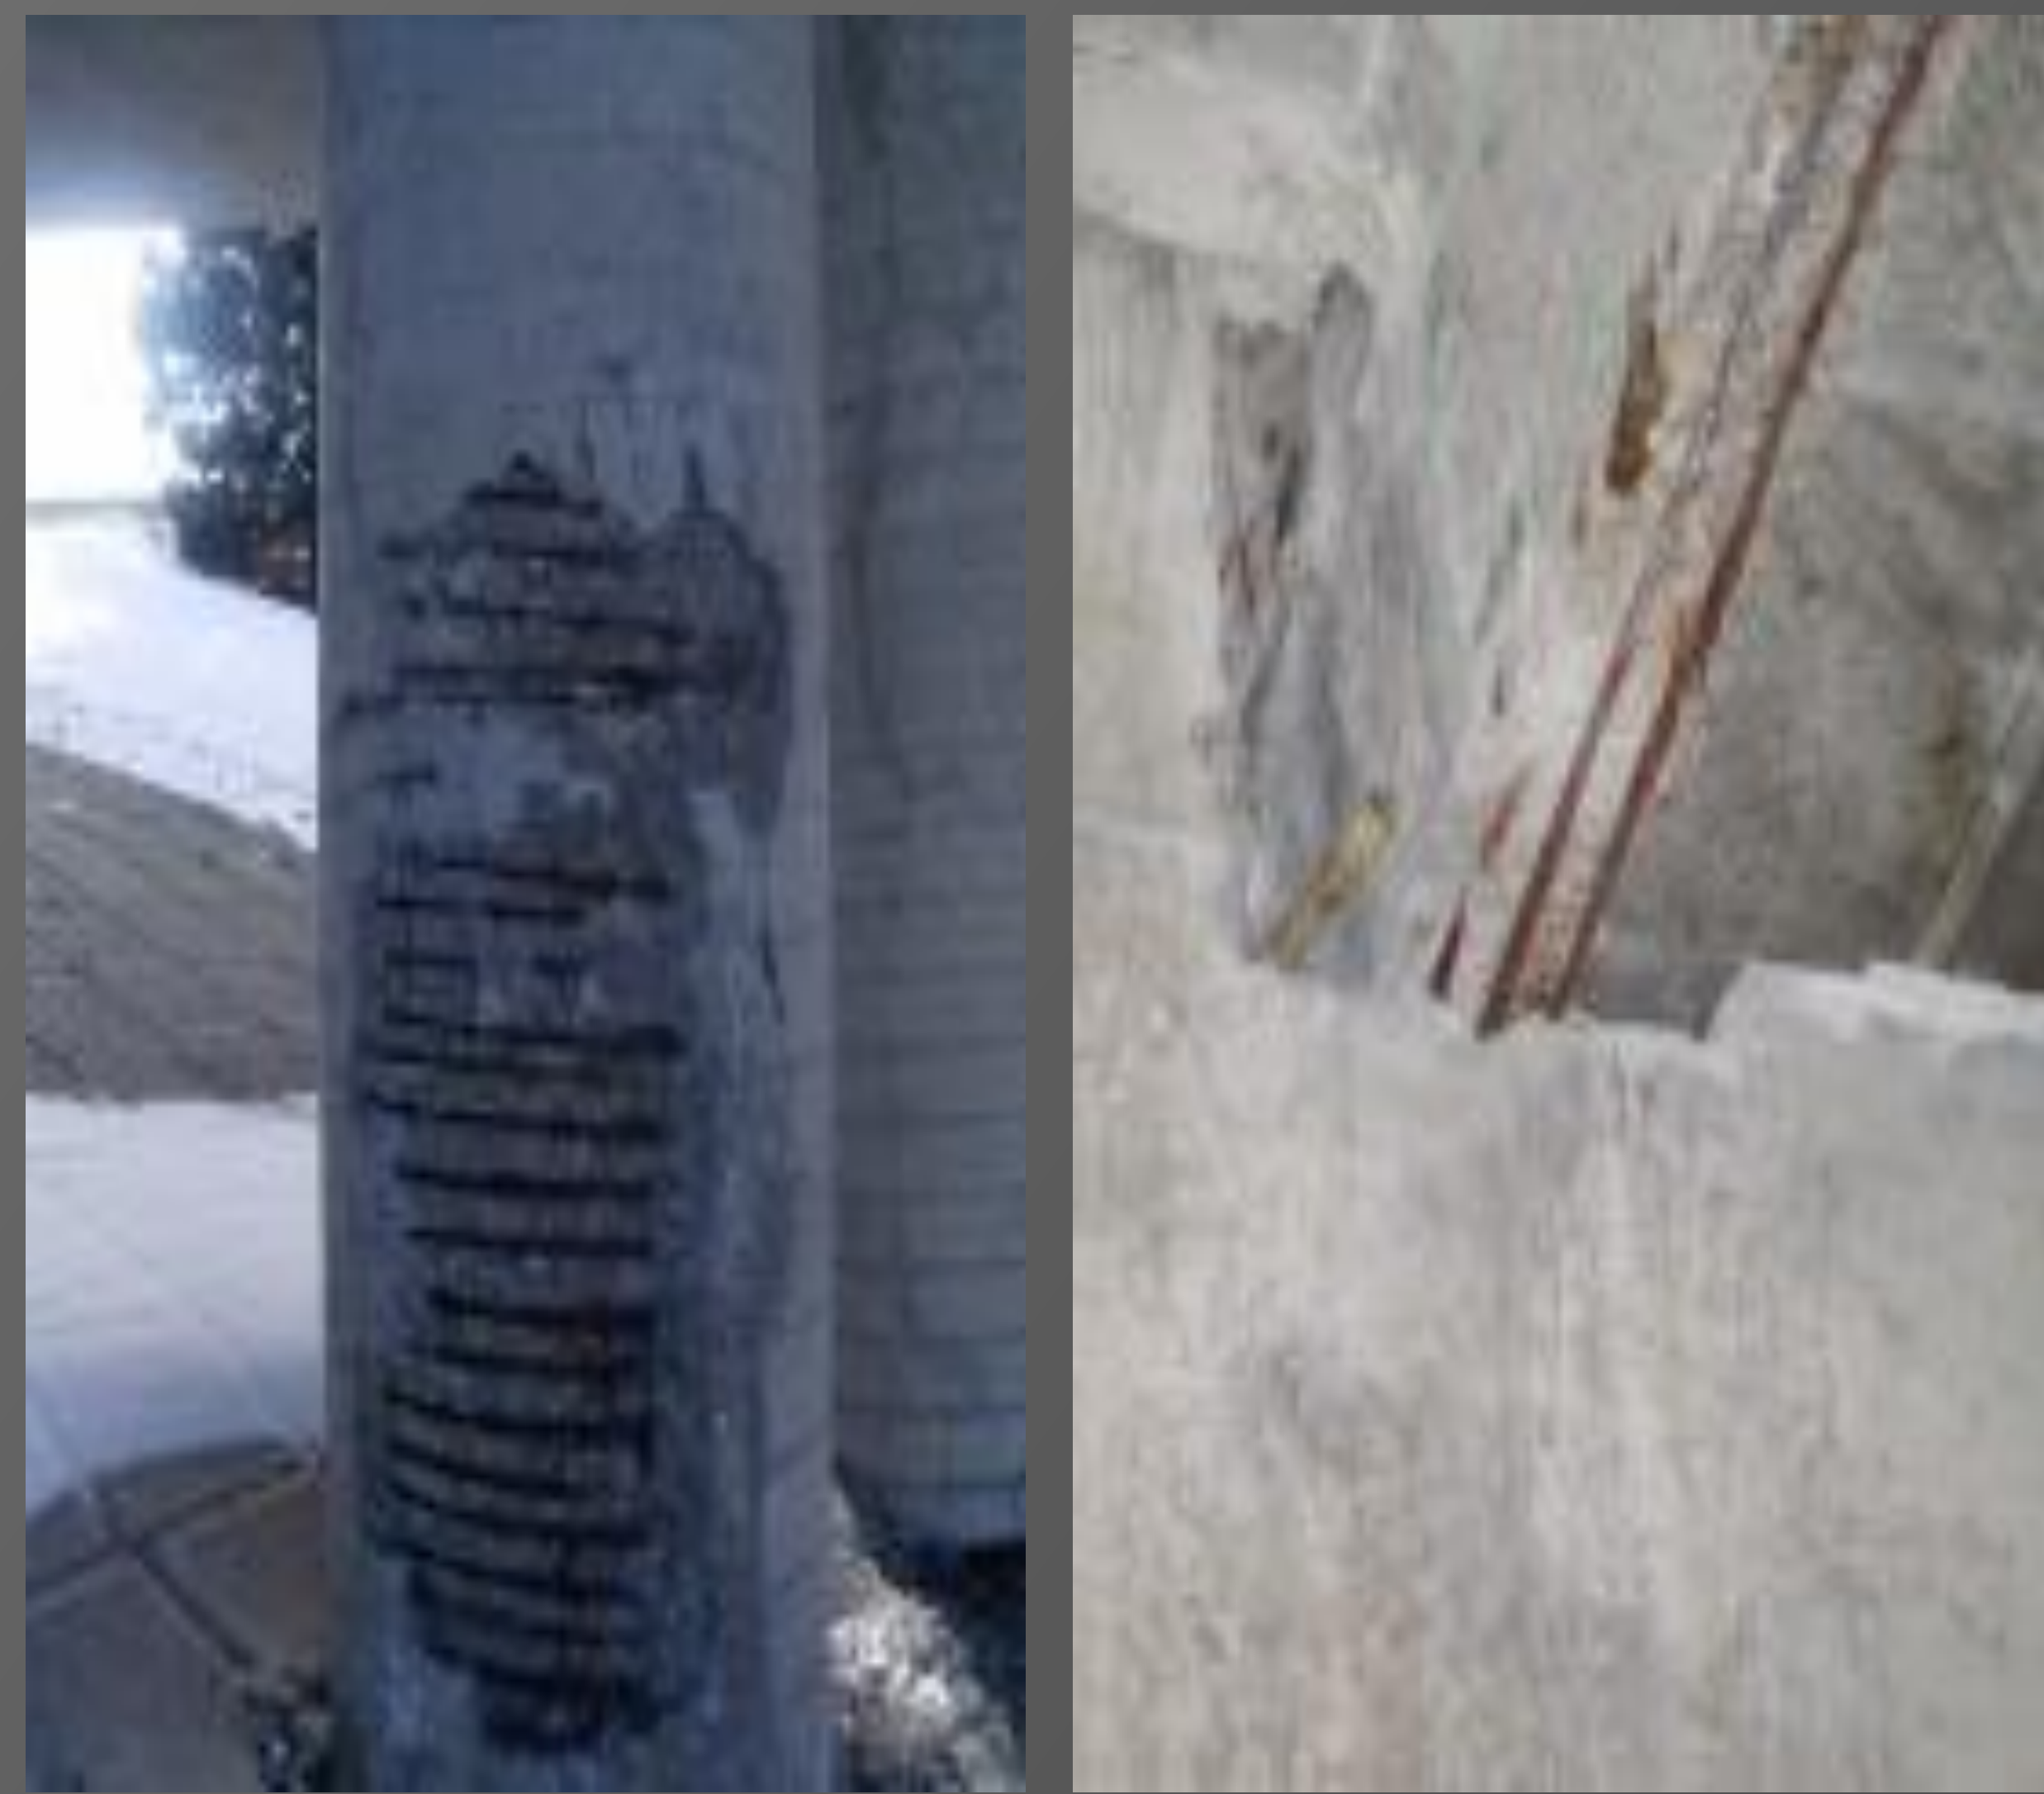
Fig 1: Reinforced concrete elements affected by corrosion

Corrosion of reinforcing steel is one of the leading causes of reinforced concrete infrastructure deterioration in North America due to the application of de-icing salts in the winter. Among the structures most affected are highway bridges and parking structures.

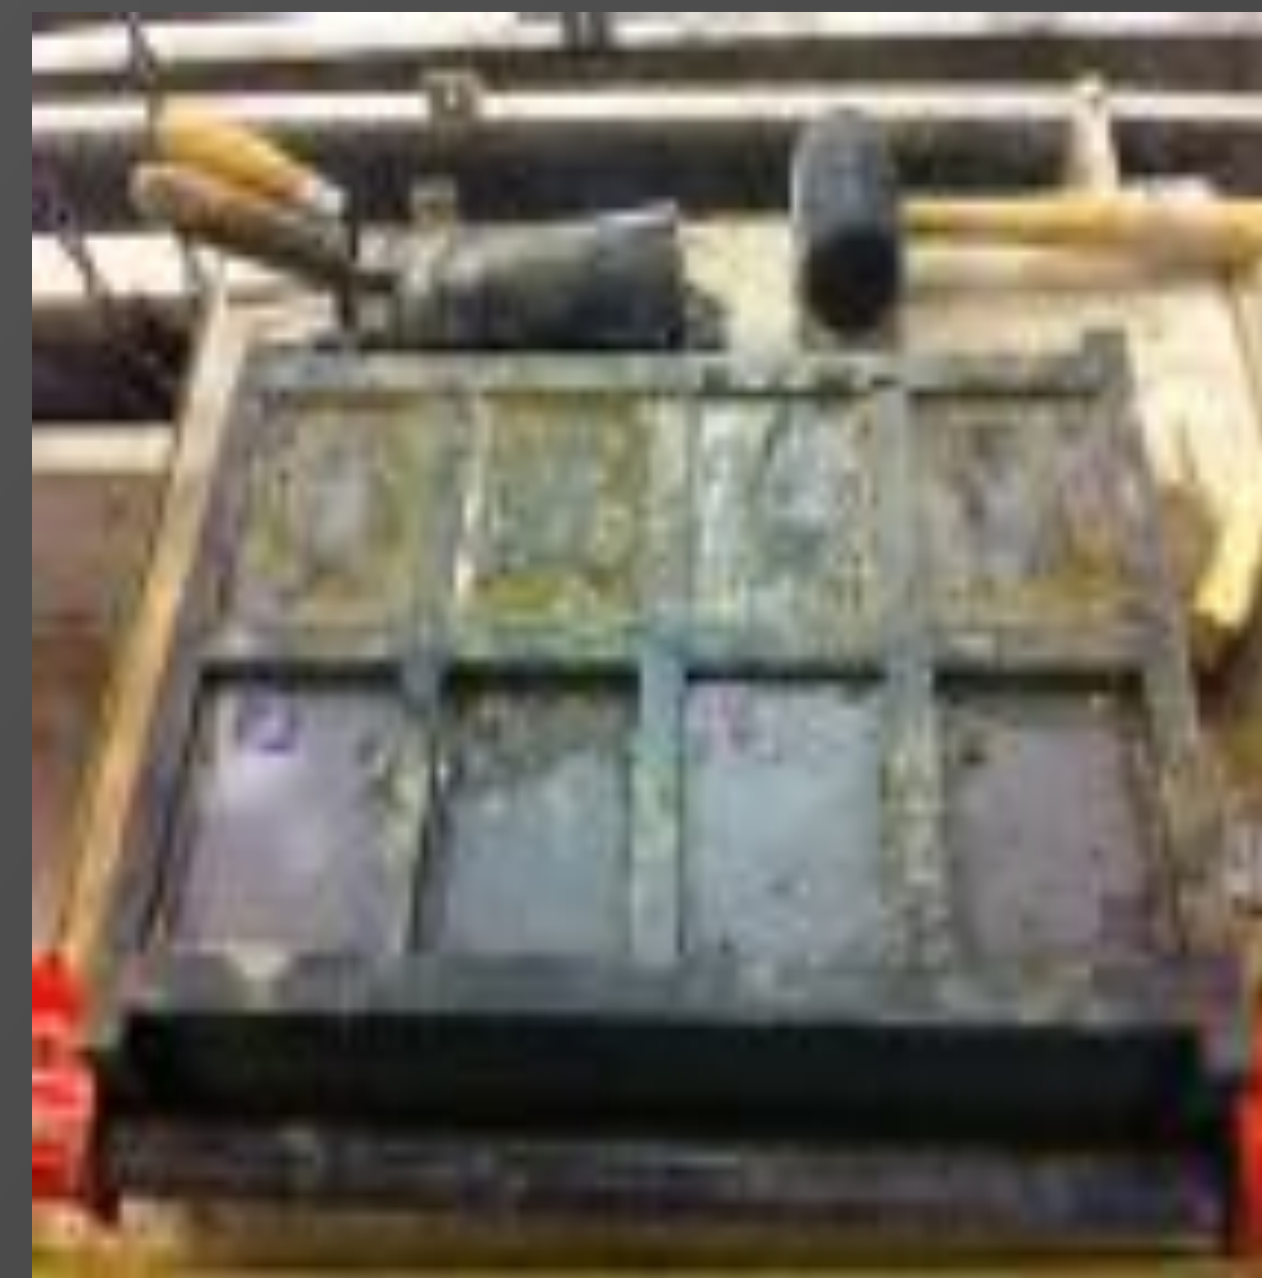
Fig. 3: Casting of samples

Two sets of mortar samples (85.6x85.6 mm) are cast in between two steel plates. One of the mortars is mixed with NaCl (3% by mass) to naturally induce corrosion on the steel. The two sets of steel-mortar-steel composite samples are tested mechanically to deduce the frictional properties of the interface.

In future experiments, care should be exercised to not contaminate the non-corroded samples with NaCl (Fig.3). For more accurate results more samples should be tested, especially to have a wider range for applying normal load (>50% f'_c).

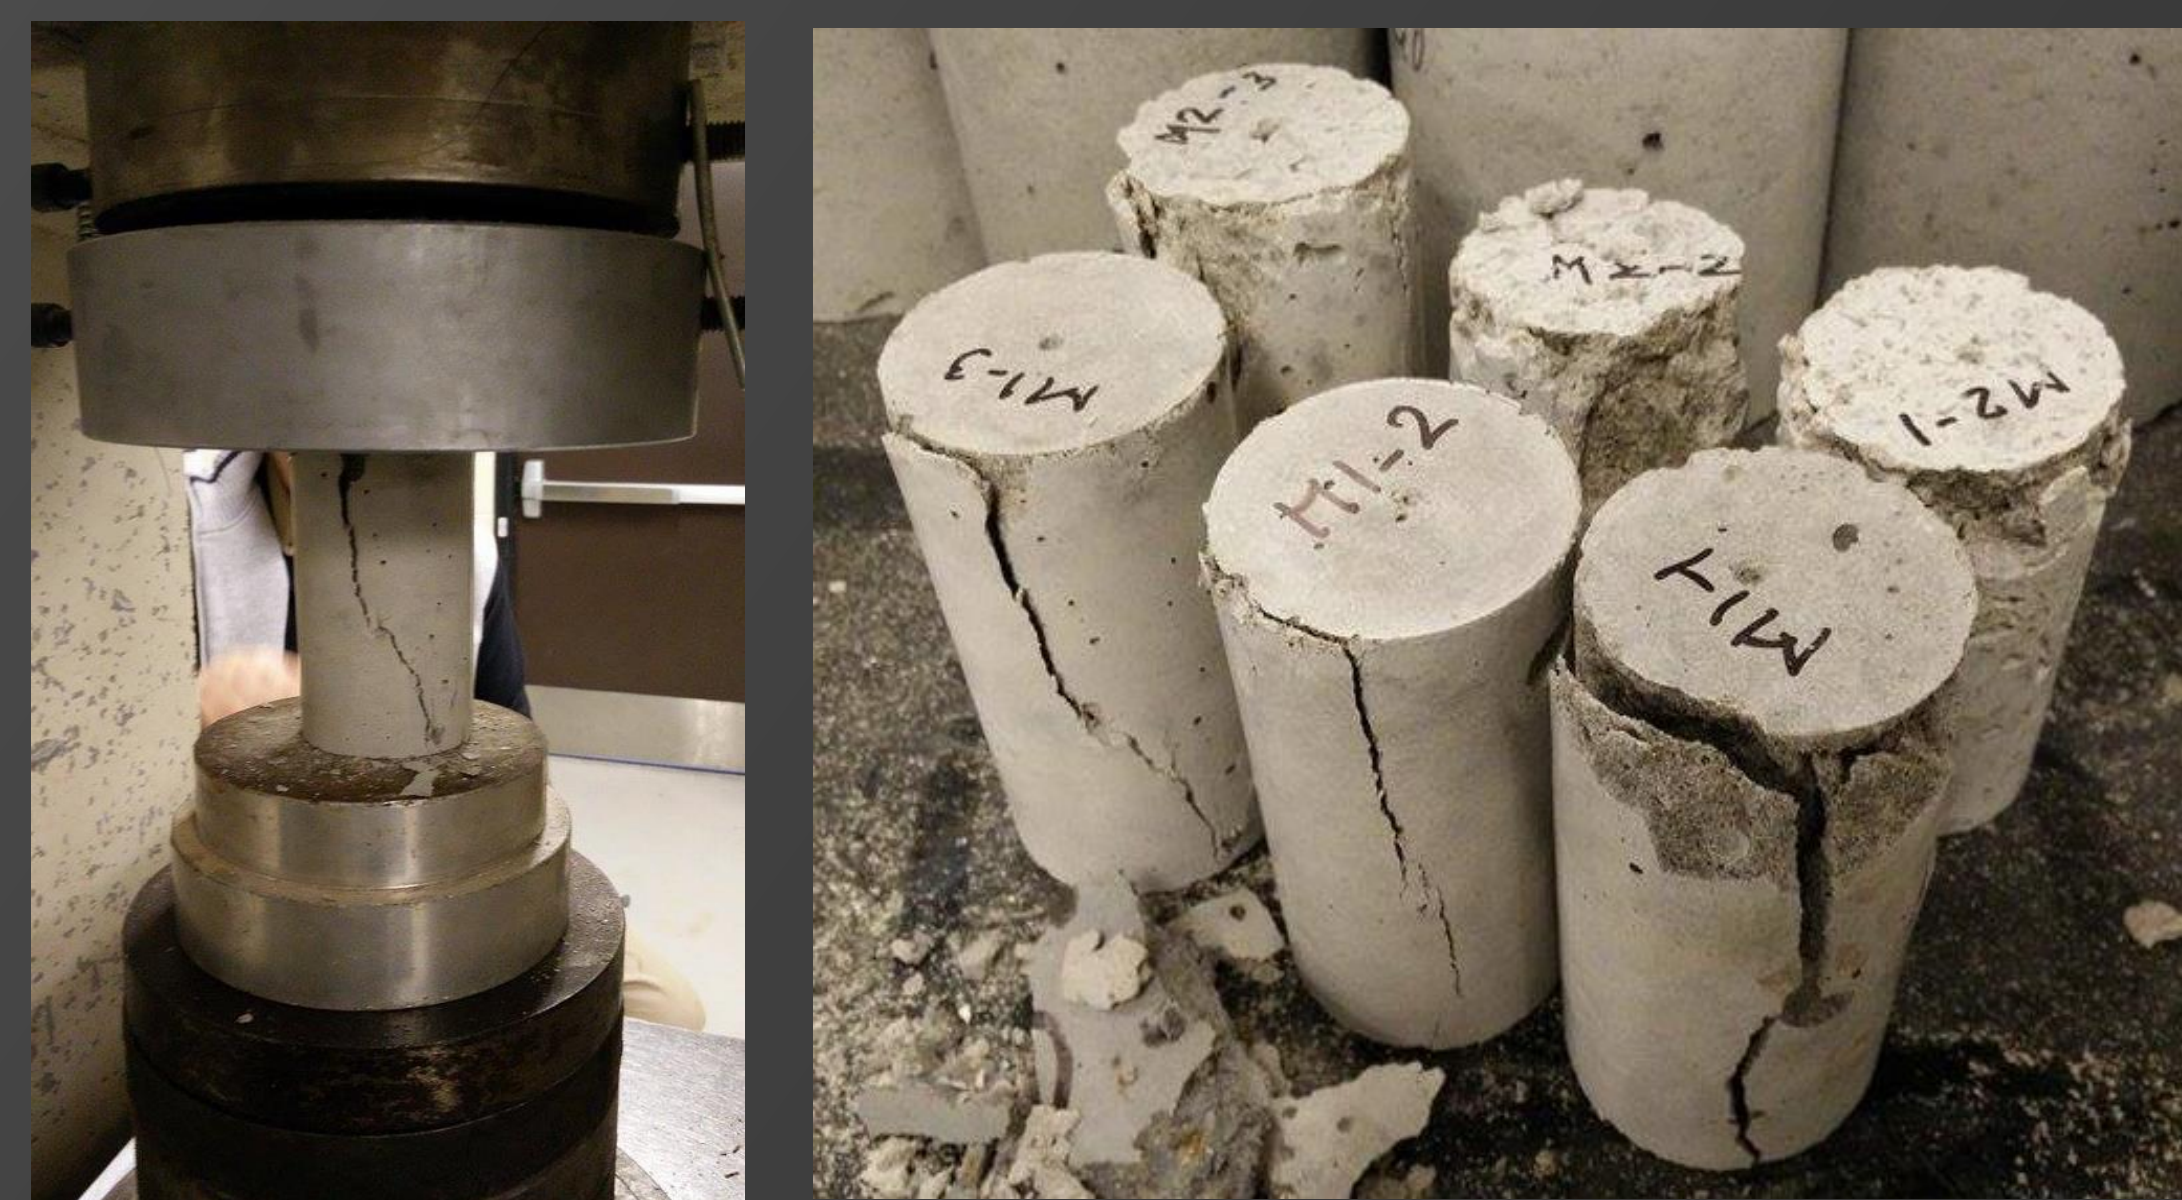
Fig. 4: Cylinder samples during and after test

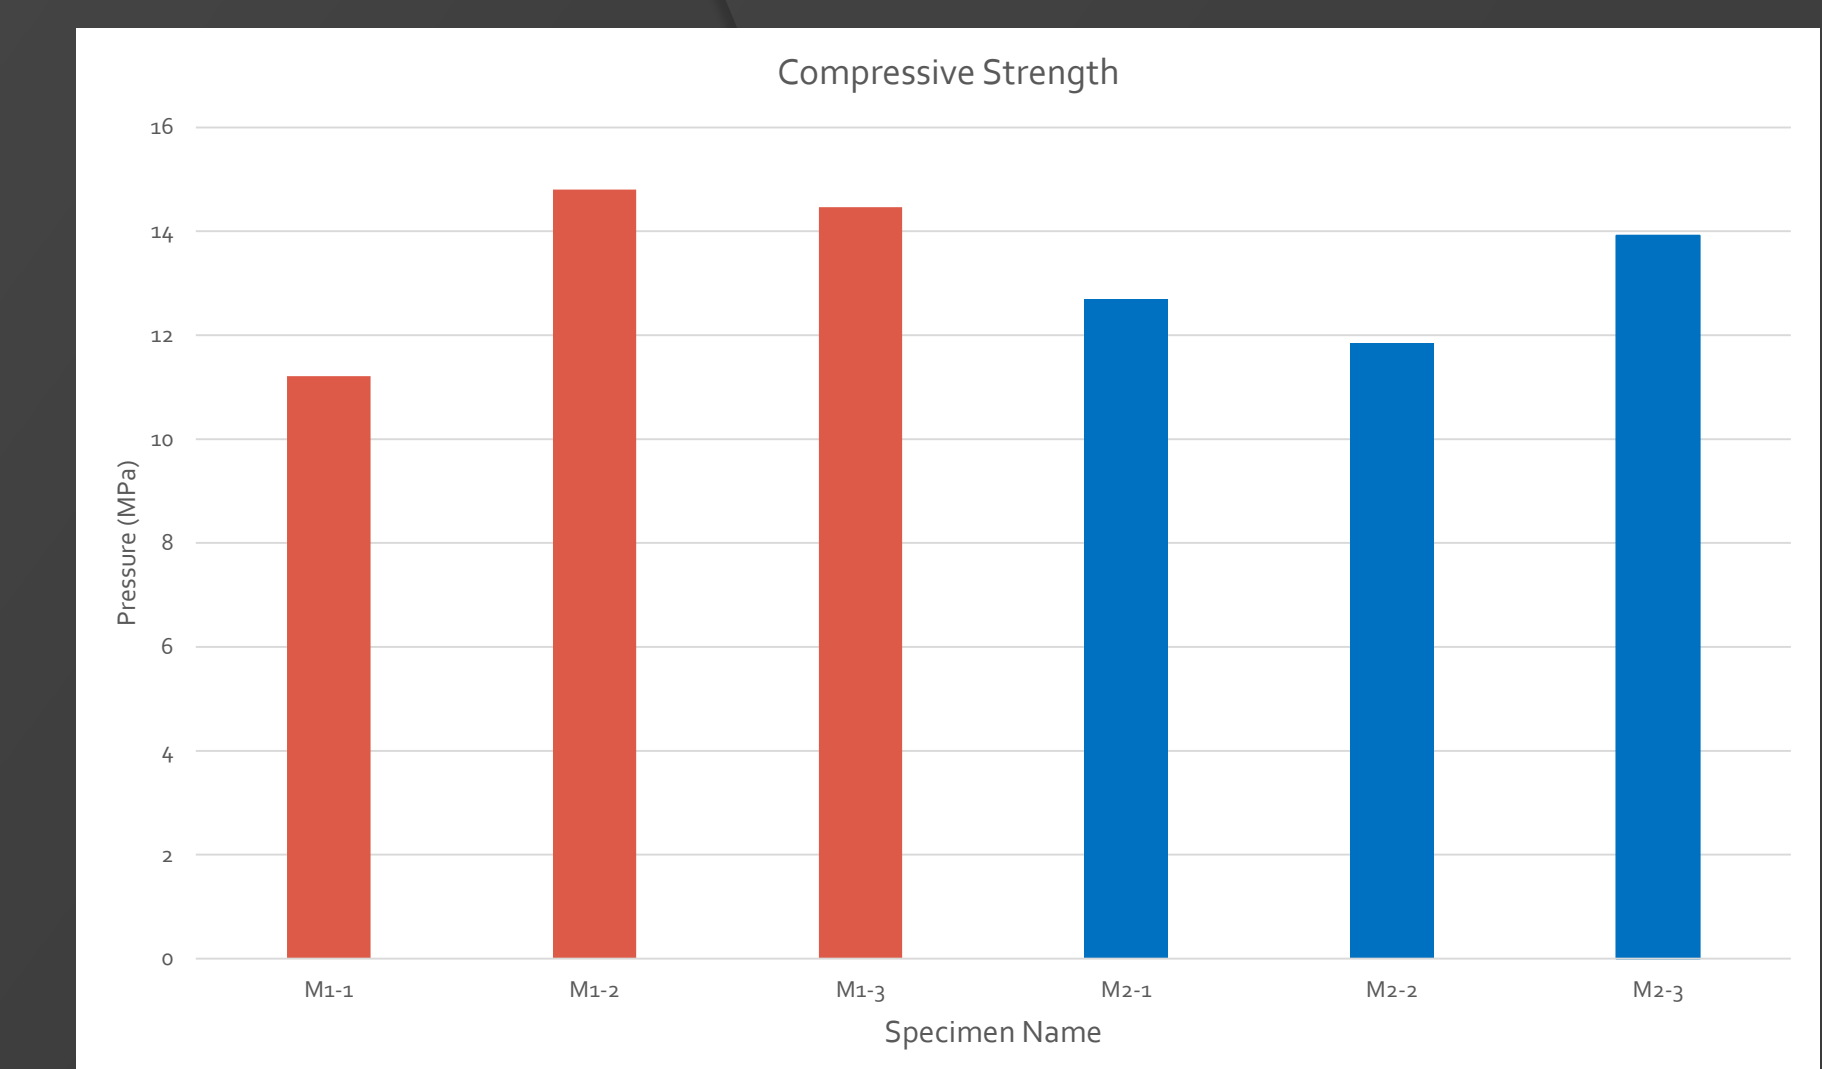
Fig. 8: Compressive strength

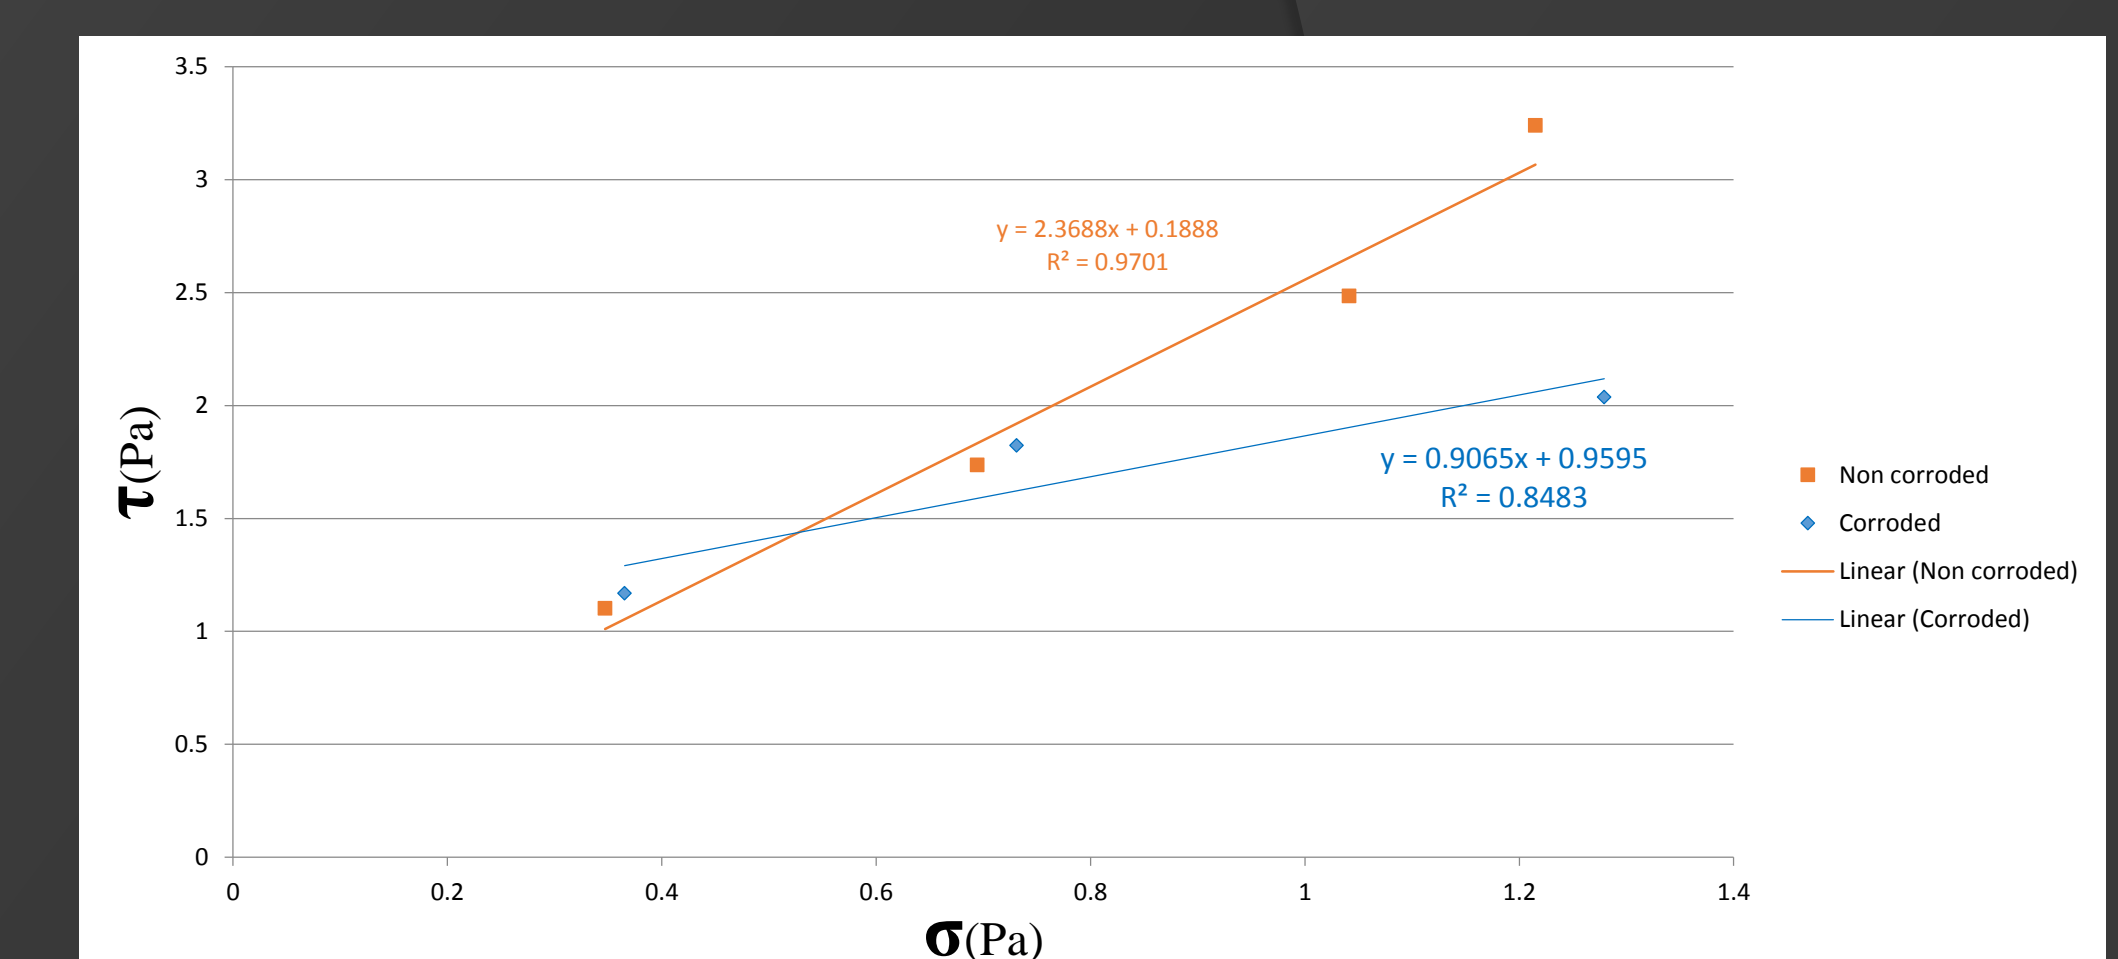
Fig. 9: Normal force versus lateral load

As seen in Fig.9 the corroded samples show a lower coefficient of friction as compared to non-corroded samples. This could be because the steel plates push the concrete away from their surfaces, due to the corrosion buildup (Fig.10) that makes the bond between mortar and steel plates weaker. Having three samples (because sample C failed) does not give us a statistically accurate answer but does mean that this phenomenon needs more research.

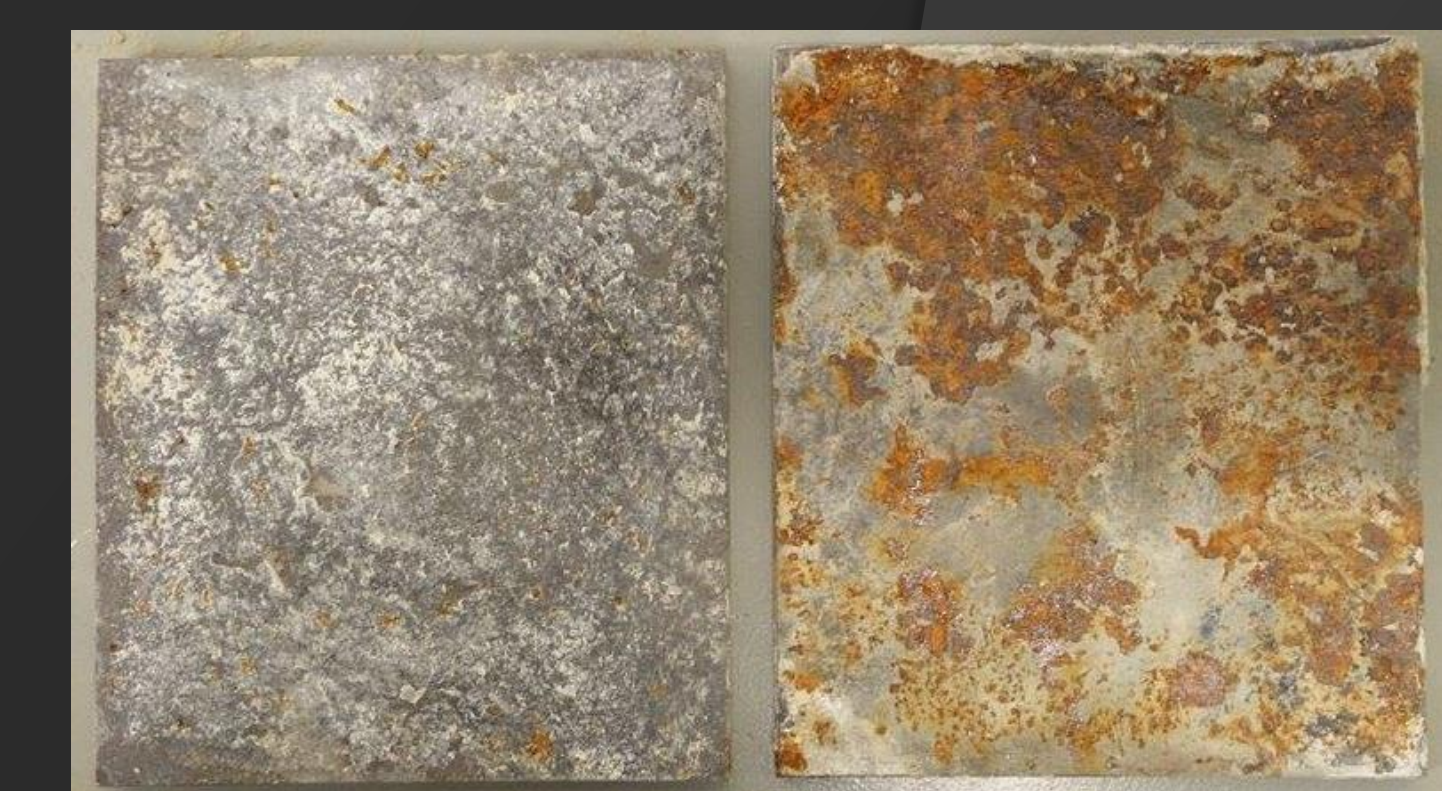
Fig. 10: Steel plate for non-corroded and corroded samples

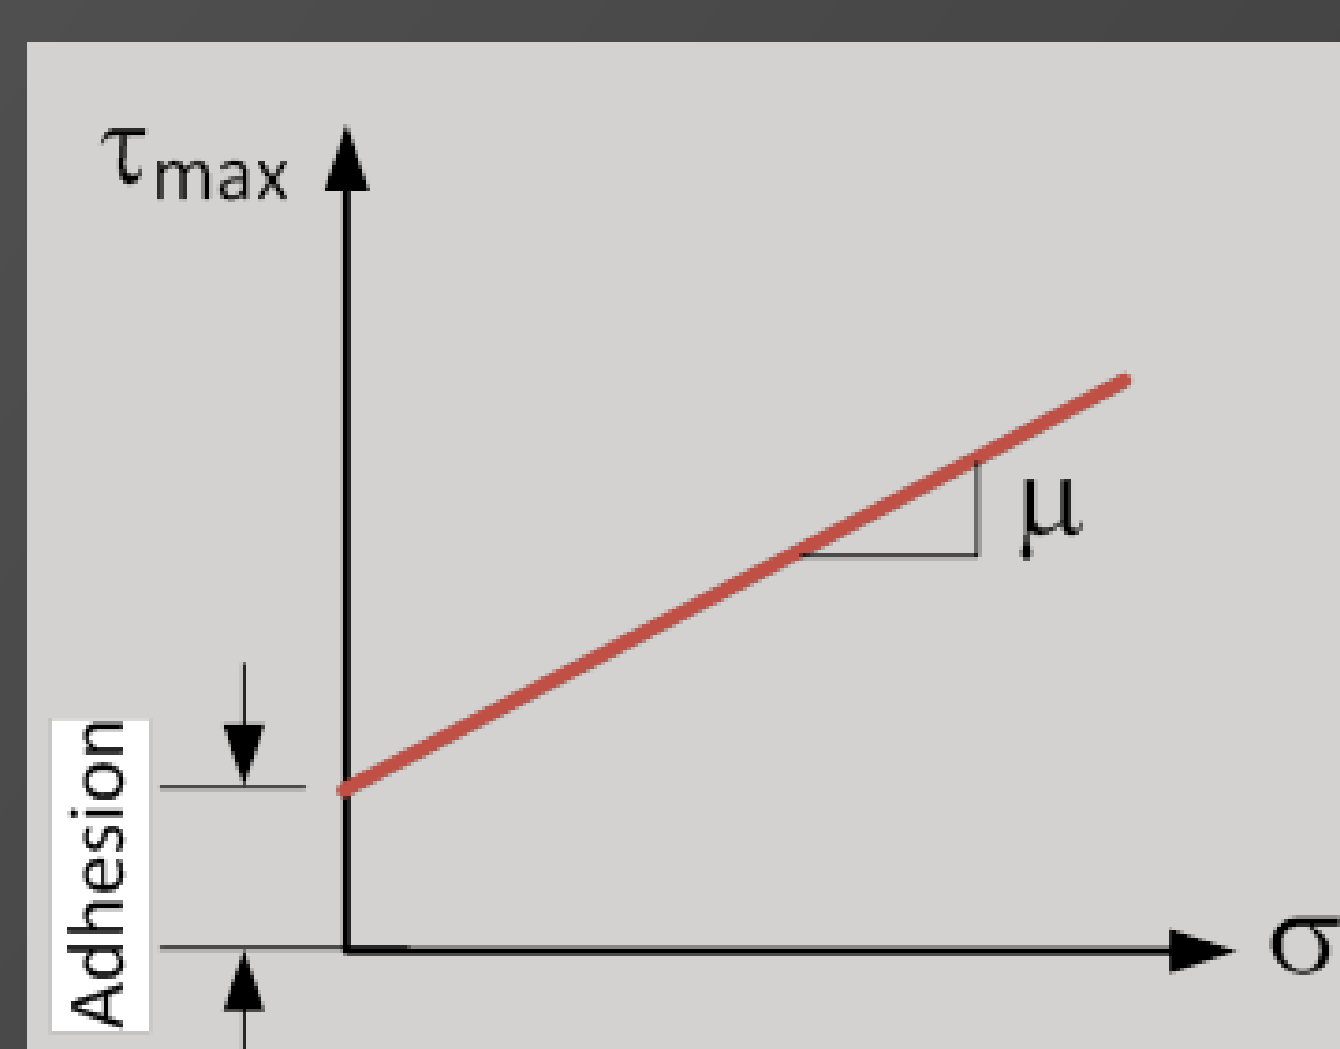
Fig. 2: Tau to sigma graph and the coefficient of friction
