Corrosion Analysis in Concrete

Roch Patenaude, Dr. Beatriz Martin-Perez
Civil Engineering

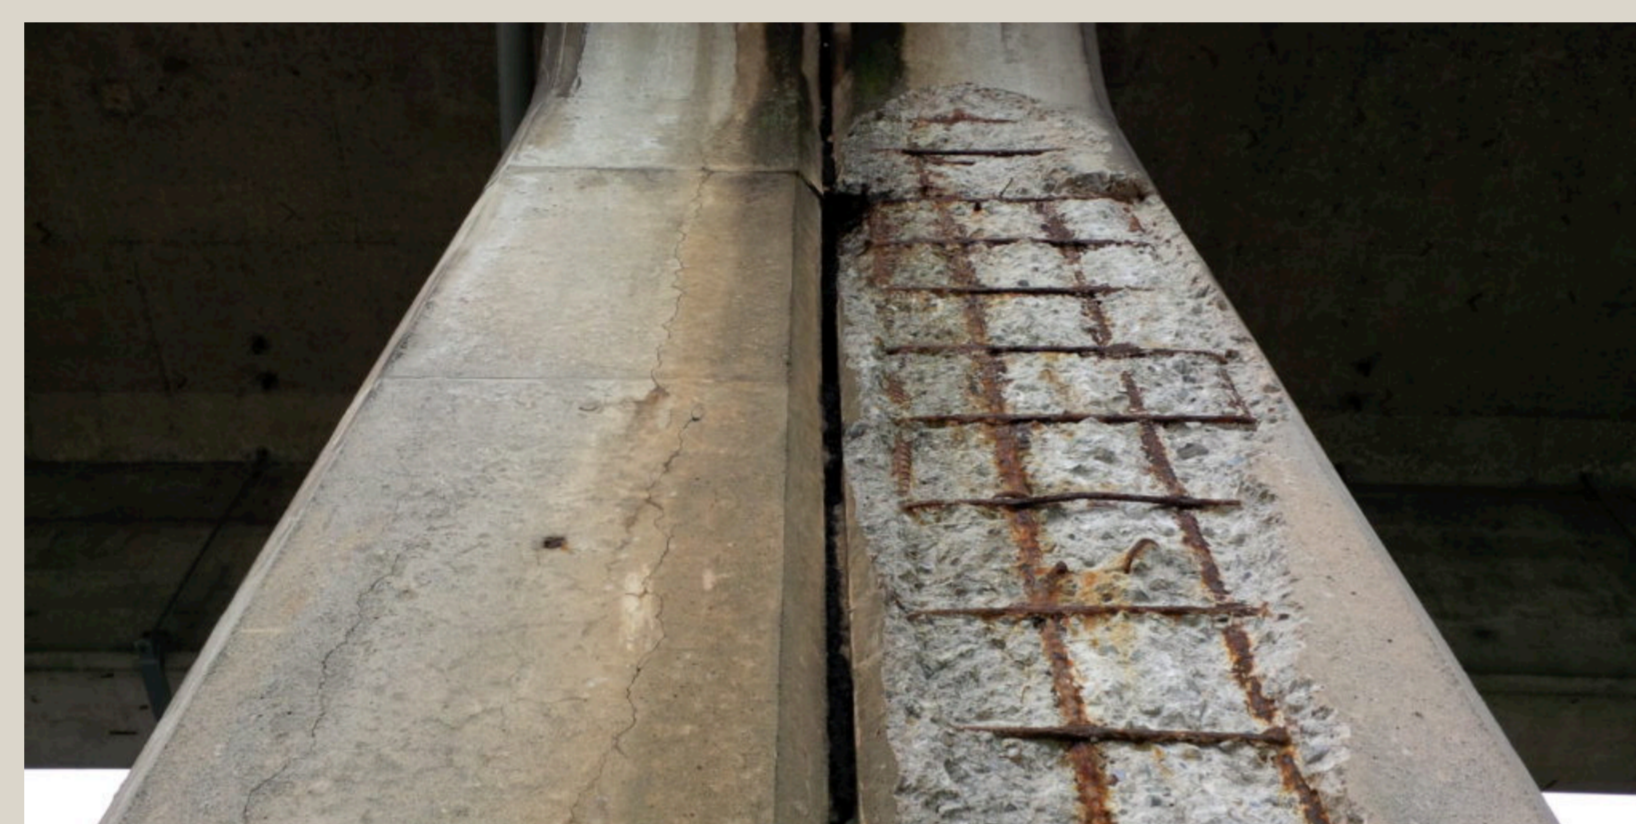
Fig. 1: Corroded reinforced concrete member

Reinforcing steel corrosion is one of the main degradation causes for reinforced concrete. The rust created by the corrosion causes the rebar to occupy more space within the concrete. This phenomenon creates tensile stresses which causes the concrete to crack. With a greater number of voids, it is then even easier for foreign elements to penetrate the concrete cover and cause the steel to further corrode.

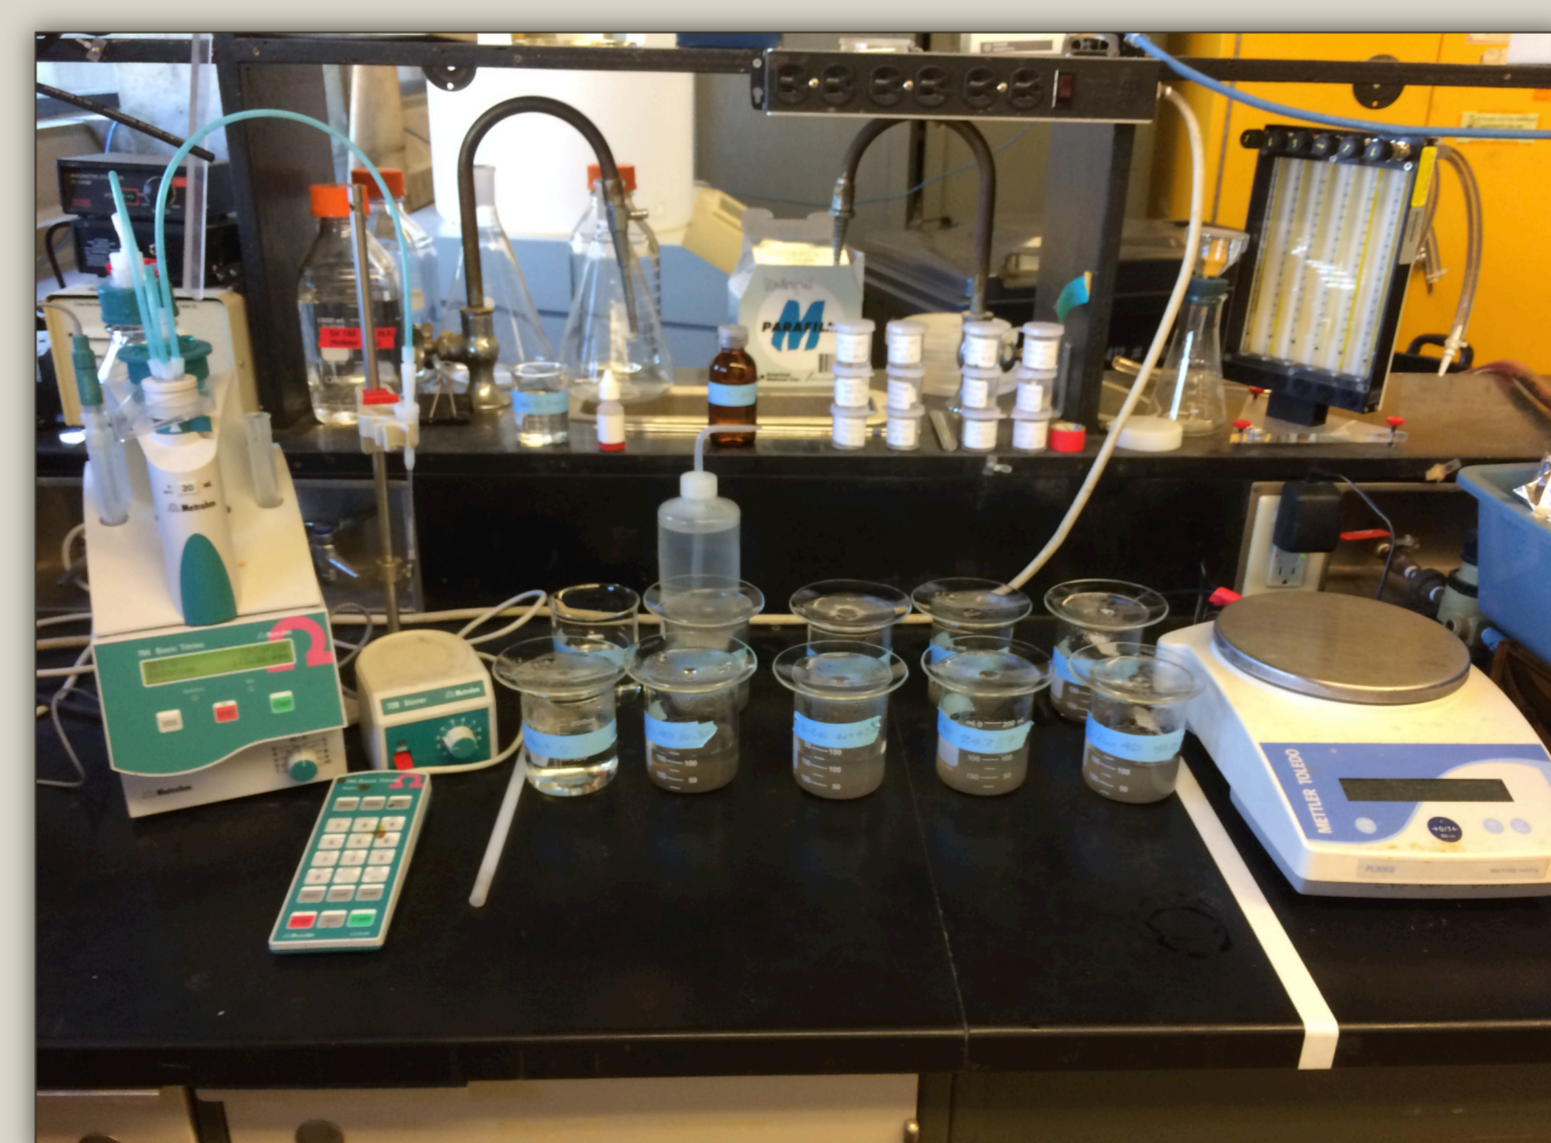
Fig. 2: Titration testing of the chloride samples using the 794 Basic Titrino.

Various types of concrete cylinders were submerged in a chloride solution for multiple weeks before being grinded into concrete powder. These powder samples were extracted at gradual depths in order to conduct chloride titration to determine the chloride penetration front.

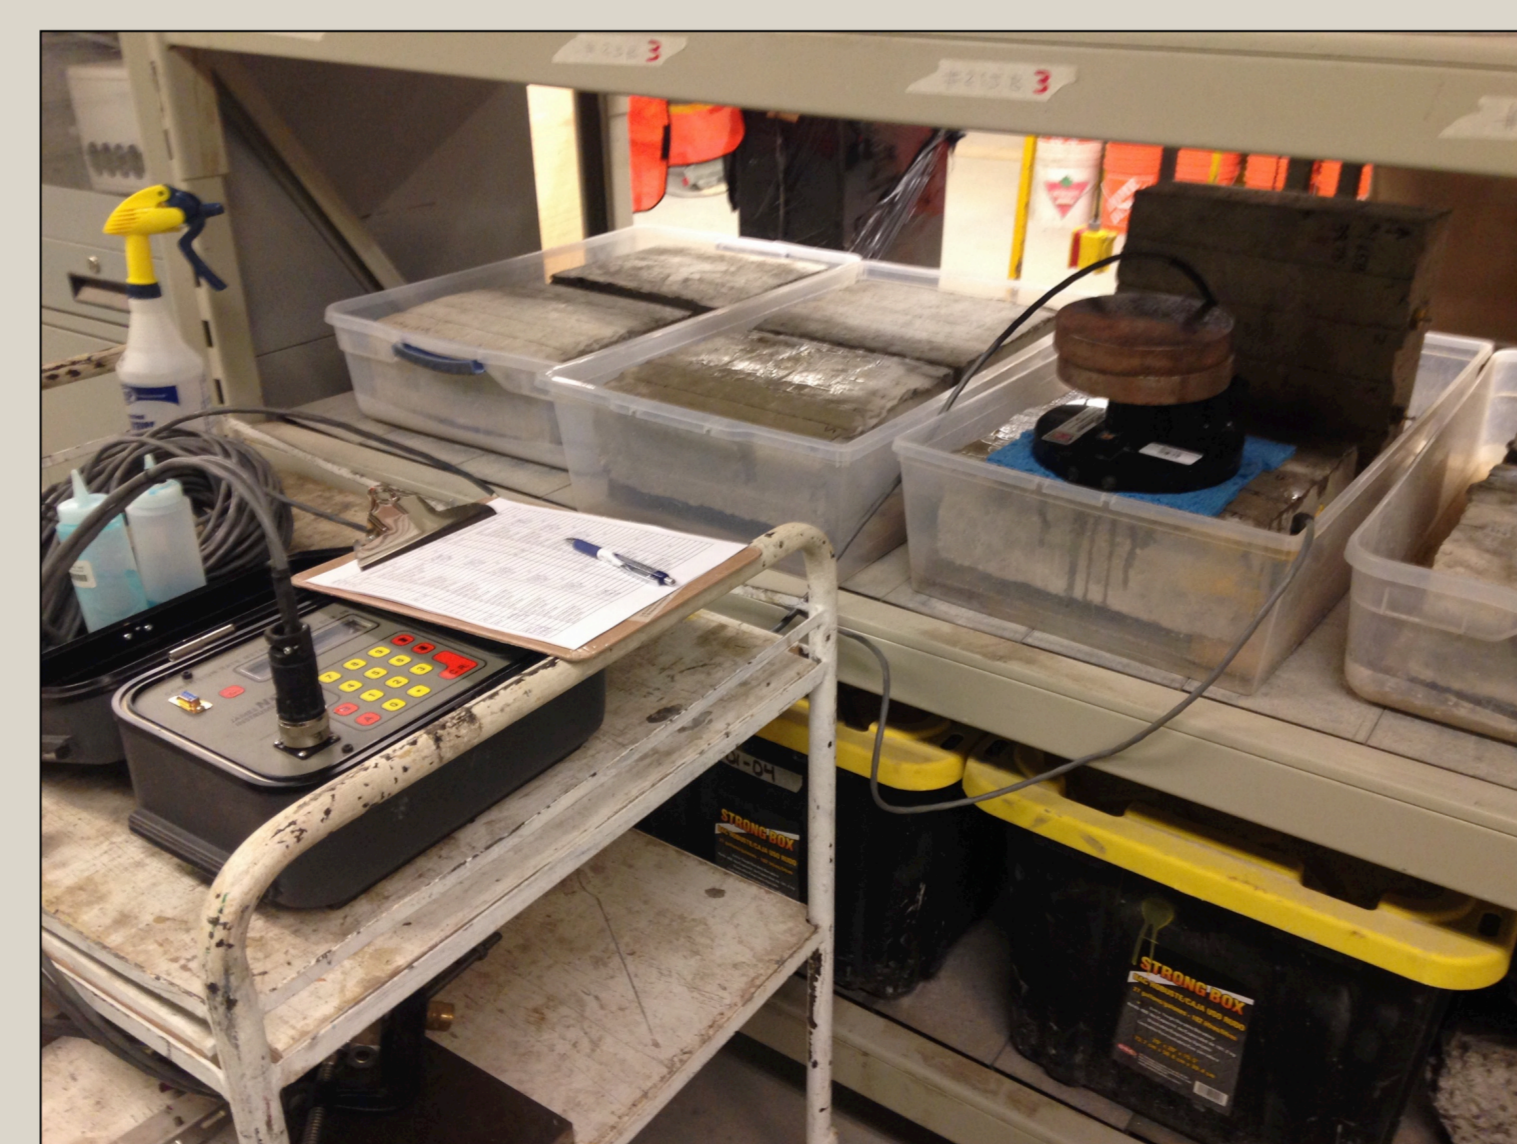
Fig. 3: Corrosion rate testing with the Gecor sensor.

Various types of concrete slabs were submerged in salt water to simulate a 100% humid environment. The slabs were then tested weekly with electric sensors to record the rate at which the corrosion was progressing through the rebar. The final mass of the rebar was then compared to the initial mass to determine the complete mass loss due to corrosion.

The Gecor device displays the following values once the recording is finished:

- The corrosion rate ($\mu A/cm^2$),
- The corrosion potential (mV),
- The electric resistance ($K\Omega$),
- The error obtained, if present.

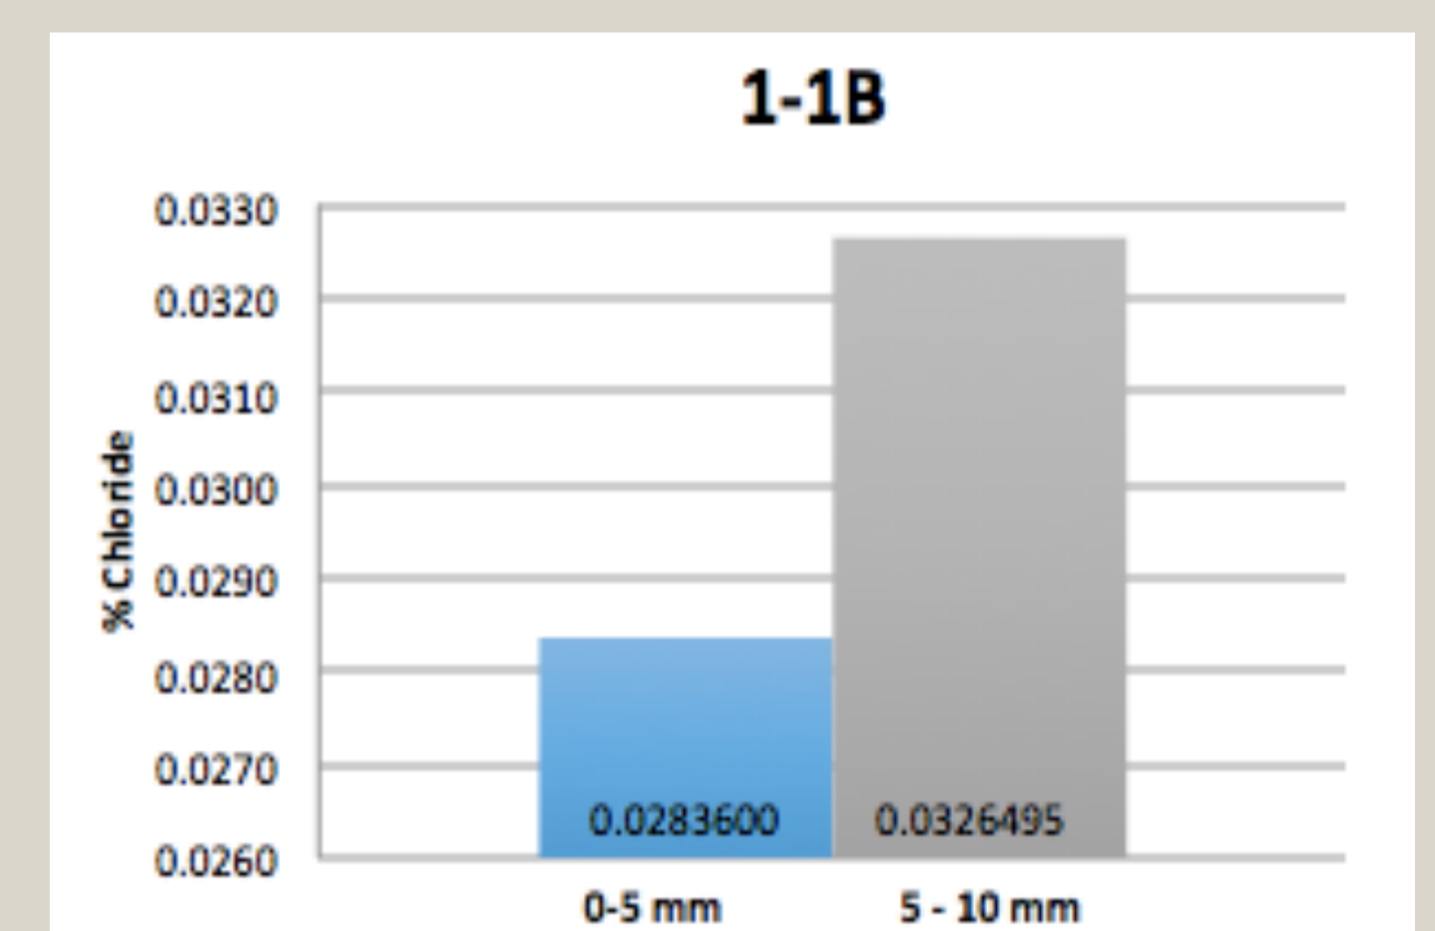
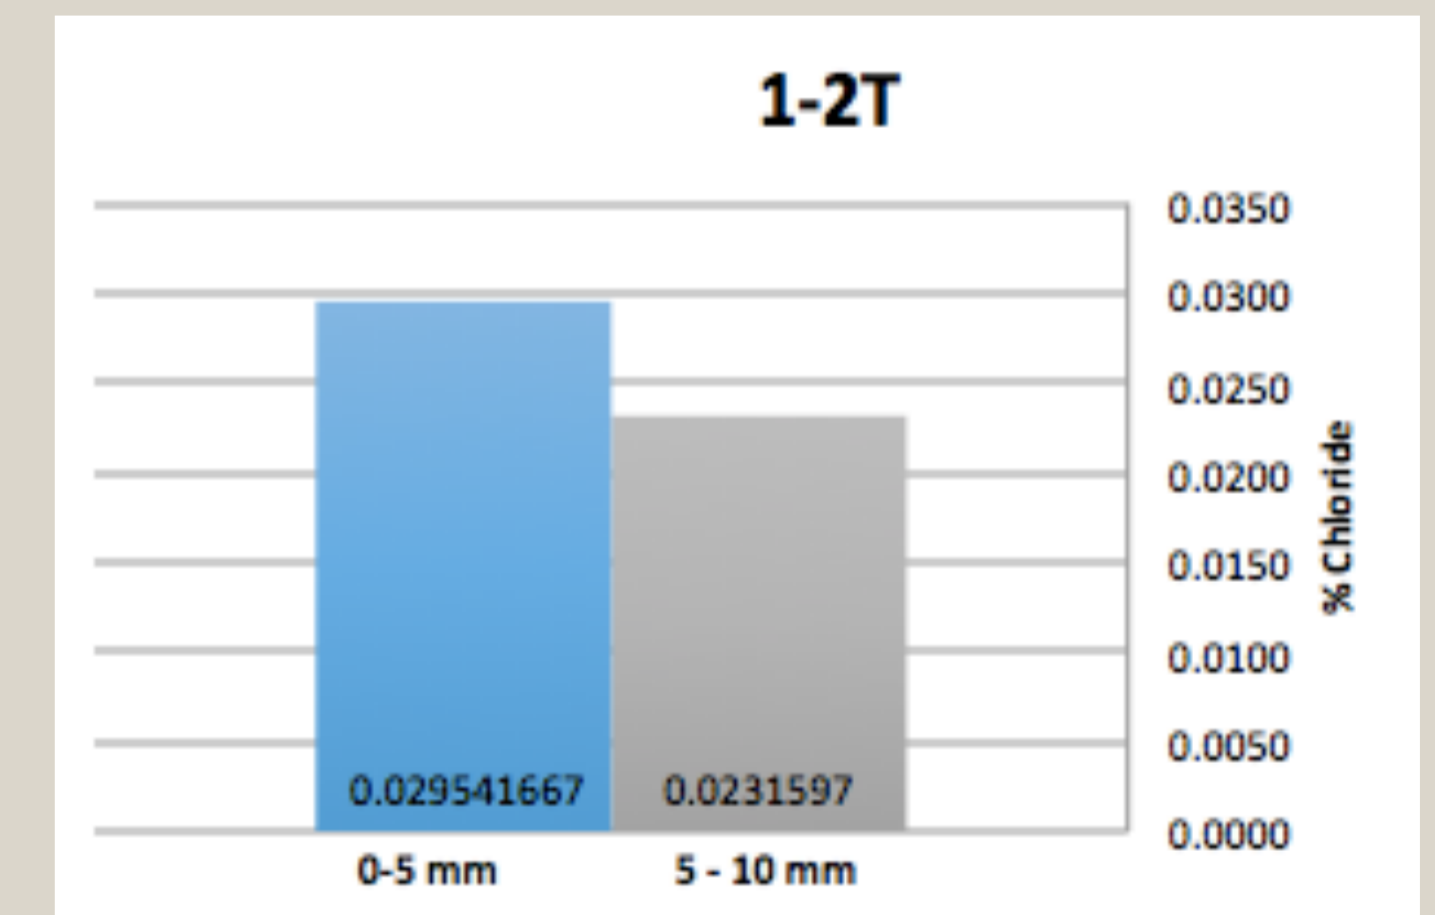
Fig. 4: Chloride profiles.

Among the 53 samples tested over the last 4 months, the majority have chloride percentages ranging from 1% to 4% by mass of concrete. Approximately 5 samples had faulty results either caused by faulty samples or experimental errors.
