Performance Requirements for Climate Resilience of Residential Roofs

A thesis submitted in partial fulfillment of the requirements for the
degree of M.A.Sc. in Civil Engineering

Department of Civil Engineering
Faculty of Engineering
University of Ottawa

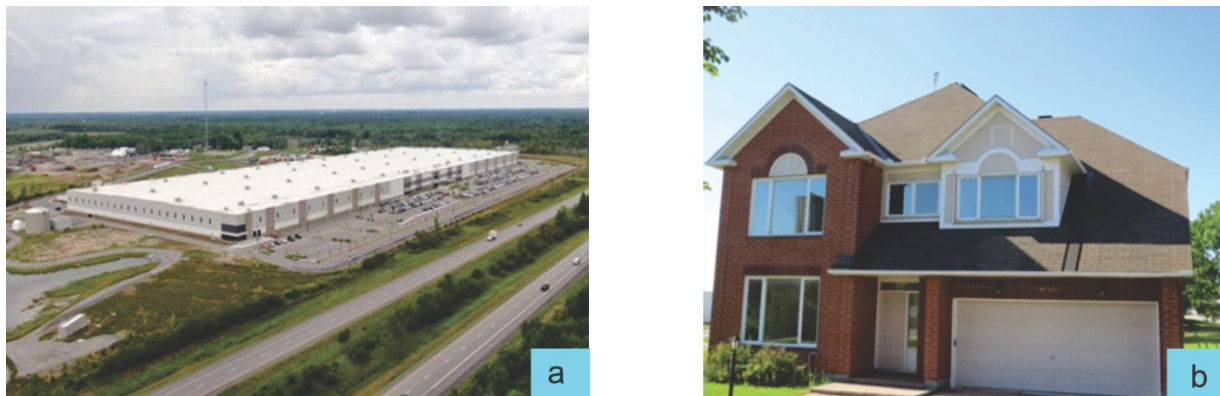
Figure 1. 1 (a) Low slope roof [3]and (b) steep slope roof [2]

The Institute for Catastrophic Loss Reduction (ICLR) reports that residential houses are less engineered and more prone to damages during severe winds [1]. Therefore, this thesis is focused on the most exposed element of a residential house, which is the roof covering. Steep slope residential roofs composed of asphalt shingles were selected due to their large popularity as a roof covering [2]. Also, there is a lack of guidelines for increasing their resistance against extreme winds. Roofs are mainly classified as low slope roofs, such as those typically used for commercial buildings and schools (Figure 1.1 a), and steep slope roofs used in residential houses (Figure 1.1 b).

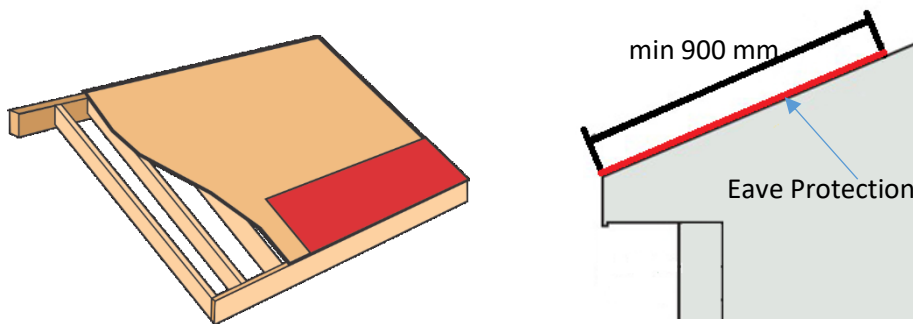
Figure 2. 8 Eave installation on a steep slope asphalt roof on top of the deck

Once the wood deck is installed, the eave protection is installed (Figure 2.8). This assists in keeping the roof free of leaks and ice dams (Figure 2.9) which can form when there is poor ventilation and loss of heat from the attic [2]. The melted snow on top of the roof freezes once it reaches the edge of the roof.

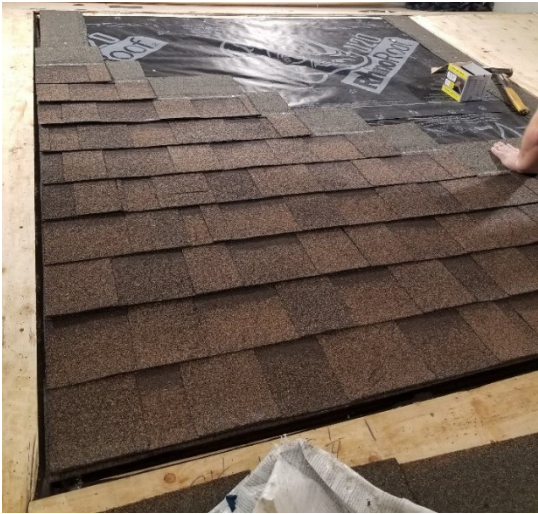
Figure 2. 14 Shingle Installation for mock-up construction at the University of Ottawa

All the layers need to meet a certain performance quality for a successful shingle. The shingles are layered on top of each other as shown in Figure 2.14.

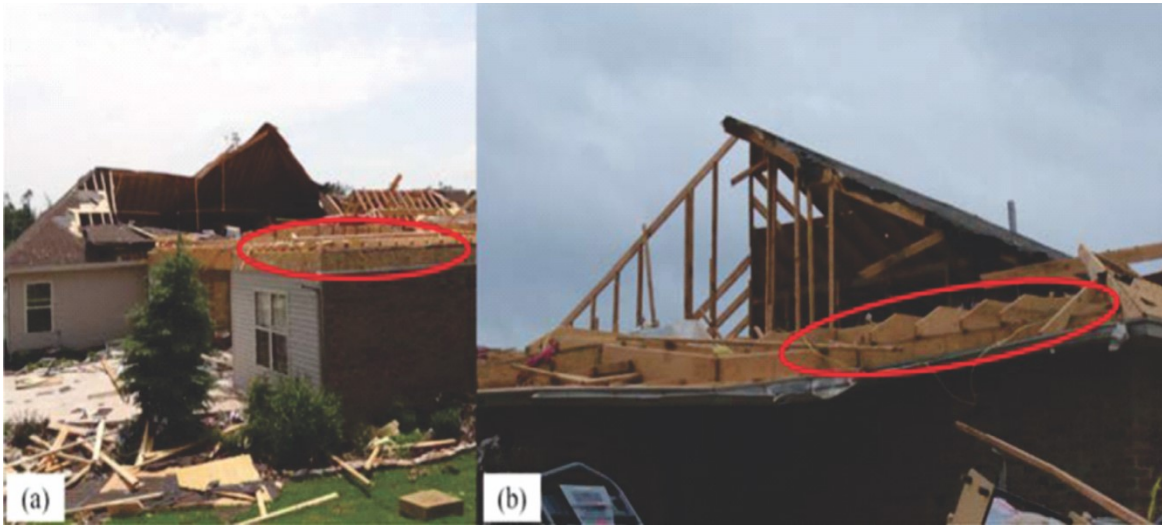
Figure 2. 21 Example of structural failures of roofs where the roof assembly was blown away [20]

In the case of a roof structural failure, the entire assembly is blown away, as shown in Figure 2.21. In this figure, the weakest link is the roof-wall junction. In Figure 2.22 the connection between the deck sheathing and the structural frame failed, and the deck was blown away along with the shingles and underlayment. This exposes the house's interior to external climatic conditions and hence increasing the severity of the damages [20].

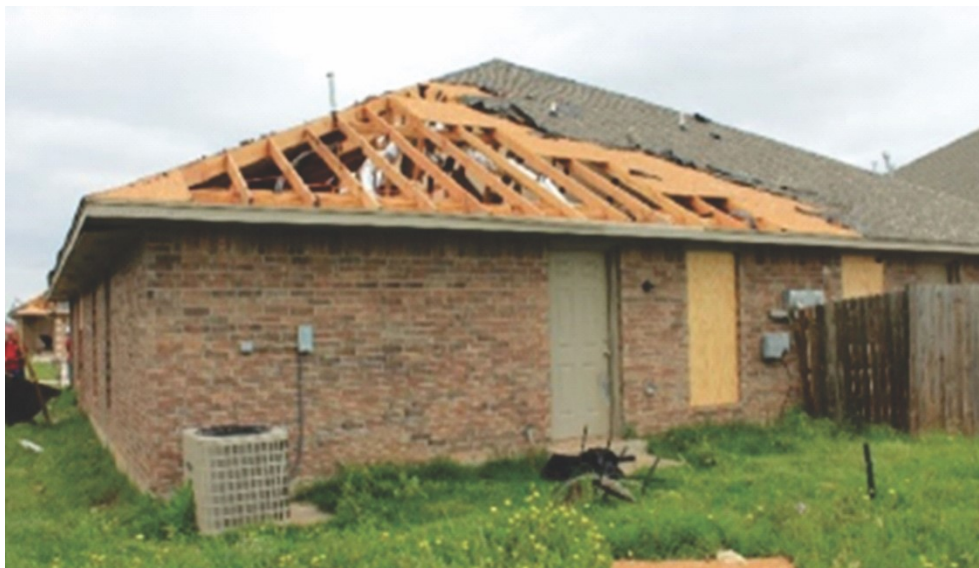
Figure 2. 22 Example of structural failure of the roof where the deck sheathing was blown away [35]

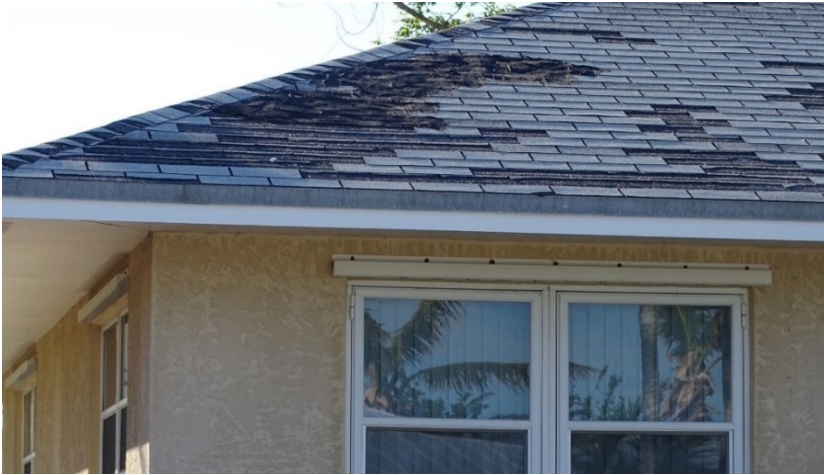
Figure 2. 23 Example of shingles blow off after a wind event in Ottawa 2020, [36]

In the case of roof covering failure, the deck sheathing remains attached to the structural frame. However, the roof coverings are blown off from the deck. An example of this type of failure can be seen on a roof located in Ottawa, Ontario [36] where the shingles were blown off during a sudden wind event in the summer of 2020 (Figure 2.23). In this scenario, the interior is still protected from water ingress by the underlayment, if it is installed underneath the shingles. Shingle failure analyses highlights the attachment of the shingles as the weakest link.

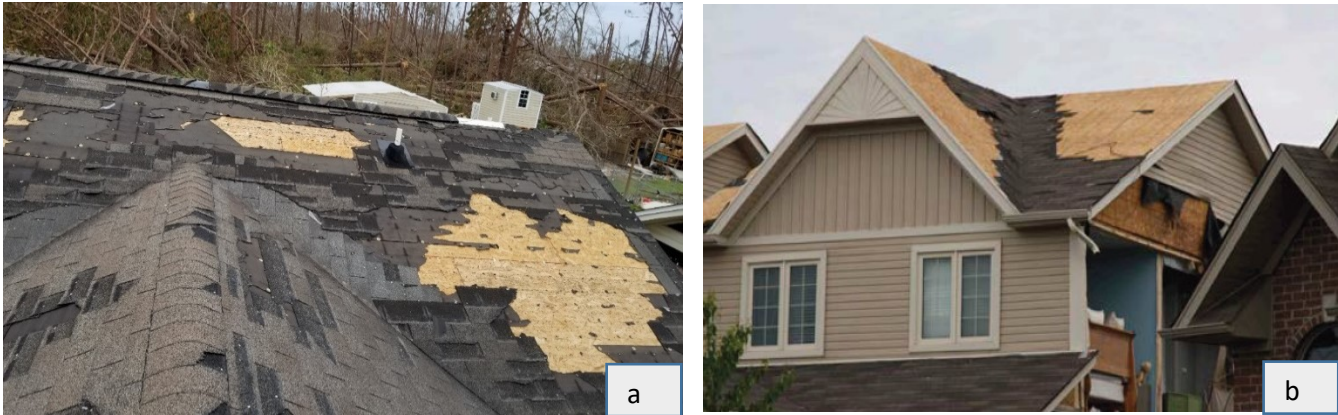
Figure 2. 24 Shingle blow off with peeled underlayment after a wind event in Ottawa 2020 [36] (a) and Angus [4] (b)

However, there are cases where the underlayment was also blown away along with the shingles as shown in Figure 2.24. The sheathing was exposed to weather elements, increasing the risk of water infiltration and damage and mold growth.

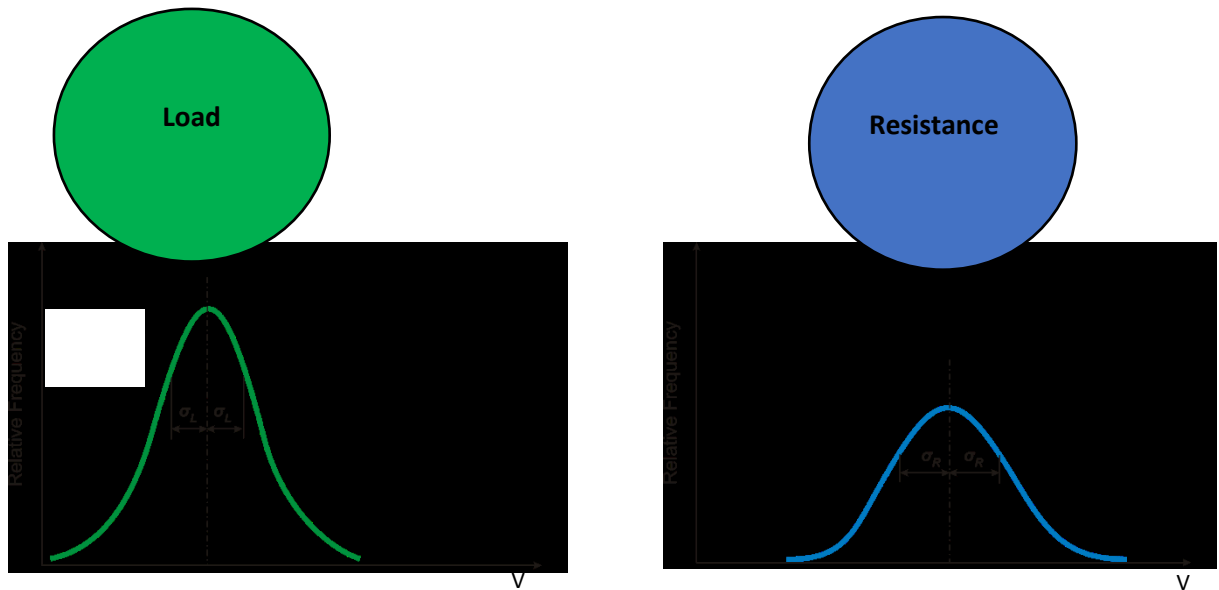
Figure 3.8 Gaussian distribution for load and resistance [57]

In a Gaussian distribution, the values of the mean, median, and mode are the same as represented by the dashed line in the middle of the distribution curve (Figure 3.8).

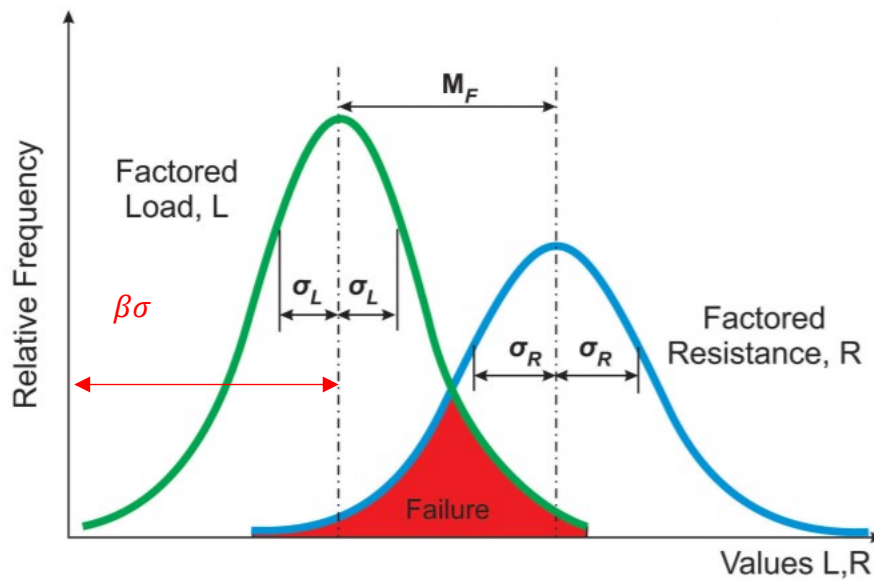
Figure 3.9 The LRFD approach [57]

The area underneath each curve of the Gauss distributions represents the total probability of 100%. By assuming the distribution of the load and resistance as known, the distribution of the difference between the two values can be found as the failure area highlighted in red in Figure 3.9, indicating that the difference between the resistance and the load is negative for this part of the curve. The term β on the graph (Figure 3.9) represents the reliability index and a larger value will correspond to a higher safety zone for the considered design equation [56].

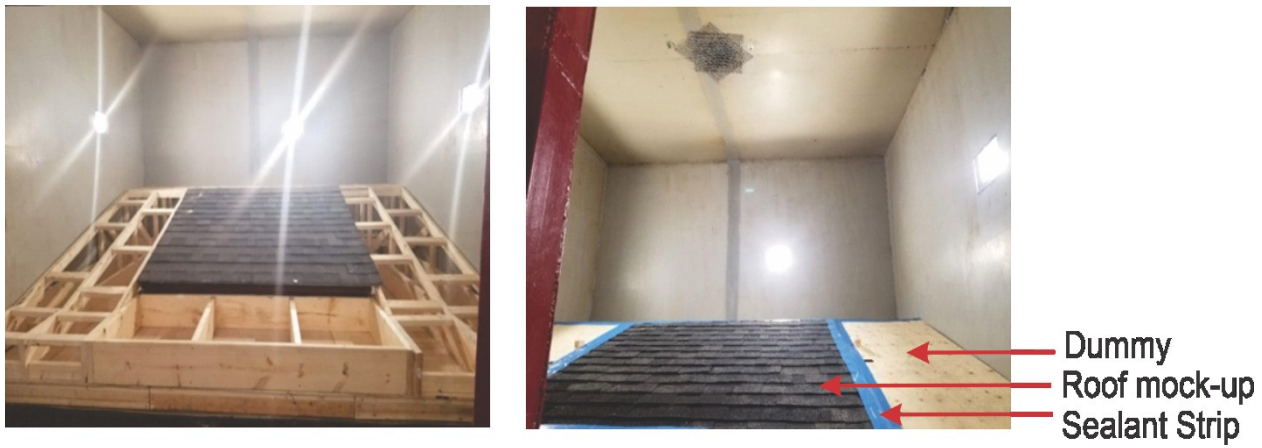
Figure 4.17 Mock-up setup in Wind damage simulator

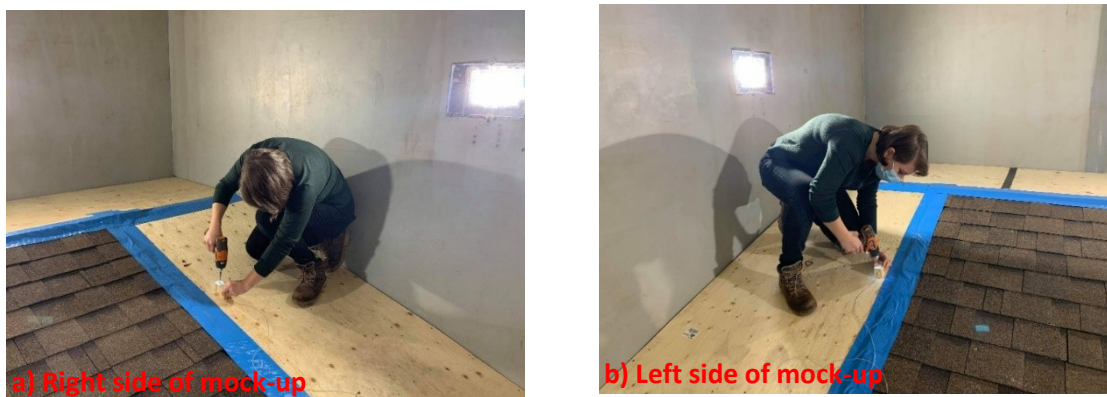
Figure 4.19 Installation of pressure taps near the mock-up

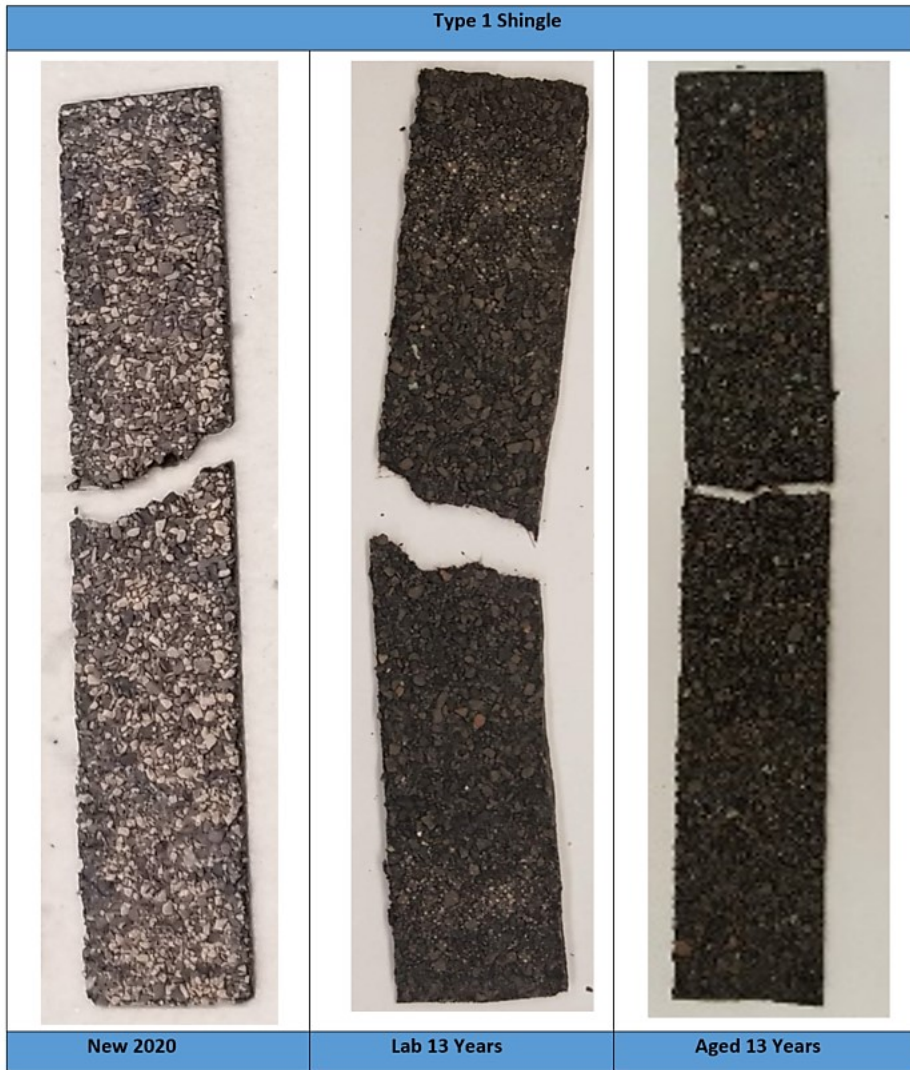
Figure 5.3. Type 1 tensile strength failure modes for MD direction

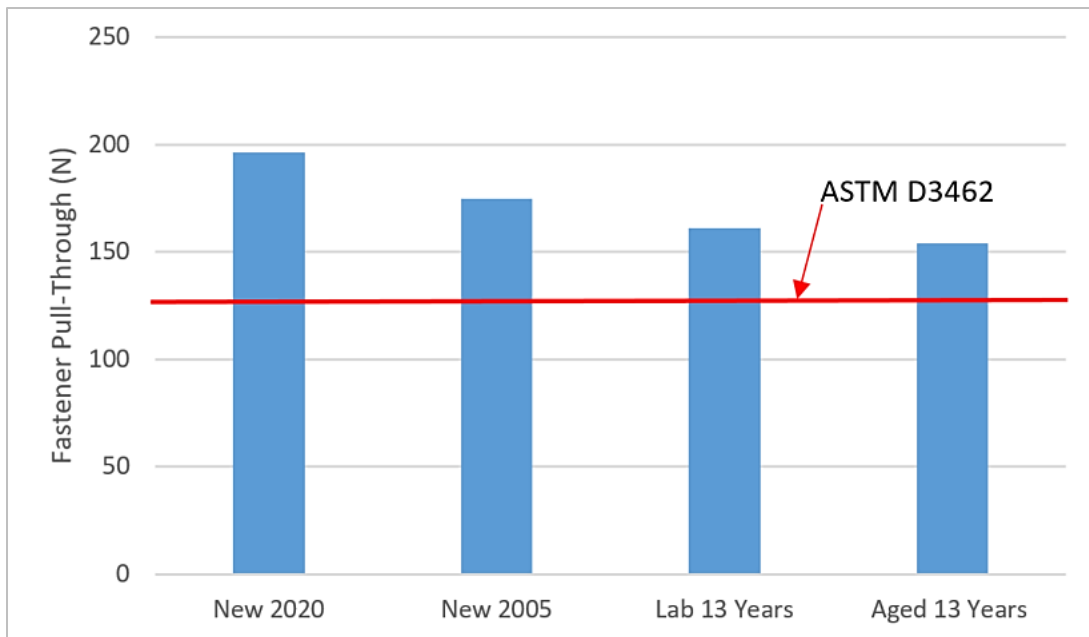
Figure 5.10 Type 1 fastener pull-through resistance evaluation results

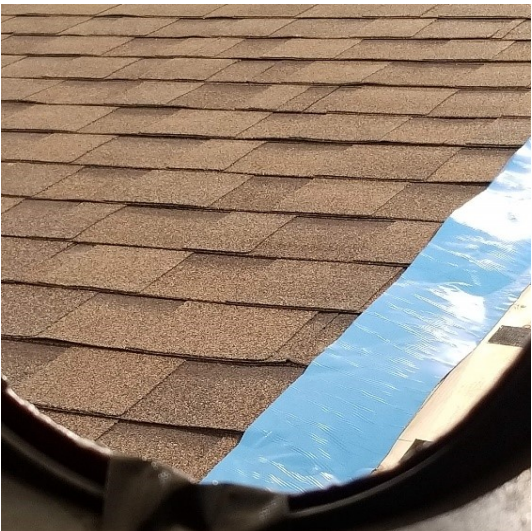
<p>a)</p>

<p>Step 1 for “New Field 2020” mock-up testing. No movement was observed throughout this test phase until the end of the 30 minutes when very light fluttering among the shingles was observed.</p>
<p>b)</p>

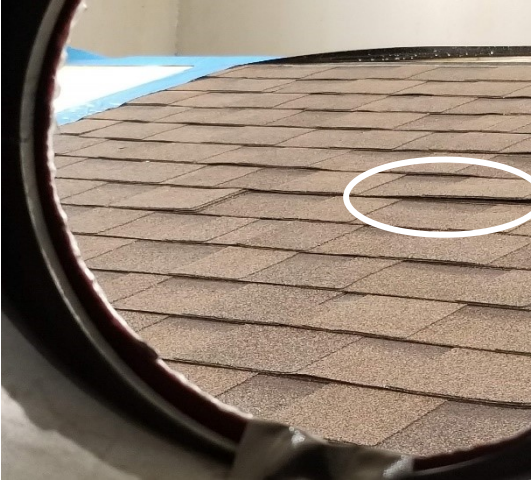
<p>Step 2 for “New Field 2020” mock-up. Light fluttering was observed.</p>

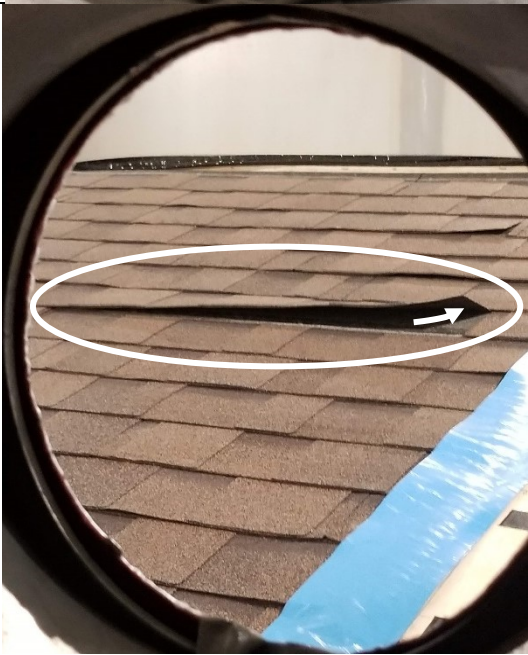
<p>Step 4 for “New Field 2020” mock-up. Lifting and curling were observed due to the disengagement of the sealant which occurred in Step 3. At this step the curling and lifting would periodically return to the original position</p>
<p>e)</p>

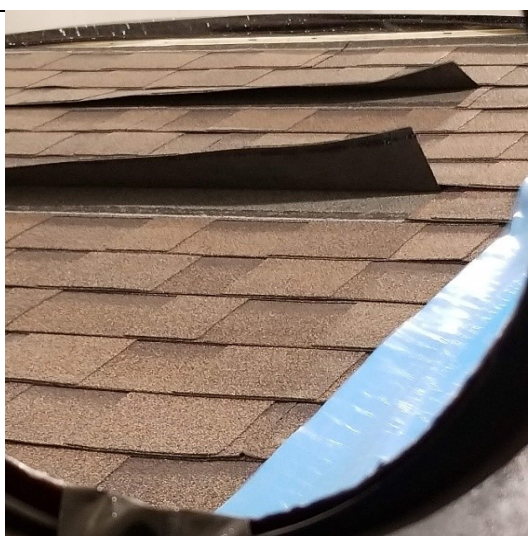
<p>Step 5 The first shingle row lifted in the picture is minimizing the uplift force experienced by the second lifted shingle row hence its lifting being slightly lower. Test failed due to disengagement of the sealant and a permanent movement from the original position of the shingles was observed.</p>

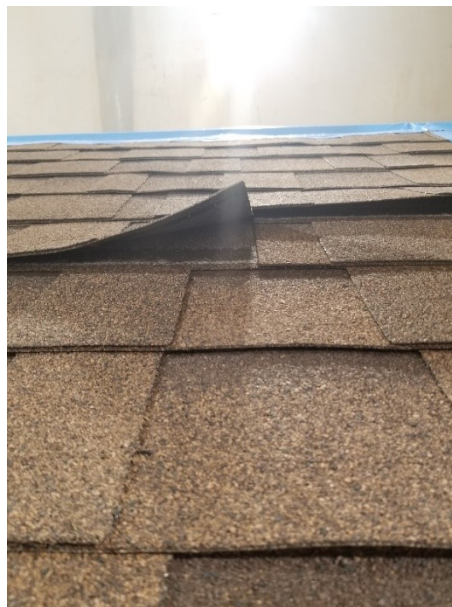
Figure 5.16 Failure mode for the tested “New Edge 2020” mock-up

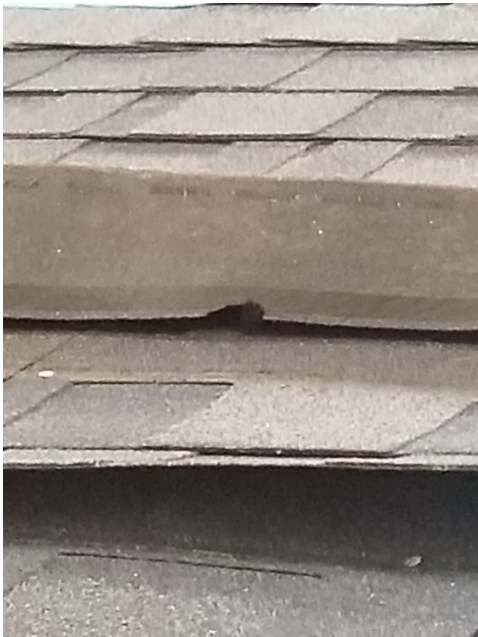
Step 4 "Aged Field 2005" mock-up. Broken shingle. Failure modes 3 and 4. Test failed.

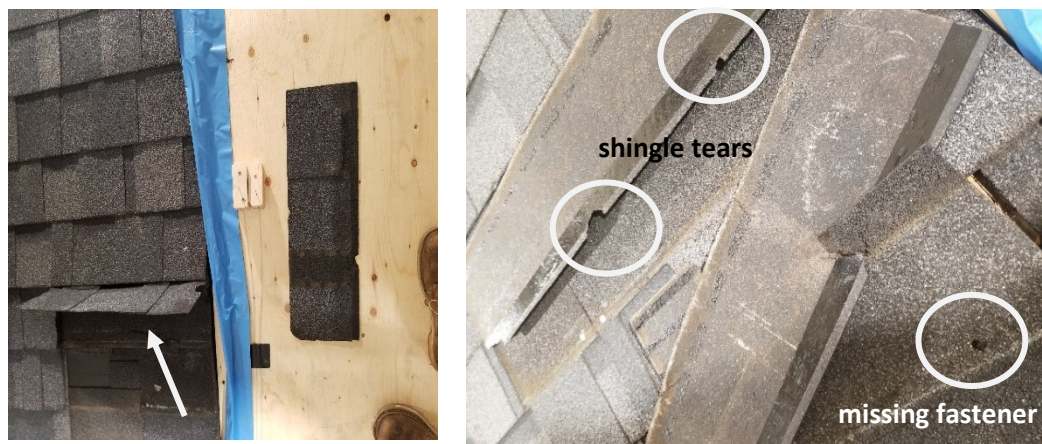
Figure 5.18 Field zone failure mode observed at the end of the test (Failure Mode 1,3,4)

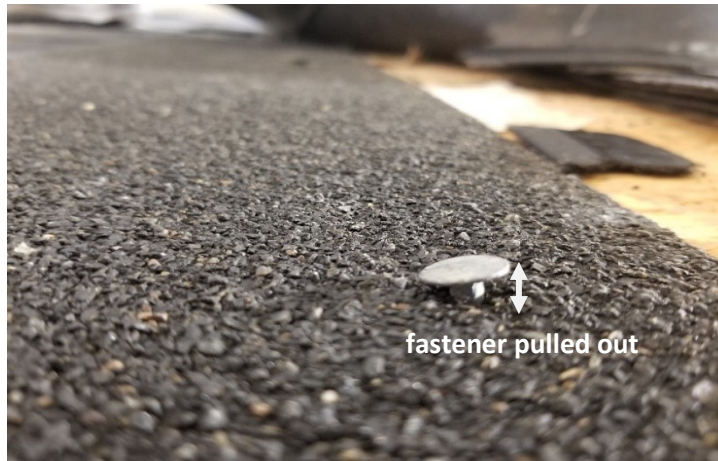
Figure 5.19 Fastener lifted from the shingle (Failure Mode 2) of the field zone mock-up

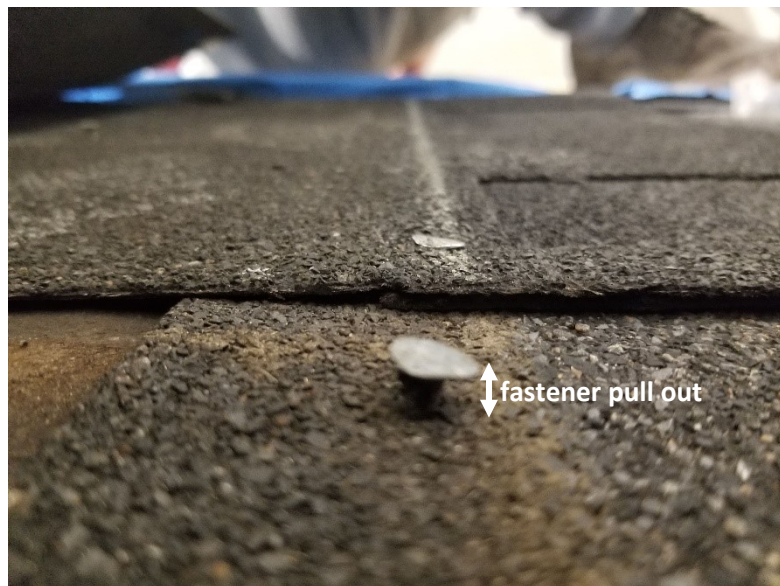
Figure 5.21 Fastener pulled out from deck and shingle tearing around fastener (Failure Mode2)
