INVESTIGATION OF DAM FAILURES

Samar Chatterjee

Submitted in partial fulfillment of  
the requirements for the degree of  
Master of Applied Science

December 1970

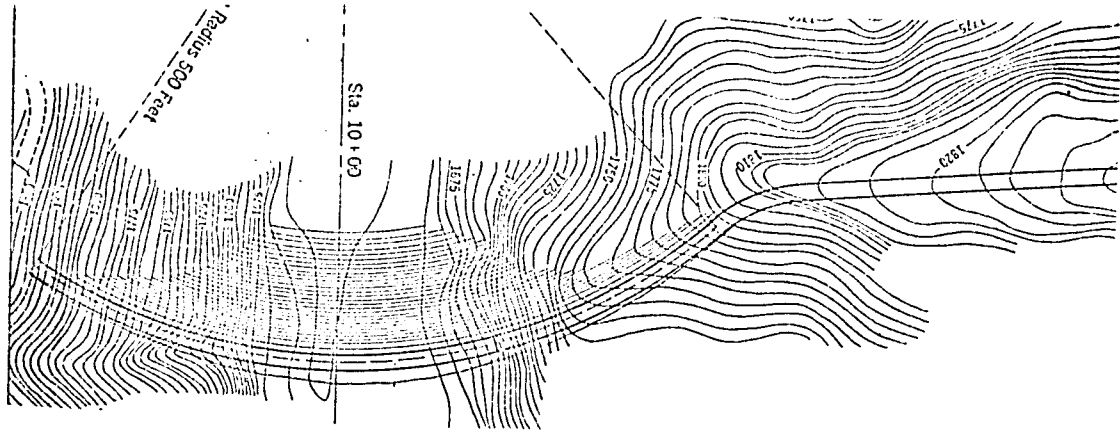
FIG. II (b) PLAN OF THE SAINT FRANCIS DAM. SOURCE: REPORT OF ASCE COMMITTEE (REF. 64)

The investigation of the failure disclosed that a deep slide had occurred at the left abutment eroding the schist to a depth of 40 feet, whereas the conglomerate in the right abutment eroded only about 30 feet. The slip surface at the left side was active up to two weeks after the catastrophe.

During the investigations, it was also pointed out that the structure suffered from several deficiencies. No foundation cut-off was provided below the upstream face. Nevertheless a small key wall had been inserted along the right abutment. There was neither any grouting done

in the foundation nor had there been any provision for foundation drainage for the relief of uplift pressure. In fact, leakage of water at the dam base was noted during the first filling of the reservoir. Unfortunately this warning was also ignored. Later, the leakage substantially increased and a few weeks before the failure drains had to be installed beneath the right abutment. The above discussion shows that many observations, made prior to the final breaching of the Saint Francis Dam, indicated the possibility of a disastrous failure; yet the symptoms observed were not taken very seriously. Obviously, inadequate understanding of the implications of the observed data could be blamed for the catastrophic failure. Since then considerable research effort has been directed to the development of a methodology for systematic analysis and observation of dams and reservoirs. Lately, Serafim and Guerreiro<sup>(45)</sup> have thus shown that a successful observation of dams is possible with a team of skilled experts.

- (1) The weaknesses inherent in the foundation was the cause of the dam failure;<sup>(47,58,59)</sup>
- (2) concrete in the dam was quite satisfactory;
- (3) Pasadena seismograph records revealed that an earthquake was not responsible for the failure;
- (4) gravity dams built on proper foundation cannot be considered unsafe;
- (5) state supervision over design, construction and operation of dams was considered a necessity for future safety.

that water penetration had undermined the rock beneath the dam. According to Turner (66) injection of neat cement grout into the underlying foundation material at a pressure almost double of the full reservoir head could have saved the dam. Unfortunately grouting was never resorted to. The presence of pores and crevices in the foundation material is potentially dangerous on account of the possibility of water percolation under a high head, into these empty cells, that develop an appreciable pore pressure. This would seriously weaken and undermine the strength and stability of the underlying material. It was, therefore, necessary to prevent the occurrence of such a situation by grouting.
