# **Repair and Retrofit of Non-Ductile Reinforced Concrete Frames with Diagonal Steel Compression Struts**

**By  
Frédéric Caron**

Thesis submitted to the  
Faculty of Graduate and Postdoctoral Studies  
in partial fulfillment of the requirements  
for the degree Master of Applied Science in  
Civil Engineering

**Department of Civil Engineering  
Faculty of Engineering  
The University of Ottawa**

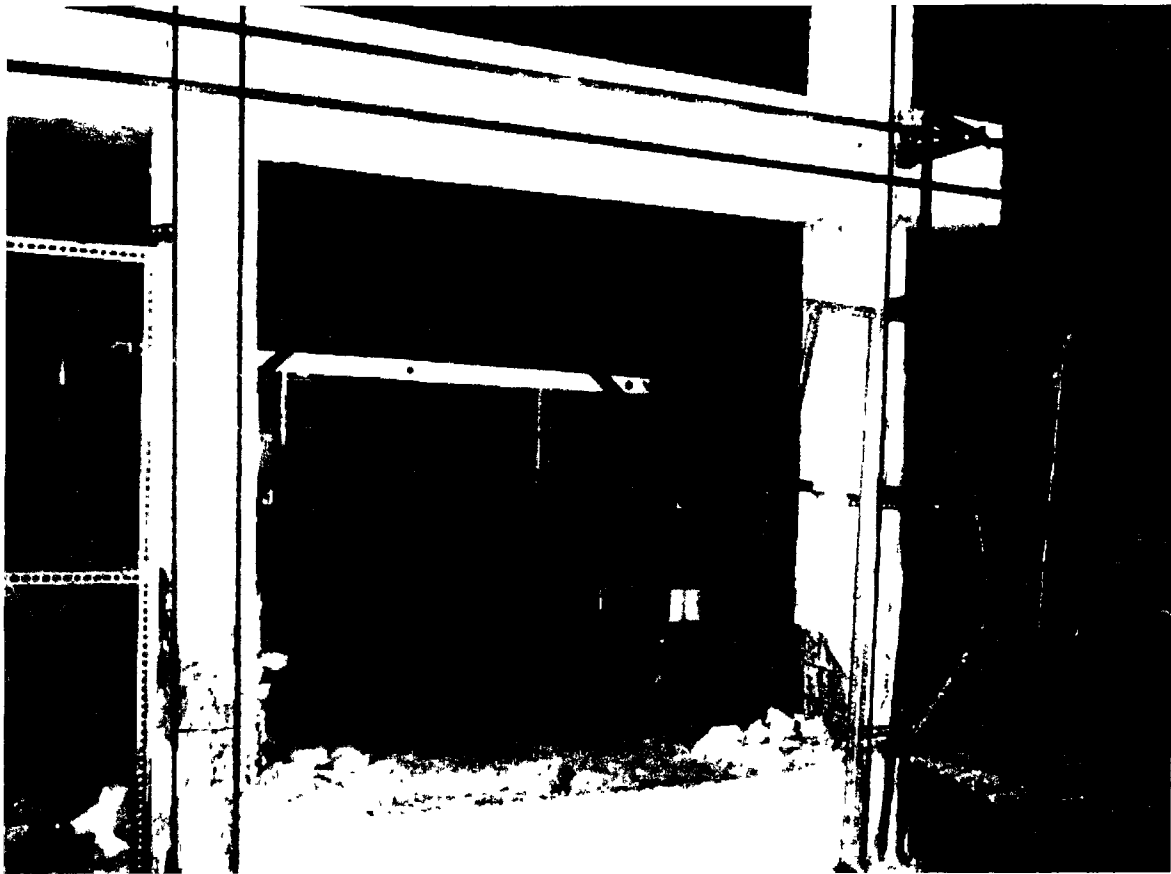
The final load cycle was the thirteenth after displacing to 2.5% lateral drift (50 mm). There were significant differences within the three repetitions in this final load cycle. When the frame was in the positive direction for the first cycle of 2.5% lateral drift, the peak load was 127.1 kN, the out-of-plane displacement was 5.04 mm, the column base anchorage slip measured -5.67 mm, and the vertical displacement of the column was -0.70 mm. In the negative direction, the peak load was -98.5 kN, the out-of-plane displacement was 4.78 mm, the column base anchorage slip measured 6.15 mm, and the vertical displacement of the column was 2.64 mm. When the frame was in the positive direction for the second cycle of 2.5% lateral drift, the peak load was 93.5 kN, the out-of-plane displacement was 6.32 mm, the column base anchorage slip measured -5.26 mm, and the vertical displacement of the column was -0.70 mm. In the negative direction, the peak load was -65.3 kN, the out-of-plane displacement was 5.54 mm, the column base anchorage slip measured 6.03 mm, and the vertical displacement of the column was 2.71 mm. When the frame was in the positive direction for the third and final cycle of 2.5% lateral drift, the peak load was 74.4 kN, the out-of-plane displacement was 5.17 mm, the column base anchorage slip measured -6.51 mm, and the vertical displacement of the column was -0.47 mm. In the negative direction, the peak load was -51.1 kN, the out-of-plane displacement was 5.83 mm, the column base anchorage slip measured 5.62 mm, and the vertical displacement of the column was 2.71 mm. Figure 4.25 displays the frame after the testing was completed. Figure 4.26 shows that there was no increase in the flexural and shear cracks in the columns or beam. As shown in Figures 4.27 and 4.28, failure in Frame BR-3R was controlled by the performance of the columns at the base including deficient reinforcement splice lengths. Furthermore, after the concrete had spalled at the splice locations, the longitudinal reinforcement was significantly bent under the lateral loading. Table 4.1 summarizes the experimental results of the repaired frame, BR-3R.

*Figure 4.25: Frame BR-3R at the end of testing (2.5% lateral drift)*

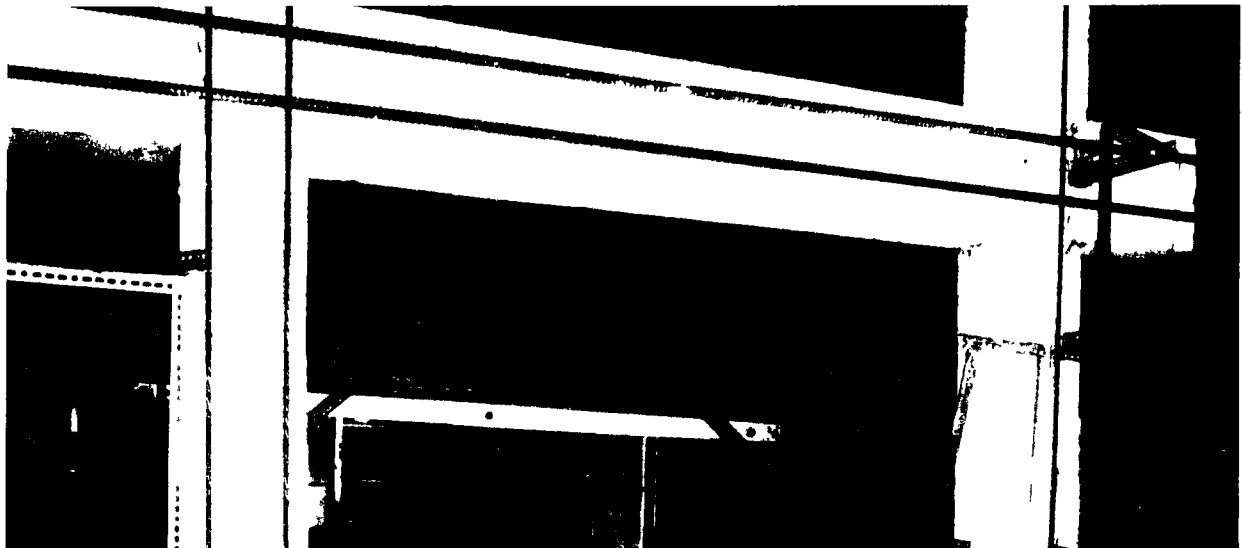
*Figure 4.26: Flexural and shear cracks in the columns and beam of BR-3R (2.5% lateral drift)*

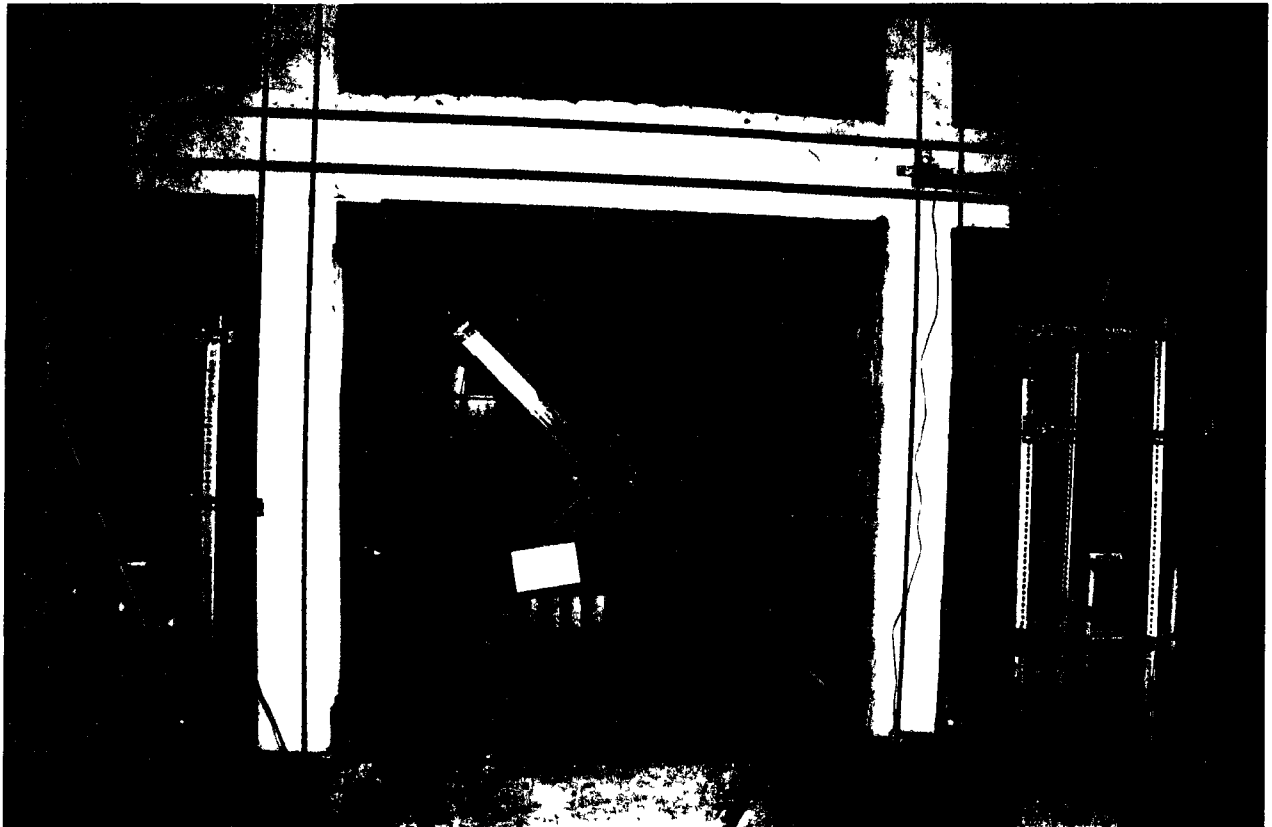
After the first load cycle to 0.05% lateral drift (1 mm), no new cracks were visible. Figure 4.35 shows BL-3R after the first load cycle. All the cracks marked on the frame at this point were pre-existing. In the positive direction, the peak load was 46.9 kN, the out-of-plane displacement was 0.52 mm, the column base anchorage slip measured -0.13 mm, the vertical displacement of the column was -0.04 mm, the strain in Gauge X3 measured  $-40 \mu\epsilon$ , and the strain in Gauge X6 measured  $-4 \mu\epsilon$ . In the negative direction, the peak load was -13.9 kN, the out-of-plane displacement was -0.17 mm, the column base anchorage slip measured 0.12 mm, the vertical displacement of the column was -0.06 mm, the strain in Gauge X3 measured  $12 \mu\epsilon$ , and the strain in Gauge X6 measured  $-2 \mu\epsilon$ .

*Figure 4.35: Frame BL-3R after the first load cycle to 0.05% lateral drift*

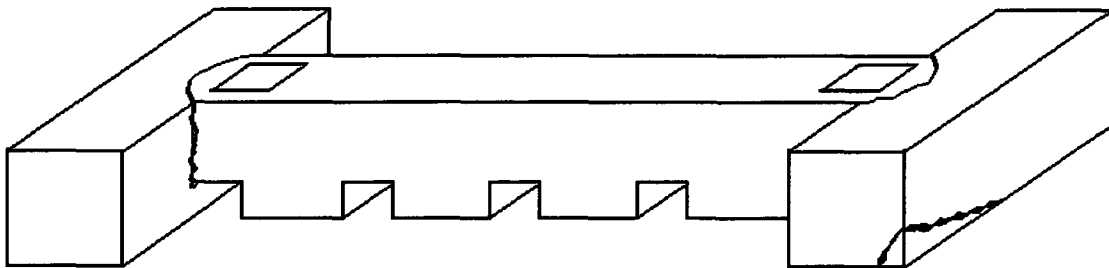
During the ninth load cycle, the imposed drift was 0.5% (10 mm) rather than 0.45% (9 mm) in the negative direction. This was the result of a problem encountered during the first repetition of loading at this drift level in the positive direction. The frame was accidentally pushed to 1.00% lateral drift (20 mm). Due to this jump in load, the foundation cracked in several places. Figure 4.42 provides a schematic of the cracks in the foundation, while Figure 4.43 provides photos of the cracking. The cracking in the foundation is denoted by the red lines. Beyond this load stage, the imposed drift in the negative direction continued to follow the initial loading protocol. In the positive direction, the frame was subjected to drifts exceeding 1.00% as given in the load-displacement response in Figure 4.29. The intent was to determine the maximum load and displacement capacity in the positive direction. The data collected beyond this point in the pushing (positive) direction was erratic due to the damage sustained in the foundation.

*Figure 4.42: Schematic representation of the cracking in the foundation in BL-3R (0.50% lateral drift)*

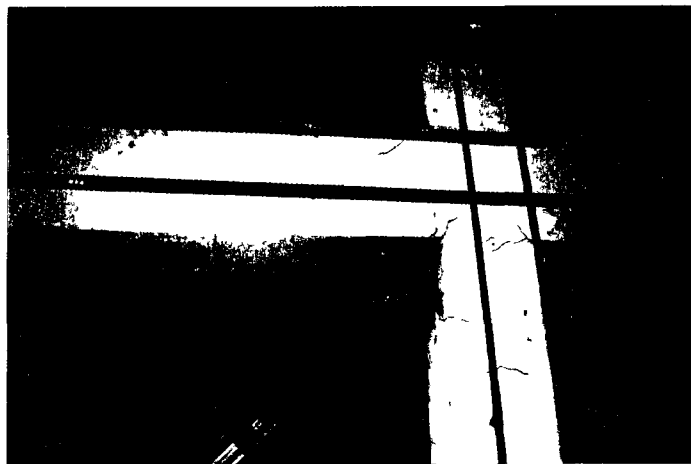
Most of the cracks on the frame after this load cycle were small and less than 1 mm in width. New shear cracks were evident in the top corners of the frame as illustrated in Figures 4.44 to 4.46. Pre-existing shear cracks in the beam are also evident in Figure 4.44 and pre-existing flexural cracks in the columns as shown in Figure 4.47 reopened. When the frame was displaced 20 mm in the positive direction, the peak load was 482.8 kN, the out-of-plane displacement was 7.32 mm, the column base anchorage slip measured -1.00 mm, the vertical displacement of the column was -0.39 mm, the strain in Gauge X3 measured -1142  $\mu\epsilon$ , and the strain in Gauge X6 measured -84  $\mu\epsilon$ . When the frame displaced 10 mm in the negative direction, the peak load was -301.3 kN, the out-of-plane displacement was 0.63 mm, the column base anchorage slip measured 1.22 mm, the vertical displacement of the column was 0.29 mm, the strain in Gauge X3 measured -309  $\mu\epsilon$ , and the strain in Gauge X6 measured -706  $\mu\epsilon$ .

*Figure 4.45: Back of the top left corner in BL-3R (0.5% lateral drift)*

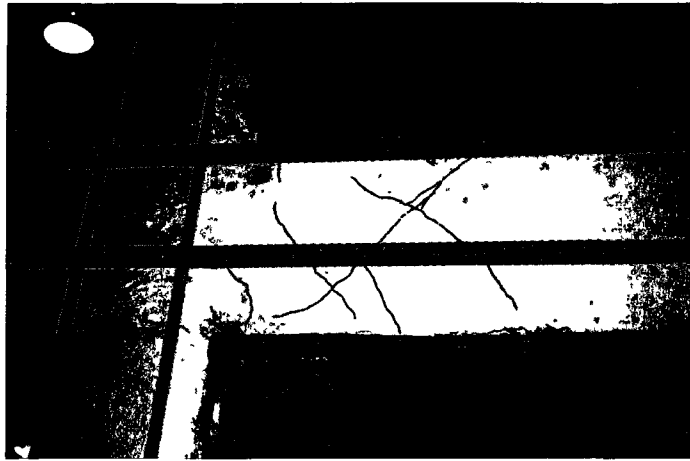
*Figure 4.46: Back top right corner in BL-3R (0.5% lateral drift)*

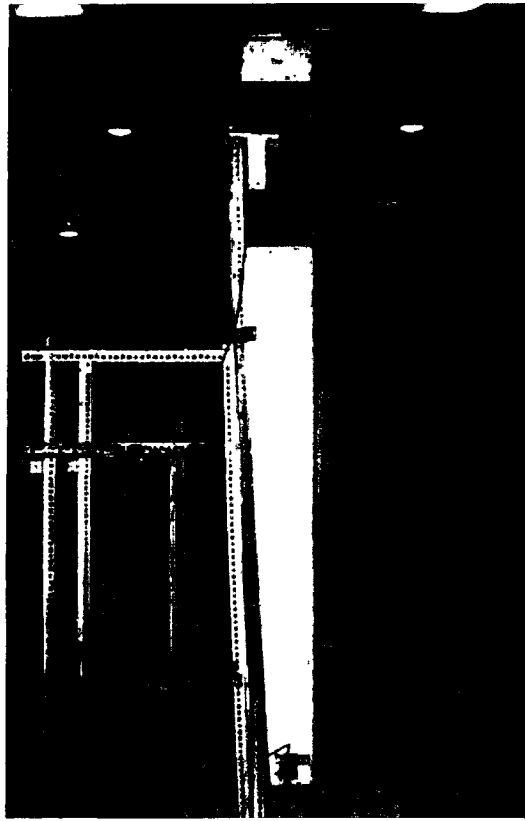
The final load cycle was the eleventh after displacing to a drift of 0.60% (12 mm). The first displacement was in the negative direction. When the frame was displaced in the positive direction, the response indicated significant out-of-plane twisting. The frame behavior was controlled by the out-of-plane response. The out-of-plane displacements of the frame are evident in Figure 4.50. Figure 4.32 also demonstrates that the out-of-plane displacement was greater than the LVDT could measure. After having completed the three-12 mm cycles in the negative direction, the frame was then displaced in the negative direction to failure, which occurred in the foundation as depicted in Figures 4.54 and 4.55. The last loading was intended to determine the maximum capacity of the retrofitted frame and to determine the mode of failure. There were no visible signs that the steel frame reached its load carrying capacity (Figure 4.53). This was also evident in the recorded strains of the steel braces. The largest strain measured was less than  $-3300 \mu\epsilon$ , which is significantly less than the strain ( $7000 \mu\epsilon$ ) corresponding to the yielding strength determined from coupon samples. Figure 4.51 shows vertical cracks formed at the base of the left column due to the out-of-plane displacements during the last loading in the positive direction. The top of the left column also cracked during the same displacement (Figure 4.51). Additional spalling occurred at the back top right corner as illustrated in Figure 4.52, which also shows an increase

Figure 4.50: Out-of-plane twisting of BL-3R (0.60% lateral drift)

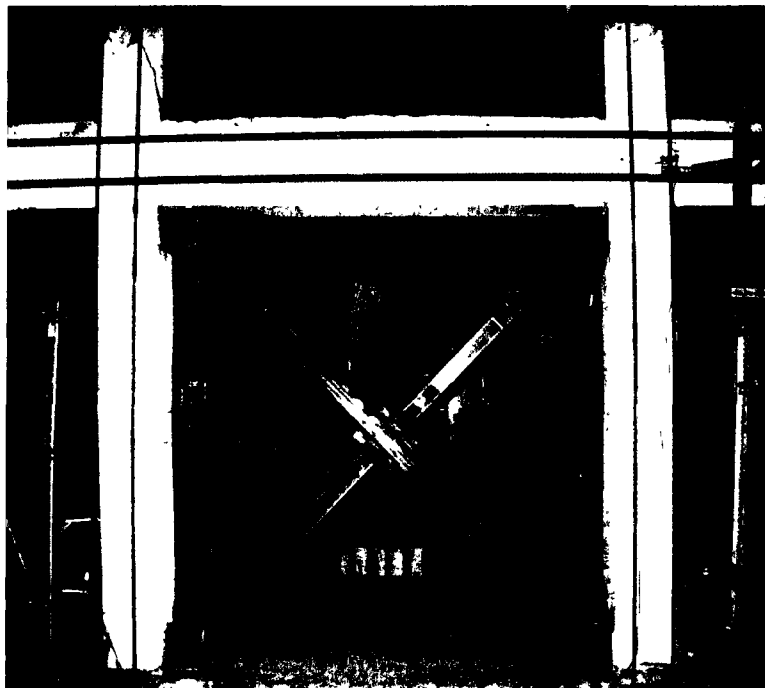
Figure 4.51: Cracking in BL-3R (0.60% lateral drift)

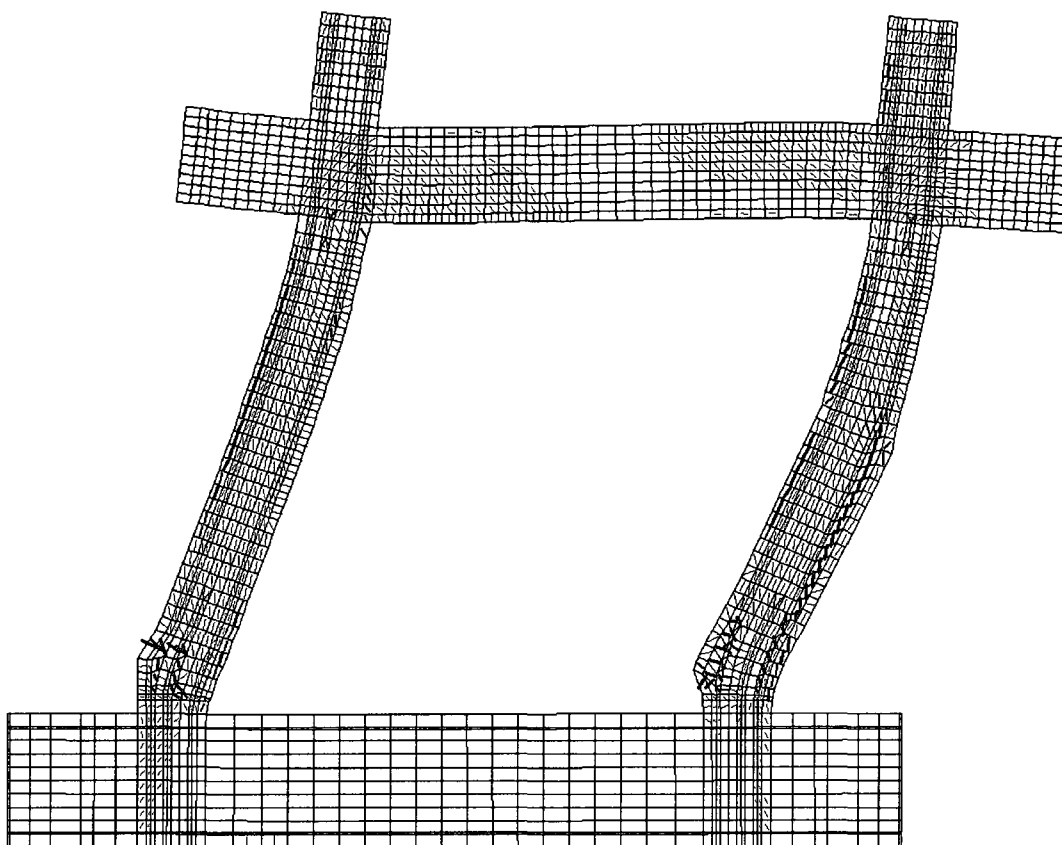
*Figure 5.7: Predicted failure condition of the repaired frame*

As observed in Figure 5.7, the predicted failure mode of the repaired frame was controlled by the columns at the base of the frame. Peak loads of -150.1 kN and 151.7 kN were sustained during loading to 1.00% lateral drift (20 mm). The up-lift of the column was approximately 1.80 mm at this drift level. The final load cycle was 1.75% lateral drift (35 mm). After having displaced to 38.7 mm, the lateral load dropped more than 50% of the peak load to 57.8 kN.
