INVESTIGATION OF BEARING CAPACITY OF THIN  
WALL RIBBED REINFORCED CONCRETE  
PANELS

A THESIS

Civil Engineering

Concordia University

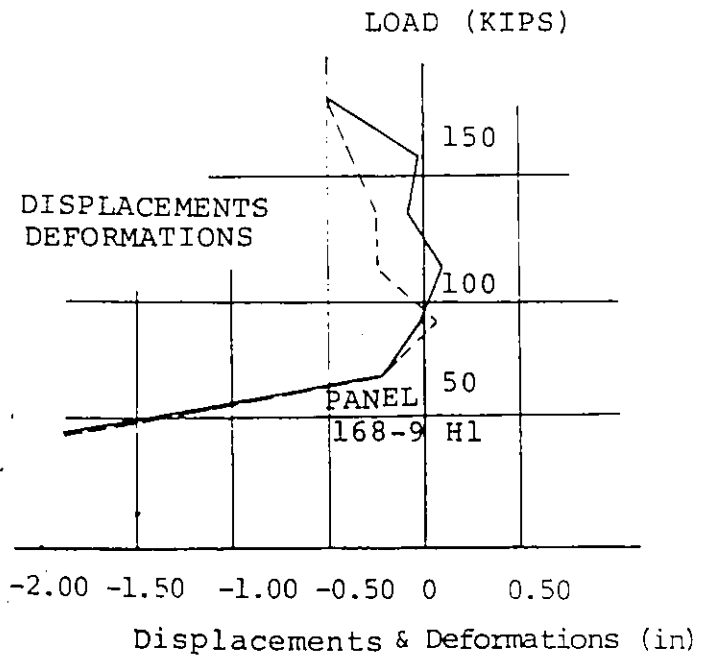
Fig. 3.2 : Horizontal Displacements and Deformations of

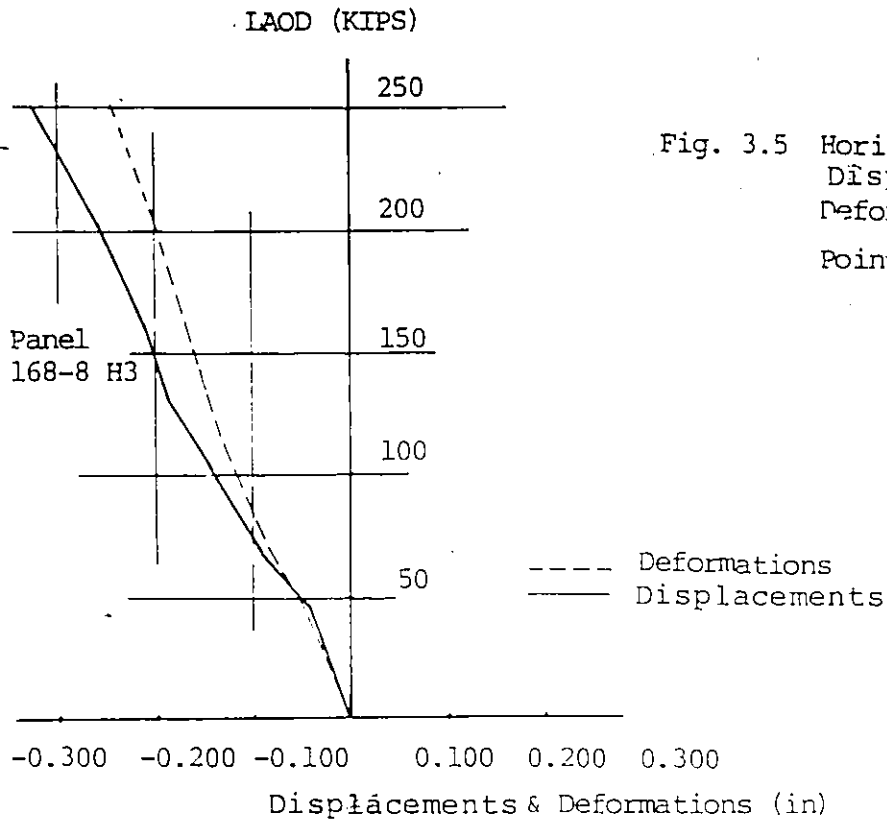
Fig. 3.5 Horizontal Displacements and Deformation of Point C<sub>3</sub>.

Fig. 3.6 Horizontal Displacements Deformation of Point C<sub>3</sub>.

Heavier reinforced panels failed at higher loads. Panels containing internal cross ribs (stiffening ribs), developed pronounced separation of cross ribs from the wall membrane and most of the failures occurred around the ribs. Two such panels tested showed similar horizontal displacements and deformations as can be seen in Figs. 3.4, 3.6-7, 3.10-11.
